Workington including Barepot and Camerton

S.19 Flood Investigation Report

Flood Event 5-7th December 2015

This flood investigation report has been produced by the Environment Agency as a key Risk Management Authority under Section 19 of the Flood and Water Management Act 2010 in partnership with Cumbria County Council as Lead Local Flood Authority.

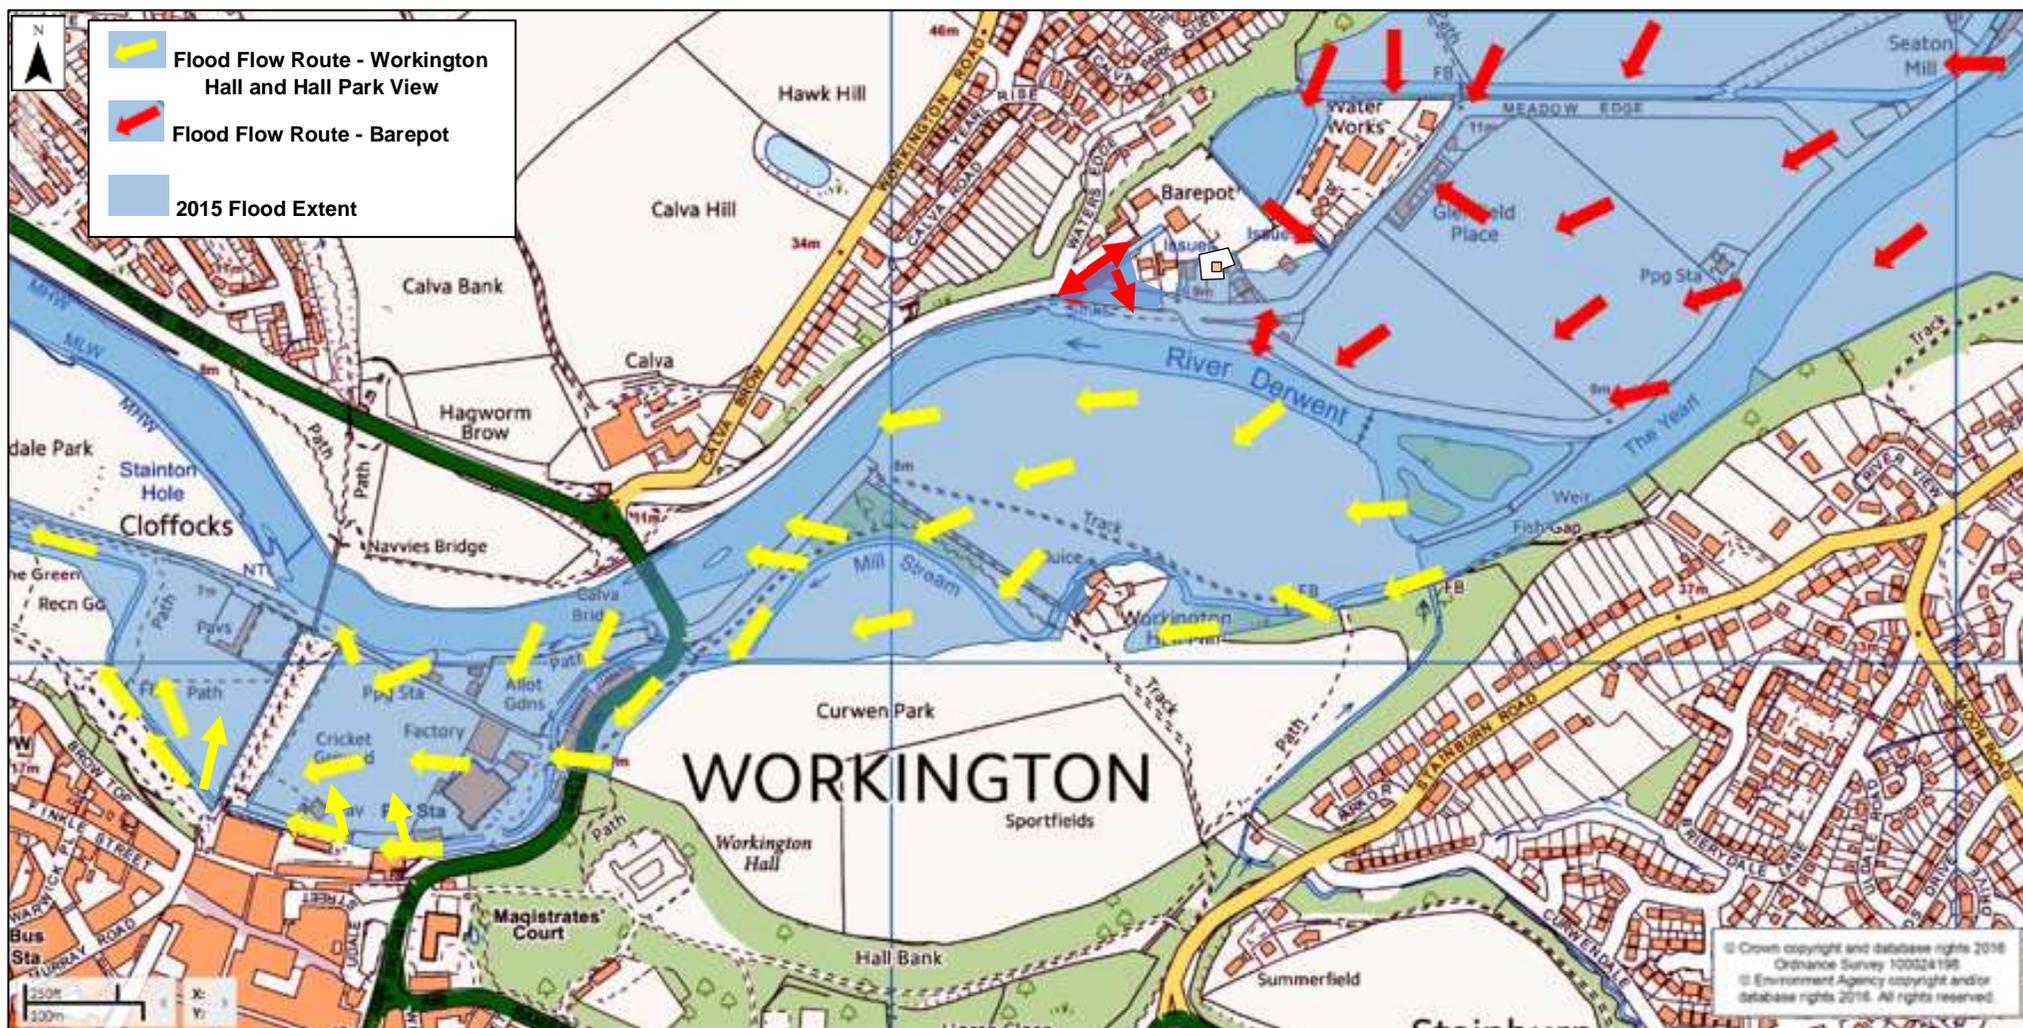
Figure 9: Overview of flow routes over Barepot, Workington Hall Park and Hall Park View

There were a number of flooding flow routes during the event, shown in **Figure 9**. The details of these flow routes, and the flooding within each of the identified areas including the upstream areas of Seaton Mill and Camerton, is discussed in the following sections.

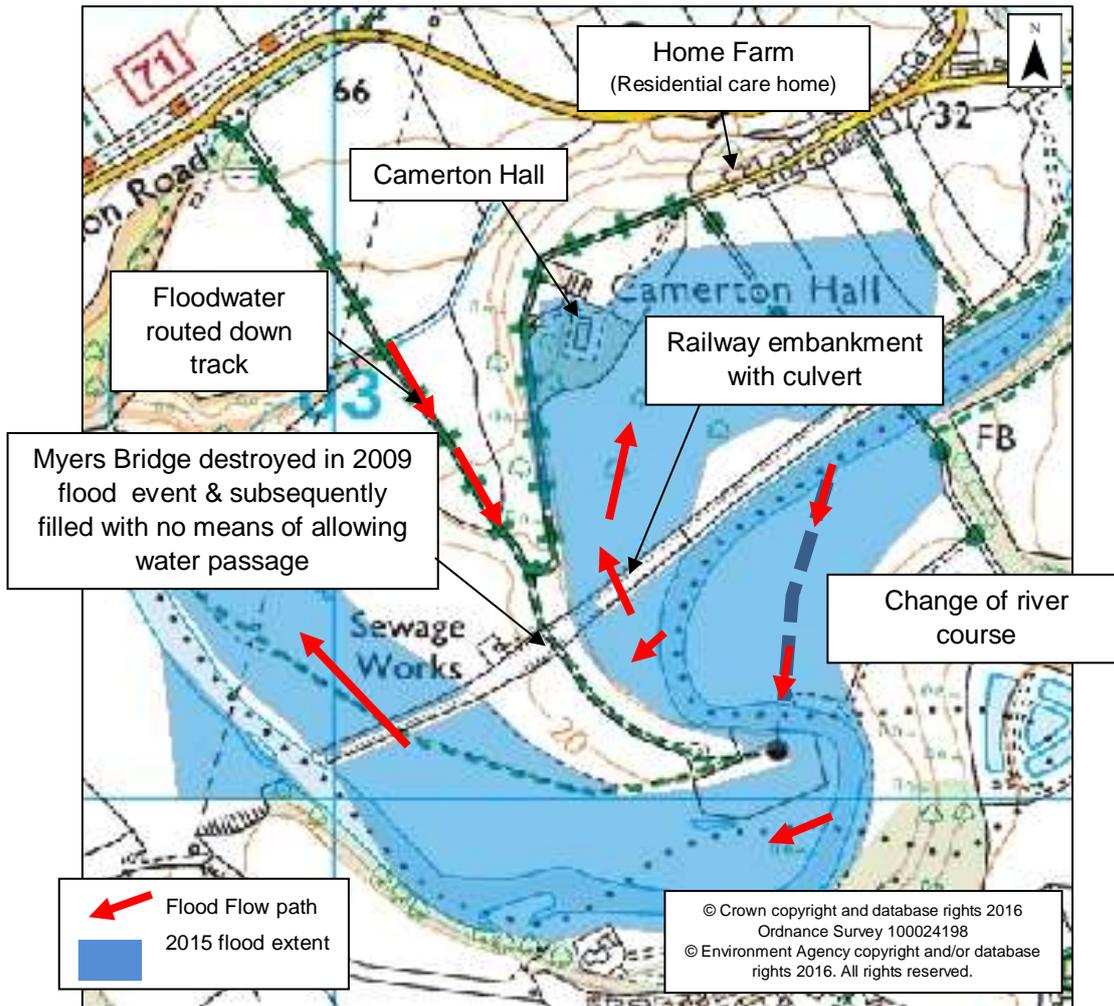
Figure 10: Camerton Hall Flooding Mechanisms

Camerton Hall, a Grade II listed property/business venue located approximately 4km upstream of Workington was flooded as a result of Storm Desmond, **Figure 10**. Camerton Cottage courtyard flooded up to door thresholds but water did not enter the property. During the 2009 event, six properties flooded in this location including Home Farm Care Home.

- Flood water passing through an open culvert through the railway embankment and converging with water flowing from the road coming down from Ivy Lodge onto already saturated ground
- The River Derwent overtopping its banks and rising some 0.75 metres above the lowest point of the railway embankment in the vicinity of Myers Bridge

- Surface water run off down the unnamed road from Ivy Lodge which failed to flow into the road drainage ditch and subsequently flowed to the lowest section being the field between the railway embankment and Camerton Hall
- Following the collapse of Myers Bridge in the November 2009 flood event, no means of allowing water passage e.g. pipework/culvert was fitted during the reconstruction of the road. As a result, flood water had no means of escape from the field adjoining Camerton Hall causing flood water to levels to be higher 100mm back up considerably. **Figure 10** and **Photograph 1**.

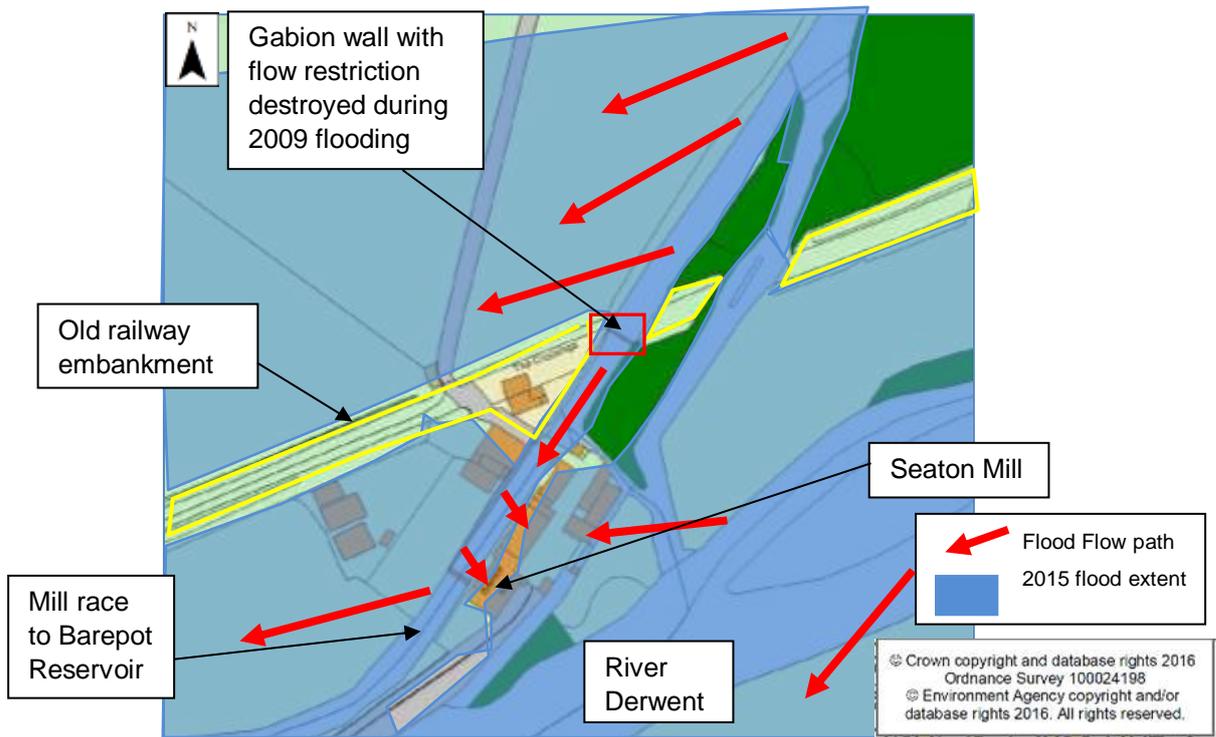
Figure 11: Seaton Mill Flooding Mechanisms

Seaton Mill has flowing water on both sides of the property, see **Figure 11**. The River Derwent flows to the front of the buildings, with the mill race to Barepot Reservoir flowing to the rear. The mill race is approximately 2-3m higher than the river. During the 2009 flood event, a wall on the mill race was washed away, leaving the flow to Barepot reservoir uncontrolled and governed wholly by the water levels on the River Derwent upstream. During 2015, a structure was constructed in the channel, designed to replace what was destroyed during the 2009 flood event. During very high river levels, the structure can be outflanked and floodwater can cross the fields to re-enter the mill race and reservoir downstream.

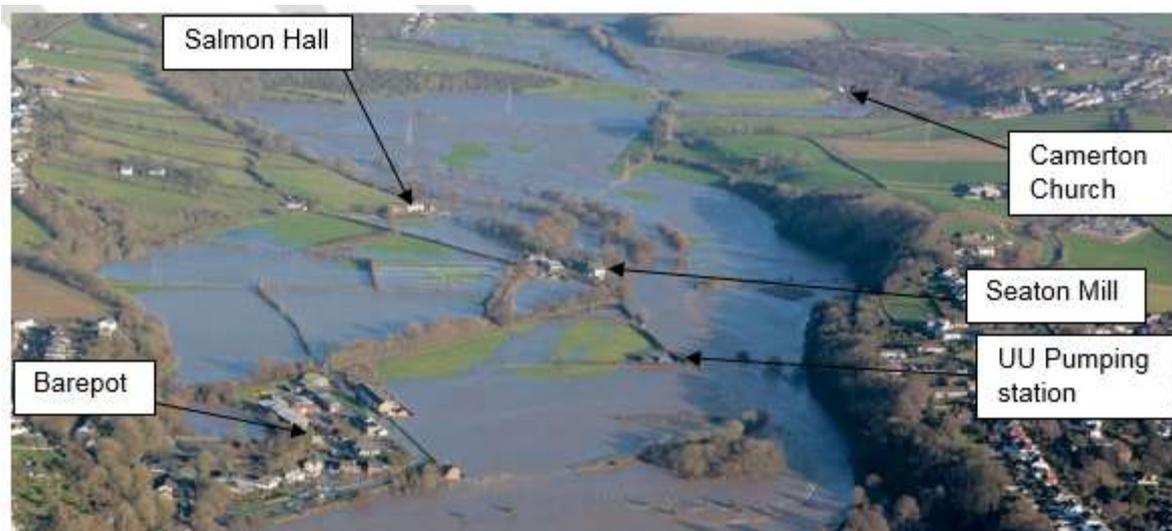
Photograph 2: Seaton Mill

The 2015 flood event resulted in water overtopping from the mill race to join floodwaters from the River Derwent in the front yard of Seaton Mill, **Photograph 2**. Personal property protection measures were used to keep the majority of the water out of the buildings.

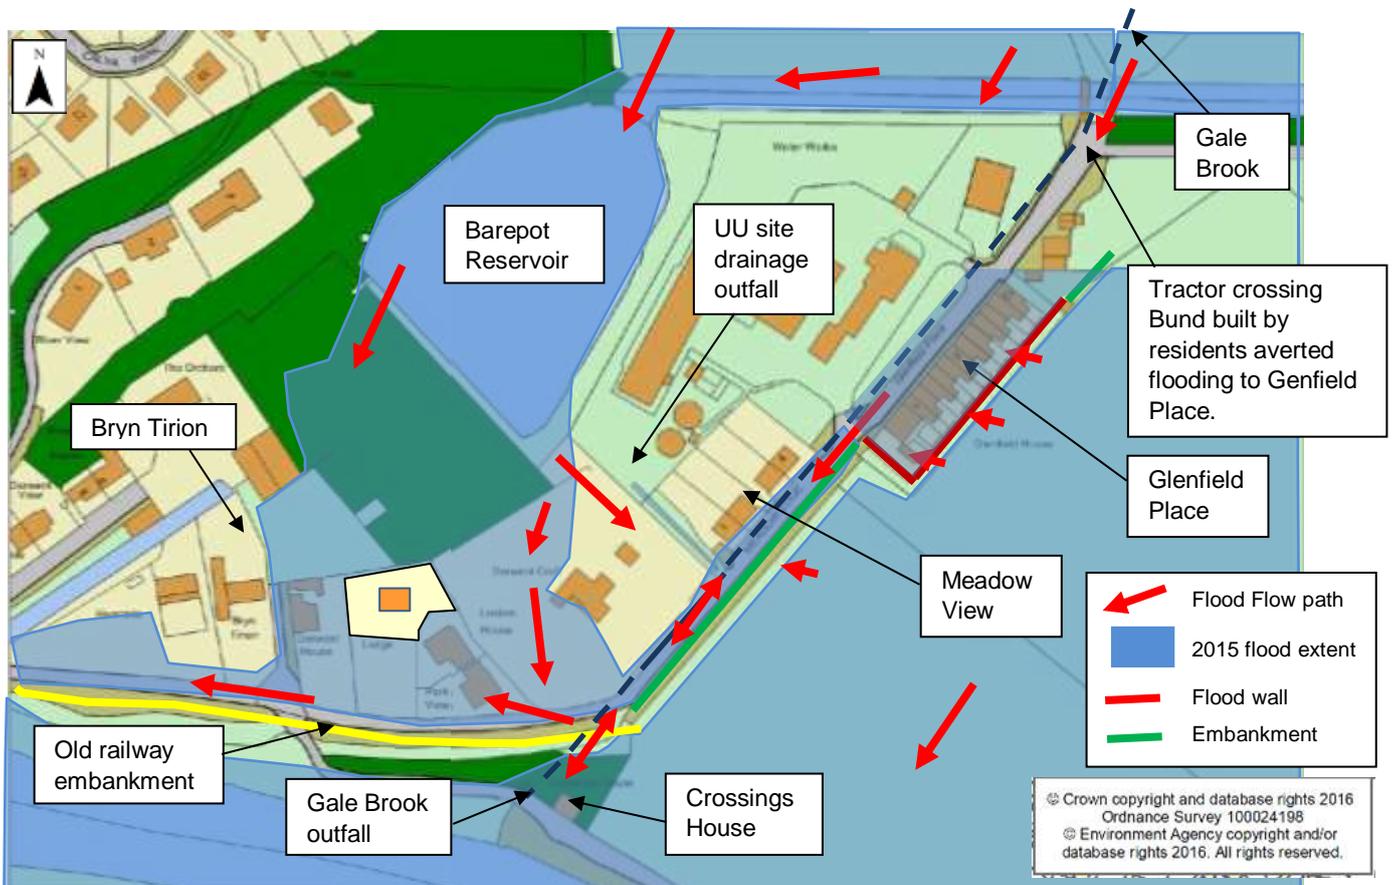
Figure 12: Barepot Flooding Mechanisms

- Gale Brook is fed from the fields north east of Barepot. These fields became flooded from the River Derwent which flowed into Gale Brook. The outfall to Gale Brook was impeded by the rising River Derwent. A post event CCTV survey was conducted in 2015 identifying defects within sections of the culvert. Reports have been submitted identifying that the defects contribute directly to the flooding of at least 3 properties.

- The flow across the fields to the North of Barepot entered the reservoir and mill race. The work to deculvert, carried out below Barepot Reservoir in 2014, contained the majority of this flow although some flow overtopped, again adding to the flooding impact in Barepot, see **Photographs 5 and 6**. Flood waters also leaked through the reservoir wall. See **Photograph 7**. Flood water also overtopped the reservoir earth embankment at the southern extent of the reservoir. This embankment is approximately 500mm below the level of the reservoir wall at the tie in point. The only drain for this floodwater was the already inundated Gale Brook.

- The overland flows from the fields also crossed over the mill race at the tractor crossing, see **Photograph 8**, and flowed down the road past Glenfield Place. The quick actions of residents constructing a bund across the tractor crossing prevented more serious flooding.
- Personal property protection measures were used by residents, and this helped to keep floodwater out of some properties.

The wrack mark surveyed following the event on the river side of the embankment was 9.3m AOD.

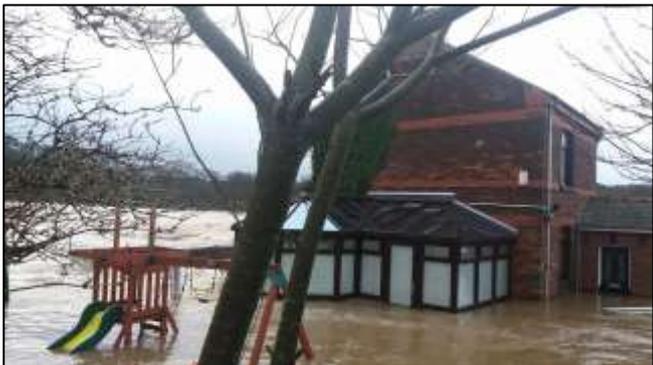
Photograph 4: Flooding at Crossings House

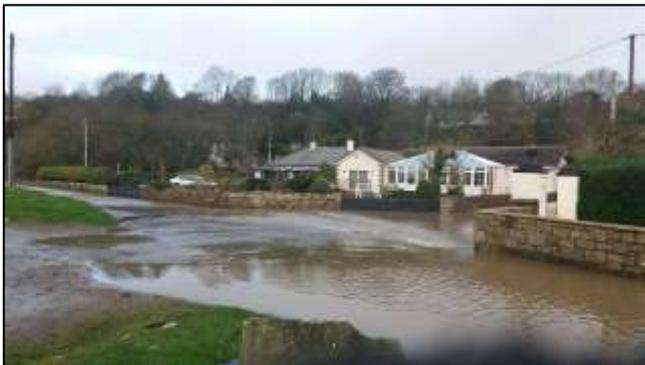
Photograph 5: Flooding outside Bryn Tiron

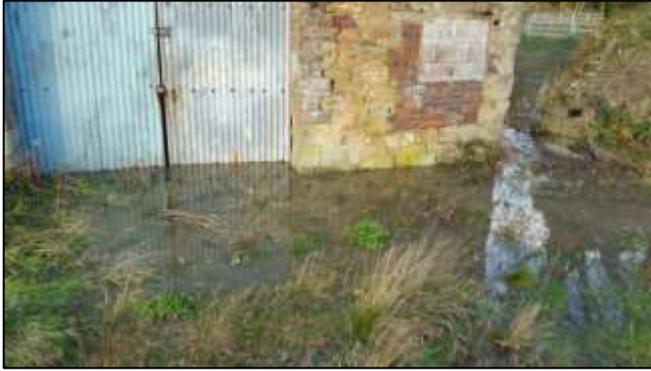
Photograph 6: Overland flow from Barepot Reservoir

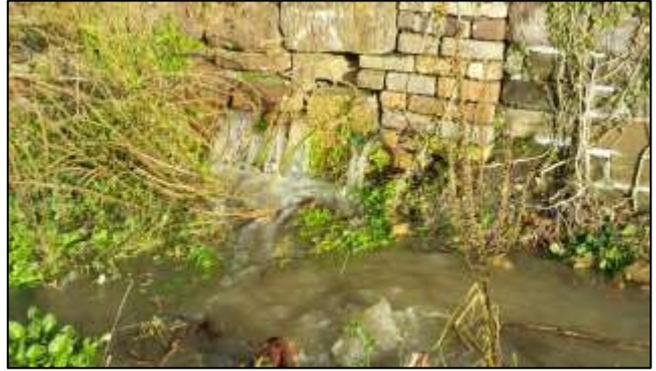
Photograph 7: Barepot Reservoir wall leaking

The flood defence embankment and wall reduce the risk of flooding to properties in the Barepot area. During the December 2015 floods there was some leakage observed through these two structures. As part of the Environment Agency's recovery programme, measures have been taken to prevent leakage along with further work to reduce flood risk for the community (shown in the plan overleaf). This work is scheduled to be completed in March 2017, with ground reinstatement being carried out in the spring growing season.

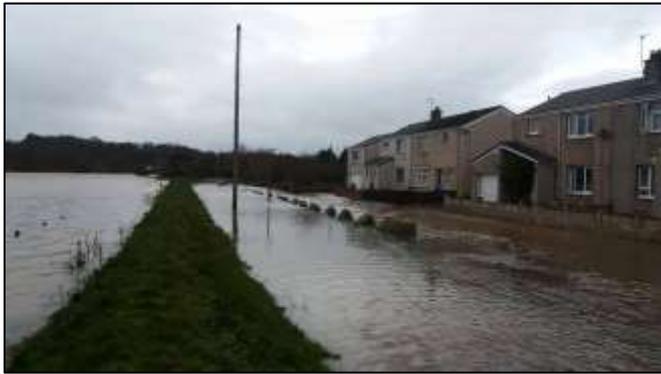
Photograph 8: Meadow Edge and Flood Bank

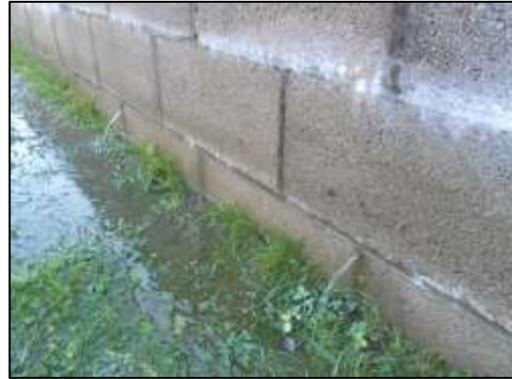
Photograph 9: Wall to rear of Glenfield Place

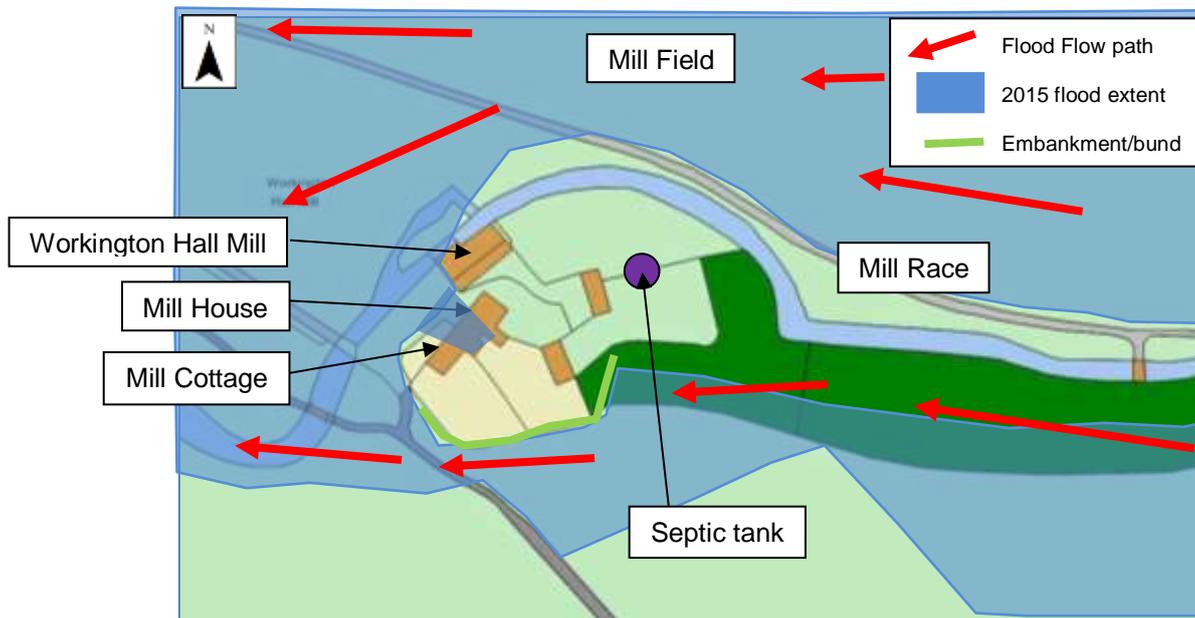
Figure 13: Workington Hall Mill flooding mechanisms

Workington Hall Mill consists of three residential properties built on raised ground in the middle of Workington Hall Park, see **Figure 13**. Mill Field lies to the north, making up the flood plain of the River Derwent which is just beyond, **Photograph 10**. The mill race is fed from the Yearl Weir on the River Derwent. The Workington Hall Mill buildings flooded in 2009. Following this 2009 event, a small bund was constructed to protect the properties. In addition to this, residents also installed personal property protection measures. Some water was seen to flow through the yard of the Mill which is suspected to be back flow, overflowing from the septic tank.

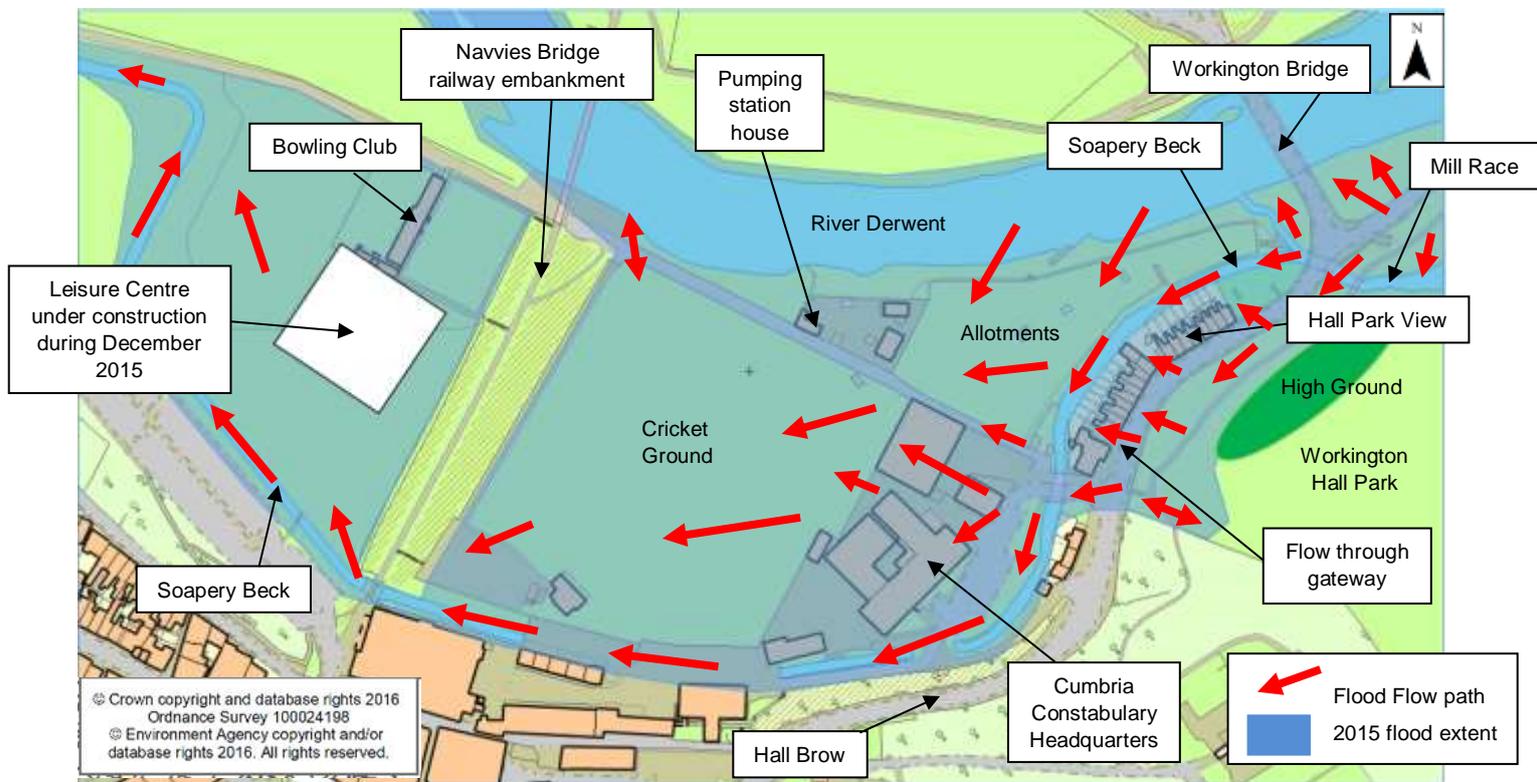
Figure 14: Hall Park View including Workington Cricket ground and Cumbria Constabulary flooding mechanisms

The area of flooding at Hall Park View is similar to that of the 2009 event. In the Hall Park View area 32 properties, 28 residential, the Cumbria Constabulary West Area Headquarters, the Cricket Club and Bowling club all experienced internal flooding. Floodwaters from the River Derwent filled Mill Field and then flowed overland to surround Workington Hall Mill, finally overwhelming the mill race downstream of the Mill to Hall Park View, see **Figure 14**.

At Hall Park View, the mill race flows under the road and becomes Soapery Beck. The bridge over this section had insufficient capacity during the 2015 event. Flood waters passing across Hall Park View overwhelmed Soapery Beck, and flowed overland through the allotments and through the Police Station into the Cricket Ground, **Photograph 11**. Soapery Beck assists in draining the area but has limited capacity and bridge obstructions, which cause the water to flow out of the channel when the capacity is exceeded.

The River Derwent flooded through Hall Park View for over 48 hours before the water level started to recede. Property numbers 1-5 Hall Brow, are built into the hillside with their basements at ground level at the rear, and first floor at ground level at the front. In these properties the basements flooded from Soapery Beck at the rear. Additionally, property numbers 1 & 2 were reported to have flooded prior to the main flooding event, on the night of the 3rd/4th December due to the intense rainfall impacting surface water drains.

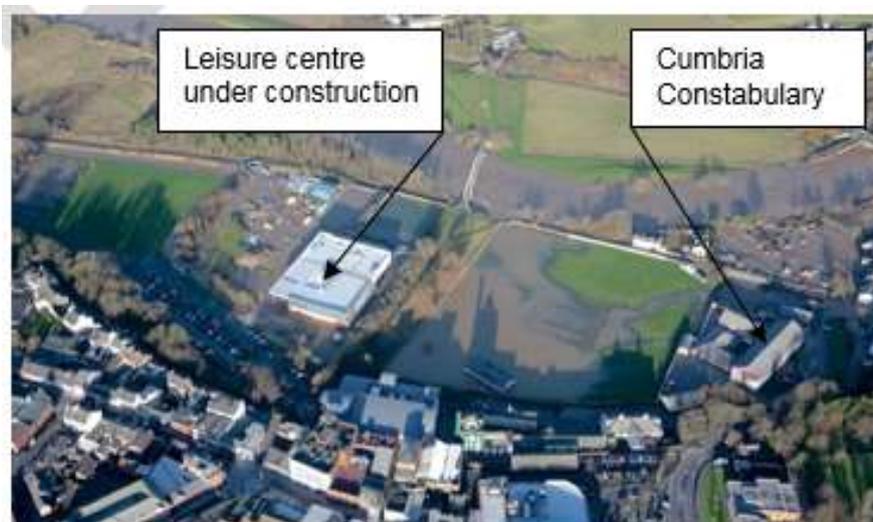
Photograph 12: Cricket Ground / Cumbria Constabulary
Photograph provided by Peter Smith Photography. Taken 06/12/2015 12:45

The Leisure Centre, under construction during December 2015, is divided from the cricket ground by the old railway embankment leading to Navvies Bridge, **Photograph 12**. Contractors thoroughly inspected the Leisure Centre site, and established that it did not receive any overflow of water from the River Derwent. Floodwater from the Soapery Beck flowed towards the main entrance of the leisure centre, but did not enter the building.

The only areas of the Leisure Centre that were flooded were near places where the blockwork was incomplete to allow contractors access to different parts of the building. There was some water in the incomplete swimming pool area, which was still exposed to the elements as its windows had not yet been installed. In addition, part of the bund wall had not yet been built to its correct height. This meant that the water could enter that area.
