11e4 Maryport to Dubmill Point

(Technical report by Jacobs)

Policy area: 11e4 Maryport to Dubmill Point

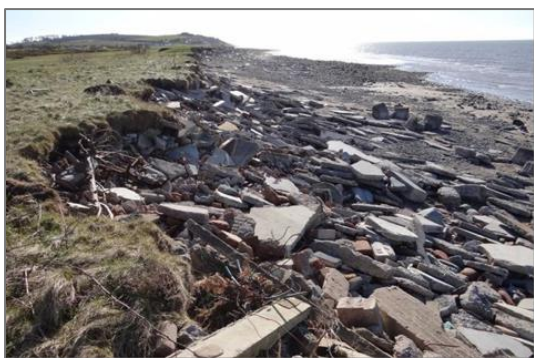
Figure 3 Tipped rubble along Maryport Golf Course. Photograph taken during CH2M (2017) asset inspection.

Here there are no formal defences, rubble has simply been tipped on the foreshore in an attempt to slow erosion. This is understood to have been in place as an informal rubble revetment prior to the SMP2 (Allerdale coastal inspections, 2008) although additional material was added to the coast in October 2012 (CEUK, 2014).

The most recent inspection in August 2017 (CH2M, 2017a) noted that there had been extensive cliffing along the edge of the Golf Course where rubble or rock revetment had thinned out, suggesting that the rubble has had some local influence on erosion.

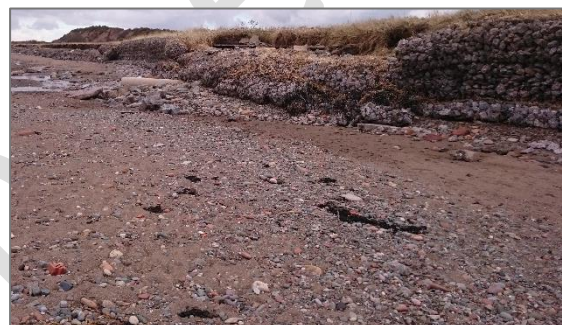
The gabions were installed prior to the SMP2 development to protect the public highway. By 2014 the gabions had been breached and the dunes were eroded in several places. The asset report concluded that gabions are generally not suitable in this location for exposure conditions experienced in winter 2013 and 2014 (CEUK, 2014).

Figure 4 February 2018 - gabion baskets along B5300 North of Maryport Golf Course.

Some recovery of the backing dunes has taken place since, but the gabions are periodically exposed. The latest formal inspection (August 2017; CH2M, 2017a) identified that there are locations where gabions are leaning towards foreshore and have the potential to collapse – here they can be considered to have failed. A site visit in February 2018 noted that there had been further damage to the gabions and backing dunes in the January 2018 storms.

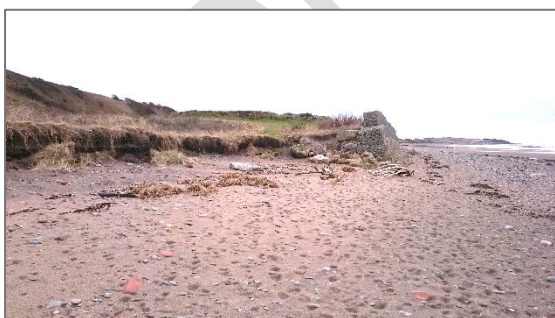
Figure 5 Erosion at northern end of gabion baskets at the Salt pans. Photograph taken during site visit in February 2018.

These gabions were installed prior to the SMP2 development (2008) to protect the Salt pans Scheduled Monument. At times the gabions have been covered by blown sand, but as a result of the 2013 and 2014 storms there was local damage where the gabions had become exposed along their toe with also some terminal erosion at both ends of the gabions (CEUK, 2014). Some recovery of the backing dunes has taken place since and in 2016 the damaged section of toe mattress was replaced and loose rock armour was placed at the northern end to help combat terminal erosion.

exposed more baskets but no damage was sustained. At the time of the latest inspection (August 2017; CH2M, 2017a) the gabion baskets were covered by dune vegetation.

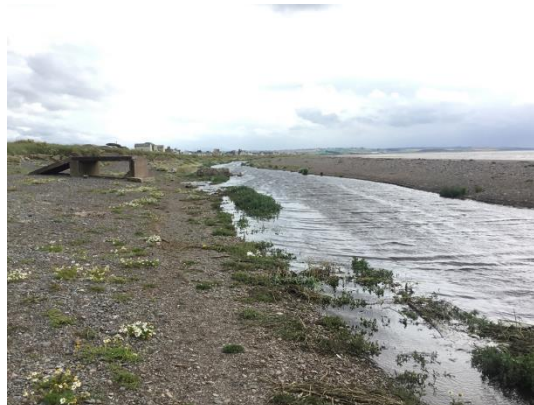
There are currently no formal defences, although beach maintenance works are occasionally carried out by the Environment Agency to remove shingle which might otherwise block discharge from the Allonby Beck.

Figure 6 Allonby frontage: the beck is diverted northwards by a shingle spit. Photograph taken during CH2M (2017) asset inspection.

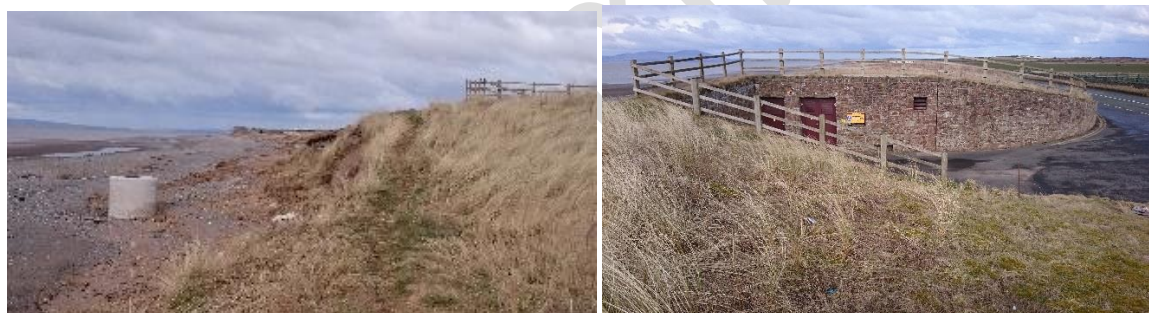
Although not formally defended there is a UU pumping station located in the eroding dunes south of Crossbeck along with several manholes in the adjacent beach. The erosion of these dunes has been raised as an issue by UU as the dune crest adjacent to their retaining wall is now less than 1 m.

Figure 7 United Utilities Pumping Station in eroded dune frontage south of Crossbeck. Photographs taken February 2018.

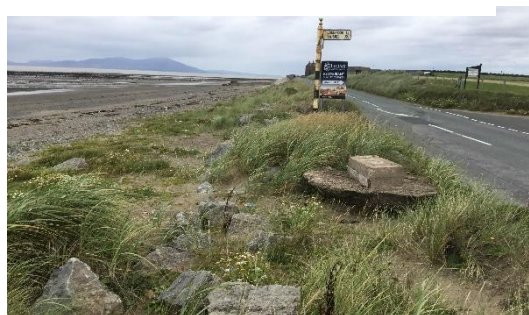
The rock armour provides protection to the edge of public highway. At times the structure has been buried by dunes, but at the time of the asset inspection in May 2010 it was noted that large sections of rock armour had collapsed (Capita Symonds, 2010, 2012).

There was erosion of the dunes during 2013 and 2014 storms and the armour became exposed, with further dune erosion recorded by April 2016. In response, some informal rocks were tipped along a section of highway to provide some emergency protection. No significant change in condition was noted in the latest (August 2017) asset inspection (CH2M, 2017a), but photographs indicate that some of this rock had become covered by beach material, although this was removed by the January 2018 storms, see Figure 8 and Figure 9

Figure 8 Allonby to Seacroft Farm showing proximity of the highway to the coast. Rock has been placed here to protect the road; occasionally this becomes partially buried by dunes. Photograph taken from CH2M (2017).

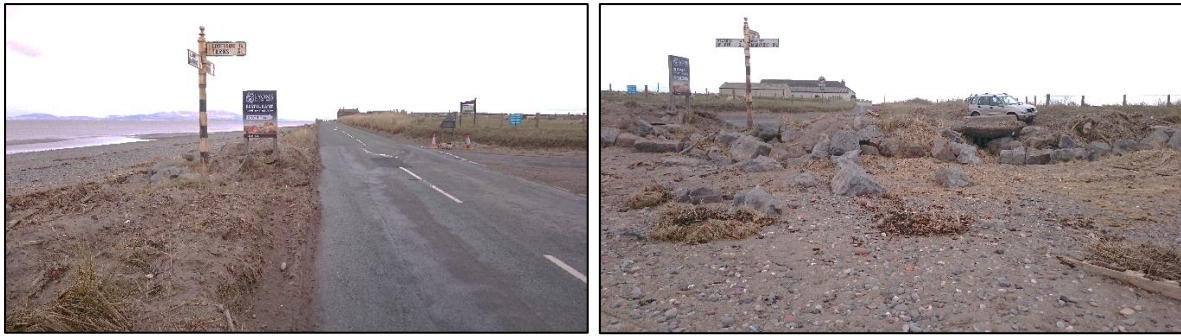
Figure 9 Allonby to Seacroft Farm showing proximity of the highway to the coast. Rock has been placed here to protect the road; occasionally this becomes partially buried by sand. Photograph taken February 2018.

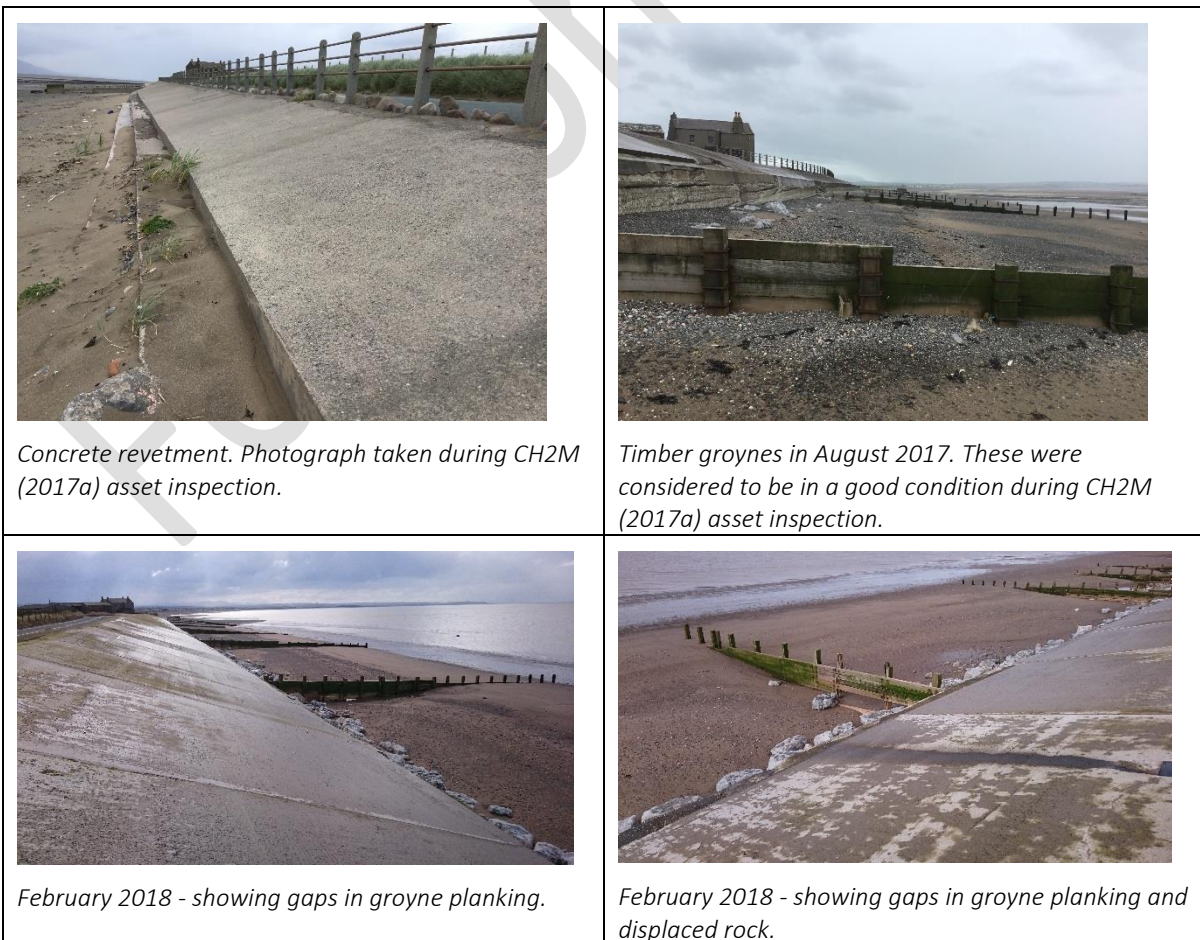
The sloping concrete or stepped revetment (Figure 10) predates the local authority asset inspections. Historical mapping indicates that the frontage has been defended since the 1920s. Rock armour was added in 2010 to combat erosion. CEUK (2014) records that the structure has seen numerous concrete remedial works, such as re-facing, and encasement of steps over many years. Although the structure is overall in reasonable condition, there are defects (CEUK, 2014). No significant damage was caused by the 2013 and 2014 storms, but it is believed that the frontage was overtopped (CEUK, 2014). New cracks were noted as being visible in sloping concrete revetment in the latest asset survey (August 2017; CH2M, 2017a). There are also timber groynes, which were considered to be in a Good condition during the August 2010 inspection; but no specific discussion of this is included in the Asset Inspection reports.

Concrete revetment. Photograph taken during CH2M (2017a) asset inspection.

Timber groynes in August 2017. These were considered to be in a good condition during CH2M (2017a) asset inspection.

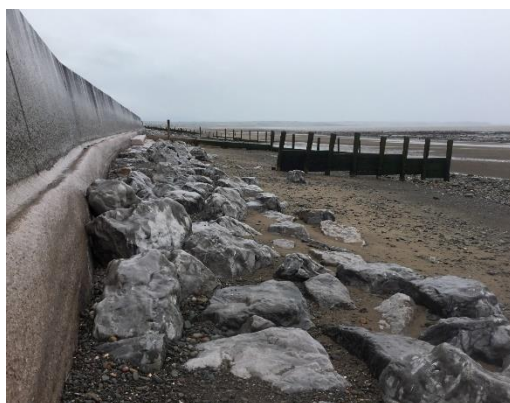
This is a continuation of the revetment to the south protecting the public highway. Rock armour was placed along the toe in 2010 to combat erosion, but this is apparently “randomly dumped” (CEUK, 2014). By 2012 the sloping upper facing was recorded as being in poor condition, with several defects evident (CEUK, 2014). Further damage was caused to the structure during the 2013 and 2014 storms, when some overtopping is believed to have occurred.

In 2015 and 2016, new concrete overlays were constructed to the upper sections of the defences, but the inspection at the time recommended toe encasement was required along the southern part (CEUK, 2015). Since completion of works in 2016, there has been no further deterioration noted (CEUK, 2015; 2016; CH2M, 2017a) (Figure 11, Figure 12).

It has been noted (CEUK, 2016) that the vulnerability of the structure is dependent on maintenance of beach levels, which current timber groyne arrangements and condition does not provide. These groynes were considered to be in very poor or failed condition at the time. Repairs to the groyne planking are understood to have been undertaken in Autumn 2017, however these groynes are very exposed and suffer frequent damage and there were missing planks when the site was visited in February 2018.

Figure 11 Revetment and seawall at Dubmill Scar. Rock armour was placed along the toe in 2010. Photograph taken August 2017.

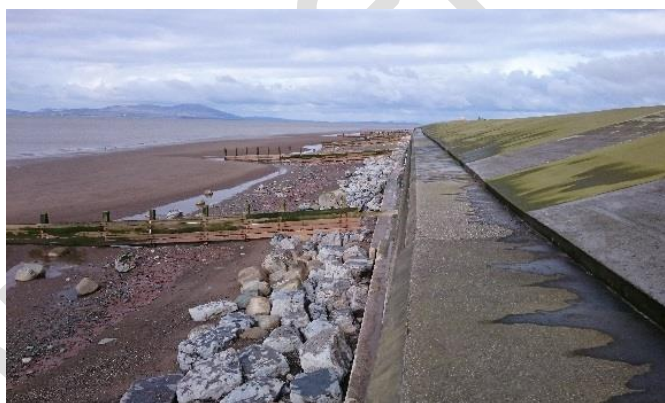
Figure 12 Revetment and seawall at Dubmill Scar. Rock armour was placed along the toe in 2010. Photograph taken February 2018.

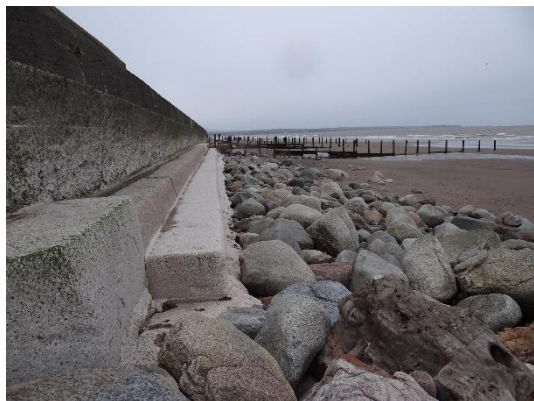
This is a continuation of the revetment to the south protecting the public highway (Figure 13, Figure 14). The sloping facing at the southern end was previously stepped revetment and was overlain with sloping concrete facing in 2012 (CEUK, 2013); the northern half of frontage having been previously similarly overlain (CEUK, 2012). Rock armour was placed along the toe in 2010 to combat erosion. At the time of the first asset inspection in 2010, the groynes were already in a very poor condition and it does not appear that any remedial works have been undertaken to address this.

There was damage caused to the upper sloping revetment due to the 2013 and 14 storms, when overtopping appears to have occurred. The latest asset inspection in 2017 (CH2M, 2017a) recorded that there was evidence of extensive cracking and movement of concrete wall adjacent to concrete revetment steps.

Figure 13 Seawall and beach North of Dubmill Scar. Rock armour was placed along the toe in 2010. Photograph taken during CEUK asset inspection (April 2016).

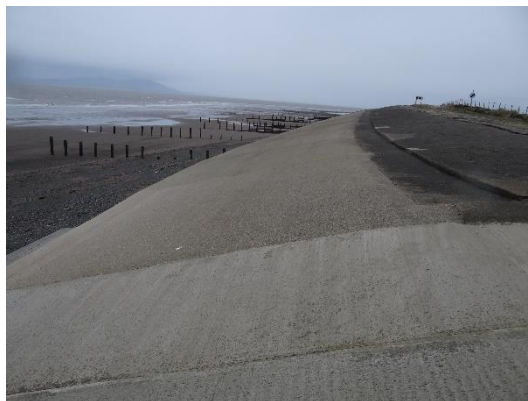
Figure 14 Upper revetment North of Dubmill Scar Photograph taken during CEUK asset inspection (April 2016).

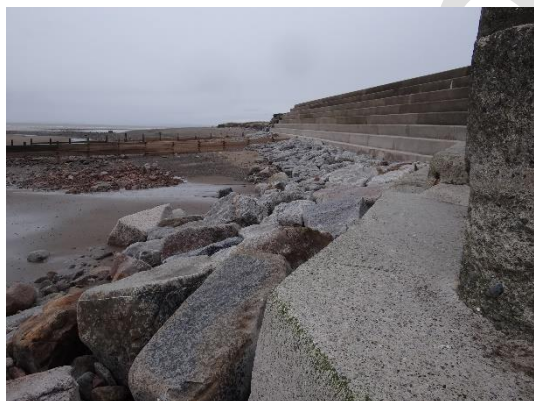
Along this stretch, the seawall is set back slightly and compared to the south, there is a change in defence form to stepped concrete wall with rock armour protection along crest (Figure 15, Figure 16). Rock armour was placed along the toe in 2010 to combat erosion. At the time of the asset inspection in 2010, the groynes were already in a very poor condition and it does not appear that any remedial works have been undertaken to address this.

There was some minor erosion of the fill behind the crest due to overtopping during the 2013 and 2014 storms (CEUK, 2014), but little change in the structure condition observed. The most recent asset inspection in 2017 (CH2M, 2017a) recorded evidence of hairline cracks but concluded that these are not having a major impact on the defence condition. The rock armour revetment was recorded as being in good condition.

Figure 15 Seawall and Beach South of Dubmill Point. Rock armour was placed along the toe in 2010. Photograph taken during CEUK asset inspection (April 2016).

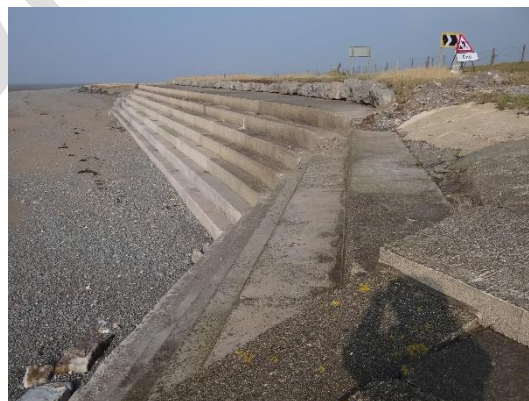
Figure 16 Crest of seawall South of Dubmill Point. Photograph taken during CEUK asset inspection (March 2015).

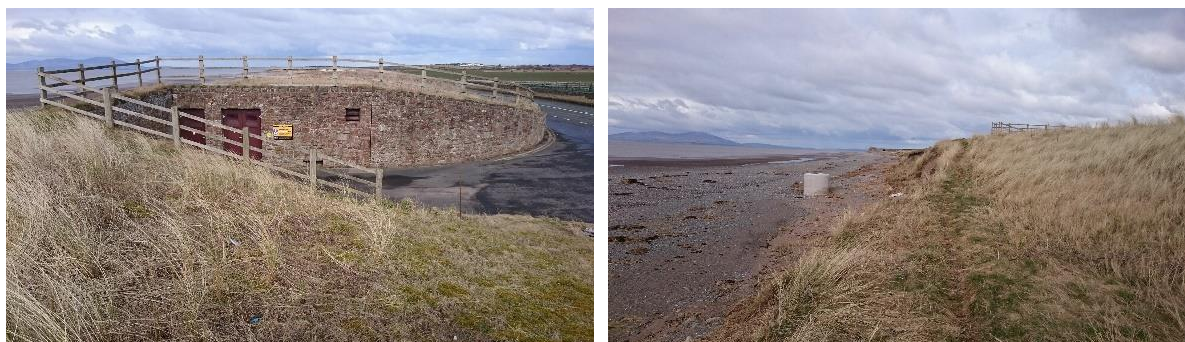
Figure 17 Allonby to Seacroft Farm, showing waste water treatment works (left) and undefended coast. Photos taken February 2018.

There is a United Utilities waste water treatment works located between the shoreline and the highway as shown in Figure 17. Following erosion since 2013 and 2014 the dune in front of the works has receded such that the dune face is now <5 m from the building (above right).

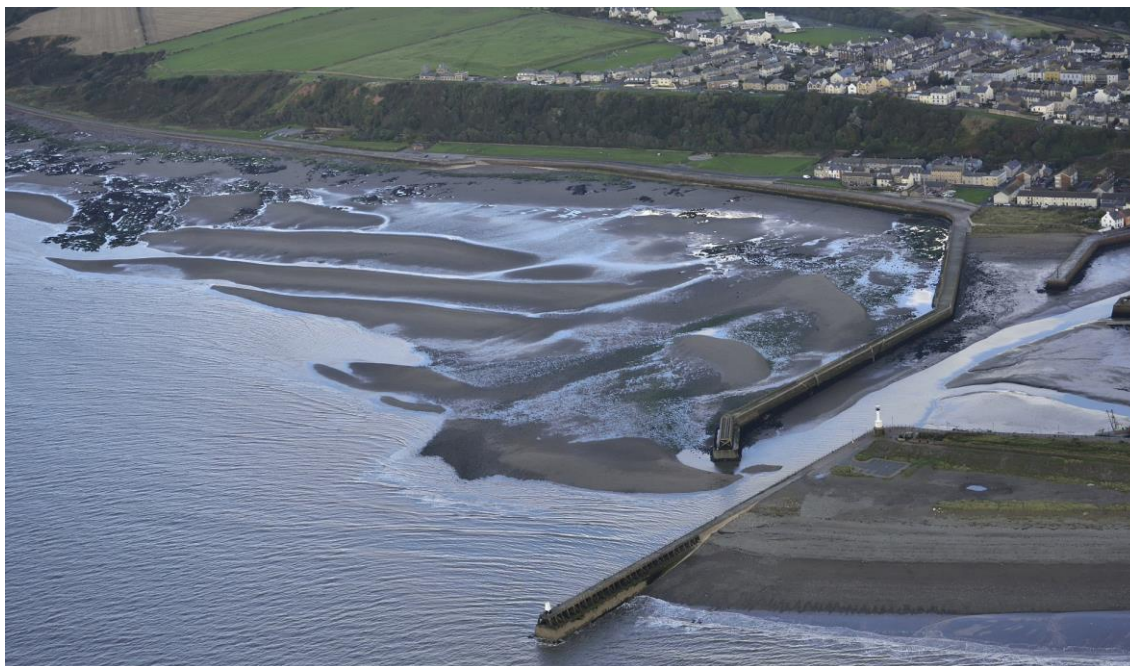
The beach is underlain by sandstone (see Figure 18), which outcrops in some locations. There is variable movement of sand around and over these outcrops resulting in changes in beach level over time, although there is currently no net change evident from the available data. Beach level dropped following construction of the seawall in the 1930s, but exposure of the resistant bedrock means no further drop is likely to occur, although the bedrock may suffer slow erosion and local fracturing due

Figure 18 Unit 11e4.1 - showing the harbour structures and seawall, which fronts a low-lying hinterland backed by cliffs. Prior to construction of defences in 1930s there had been large scale erosion of these cliffs. The beach is characterised by mainly sand, with outcrops of sandstone exposed in places. Photograph ©North West Regional Monitoring Programme.

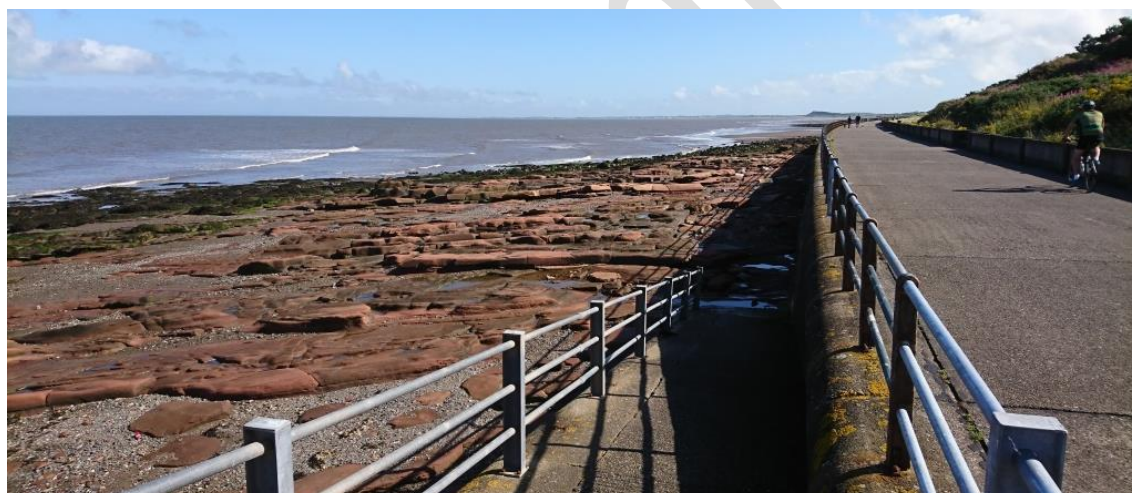
This structure is built over sandstone bedrock across much of its length. There are defects present along the length of asset on promenade and inner face, crest and outer face of concrete wall. Previously there have been repairs undertaken to the promenade surfacing (2014 and 2015) (CEUK, 2016). There is evidence that the structure has previously been overtopped (during 2013 and 2014 storms) (CEUK, 2014) and the promenade surface shows signs of cracking and slab settling which may indicate sand outwashing. Current condition is rated as Fair (CH2M, 2017a).

There is evidence from discolouring of the structure that beach levels along this frontage have dropped historically, following construction of the seawall in the 1930s, but exposure of the resistant bedrock means no significant further drop is likely to occur, although the bedrock may suffer slow erosion and fracturing due to abrasive and impact forces. No monitoring data has been collected along this section since 2014, but previous data showed no significant erosion of the bedrock (CH2M, 2017b).

Figure 19 Sandstone bedrock outcrop fronting seawall and cliffs. Photograph taken during CH2M (2017) asset inspection.
