11e3 Workington to Maryport

(Technical report by Jacobs)

Policy area: 11e3 Workington to Maryport

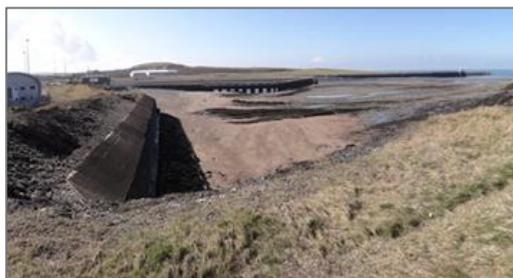
North of Workington Pier: vertical concrete seawall, rock revetment (30 m) – Port of Workington

Figure 3 North of Working Pier. Photograph taken during CH2M (2017a) asset inspection.

In 2012 the wall was identified to be in fair condition with some surface defects but not under any apparent distress. There have been no changes in structure or conditions since. Current maintenance is understood to be carried out by Port of Workington, which is owned and operated by Cumbria County Council. The Port Manager has advised that the rock armour was placed around 10 years ago to manage toe scour and raised concern about the condition of this defence and the associated risk to land adjacent to the port.

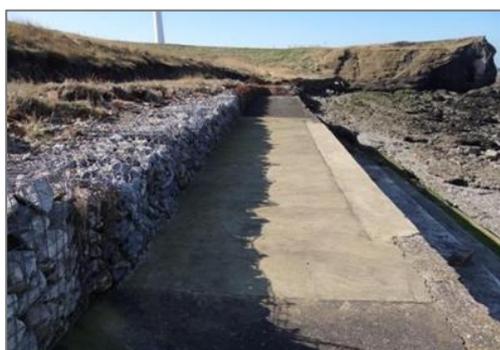
North Side 1: concrete sloping or stepped revetment and gabion wall (250 m) – Allerdale BC

Figure 4 North Side defences. Photograph taken during CH2M (2017a) asset inspection.

Deterioration of this asset has been ongoing since the first recorded inspection in 2010. Although some concrete repairs and replacement crest gabions have been carried out over time, the latest inspection records this as generally dilapidated and overall in poor condition. In 2016, some armour stone boulders were placed along the failed section near the southern end, although these were observed to be of 'limited value'.

The current defences pose a health and safety risk in respect of access due to the damage they have sustained.

Current management is to carry out remedial works and maintenance as required. Damaged gabions require replacement but a more robust construction e.g. rock armour with appropriate geotextile filter, may be too expensive to provide the short term fix required.

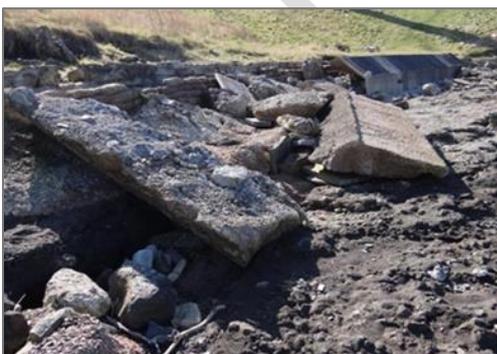
North Side 2: concrete sloping revetment and gabion wall (80 m) – Allerdale BC

Figure 5 North Side defences. Photograph taken during CH2M (2017a) asset inspection.

This section has been in poor condition since the first inspection carried out as part of the North West Regional Monitoring Programme, in 2010: precast slabs having broken away on sections of the face and apron and the concrete at the foot of the grass banking had eroded in large sections.

Further damage to the structure occurred in 2014 when the paving slab facings suffered significant damage in the middle of the frontage end, where the exposure is greatest due to lower beach levels, exposing a concrete filled sandbagged wall behind.

Although no worsening of conditions has been identified since, deposits behind the defences remain vulnerable to erosion. Current management is to monitor condition but to not actively maintain. Current requirements include the need for repairs to damaged sections to address health and safety risks.

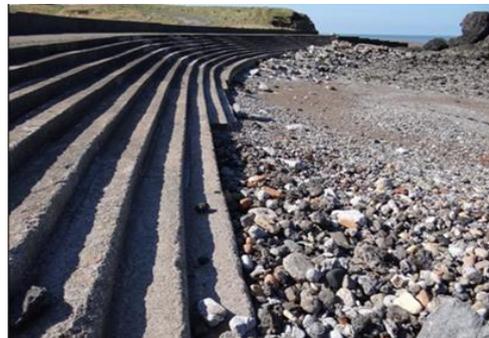
The defence has been considered to be in poor condition since 2015, with the groynes considered to be in poor condition since 2012. There has been no notable change in condition since.

Figure 6 Oldside stepped revetment. Photograph taken during CH2M (2017a) asset inspection.

Current management is to monitor condition and carry out remedial works as necessary. No specific outstanding actions identified as this length is in a better state than most of the other sections of wall.

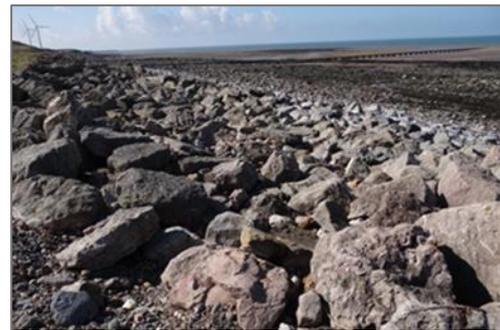
Lowca Lane: rock revetment (190 m) – Network Rail

Although in general this rock revetment is in good condition, approximately 50 m south of slipway, there has been localised disruption and overtopping of the armour, causing washout of the fill behind, noted in 2014. Asset inspection reports suggest that this was where the armour profile was deficient. Although no remedial works appear to have been carried out to this damage, there has been no observed change in condition since.

Figure 7 Rock revetment at Lowca Lane. Photograph taken during CH2M (2017a) asset inspection.

Current management is to monitor condition and carry out remedial works as necessary. Remedial work to low spot is still required.

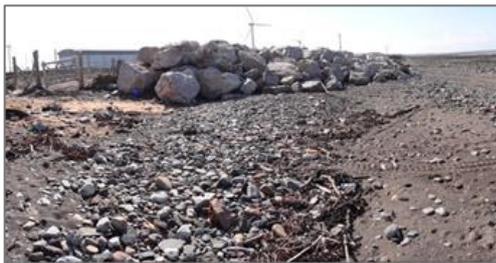
Sewage works (Workington WwTW): vertical concrete seawall and rock revetment (230 m) – Network Rail

Figure 8 Defences at sewage works (Workington WwTW). Photograph taken during CH2M (2017a) asset inspection.

In 2012 the rock revetment, constructed in front of the rear vertical wall, was identified to be in good order. Prior to this there had been little change at the terminal north end of this section, although inspections noted that beach levels are variable and storm conditions could cause draw down that potentially could undermine the wall causing it to fail.

In 2014 a short section of vertical wall at rear end had been breached during storms but this was replaced with a new section of rock armour. In 2015, the armour stone section was improved across the entire length, such that the wall section is now largely redundant.

Current management is to monitor condition and carry out remedial works as necessary. No specific outstanding actions identified.

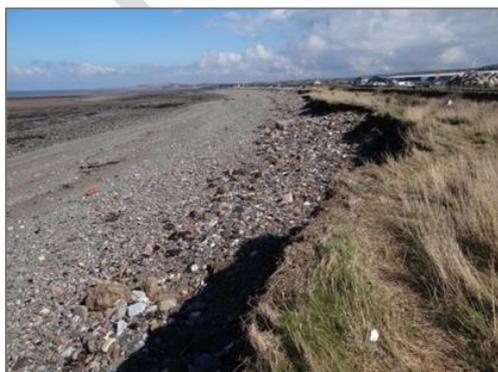
Seaton to St Helen Halt: natural or tipped shoreline (1051 m) – Network Rail

Figure 9 Seaton to St Helen Halt: beach includes tipped material. Photograph taken during CH2M (2017a) asset inspection.

This is a largely unprotected section of frontage along which tipped material from local industries has historically been tipped. This practice has now ceased. A rear blockwork wall or fence (NR boundary) runs along the landward edge of the foreshore.

Current management is to monitor condition but to not actively maintain.

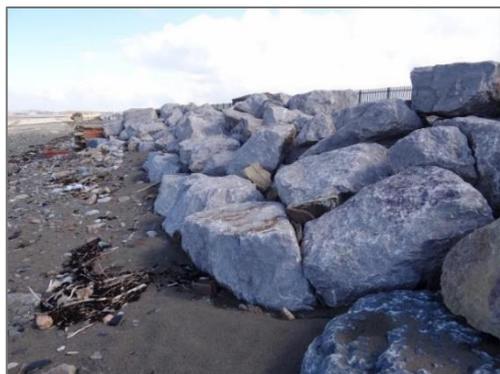
St Helen Halt: rock revetment (168 m) – Network Rail

Figure 10 Rock revetment along St Helen Halt. Photograph taken during CH2M (2017a) asset inspection.

These defences were constructed in 2014 to protect the railway. The flanks remain vulnerable to erosion and in 2016 Network Rail were observed stockpiling armour stone on landward side of railway adjacent to this section, presumably to extend the defences at both ends (although it is not clear if these works have since been carried out). Note that some of the pink armour indicates a conglomerate material rather than a natural rock (origin unknown and physical characteristics are potentially suspect).

Current management is to monitor condition and react to events after they occur, although the stockpiling of armour indicates a more proactive approach.

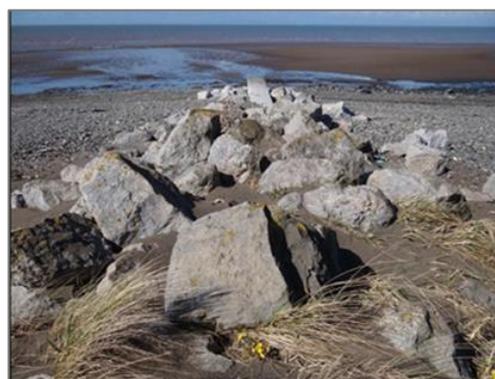
In 2012, the wall was buried apart from at the underpass adjacent to outfall. A new rear floodwall had been constructed on landward side of railway and underpass. By 2014, winter storms had eroded tip deposits, exposing blockwork revetment on northern side of underpass at Flimby. The revetment at this time appeared to be in good condition but was more exposed.

There has since been some recovery of deposits over the revetment either side of Flimby Outfall, mostly due to sand movement by wind, but otherwise no changes have been observed.

Figure 11 Figure 11 Defences at Flimby Outfall. Photograph taken during CH2M (2017a) asset inspection.

Current management approach is to monitor condition but to not actively maintain. Exposure of wall may require reappraisal of this by Network Rail.

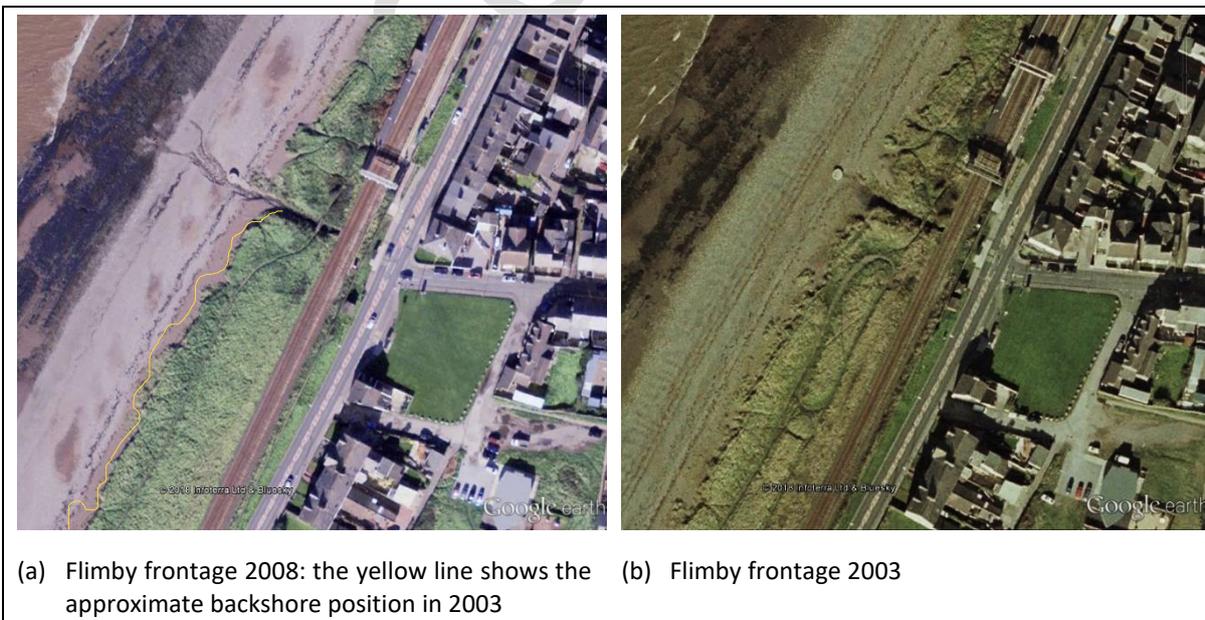
Just south of the railway station, where a low grassed bank fronts the railway line, beach levels have fluctuated over time by around a metre, but net change between 2012 and 2017 was small. It is likely that sand builds up on the southern side of the small beck that outflows here, before being moved northwards. The data suggests that between 2013 and 2014 there was some erosion of the crest of the grassed bank, whilst evidence from Google Earth images from 2003 and 2008 (see Figure 12 below) suggests that erosion has been an ongoing trend since 2003.

Figure 12 Google Earth images from 2008 and 2003 showing backshore changes near Flimby railway station

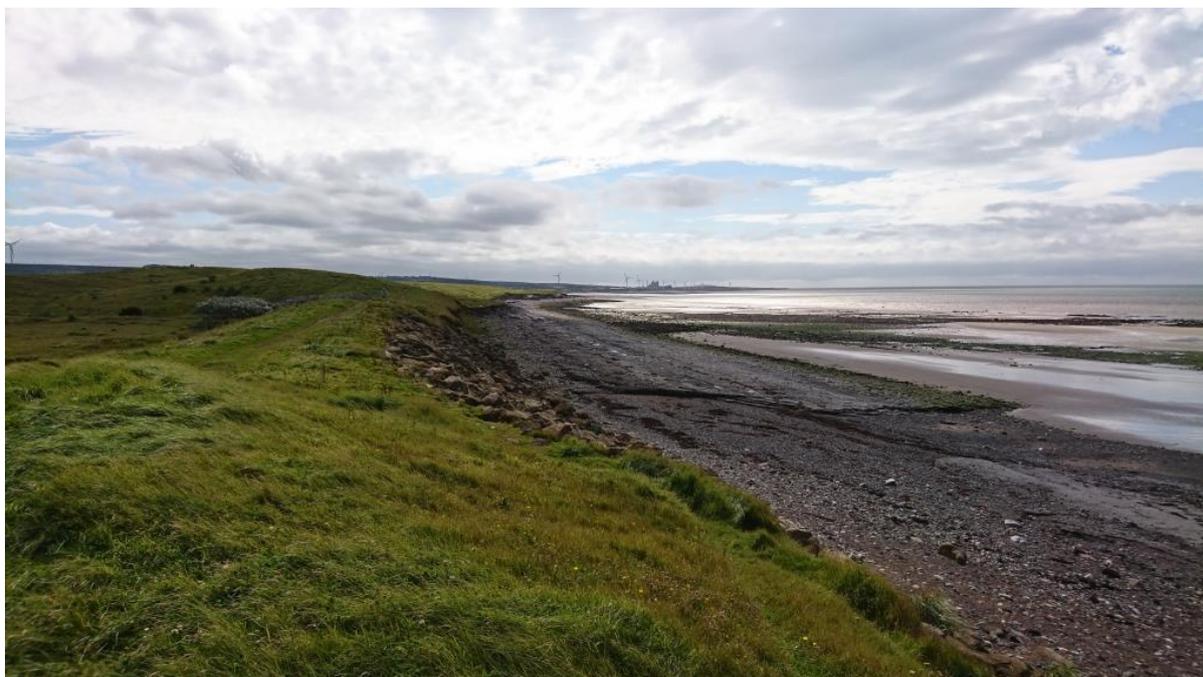
There has been ongoing slow erosion of the unprotected slag cliffs, which has previously severed access paths along the cliff top in places (CEUK, 2014). Beach monitoring data (as part of the North West Regional Monitoring Programme) is not collected along this frontage, but reportedly the beach and foreshore at Maryport, to the north, have been progressively lowering and reducing in volume over time (CEUK, 2016; CH2M, 2018).

Figure 13 Maryport frontage, showing low slag slopes fronted by a shingle and sand beach.

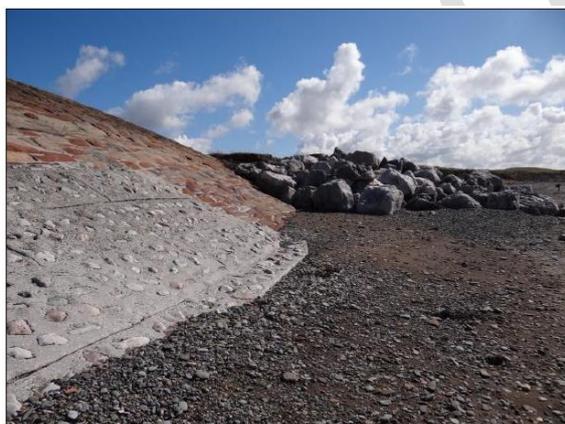
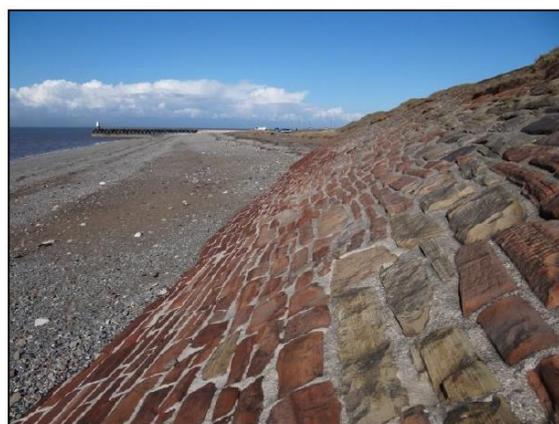
The defences consist of a sandstone block embankment (constructed in 1860) with access road and marine basin immediately to landward (Figure 14). At the harbour entrance there is a timber framed pier structure with a central concrete core which restricts the movement of sediment northerly across the harbour mouth, causing a build-up of deposits to the south. A concrete outfall groyne crosses the foreshore approximately 300 m from the harbour, which assists in holding beach levels to a degree on its south side (CEUK, 2013). At the southern end, the defence turns inland and abuts the natural shoreline in unit 11e3.3. At this end the toe of the embankment has been protected by rock armour to address lowering beach levels, but this end remains vulnerable and there has been some movement and displacement of armour stone in the past. The condition of the defences is currently defined as Fair (CH2M, 2017a).

Figure 14 Defences along Maryport Marina: (a) at the southern end of the defences, where they turn inland, rock has been placed to address beach lowering, there has also been concrete encasement of the original structure; (b) to the north, the beach widens in front of the defence, due to sediment build up at Maryport South Pier. Taken from CH2M (2017a).
