11e6 Silloth to The Grune

(Technical report by Jacobs)

Policy area: 11e6 Silloth to The Grune

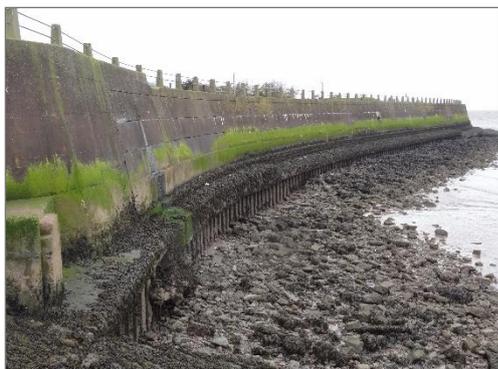
Figure 3 Vertical seawall at Silloth North Pier. Photograph taken during CEUK asset inspection (March 2016).

The defences comprise a vertical concrete wall supported by a concrete apron with a steel sheet pile toe curtain. The beach in front comprises coarse cobbles and shingle. A combination of wave reflections and the proximity of the Swatchway Channel have resulted in the denudation of finer sediments and a narrow beach width.

The structure is exhibiting normal wear and tear for its estimated age (50 to 60 years).

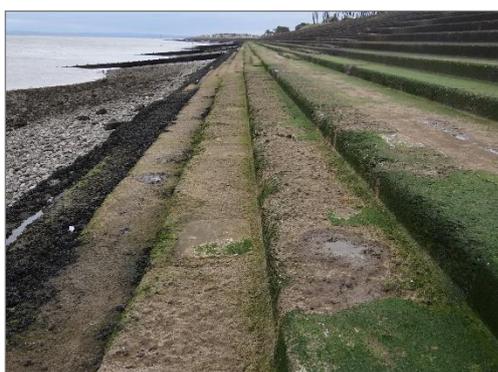
Figure 4 Stepped concrete revetment with sheet piled toe and timber groynes at Silloth. Photograph taken during CEUK asset inspection (March 2016).

The primary coastal defence across this frontage comprises a stepped concrete wall supported by a steel sheet pile toe curtain (mostly buried). The current defences are nearly 40 years old and exhibiting signs of wear and tear, notably:

- Abrasion and surface pitting and spalling to steps
- Cracking, notably at the northern interface with the adjacent defence section.

In addition, there is substantial algal growth on lower steps which presents a health and safety hazard to users. The foreshore is narrow due to the proximity of the Swatchway Channel, is timber groyned across its whole length and comprises a mixture of shingle and cobbles from which the finer sediments have been lost.

Additional quarried cobble has been added to this section since the 1960s. It is the nature of the coarse sediments that are predominantly responsible for the abrasion on the lower steps. Other than the general wear and tear there has been no significant deterioration in condition or major damage to the structure in the past ten years

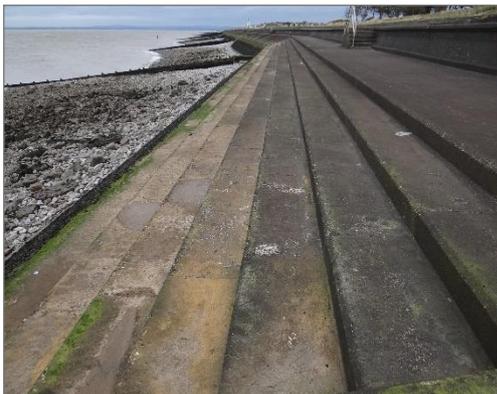
The primary coastal defence across this frontage comprises a stepped concrete revetment (with narrower treads than on the Silloth Bay section to the south), supported by a steel sheet pile toe curtain. At the crest there is a wave return wall with a secondary promenade and rear wall to landward. The current defences are nearly 40 years old and exhibiting signs of wear and tear, notably:

- Abrasion and Surface pitting and spalling to steps;
- Cracking to steps.

In addition, there is substantial algal growth on lower steps which presents a health and safety hazard to users.

Figure 5. Stepped concrete revetment with sheet piled toe, rear wave return wall and timber groynes between Solway Lido and Eastcote. Photograph taken during CEUK asset inspection (March 2016).

The foreshore is narrow due to the proximity of the Swatchway Channel but starts to widen out towards the northern end. It is timber groyned across its whole length and comprises a mixture of shingle and cobbles from which the finer sediments have been lost. Additional quarried cobble has been added to this section since the 1960s. Despite the close spacing of the groynes, there is evidence of northerly longshore drift across this section with steps in level across groynes. The frontage terminates at the slipway at Eastcote where a substantial concrete encasement to a surface water outfall acts as a more substantial groyne preventing upper beach longshore drift.

It is the nature of the coarse sediments that are predominantly responsible for the abrasion on the lower steps. The middle section of one of the groynes collapsed in 2011 and 2012 and has not replaced. Other than the general wear and tear identified there has been no significant deterioration in condition or major damage to the structure in the past ten years.

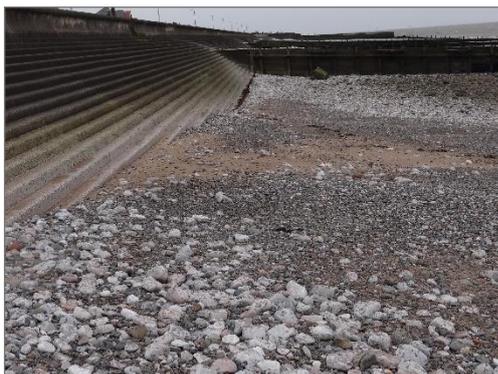
Figure 6. Stepped concrete revetment with sheet piled toe and rear wave return wall and timber groynes at Skinburness. Photograph taken during CEUK asset inspection (March 2016).

The primary coastal defence across this frontage comprises a stepped concrete revetment (with generally equal treads and risers, apart from locally at the northern end where the treads are wider), supported by a steel sheet pile toe curtain. At the crest there is a wave return wall.

It is believed that the current defences were constructed in the 1980s. These are exhibiting signs of wear and tear, notably cracking and abrasion, surface pitting and spalling to steps.

The foreshore is wider here as the Swatchway Channel is further offshore and the upper beach sediments exhibit a greater proportion of fine sediment. Lower beach sediments are predominantly sand and mud. The frontage is timber groyned across its whole length. Despite the close spacing of the groynes, there is continued evidence of northerly longshore drift across this section with steps in level across groynes and toe piles exposed in the southern half of groyne bays but buried in the northern half. Additional quarried cobble was added to this section at the end of the 20th century.

It is the nature of the coarse sediments that are predominantly responsible for the abrasion on the lower steps. There are some missing planks to timber groynes. Other than the general wear and tear identified there has been no significant deterioration in condition or major damage to the structure in the past ten years.

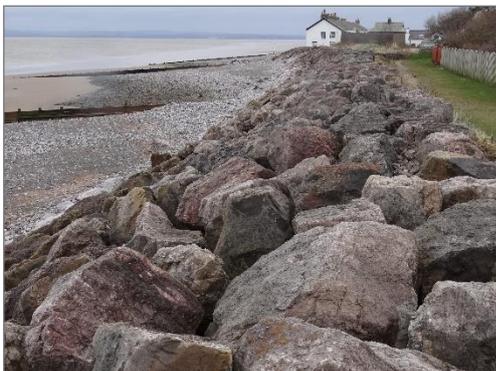
The primary coastal defence comprises a rock armour revetment, most of which dates from 1999, although a short section at the northern end predates that. The revetment is in good condition with no obvious signs of rock movement, although overtopping waters did penetrate through the crest in places during the winter 2013 and 2014 storms. The revetment locally reduces in crest elevation in front of shoreside cottages (seen in background of Figure 7).

Figure 7. Rock armour revetment with timber groynes at Skinburnessbank. Photograph taken during CEUK asset inspection (March 2016).

The foreshore is timber groyned and comprises a mixture of cobbles, shingle and sand. Continued longshore drift northerly evident across this section with upper sections of groynes buried. Additional quarried cobble was added to this section at the end of the 20th century.

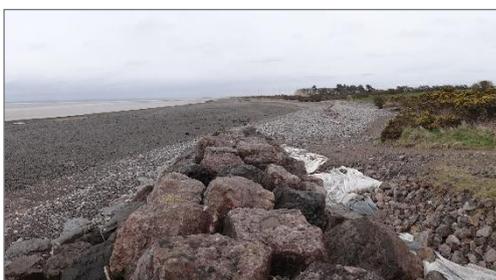
At the northern end, the adjacent undefended frontage of The Grune is setback and the terminal end of the revetment is being gradually outflanked, as can be seen in Figure 8. The northern end of the frontage is only protecting a single property. Improved management of this interface is required.

Figure 8. Terminal end of rock armour revetment at The Grune. Photograph taken during CEUK asset inspection (March 2016).

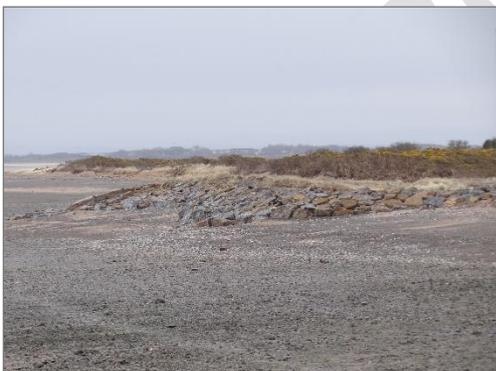
Figure 9. Rock armour revetment at The Grune. Photograph taken during CEUK asset inspection (March 2016).

This section is the only length of artificial defence on The Grune, erected by a private landowner in 2008 to halt ongoing erosion.

The beach conditions are predominantly a mixture of shingle and sand becoming finer in a northerly direction.

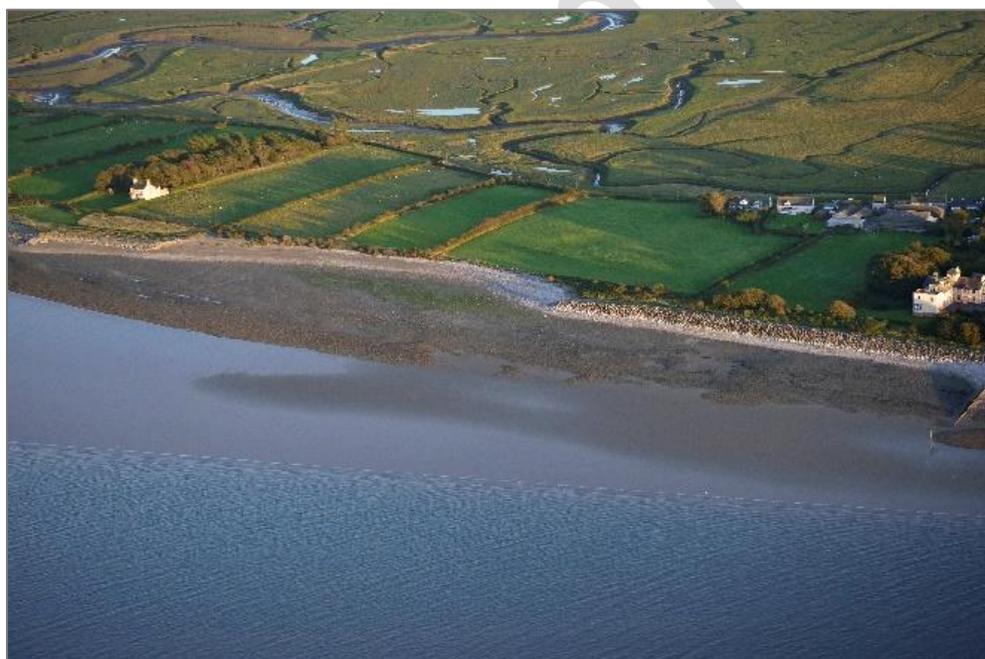
Apart from a short section of local privately funded and managed defences in the vicinity of Grune House (see Figure 10, left) and the terminal end of the hard defences across the Skinburnessbank frontage (see Figure 10, right), there are no defences on the Grune and the natural shoreline features react to the physical process regime. The two sections of defences are influencing behaviour with backshore erosion taking place at a greater rate here. In addition, this is occurring where ground levels indicate that there is the greatest risk of flood waters linking across the neck of the spit. If this behaviour continues, there is a risk of outflanking in the future, presenting a risk to the property that the defences are protecting.

Figure 10 Juxtaposition of private defences on the Grune and terminal end of ABC rock armour revetment at Skinburnessbank. (Photograph © North West Regional Monitoring Programme, October 2015).
