11c11 Outer Leven Estuary

(Technical report by Jacobs)

Policy area: 11c11 Outer Leven Estuary

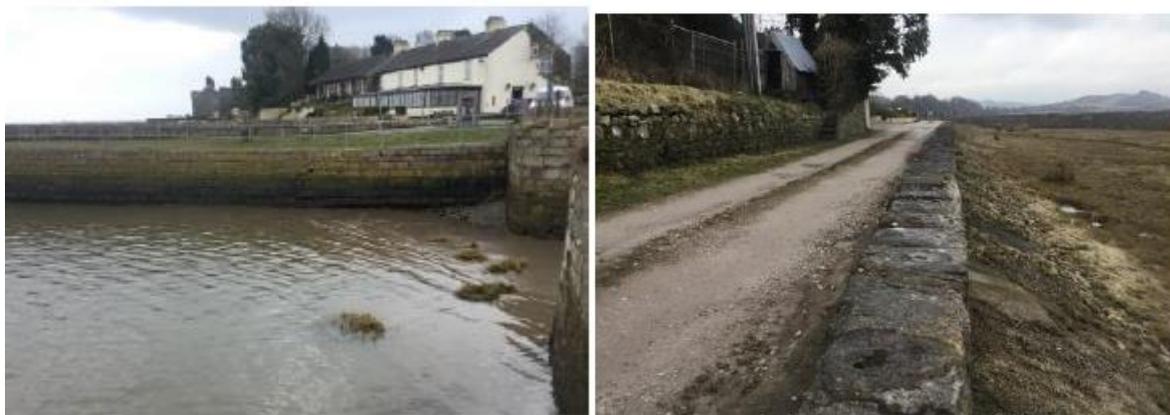
Lock to Hammerside Point (11c11.3 and 11c11.4) - Along this frontage a sea wall is present; this is currently in good condition, fronted by a sloped revetment in fair condition with vegetation covering most of the element (Figure 4). Gabions are located at the western end of the asset, which are in good condition (Figure 5). Vegetated saltmarsh with numerous creeks and drainage depressions are visible along the length of the asset and cliffing of saltmarsh is visible at the seaward extent (CH2M, 2017). For the purpose of this assessment it is assumed that the 11c11.3 and 11c11.4 boundary is located at the south end of the defences at Hammerside Point.

Figure 4 Policy unit 11c11.3 and 11c11.4 Lock to Hammerside Point - Seawall

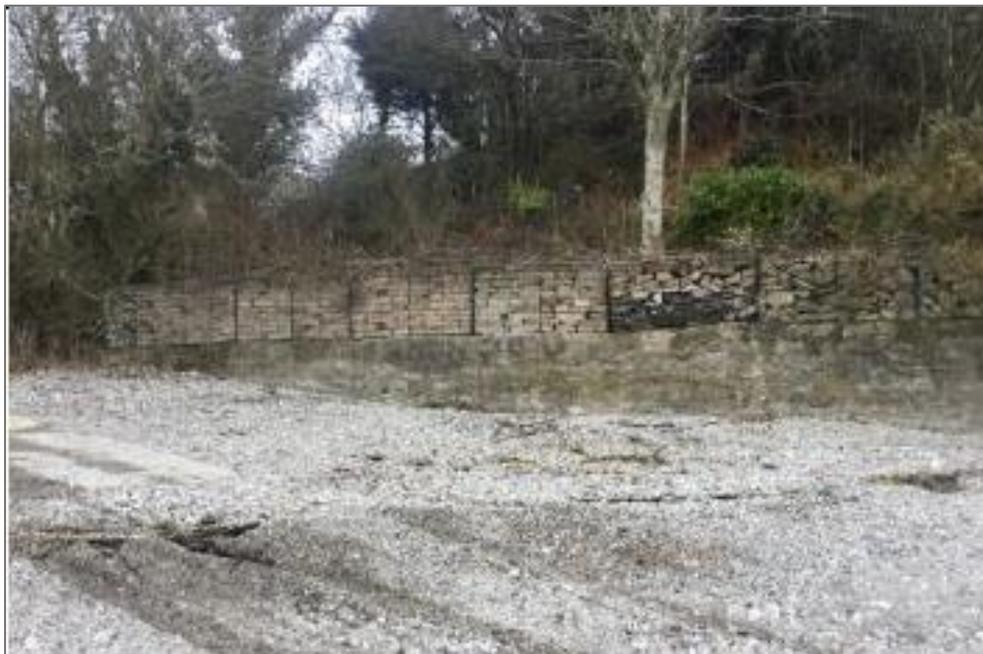
Figure 5 Policy unit 11c11.3 and 11c11.4 Lock to Hammerside Point – Gabions

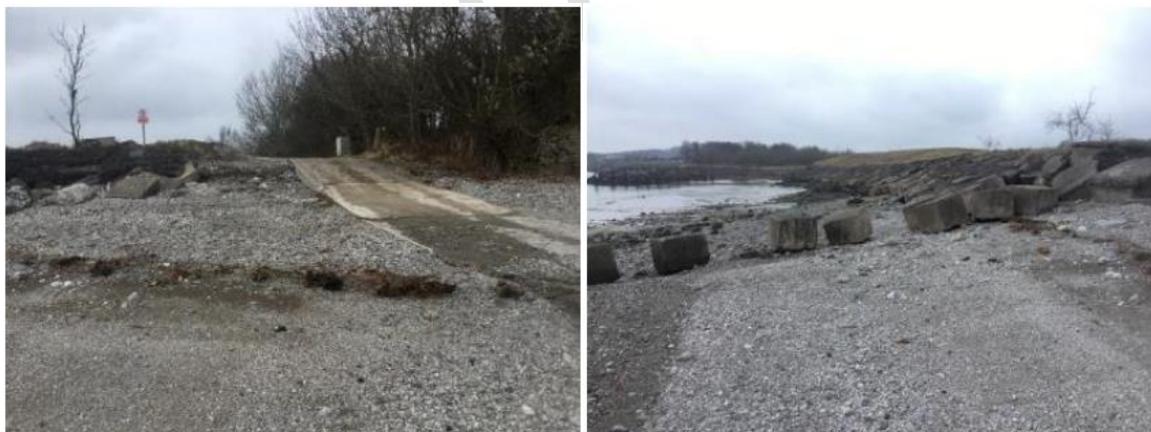
Hammerside Point to Priory View (11c11.4 and 11c11.5) - All the elements along this section of the frontage are in poor condition (Figure 6). High ground¹ consisting of made ground at Ainslie Pier is in poor condition and nearly vertical in places, (Figure 7). The steep slope is unstable in places and cliffing visible along the length of this section.

Figure 6 Hammerside Point to Priory View (11c11.4 and 11c11.5) - mixture of rock armour revetment and sloped revetment

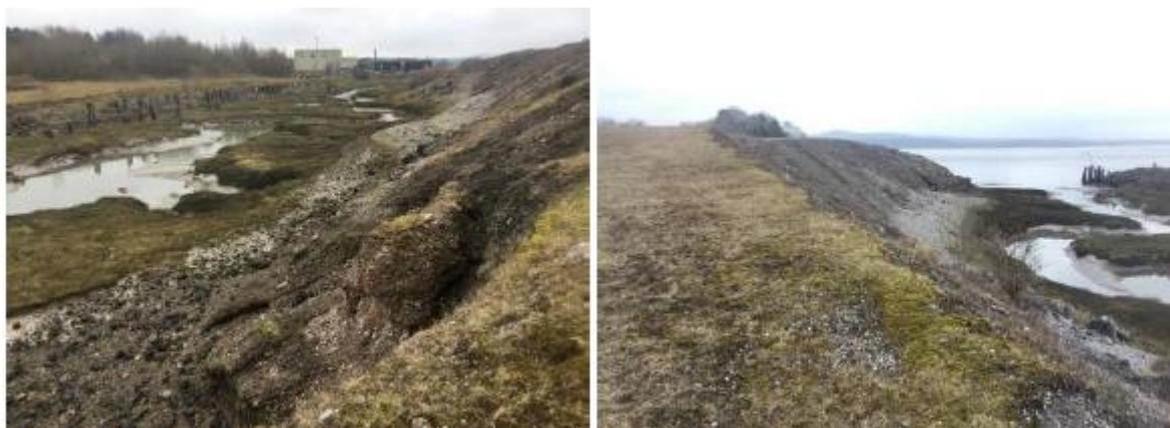
Figure 7 Hammerside Point to Priory View (11c11.4 and 11c11.5) - Ainslie Pier

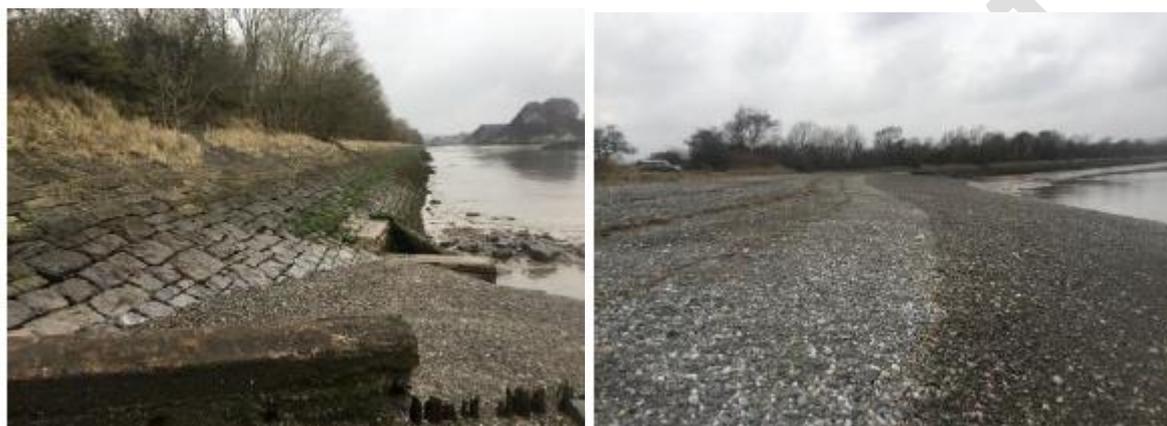
The sloped revetment along the dismantled railway is in good condition, though the exposed face, crest and landward face of the vertical wall is in very poor condition with missing blockwork at numerous locations (Figure 8).

Figure 8 Hammerside Point to Priory View (11c11.4 and 11c11.5) - revetment along the dismantled railway

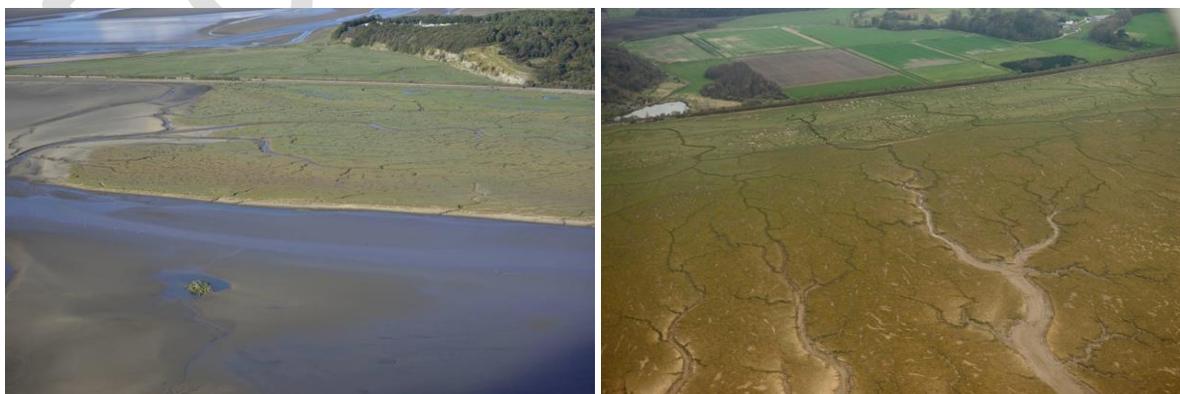
The railway embankment that extends along this frontage is understood to be in a fair condition, although the latest asset inspection (CH2M, 2018b) reported that it was largely unseen due to vegetation cover and access restrictions. Some heavy rutting due to vehicular traffic was reported at most eastern point of the asset, close to railway crossing and River Eea, (CH2M, 2018b).

Figure 10 11c11.1 Railway embankment and saltmarsh extending south; 2015 aerial images © North West Regional Monitoring Programme.

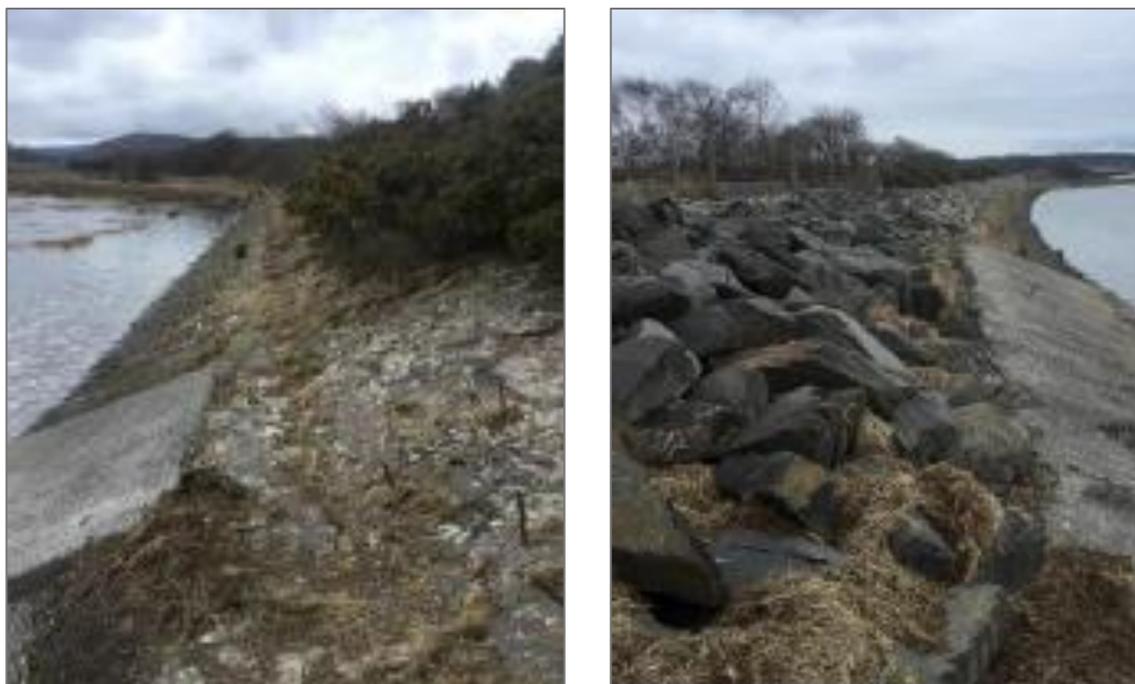
The railway embankment consists of a sloped blockwork revetment (Figure 11). The latest asset inspection (CH2M, 2018b) identified the structure to be in fair condition with some vegetation cover and missing mortar in several locations. At the western end rock armour revetment has been added to the western end of the asset which is in a good condition (CH2M, 2018b).

Figure 11 11c11.2 Railway embankment. Taken from CH2M (2018b).

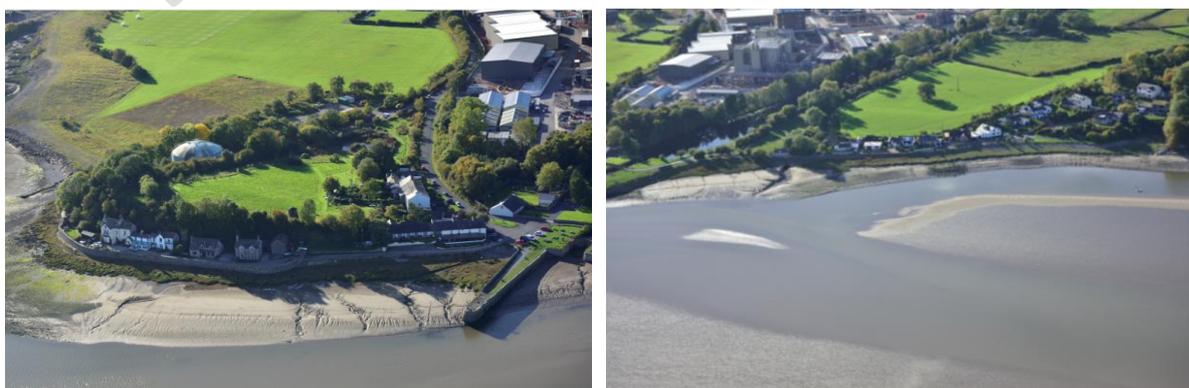
This frontage (Figure 12) consists of saltmarsh, shingle and boulders and the channel bank is at a shallow angle although some cliffing of the saltmarsh has been observed (CH2M, 2018b).

Figure 12 11c11.3 Canal Foot. 2015 aerial photograph © North West Regional Monitoring Programme.

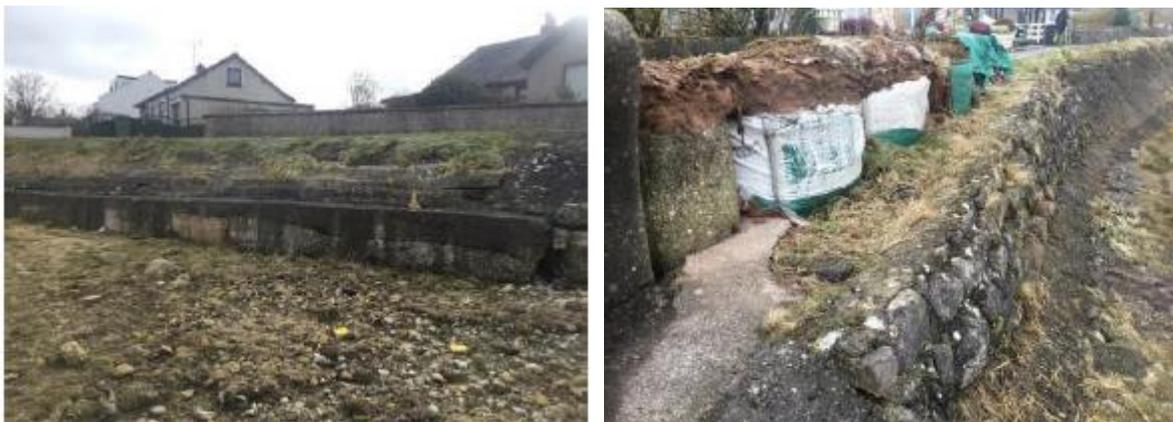
The latest asset inspection (CH2M, 2018b) noted that there are a number of structures present along the frontage, in variable condition, with some stretches in poor condition (Figure 13). It is also evident that works have been undertaken by residents to reduce overtopping, namely the placement of earth filled bags along the crest of the wall adjacent to the road. There is a parapet on the landward face of a flood gate which is loose and needs immediate repair and may become a health and safety issue.

Figure 13 Canal Foot- vertical walls and earth filled bags. Taken from CH2M (2018b).

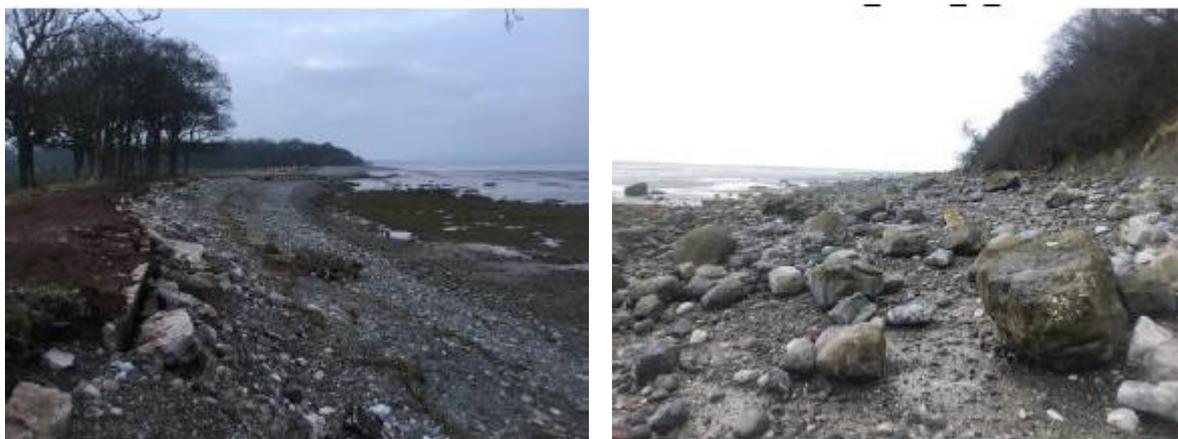
The banks of the channel are in a fair condition, comprising of shingle and sand. The higher ground consists of a dilapidated sea wall, rock debris, rock armour and earth, Figure 15. The latest asset

inspection (CH2M, 2018b) concluded that all defence elements are in poor condition with debris being strewn along the beach (Figure 15).

Figure 15 11c11.5, illustrating that debris is being strewn along the narrow backshore. Taken from CH2M (2018b).

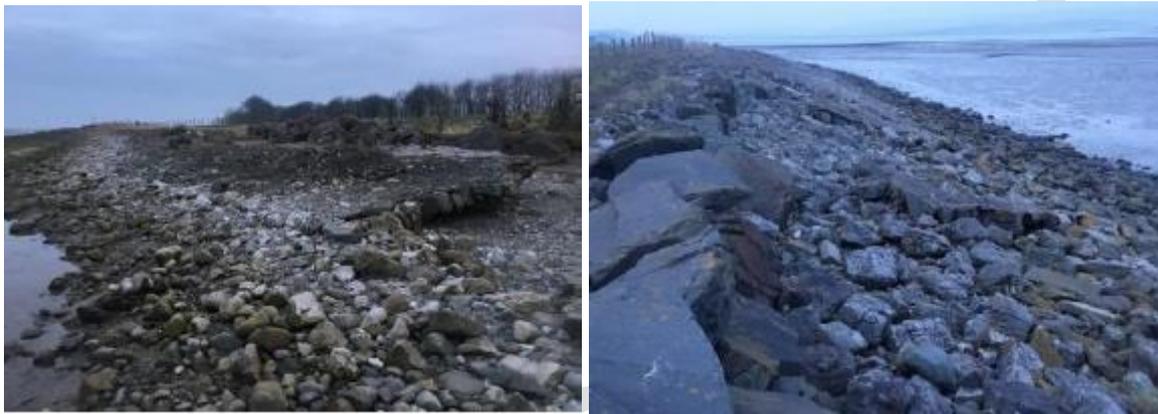
From Red Lane south, the revetment is in a poor condition, but it does have some residual protection given by presence of loose material from revetment at toe of slope (Figure 16).

Figure 16 11c11.6 – South of Red Lane – defences in poor condition. Taken from CH2M (2018b).

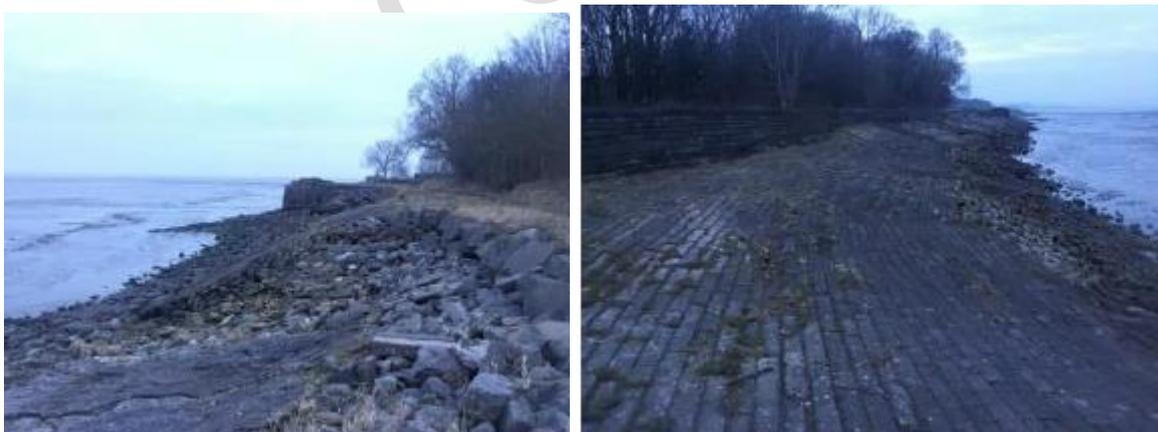
South of here, to Cooper Lane, a length of 280 m, there is a stone revetment, which varies from good to poor condition (Figure 17). Significant loss of stone blocks, which have been washed out in places, although the failed blocks are still providing protection to toe of defence in some areas.

Figure 17 11c11.6 –non main water course to Cooper Lane – revetment varies from poor to good condition. Taken from CH2M (2018b).

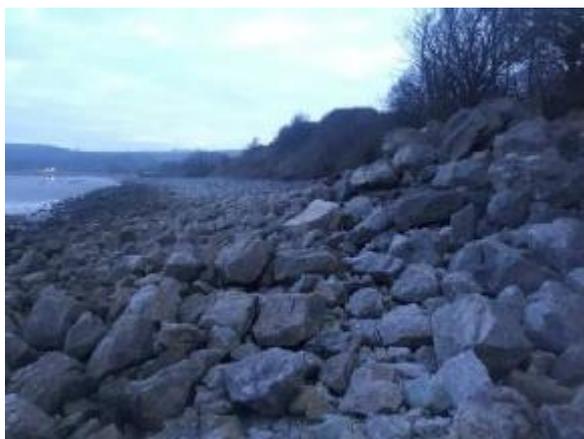
From Cooper Lane to Wadhead Hill, a new rock armour revetment has been placed on top of the existing wall (Figure 18). Outflanking has occurred at the end of the defence, where the ground has become eroded. The rock armour is in fair condition with slumping visible in places and some rock displacement.

Figure 18 11c11.6 –Cooper Lane to Wadhead Hill – rock revetment. Taken from CH2M (2018b).

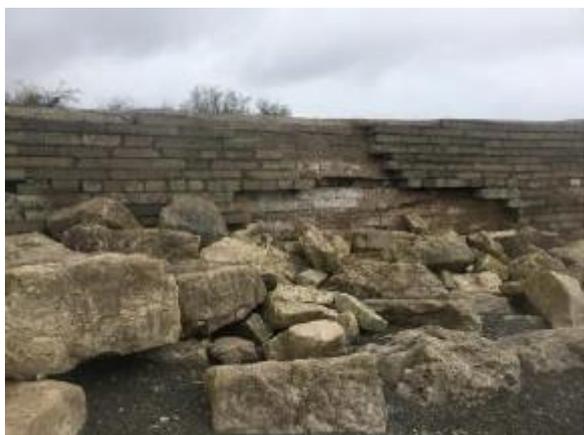
From Wadhead Hill to Coast Road there is a sloped revetment, which is in poor condition, with failed concrete patch repairs and large holes visible. The vertical masonry wall has failed and lost extensive sections of brickwork (Figure 19). The crest of the structure has lowered, with large area of crest missing. Rock armour has been placed to fill the gap between missing areas of wall but this is in poor condition.

Figure 19 11c11.6 –Wadhead Hill to Coast Road – revetment
