# Woodend Farm

## Flood Investigation Report 42

**Flood Event 30/8/2012**

This flood investigation report has been produced by Cumbria County Council as a Lead Local Flood Authority under Section 19 of the Flood and Water Management Act 2010.

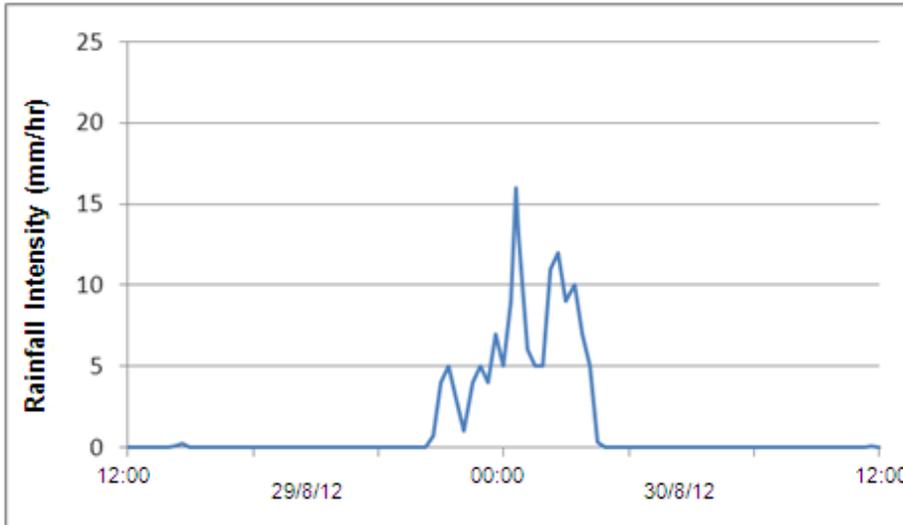
Figure 2. Rainfall intensity at Woodend Farm from 12pm, 29/8/12 to 12pm, 30/8/12

No rain gauge data is available and the following has been calculated from radar data. Peak rainfall at Woodend was about 16mm/hr and occurred at about 12:25am. The rain started at 9:35pm and finished at 3:00am with 33mm in the period. The normal average total rainfall for the whole of August is 92mm (1981-2010).

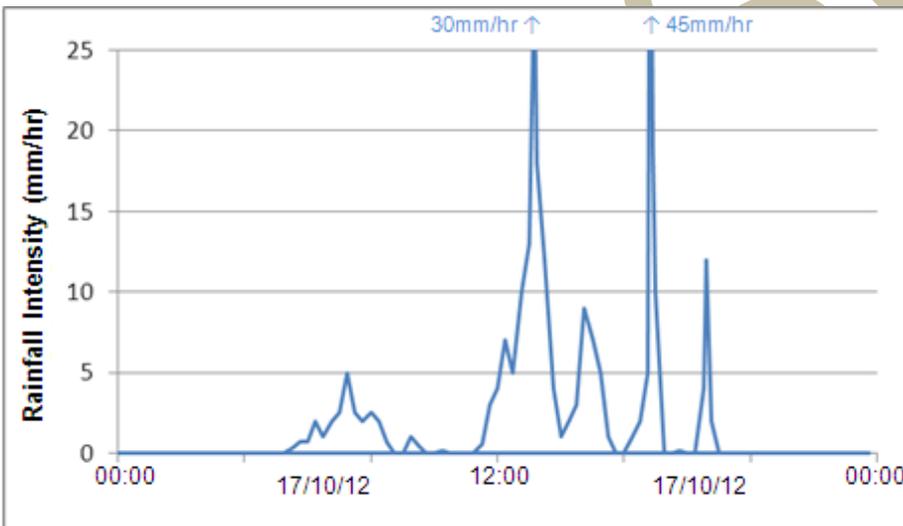
Figure 3. Rainfall intensity at Woodend Farm on 17/10/12.

Radar data shows that the rain started at 5:30am with light showers and the main event started at 11:30am with a peak rainfall of 45mm/hr at 4:50pm. There had been another huge spike in rainfall of 30mm/hr at 1:10pm and numerous other bursts of very heavy rain. The storm finished at 6:30pm after 44mm had fallen.

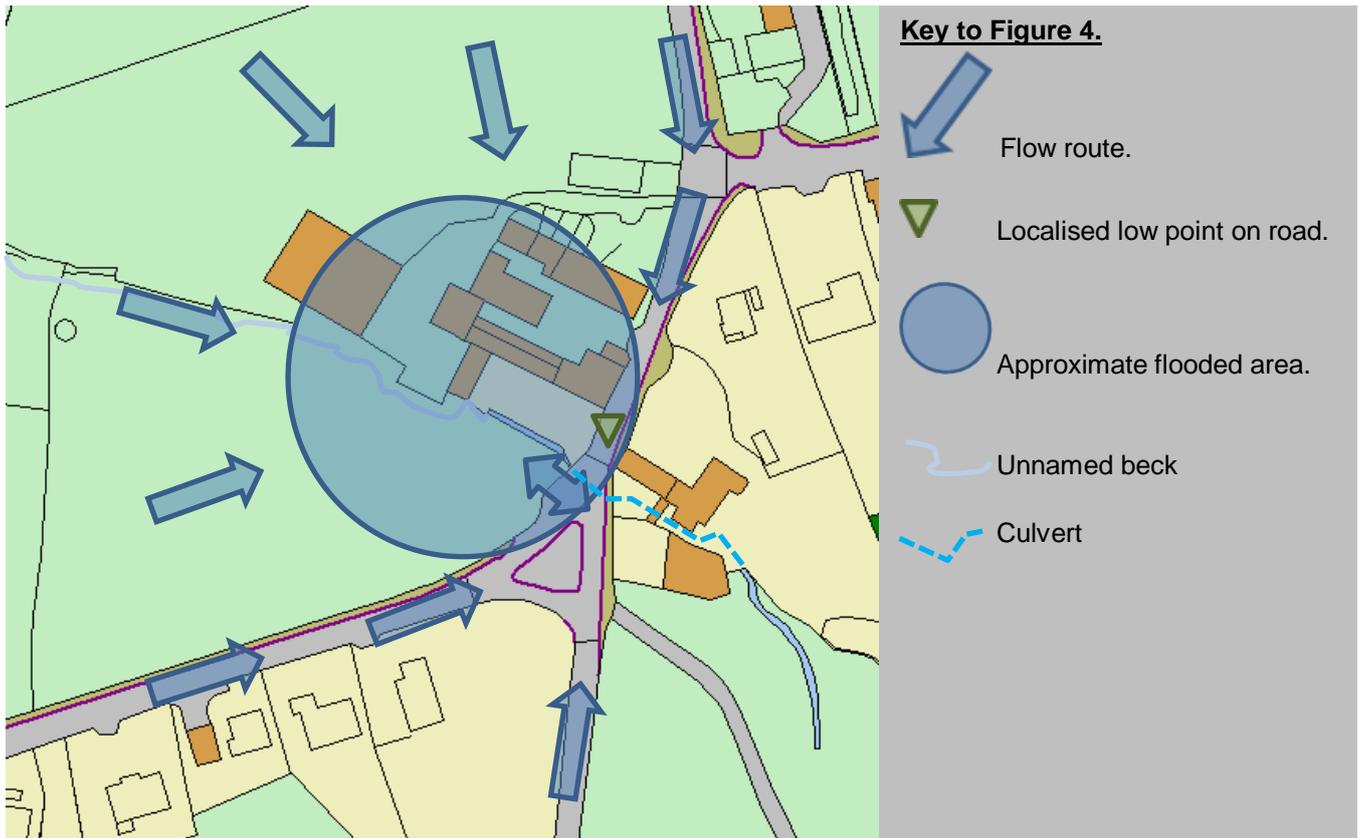
Figure 4: Flood flow routes at Woodend.

Water reached Woodend Farm from all directions, the main source being the unnamed beck coming from the west. The rainfall intensity caused surface water to flow over the fields towards the farm. Flood water was also brought to the farm along road surfaces which converge on this area with the crossing over the beck, which is culverted downstream of this point.

A hole in the parapet wall above the culvert entrance allows road water to drain directly into the beck. When the beck level rises, this drainage route is reversed and water from the beck flows onto the road. During both flood events, the culvert could not take all the water and so flood water levels rose at the culvert entrance.

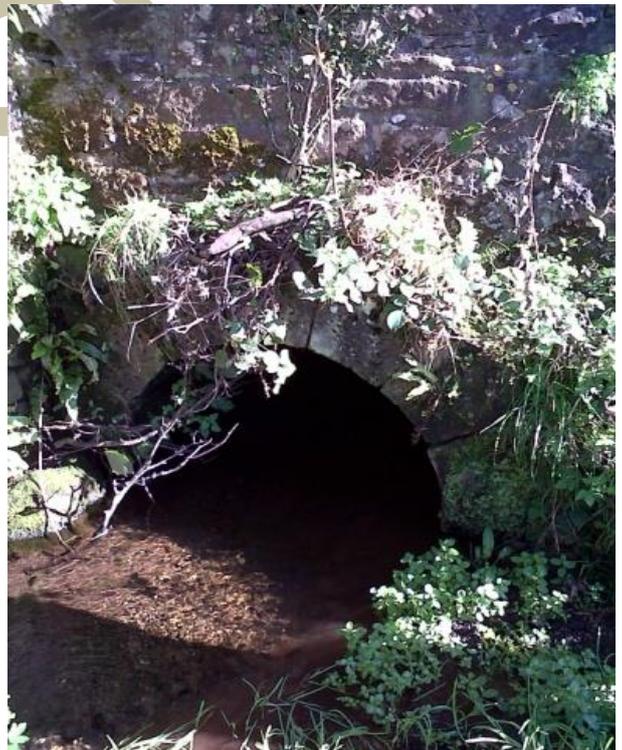
Figure 5. Culvert entrance

The watercourse flows for 680m until it reaches the culvert at Woodend Farm. This presents a restriction to the flow causing a rise in flood waters in front of the culvert entrance.

The culvert starts as an 800mm diameter arch constructed in brick. It is in fairly good condition but there are numerous design problems.

- It is smaller than the stream channel so flows are likely to exceed the culvert capacity as proven by the flooding.

- Services are routed through the culvert in more than one location. This reduces capacity as well as increasing the risk of blockages.

- Culvert construction and cross-section varies (it is an arch at the entrance but the exit is rectangular) which result in a loss of hydraulic efficiency.
- There are four changes in direction within the culvert which also result in a loss of hydraulic efficiency, and make maintenance difficult. In modern culverts access for maintenance must be provided at each change in direction. This culvert is not of modern design and appears to have been constructed in stages.

The culvert is clearly inadequate to deal with flows observed in 2012. It appears to be causing severe flooding on a 3-5 year basis. This can be addressed by increasing capacity and/or reducing the flows in the beck. Due to the proximity of various utility services the construction of a new culvert would be complex.

Action by	Recommended Action	How
County Highways / LLFA	Increase capacity of culvert	<ul style="list-style-type: none"> <li>• Examine feasibility of culvert enlargement or new culvert route.</li> <li>• Investigate sources of funding.</li> <li>• Commission hydraulic study.</li> <li>• Request removal of gas pipe through the middle of the culvert. <b>Completed</b></li> </ul>
County Highways	Reduce surface water in culvert.	Investigate possibility of diverting surface water collected on roads to downstream side of culvert.
LLFA / Land Owner	Reduce flow.	Investigate feasibility of upstream attenuation.

- A new culvert could be installed to cross the road, most likely as an overflow to the existing culvert but it could also be done as a replacement. This would appear to be the most straightforward solution to the flooding.

A new culvert would have to be as short as possible, with good access made available and no development above it. Current regulation would most likely require the length of culvert to be reduced. It would have to deliver improvements over the current situation to flood risk and ecology.

- It may be possible to increase flows within the existing culvert by improving the culvert geometry to maximise hydraulic efficiency. Streamlining the inlet or outlet is the most likely way that this could be achieved. Removing the service crossings, reducing the sharpness of the corners, and lining the culvert to remove roughness may also have an effect. A hydraulic study would be required to determine the flow conditions within the culvert and to assess whether any of these actions would have a significant effect on increasing capacity. The LLFA would have to either conduct or commission this survey.

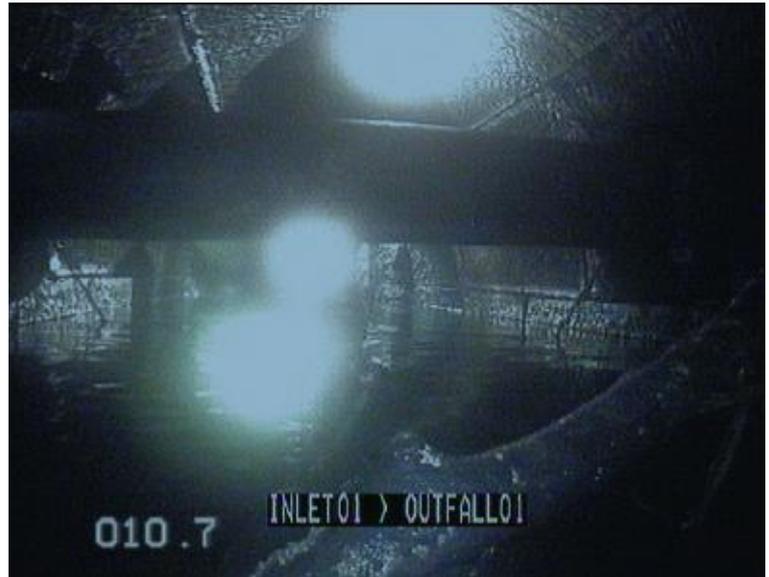
**Figure 6. Picture from CCTV survey showing service pipe passing through the culvert and a branch caught on it**
