# Millom and Haverigg

## Flood Investigation Report

**30<sup>th</sup> September 2017**

This flood investigation report has been produced by Cumbria County Council as a Lead Local Flood Authority under Section 19 of the Flood and Water Management Act 2010.

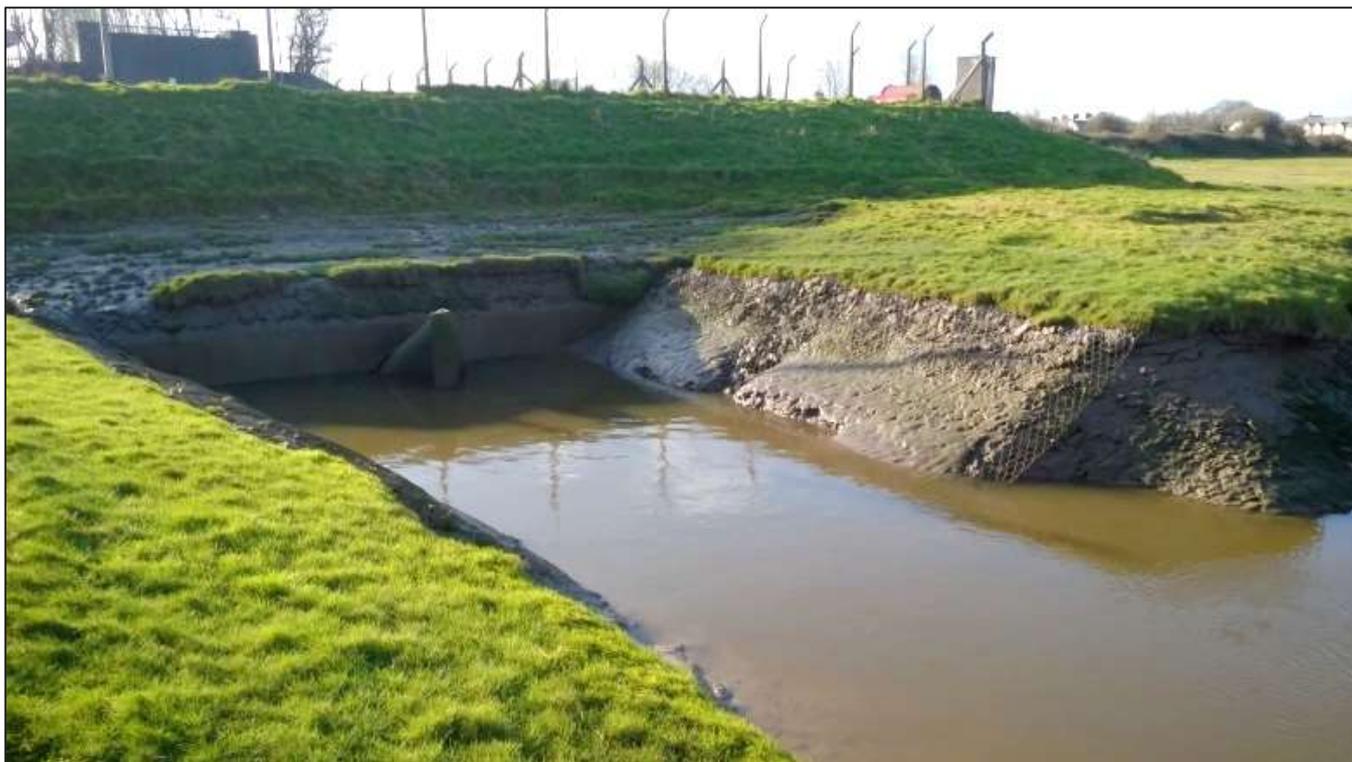
**Photograph 1: Duckbill valve at King Street Pumping Station**

The following photograph shows the tidal valve at the discharge point from the King Street Pumping Station. This is known as a duckbill check valve and allows water to flow in one direction only. This does not restrict the volume of water that can escape from the pumping station but serves to protect the pumping station from tidal flows.

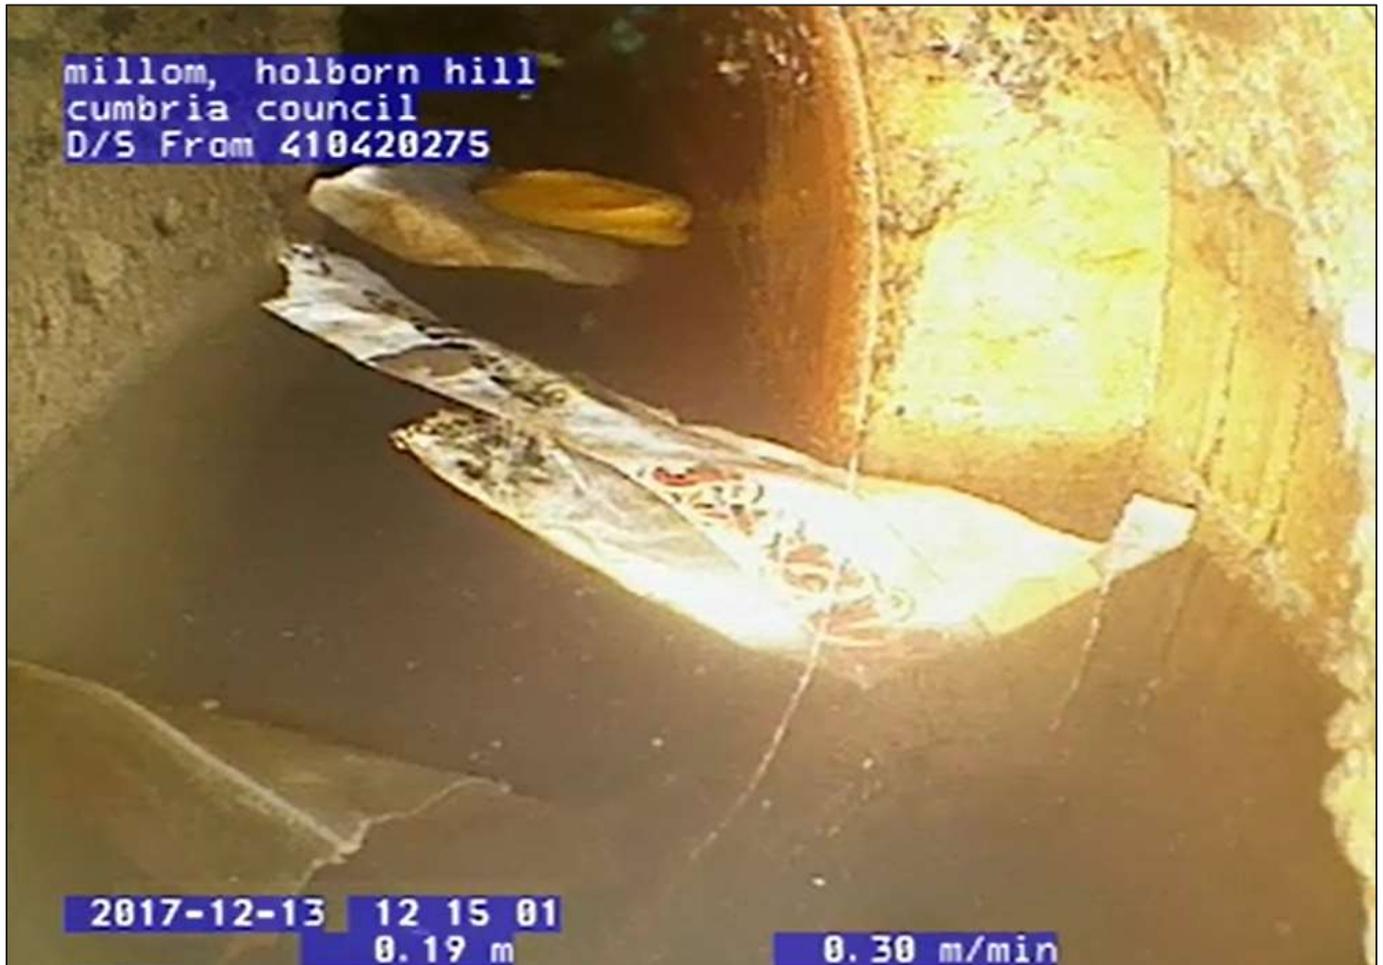
Figure 15: Standing water in damaged highway gully

Example below concrete severely restricted the capacity of the gully.

The highway and combined sewer has been visually inspected, surveyed by CCTV and dye tested where necessary. The system runs effectively during downpours however there was one area of damage which blocked a single highway gully on the corner of Finch St/Holborn Hill. See figure 15 above.

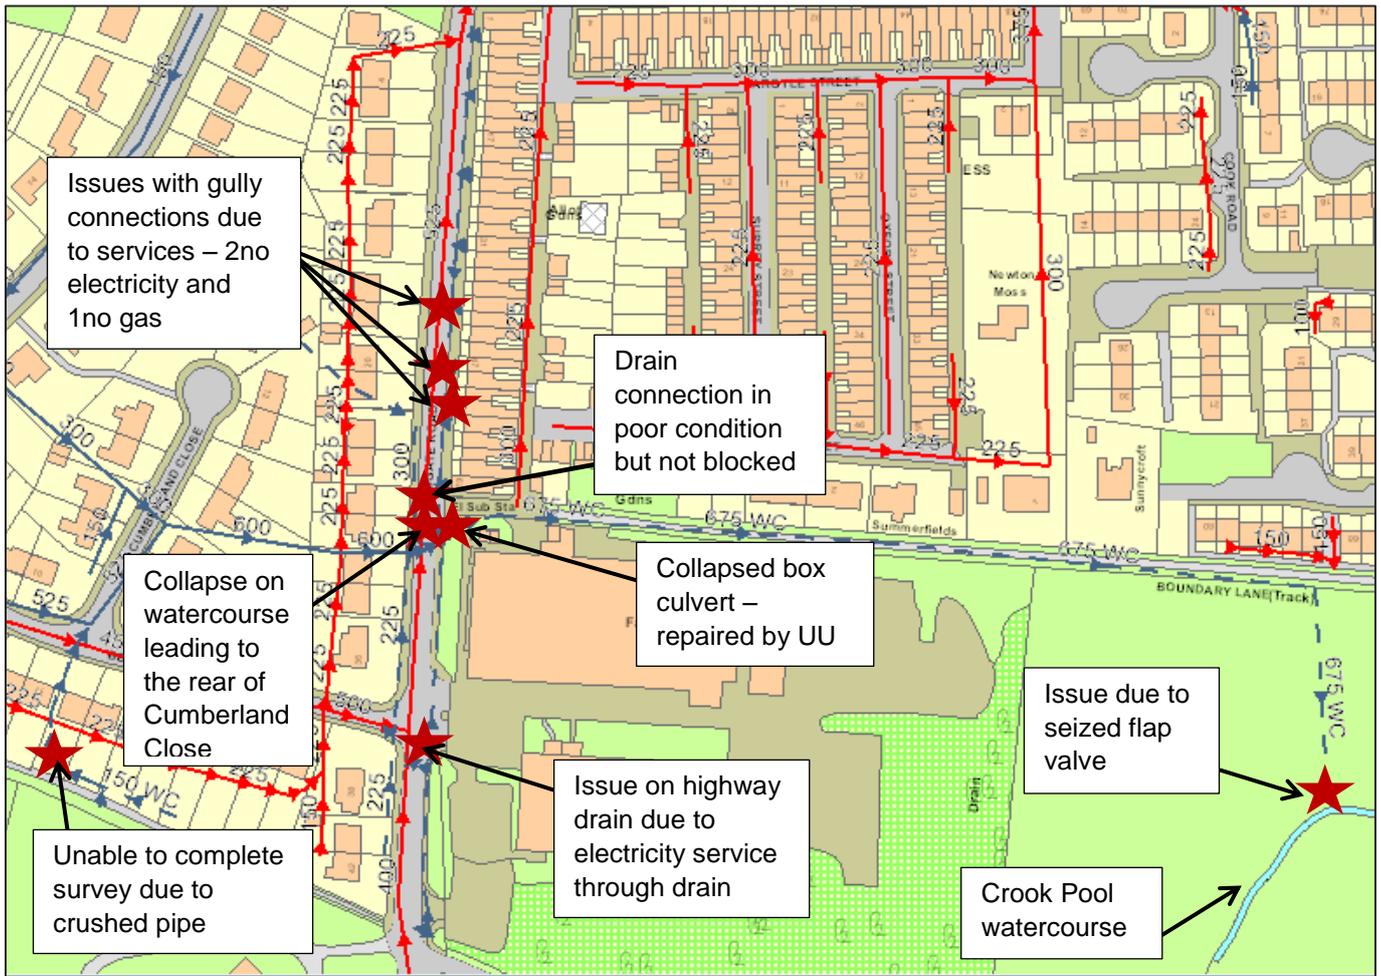
**Figure 19: Location of issues on the surface water drainage systems in Mainsgate Road and Bowness Road**

During the investigations as detailed in Figure 19 several issues were found on the drainage systems which are summarised as follows –

- Seized flap valve – the LLFA to work with landowner to resolve
- Collapse on the watercourse from Cumberland Close – to be programmed for repair in the near future
- Collapse on the culvert through the grounds of the factory – now repaired
- Badly damaged drain connection – to be programmed for repair in the near future
- 4no damaged drains due to service installation – 1no gas to be programmed for repair in the near future 2no electricity which have temporarily been reinstated and one that has been permanently repair, see **figure 20**.
- Crushed pipe rear of Bowness Road – the pipe is still operating but camera is unable to progress – to be investigated further

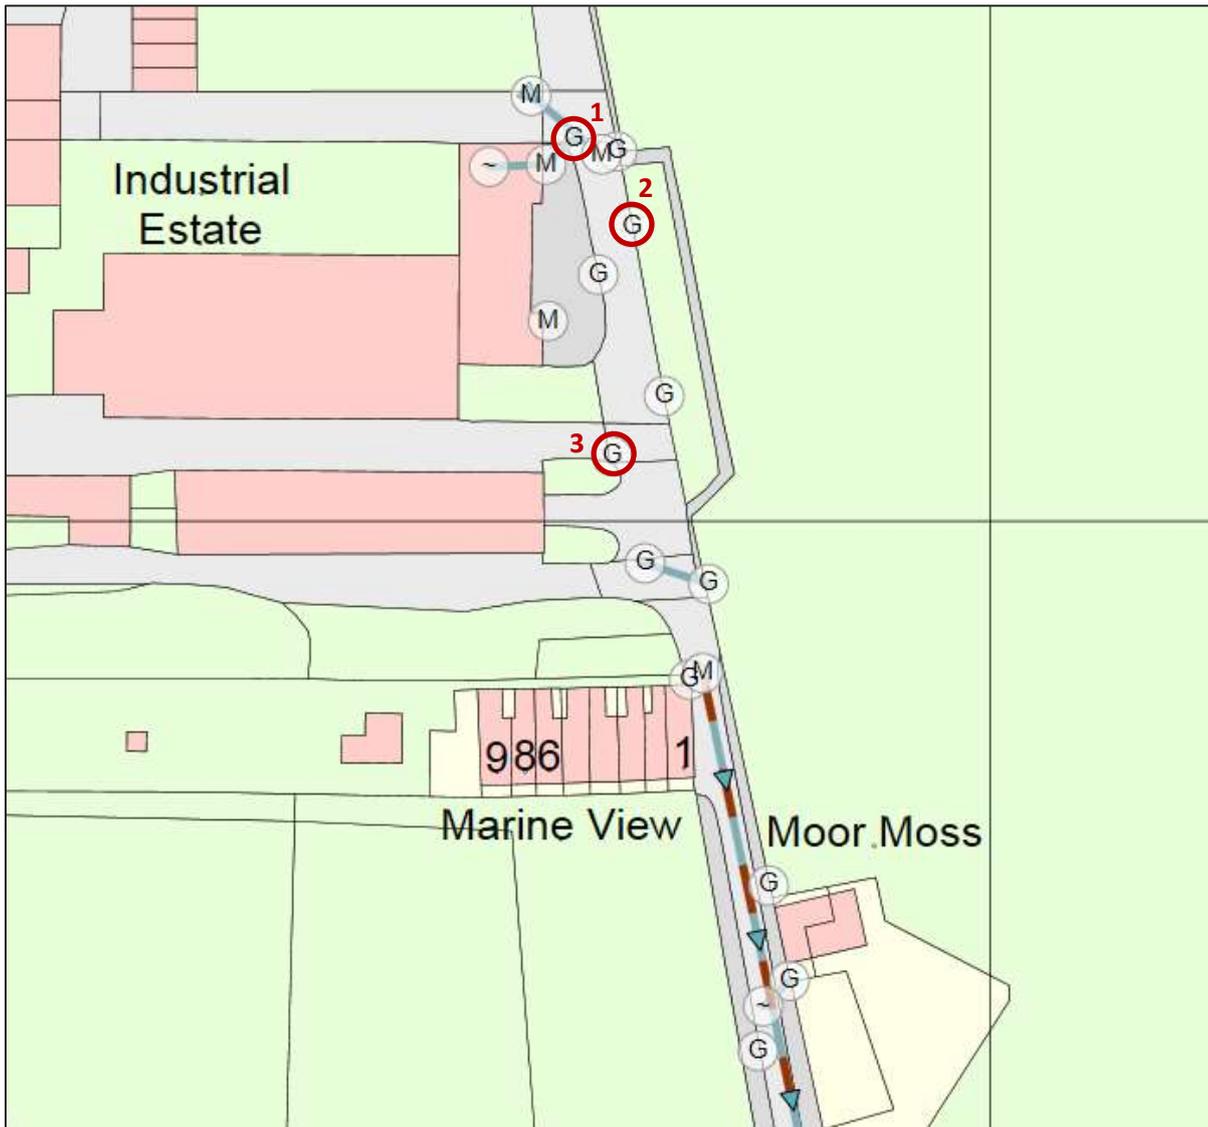
**Figure 24: Obstructed Highway Gullies**

Three of these highway drains were found to be defective (see **figure 24** for reference):-

- Number 1 was heavily silted. This has since been cleared and is now in full working order.
- Number 2 was covered by a sheet, presumably to protect the drain from gravel (see **figure 25**). The sheet has been removed and the gully is fully functional.
- Number 3 has partially collapsed, severing the link between the gully and the combined sewer. This is now scheduled for repair as soon as funds are available.

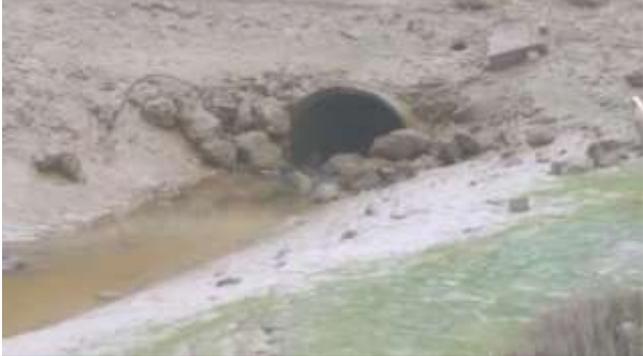
Inlet 2	IL 1.113	Concrete pipe 1700mm dia	Some stones at entrance – would benefit from removal
