Holme

Flood Investigation Report

North Road, Holme

Flood Event 22nd November 2017

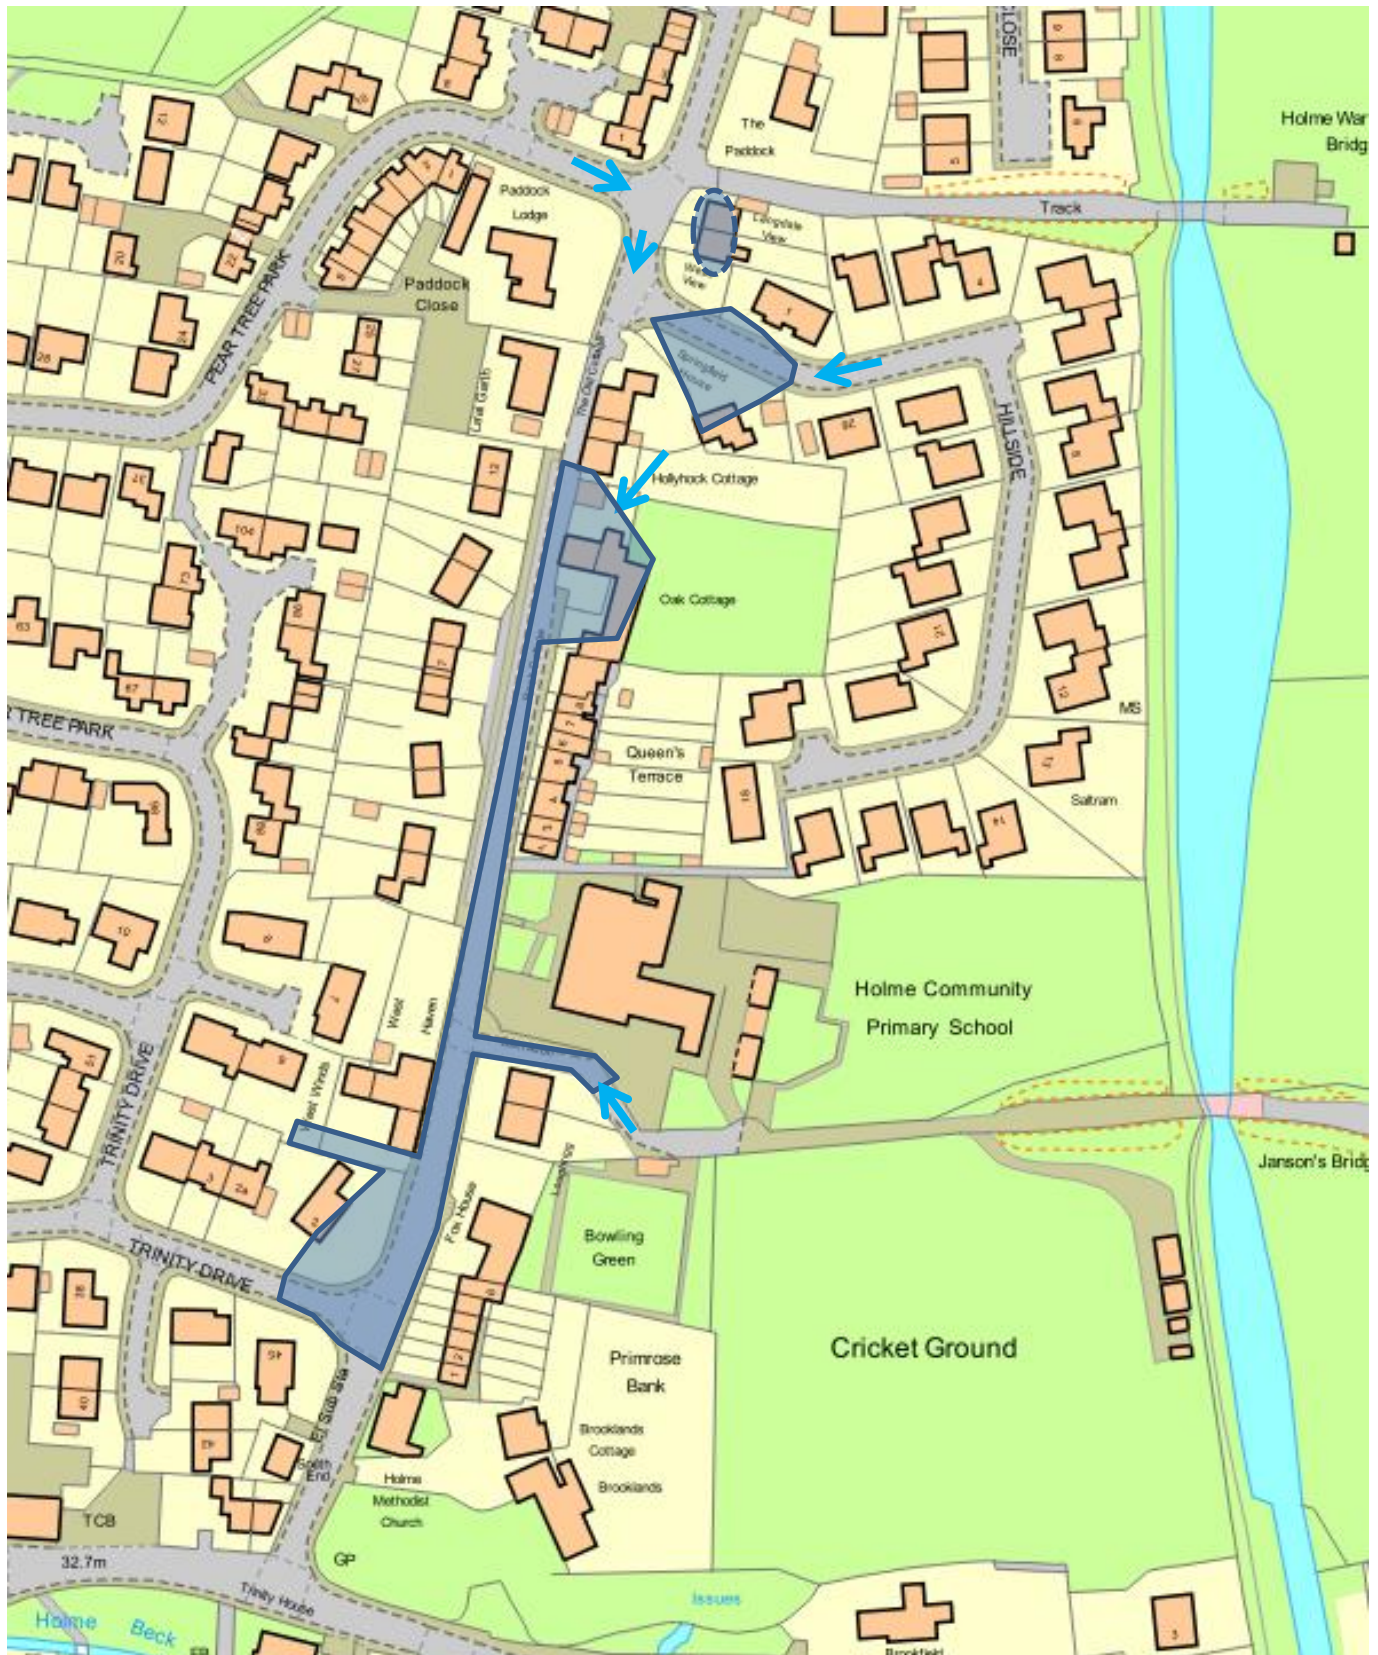
Figure 9: Extent of flooding on North Road, 22nd November 2017.

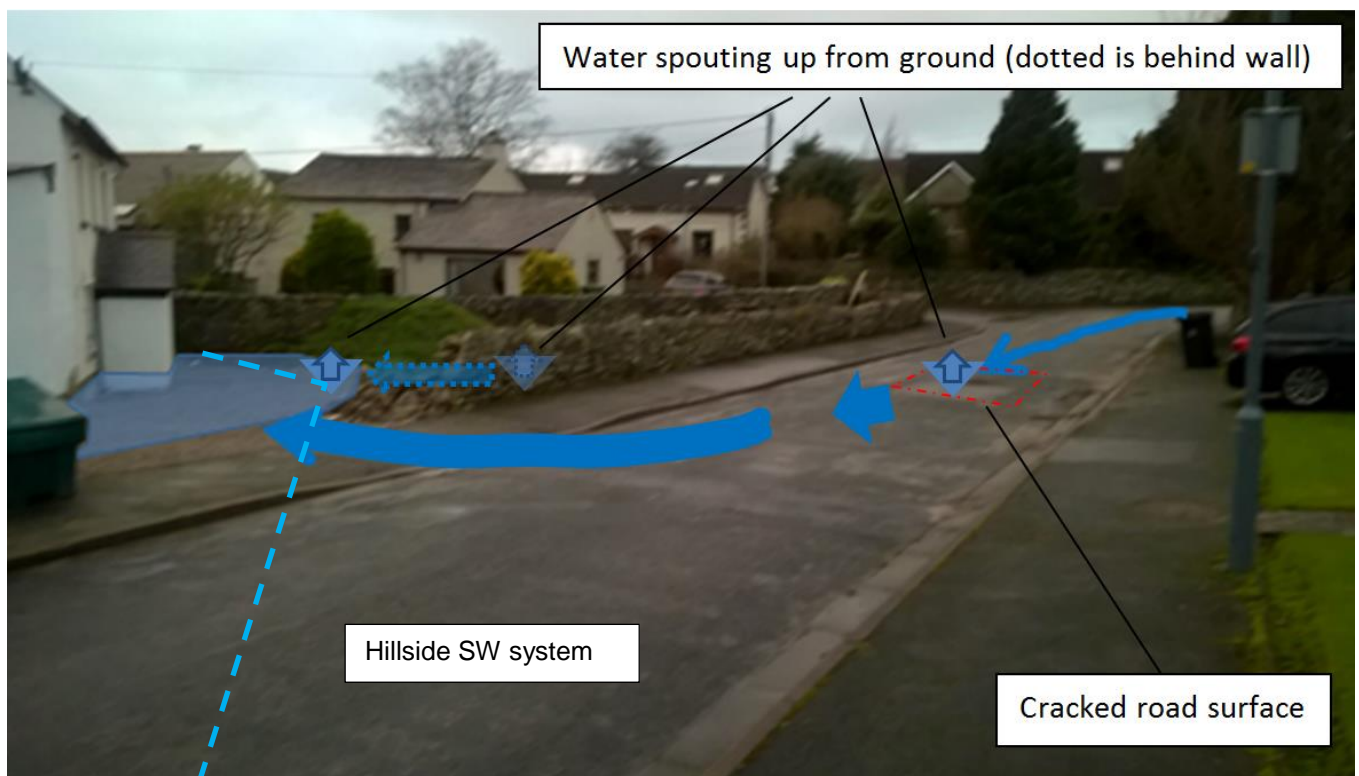
Springfield House is at a localised low point which was filled with water spouting up from below out of a manhole and out of the ground at other locations nearby. The manhole is only fed by drainage serving Hillside itself and is dry in normal conditions. There was some contribution from surface flows of flood water that had exceeded the capacity of the local drainage system (see figures 10 and 11). There was severe flooding at Springfield causing the fire brigade to spend five hours at the scene.

Figure 10: Flow routes around Springfield. Approximate line of culvert shown by dashed line.

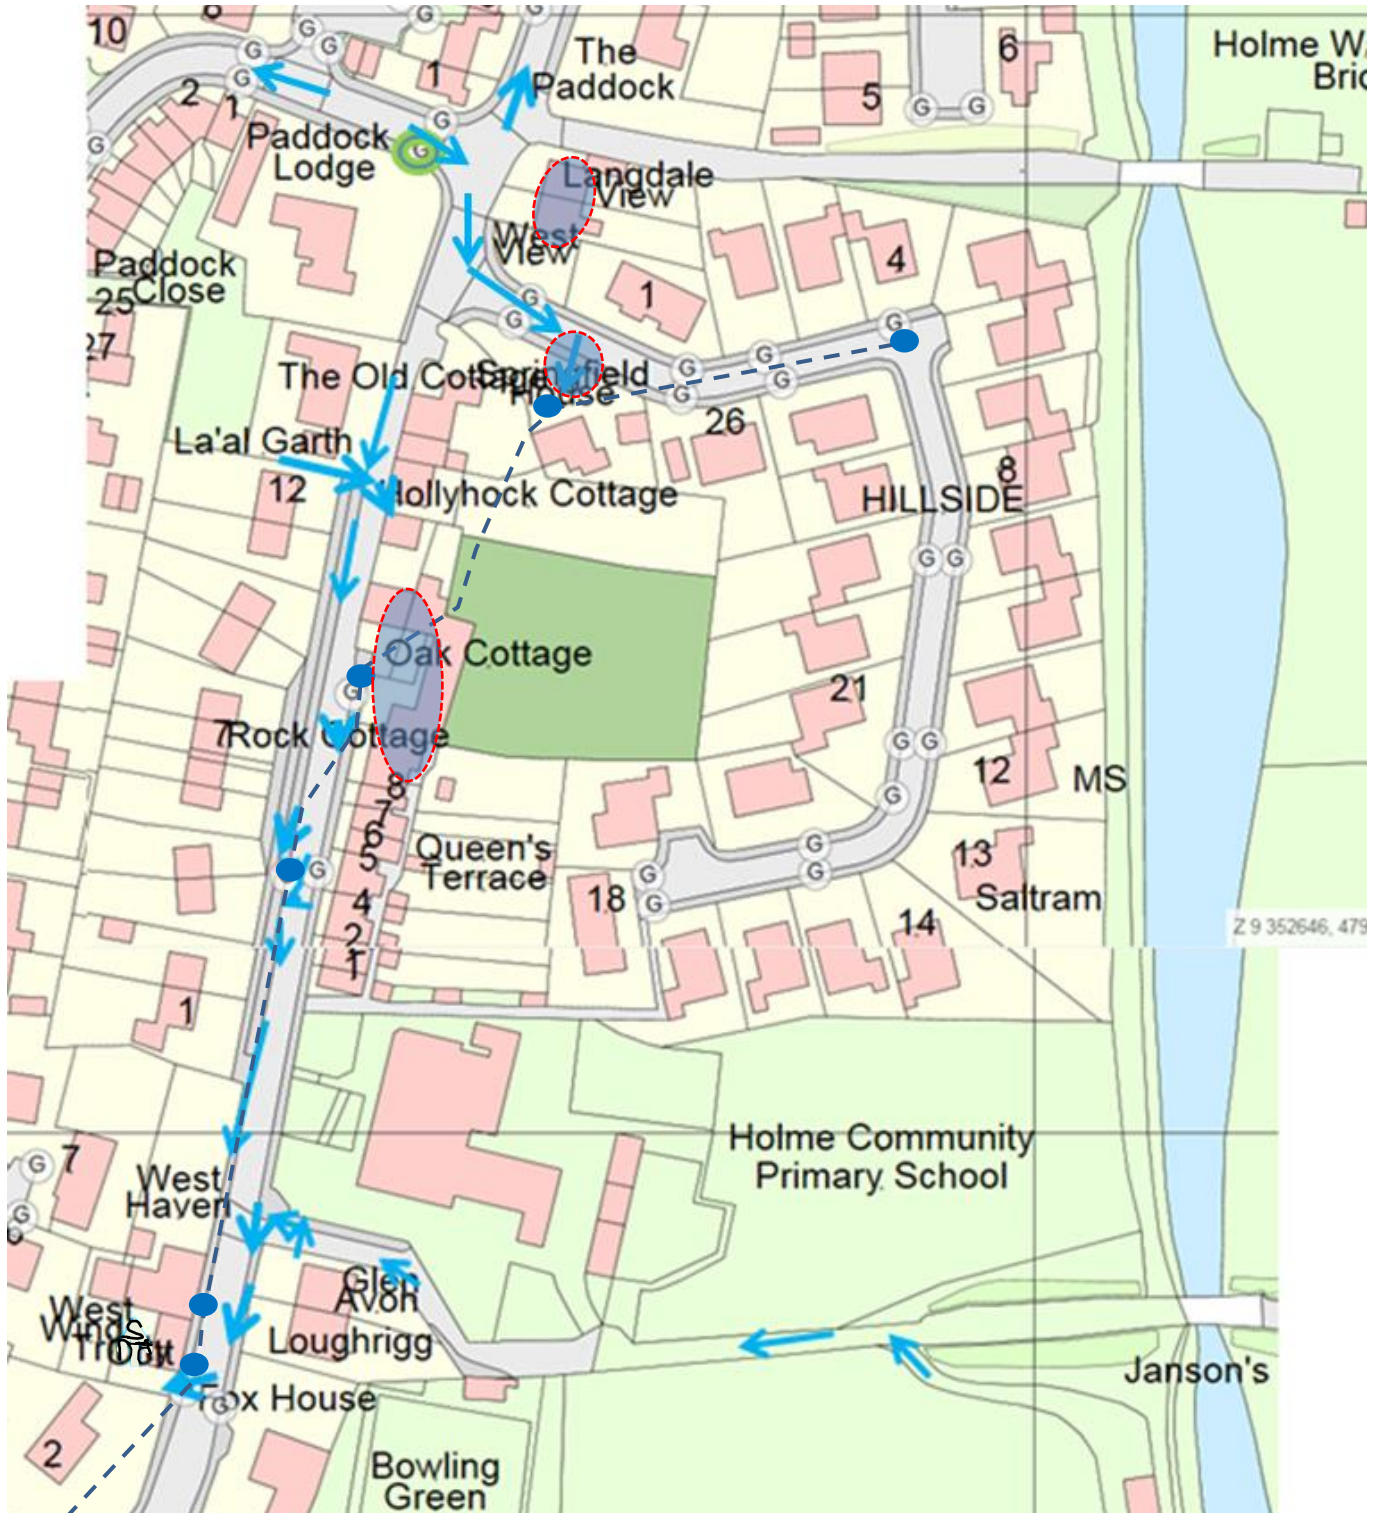
Because of the flooding it had been assumed that there was a collapse somewhere but we have found no sign of a collapse. The culvert is stone built and the shape is irregular and, although functional, there are places where capacity is reduced. This occurs all along the length of the stone culvert towards Trinity Drive open beck, more so in the section between Springfield house and Oak Cottage. The line of the culvert is indicated in figure 11 (below) and detail of the culvert is in appendix 1.

Figure 11: Observed and reported surface flows indicated by blue arrows around North Road. Main line of culvert indicated by dashed line with manholes on it indicated by blue circles. Reports of groundwater flooding indicated with red circular outline.

Flood water at Oak Cottage, Oaklands, and Mayland Cottage also rose up from the ground through concrete floors (see figure 11).

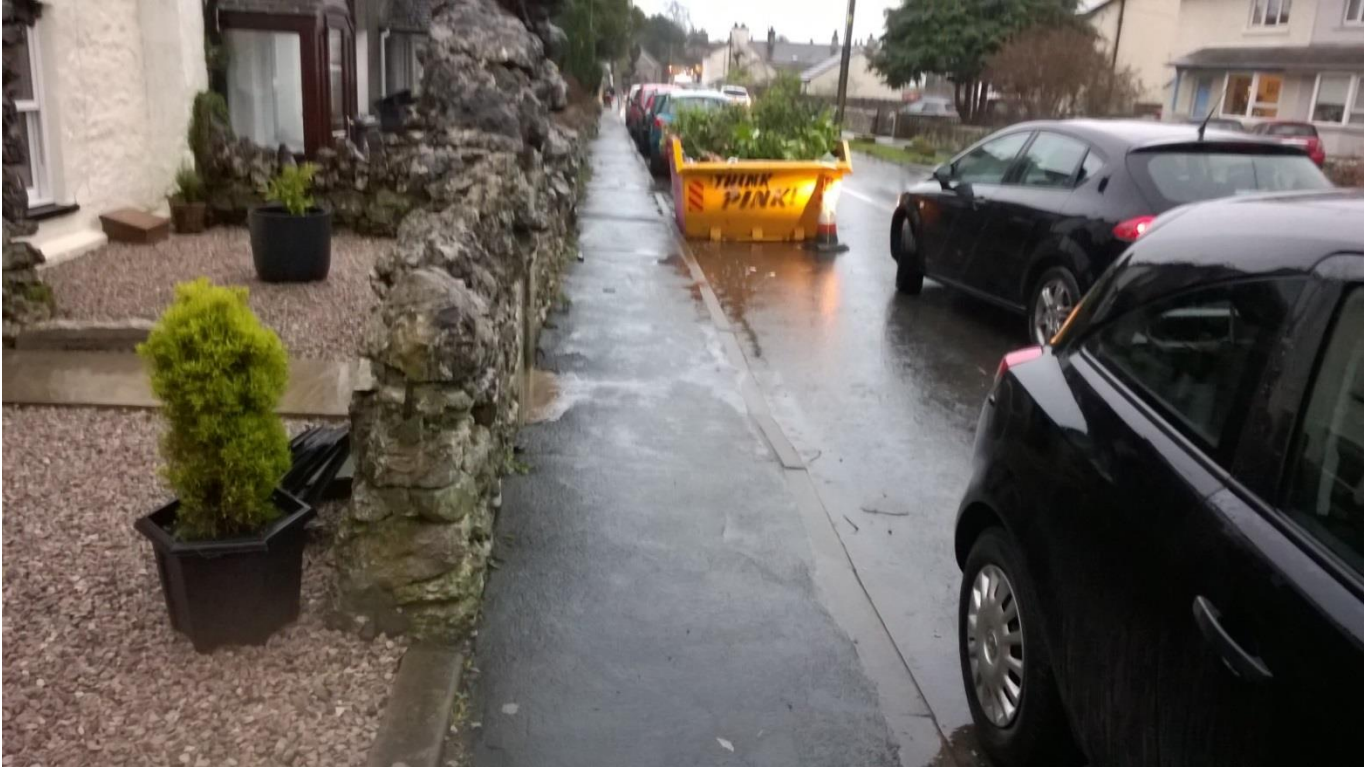
At Rock Cottage and Mayland Cottage some of the flow was coming by a surface route via North Road (see figures 11 and 12). The cottages are lower than the road and dropped kerbs let the water come to the front door. A skip didn't help as the flow had to build behind the skip before it could spill around. At Rock Cottage they managed to prevent damage from this route by improvised flood defences and sweeping flow away until 7:15am. There was no surface runoff from the back. However groundwater rose through the concrete floor here.

Figure 12: Water pooling upstream of the same skip on North Road during heavy rain on 14th December 2017. No flooding occurred on 14th December 2017 so it can be assumed that surface flows were much greater during the flood event of 22nd November 2017.

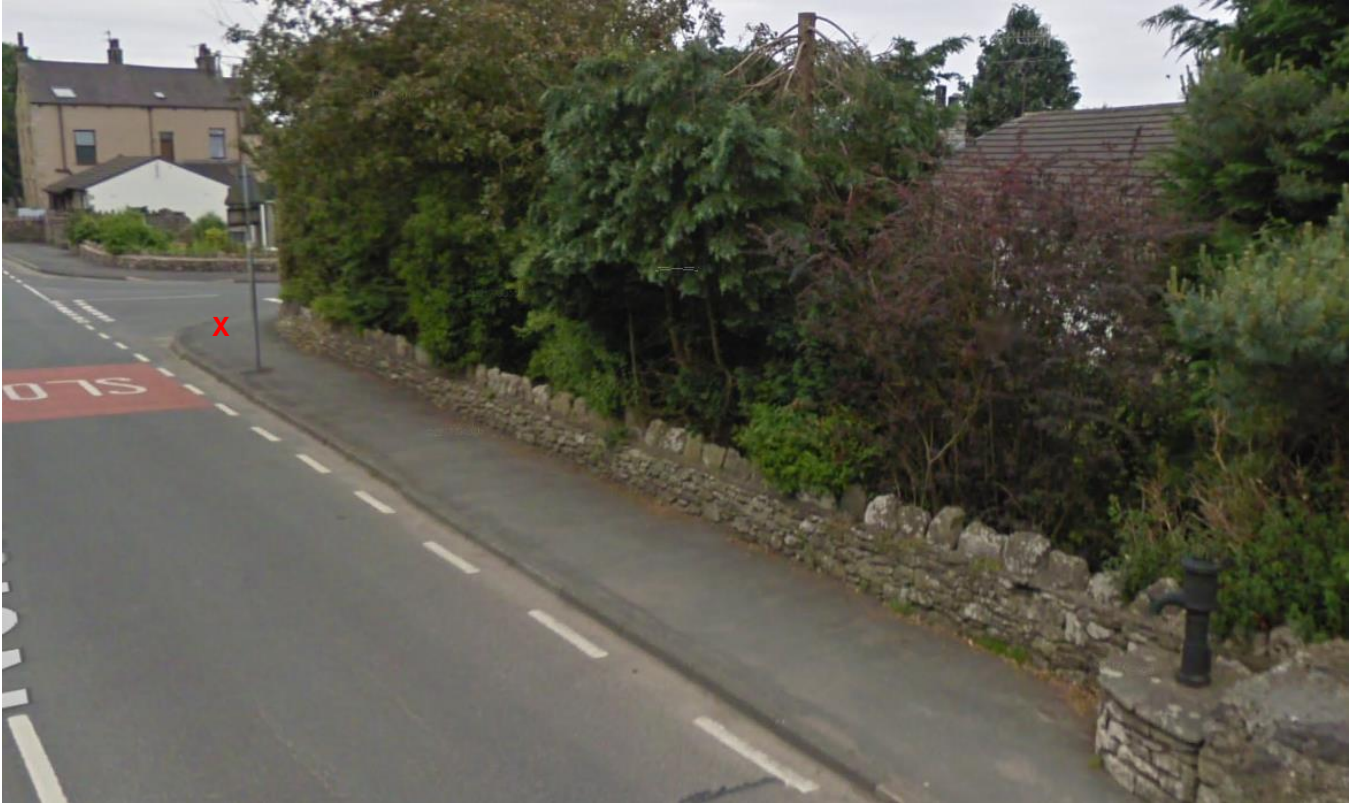
Figure 13: The pump in the bottom right of the picture is now purely ornamental. It is believed to have been moved from approximately the location as indicated by a red X.

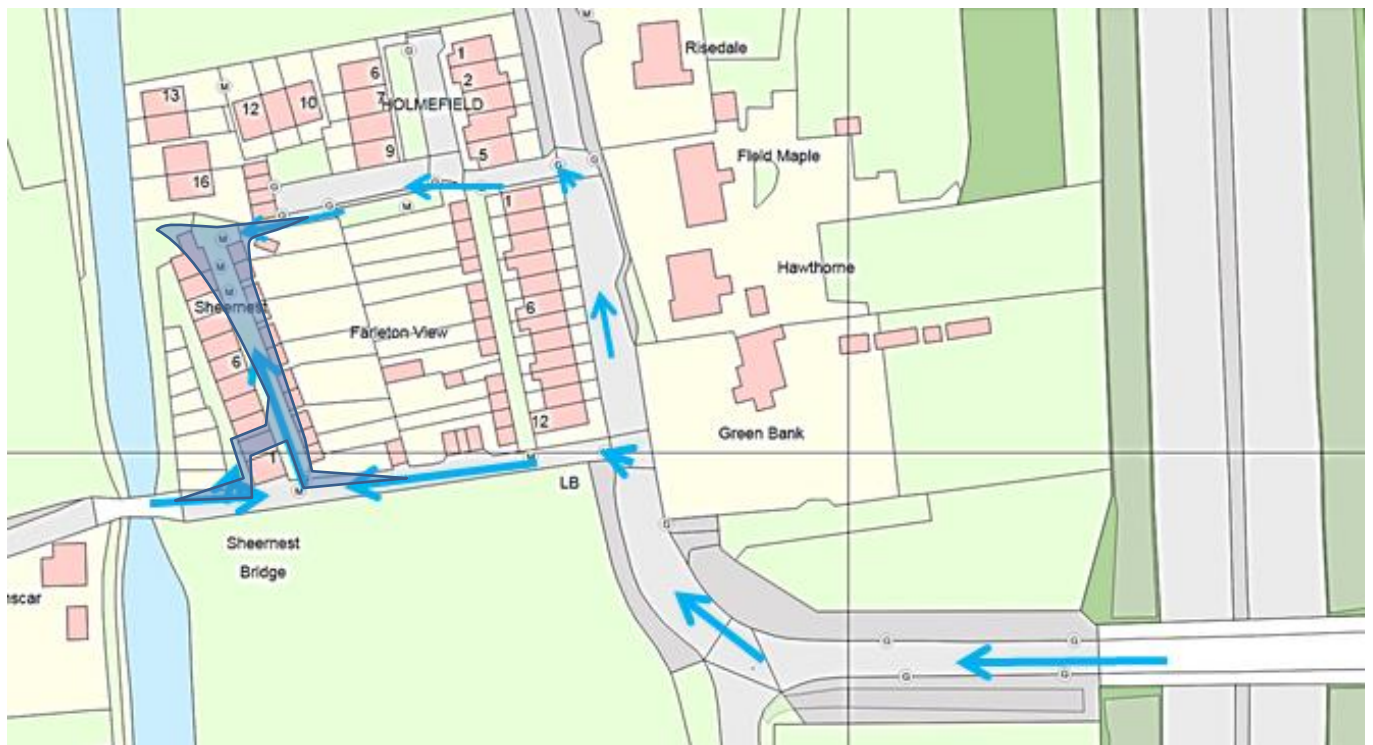
Figure 15: Extent of flooding and reported flows leading to Sheernest Cottages indicated by blue arrows.

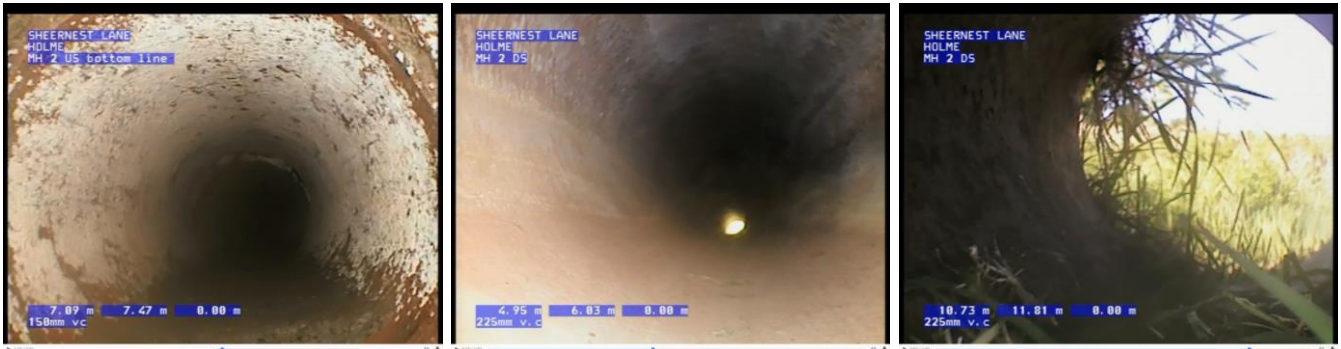
Figure 16: Images from CCTV survey along Sheernest Cottages back alley to northernmost outfall drainage run.

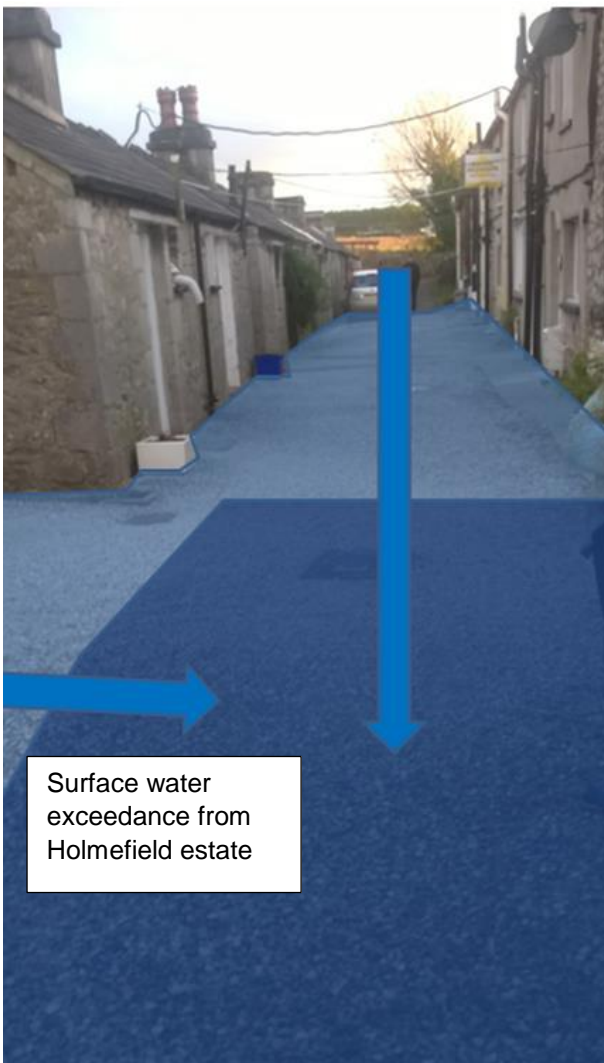
Figure 17: Surface flows from Sheernest Lane (top) and Holmeffield (left) start to flood in the darker shaded area and built up to fill the whole alley way.

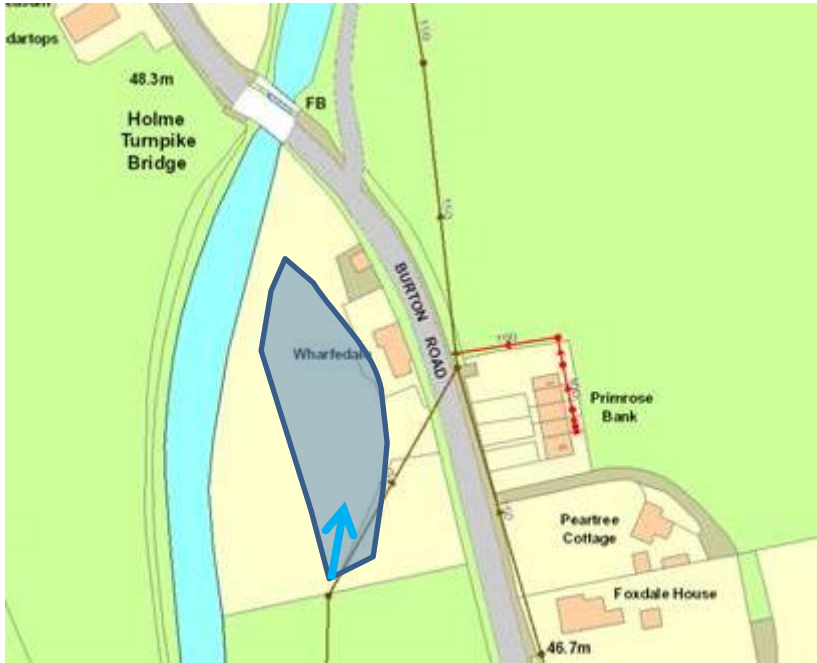
External flooding occurred at Wharfdale Cottage from water flooding out of a manhole on the foul system. This indicates a significant misconnection of surface water which is thought to have been the flood water at Sheernest getting into the foul system. United Utilities have surveyed this sewer and found no defect which means that the issue is hydraulic, the full discharge of the Wharfdale Cottage sewer is unable to connect with a downstream sewer that is running already at close to capacity. Repairs and improvements at Sheernest will reduce surface water getting into this system.

Figure 19. Wharfdale Cottage. Near miss of internal flooding out of foul sewer system.

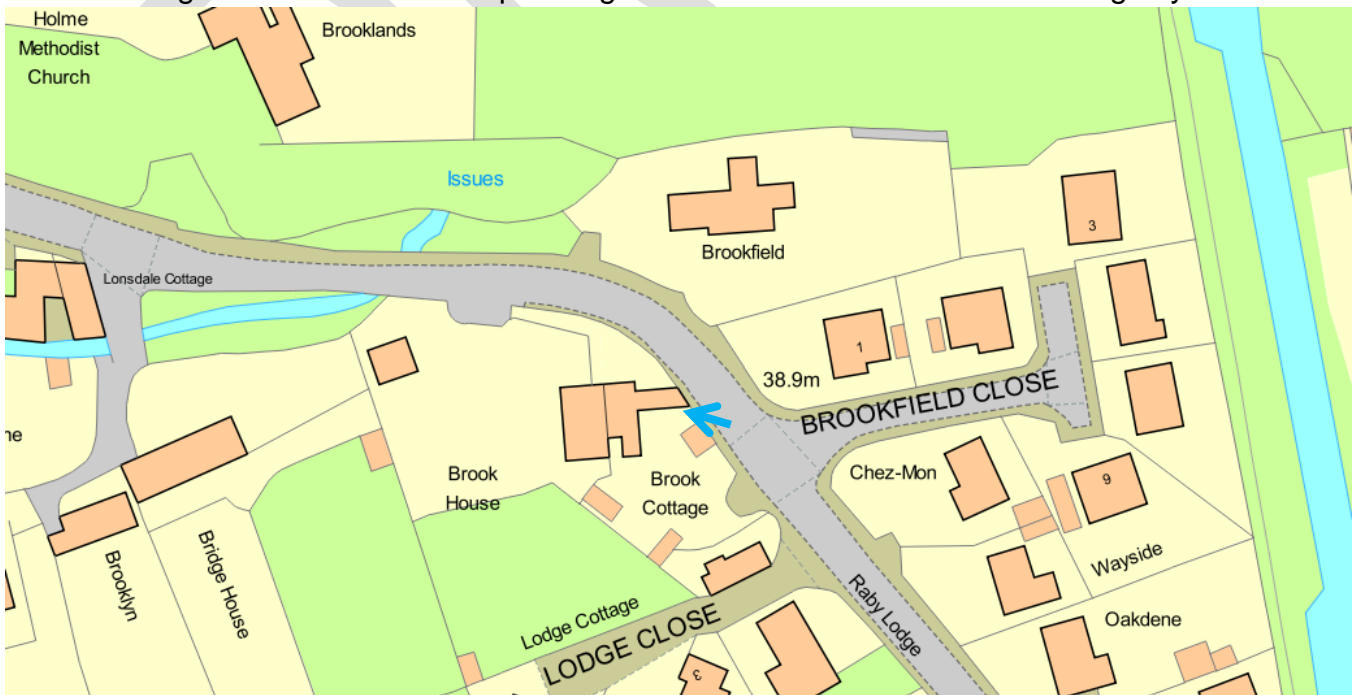
Water entered through the garden gate from the road where it becomes trapped in the yard by the building walls. Water came into kitchen, hall, and toilet, through the walls to a depth of 25mm throughout. It also backed up through the surface water and foul drainage systems.

Figure 20: Reported flood route at Brook Cottage on 22nd November 2017.

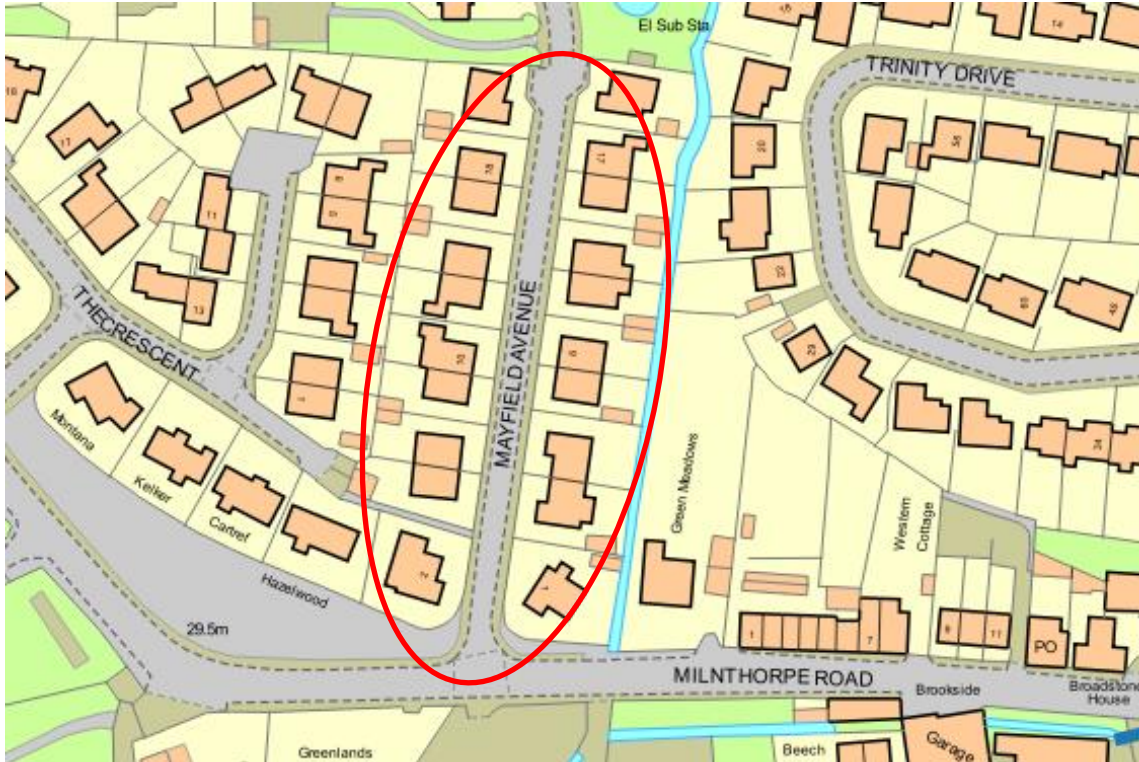
Frequent garden flooding has been reported on the older part of Mayfield Avenue. The gardens fill with ground and surface water which drains away very slowly. This occurs after every medium to heavy rainfall event.

Figure 21: Mayfield Avenue. The groundwater issues reported occur within the area circled in red.

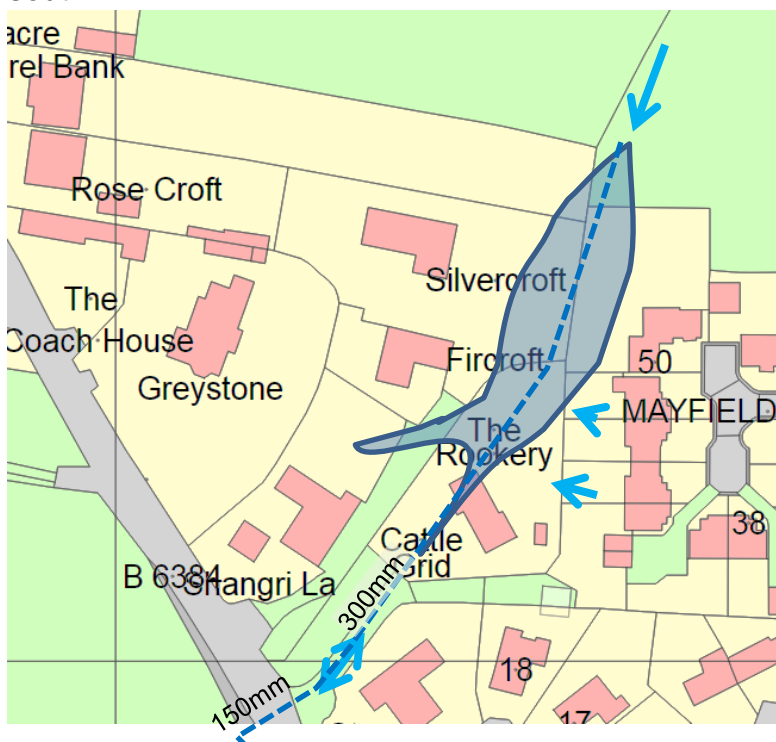
External flooding is reported to have occurred affecting three properties around Silvercroft. There are three reported sources of this flood water. These are surface water from the field to the north, runoff from overflowing soakaways from the Mayfield Avenue development to the east, and water backing up from where the culvert reduces in size under the highway to the south.

Figure 22: Silvercroft area: Extent of flooding. Line of culvert indicated by dotted line.

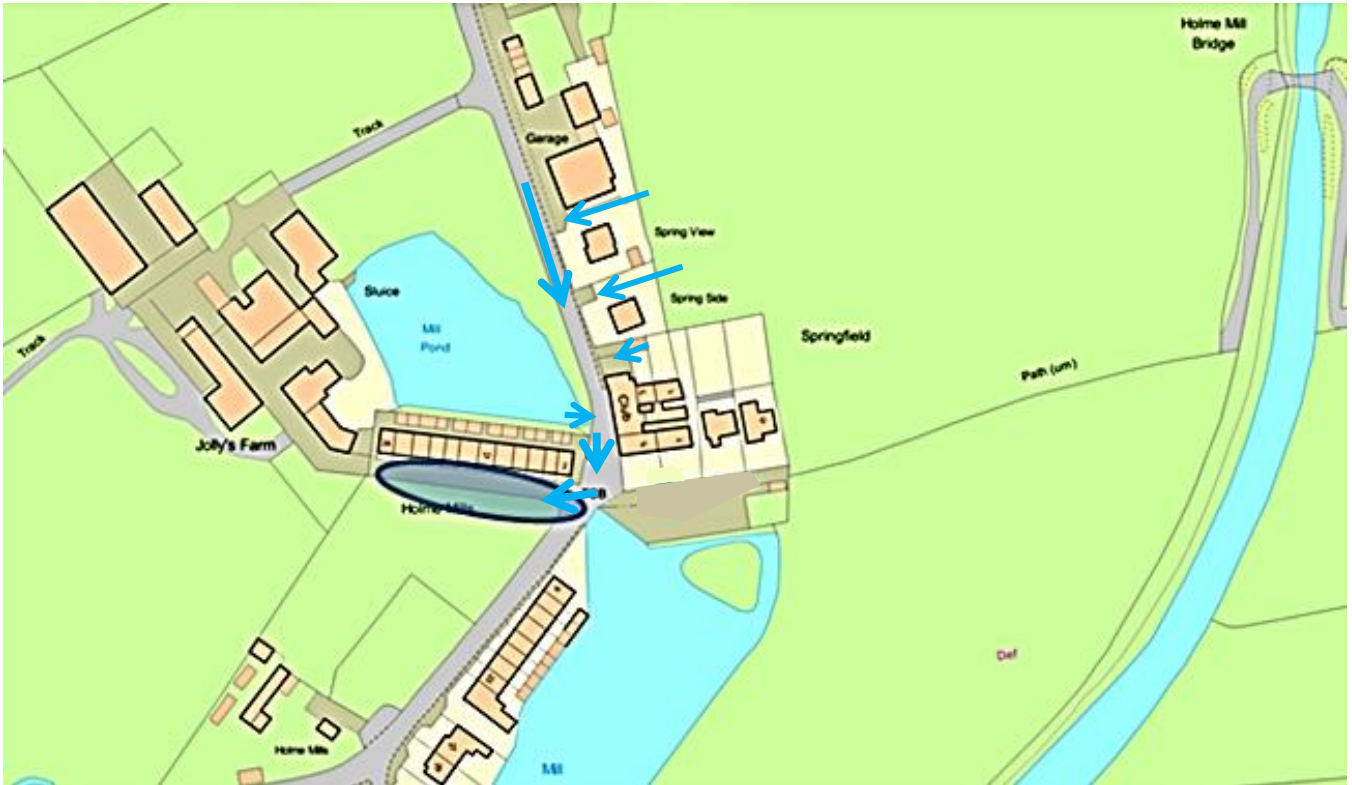
External flooding is reported to have occurred on the road serving the terrace leading up to Jolly's Farm. Heavy rain and snow melt are said to cause run off from the fields and to cause springs to emerge from underground. There have been blocked drains and the flow into the reservoir has been blocked in the past. There is a hole in the reservoir wall which is an overflow to let water out of the reservoir.

Figure 23: Flooding and flow routes at Holme Mills.

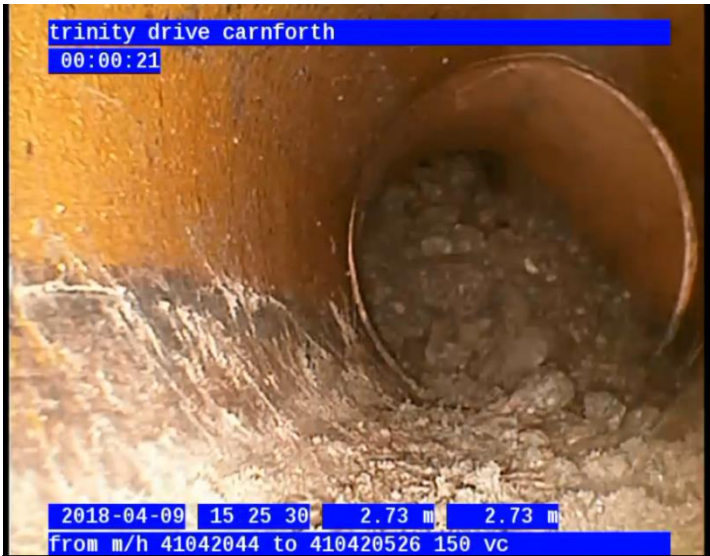
This picture is beneath one of the locations where water spouted up from the ground. The soil had collapsed in from the top next to the garden wall. This has been repaired and the pipe leads to the manhole in the pavement which is the top of the run. Continues as 150mm dia. Clay pipe.

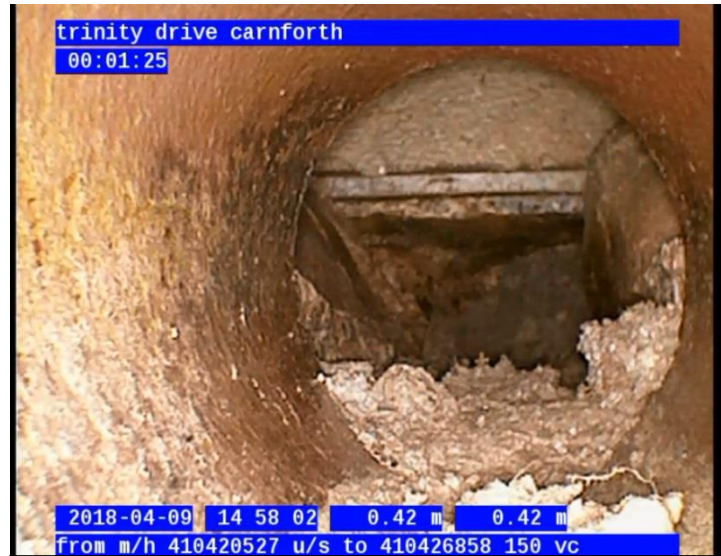
This ends at a failed land drain from the days when this land was undeveloped fields. A small quantity of water could be added to the system by this route. Continues as 150mm dia. clay pipe.

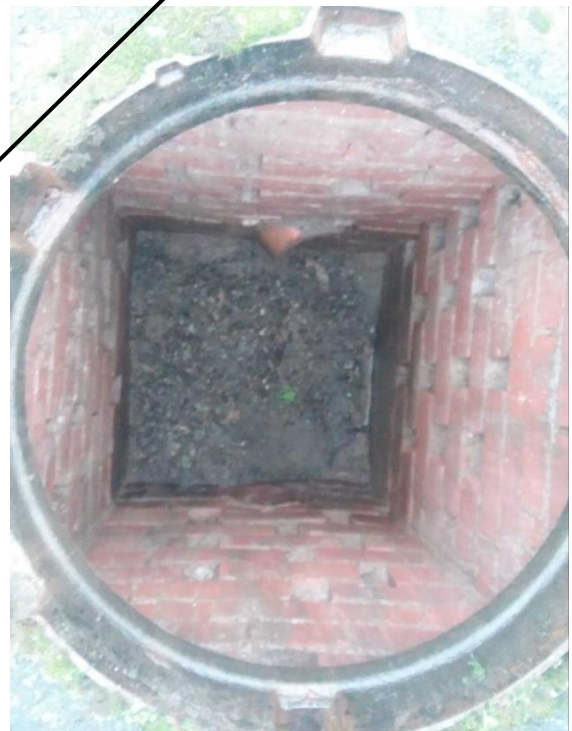
This manhole has gaps in the brickwork which are to allow water in the ground into the system to be drained away. Continues as 150mm dia. clay pipe.

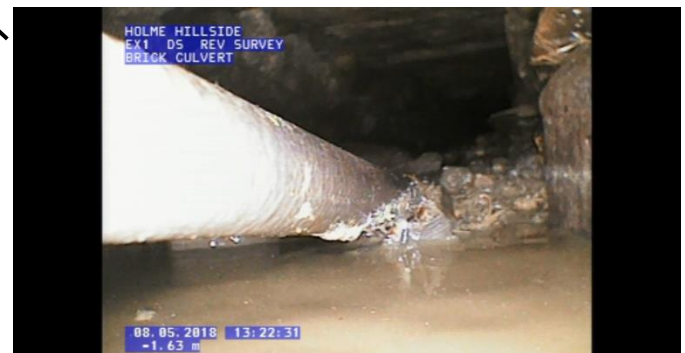
Survey ends here, just beyond the fence line, where collapse is near total and there is an unidentified pipe within the culvert barrel. No further progress with camera in downstream direction. Significant flow does come through as proven by dye testing.

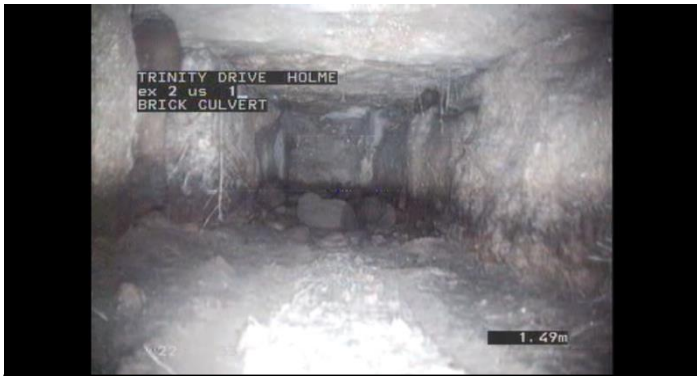
The left branch looking upstream is either capped off or has collapsed directly beneath the wall of the building. The dimensions are 300mm x 300mm stone.

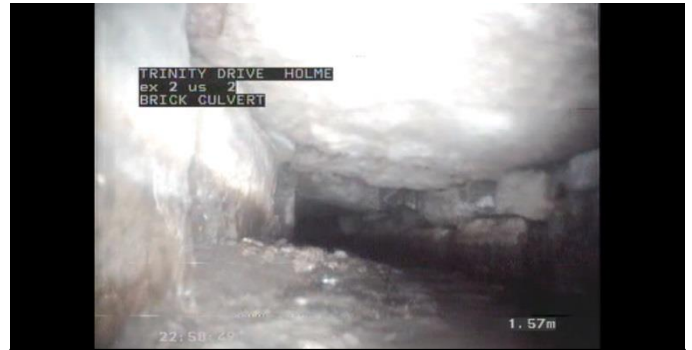
No further progress in upstream direction, low roof and debris shoal directly beneath wall of building restricts clearance and camera can't get through. Significant flow does come through this branch though as seen with dye testing.

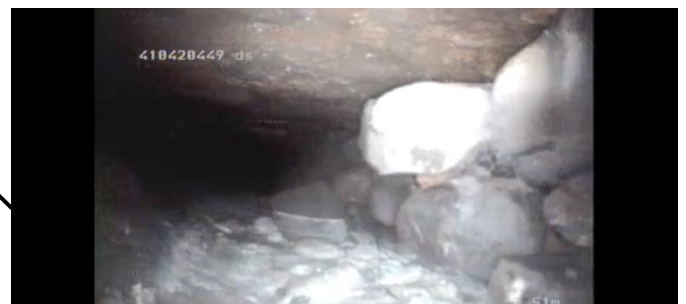
Debris shoal restricts clearance and camera can't get through. Walls crumbling in. Where good the shape is approx. 450mm w x 300mm d stone.

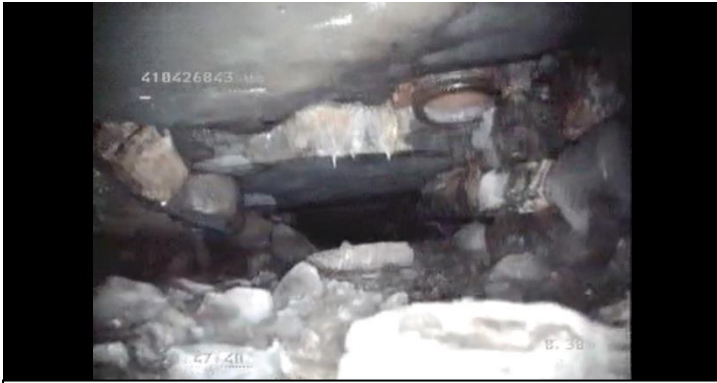
Debris, stones on base from culvert wall.

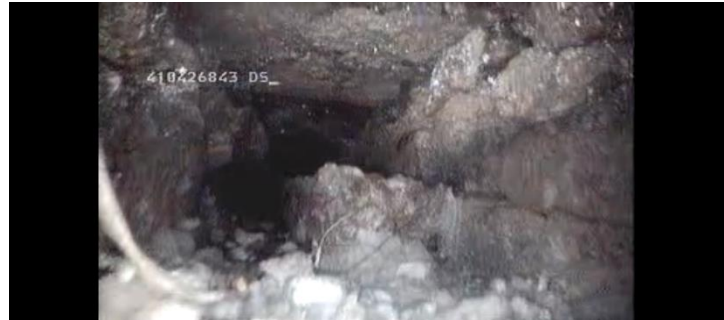
Large brick in the line from side. Where good the dimensions are recorded as 250mm x 250mm, stone.

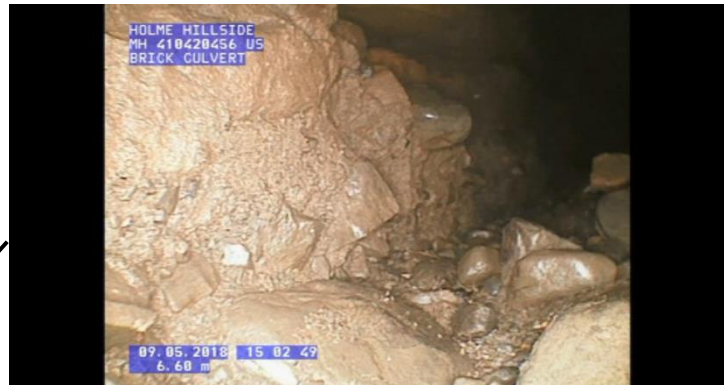
Stone debris restricts clearance deflects camera into sides. Camera can't get through.

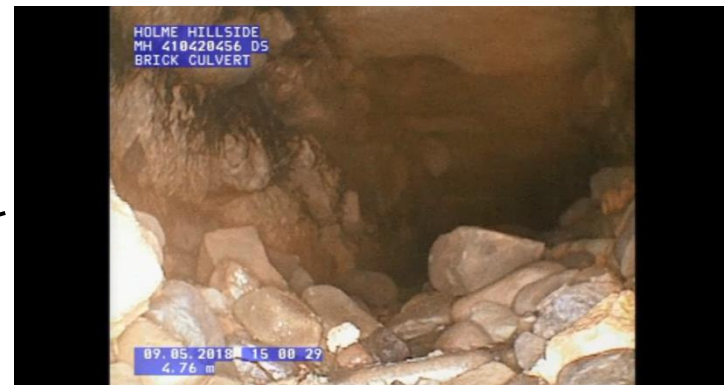
Large stone debris deflects camera into sides. Camera can't pass. This section is recorded as 450mm x 450mm, brick.

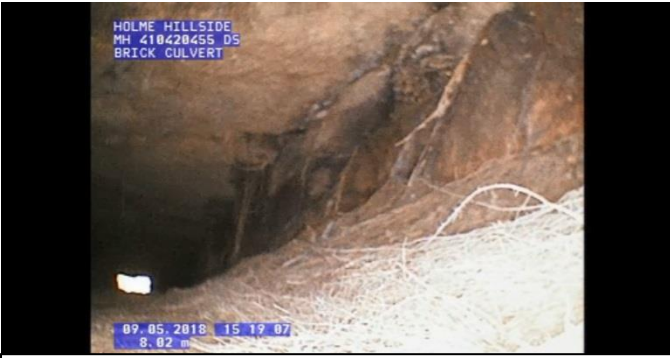
Camera caught in roots. Daylight visible downstream. 450mm x 450mm, brick.

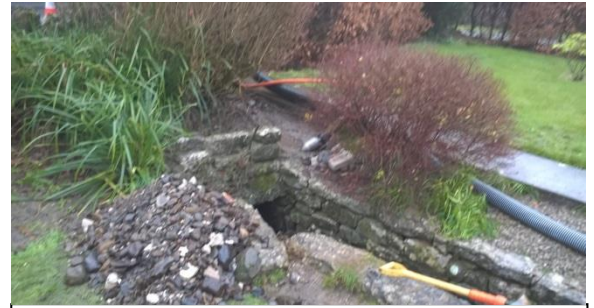
Lots of gravel collects at step down as open channel changes to pipe. CCTV image is looking upstream to waterfall. 450mm dia. concrete pipe.

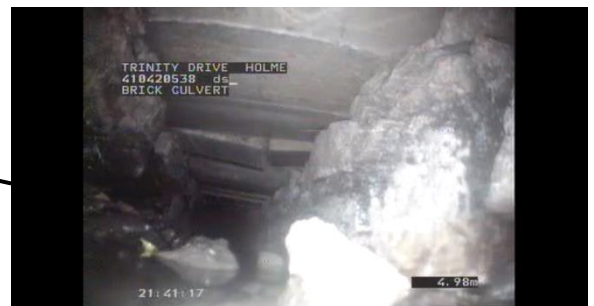
Walls tilting inwards preventing passage of camera. 450mm x 450mm, brick.

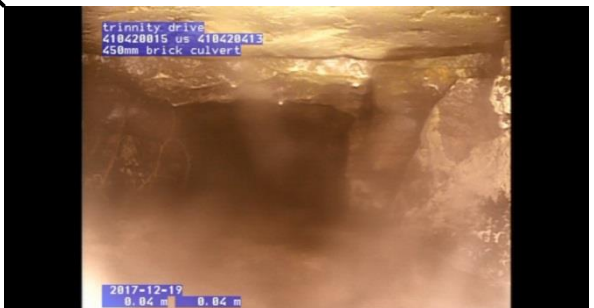
Walls tilting inwards preventing passage of camera. 450mm x 450mm, brick.

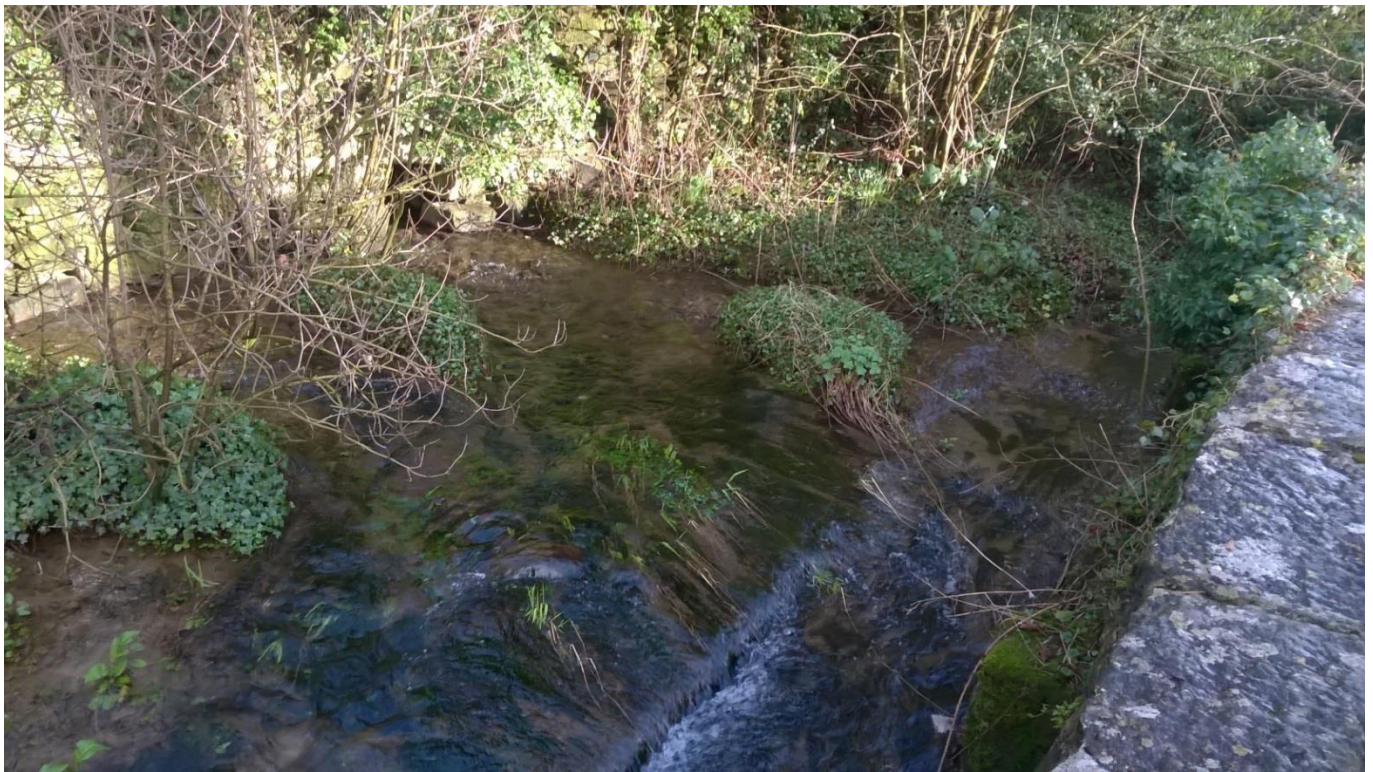
Water can be seen welling up from the stone from the road near Brooklands. This process is visible here and there are indications that this is occurring out of sight at a number of locations across the village.

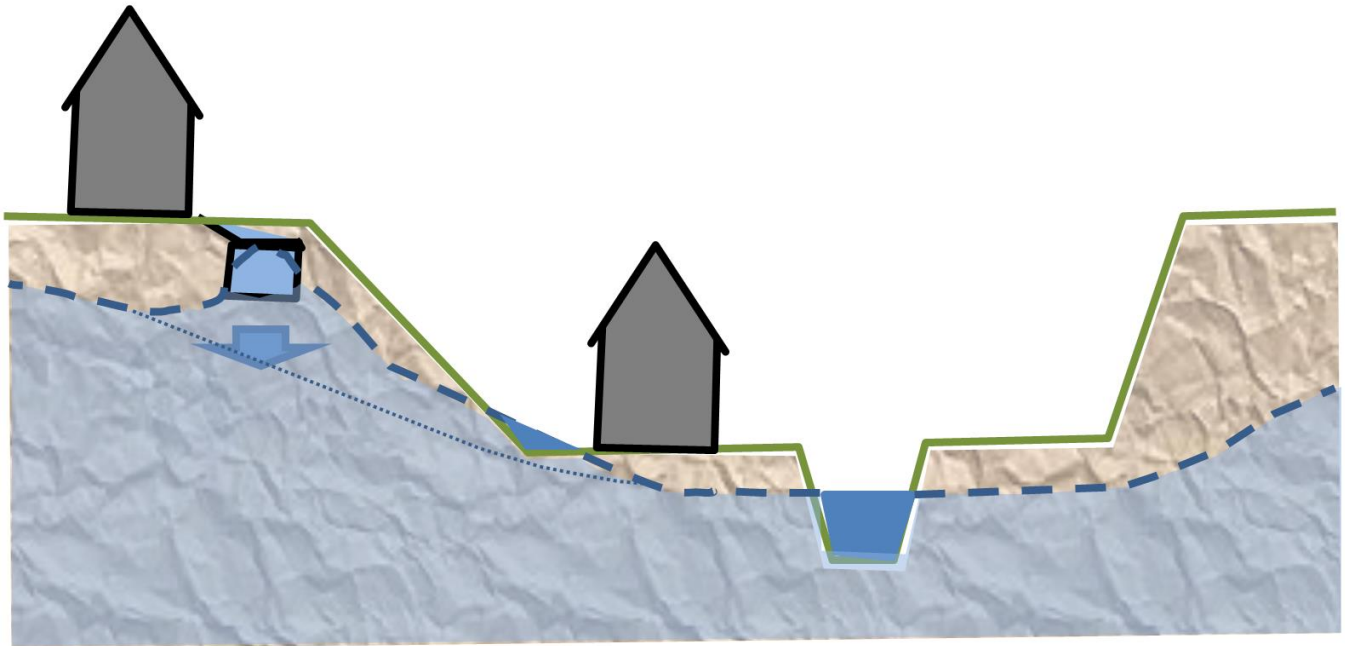
Groundwater flooding at Mayfield/Silvercroft. Water table intersects with the level of the watercourse and rises with the topography. It can also rise locally under an input of water as from a soakaway and where this intersects with the surface flooding can occur. This is a particular risk at the base of a slope.
