Kendal

Flood Investigation Report

Sandylands and Mintsfeet on the 6th December 2015

Flood Event 5-6th December 2015

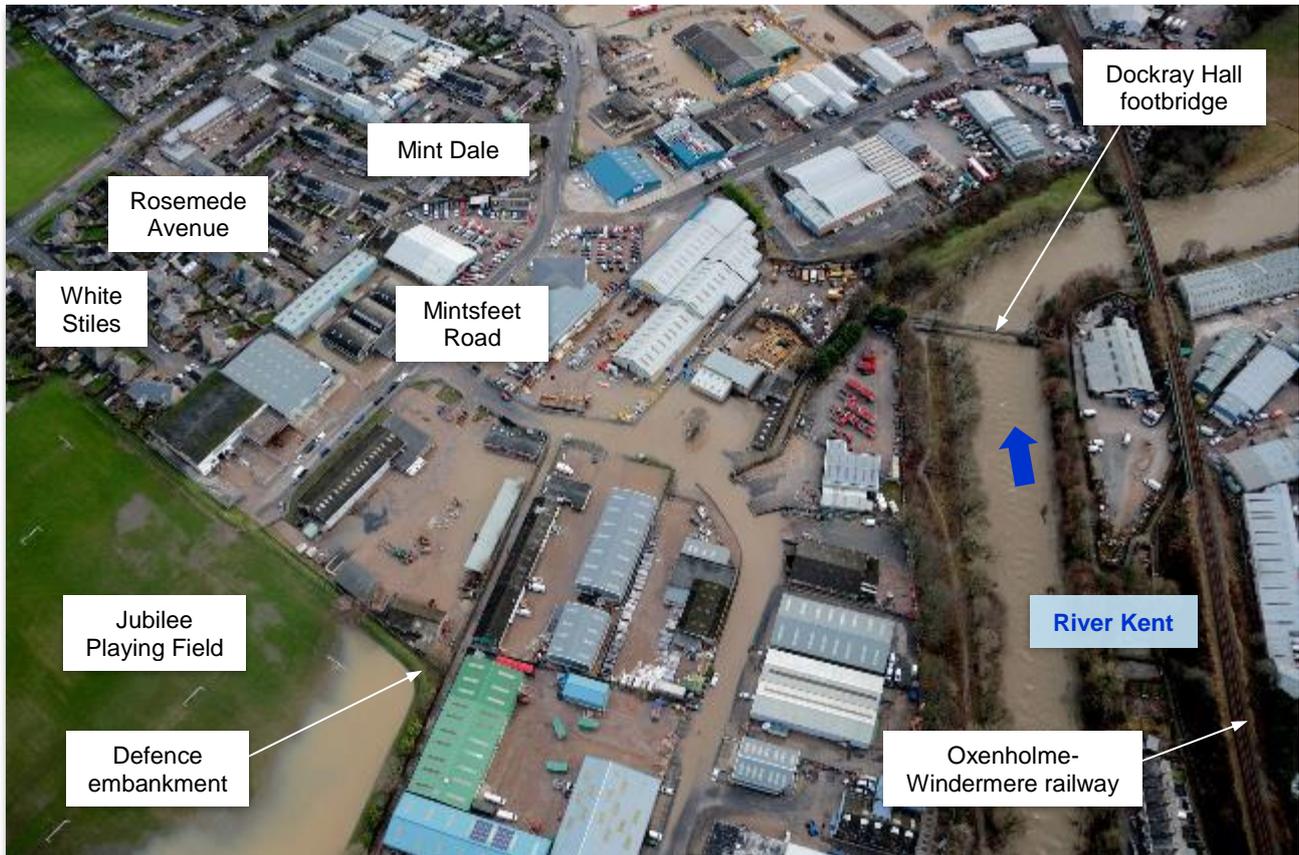
Floodwater from these sources was then able to flow through the business park and across the Jubilee Playing Fields to the south, where it was initially impounded against the existing flood defence embankment highlighted on Figure 12 and shown in Figure 13.

Figure 13: Aerial photograph from 6th December showing the flooding in Mintsfeet and the existing flood defence embankment along the south and western boundaries of the Jubilee Playing Fields

Whilst the embankment in the Jubilee Playing Fields impounded floodwater initially, the sheer magnitude of the flood event meant that it was overwhelmed. This caused flooding to residential properties on Finley Close, Finley Drive, White Stiles, Rosemede Avenue and Mintsfeet Road, with internal flood depths reported to reach 1.2m (see Figure 14). Commercial properties on Mintsfeet Road, including those in the Mintsfeet Industrial Estate were also affected. In addition to the damage caused by internal flooding to property, the combined depth and velocity of the floodwater resulted in widespread structural damage, with a number of boundary walls destroyed in the area.

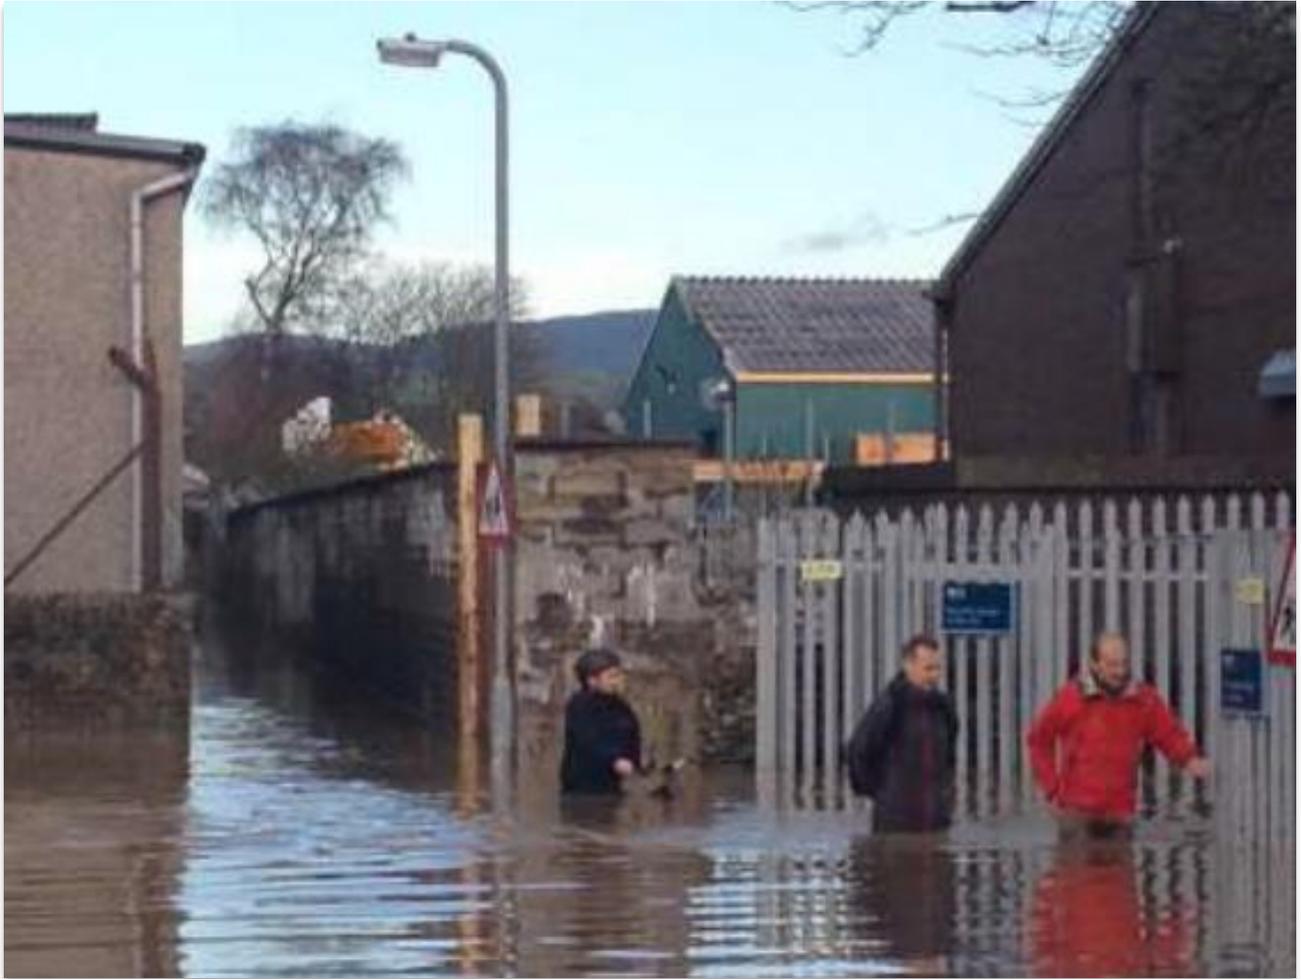
Flooding in the Mintsfeet area took days to drain away. This is due to there being a limited number of surface water outfalls. The combined sewer network in the Mintsfeet area is pumped and the pumping station was damaged during the flooding. This essentially meant that a small Combined Sewer Overflow (CSO) was the only available outlet for the flood water, which drained over a period of days.

Figure 14: Flooding in the Mintsfeet area

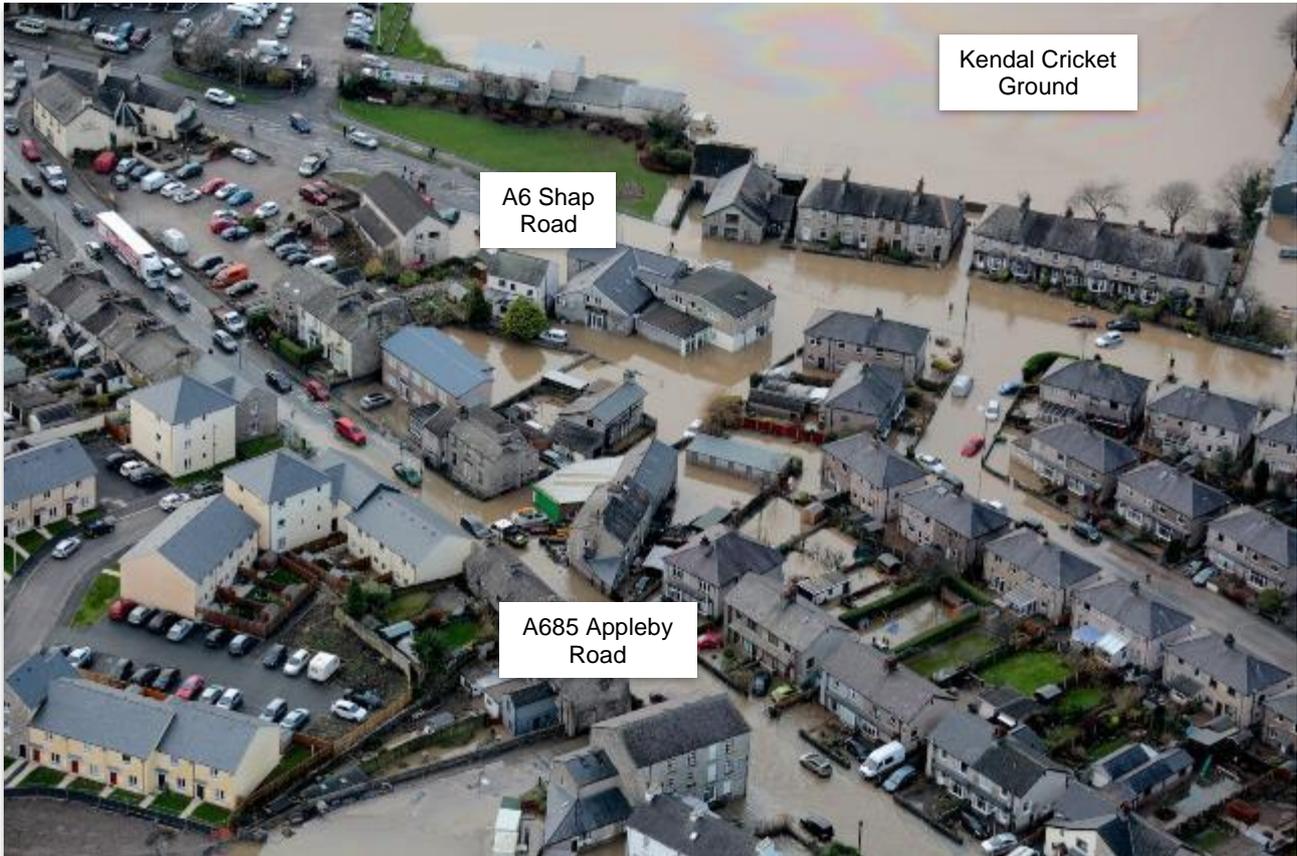
Figure 16: Aerial photograph of Shap Road and Appleby Road area on 6th December 2015

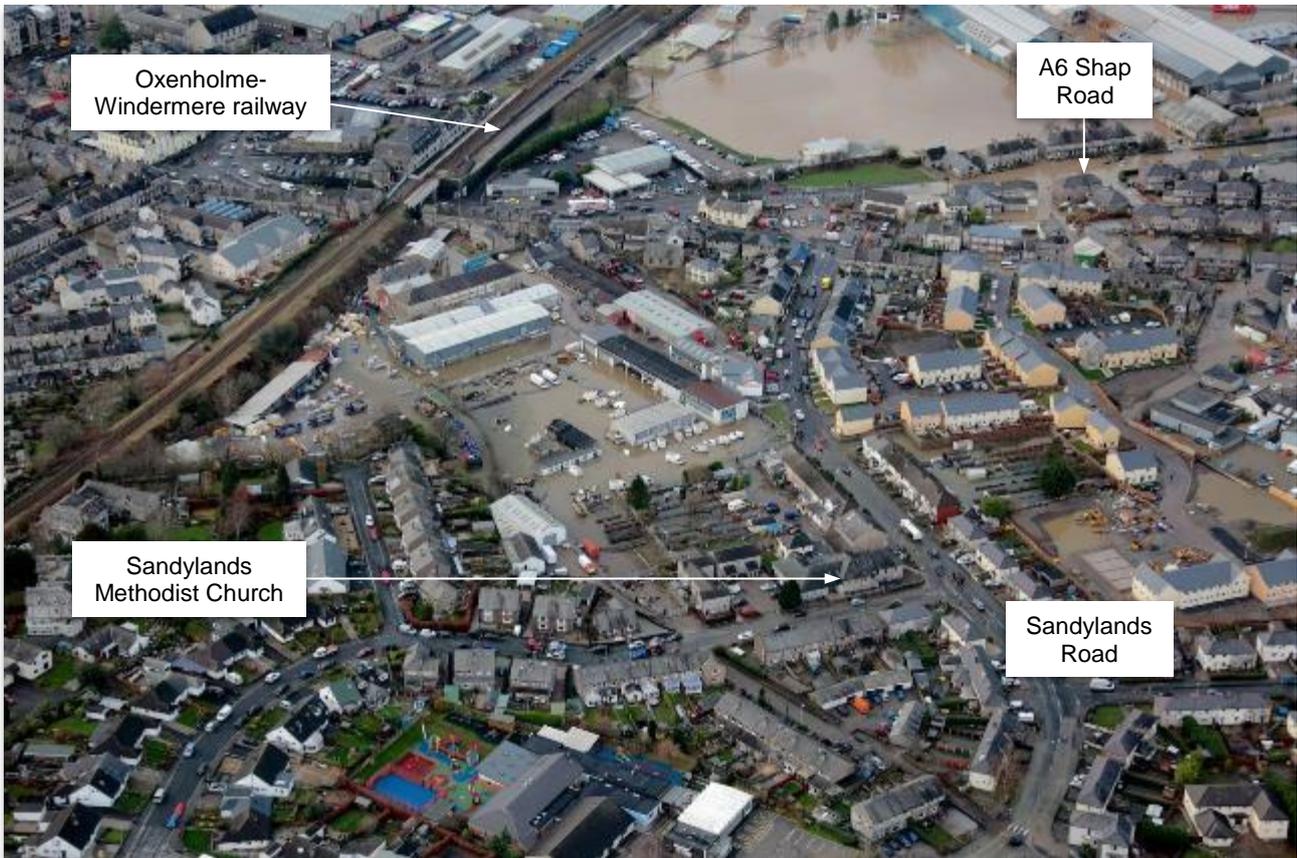
Figure 18: Aerial photograph of the Sandylands area on 6th December 2015

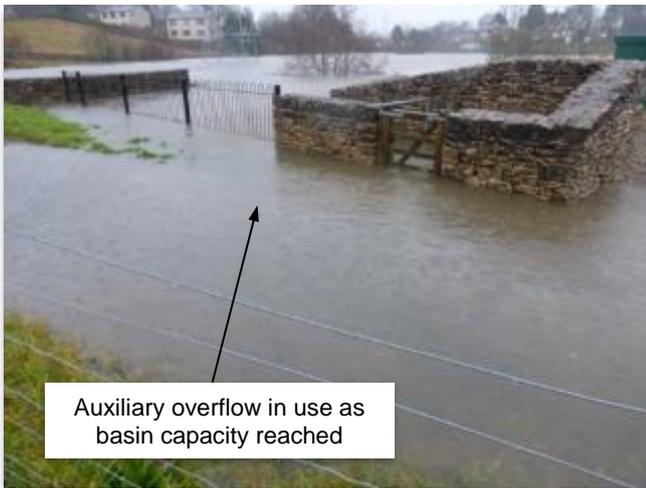
Environment Agency telemetry, which monitors water levels at the FSB, indicates that the basin spillway level was reached around 12:45. The telemetry indicates that levels within the FSB continued to rise through the afternoon, before peaking around 18:00 and slowly receding through the late evening and into 6th December. During the Storm Desmond event, it is apparent from photographs taken on the afternoon of 5th December that the capacity of the storage basin was reached. In Figure 19, the photograph on the left clearly shows that at 16:00, the basin is full and the auxiliary overflow (a protected section of embankment shown in the foreground of the photograph) is in use.

Auxiliary overflow in use as basin capacity reached

Figure 19: Stock Beck FSB at 16:00 05/12/2015 (left) and at 08:57 06/12/2015 (right)

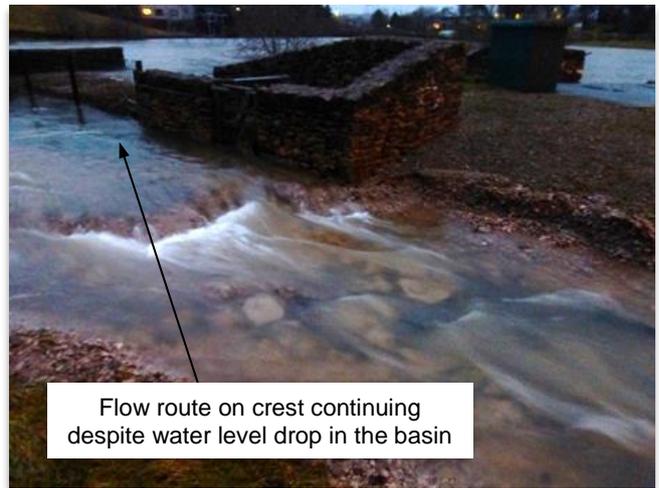
Flow route on crest continuing despite water level drop in the basin

Furthermore, the photograph on the right in Figure 19 shows water flowing along the crest of the water-retaining embankment after water levels in the main storage basin have started to recede. This water was able to by-pass the storage basin and flow down Calder Drive, causing further internal flooding to a number of properties. The source of the overland flows in this particular case was one of the tributaries of Stock Beck, which drains a steep catchment off the fells due east of Sandylands. At the point of entry into the basin, the watercourse is in open channel and the bed level of the channel is close to the level of the embankment crest. As it meets the embankment, the watercourse then enters into culvert via a trash screen and drop structure as shown in Figure 20.

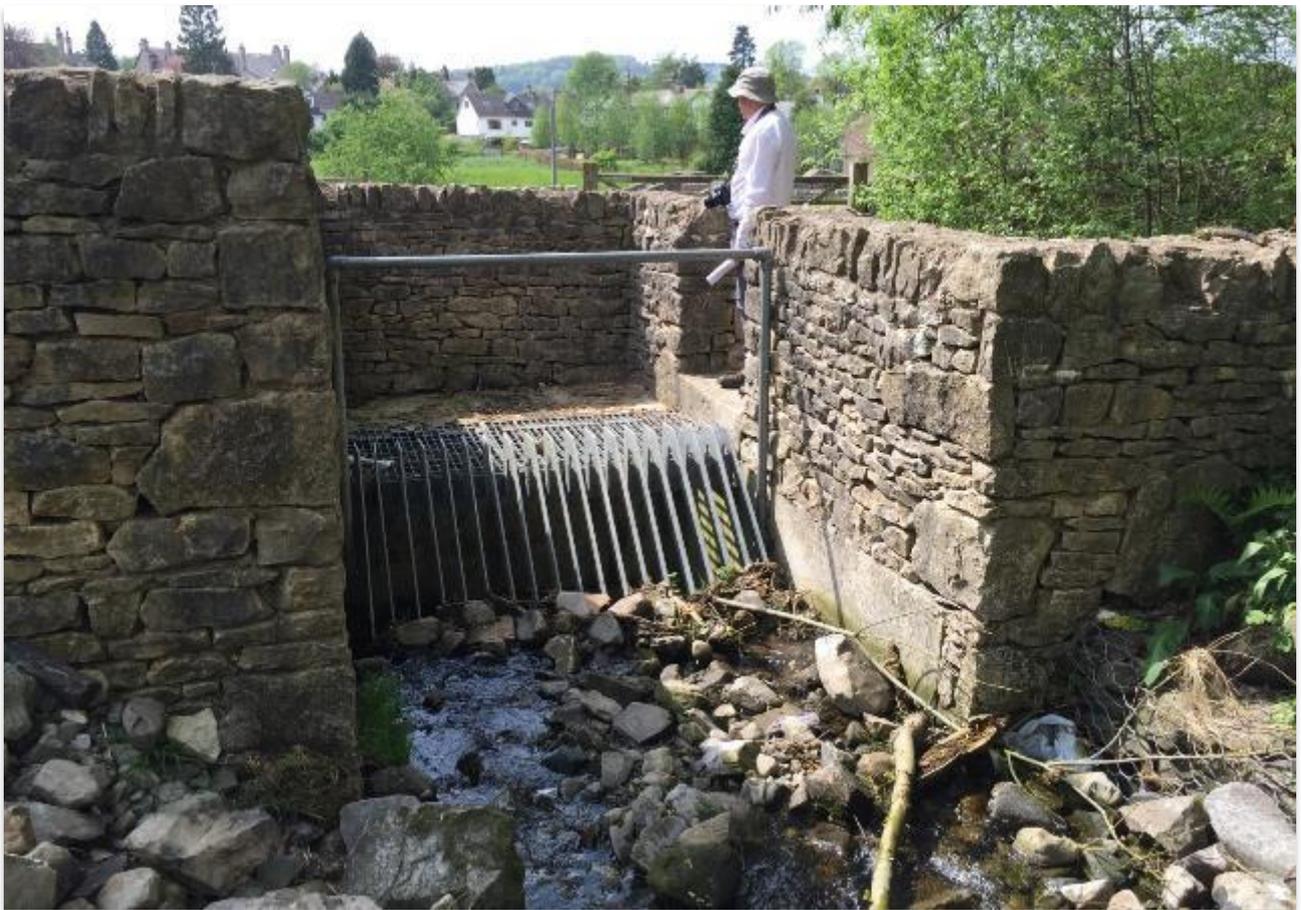
Figure 20: Stock Beck tributary culvert inlet to Stock Beck FSB

During the event, the trash screen was blocked by debris and the inlet capacity of the culvert exceeded, causing water levels to back up. A significant amount of debris was washed down onto the screen from

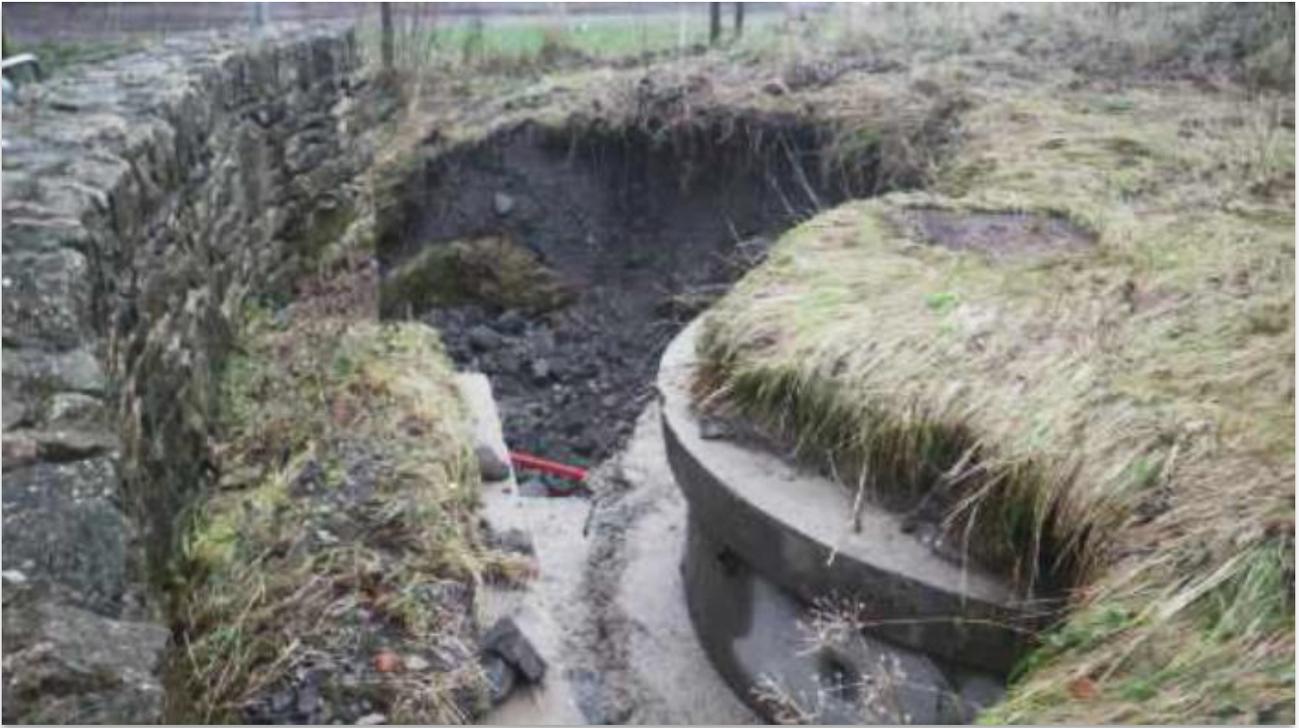
a damaged outfall structure immediately upstream. Material was scoured from behind the structure due to discharge from an outfall pipe on the right bank flowing into the discharge from the outfall, with the subsequent turbulence causing the extensive scour illustrated in Figure 21. Unfortunately, the design of the inlet structure is such that the access provided to allow the screen to be cleared also provided the pathway for the water to escape. Flows passed through the gated opening as opposed to entering the culvert and spilled onto the basin embankment crest. The topography of the crest is such that these flows were then channelled along the crest (as opposed to spilling back into the basin) before continuing into Calder Drive.

Figure 21: Scour damage to rear of outfall structure upstream of Stock Beck FSB

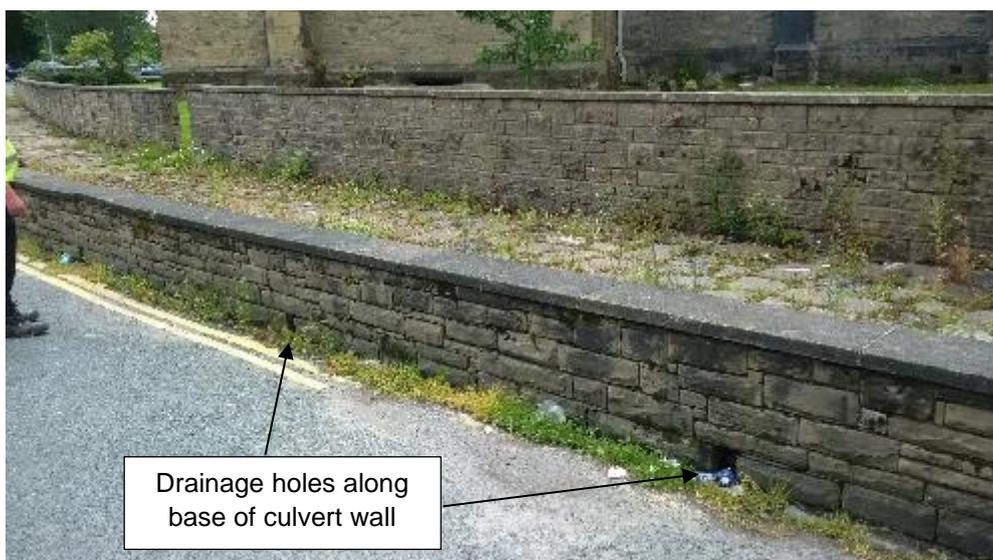
Residents on Castle Crescent reported that post-flood water drained away from the area via the redundant Stock Beck culvert. The redundant culvert has drainage holes along the base of its raised wall (see Figure 23), allowing water to enter the culvert, and runs along Castle Crescent to the rear of St George's Church, before passing under Gooseholme and discharging to the River Kent via a small pipe. This arrangement provides surface water drainage to the area during and after periods of prolonged rainfall.

Figure 23: Redundant Stock Beck culvert on Castle Crescent

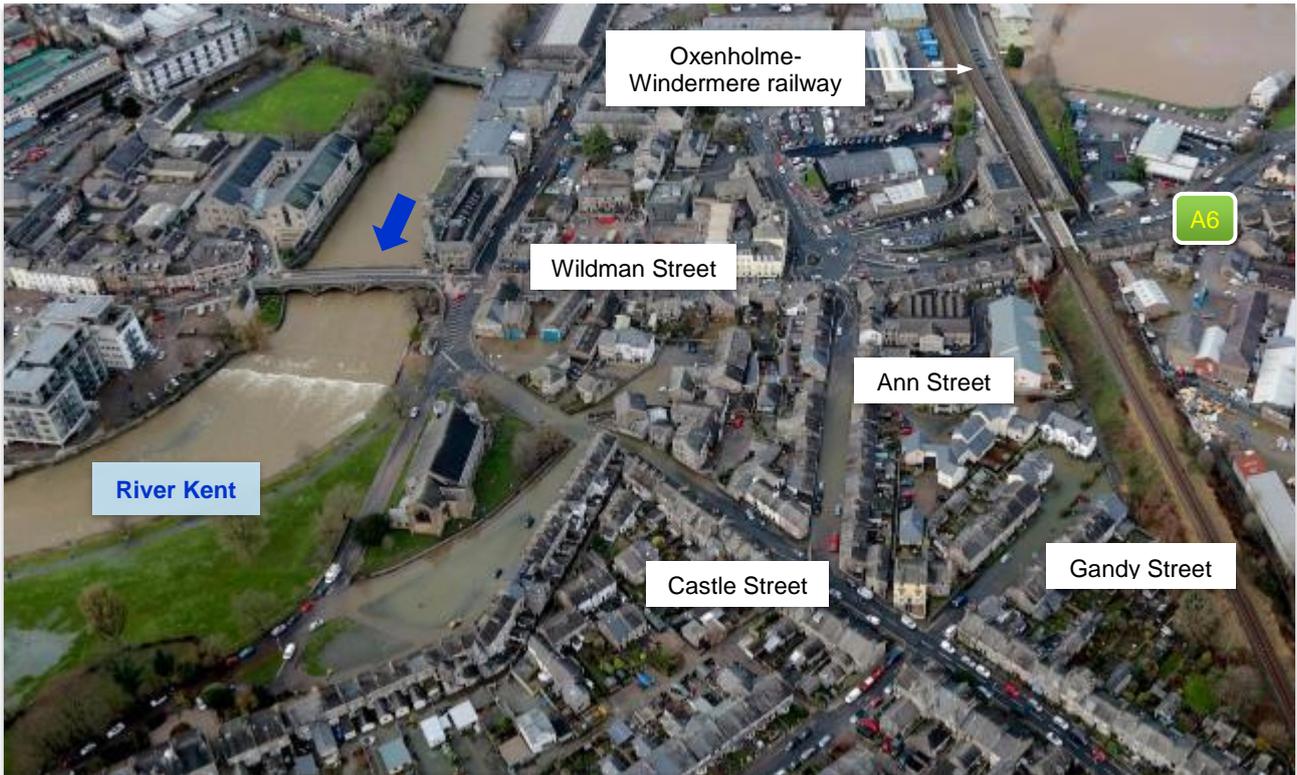
Figure 24: Aerial photograph of the Ann Street and Castle Street area on 6th December 2015

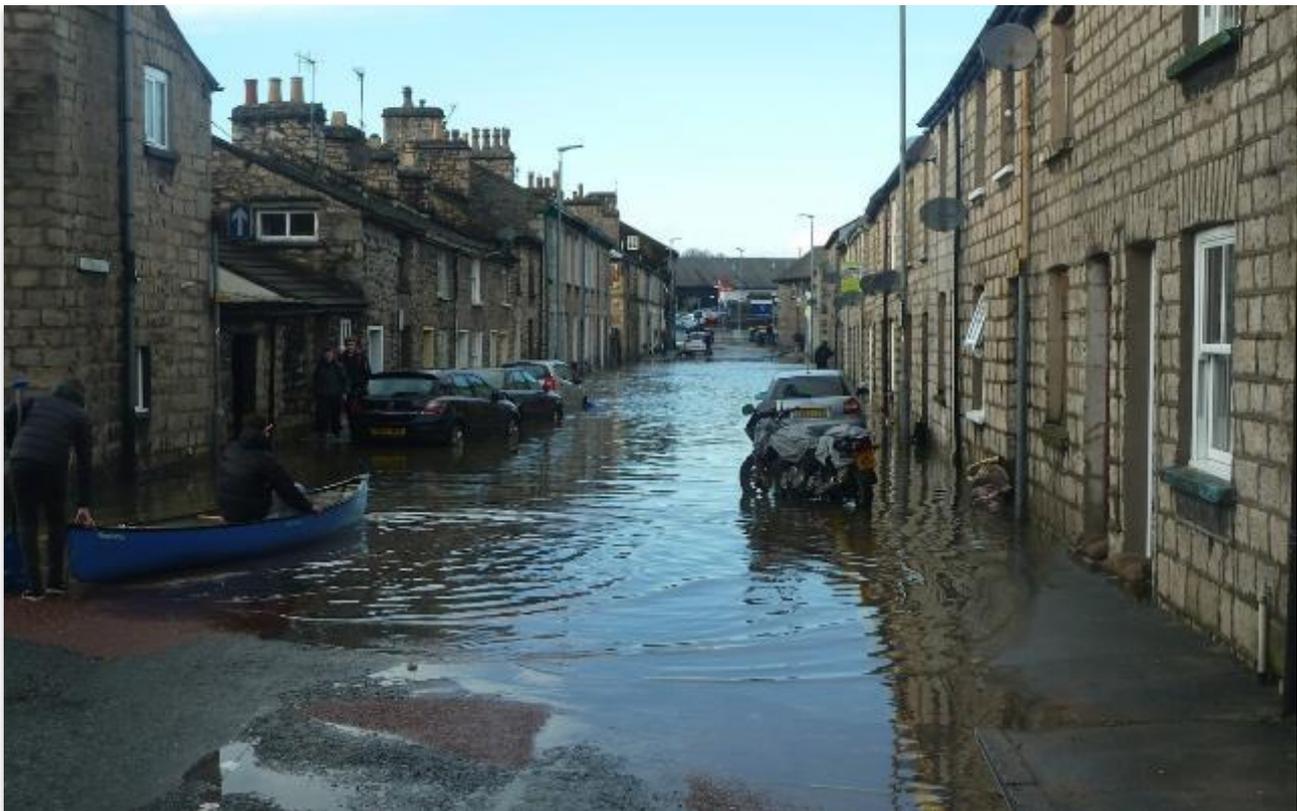
Figure 25: Ann Street in the aftermath of the event on 6th December 2015

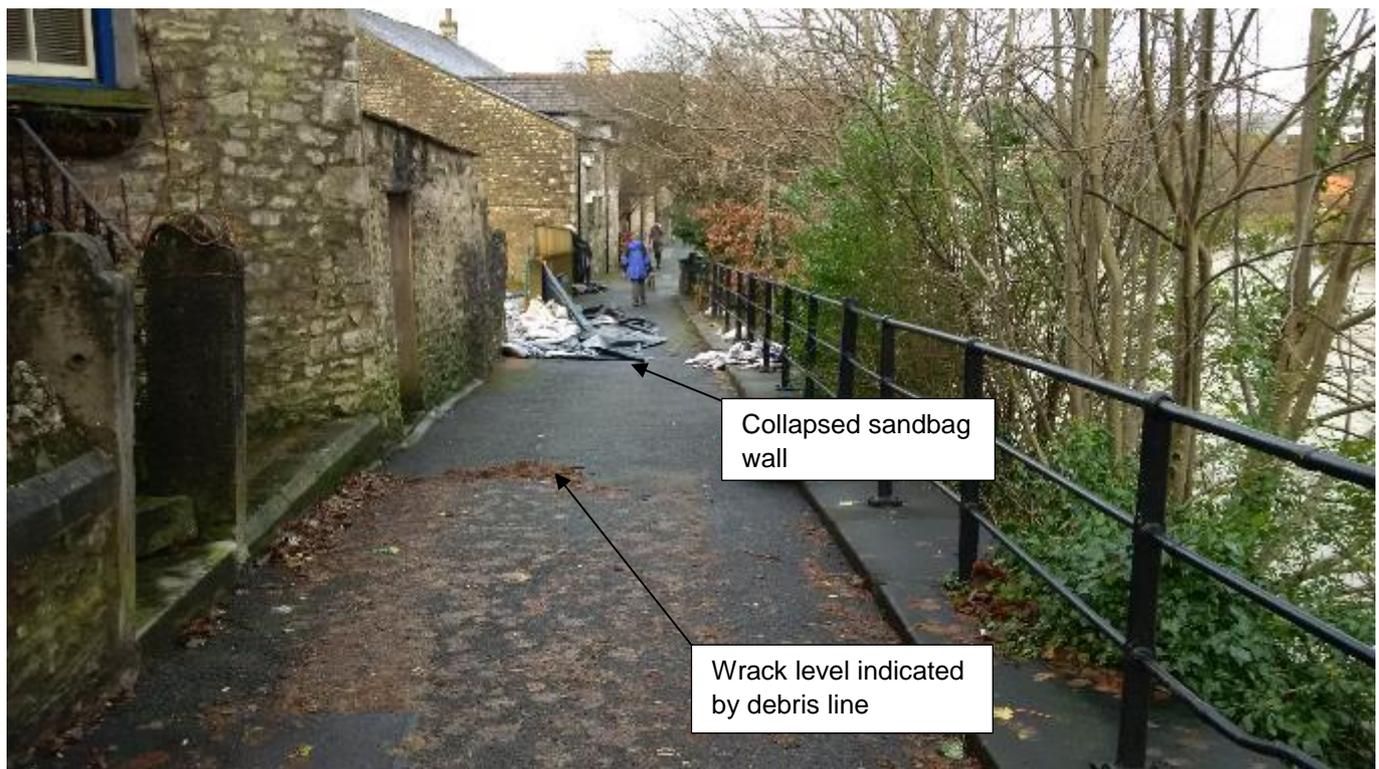
Residents of Benson Green raised concerns that Victoria Bridge reached capacity, and therefore acted as an obstruction to flow during the flood event, raising flood levels at their properties situated upstream of the bridge. Figure 26 shows the wrack level (marking the peak water level) on the riverside path on the right bank of the River Kent adjacent to Victoria Bridge. This level has been surveyed as 45.30m AOD, which, when compared to the Victoria Bridge soffit level of 45.12m AOD, shows that Victoria Bridge did reach capacity during the flood event by around 0.18m. Figure 26 also shows a collapsed sandbag wall, which has collapsed towards the river, illustrating the force of water flowing towards the river from the rear of properties in Benson Green.

Figure 26: Wrack level on the riverside path at Benson Green, adjacent to Victoria Bridge. Note the sandbag wall which has collapsed towards the river.

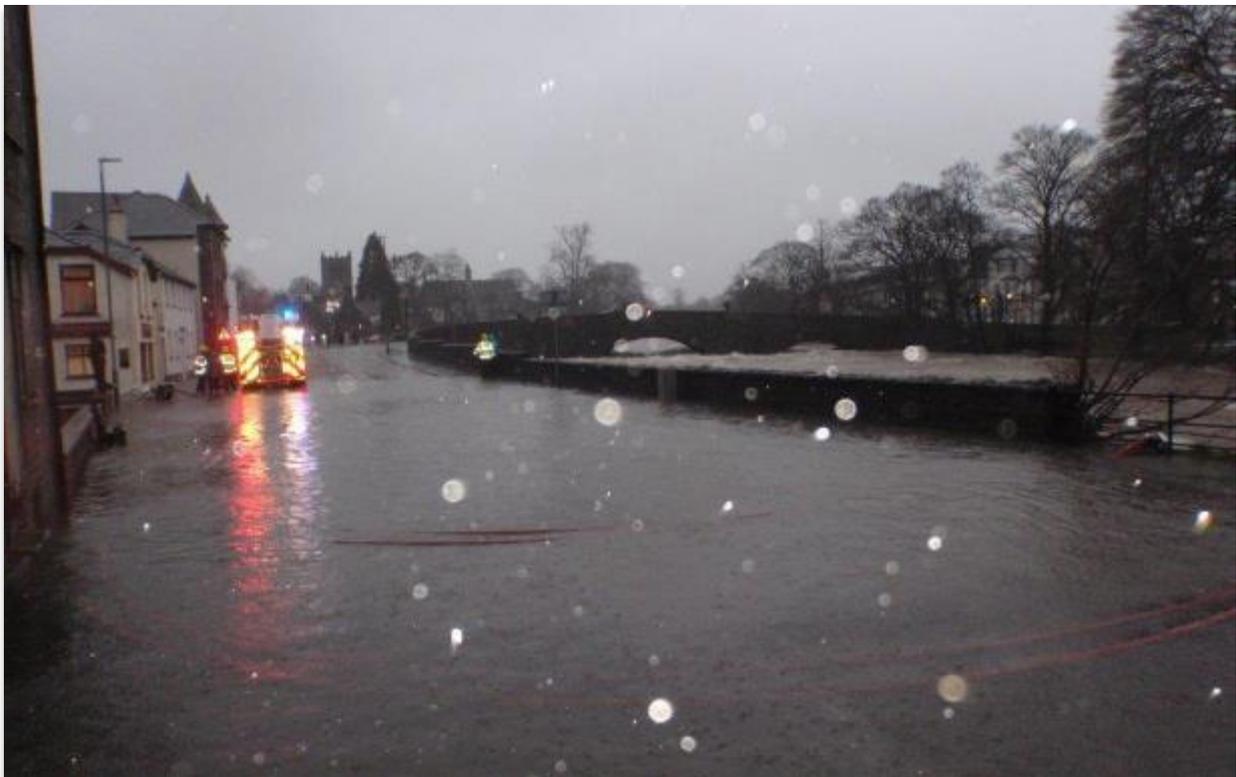
The east and west sides of Kendal are connected by a series of bridges over the River Kent and these have varying ages and construction types. The bridges include road bridges, pedestrian footbridges, and a railway viaduct, and are thought to have exacerbated the flooding along the banks of the River Kent. Evidence suggests that these bridges reached their capacity during the event and Figure 29 shows the water level in the River Kent approaching the soffit of the eastern arch of Nether Bridge. The railway viaduct is also thought to have had a role in diverting flow in the River Kent into the Mintsfeet area. Further investigatory work is required to fully assess the role of the bridges and to identify where conveyancing improvements can be made.

Figure 259: Nether Bridge, taken on the right bank of the River Kent looking north

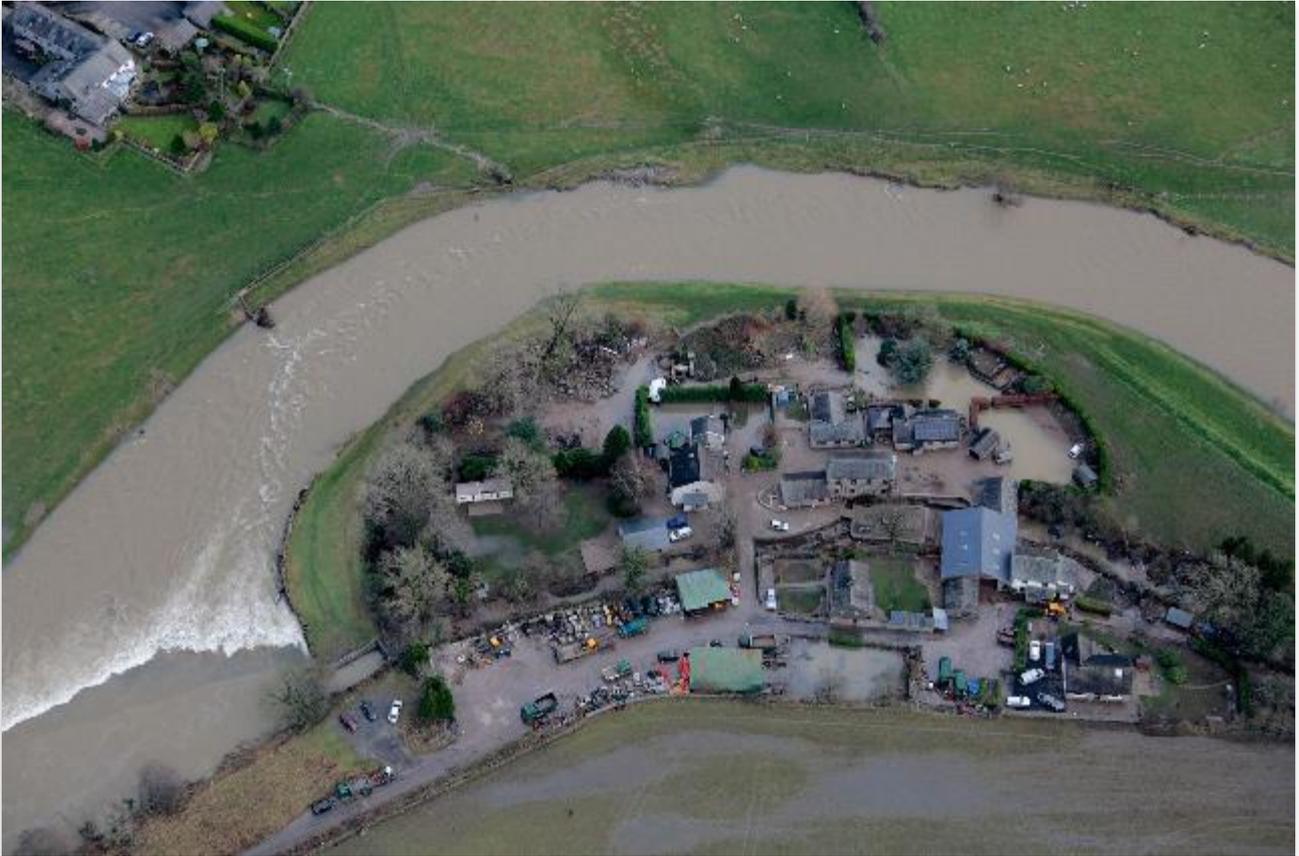
Figure 32: Aerial photograph of Helsington Mills on 6th December 2015

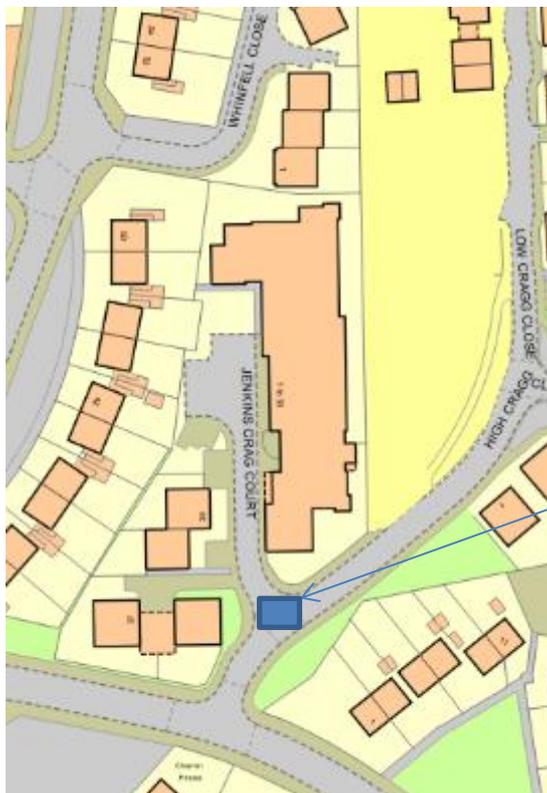
6. Jenkins Crag Court

Capacity issue of surface water storage system being investigated by UU and housing association
