# Keswick

## Sec 19 Flood Investigation Report

## Flood Event 5-6<sup>th</sup> December 2015

This flood investigation report has been produced by the Environment Agency as a key Risk Management Authority under Section 19 of the Flood and Water Management Act 2010 in partnership with Cumbria County Council as Lead Local Flood Authority.

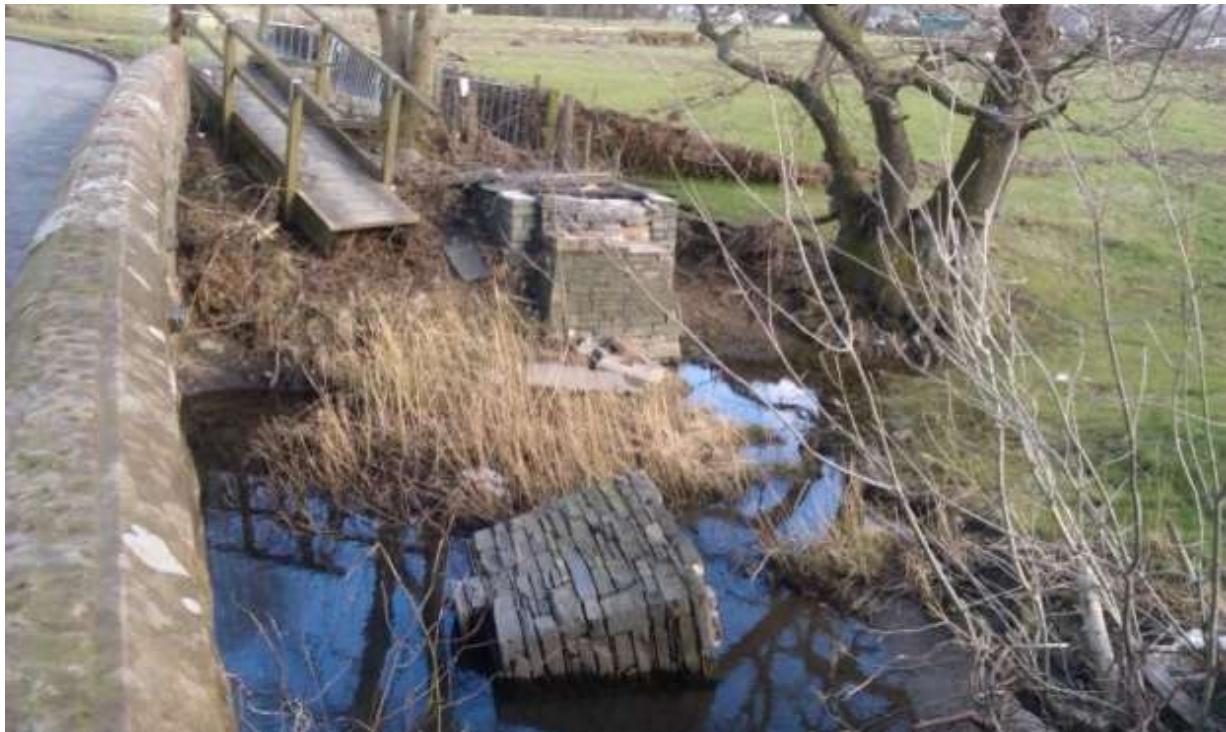
sediment deposited, a significant amount of woody debris and manmade objects were also transported downstream into the town, all of which caused a potential increase in flood risk due to reduced channel capacity. This debris caused blockages to the bridges and culverts, including those associated with the A66, within the town and wider catchment, increasing the impact of flooding by restricting flows and impeding conveyance of water flowing downstream, **Photograph 3**.

**Photograph 3: Damaged storm water bridge, Howrahs**

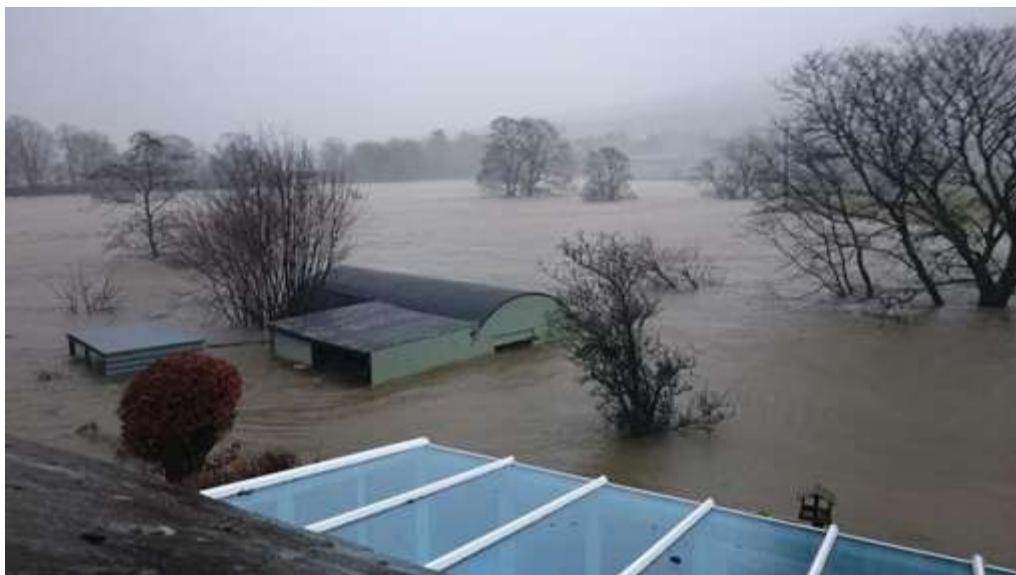
New Bridge is located at the confluence of the Rivers Glenderamackin and St John's Beck, **Figure 11**. The capacity of the structure to permit flows through the arches was exceeded. This resulted in substantial backing up of water and flooding of land upstream, **Photograph 4**. The Glenderamackin sub-catchment comprises a significant portion of the upstream area feeding the Greta and Derwent catchment, and incorporates drainage from the south and east slopes of Blencathra, Trout Beck and Mosedale Beck.

Photograph 4: New Bridge 5<sup>th</sup> December 2015

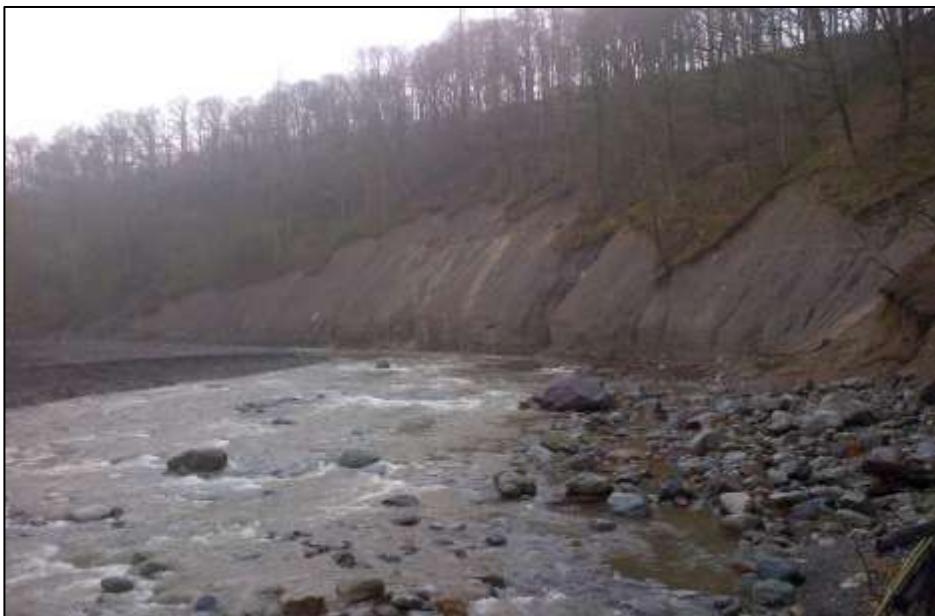
As a result of the flood event, the river has reverted back to its original course and eroded more material from the base of the landslide and the river is now significantly wider in places. In tandem with the saturation on the eroded face, the erosion has led to failure of the river slope. The lower part is now over-steepened and is subject to continued erosion from the river. The slope failures have removed a large number of trees and high volumes of eroded material, contributing to the flooding impact on Keswick.

**Photograph 5: Erosion/landslide feature upstream of Low Briery Holiday Park**

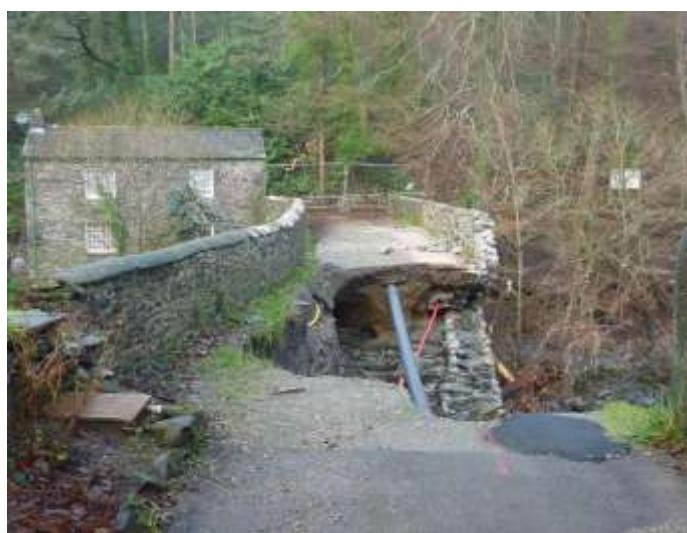
During December 2015, river levels exceeded the top of the bridge arch. These elevated levels flooded properties 6 to 9 Forge Lane on the left bank. There was also considerable damage to Forge Bridge, as shown in **Photograph 6**, from both the high water level and debris including large trees and caravans. Significant scouring of the river bank also occurred on both the left and right hand sides.

**Photograph 6: Forge Bridge Partially Collapsed**

Forge Bridge resulted in water being held back so that the upstream river level greatly exceeded that of downstream. Complete failure of the bridge may have had a severe impact on downstream structures and the town itself. It was reported by a resident that the extent of flooding in the area was much more

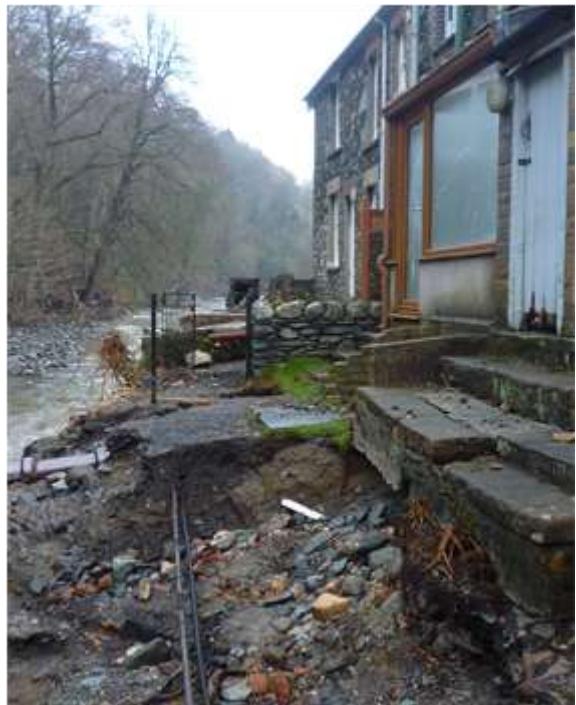
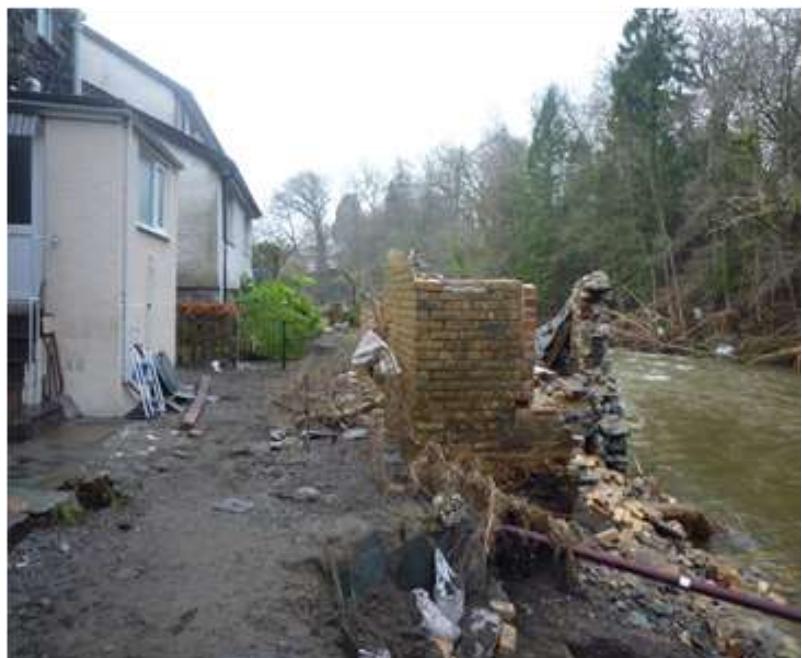
**Photographs 7 and 8.** In some cases, very little ground remained to the rear of the property. After the flood event some of these properties were declared structurally unsafe. Damage was also sustained to property at Toll Bar Cottage located on the downstream side of the bridge.

**Photographs 7 and 8: Scour damage to the rear of properties**

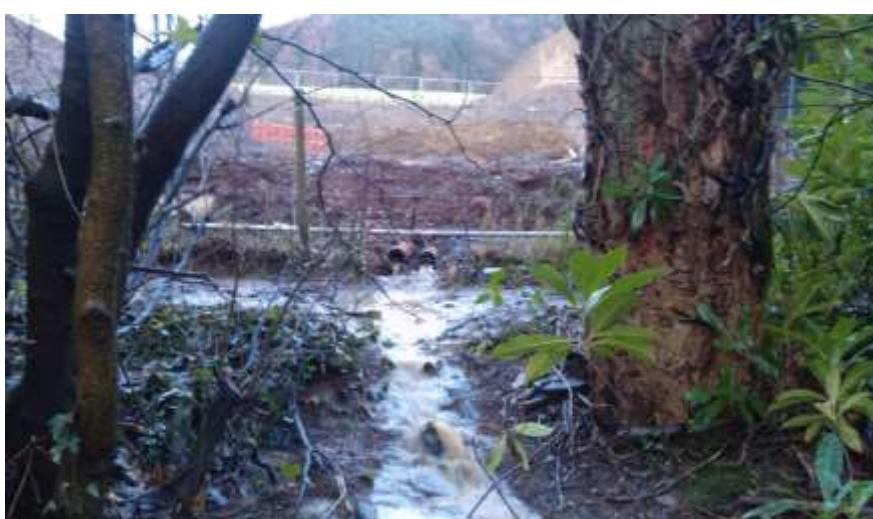
Flooding was observed on Brundholme Road, from surface runoff through the new development area, **Figure 16** and **Photograph 9**. Surface water from the construction site was silty and this blocked the road gullies on Brundholme Road causing local flooding in the area. A constriction of the drainage pipe taking water from Brundholme road has been identified. Two properties were flooded from surface runoff and one property flooded as a result of surface water runoff in addition to ingress from the River Greta.

**Photograph 9: Surface water flooding through the new development area**

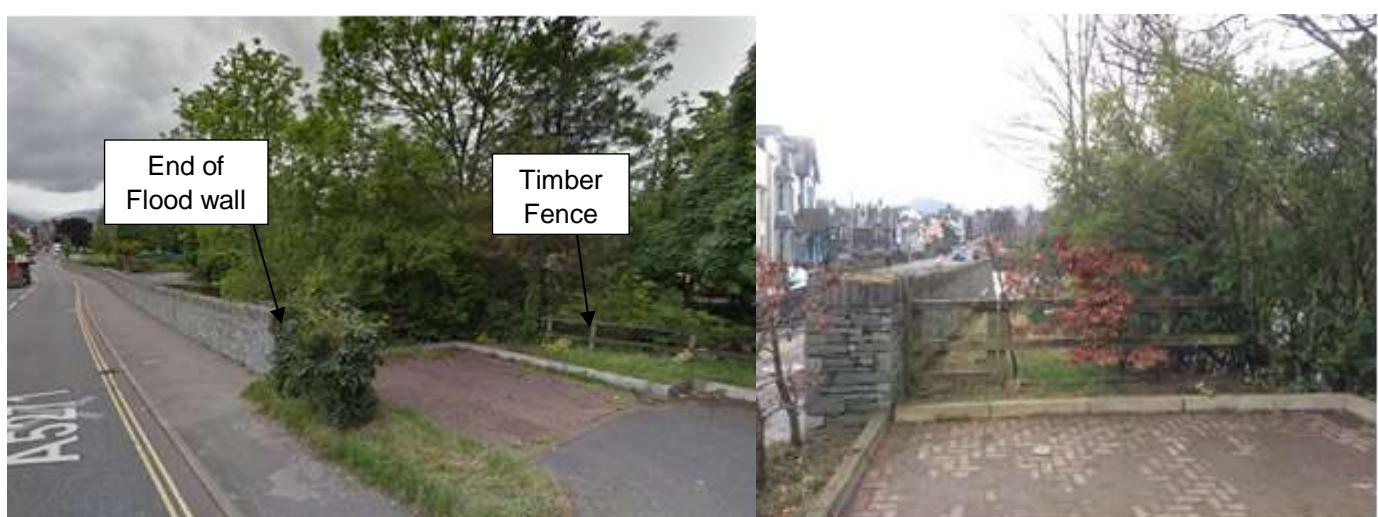
This is an area of residential properties and businesses on the left bank of the River Greta, outlined by Greta Street, Wordsworth Street, Canister Lane, and Penrith Road, **Figure 17**, which acts as a key access route into the town. A flood defence wall runs along The River Greta and at its upstream limit, terminating at an area of slightly raised ground as shown in **Photographs 10 & 11**.

**Photographs 10 and 11: Left bank of River Greta where defences were outflanked**

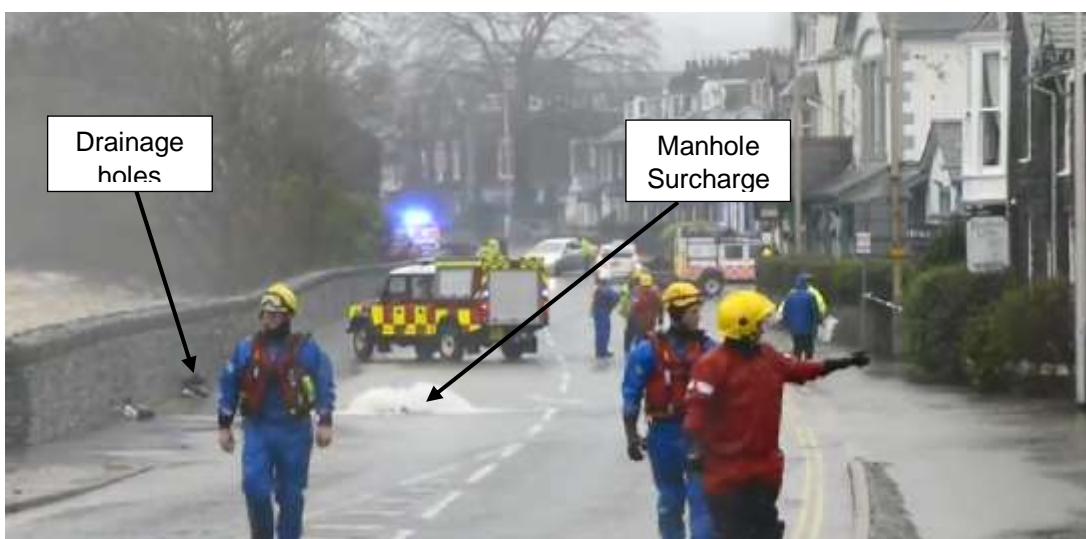
In addition, surface water runoff flowed onto Ambleside Road, continuing in the direction of the River Greta. Surface water flooded numerous properties within the area between Ambleside Road and Penrith Road. It was also noted that a manhole at the junction of Penrith Road and Greta Street shown in **Photograph 12** started surcharging prior to the river overtopping or outflanking the flood wall.

**Photograph 12: Manhole surcharge and flooding through drainage holes at the base of the flood defence wall on Penrith Road**

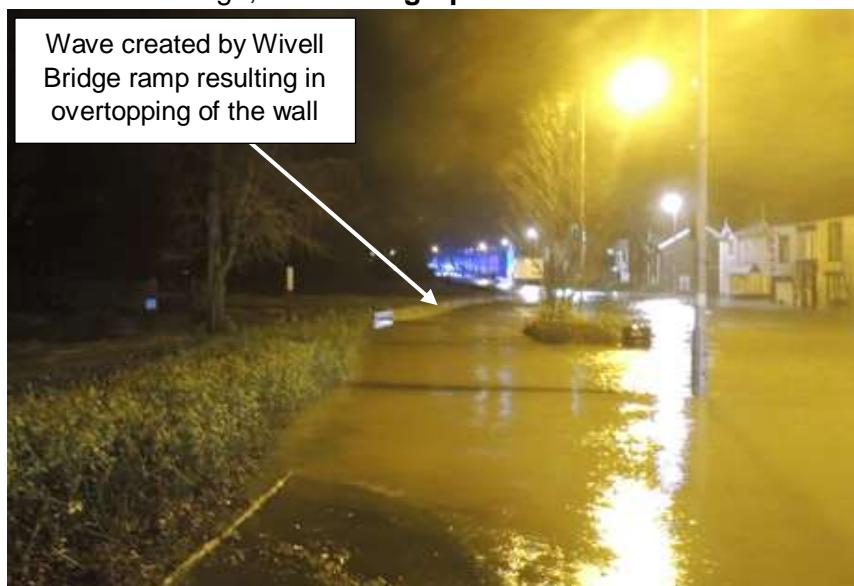
The River Greta continued to rise, eventually resulting in the outflanking of the wall at its eastern extent. The flood wall was not overtopped at this location, with the exception of a wave created by the access ramp on the left bank of Wivell Bridge, see **Photograph 13**.

**Photograph 13: Wave created by the access ramp on the left bank at Wivell Bridge**

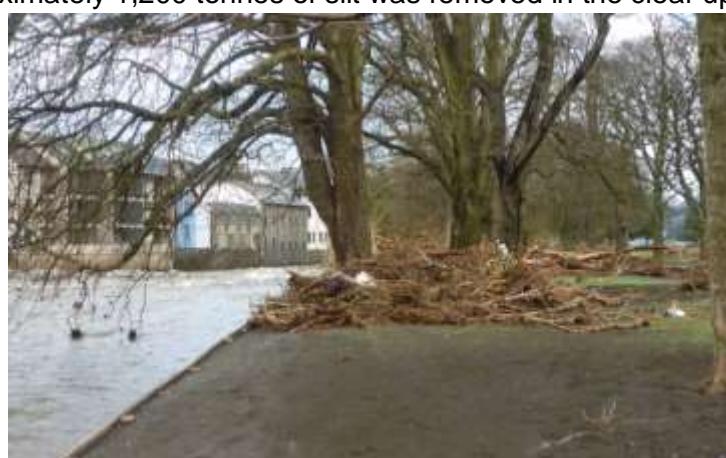
This area is on the right bank of the river and is divided into upper and lower Fitz Park by Station Road. Upper and Lower Fitz Park are not defended and are intended to be used as flood plain storage during a flood event, **Figure 18**. At Lower Fitz Park, 2m depth of flooding was recorded, and at the football club pavilion, 0.25m of flooding was reported inside the building and 1m outside. The floodwater deposited mud, silts and gravels up to a depth of approximately 300-450mm across the entire park and caused significant damage and destruction to the park facilities, all of which were uninsured, see **Photograph 14**. Approximately 1,200 tonnes of silt was removed in the clear up.

### **Photograph 14: Accumulation of debris in Fitz Park**

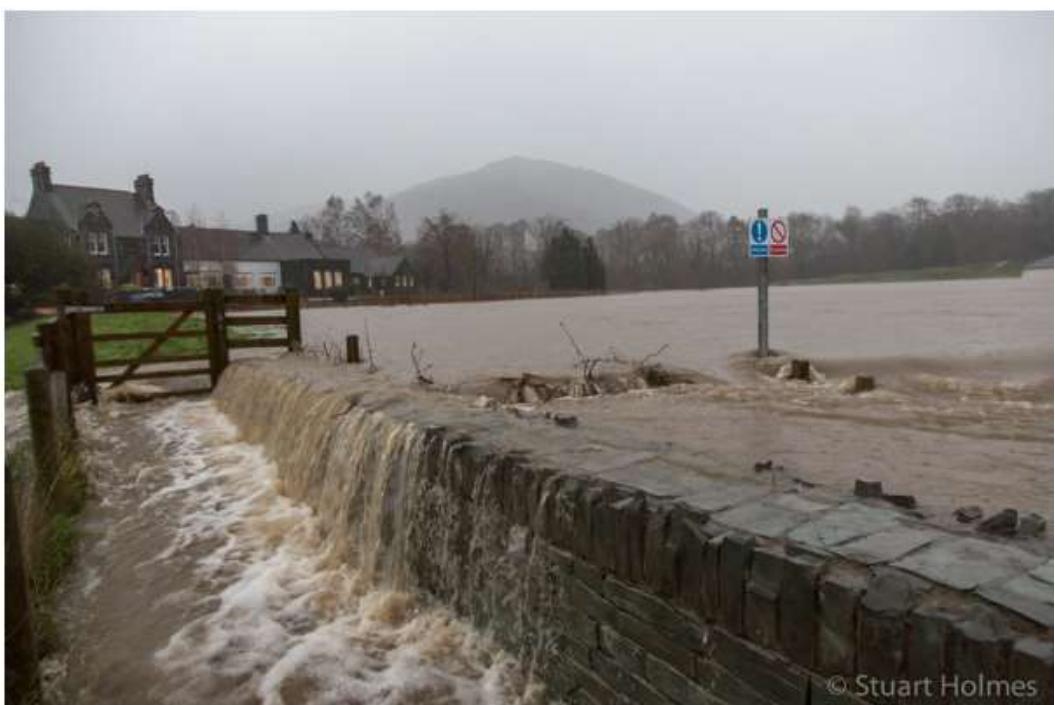
The flood embankment and defence wall along Crosthwaite Road were both overtapped despite efforts by the Environment Agency to bolster the defences with sandbags during the event, **Photograph 15**. There was also some seepage through the base of the vehicular floodgate at the northern end of Crosthwaite Road. Seepage was also observed through the flood defence wall near the upstream end of Crosthwaite Road, as well as further downstream. Water from these routes led to Crosthwaite Road being flooded from Fitz Park. Upstream headwall damage was also sustained by the Station Road Bridge.

**Photograph 15: Overtopping of the defences along Crosthwaite Road**

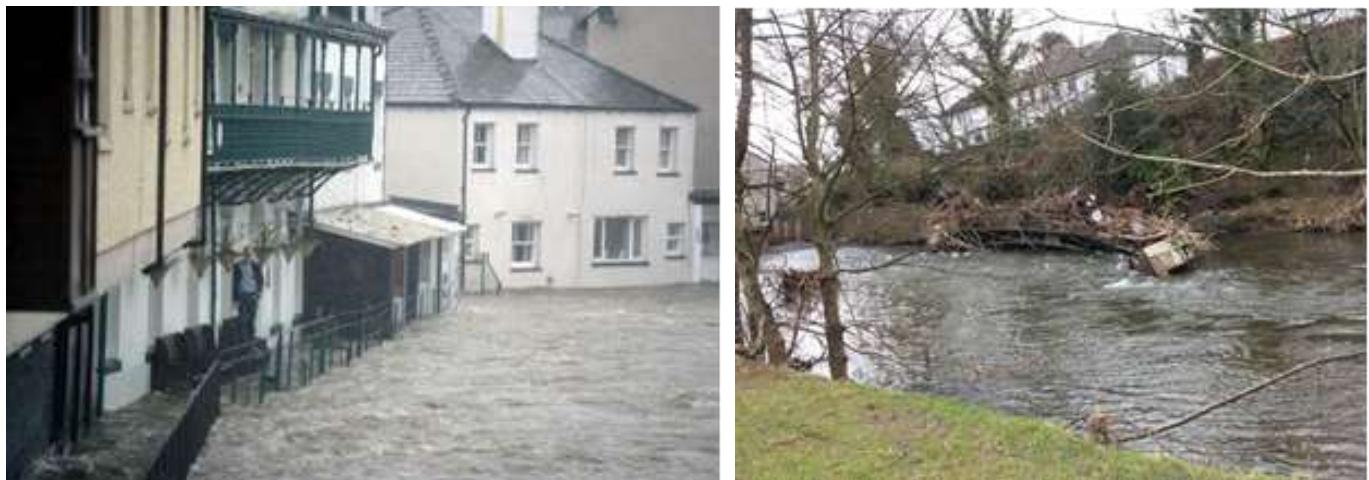
The Environment Agency laid sandbags along this stretch of flood wall to provide additional protection, however this was still overtapped as river levels rose. Residents also reported that floodwater entered the properties through the floors, which, combined with surface water would account for water collecting behind the defences prior to overtopping. Knight's Bridge, the footbridge that connects Millbank at the top of Stanger Street to Lower Fitz Park was washed away during the flood, **Photographs 18 & 19**.

**Photographs 18 and 19: Riverside view of Youth Hostel (left) and washed out footbridge resting on left bank abutment (right)**

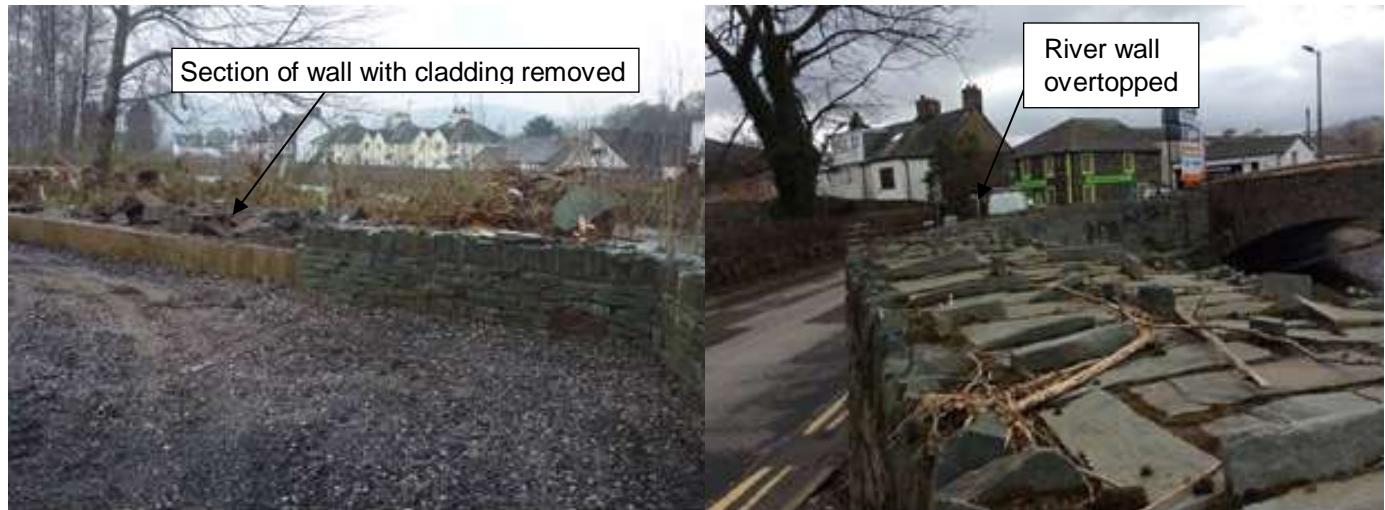
At the north end of Southe Hill Trading Park, the flood wall ties into a breeze block wall located on high ground. At the time of the event the cladding had been removed from the top of the wall for maintenance purposes, making the defences more susceptible to early overtapping at this location, **Photograph 20**.

**Photographs 20 and 21:** River overtopped its bank/flood wall at Southey Hill Estate (left) and the river wall overtopped at upstream of Greta Bridge (right)

Flood water from overtopping of the defences upstream of Greta Bridge, **Photograph 21**, flowed across Main Street towards Elliott Park. This resulted in the flooding of all properties between Tithebarn Street, Main Street and the River Greta, including properties on Elliott Park, Coleridge Court and Riverside Court as well as Booths supermarket. This is shown on **Photograph 22**.

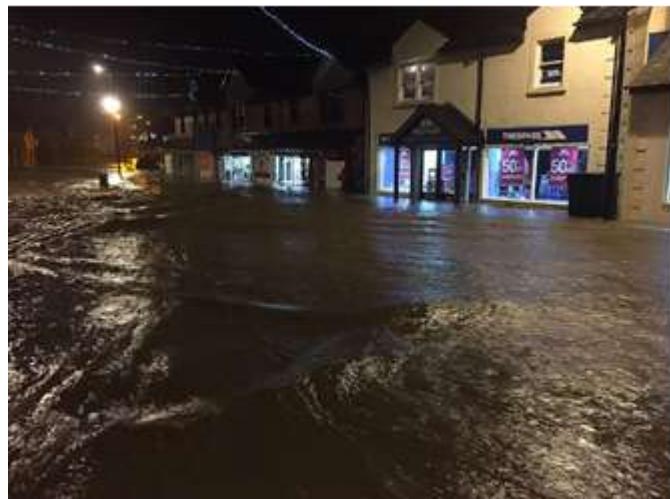
**Photograph 22: Flooding at Booths store and on Main Street/Tithebarn Street**

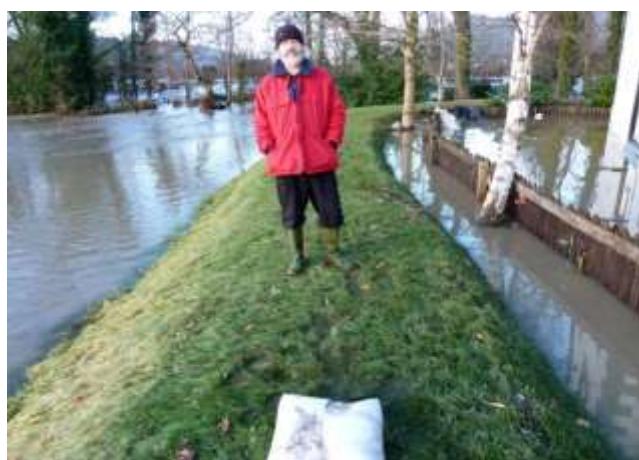
Local residents reported that the onset of flooding was rapid with flood water entering Elliott Park at 15:05, water was observed flowing over the embankment crest from Elliott Park side onto the floodplain by 15:25. The water level on the floodplain downstream of Elliott Park at the Rugby Football Club was reported to be significantly lower than the level within Elliott Park. It is therefore felt that in this incident, as was the case in the 2009 flood event, the embankment acted as a barrier to flow and impounded water in Elliott Park, exacerbating the impacts of the flooding to the area.

**Photograph 23: Flooding level differences at Elliott Park**

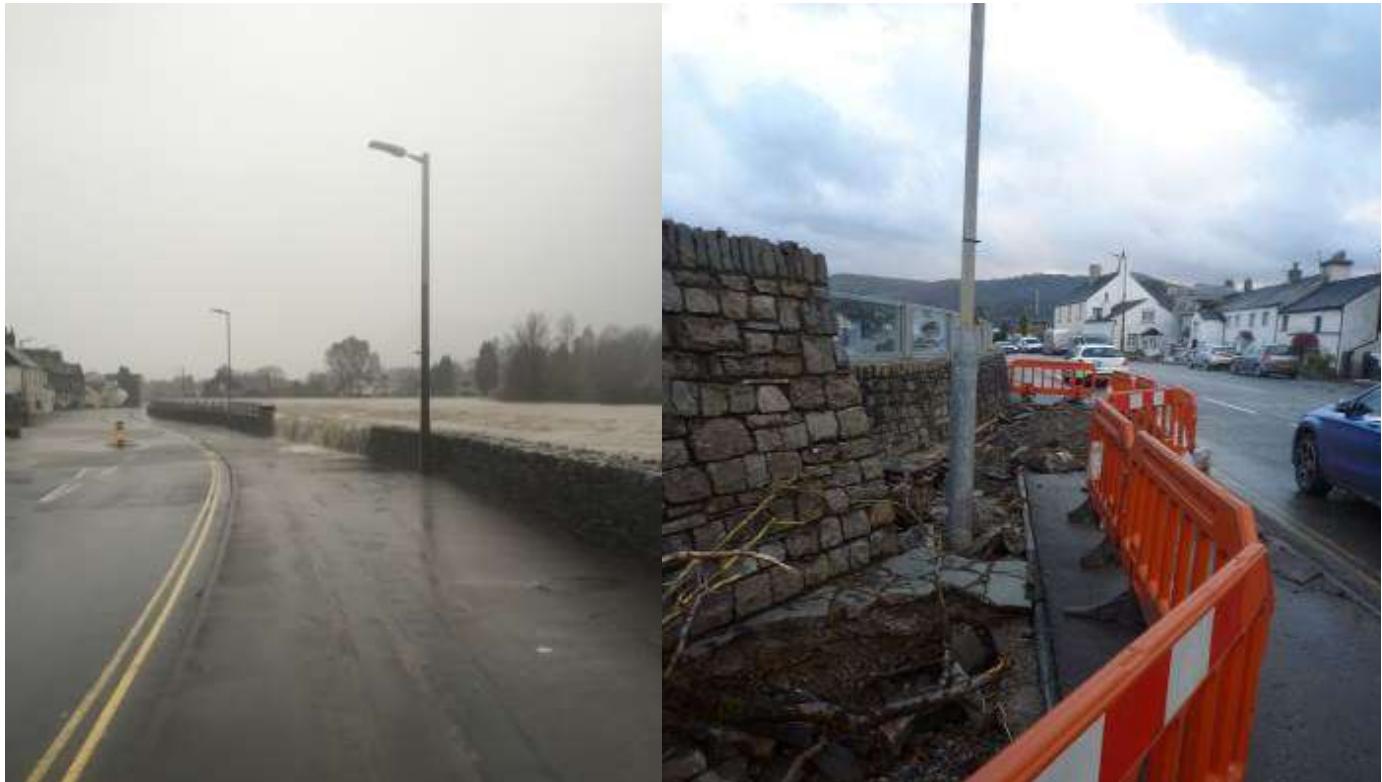
**Photograph 25 and 26: Flooding at High Hill Road - Floodwall first overtopped where glass panels finish (left) and scoured footpath (right)**

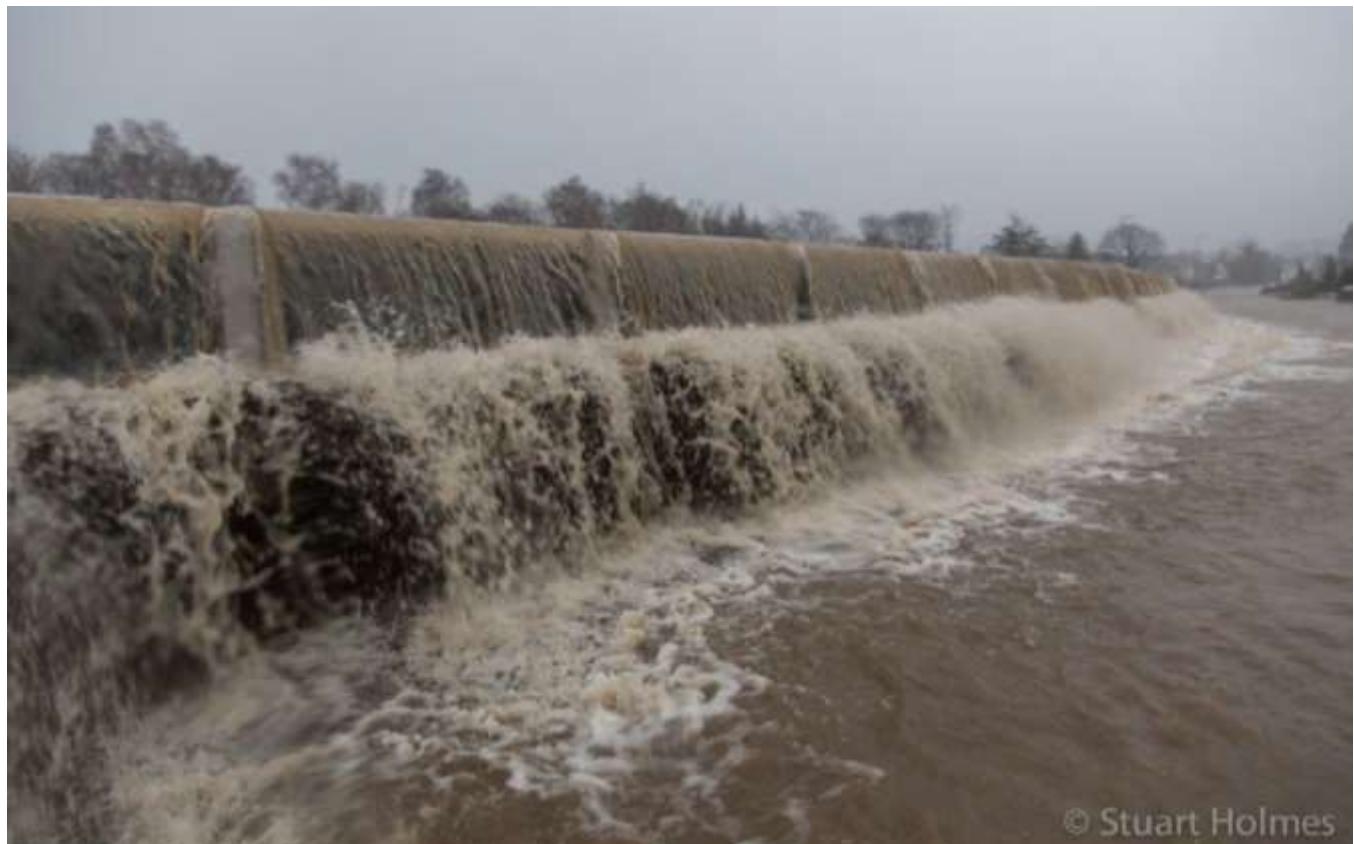
**Photograph 27: Overtopping of flood defences on High Hill Road**

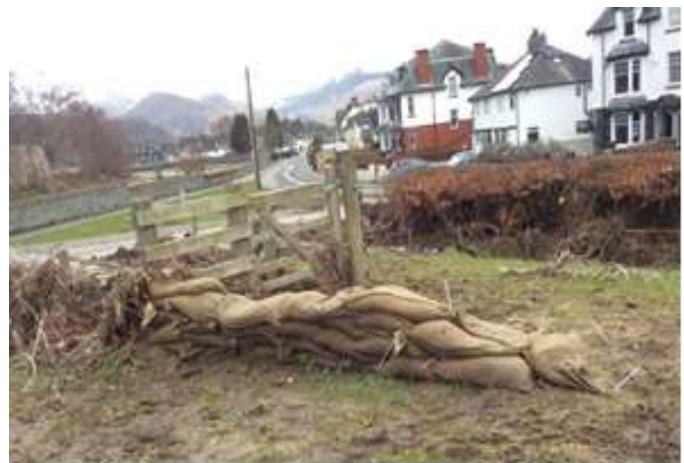
**Photograph 31: Crosthwaite Road flood defence embankment that was overtapped**

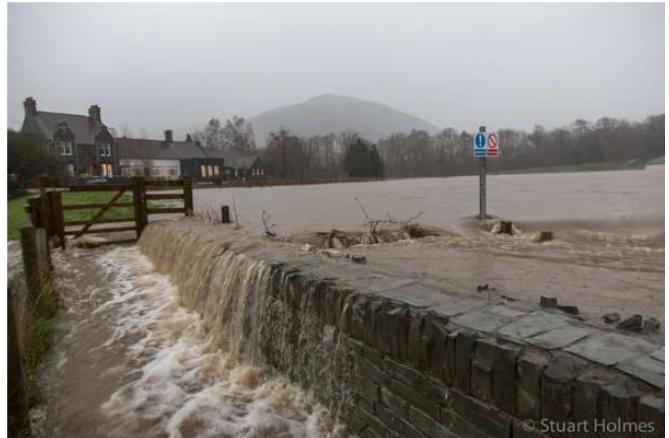
length in the Crosthwaite Road area at around 15:00 (**Photograph 33**). The flood defence wall and embankment were also overtapped leading to flooding from Fitz Park, **Photograph 32**.

**Photograph 32: Overtopping of flood defences on Crosthwaite Road**

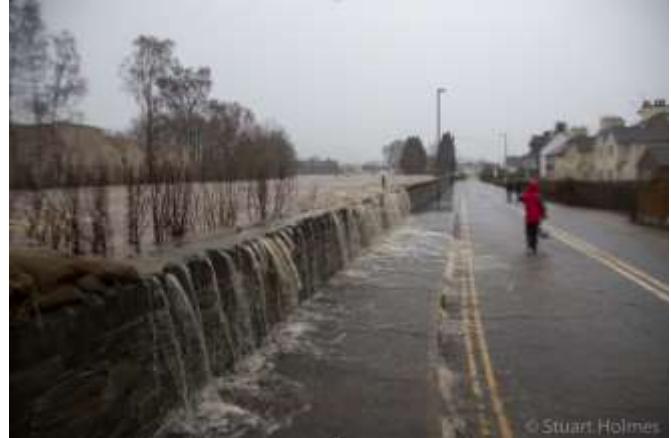
**Photograph 33: Overtopping of flood defences on Crosthwaite Road**

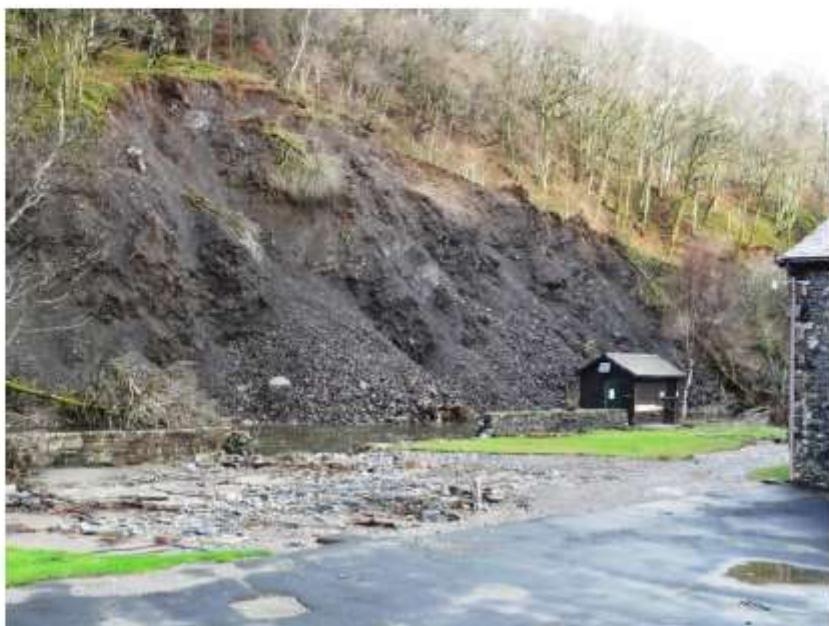
**Figure 11: Part of the bottom of the Brundholme woods slope where the river has eroded the bottom of the slope (the brown hut is the EA gauging station).**

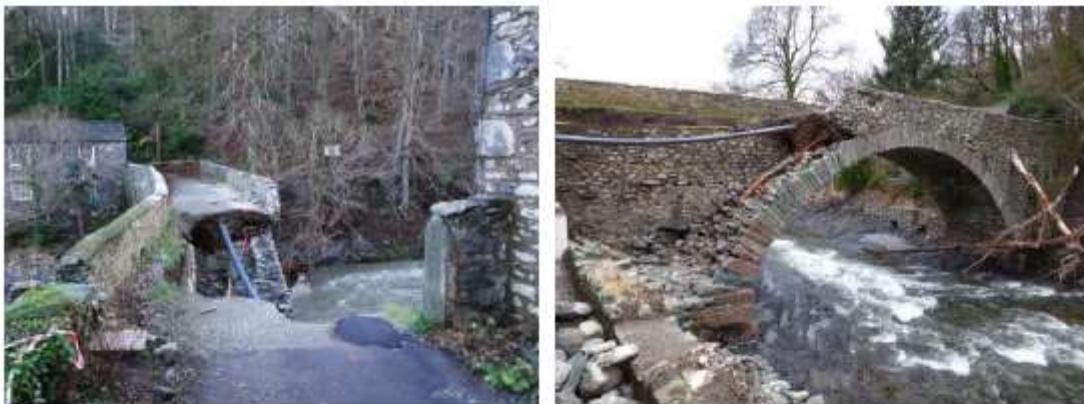
Figure 12: Damage to bridge in The Forge area.

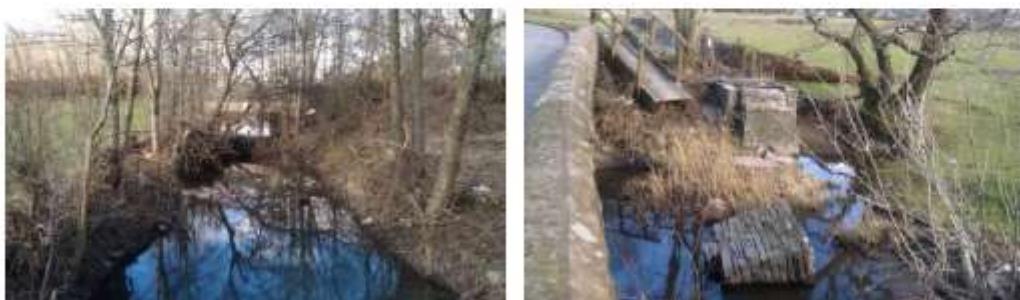
Figure 23: Howrahs culvert and damaged storm water bridge.
