# Sandwith

## Flood Investigation Report No.40

**Flood Events: Summer 2012**

This flood investigation report has been produced by Cumbria County Council as a Lead Local Flood Authority under Section 19 of the Flood and Water Management Act 2010.

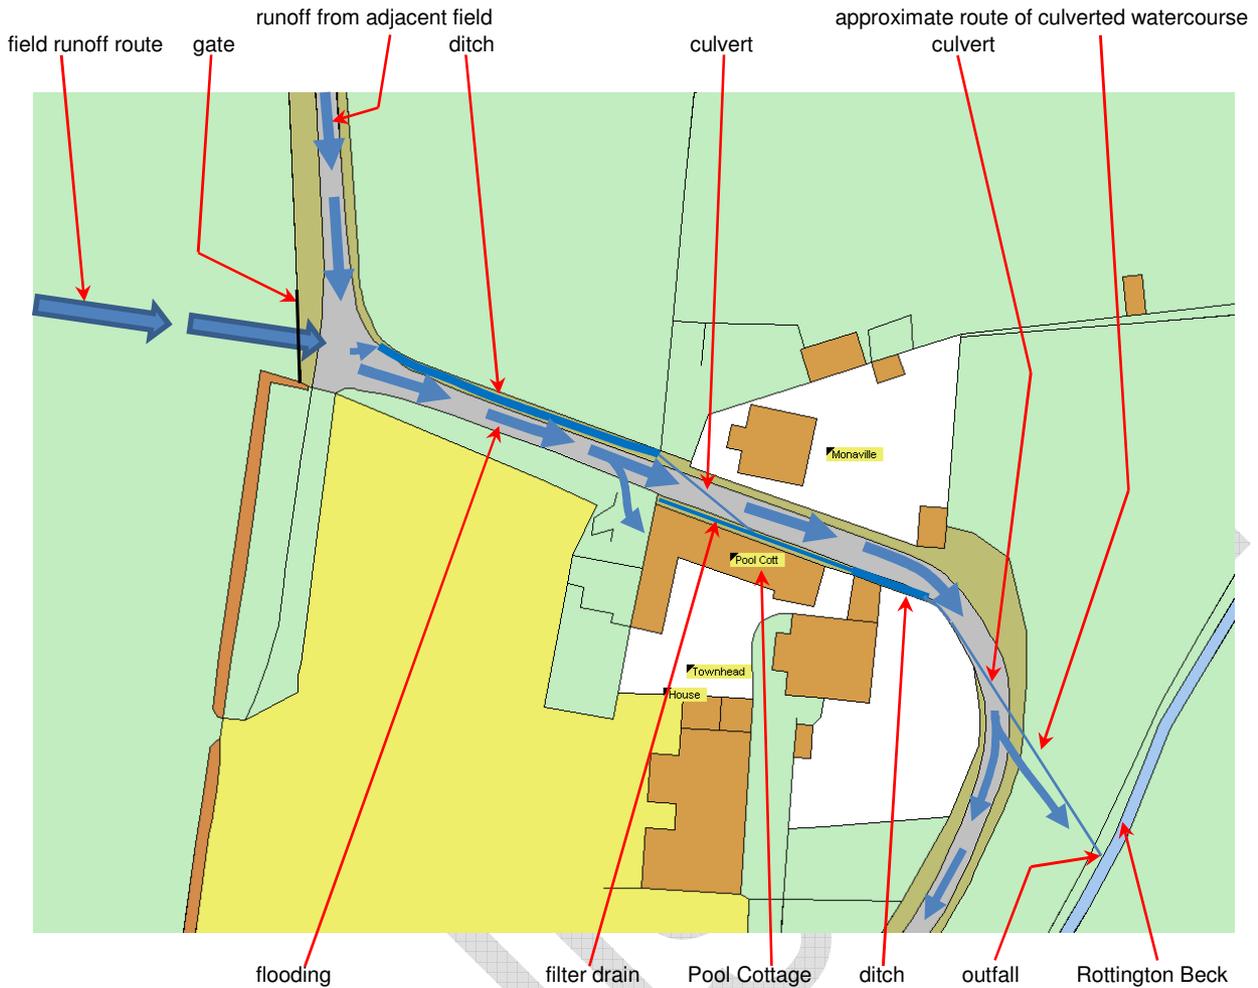
**Figure 4: Pool Cottage Flood Routes**

During heavy rainfall events, surface water runoff, containing silt and debris, flows from fields, and down a lane to discharge into a ditch on the north side of the lane; see Figure 4 “Pool Cottage Flood Routes”. This ditch crosses the lane in a 150mm dia. culvert and then runs alongside Pool Cottage before crossing the lane again to discharge into the Rottington Beck about 30 metres away. The ditch fills with silt from the field, which together with the culverts surcharging, results in flooding in the lane. Over the summer 2012 Pool Cottage did not flood internally because sandbags were used for protection.

This swollen runoff, full of silt and debris, continues down the lane and flows through the village depositing the contents on the way and presenting a flood risk to properties. However at the first bend in the lane by Townhead House, some of this runoff diverts down to Rottington Beck and can block the culvert at the head of the village.

Surface water flooding mapping records held by the LLFA shows Pool Cottage as susceptible to flooding. The cause of the flooding was surface water runoff from the fields to the west exacerbated by the ploughing methods adopted. Debris and silt was washed on to the road, blocking drainage ditches and culverts. These drainage features then surcharged causing further flooding to the road threatening Poole Cottage and the village with internal flooding.

This problem has been compounded by the culverts across the lane having been damaged during the laying of a United Utilities foul water sewer about 6 years ago. A CCTV survey has revealed a blockage caused by a deformed pipe in the culvert adjacent to Pool Cottage.

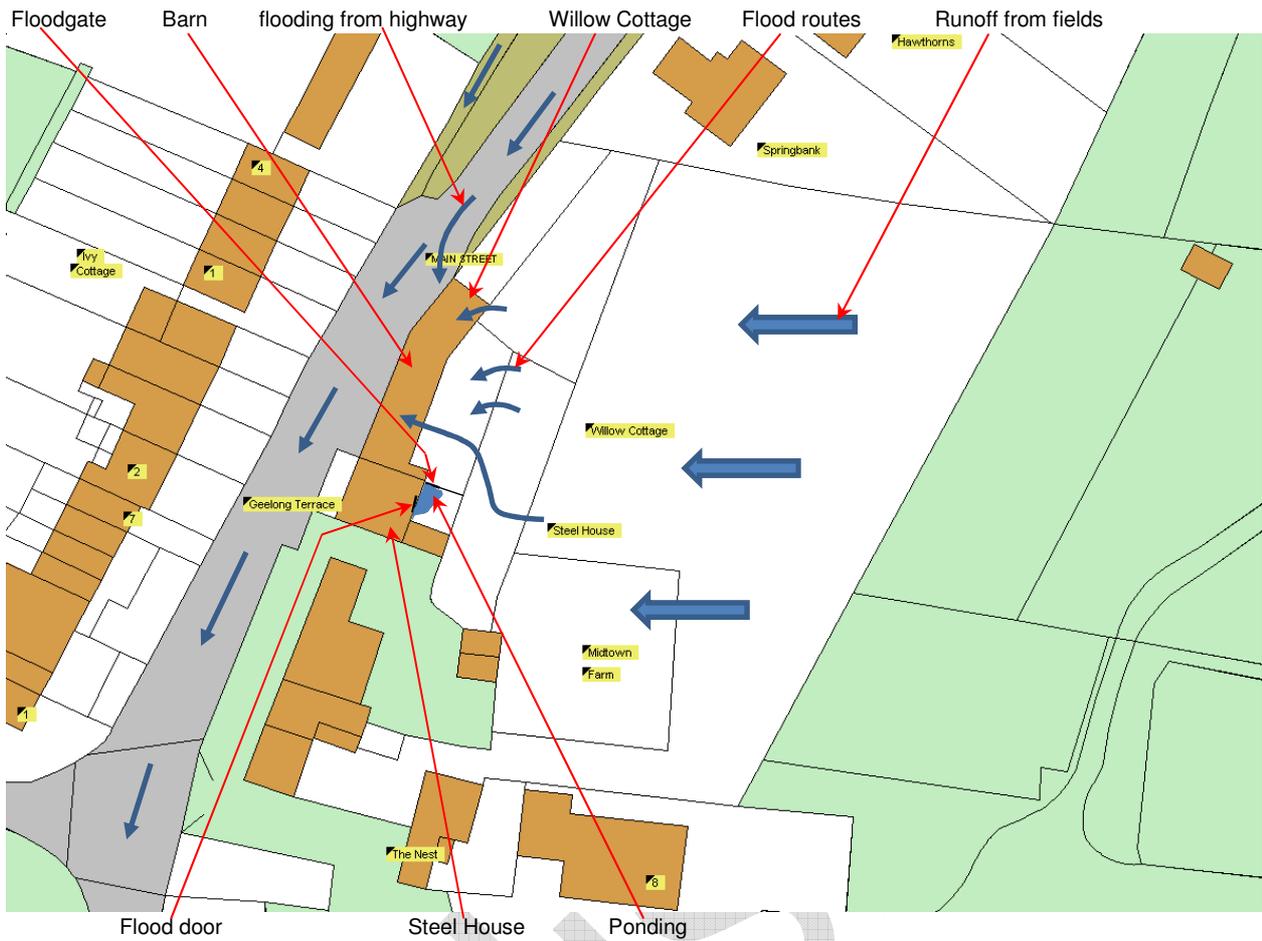
**Figure 5: Steel House Flood Routes.**

Figure 3 shows the location of Steel House in the village along Main Street. The source of flooding to Steel House was surface water runoff from the fields behind the cottage to the east; see Figure 5 “Steel House Flood Routes”. Following previous flooding, resilience measures were put into place, including a floodgate in the back garden. Unfortunately this was left open on 30<sup>th</sup> August 2012 and some severe ponding was experienced on the low level patio at the rear of the property. When the floodgate was closed it successfully diverted the floodwaters through the adjacent barn.

On the north side of Steel House, Willow Cottage was also affected by surface water runoff from the fields and there was internal flooding to the cottage. Some of this flooding was caused by floodwaters from Townhead fields.

Surface water flooding mapping records held by the LLFA shows Steel House as susceptible to flooding. The main cause of the flooding was sheet runoff from fields behind that were already saturated by previous rainfall events. A neighbouring garden lies above the property and beyond this are the fields and buildings of an equestrian centre. The large house connected to the equestrian centre is accessed by a metalled road from the north (see Figure 10). It is unlikely that this metalled road contributed significantly to the flooding to the rear of the properties. However it did contribute to the highway flooding by discharging onto the road junction to the north.

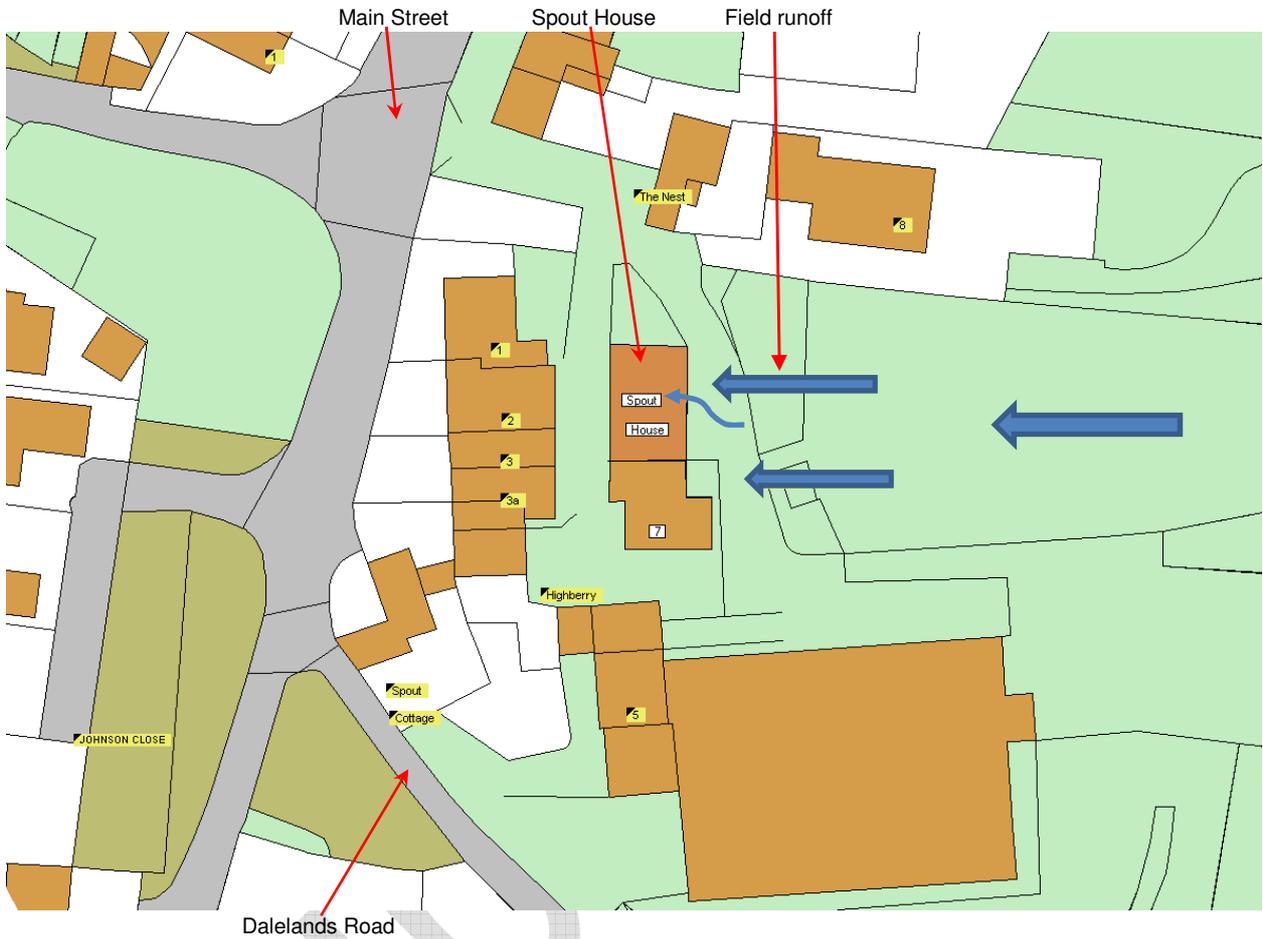
Figure 6: Spout House Flood Routes

Although this was reported as a watercourse problem, the source of flooding to Spout House was surface water runoff from the fields behind the house to the east; see Figure 6 “Spout House Flood Routes”.

Surface water flooding mapping records held by the LLFA shows Spout House as susceptible to flooding. Flooding occurred as a result of surface water runoff from fields behind that were already saturated by previous rainfall events.

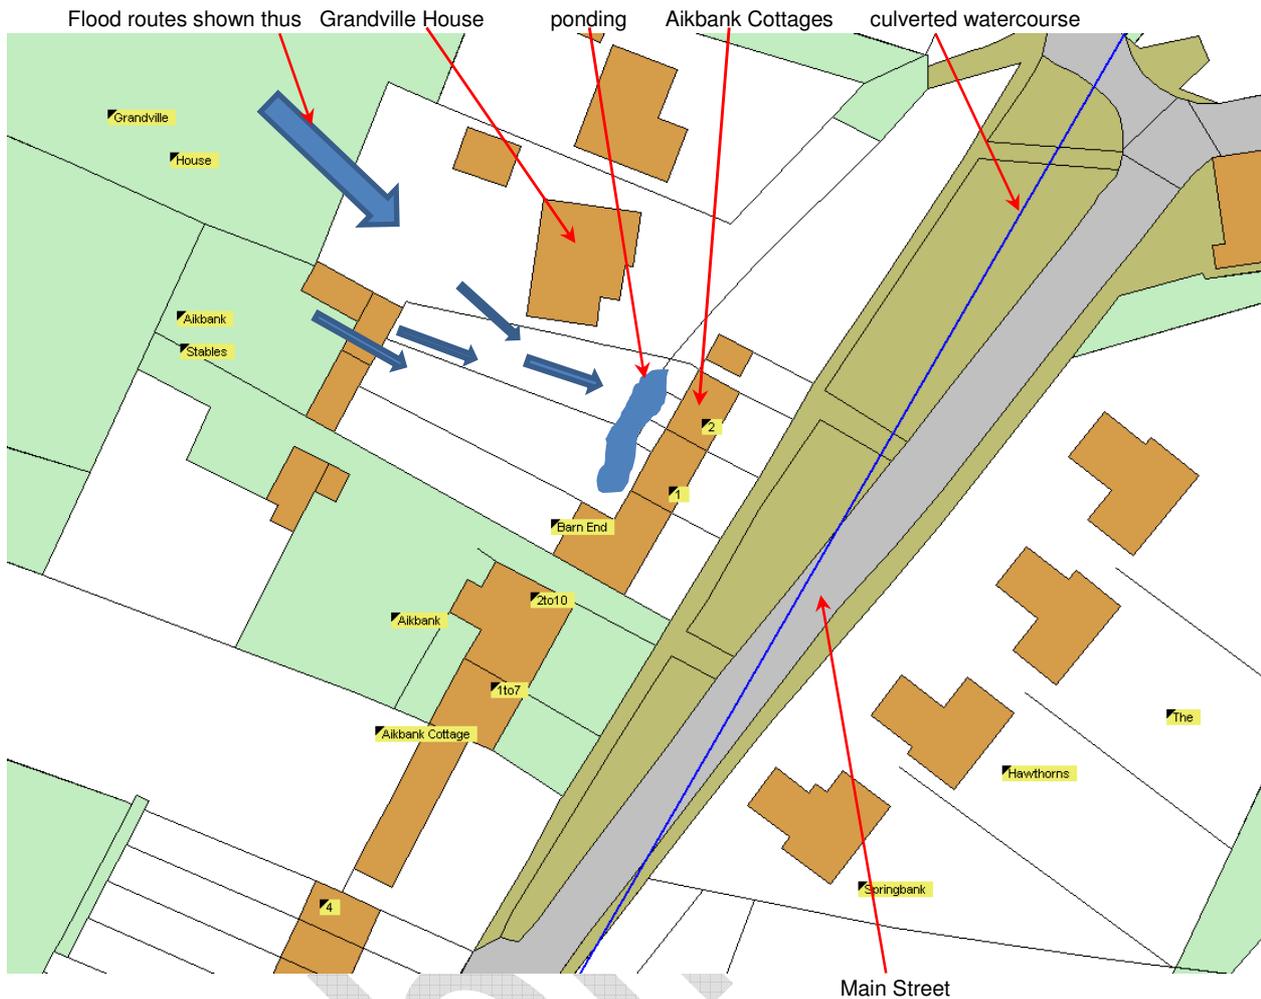
**Figure 7: Previous Aikbank Cottages' Flood Routes.**

No.2 Aikbank Cottage is an end terrace cottage cut into the hillside on its rear north-western face. It has a long garden with a stable development at a higher level. In the flood event of 22<sup>nd</sup> June 2012, the main route of the surface water runoff from the fields was intercepted by the sandstone boundary wall between Grandville House and No.2 Aikbank Cottages (see Figure 7 "Previous Aikbank Cottages' Flood Routes"). However the groundwater and surface water flowed through the wall and flooded the garden of No.2, which in turn flooded the garden of No.1 at a lower level.

During the flood event of 22<sup>nd</sup> June 2012, both Nos. 1 and 2 Aikbank Cottages were flooded from groundwater and surface water runoff from the fields to the west, behind the cottages. The flooding was external.

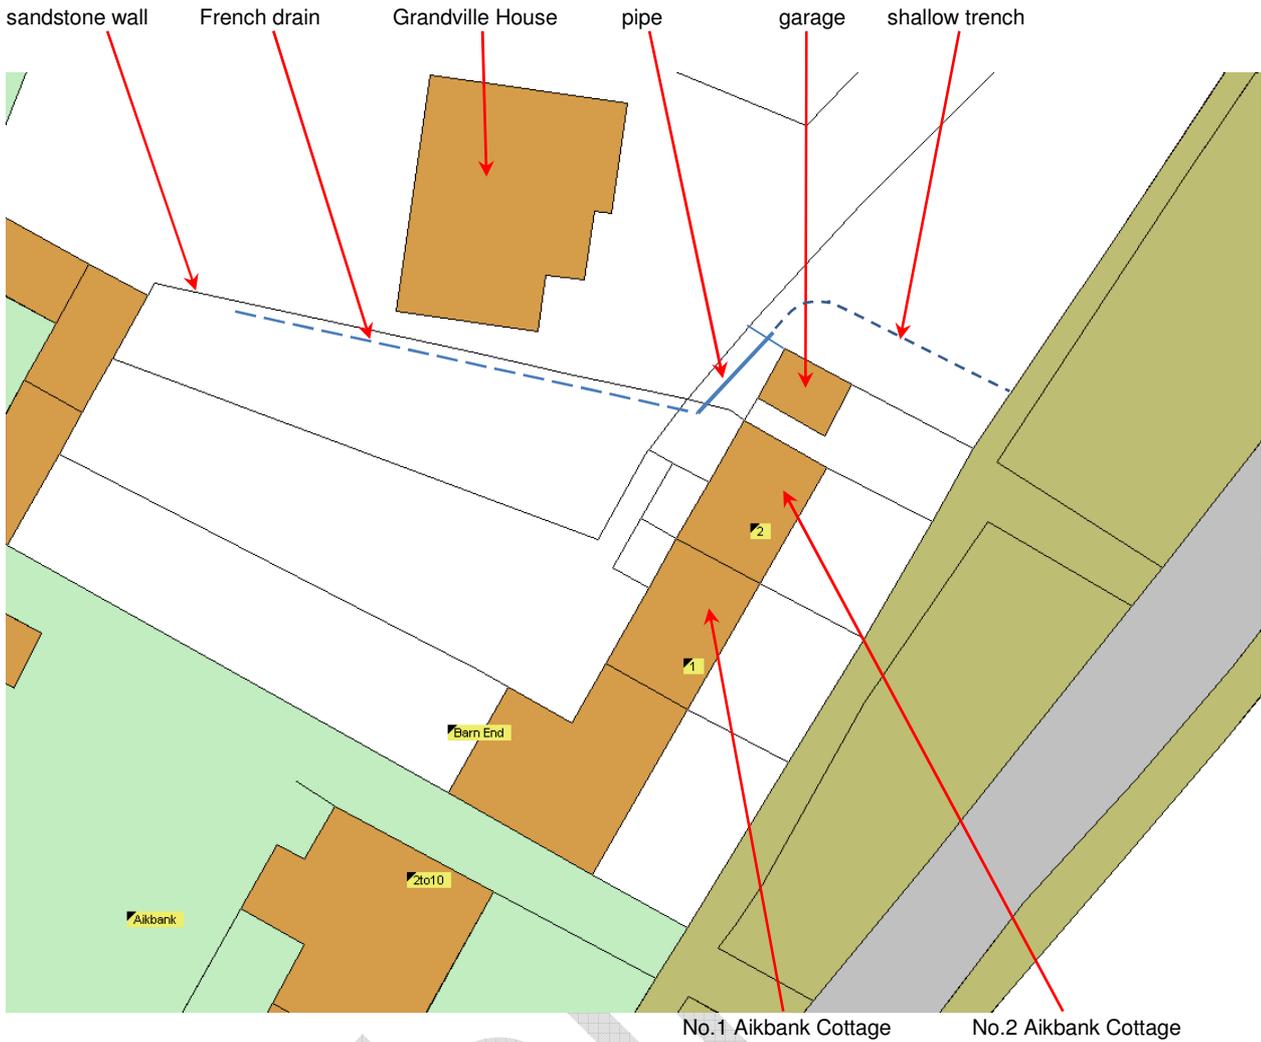
Figure 8: Aikbank Cottages Drainage Route

Subsequent to this flooding, the owner of No.2 carried out some resilience work. A french drain was laid on the south side and parallel to the sandstone wall (see Figure 8) connecting to a pipe through the wall. This pipe continued behind the garage on the north end of the property, through another wall discharging into a shallow trench in public open space. The shallow trench discharges onto the footpath and is intercepted by a gully in the footpath. At the time of the August 2012 flood, the french drain successfully intercepted the runoff from fields and prevented flooding in the gardens of both the cottages.

Surface water flooding mapping records held by the LLFA shows Aikbank Cottages as susceptible to flooding. It occurred as a result of surface water runoff from fields behind that were already saturated by previous rainfall events. This has been intercepted by a french drain but its discharge has not yet been finalised. Surface water runoff from the recent development behind these properties and adjacent fields should be further investigated in order to review any potential mitigating measures.

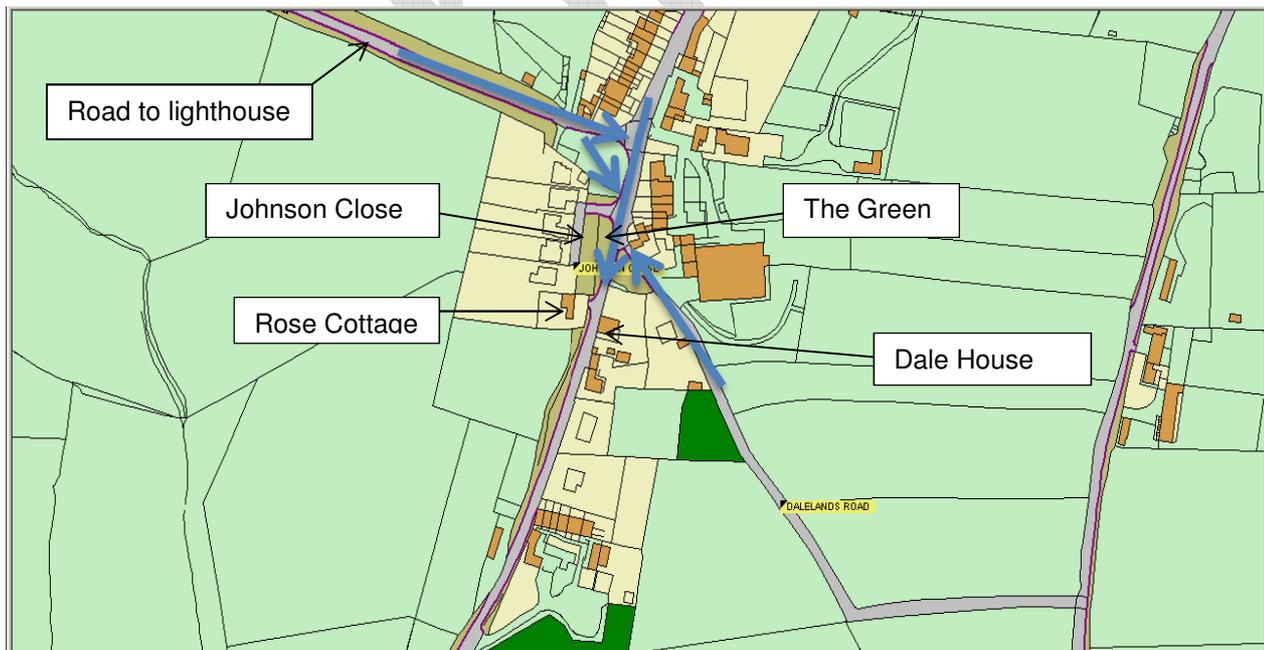
Figure 9: Rose Cottage and Dale House Flood Routes.

See Figure 9. Rose Cottage is situated adjacent Rottington Beck with Dale House directly opposite. This is a low lying area in relation to surrounding ground and floodwater on the carriageway in this area was reported to be up to 500mm deep. There is a piped culvert to the front of Rose Cottage that is approximately 1m diameter. It was noted that the size reduces in numerous locations downstream, culminating in a pipe of around half this diameter that discharges into Rottington Beck.

Surface water runs down both Dalelands Road and the lighthouse road culminating in a large build up trying to flow through a piped culvert (also the main village watercourse) in front of Rose Cottage and Dale House. The pipe that runs across The Green in front of Johnson Close that receives all the surface water from the lighthouse road does not have enough capacity during such severe rainfall events. Excess water then runs further down the road to the Main Street junction before contributing to flows in the open watercourse close to Rose Cottage and Dale House.

The piped culvert in front of Rose Cottage was unable to cope with the volume of water heading to this low point in the village and the build up of water then spilt into the driveway of Rose Cottage and internally into Dale House.
