11c15 Walney Channel (mainland)

(Technical report by Jacobs)

Policy area: 11c15 Walney Channel (mainland)

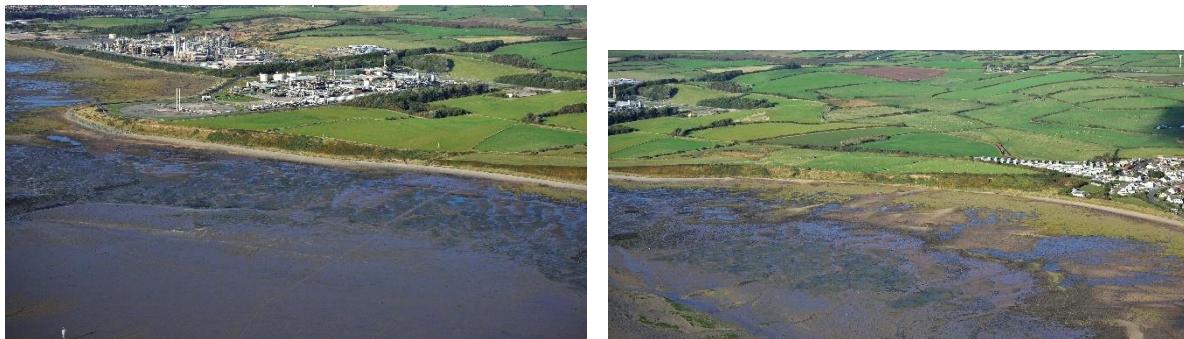
The cliffs are cut into glaciofluvial sands and gravels, with raised beach deposits (gravels) also exposed in places. There is only one monitoring point appraised as part of the North West Regional Monitoring Programme. Data from this point, for 2012 to 2016, indicate little discernible change in either cliff position or beach level. There is, however, some evidence that the intertidal flat may be starting to experience some narrowing, with changes at the seaward edge of the flat, possibly suggesting landward movement of the channel and resultant steepening of the landward bank of the channel. This trend would need to be confirmed through further monitoring. At present, the channel lies around a kilometre away from the cliffs; therefore, there is currently not an issue, but if there is a progressive migration of the low water channel, this could have implications for the longer term. No predictions of future change were provided as part of NCERM.

There are limited assets at risk from erosion: most of the cliff top land is used for agriculture, but there are a couple of properties at the eastern end of the unit.

Figure 2 Clifffed frontage between Rampside and Westfield Point. 2015 aerial photograph (c) North West Regional Monitoring Programme.

- Continued monitoring of cliff and intertidal change, as part of the North West Regional Monitoring Programme, to identify any changes in observed trends and any possible increase in risk level. At this stage it is not thought necessary to add any additional profiles, but should the profile data available indicate significant change, in particular ongoing shoreward migration of the low water channel, further profiles or use of remote sensing, such as LiDAR, could be beneficial.

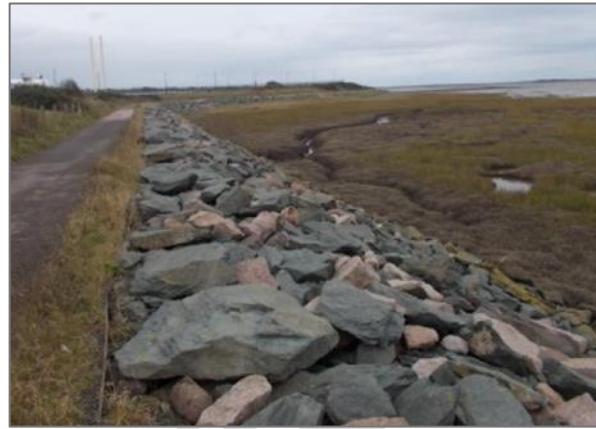
At Westfield Point, there is a rock revetment, which is currently maintained by United Utilities, with embedded outfall. The latest asset inspection (Barrow Borough Council, 2016) estimated a residual life of 10 to 20 years and noted that the armour was in Good condition. The cliffs behind were recorded as being heavily vegetated, although some subsidence was noted at the crest, which could be indicative of overtopping.

*Figure 3 Westfield Point rock armour revetment.
Photograph taken from latest asset inspection report
(Barrow Borough Council, 2016).*

- Defence inspections covering the revetment at Westfield Point should monitor for signs of outflanking where it abuts the undefended cliffs. Any extension of the revetment here may require consent from Natural England due to the designation of the intertidal zone and a scheme level HRA and AA may need to be undertaken.

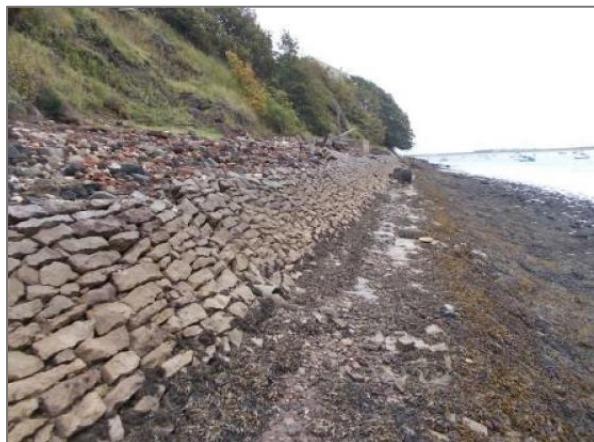
Table 4), with a short stretch of private defences at the Boat Club. These are generally in Fair condition, with a residual life of 10 to 20 years. The key exception is the revetment to the south of the bridge, which is considered to be in Poor condition (in 2016), with a 5 to 10 year residual life (Figure 4).

Figure 4 Barrow Borough Council defences south of the Jubilee Bridge, adjacent to the BAE site. Photograph taken from latest asset inspection report (Barrow Borough Council, 2016).

Location	EA Asset Ref.	Structure Type	Estimated residual life (years)	Overall condition	Responsibility	Additional notes
Former BAE West Shop	011KC90230 201C05 (210/8021)	Revetment	5 - 10	Poor	Barrow Borough Council	Built 1950. Toe constructed of rubble rock and consolidated slag. Some pitching missing to limestone revetment mainly towards top of slope. The top of the revetment has lost significant stone which is now laying on the foreshore in front of the revetment toe. There are increased areas of subsidence of the embankment due to lack of stability at the top of the cliff.
North of Jubilee Bridge	011KD90250 101C07 (210/8022)	Vertical Concrete Sea Wall	10-20	Fair	Barrow Borough Council	Built in 1986. There is some undercutting of a connecting ramp or revetment and also what appears to be a significant land tip of bricks. The primary structure of concrete wall is in generally good condition apart from some spalling at the toe. However, there are areas of transverse and longitudinal cracking within the concrete wall.

- **North of Jubilee Bridge** (Barrow Borough Council) – There is undercutting of the revetment and also cracking observed within the concrete wall – continued monitoring recommended.

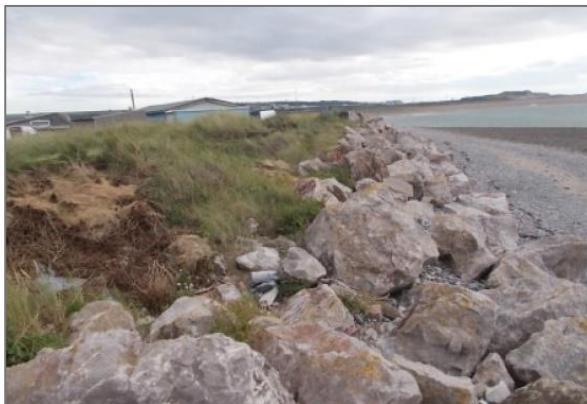
Along the majority of the frontage there are no formal defences, apart from a short stretch of rock toe work at Lowsy Point (Asset ref: 011KD90250401C02 (210/8038)) – see Figure 6). This believed to have been constructed in 1990 and is the responsibility of Barrow Borough Council. Previous overtopping of structure has caused erosion of low dunes behind, increasing the risk to the properties at the Point. The latest asset inspection considered the defence to be in Poor condition, with an estimated residual life of 10 to 20 years. Although the inspection also reported that the condition of the revetment has not deteriorated since the previous inspection.

Figure 6 Rock toe at Lowsy Point. Photograph taken from latest asset inspection report (Barrow Borough Council, 2016).

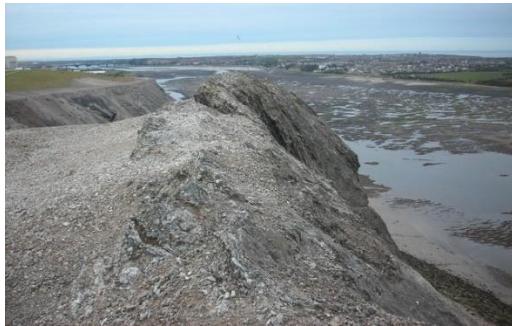
At the southern end of this unit (north of the defences at Ormsgill), the backshore consists of cliffs cut into slag deposits, formed of waste from Barrow iron and steel works (Figure 7 and Figure 8). The first works were founded in 1859 and ceased operation in the 1980s. The northern and southern parts were reclaimed in the 1990s; the southern section of the site has been redeveloped and forms a business park and public open space, whilst the northern part is less accessible and is mainly open space. The central slag bank was operated for the extraction of secondary aggregate until 2008, with a reclamation programme in place since. The site is one of the most prominent land marks on the Furness Peninsula and is a popular area for walkers, with a path running along the top of the bank. There have, however, been incidents of people falling down the steep face of the bank and becoming stranded on the narrow beach below.

Figure 7 View from the Ormsgill Slag Bank in 2007. Image reproduced under Commons Copyright (geograph.org.uk - 485043.jpg Rosalind Mitchell CC BY-SA 2.0.)

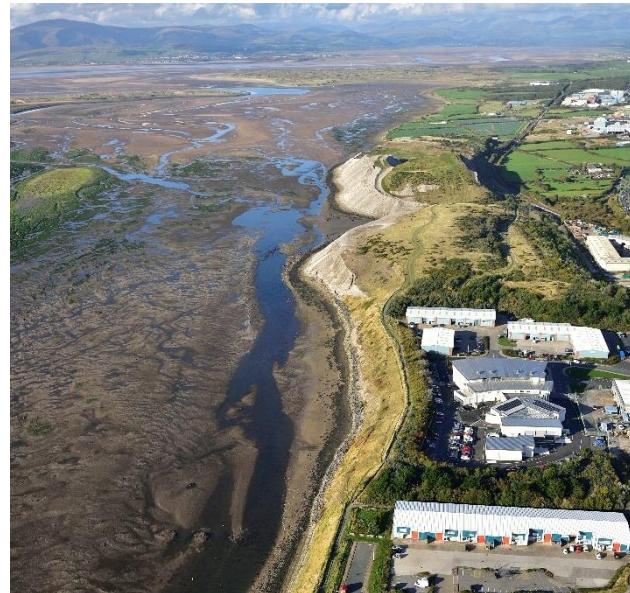
Figure 8 Ormsgill frontage, showing defended frontage to the south, the slag bank and lower lying cliff cliffs beyond, with Lowsy Point and Sandscale Haws dune system to the north.

Further north, the slag cliffs are replaced by low till cliffs (Figure 8). The immediate hinterland is mainly used for agricultural purposes, although some of this land is currently used for a solar farm, but further inland the landscape becomes more industrial again.

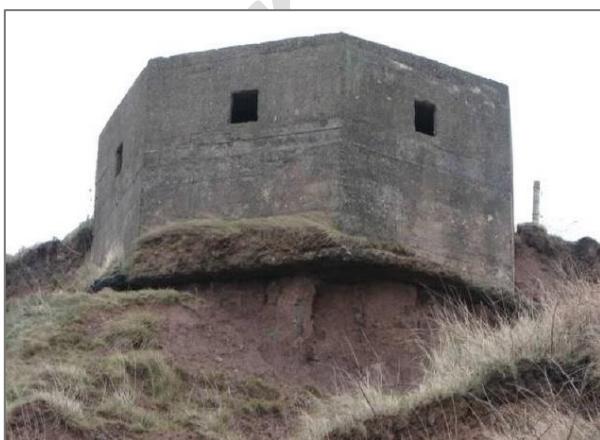
There are a number of Second World War pill boxes along this stretch, some of which have been eroded out of the cliffs (Figure 9 and Figure 10). There is no monitoring data for this stretch, but as this is a low energy environment erosion rates due to coastal processes are anticipated to be low. However, the pill boxes indicate that erosion does occur along this frontage, although the cause of this erosion is uncertain. There is also a short stretch of defence (presumably private owned) along this stretch - no data is available for this, but it appears to be sloping revetment, possibly associated with an outfall (Figure 10). Recent aerial images (available from www.magic.gov.uk) indicate this defence may be starting to fail, with the photographs indicating some upheaval between units (although this requires confirmation).

Figure 9 Erosion of a Second World War pill box between Hindpool and Lowsy Point (2009). Taken from: www.derelictplaces.co.uk/

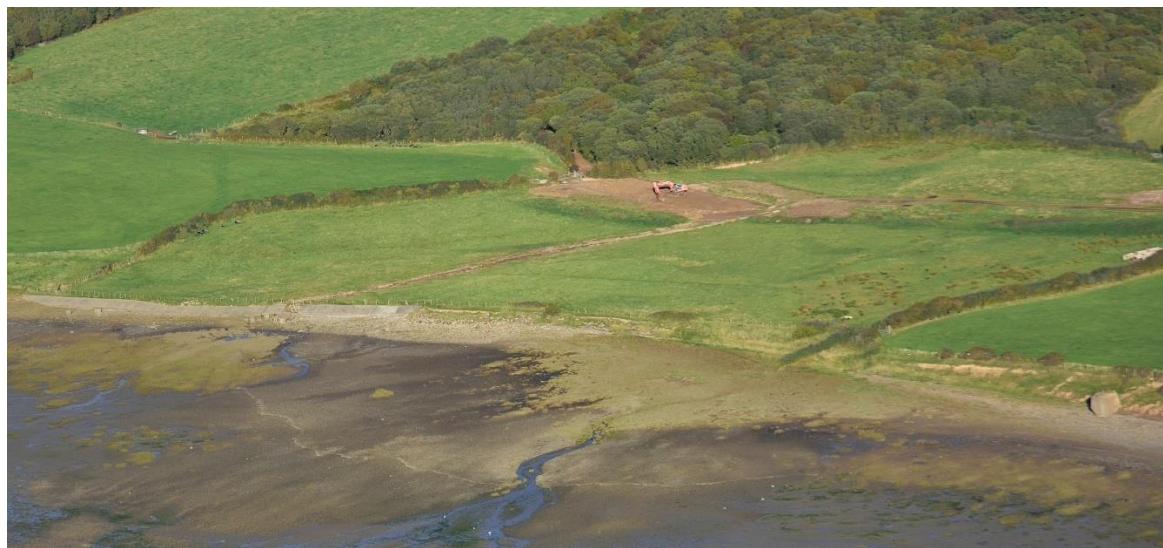
Figure 10 Low till cliffs between Hindpool and Lowsy Point. Also shows the erosion of a pill box (far right) and presence of a short length of revetment defence (presumably privately owned). 2015 aerial photograph © North West Regional Monitoring Programme.

- Further investigation into short length of defences between Hindpool and Lowsy Point to determine ownership and purpose of defence. Any further works are likely to require consent from Natural England, given the environmental designations covering the intertidal zone and associated buffer zones. There may also need to be a slight amendment to the SMP2 to cover any future works.

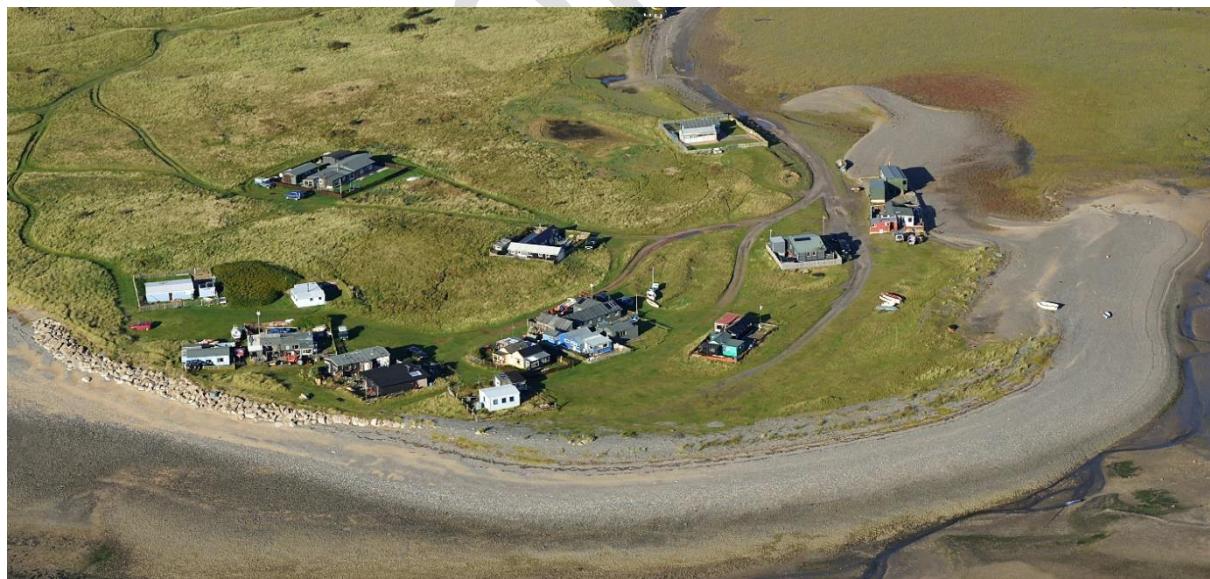
Rock has been placed here, presumably to reduce erosion risk to these properties (Figure 11); the defence is believed to have been constructed by Barrow Borough Council and maintained by National Trust.

Figure 11 Lowsy Point, showing the rock armour. 2015 aerial photograph © North West Regional Monitoring Programme.

At Lowsy Point, the short stretch of rock revetment appears to be providing limited protection to the collection of properties here. Due to proximity of properties to the shoreline there is little opportunity to realign the defences without first relocating properties landwards. There is limited economic justification for maintaining defences here, but it is possible they could be privately funded; but this would require consent from both Natural England and the landowners, the National Trust. There does not appear to be a significant impact of the defences on adjacent shorelines, which might be expected given the short length of defence present and the net accretion trend along the dune system as a whole; but this is based on observations from aerial photographs alone and further investigation may be required.

- Discussion between Cumbria County Council, National Trust, Natural England, Barrow Borough Council and local property owners to consider further management of Lowsy Point. There may also need to be a slight amendment to the SMP2 to cover any future works.
