Keswick

Flood Investigation Report

High Hill, River Greta Flood Defence

Flood Event 5-6th December 2015

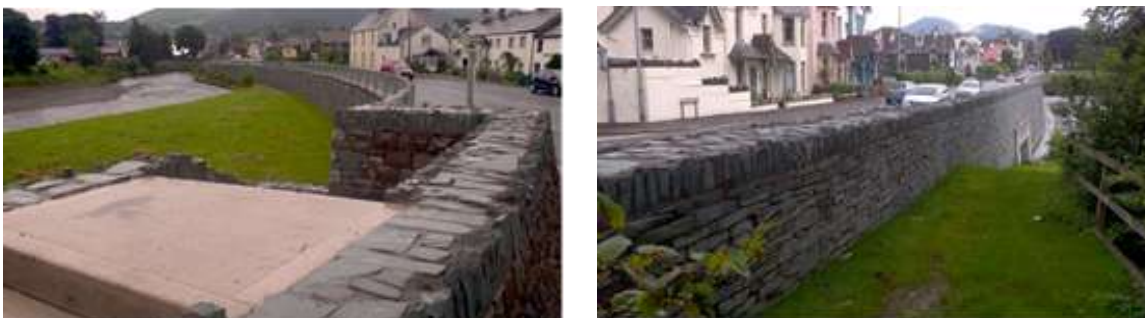
Figure 4 Photos of Keswick Flood Risk Management Scheme - Flood wall along High Hill and Penrith Road

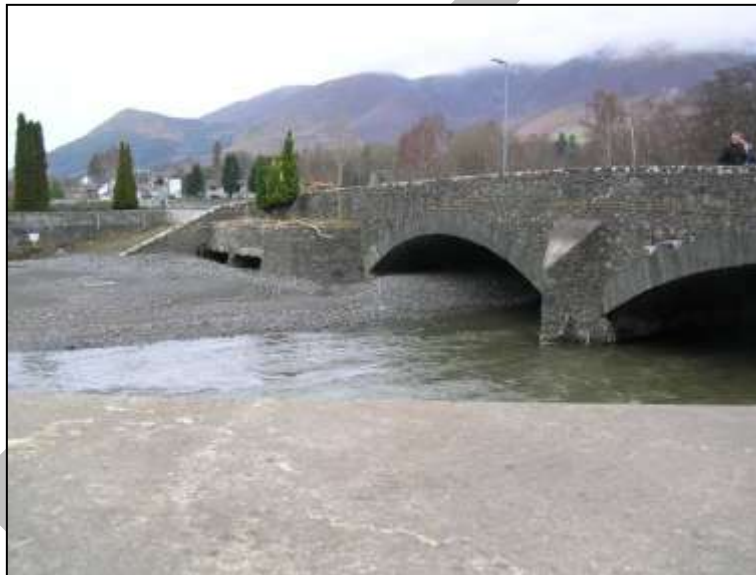
As a result of the erosion experienced upstream of Keswick a significant amount of material was deposited along the River Greta corridor through the town. In addition to the gravel/boulders and sediment deposited, a significant amount of woody debris and manmade objects were also transported downstream into the town, all of which caused a potential increase in flood risk due to reduced channel capacity. This debris caused blockages to the bridges within the town increasing the restriction to flow, figure 8.

Figure 8 Blockage of culverts downstream of Greta Bridge

Immediately after the flooding the most critical scour holes were filled including scour damage on the landward side of the flood bank on Crosthwaite Road. Major debris deposits, which posed a risk of future blockages to structures, were removed after the flood event by the Environment Agency once river levels had sufficiently receded. The Environment Agency undertook emergency works to remove accumulated debris from the River Greta channel from Low Briery to the confluence with the River Derwent. This included the removal of an estimated 25,000 tonnes of gravel from the River Greta at Greta Side, the Pencil Works, and Greta Bridge areas.

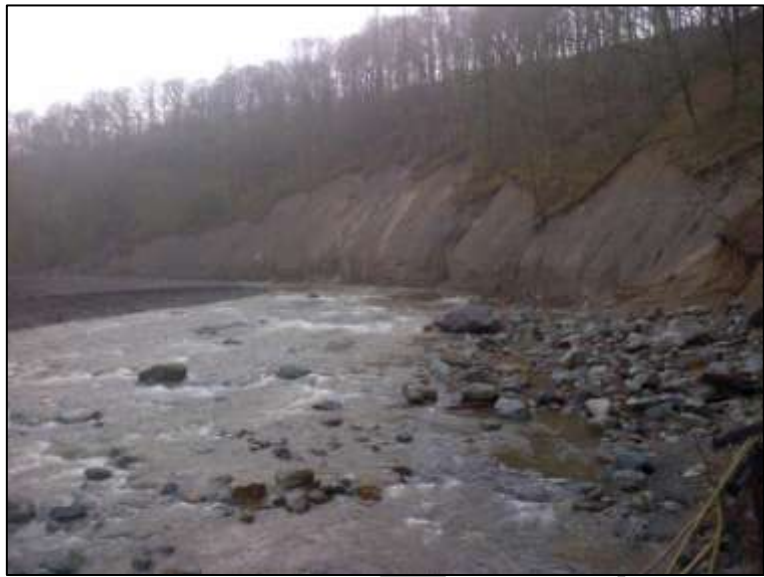
led to failure of the river slope. The lower part is now over-steepened and is subject to continued erosion from the river. The slope failures have removed a large numbers of trees and high volumes of eroded material, contributing to the flooding impact on Keswick.

Figure 11 Erosion/landslip feature upstream of Low Briery Holiday Park

- We are working with a team of geologists and geomorphologists to understand the significant changes to the river Greta upstream of Keswick and to develop a plan for the future management of the system, particularly with regard to the huge amount of loose gravel material that is now present.
- Recovery works to repair damaged assets are ongoing.

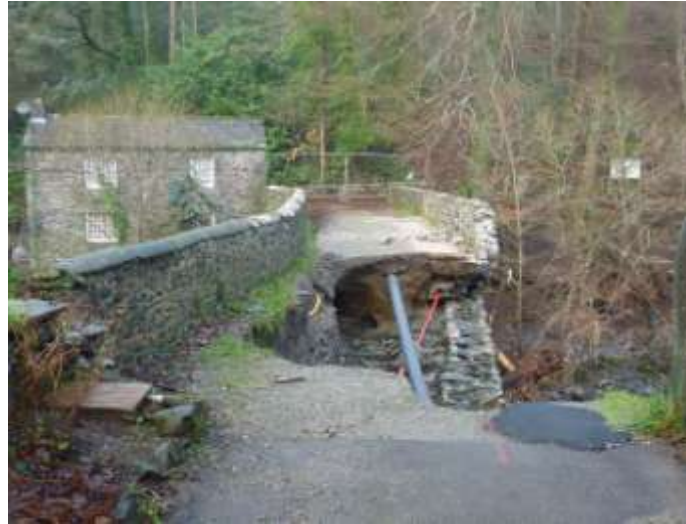
This is an area of residential properties upstream of Keswick occupying both banks of the River Greta including Bridge House which is tied into the bridge itself. Forge Bridge forms a constriction to river flows and can cause elevated river levels immediately upstream. During December 2015, river levels exceeded the top of the bridge arch. These elevated levels flooded properties 6 to 9 Forge Lane on the left bank. There was also considerable damage to Forge Bridge, as shown in Figure 10, from both the high water level and debris including large trees and caravans. Significant scouring of the river bank also occurred on both the left and right hand sides.

Figure 13 Forge Bridge Partially Collapsed

The depth of flooding at the Forge was recorded to be in excess of 1.5m. A resident reported that the extent of flooding in the area was more extreme than the 2009 flood event.

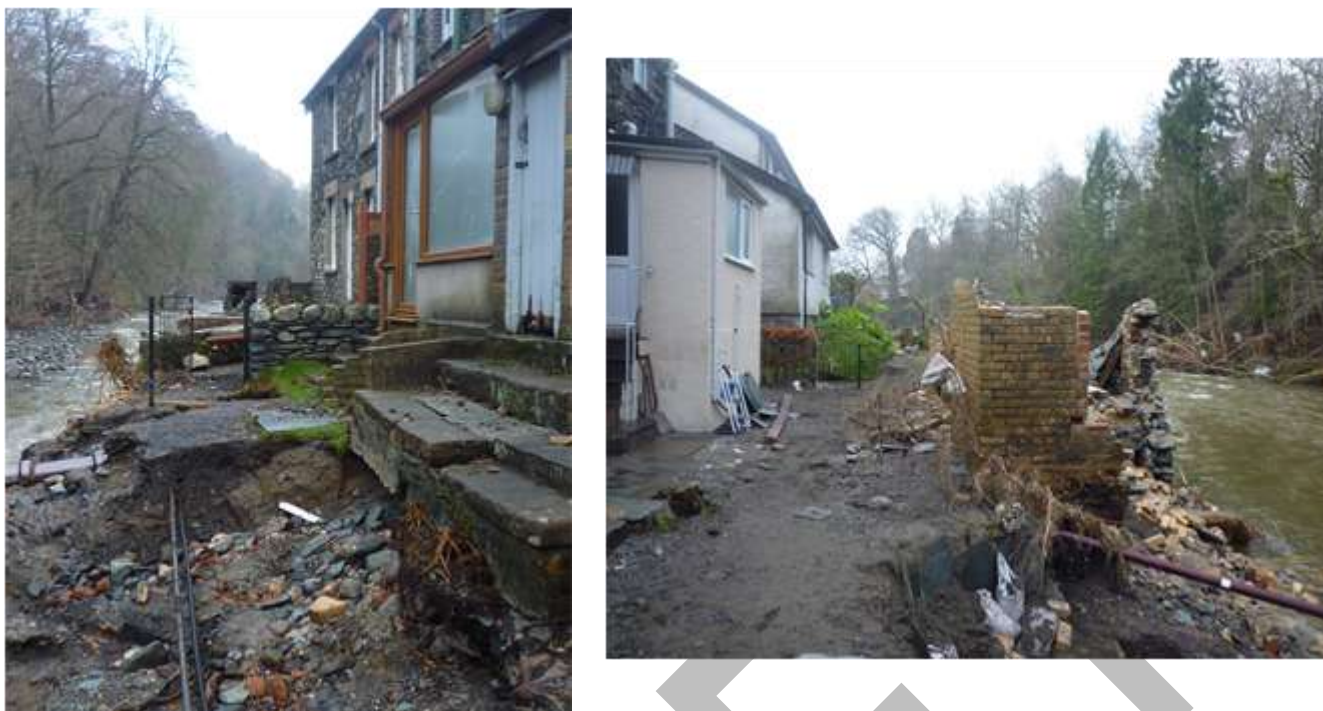
Significant erosion of the river bank upstream of the bridge took place with between 5m and 10m of the gardens of these properties being lost to the river. 3-9 Lydia's Cottages and 'Arkanum' all suffered severe bank erosion, with associated destruction of outhouses, boundary walls, and services. In some cases, very little ground remained to the rear of the property. After the flood event some of these properties were declared structurally unsafe. Damage was also sustained to property at Toll Bar Cottage located on the downstream side of the bridge.

Figure 15 Scour damage to the rear of properties

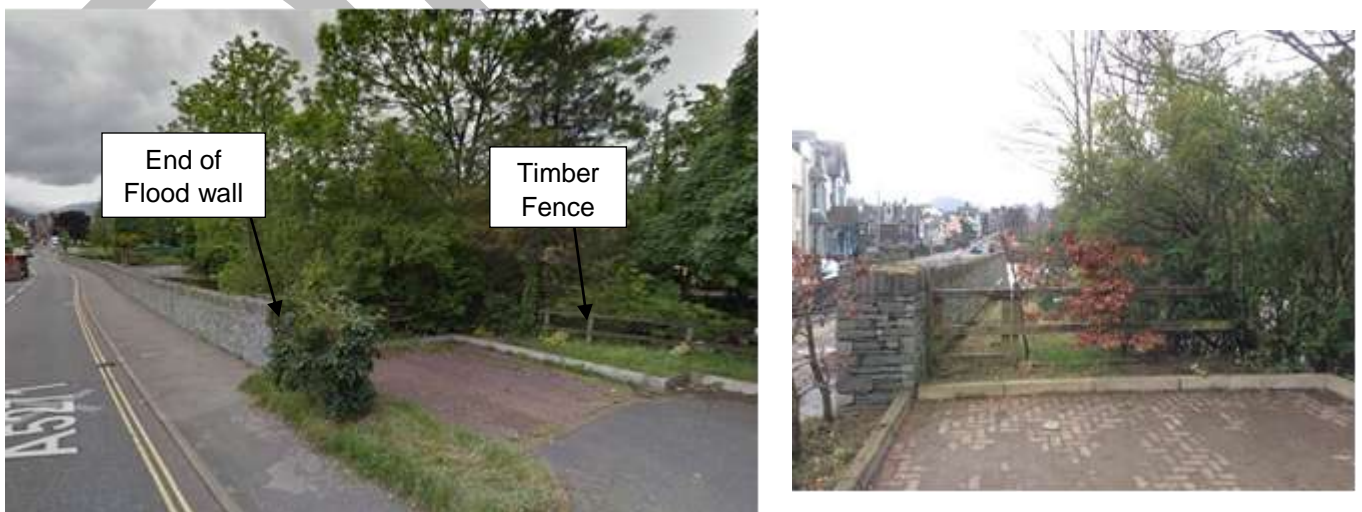
Figure 19 Left bank of River Greta where defences overtopped

In addition, surface water runoff flowed onto Ambleside Road, continuing in the direction of the River Greta. Surface water flooded numerous properties within the area between Ambleside Road and Penrith Road. It was also noted that a manhole at the junction of Penrith Road and Greta Street shown in figure 20 started surcharging prior to the river overtopping or outflanking the flood wall. Overtopping of the flood defence wall finally occurred from the River Greta prior to outflanking at the end of the floodwall, figure 19.

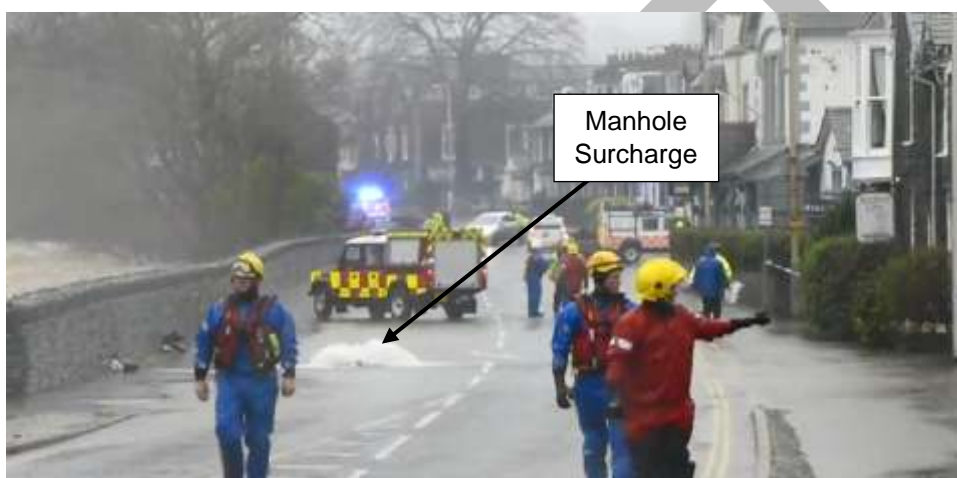
The initial cause of flooding was from surcharging of the Castlehead culvert which takes water from a small watercourse in the Ambleside Road area to the River Greta. Flooding was then observed in this

Figure 20 Manhole surcharge on Penrith Road

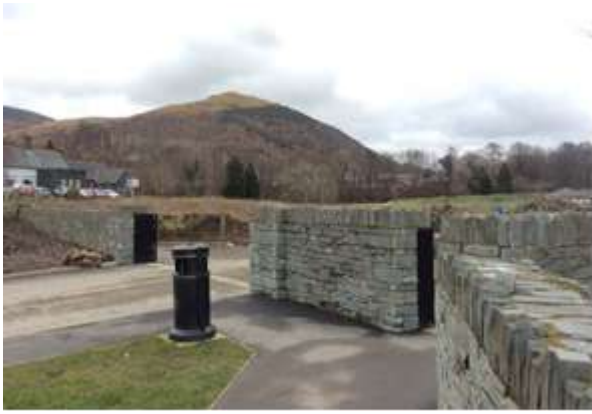
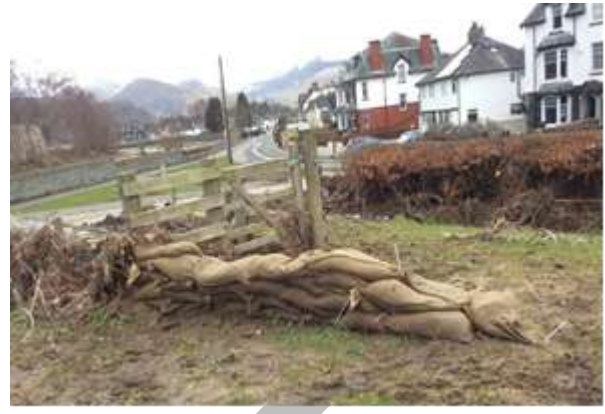
The flood embankment and defence wall along Crosthwaite Road were both overtopped despite efforts by the Environment Agency to bolster the defences with sandbags during the event. There was also some seepage through the base of the vehicular floodgate at the northern end of Crosthwaite Road. Seepage was also observed through the flood defence wall near the upstream end of Crosthwaite Road, as well as further downstream. Water from these routes led to Crosthwaite Road being flooded from Fitz Park. Upstream headwall damage was also sustained by the Station Road bridge.

Figure 22 Crosthwaite Road Flood defence wall and embankment which were overtopped

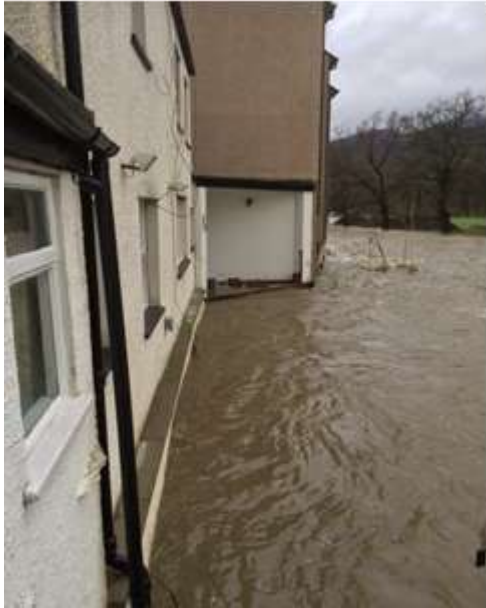
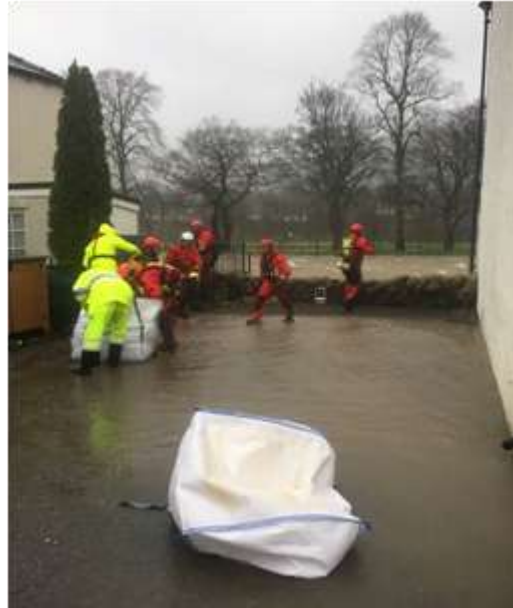
The Environment Agency laid sandbags along this stretch of flood wall to provide additional protection, however this was still overtopped as river levels rose. Residents also reported that floodwater entered the properties through the floors, which, combined with surface water would account for water collecting behind the defences prior to overtopping. The footbridge that connects Millbank at the top of Stanger Street to Lower Fitz Park was washed away during the flood.

Figure 24 Riverside view of the properties and river flow between properties on Greta Side

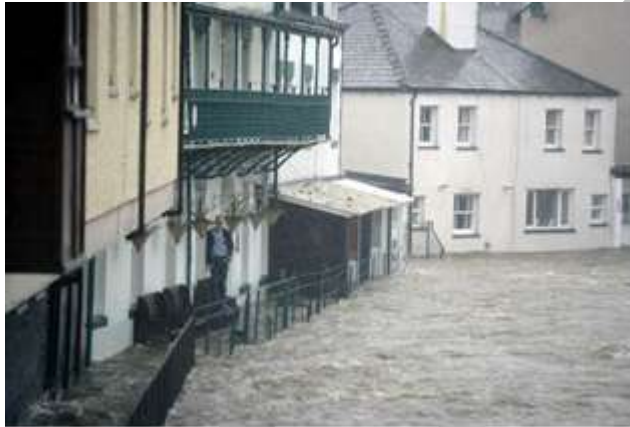
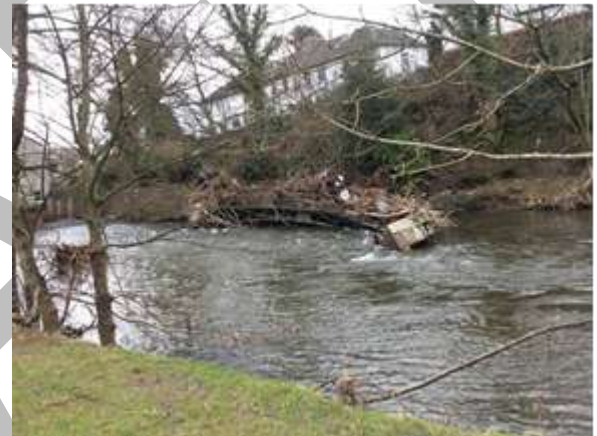
Figure 25 Riverside view of Youth Hostel and washed out footbridge resting on left bank abutment

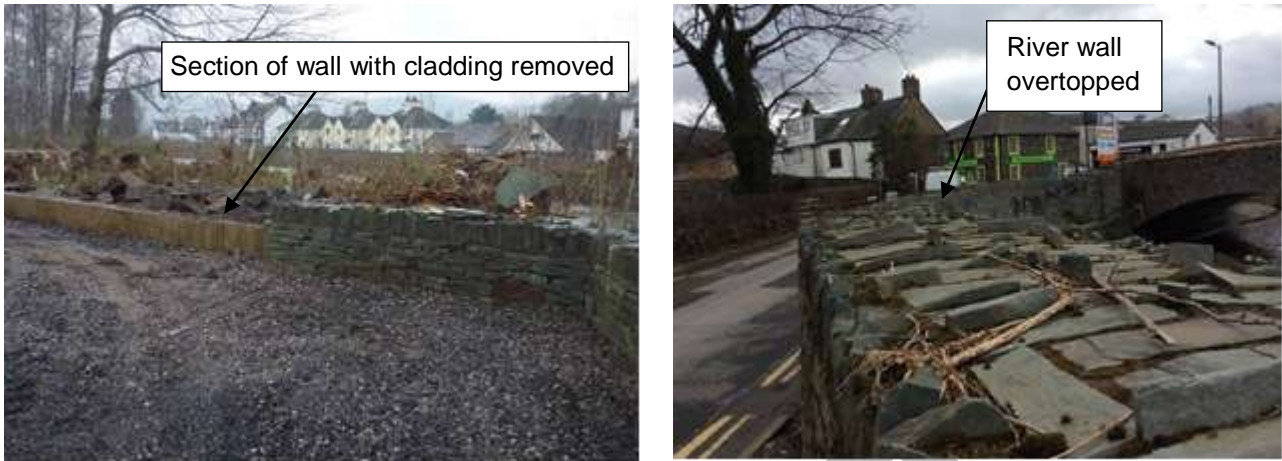
Two mechanisms of flooding were observed from the river. Firstly, the flood defence walls were overtopped immediately upstream of Greta Bridge. Greta Bridge acts as an obstruction to flow leading to higher river levels upstream of the bridge. This increased the risk of defences being overtopped. The effect of this obstruction was worsened by debris in the river blocking the bridge arches.

Figure 27 River overtopped its bank/flood wall at Southey Hill Estate and the river wall overtopped at upstream of Greta Bridge

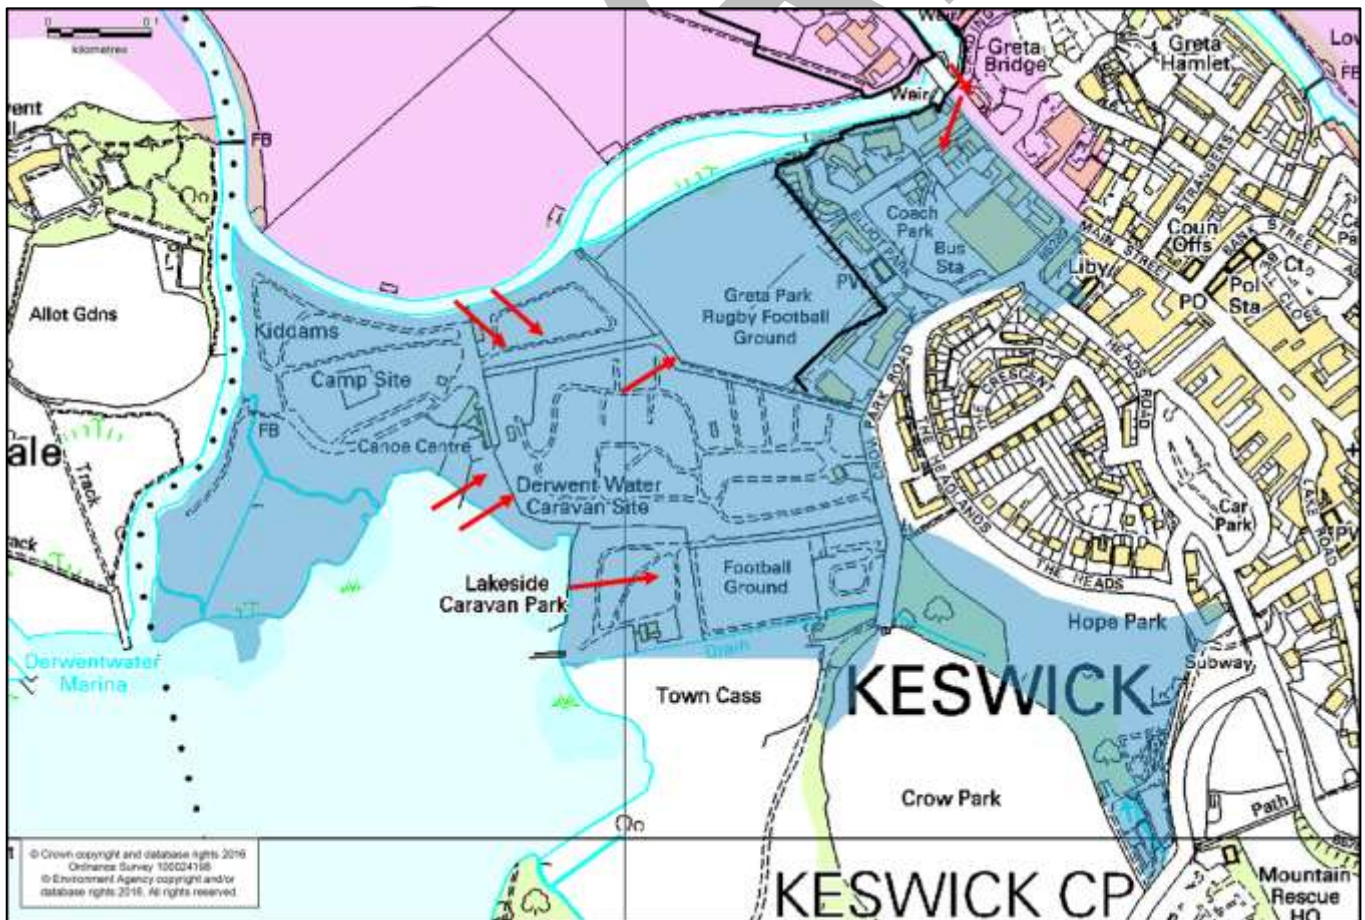
Figure 28 Source of Flooding and Flood Extent on the South of the Main Street

The River Greta overtopped immediately upstream of the Greta Bridge, and flowed across Main Street towards Elliott Park. This resulted in the flooding of all properties between Tithebarn Street, Main Street and the River Greta, including properties on Elliott Park and Riverside Court as well as Booths supermarket and the rugby football ground. This is shown on figures 29 and 30.

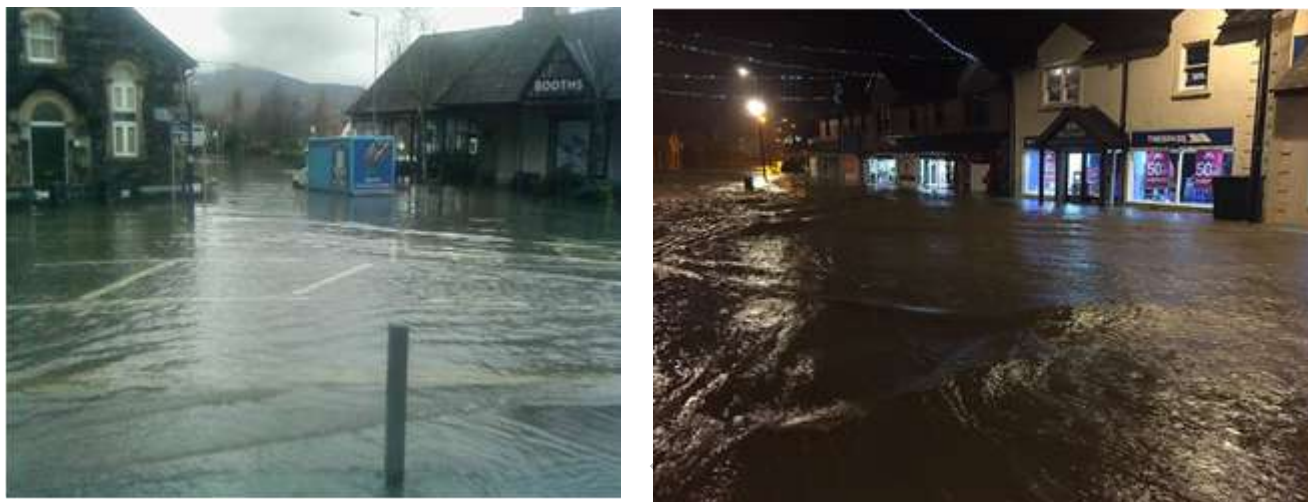
Figure 29 Flooding at Booths store and on Main Street/Tithebarn Street

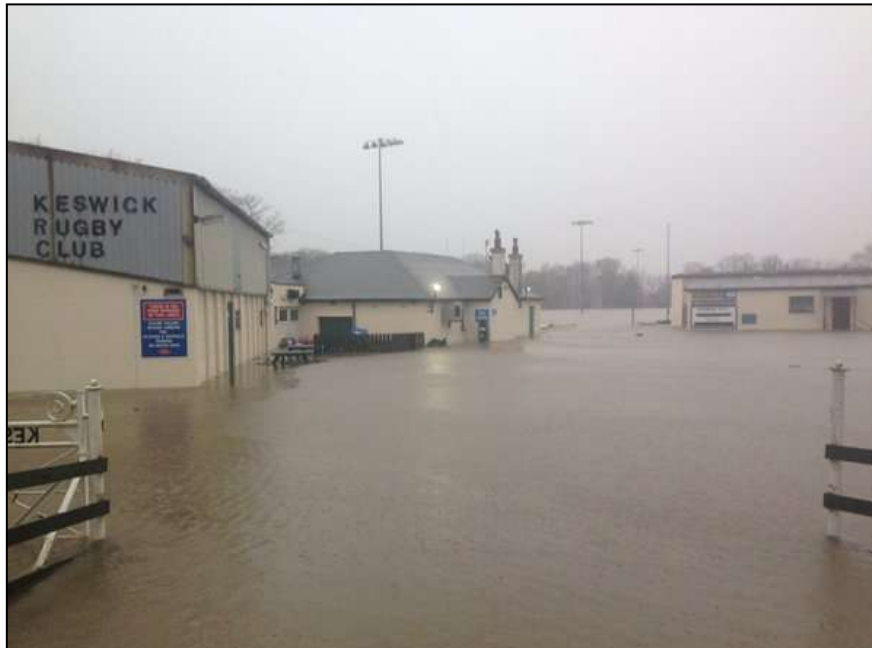
Local residents reported that the onset of flooding in Elliott Park was rapid, with the water level reaching the top of the embankment at the Rugby Football Club within half an hour. The water level on the floodplain downstream of Elliott Park at the Rugby Football Club was reported to be significantly lower than the level within Elliott Park. Water was observed flowing over the embankment crest from Elliott Park side onto the floodplain. It is therefore felt that in this incident, the embankment acted as a barrier to flow and impounded water in Elliott Park, exacerbating the impacts of the flooding to the area.

Figure 30 Flooding at Keswick Rugby Club

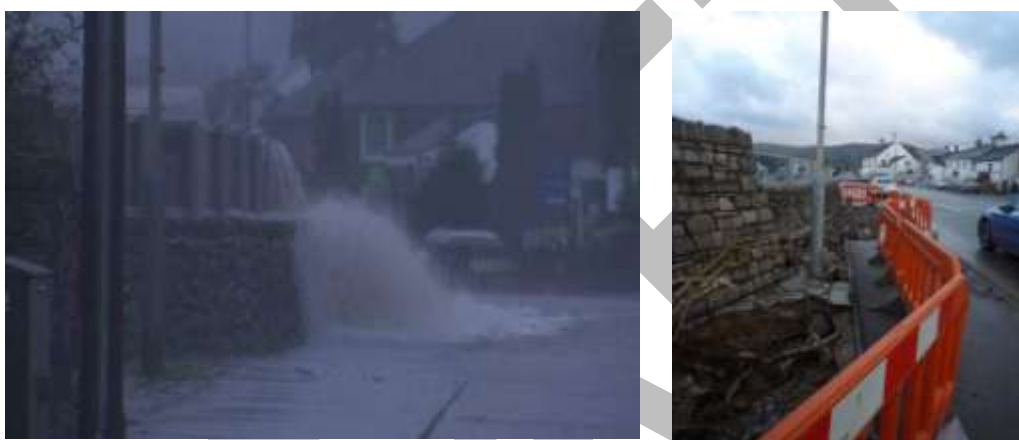
It was reported that flooding to this area started at the flood wall on High Hill road, where it was overtopped at the river bend. Initial overtopping along High Hill Road was observed at 13:00 on 5th December. Here, floodwater scoured out stone pitching on the defended side of the defence along with a section of footpath approximately 10m long. Residents on High Hill Road reported that soon after this the flood embankment on the river Derwent flood plain to the rear was overtopped. The flooding to these properties is therefore understood to be from both rivers.

Figure 32 Flooding at High Hill Road - Glassed floodwall overtopped and scoured footpath

Despite the record flows experienced on the Rivers Greta and Derwent in Keswick, only minor damage was experienced to Environment Agency assets. This mainly comprised damage to seals on floodgates and the glass panels on High Hill Road, which will subsequently be repaired by the Environment Agency. The minor damage experienced does not compromise the standard of protection offered by the flood risk management scheme to Keswick.
