# Cockermouth

## Flood Investigation Report

## Flood Event 5-6<sup>th</sup> December 2015

This flood investigation report has been produced by the Environment Agency as a key Risk Management Authority under Section 19 of the Flood and Water Management Act 2010 in partnership with Cumbria County Council as Lead Local Flood Authority.

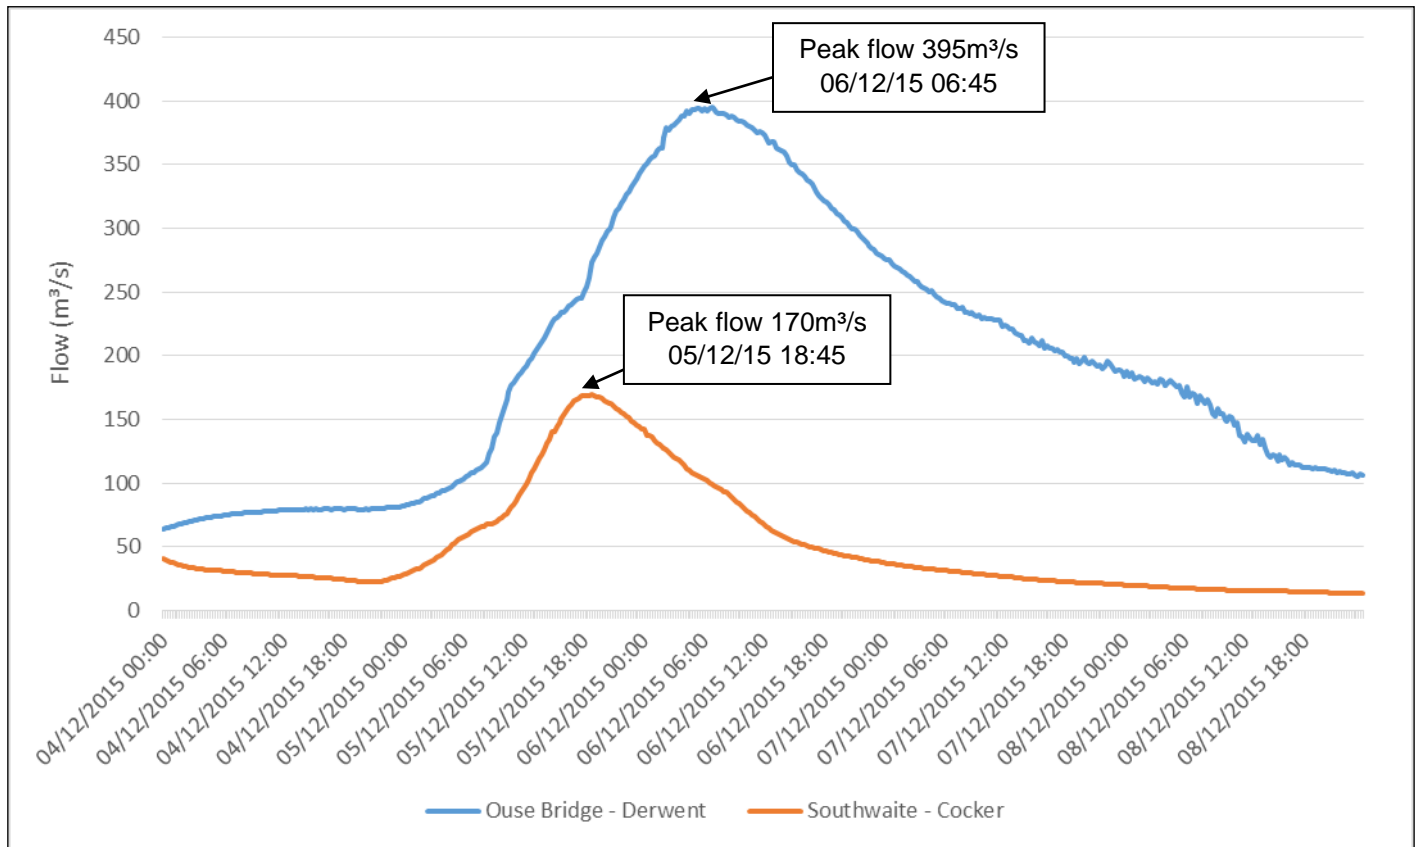
**Figure 6-Flow measured at river gauges upstream of Cockermouth**

Table 5 shows the peak flows recorded at these gauging stations. For the Ouse Bridge gauging station on the River Derwent, the flows on 5<sup>th</sup> December were higher than those for any previous event. Flows calculated at Southwaite Bridge on the River Cocker were less than the November 2009 event and this is reflected in the flooding extent and mechanisms.

Gauging Station	River	Peak flow (m3/s)					Estimated AEP of Dec 2015 event
		Dec 2015	Past events				
			June 2012	Nov 2009	October 2008	Jan 2005	
Ouse Bridge	Derwent	395	154	378	187	196	0.1%-0.3%
Southwaite	Cocker	170	110	201	117	107	1%

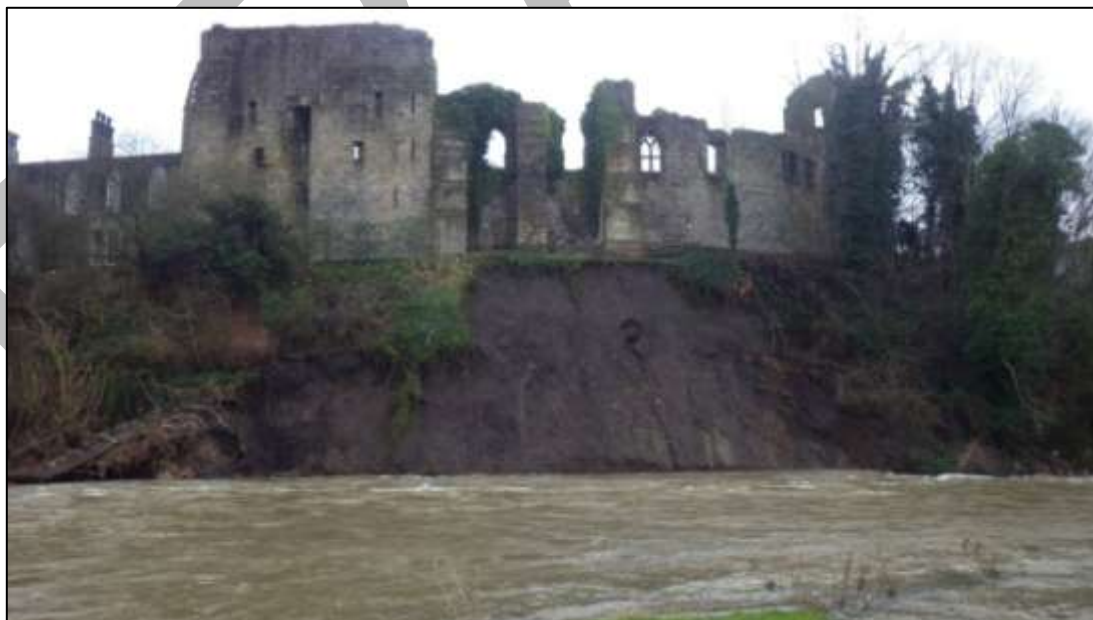
A number of areas in Cockermouth were identified to have experienced significant erosion during this flood event. In particular, the riverbank at Cockermouth Castle was severely eroded, and the castle has been identified as being at risk of damage. Damage to this bank, and fallen trees on the upstream island led to blockages at Gote Bridge. Figure 8 shows the riverward side of the castle and the erosion to the bank at this location. There was also significant erosion around Bitter Beck and to the playing fields and footpaths east of Gote Road.

**Figure 8-Cockermouth Castle showing erosion to riverbank. Taken 21/12/2015**

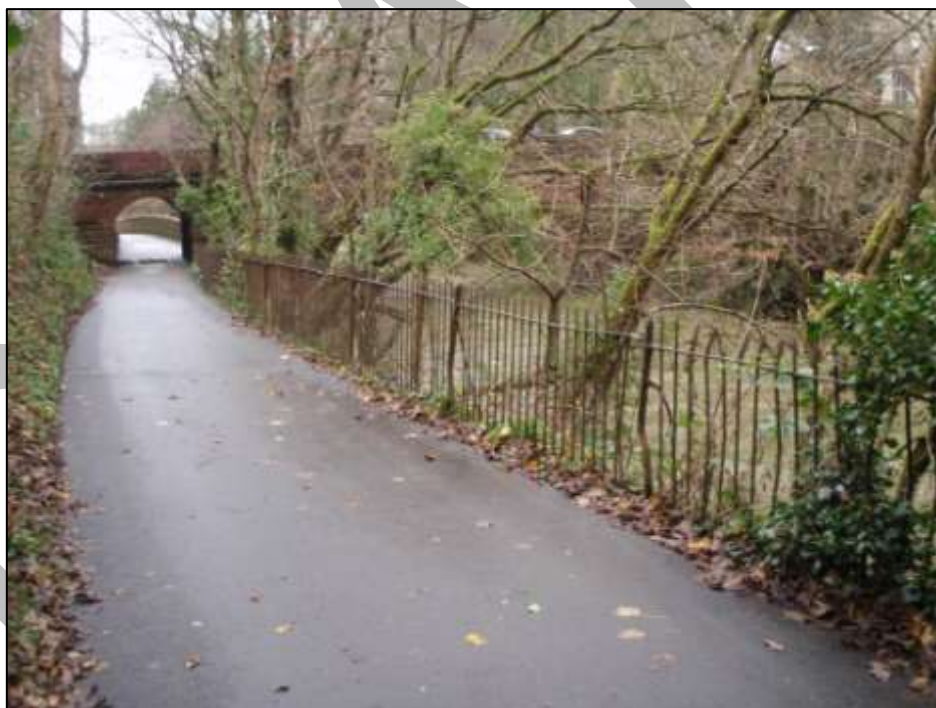
Water from the River Cocker overflowed the riverbank between the Victoria Road Bridge and Victoria Jubilee Railway Bridge. Figure 10 shows the riverbank which does not have any raised defences at this location. After overtopping the riverbank, the floodwater passed through the pedestrian archway. The water level was high enough to pass over the raised road hump, located at the upstream end of Rubby Banks Road. This road hump is higher than the level of the flood defence wall but was thought to be overtopped due to the Victoria Road Bridge restricting flow and raising the river level upstream of the bridge.

**Figure 10-Riverbank between Victoria Jubilee Rail Bridge and Victoria Road Bridge (facing downstream). Taken 9/12/2015 at 11:40**

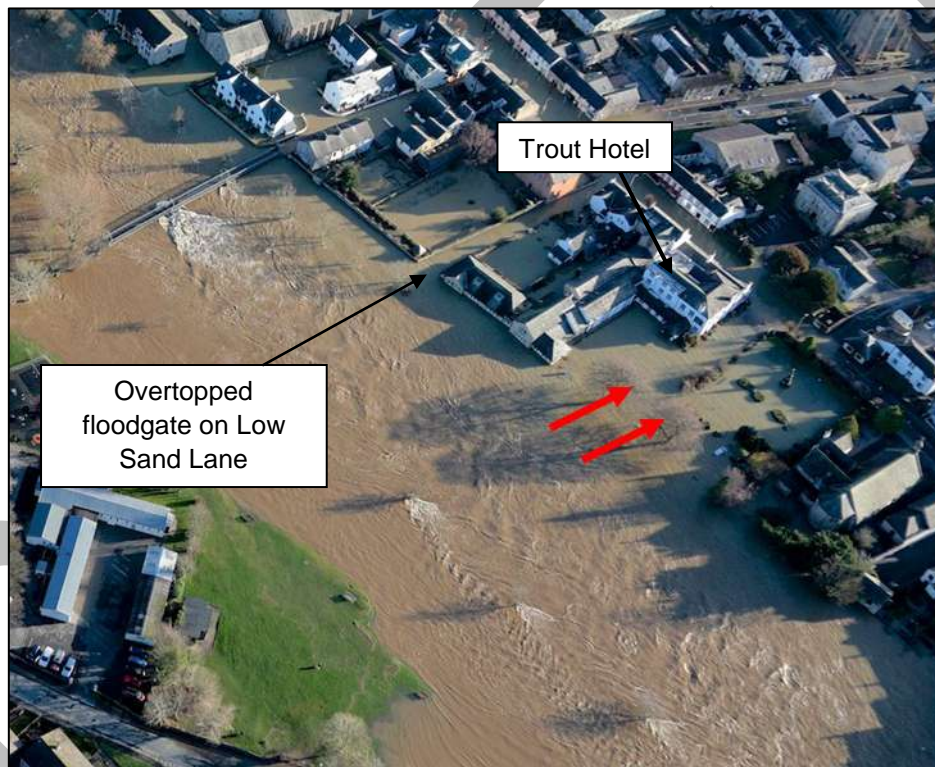
There was significant flow onto Main Street through the car park at the Trout Hotel. Floodwater also overtopped the flood barrier on Low Sand Lane, upstream of the hotel. This route is highlighted in Figure 13. Floodwater then continued to flow down Main Street and formed the main flood route into the area. The amount of water following this route was increased by debris at Gote Bridge obstructing flow and leading to a higher river level at the Trout Hotel.

**Figure 13-River Derwent at Main Street area highlighting flow route through the Trout Hotel car park. Photograph provided by Peter Smith Photography. Taken 06/12/2015 12:37**

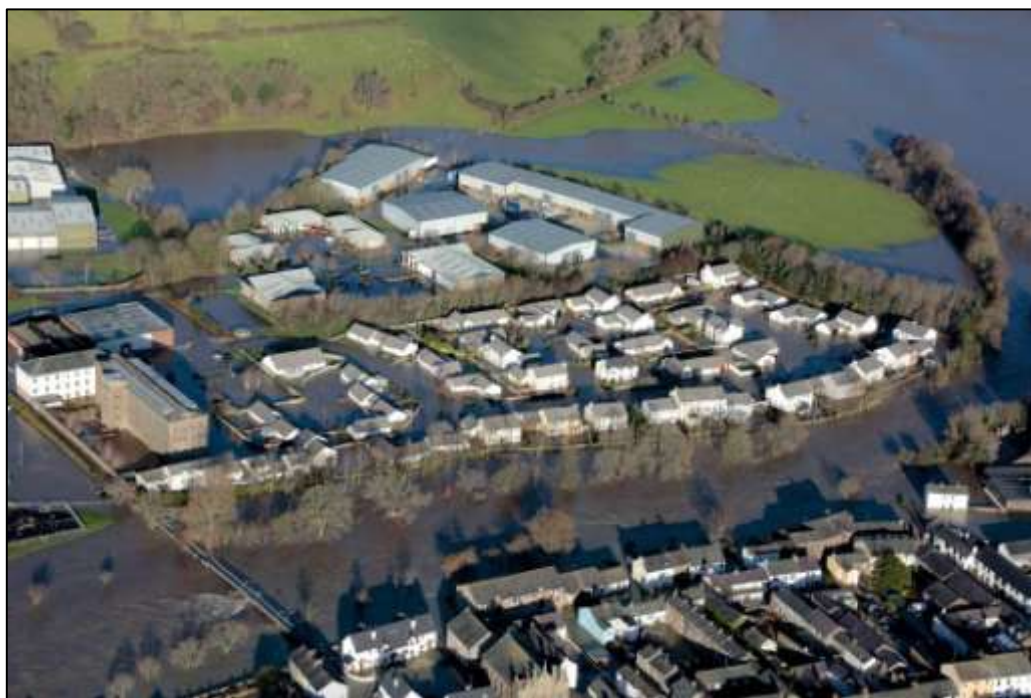
Flow on the right bank of the River Derwent overtopped the defences at this location. These defences were also outflanked with water travelling overland via routes upstream of Derwent Mills and at the eastern extent of the Derwentside Gardens estate. Figure 15 shows this area during the flood event. Flood water was observed by residents to be flowing back towards the River Derwent over the embankment at the southern extent of the estate.

**Figure 15-Derwentside Gardens during event showing flow route upstream of defence.**  
 Photograph provided by Peter Smith Photography. Taken 06/12/2015 12:37

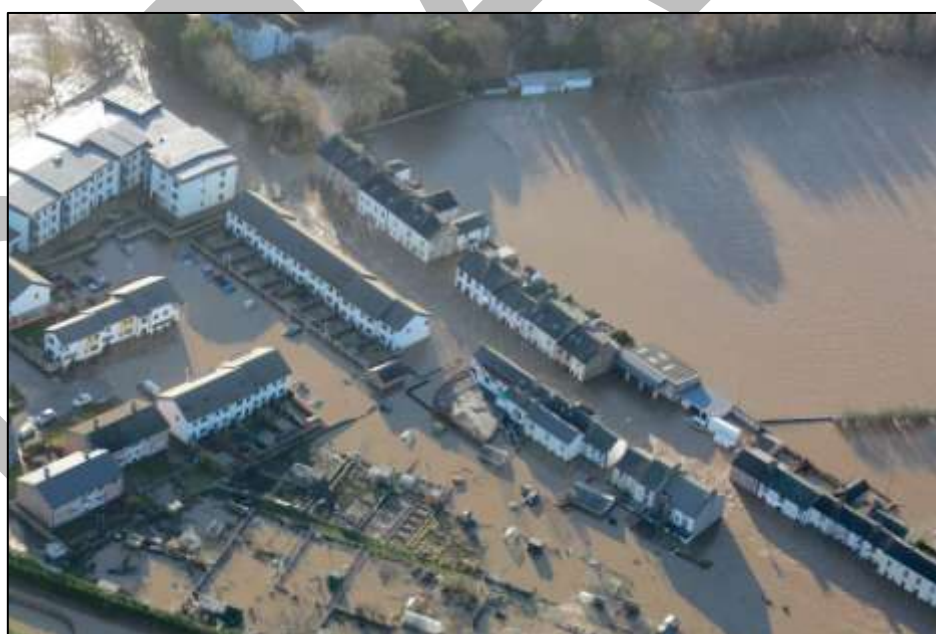
**Figure 17-Gote Road area during event. Photograph provided by Peter Smith Photography. Taken 06/12/2015 12:35**

Gote Bridge caused an obstruction to the river leading to higher river levels upstream of the bridge. This was visible during the event where there was a significant difference in levels upstream and downstream of the bridge. A number of trees and other debris partially blocked the bridge arches at peak flows, increasing the impact of this. This exacerbated the overtopping of the defences and the flow into this area.
