# Lyth Valley

## Draft Flood Investigation Report

Ulpha Pumping Station, Lyth Valley

## Flood Event 5<sup>th</sup> – 6<sup>th</sup> December 2015

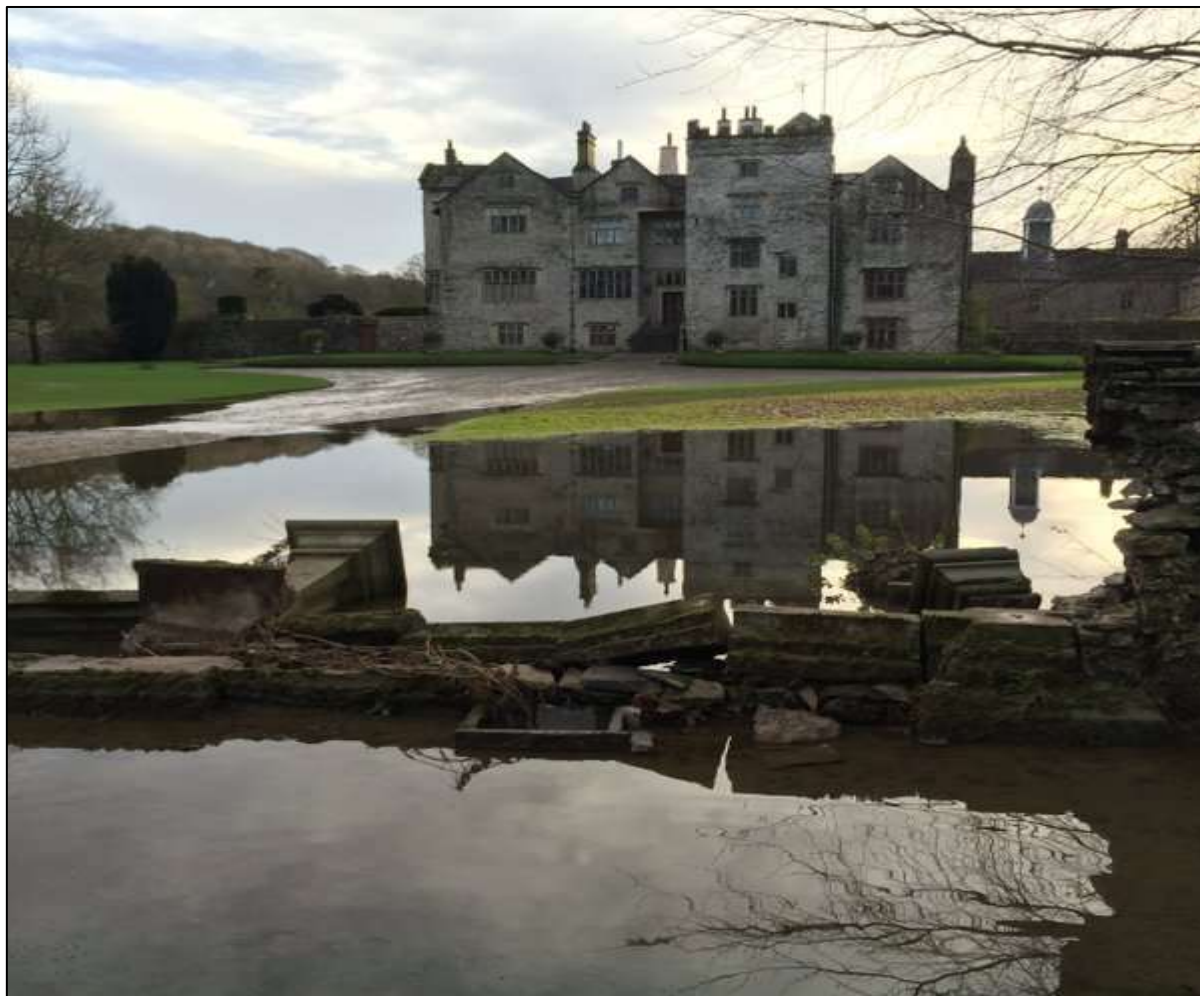
**Photograph 5:** Receding Floodwater at Levens Hall, December 2015

The flooding also resulted in an estimated £100,000 of flood damage at the Levens Hall complex, a historic manor house that is located adjacent to the River Kent and the A6 road (**Photograph 5**).

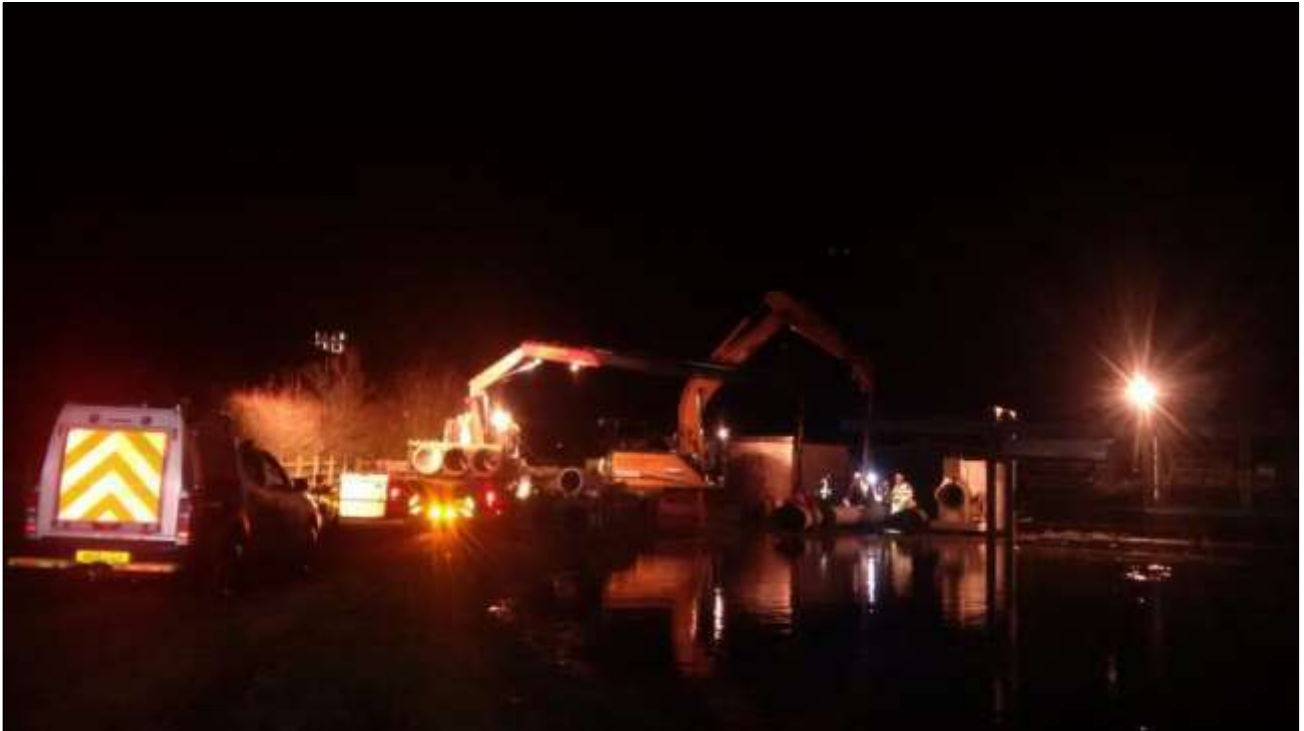
**Photograph 6:** Additional Storm water Pumps Deployed at the Sampool Pumping Station

**Photograph 6** to **Photograph 9** show some of the additional storm water pumps deployed at the Lyth Valley Pumping Stations during the flooding incident.

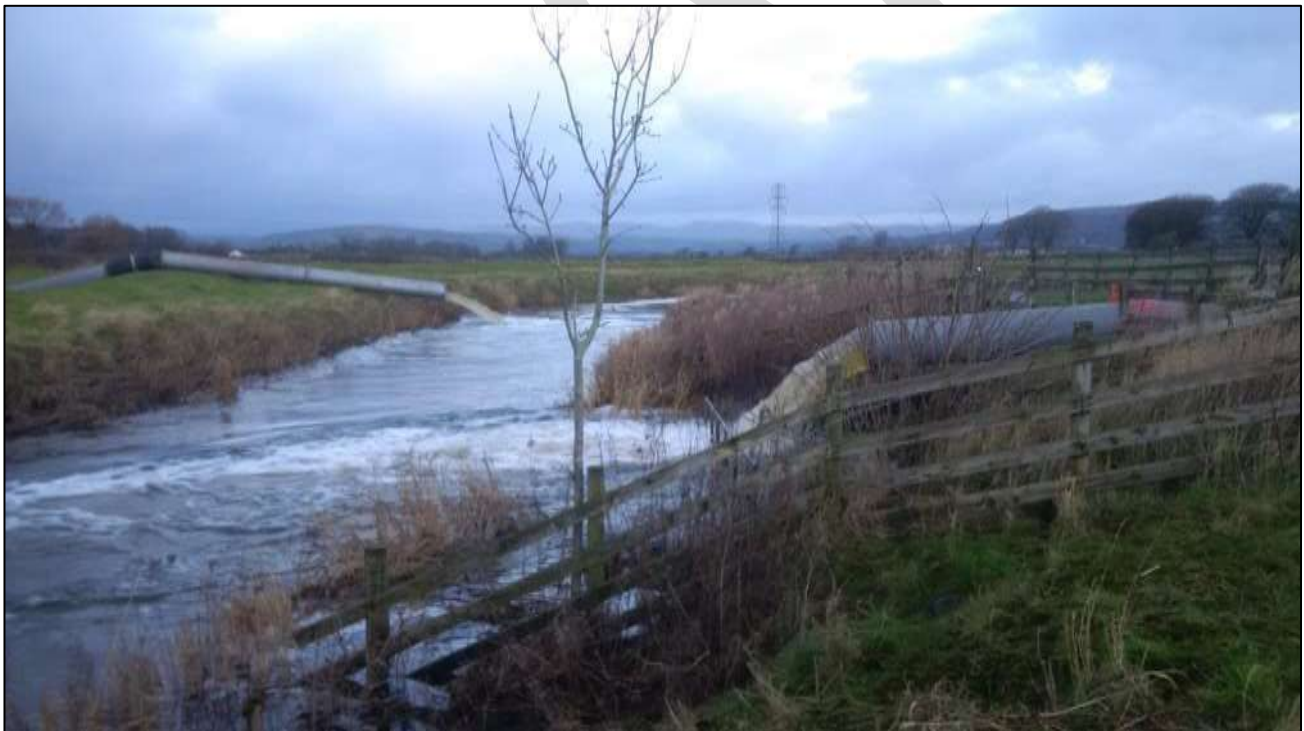
**Photograph 7:** Additional 24" Storm water Pumps Deployed at the River Gilpin at Sampool PS

11<sup>th</sup> December 2015, 08:47, NGR SD 47225 85593

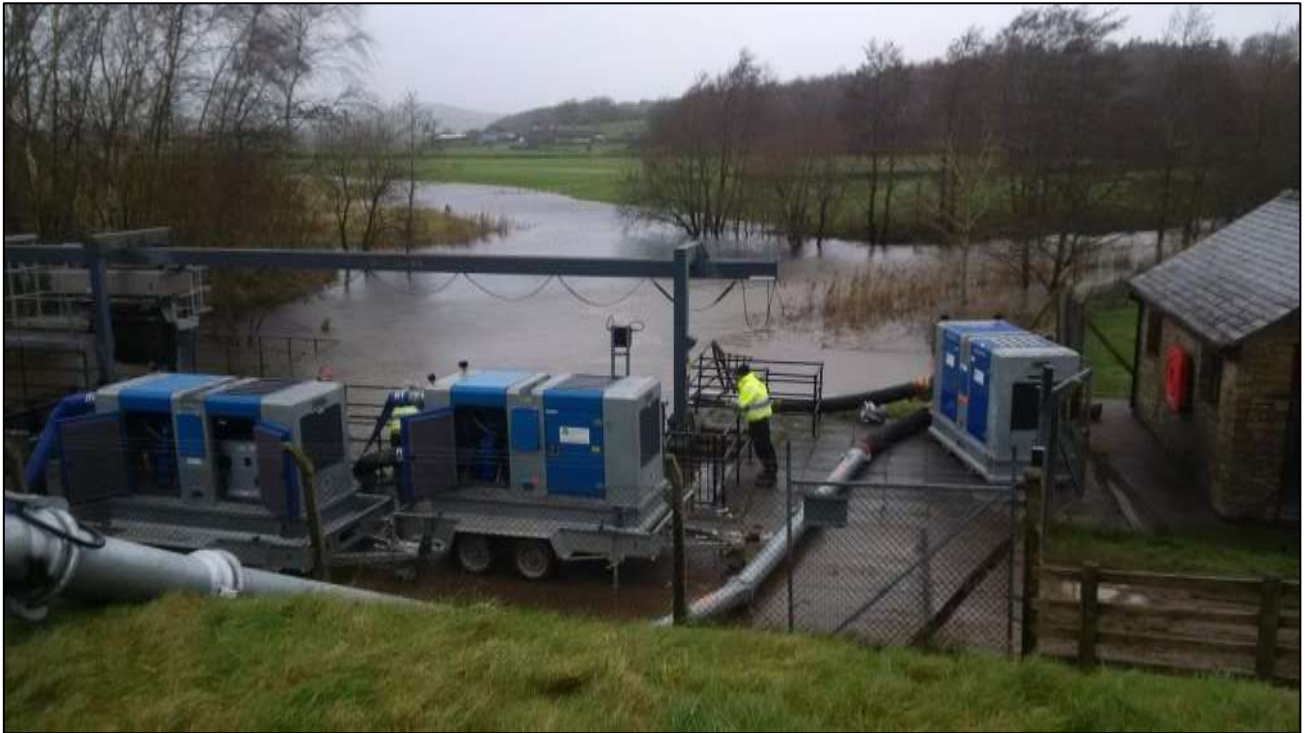
**Photograph 8:** Additional Storm water Pumps Deployed at the Ulpha Pumping Station

9<sup>th</sup> December 2015, 12:22, NGR SD 49622 79659

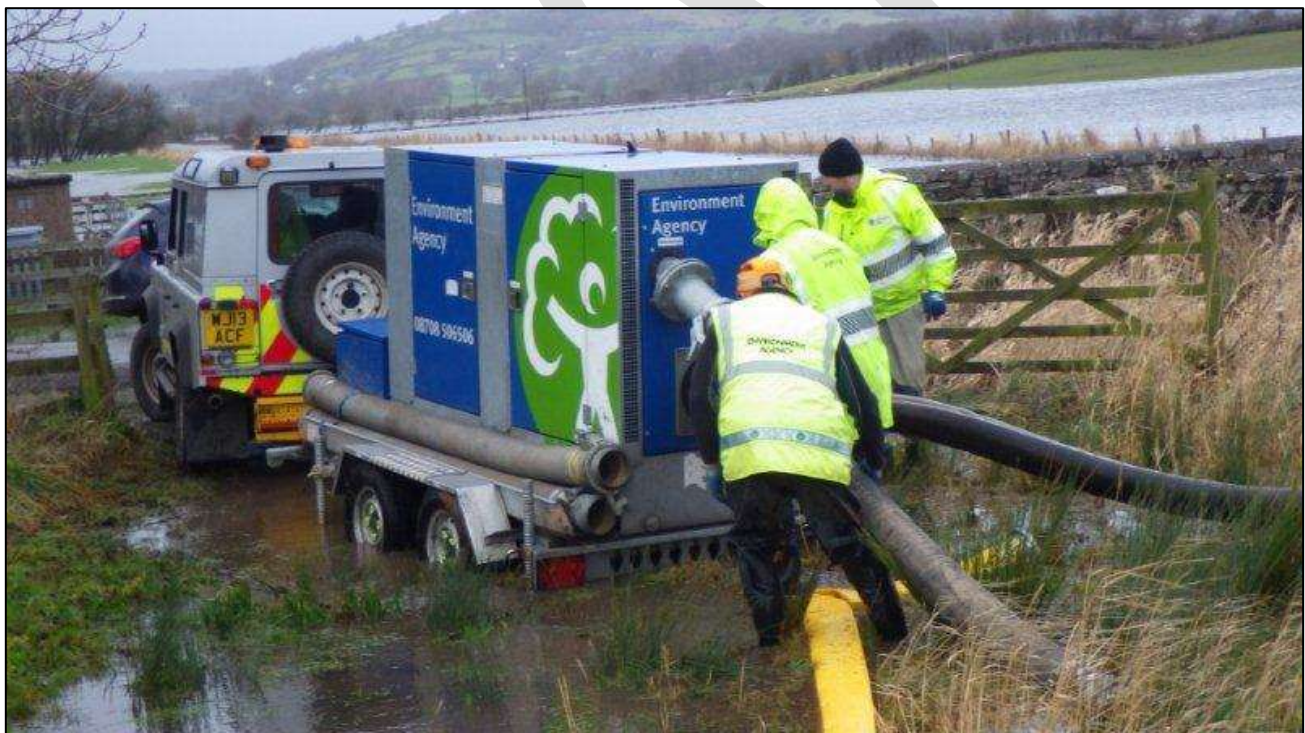
**Photograph 9:** Additional Storm water Pumps Deployed at the Pool Bridge Pumping Station

9<sup>th</sup> December 2015, NGR SD 49673 79607

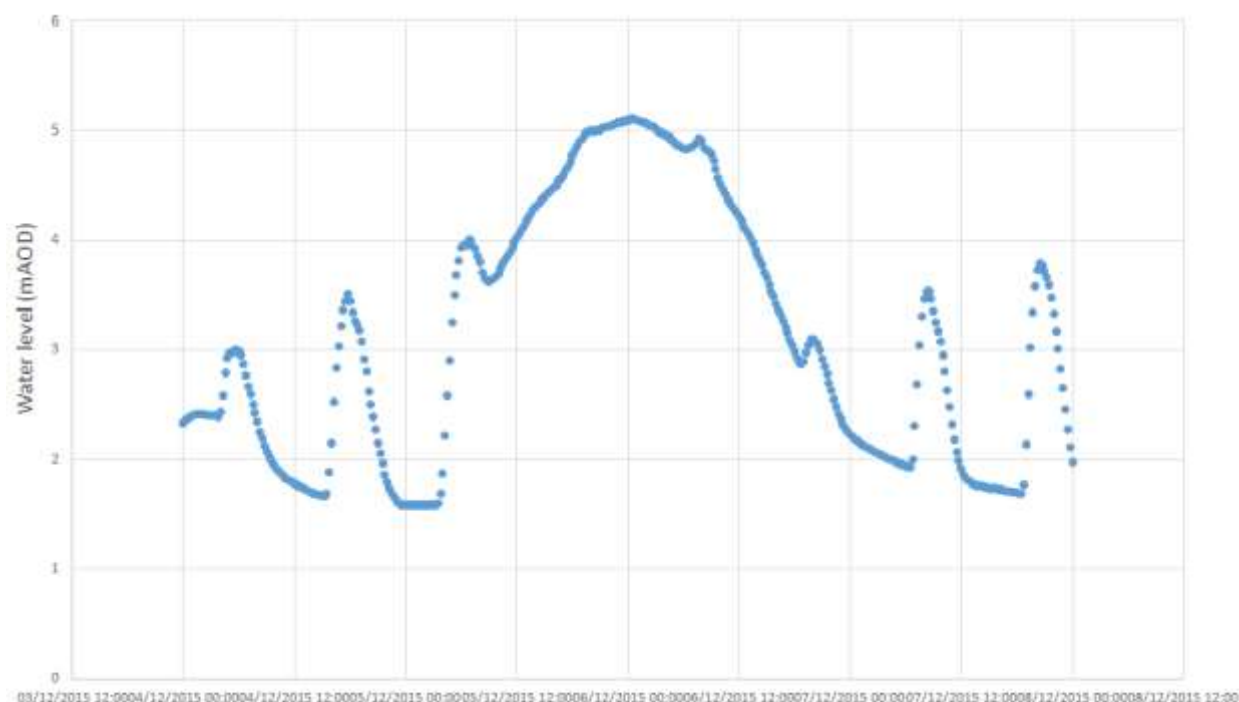
The tidal data as recorded at Lancaster Quay on the River Lune is shown in graph 3 below.

**Graph 3: Tidal data recorded at Lancaster Quay on the River Lune, 5<sup>th</sup> December 2015**

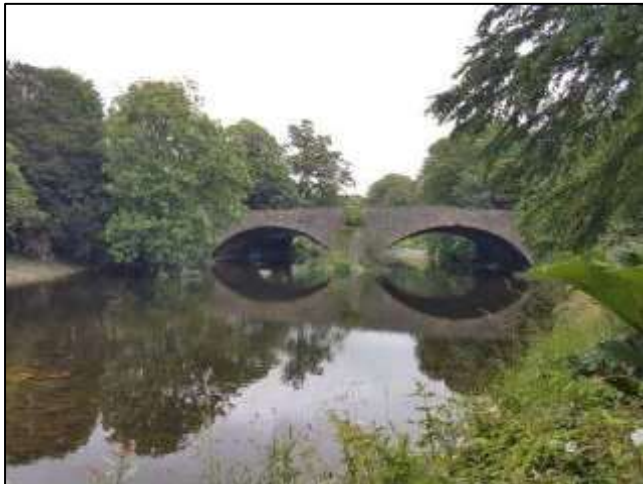
**Photograph 11:** A6 Road Bridge at Levens Hall

The survey team undertook a visual inspection of the A6 Road Bridge over the River Kent at Levens Hall (**Photograph 11**). The A6 Road Bridge is located between Levens Hall and the associated Deer Park. This is a substantial twin arch structure with significant capacity for dry-weather flows on the River Kent. At the time of writing the hydraulic modelling project of the River Kent has not been completed; it is therefore not possible to quantifiably determine whether the structure throttled flood flows on the River Kent during the December 2015 flooding. Anecdotal reports from local observers indicate that it may have constrained flows and resulted in a 'backing up' of floodwater within the Levens Hall Deer Park during the incident. Flows also reportedly overtopped the structure during the flooding incident.

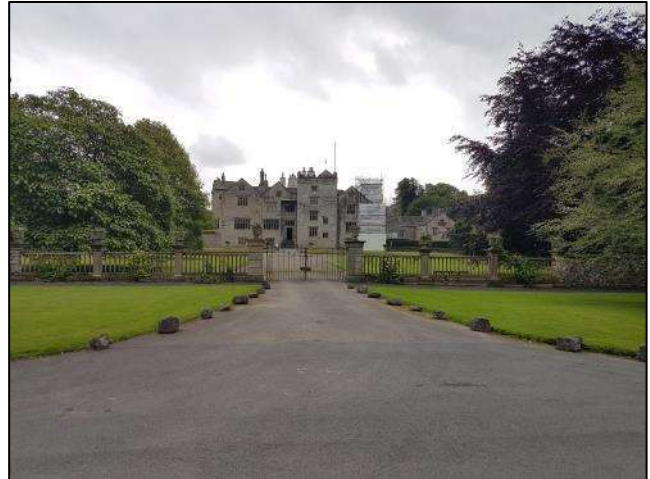
**Photograph 12:** Refurbishment Works at Levens Hall

At the time of the site visit, refurbishment works were being undertaken at Levens Hall (**Photograph 12**). The gardens and the complex's car park are immediately adjacent to the River Kent with relatively little freeboard above the river banks on the River Kent. Levens Hall itself is slightly elevated above the surrounding land but is still located within an area at risk of an extreme flood (i.e. the Environment Agency's Flood Zone 2).

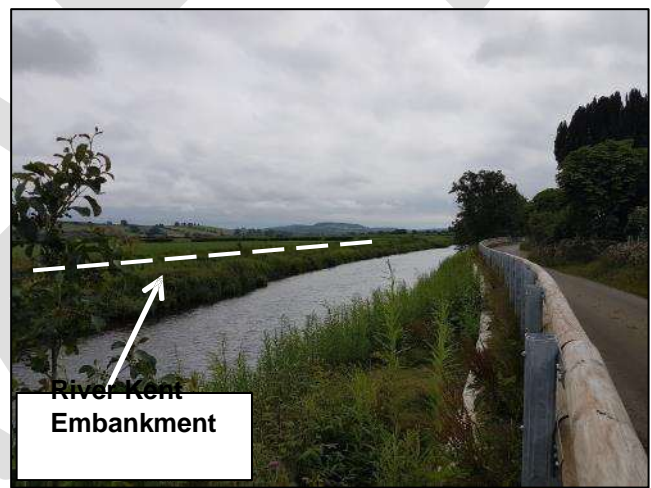
**Photograph 13:** River Kent Embankments

There is a raised embankment on the left bank of the River Kent downstream of Levens Hall, which provides protection to farmland belonging to Ninezergh Farm (as shown in **Photograph 13** and **Photograph 14**). The flooding mechanisms observed locally during the flood event, as well as the impacts of the flooding to the local area in the proximity of the embankment, have resulted in local residents concluding that the embankment has a detrimental impact on flood risk to their property.

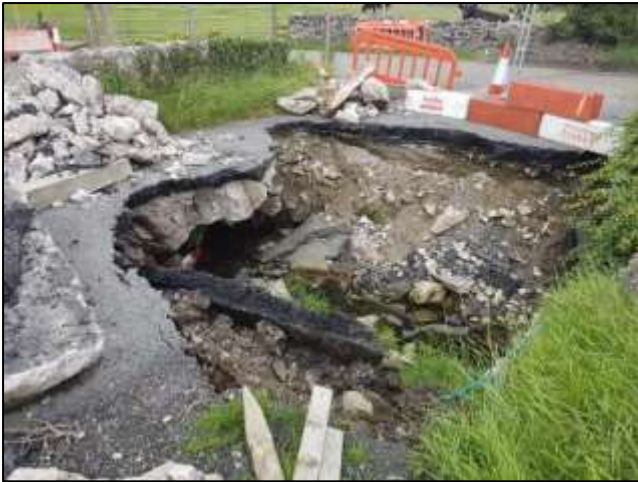
The Levens Catchwater near Low Levens also overtopped during the flood incident and this resulted in local damage to an access bridge and surrounding properties (**Photograph 15** and **Photograph 16**).

**Photograph 15:** Flood Damage on an Access Bridge over the Levens Catchwater

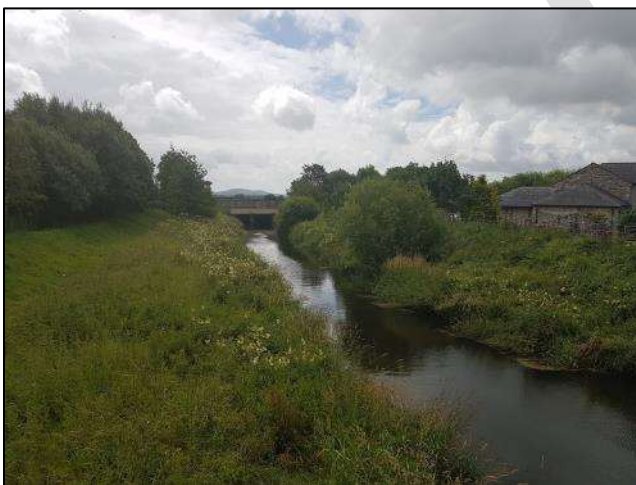
**Photograph 17:** A590 Box Culvert at Gilpin Bridge, Looking Downstream

The River Gilpin discharges into the River Kent at NGR SD 47473 84210. Approximately 550m upstream of the confluence the River Gilpin passes beneath the A590 road bridge (**Photograph 17**), fitted with tidal flaps. Another 50m further upstream it also passes beneath the A5074 at Gilpin Bridge (**Photograph 18**).

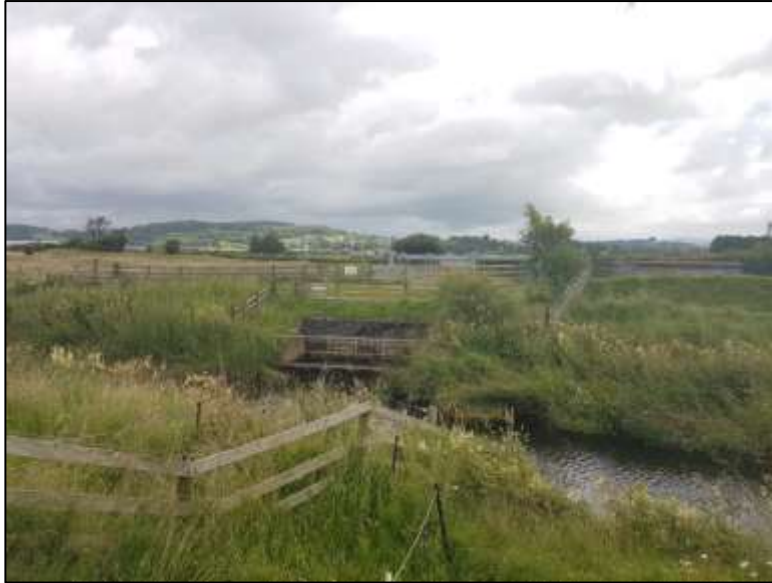
**Photograph 19:** Sampool Pumping Station at the River Gilpin

The Sampool Pumping Station is located just upstream of the A5074 road bridge over the River Gilpin. This Environment Agency asset pumps water from the Levens Main Drain into the fluvial river system and was functional during the flooding incident. There is also a siphon culvert to allow water in Levens Main Drain to flow by gravity under the River Gilpin.

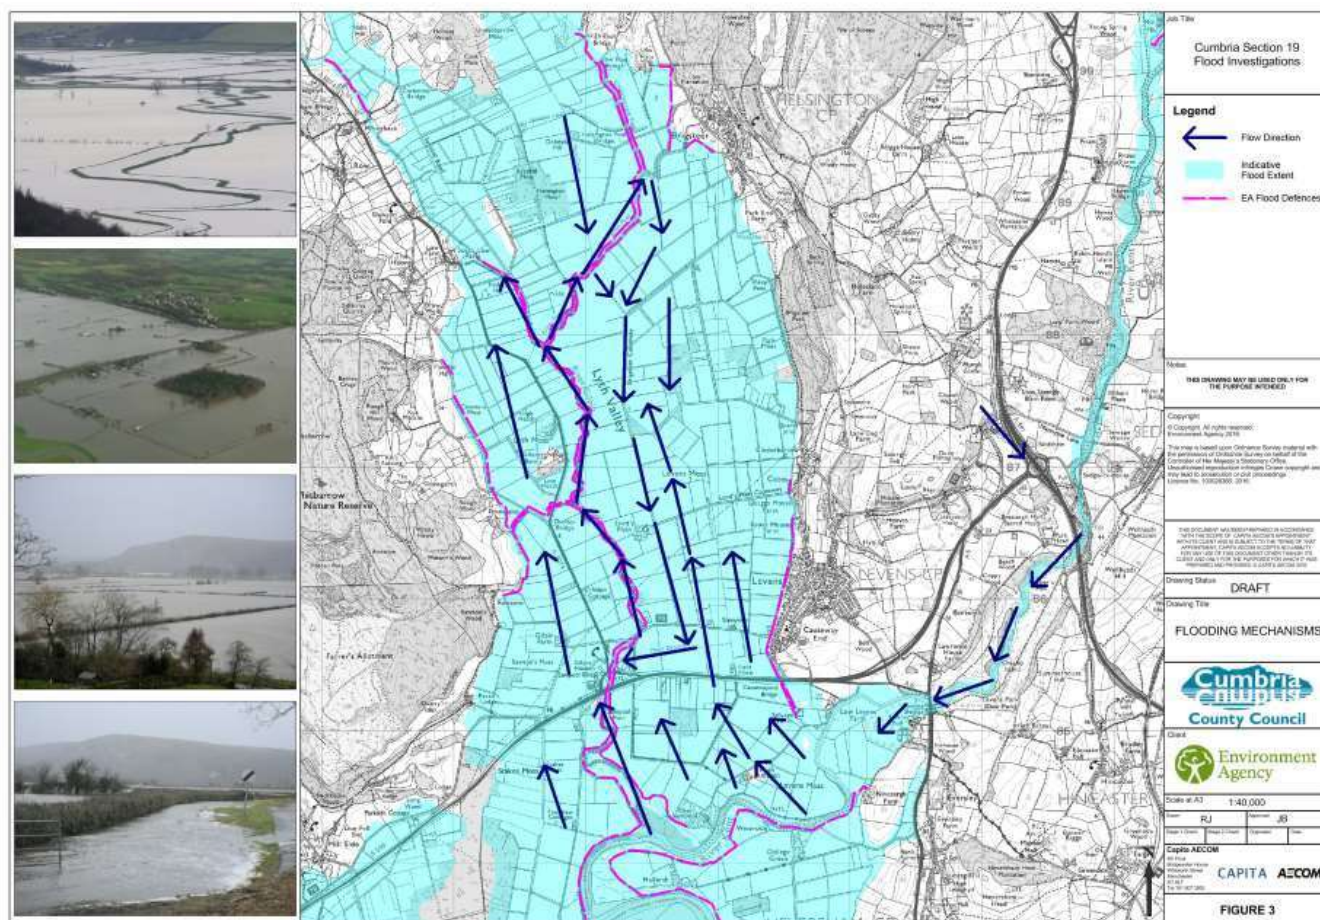
Figure 3: Flooding Mechanisms

- Saturated soils in the Lyth Valley and River Kent catchments following intense rainfall throughout November and the first few days of December 2015. Heavy rainfall resulted in a smaller flood event on the 10<sup>th</sup> November that caused a breach in an earth embankment on Brigsteer Beck. This did not result in any direct property flooding but later had some influence on the subsequent flooding mechanisms on the 5<sup>th</sup> December 2015.

- A significant volume of fluvial floodwater was routed through the River Kent catchment during the 5<sup>th</sup> December 2015 following the intense rainfall. The floodwater peaked at 20:45 that evening. It was observed that water levels at locations in the lower valley continued to rise until Tuesday 8<sup>th</sup> December, and did not start to drop until Thursday 10<sup>th</sup> December.

- The A590 road closure at Brettargh Holt was caused by the culverted ordinary watercourse exceeding its capacity and combining with surface water flooding on the public highway.

- The flooding that occurred within the Lyth Valley was not a result of pumping inadequacy; the pumping stations are designed for land drainage purposes and not for flood risk management. Additional pumping capacity is unlikely to have yielded significant betterment during the flood event due to the volumes of floodwater and flat valley topography.
