Warwick Bridge

Flood Investigation Report

Flood Event 5-6th December 2015

This flood investigation report has been produced by the Environment Agency as a key Risk Management Authority under Section 19 of the Flood and Water Management Act 2010, in partnership with Cumbria County Council as Lead Local Flood Authority.

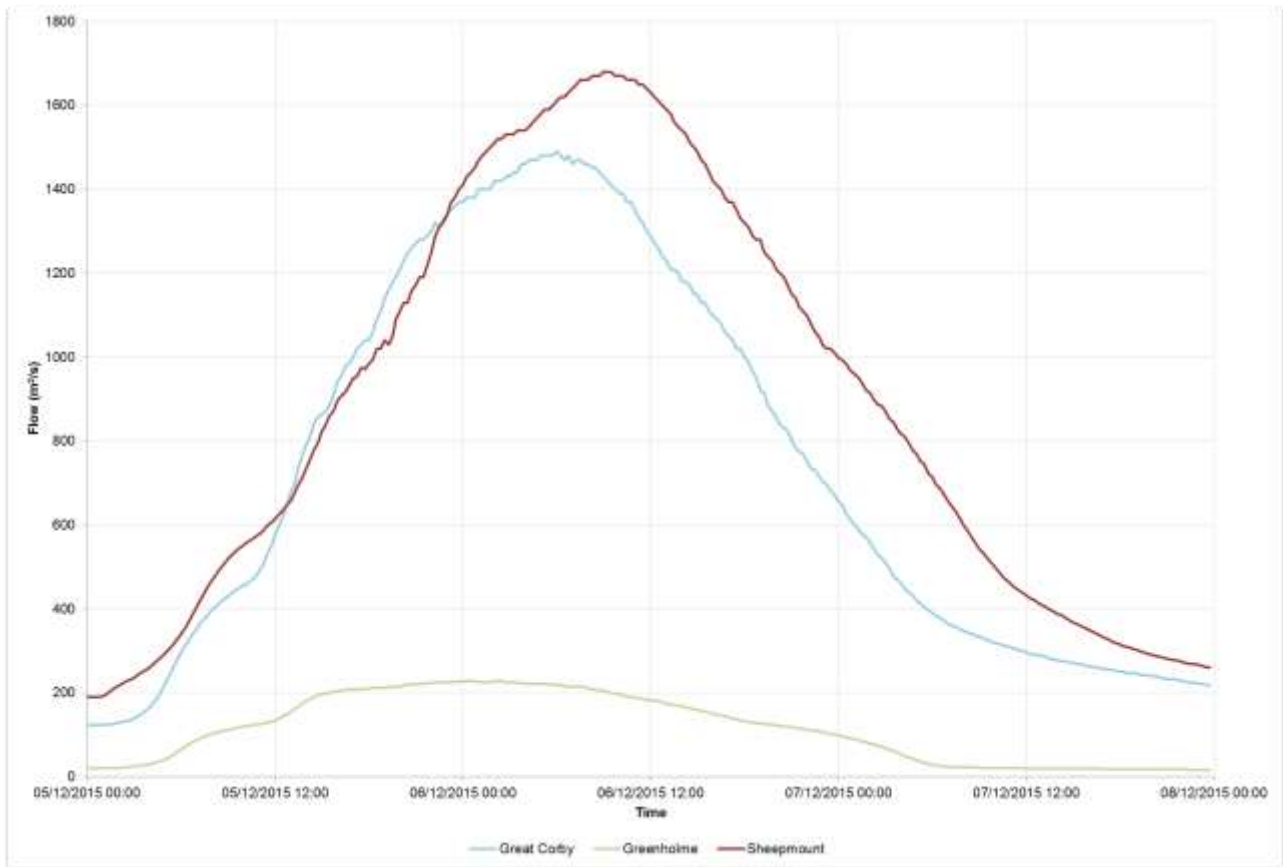
Figure 4: Gauged river flows at various locations in the Eden catchment on the 5th-6th December 2015

At Great Corby gauging station, the level of the River Eden peaked at 25.6m AOD at 06:00 on Sunday 6th December. This was the highest river level ever recorded and exceeded the previous record level of 25.4m AOD (January 2005).

The recorded peak flow at Great Corby gauging station is greater than any flow previously recorded at this location on the River Eden and initial analysis of this data suggests that the December 5th event had a 0.25% probability of occurring in any given year (0.25% Annual Exceedance Probability or AEP).

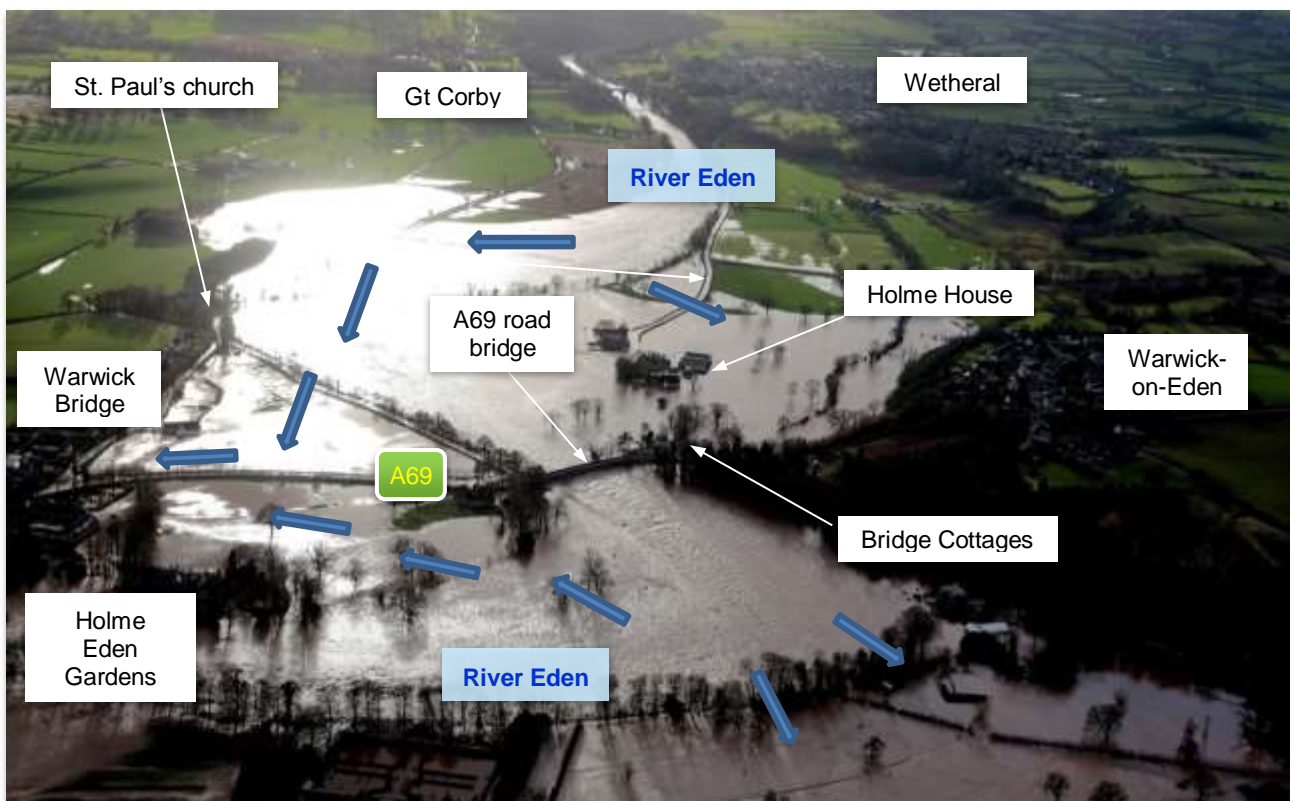
Photograph 1: Flooded extents at Warwick Bridge on the 6th December 2015, looking south

An overview of the principal flood flow routes in and around Warwick Bridge is presented in photo1 as an aerial photograph taken on 6th December 2015 showing the flooded extents in and around Warwick Bridge.

The principal source of flooding was from the River Eden near the A69 road bridge with flooding occurring first to Bridge Cottages, Eden Garth and Holme House located along the B6263 road to Wetheral. Flood waters then flowed over land and along the A69, across Downagate Community playing fields before joining flood flows from the River Eden and Cairn Beck on Little Corby Road. Holme Eden Hall and adjoining properties were also affected by the flooding.

The principal source of fluvial flooding in Warwick Bridge was from the River Eden. As shown in Photo 1 previously, the river makes a series of broad meanders as it flows past the west side of the village and during the main flood event, the floodplain within these meanders became inundated.

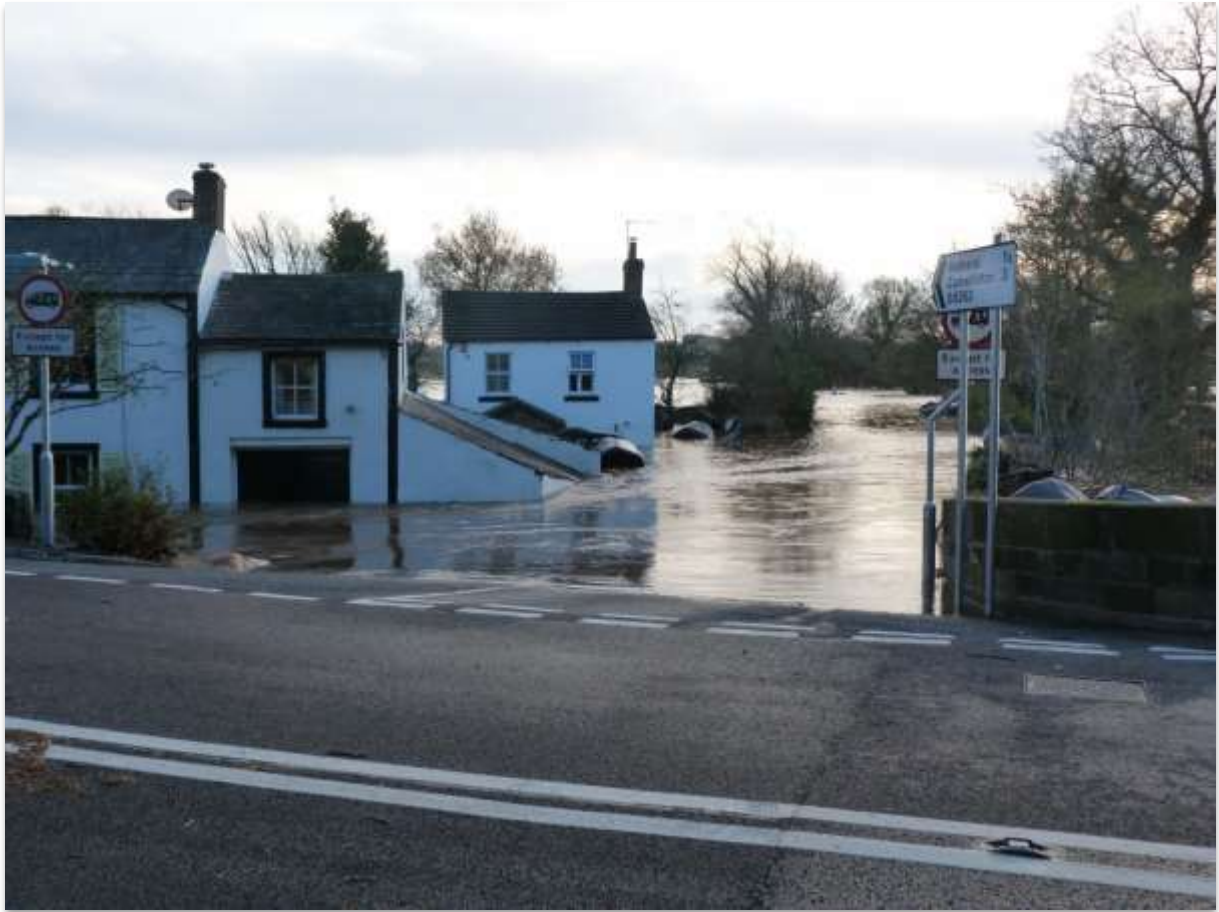
Photograph 2: Flooding to Bridge Cottages off the A69

Whilst most of the properties in Warwick Bridge are not located within the flood plain, a number of individual properties outside of the village are located within the flood plain. These properties include Holme House and Eden Garth to the south, together with the Bridge Cottages terrace, situated immediately adjacent to the A69 bridge over the River Eden on its left bank. These properties suffered significant flooding as the river overtopped its banks and the depth of the flooding to Bridge Cottages is shown in Photograph 2. The maximum reported flooding depth at Bridge Cottages was approximately 1.8m (6ft) and hay bales carried downstream from the neighbouring Holme Farm, washed over the hedgerow and were deposited in the yard. Holme Farmhouse was reported to have flooded to approximately 0.9m (3ft).

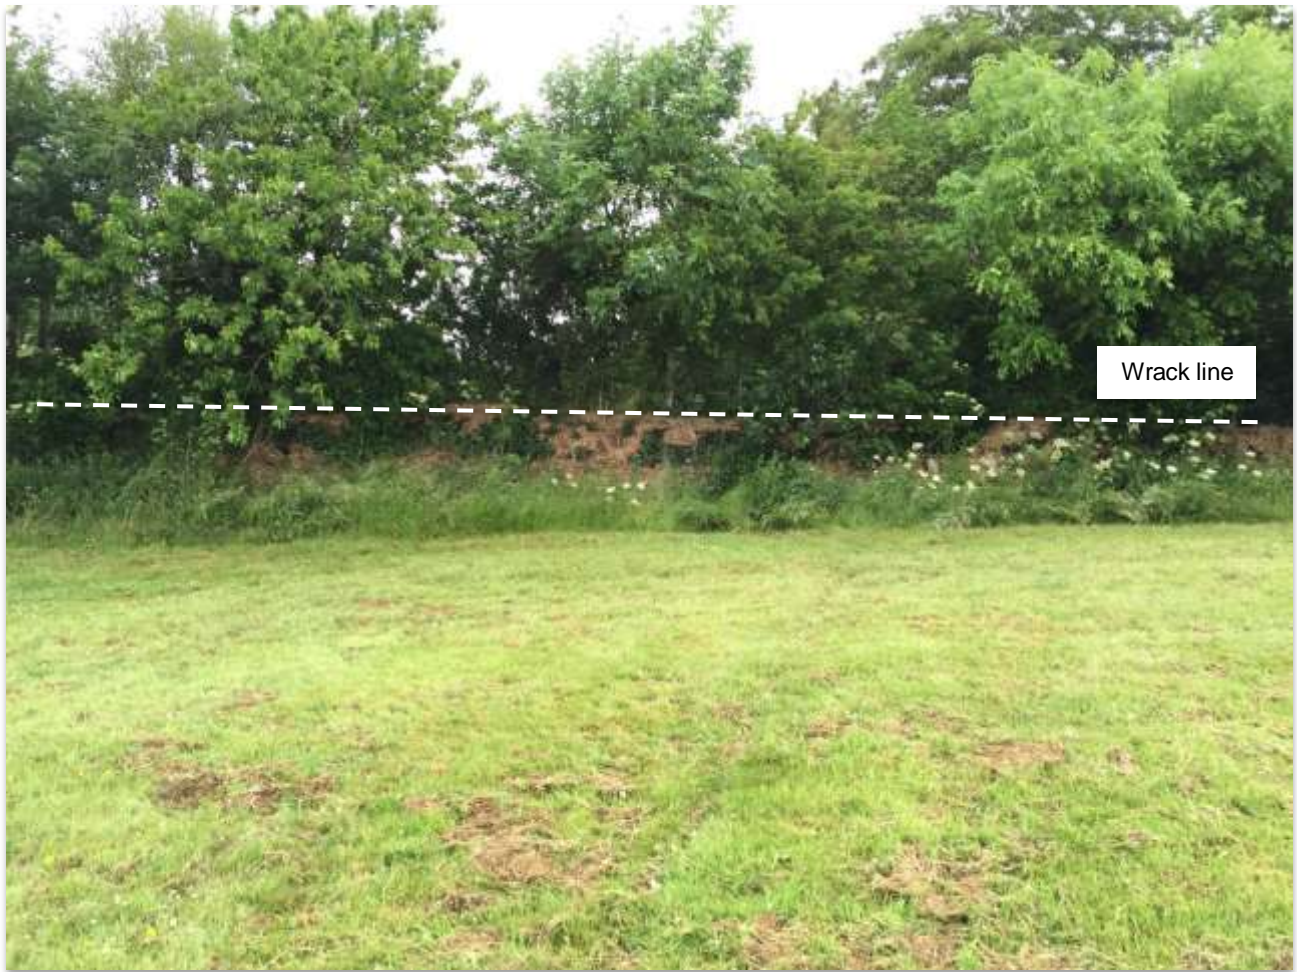
Photograph 3: Wrack line along northern boundary of the Downagate Community Centre playing fields

Upstream of the A69 road bridge, the Downagate Community Centre playing fields on the right hand bank of the river were inundated as flows surged towards the A69. The wrack line (Photograph 3) along the wire fence that forms the boundary of the field with the A69 indicates that the floodwater was approximately 1.3m deep in places and as the depth increased, so more water was able to inundate the A69 and flow into the village. The Downagate community centre was reported to have flooded to a depth of approximately 1.8m (6 ft).

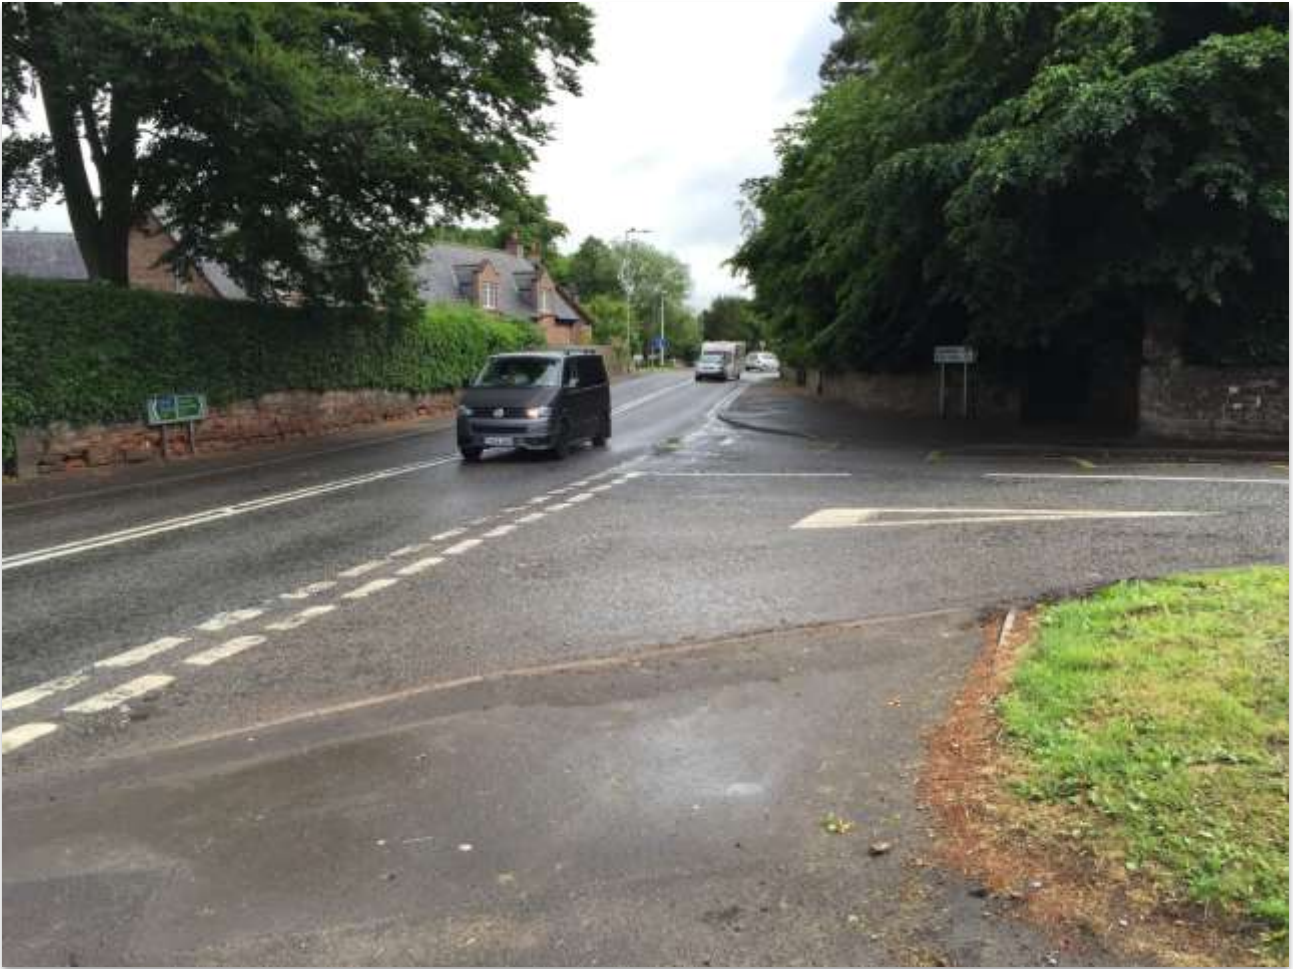
Photograph 4: Principal flow path along the A69 into the centre of Warwick Bridge

Land to the north of the A69 is separated from the road by a stone wall standing approximately 1.5m high. This wall had a significant impact on preventing excess flood water at the road bridge from crossing over the A69 and being able to flow back into the River Eden downstream of the bridge. Instead, flood water flowed along the A69 into the centre of Warwick Bridge (see **Error! Reference source not found.** and Photograph 4). Properties on both sides of the A69 suffered flooding, while Warwick Bridge primary school only just avoided being flooded.

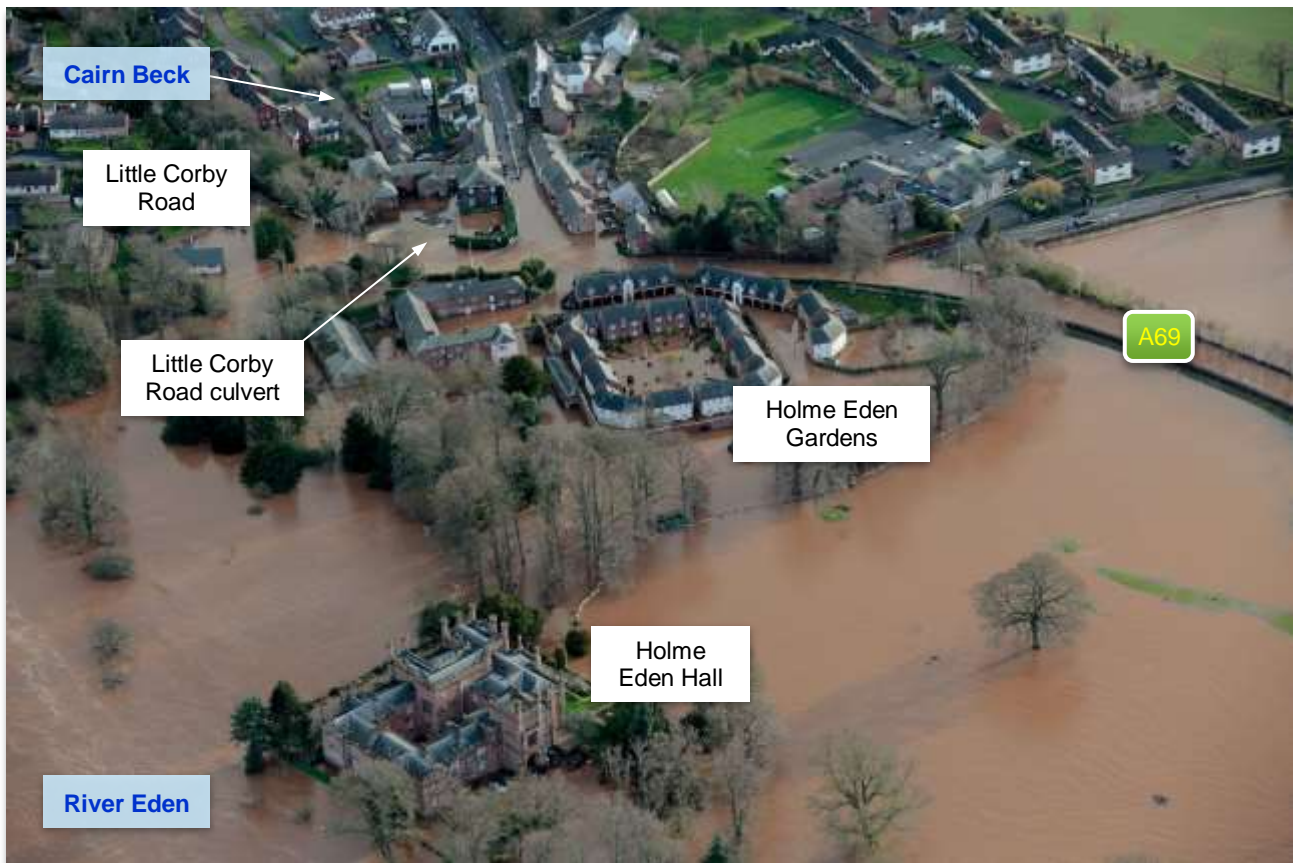
Photograph 5: Flooded extents in the centre of Warwick Bridge

Once in the village, floodwater flowed down the access road to Holme Eden Hall off the junction of the A69 with Little Corby Road. This access road is narrow and flanked by stone walls, meaning that flow velocities were high. The floodwater affected numerous properties in this location, including homes built relatively recently within a former walled garden. Photograph 5 is an aerial photograph taken on 6th December 2015 and shows the extent of flooding within the village, including the flooding to properties within the former walled garden.

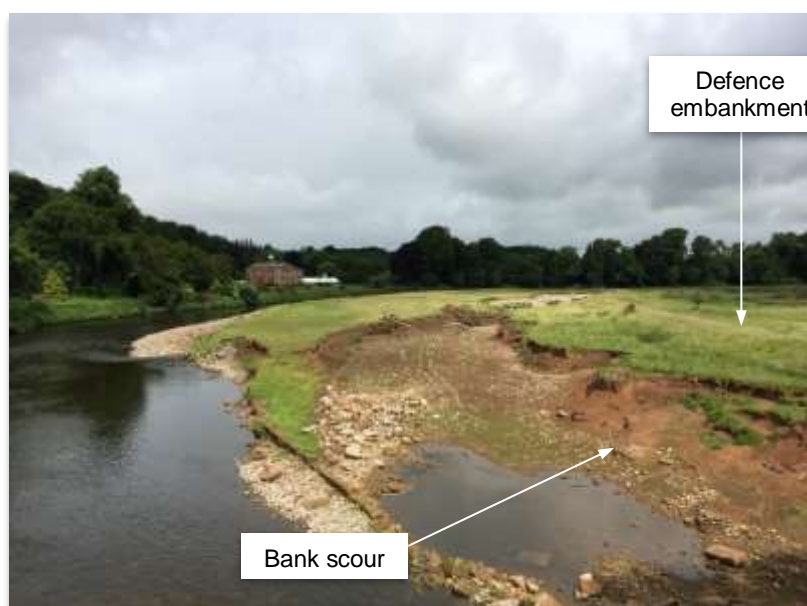
Photograph 6: Scouring to right bank of the River Eden downstream of the A69

Downstream of the A69 road bridge flood flows from the River Eden overtopped the flood embankment and merged with flood water that had entered the village from the Downagate Community Centre playing fields. The defence embankment is shown in Photograph 6.

Photograph 6 also shows evidence of significant scouring of the right hand bank, which occurred immediately downstream of the bridge. The road bridge was temporarily closed following the flooding whilst inspections were carried out.

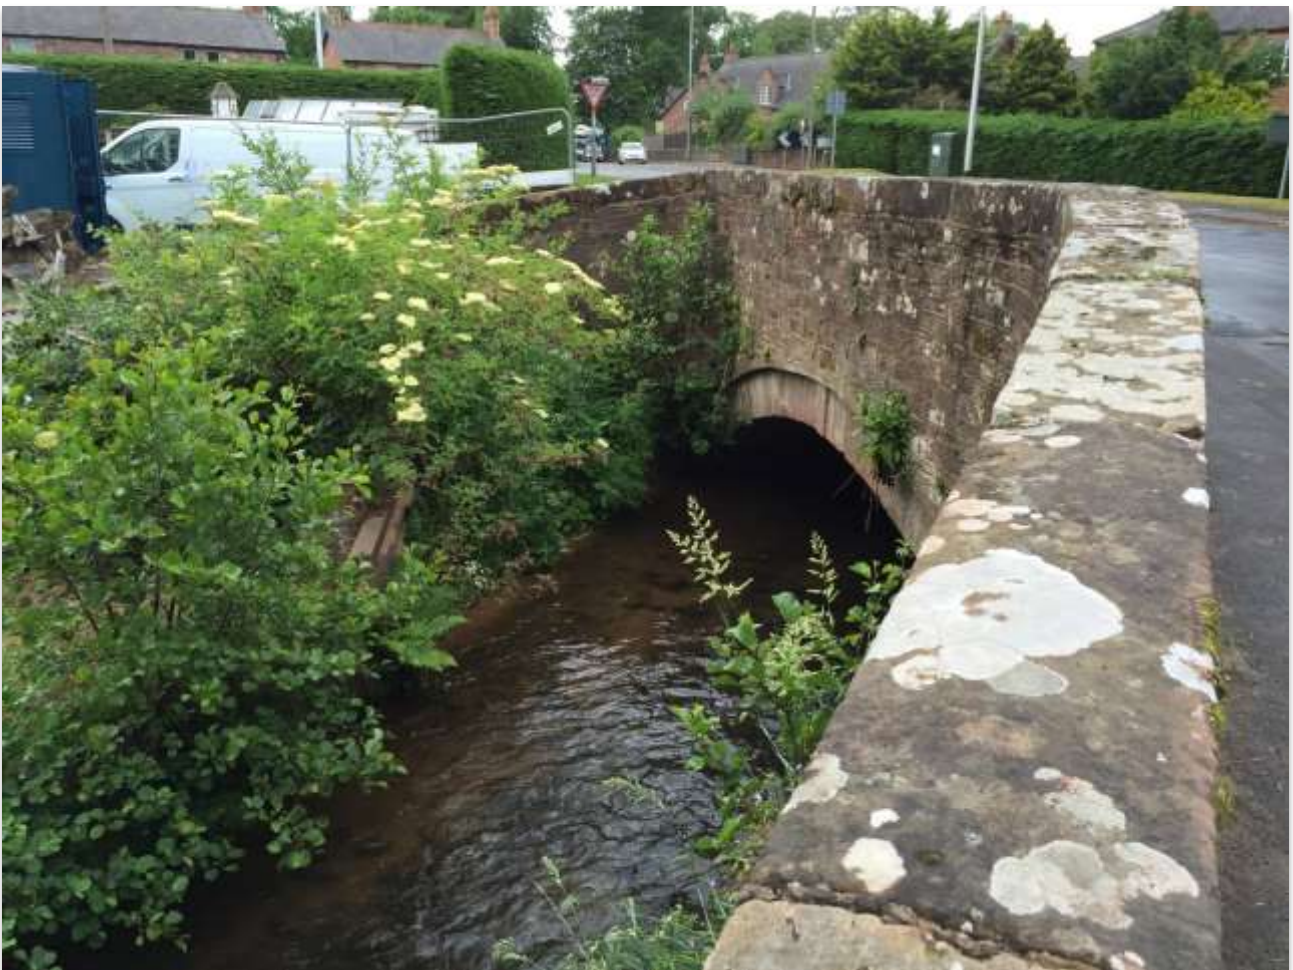
Photograph 7: Little Corby Road culvert (Cairn Beck)

In the centre of Warwick Bridge, flooding from the River Eden was exacerbated to a certain extent as a result of flooding from Cairn Beck. Cairn Beck and Trout Beck meet immediately upstream of the A69 opposite Waters Meet and pass beneath the A69 via a system of culverts. This system also incorporates a bifurcation and fish pass structure which diverts flow from Trout Beck into a Mill Race, which runs parallel to Cairn Beck before returning to the main channel upstream of the Little Corby Road culvert.

During the Storm Desmond event a combination of a high water levels on the River Eden and capacity limitations at the Little Corby Road culvert caused flows in Cairn Beck to back-up and contributed to the flooding on Little Corby Road. Photograph 7 shows the upstream face of the Low Corby Road culvert, which is significantly skewed (i.e. is not perpendicular) to the alignment of the Cairn Beck channel. This type of arrangement has the effect of reducing the overall capacity of the culvert due to the sharp change of direction that flows have to go through. This means less water can get through the culvert and it creates higher water levels upstream of the structure.

Whilst the arrangement of the Little Corby Road culvert may have caused some initial backing-up of flows, the principal cause was the exceptional water level on the River Eden. Photograph 5 shows how the flood from the River Eden extended into this location in the village causing flood flows in Cairn Beck to back-up.
