Red Beck Park

Flood Investigation Report

This flood investigation report has been produced by Cumbria County Council as a Lead Local Flood Authority under Section 19 of the Flood and Water Management Act 2010.

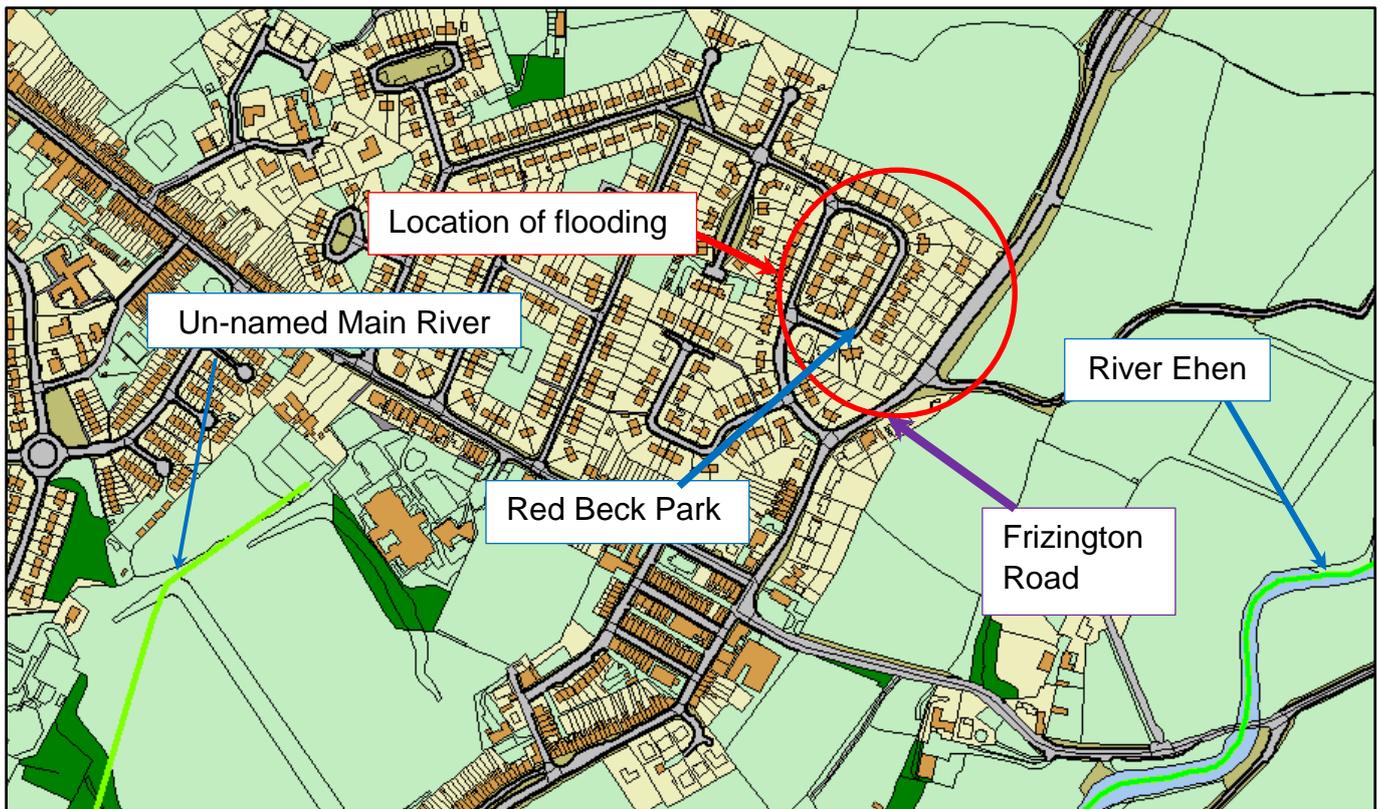
Figure 2: Cleator Moor Layout

Figure 2 indicates the area of Cleator Moor that is affected by suspected water flooding and the location of watercourses in relation to the affected area. It can be seen that the River Ehen flows in a south-westerly direction towards the Irish Sea. There are no ordinary watercourses within the area.

As no watercourse or obvious surface water flooding was reported in the vicinity of Red Beck Park it has been decided that the most likely cause of flooding is from a perched ground water table during high rainfall events.

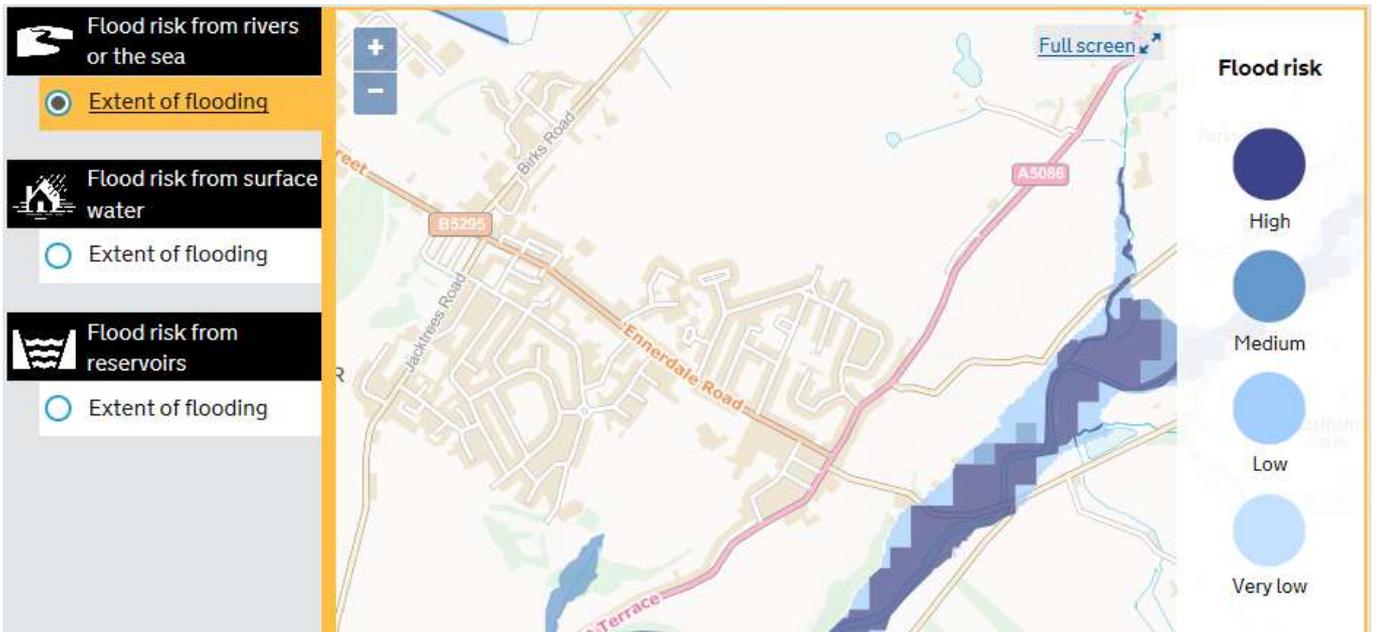
Figure 3: Flood Risk from rivers or the sea

The following plans indicate the flood risk in the Red Beck Park / Frizington Road area for River flooding and Surface Water as indicated on the Environment Agency flood risk mapping.

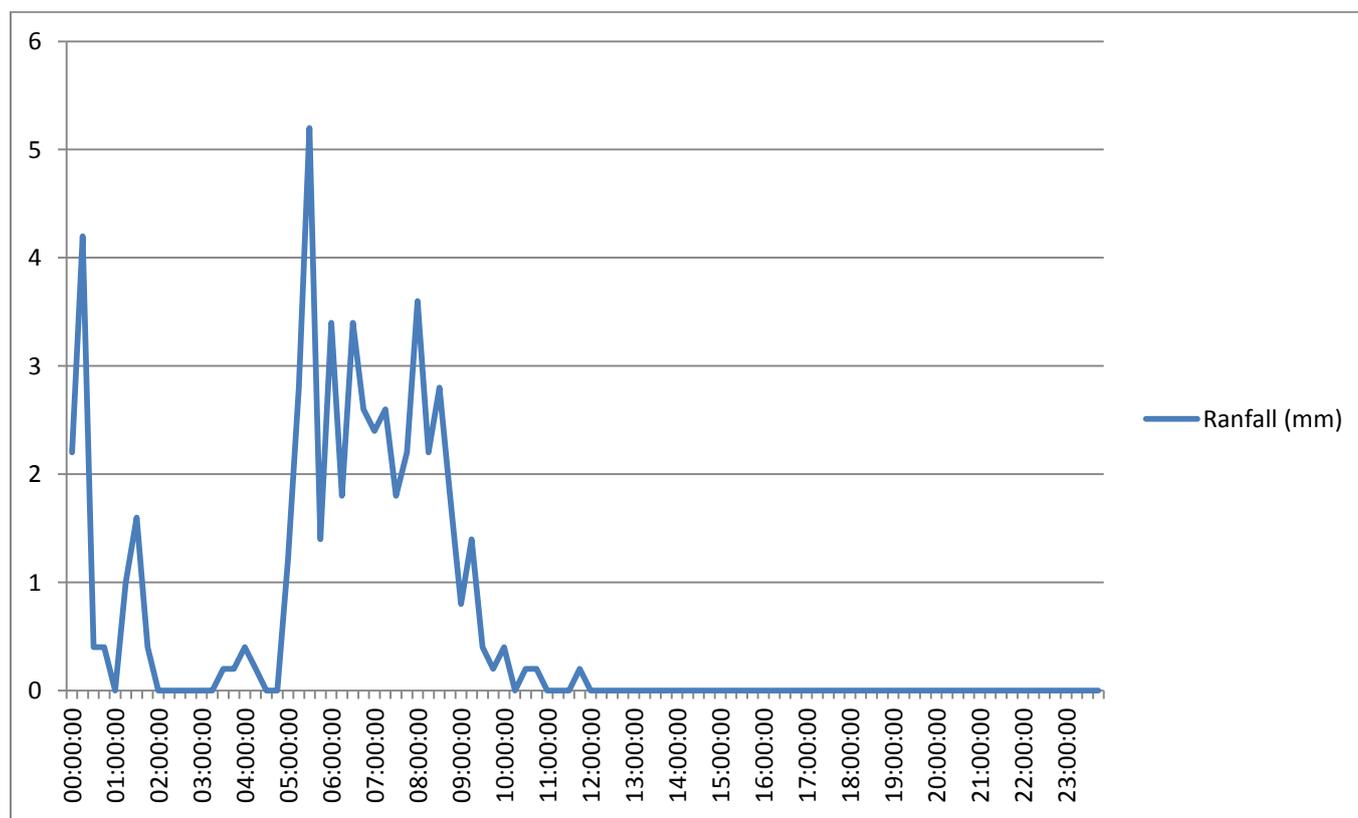
Figure 5: Rainfall Data from 22 August 2016

On 22nd August 2016 there was an event that resulted in perched ground water / surface water entering the sub floor of a number of dwellings at Red Beck Park / Frizington Road. The graph in figure 5 illustrates the extent of this rainfall.

Prior to the ground water flooding which occurred at Red Beck Park on 22nd August 2016, a heavy rainfall event took place on 20th August 2016 where 45mm of rainfall fell between 04:00am and 21:15pm. This is likely to have saturated soils and increased the height of the water table in the area.

Environment Agency data showed that for the 22 August 2016 57mm of precipitation fell. The highest hourly recorded rainfall rate was between 05:00am and 06:00am at 14mm. The peak of this event was at 05:15am where 5.2mm of rainfall fell in 15 minutes.

To place these figures into perspective, the average total rainfall for the whole of August was 92mm (based on 1981-2010 dataset) at St Bees Head which is the closest rainfall monitoring station.

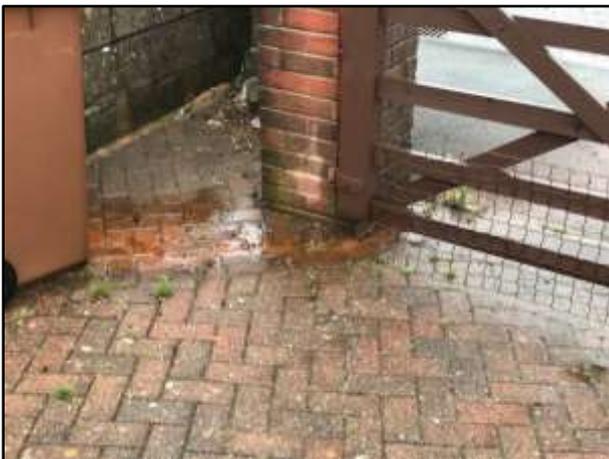
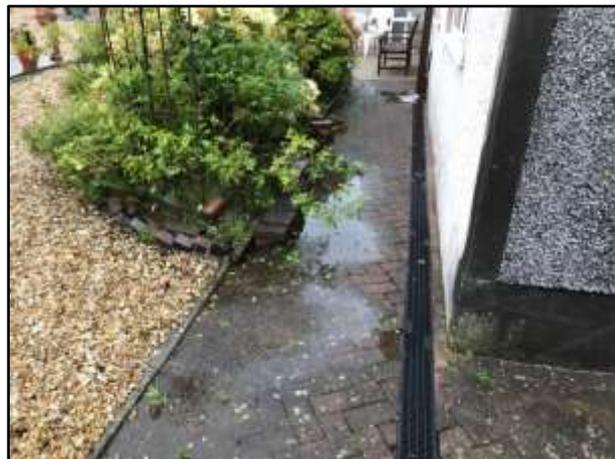
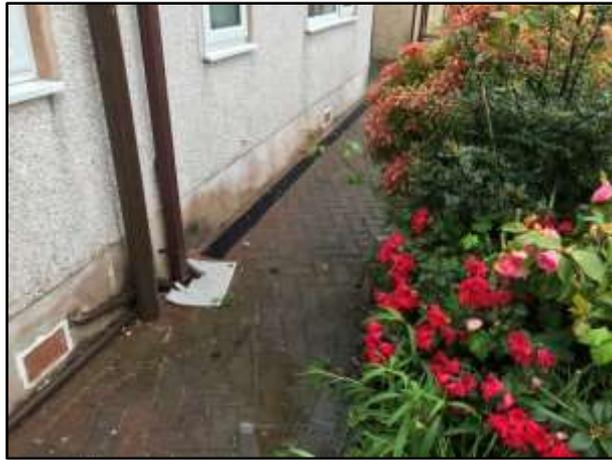
A desktop study carried out by the Lead Local Flood Authority indicated that the residential properties are located within an area where there are poor soils which are known to be slowly permeable and seasonally wet clay soils with impeded drainage. This creates a situation during a heavy rainfall event where any surface water falling within the area is unable to drain away through the soil structure and is retained near the surface of the soils. This can create a situation where water is at a higher risk of percolating into floor voids and other areas. Once located in these areas due to the poor percolation rates the water tends to remain trapped.

This situation with a perched water table can sometimes be identified by water sitting on ground surfaces or appearing to run from the ground during heavy rainfall events as shown in the following photographs:

Photographs 1, 2 & 3: Examples of ground water flowing above the ground surface in the Rad Beck Park / Frizington Road area.

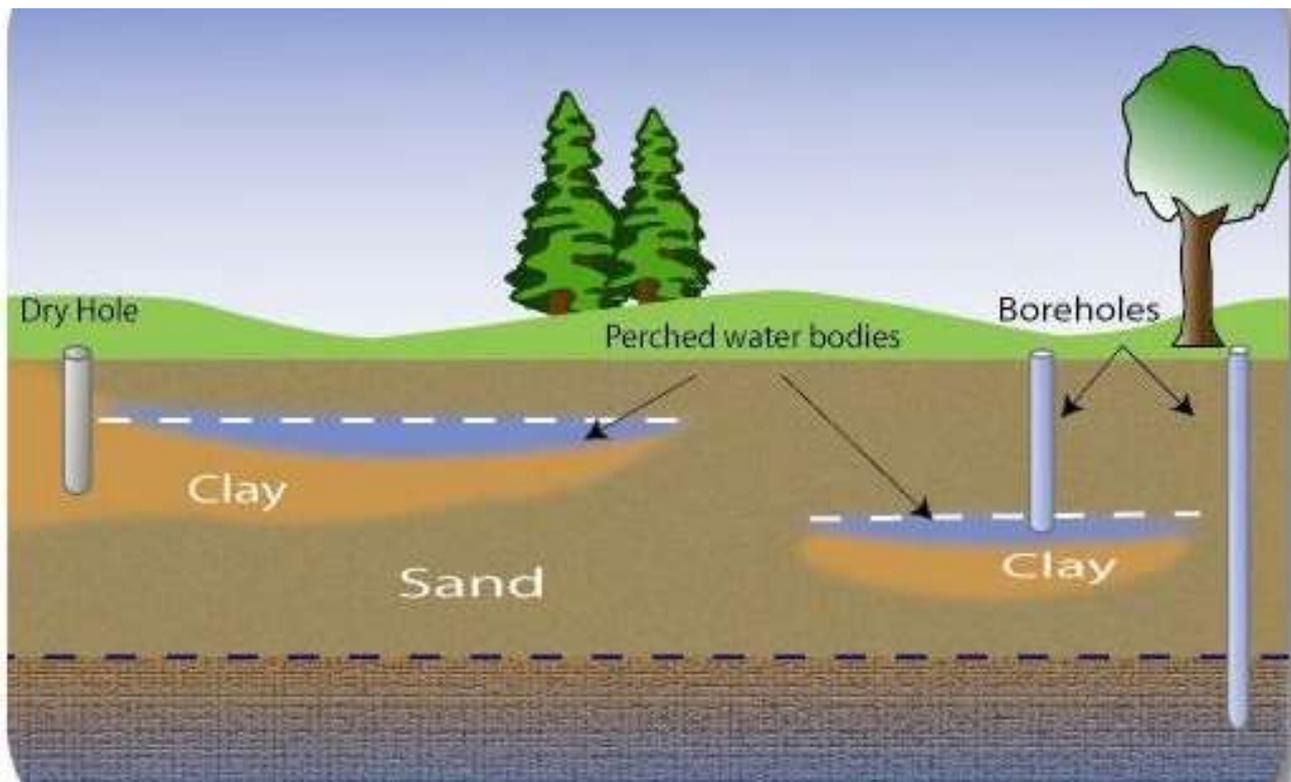
Figure 5: Diagram indicating perched water bodies

A perched water table is generally defined as a reservoir of water within the ground maintained temporarily or permanently above the standing water level within the ground below it and is usually caused by the presence of a stratum which is of low permeability or is impervious. It is understood from the desktop study that this is likely to be the case in this area.

As detailed earlier in the report it is considered from information from various websites including Soilscales, Geoindex Onshore and UK Sustainable Drainage that the soils in the area around Red Park Close and Frizington are of a poor permeable nature. It is therefore considered that the cause of the standing water below the floorboards in these properties is due to a perched water table which is usually more visible during periods of heavy rainfall.

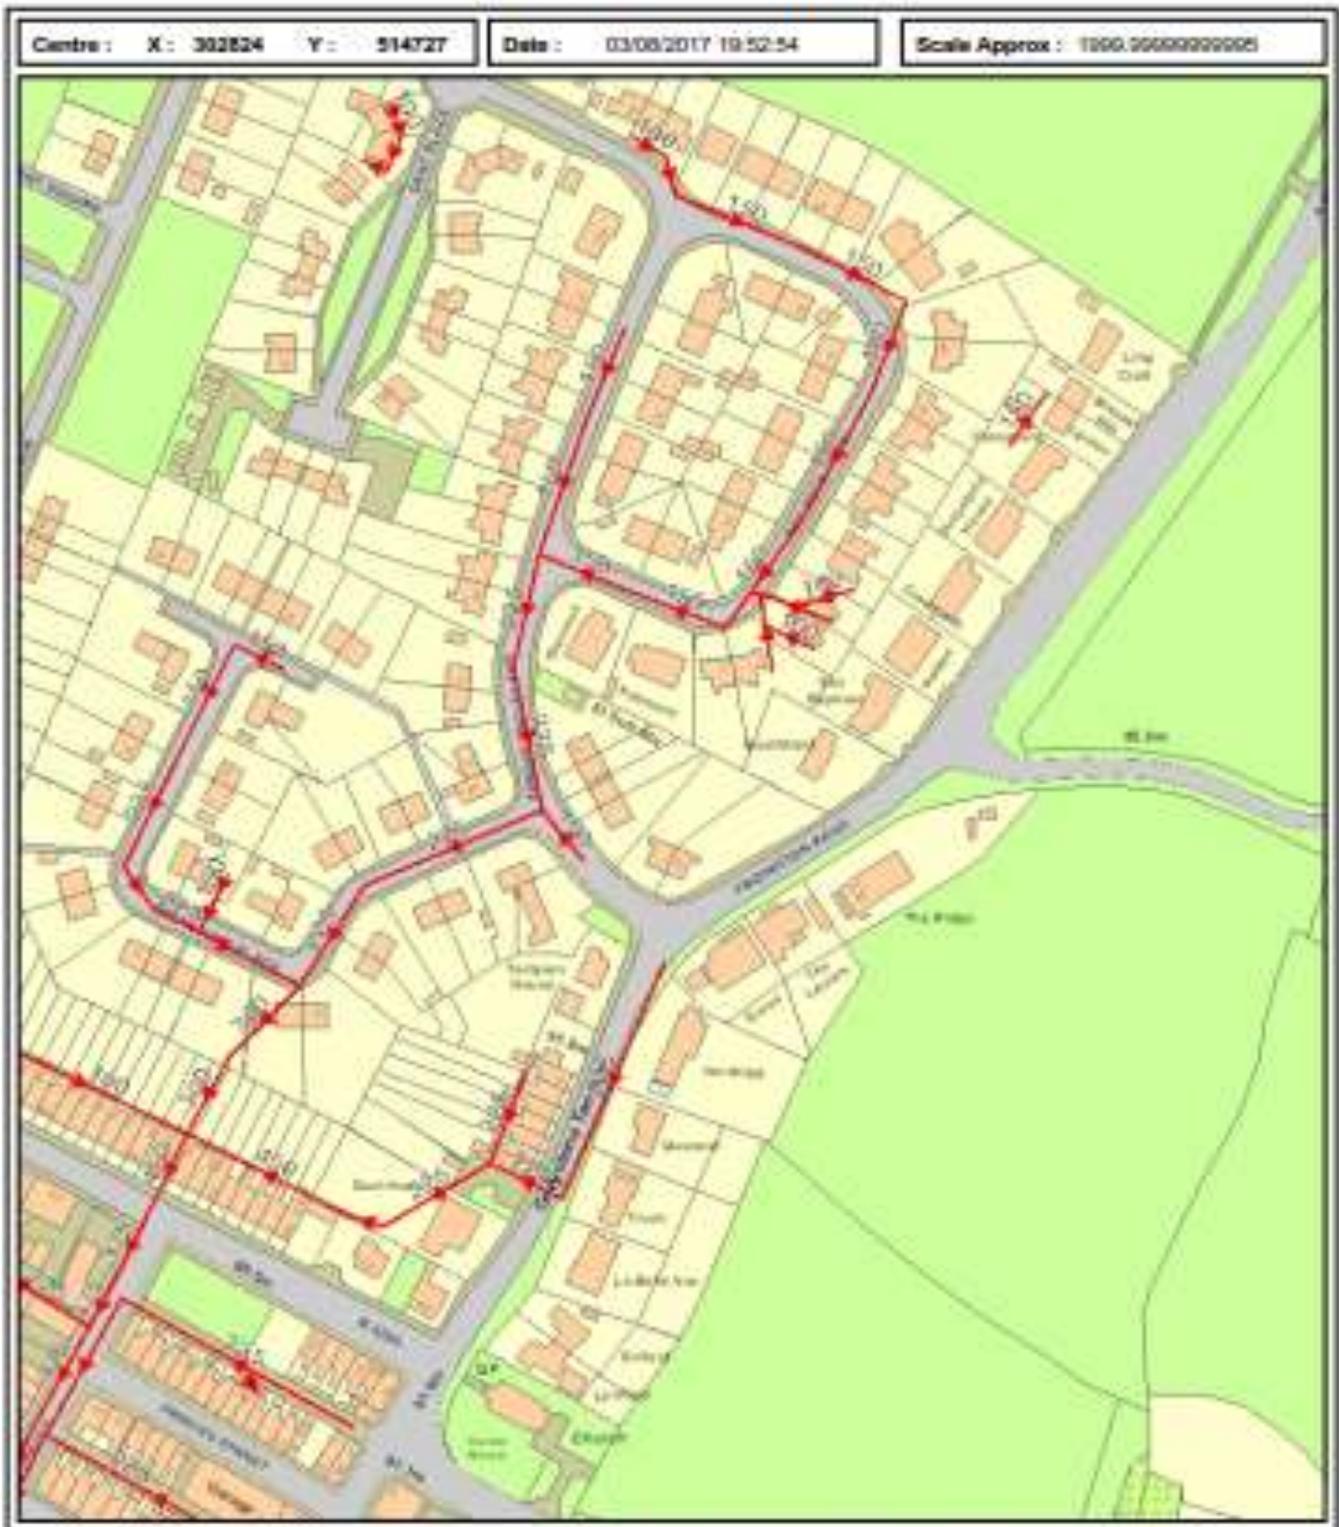
Extract from maps of United Utilities' Underground Assets

The position of the underground apparatus shown on this plan is approximate only and is given in accordance with the best information currently available. The actual positions may be different from those shown on the plan and private service pipes may be shown by a blue broken line. United Utilities Water will not accept liability for any damage caused by the actual position being different from those shown.
