**Cumbria
Coastal
Strategy**

**Technical Appraisal
Report for Policy Area**

11d6 St. Bees

(Technical report by Jacobs)

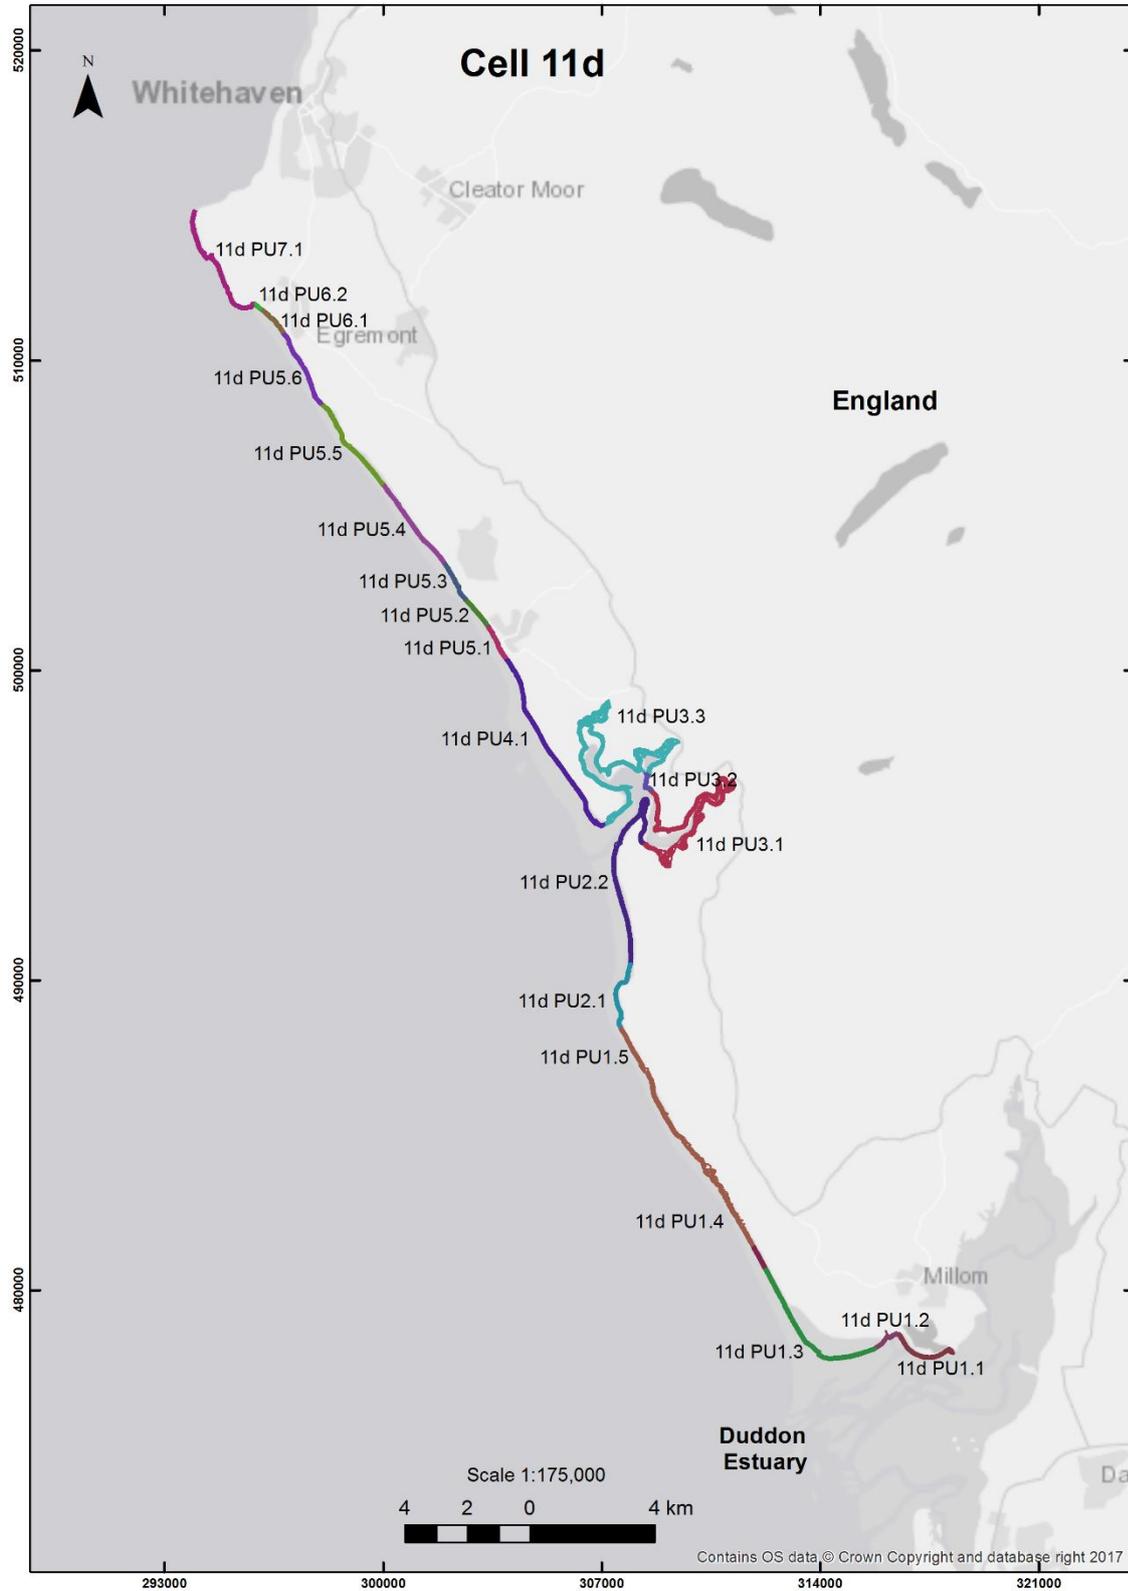
Figure 1 Sub Cell 11d Hodbarrow Point to St Bees Head Location Plan of Policy Units. Baseline mapping © Ordnance Survey; licence number 100026791

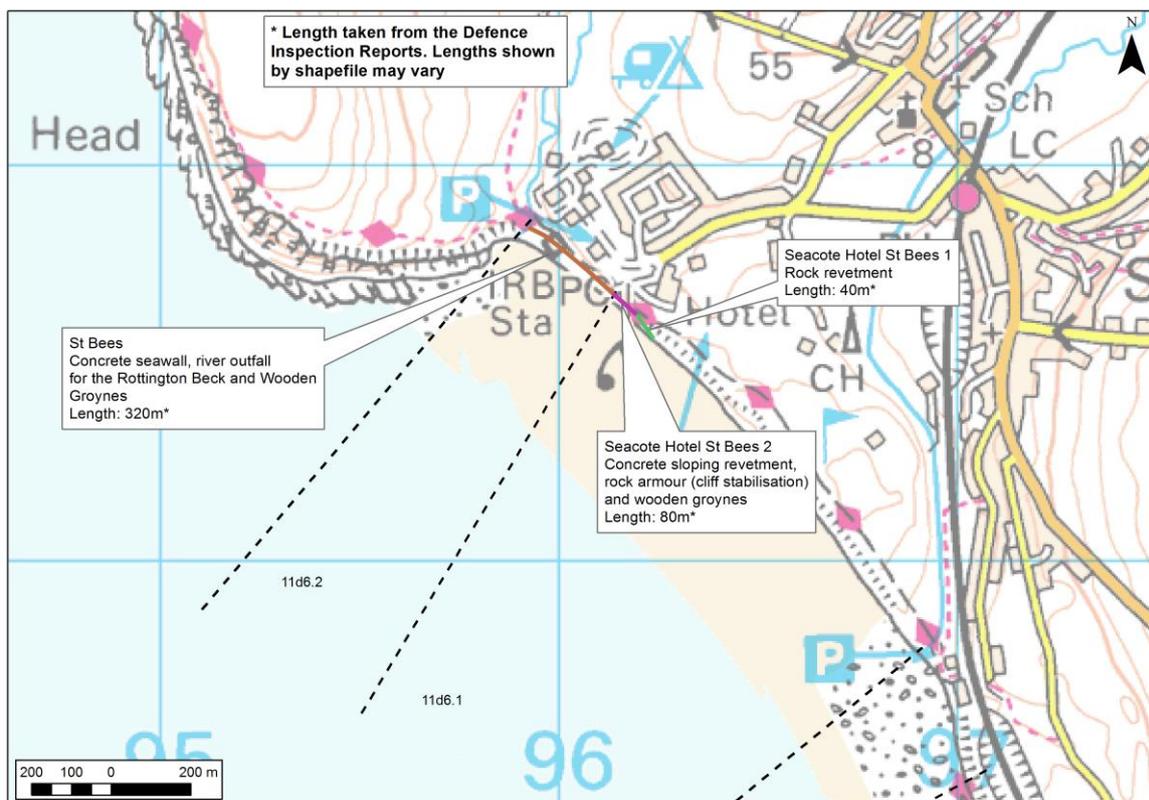
Figure 2 Policy unit location plan and defence overview. Baseline mapping © Ordnance Survey: licence number 100026791.

This policy area includes both undeveloped till cliffs between Pow Beck and the start of the promenade at St Bees, and the defended priority frontage of St Bees promenade, extending north to the transition to the hard rock cliffs of St Bees Head, see Figure 2 and Figure 3. A small stream, Rottington Beck, drains through the beach at the northern end of the St Bees frontage, the position of its discharge is held by the northern retaining wall of the promenade (Halcrow, 2011).

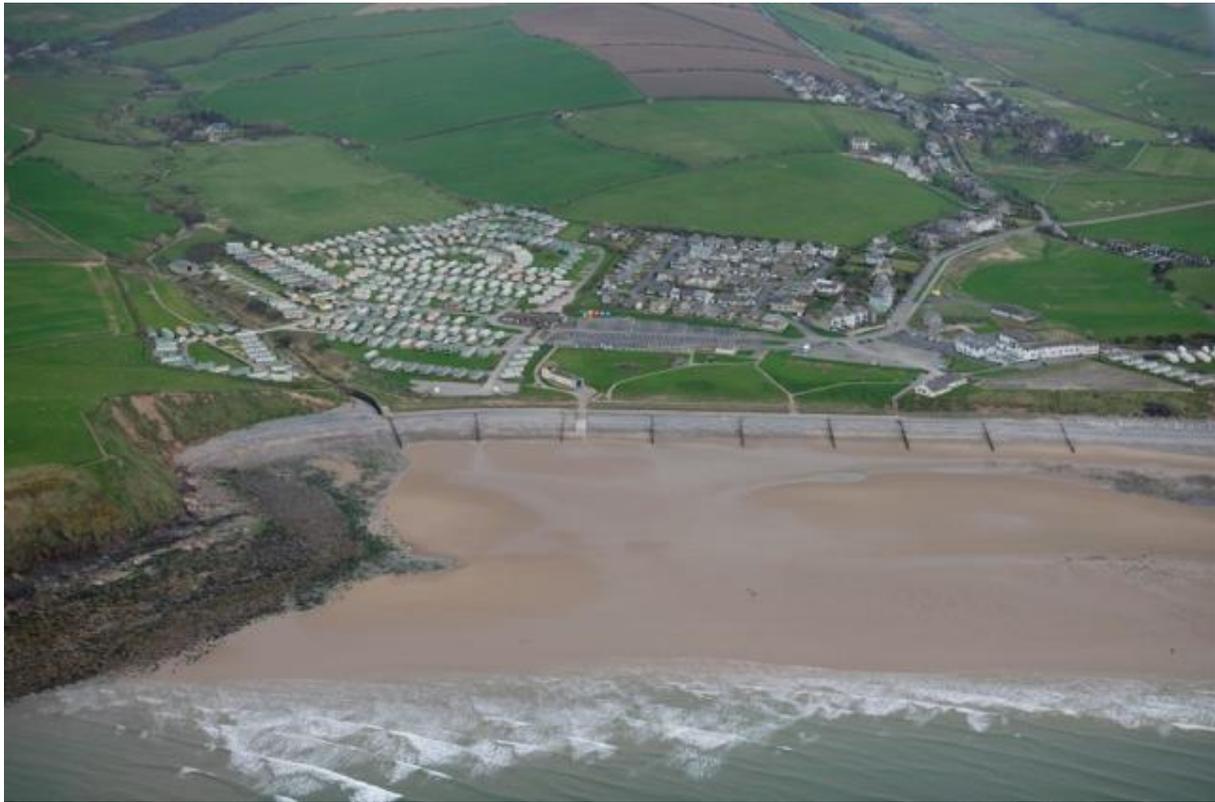
Figure 3 St Bees Frontage © North West Regional Monitoring Programme, 2015

The shoreline from Rottington Beck, in the north, along St Bees to the Seacote Hotel, in the south, is protected by a concrete seawall fronted by timber groynes. At the far southern end of policy unit 11d6.1 the frontage transitions into low till cliffs; which are defended by a rock structure.

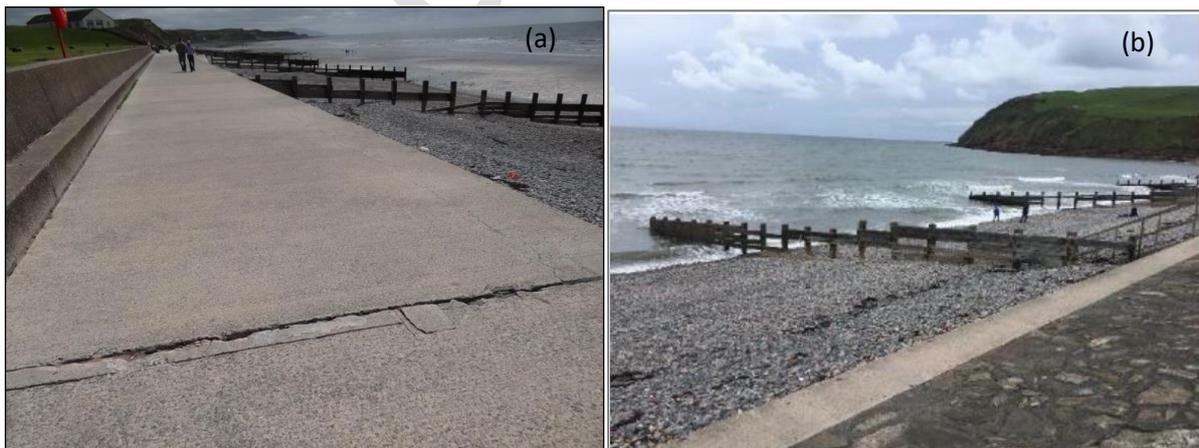
Figure 4 (a) St Bees Concrete seawall and wooden Groynes (b) South end of promenade

The seawall, the promenade and the timber groynes were constructed in the late 1950s. Along St Bees promenade there are nine timber groynes, the upper gravel beach is present throughout the section with the foreshore being comprised of boulders and gravel (scar features) predominantly in the south, with sand increasingly prevalent towards St Bees Head. The timber groynes are in a poor condition, with several missing groyne planks, Figure 4.

The sea wall structure is in a fair condition and reasonably well protected by the shingle beach. The foreshore is mobile across the whole of this frontage and vulnerable to movement and draw down during storms. Beach movement is controlled to a degree by the timber groyne field although there is little evidence of longshore drift. The beach is prone to cross shore movement and material tends to be drawn down during storms, leaving the backshore structures exposed to waves leading to increased overtopping and shingle being thrown onto the promenade.

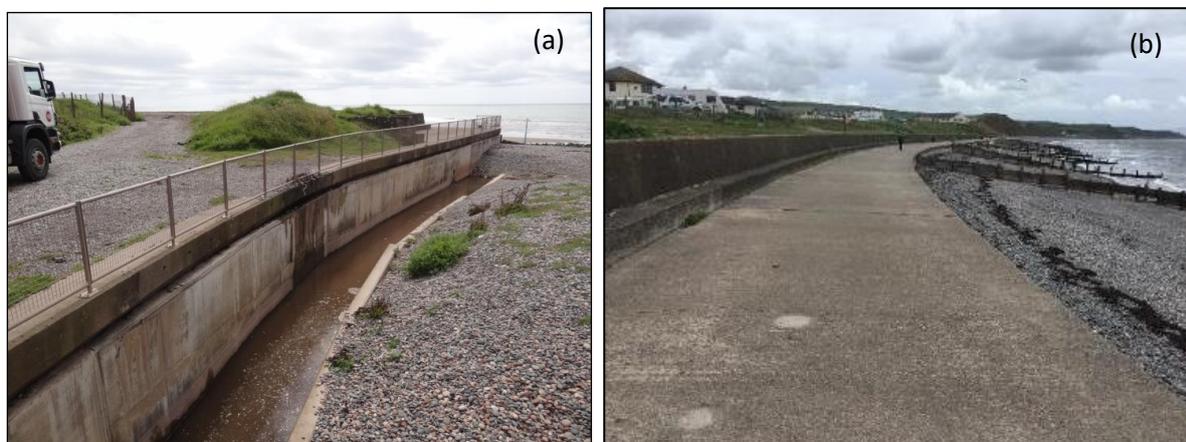
Figure 5 (a) River outfall for the Rottington Beck and (b) North end of promenade

Channel works at Rottington Beck were completed in 2014, the scheme provided a concrete face to the existing piles and building a concrete channel wall to provide a new channel for the beck. In 2016 armour stone was placed in front of the wall and at the edge of the concrete channel to prevent the beck from outflanking the concrete channel. At St Bees (11d6.2) the seawall is periodically overtopped by wave action but in a generally good condition (CH2M, 2017b), Figure 5.

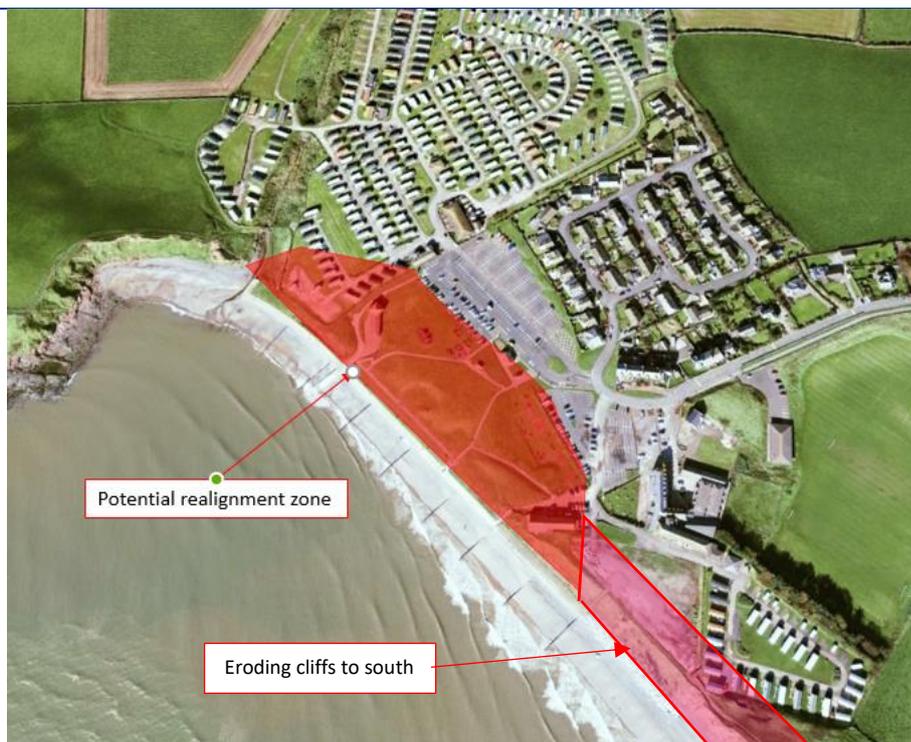
Figure 6 Option 6 – Potential realignment zone

<p>This would require the set back of defences which could result in loss of some recreational space and tourism (campsite, café etc.) but potentially reduce maintenance costs to defences. This will involve the removal of the existing structures and options to determine the set back defence line and options.</p>
Technical	<p>There is concern that the alignment of the defences may not be sustainable in the long term, due to economic justification and sea level rise. Therefore there is a need to consider alternative alignment for the long term epochs (50 to 100 years).</p> <p>Prior to any scheme, detailed understanding of the potential implications on the realignment needs to be fully investigated and ensure the most rational, sustainable alignment be adopted, with the consideration of any future consequences.</p> <p>The range of possible realignments needs to be investigated, potential options could involve:</p> <ol style="list-style-type: none"> (a) Retreat to natural high land – removal of the existing defences and allowing the shoreline to adjust to a natural alignment. (b) Identify a new set back location and ensure a suitable standard of protection to the assets at risks. <p>For both options a more sustainable shoreline could be created through natural erosion of the shoreline (cliffs and beach), a potential realignment zone has been identified to give an indication of the area that may be affected by an alternative alignment.</p> <p>The amenity facilities, parts of the caravan park and property in and adjacent to the erosion risk zone could potentially be relocated or adapted through roll back but this would need to be considered through the land use planning process implemented under a Coastal Change Management Area.</p>

There would be a need to undertake technical studies to assess the feasibility, costs and benefits of new set back alignments. This would depend upon the extent of sea level rise to be catered for as it may be possible to link together areas of slightly higher natural topography.

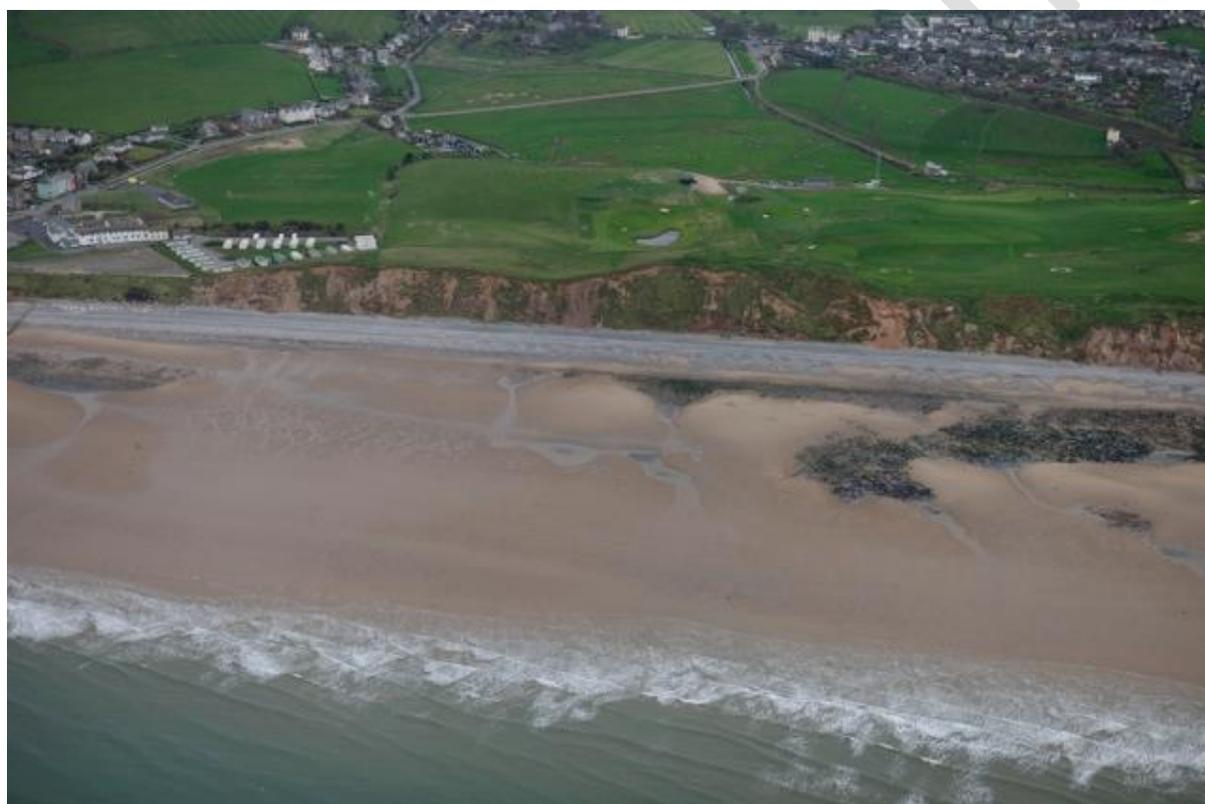
Figure 7 Pow Beck to St Bees promenade. Aerial photograph © North West Regional Monitoring Programme, 2015.

The existing SMP2 policy along this frontage is No active intervention from the short term, to “allow continued natural erosion of the designated cliffs”. The primary justification for the policy was that it allows a continuation of natural processes along the eroding designated cliff section, supportive to the geological SSSI (St Bees Head) between Pow Beck and St Bees Promenade (Figure 7).

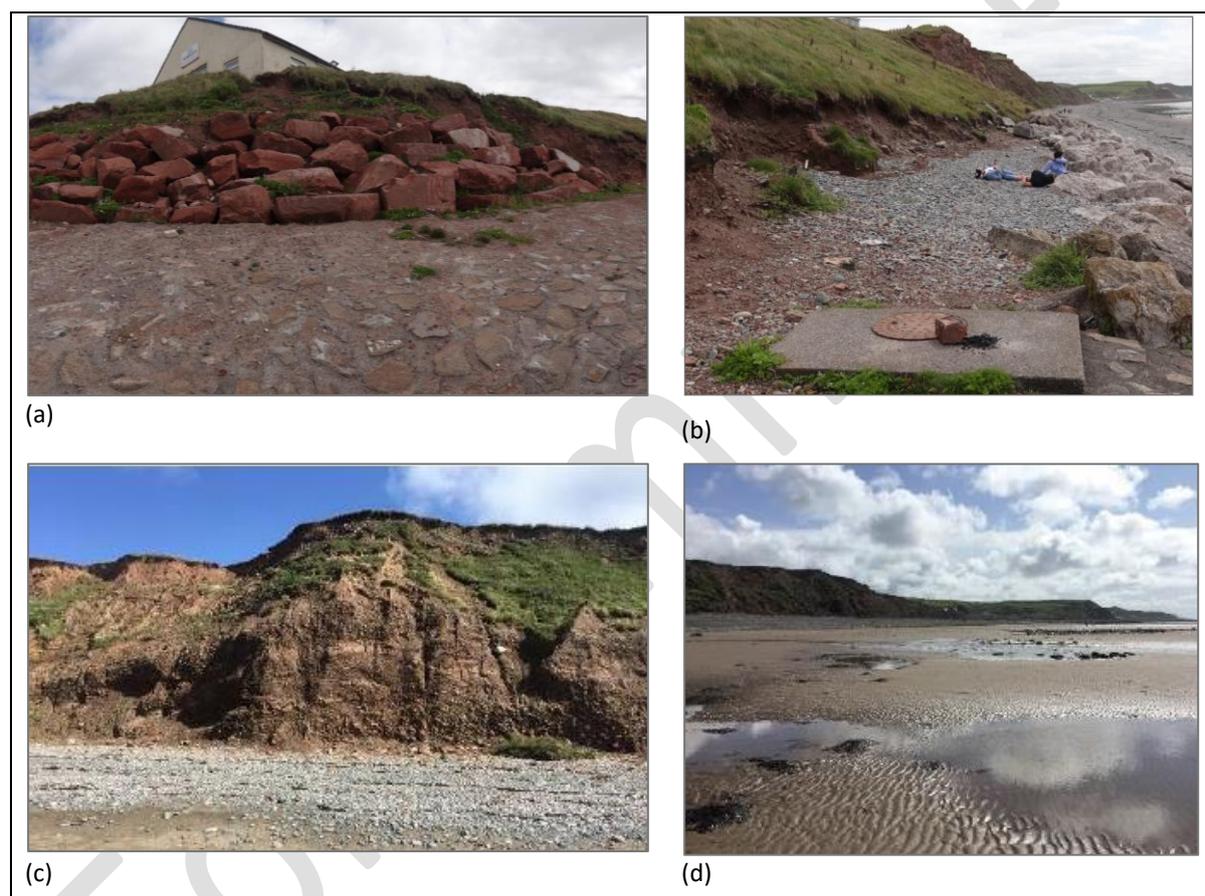
Figure 8 (a) Seacote Hotel St Bees 2 boundary wall with rock protection, (b) Seacote Hotel St Bees 1 Rock protection (11d6.1), (c) Part way along golf club cliff and (d) South end of golf club cliffs

Defences are present, in the form a rock revetment, along the Seacote Hotel. These have a residual life of around 20 to 50 years and are privately maintained (Seacote Hotel) (see Table 6 and Figure 8). The remainder of the frontage, along St Bees Golf Course is undefended. Here the cliffs are active and showing signs of rock falls and mudslides. There is limited debris at the base of the cliffs, suggesting it is fairly rapidly incorporated into the beach. Futurecoast provides an erosion estimate of 50 to 100 m over 100 years. The recession potential is in the order of 0.5 m per year to 1.0 m per year, but a single landslide event could cause up to 10 to 50 m of erosion (Halcrow, 2011).
