**11c14 Walney Island**

**(Technical report by Jacobs)**

# Policy area: 11c14 Walney Island

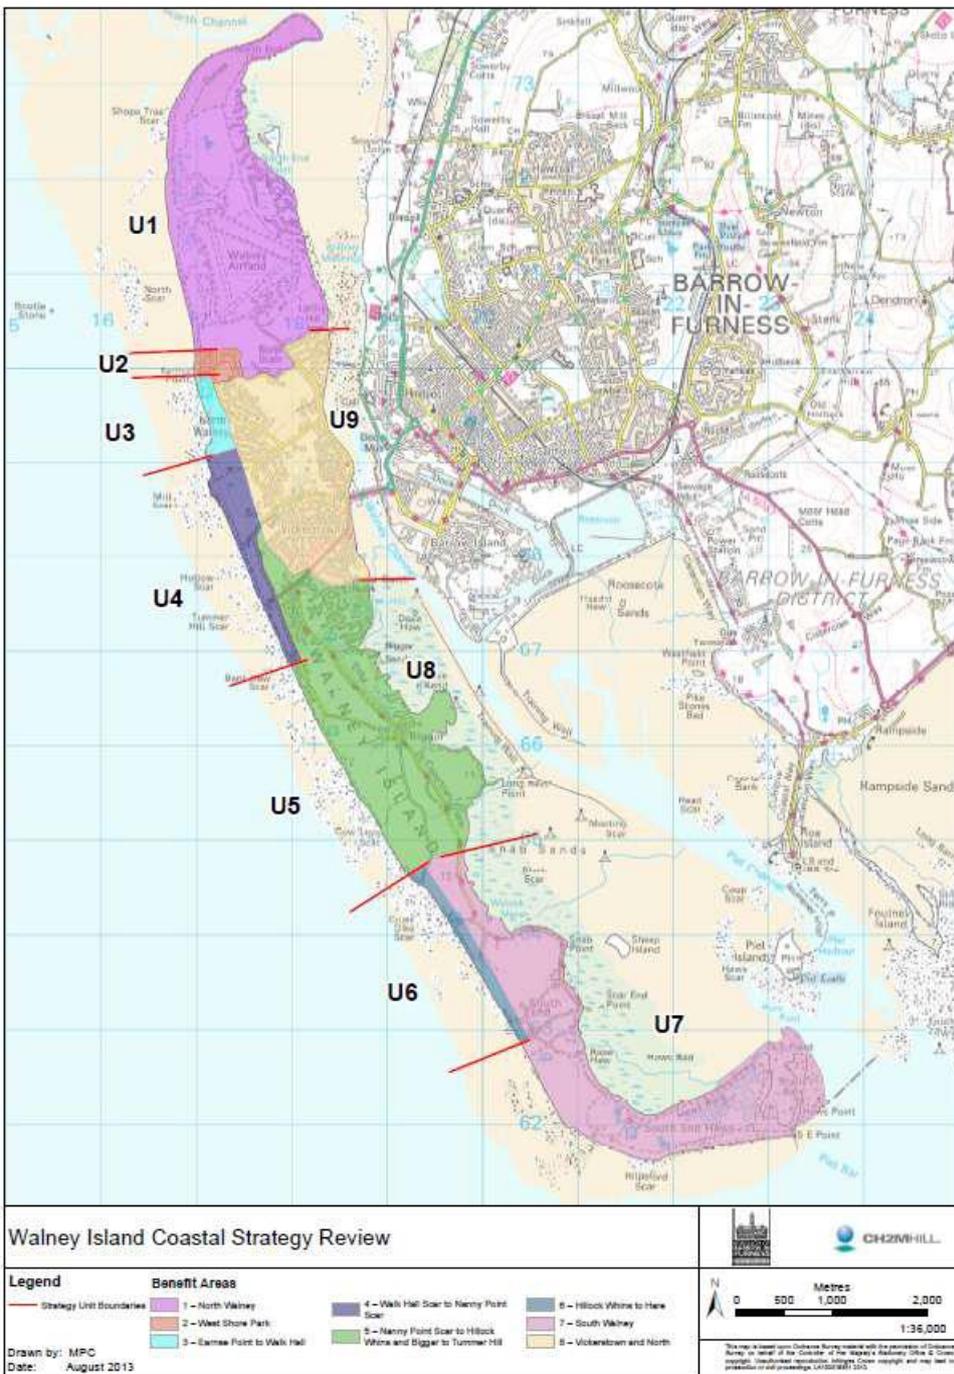
Figure 2 Subdivision of coast, for Walney Island Strategy.

It should be noted that the Walney Island Strategy divided the coast into nine revised units for the development and assessment of options, named Units 1 to 9, rather than the eight policy units defined by the SMP2 in order to better account for land areas that are at flood and erosion risk from the shorelines on both sides of the island. Options were then considered in terms of the benefit areas, meaning that Units 5 and 8 were combined into a single benefit area (Benefit Area 5) due to the shared flood plains (see Figure 2).

For the purposes of this strategy, the Walney Island Strategy Benefit Areas (1 to 8) have been used, rather than the SMP2 policy units.

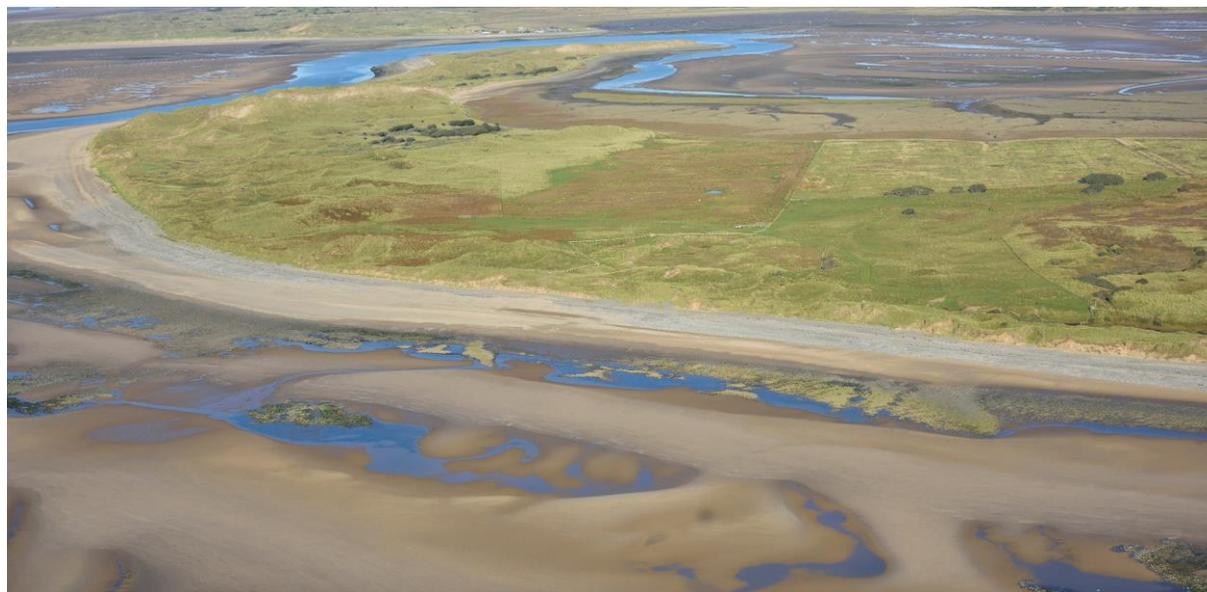
However, more recently it was identified that a secondary tidal channel had split from the main Jubilee Channel, which started to reverse this trend (Halcrow, 2012). There are only two North West Regional Monitoring Programme profile monitoring locations that cover the western shoreline of North End. Data from these show that the sand dunes at Shope Tree Scar, North End Rabbit Warren, retreated around 8 m between 2008 and 2016, but most of this erosion occurred between 2013 and 2014, probably in response to the winter storms. Beach levels since have shown some recovery. The profile further south shows that over the same period there has been net accretion of the dune. Oblique aerial images (latest from 2015) suggest that in general the frontal dunes are well vegetated and show little sign of mobility, apart from a short stretch, when bare sand is visible (Figure 3).

*Figure 3 North Walney illustrating that the frontal dunes are generally well vegetated and show little sign of erosion, part from a short stretch at the right hand side of the photograph. Also shown are the mobile bars and channels along the foreshore, which may locally have an influence on exposure conditions. 2015 aerial photograph © North West Regional Monitoring Programme.*

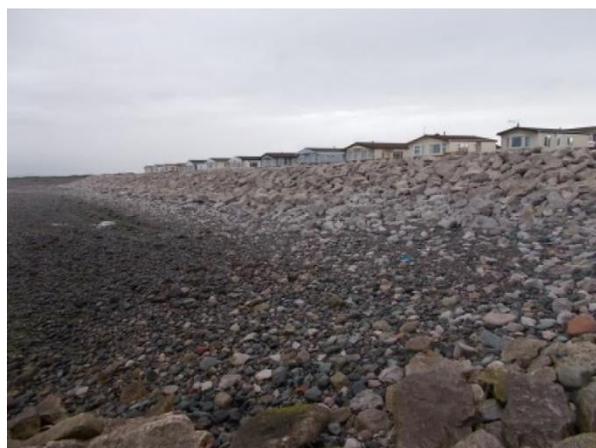
A new rock armour defence was installed a couple of years ago and remains in Very Good condition (Barrow Borough Council, 2016). This defence is privately maintained. The defences are temporary as they are due to be removed after 20 years to allow for the Park owners and residents to develop and implement an adaptation strategy in conjunction with the Council (Barrow Borough Council, 2016).

Figure 4 Rock armour defence at West Shore Park (Barrow Borough Council, 2016).

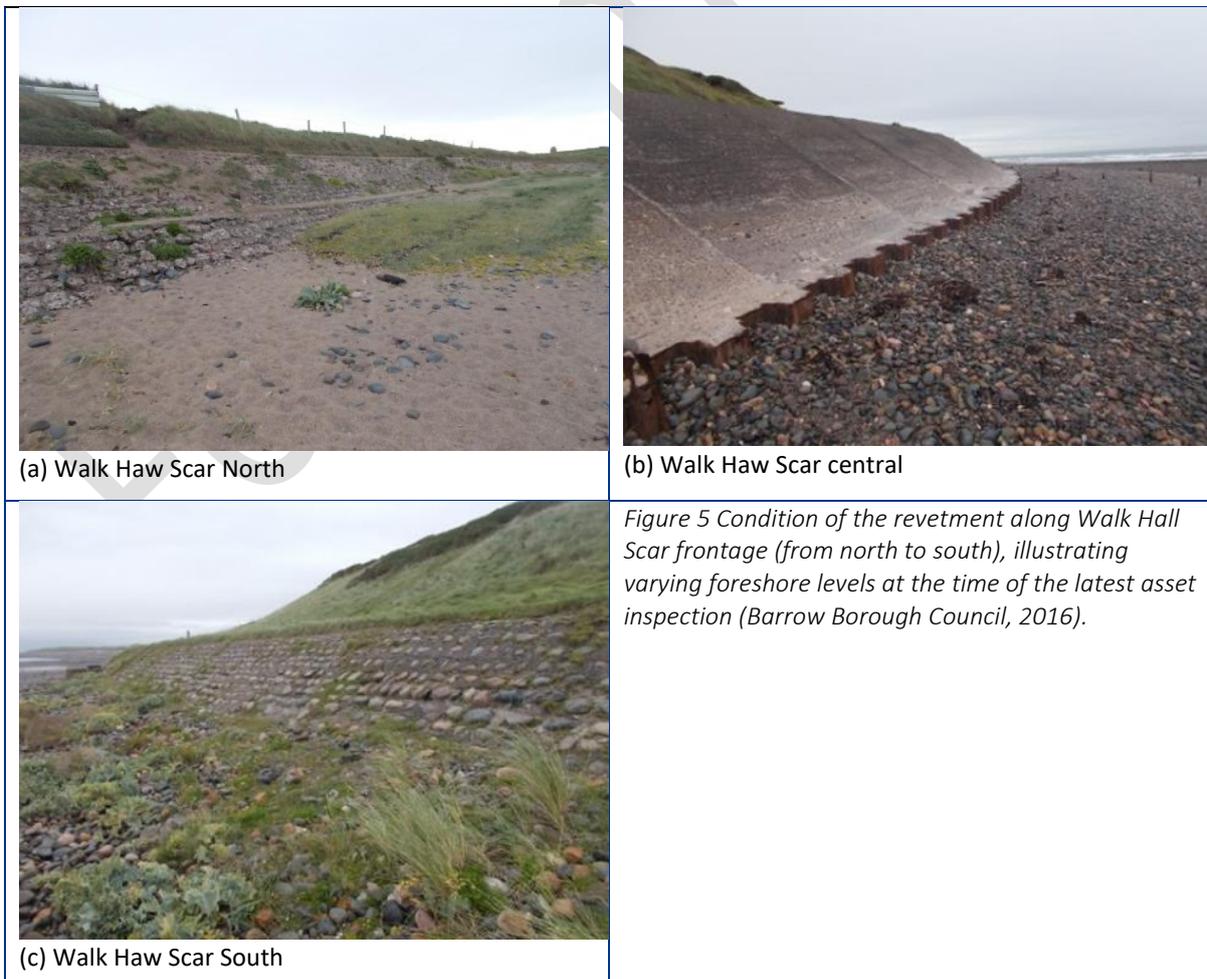
This frontage has been largely defended since the 1950s in the form of revetments (Figure 5). Whilst these have prevented erosion and shoreline retreat, the Walney Island Strategy identified that they caused beach lowering over time with subsequent defence failure.

A fish tail groyne was constructed at Earnse Point in the 1990s; this has trapped sediment enabling the build-up of beaches, which now protect the old defences. The latest asset inspection (Barrow Borough Council, 2016) identified this to be in Good condition, with some minor displacement of rocks. It was noted that shingle has built up substantially on the southern side further reinforcing the groyne but concluded that the level of build-up did not appear to have increased significantly since the last inspection. A rock revetment continues to the north of the groyne. This is currently in Good condition, with only minor rock displacement in places.

To the south of Earnse Point groyne, at Walk Hall Scar, revetments have been constructed in the past to manage the risk of erosion. At the northern end, there has been accretion along the foreshore with vegetation growth. Here, although small rocks are missing from the revetment in places, the latest asset inspection (Barrow Borough Council, 2016) suggested that no repairs were necessary. Along the central section, there has been lowering of foreshore levels, which has exposed sheet piling at the toe of the structure. Further south, there has been vegetation growth at the toe, suggesting accumulation of sediment here; although evidence of undercutting (Barrow Borough Council, 2016) suggests lower levels in the past.

The latest inspection suggests a current condition grade of Fair and residual life of 5 – 10 years for the length of the revetment.

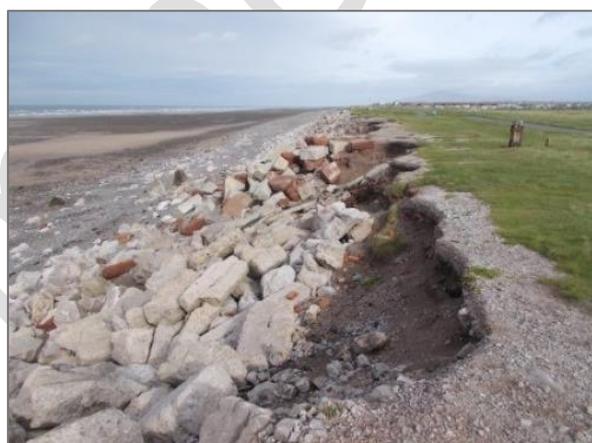
At the northern end of this unit, at Bent Haw (see Figure 6), the defence, which dates from the 1980s, has a crest level of 9.1 m and is made up of rock armour and large stone blocks, with some areas of tipped rubble and bricks. The 2016 asset inspection (Barrow Borough Council) notes that many of the blocks have been displaced and there are increasing areas of the rocks slipping. Some repairs have been made with rock armour.

At the locations where rocks have slipped there has been further erosion. The residual life of the structure is recorded as less than 5 years, with current condition being Poor.

*Figure 6 Bent Haw rock revetment, with erosion evident behind the revetment (Barrow Borough*

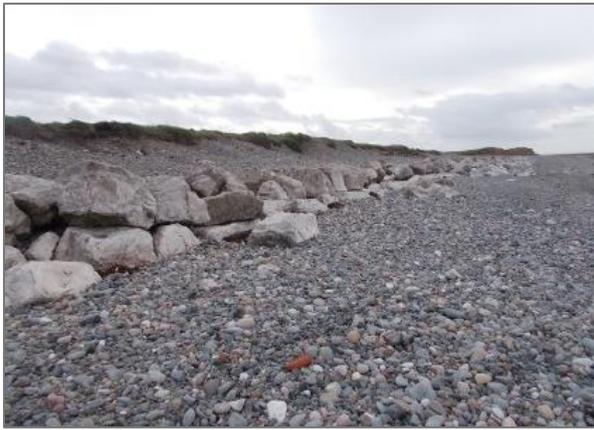
At Bent Haw tip, a linear rock armour bund was constructed along the front of the southern tarmac car park in 2000 to prevent erosion of the former Bent Haw landfill, which was previously run by Barrow Borough Council (Figure 7). The rock embankment has a crest level of 6.0 m. Although the latest asset inspection report (Barrow Borough Council, 2016) concurs with the strategy in the residual life of 5 to 10 years, it does note that shingle has now built up in front of the embankment and is providing protection to the previously exposed material along almost the entire length of the defence (see Figure 7). This is evidence that the defence is being overtopped but the build-up of shingle may now help extend the life of the defence beyond the estimate provided by the Walney Island Strategy.

*Figure 7 Bent Haw showing accumulation of shingle behind the rock revetment, which is now providing some protection to the low till cliffs behind (Barrow Borough Council, 2016).*

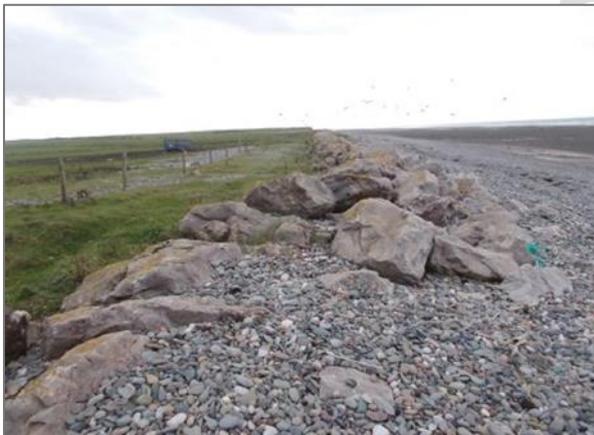
*Figure 8 Cow Leys Lane rock revetment (Barrow Borough Council, 2016).*

The latest asset inspection report notes that to the south of this unit, at Cow Leys Lane, the rock revetment (Figure 8) (which is maintained by Barrow Borough Council) now provides little protection due to previous outflanking of the defences due to erosion of undefended sections either side.

However, the report also noted the establishment of vegetation on the foreshore at the toe of the revetment and accumulation of shingle at this location, which suggests some current stability. This may extend the life of the defence beyond the estimate provided by the Walney Island Strategy.

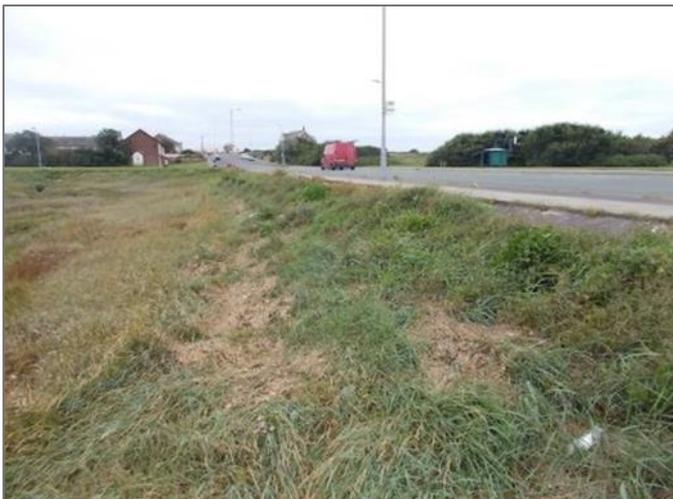
Along Unit 8, which lies along the eastern side of the Island, flood defence is provided by an earth bank that runs northwards from the village of Biggar towards Tummer Hill; this has a crest level of 6.0 m and is maintained by Barrow Borough Council. At Tummer Hill, the most recent inspection (Barrow Borough Council, 2016) concluded that the defence condition was Fair with an estimated residual life of 10 to 20 years. The defence was noted to be covered in heavy vegetation and protected by a well developed saltmarsh.

Figure 9 Tummer Hill – man-made embankment (Barrow Borough Council, 2016)

There are three outfalls through the embankment. These were judged to be in Fair to Good condition, although some issues of siltation were noted.

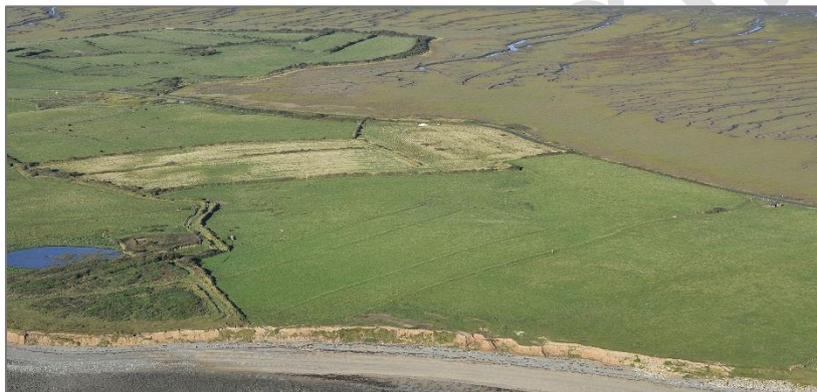
Creephaw Marsh Embankment lies to the south of Biggar and provides some protection to low grade farmland. The overall condition was defined as Fair, in the 2016 inspection (Barrow Borough

Figure 10 Creephaw Marsh Embankment in the background showing the wide expanse of fronting marsh. 2015 Aerial photograph © North West Regional Monitoring Programme.

Council), but it was noted that the embankment was heavily vegetated. There is a wide expanse of marsh in front of the defence, meaning that exposure conditions are low. Creephaw Marsh Floodgate was noted to be of lightweight material but the asset inspection reported that due to the protection from a well developed salt marsh there is little pressure on this asset. There is little evidence of flooding behind the embankment from high tide.

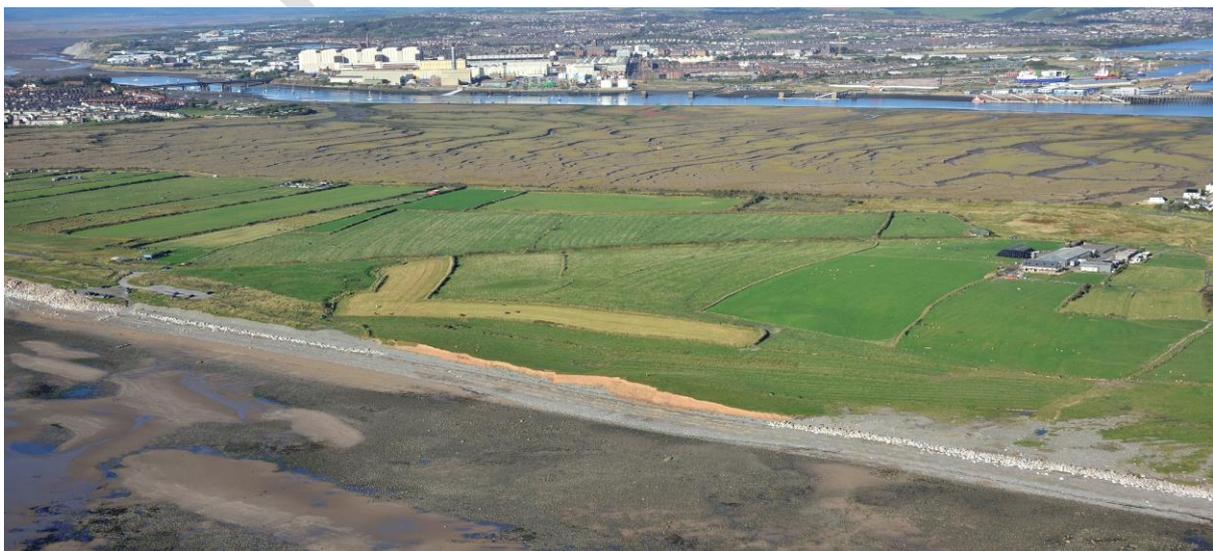
Figure 11 Shoreline between Bent Haw carpark (left hand side) and Cow Leys Scar, showing rock armour stretches, with erosion continuing behind and active low cliffs between. 2015 Aerial photograph © North West Regional Monitoring Programme.

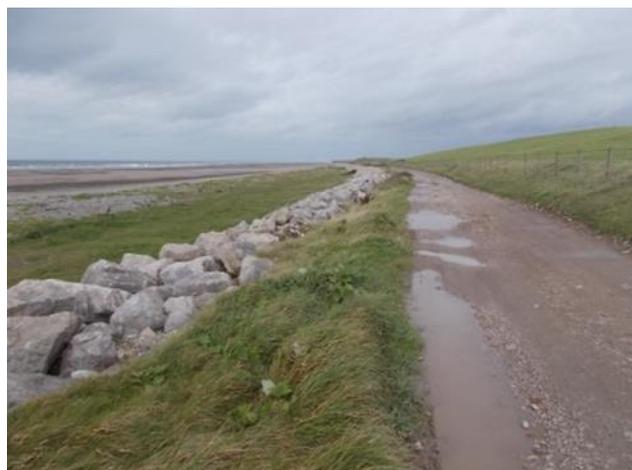
To the south of the unit, in front of the more recent Cumbria Waste Management Ltd site protection is provided by a rock revetment (crest level 8.4 m) maintained by Cumbria County Council. The latest asset inspection (Barrow Borough Council, 2016) recorded the structure to be in Good condition, with vegetation becoming established along the foreshore at the toe of the revetment (Figure 12).

*Figure 12 Low Bank revetment, showing the development of vegetation along the toe of the structure (Barrow Borough Council, 2016).*

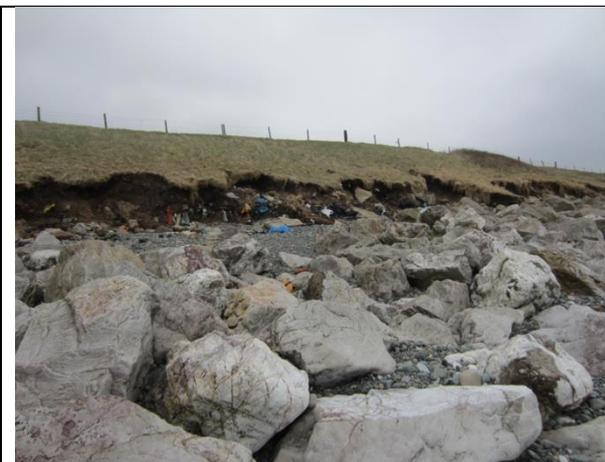
However, since the Walney Island Strategy was approved, an area of the historic landfill has been subject to wash out by the sea following the winter storms of 2013. A separate report was produced by Cumbria Waste Group (CWG) in 2014 which reported that the site, which lies between Hillock Whins and White Horse Scar, covers around 14 ha (see Figure 13), but that the depth of deposited waste is not known. The central part of the site (indicated as Area A on the map below) is bounded by a bund protected by rock armour. There has been damage to the rock armour and some has been removed by wave action. There has been erosion of the perimeter bund and exposure of some waste (Figure 14). Along the northern end of the site (indicated as Area C on the map below) there is no perimeter bund and this frontage is undefended; this is where waste has become exposed (Figure 15). The CWG report also states that Barrow Borough Council's Coastal Survey refers to monthly high tides overtopping the rock armour along Area A.

Figure 14 Area A, section B-C, shown on map above, illustrating erosion of the perimeter bund behind the rock armour. Taken from CWG (2014).

It is understood that Cumbria County Council are currently seeking a longer term permanent solution to the problem, to mitigate the impacts of coastal erosion along the frontage, beyond the current strategy of reactive maintenance. This will involve a four phase approach from preliminary investigatory work, through options development and concept design work, to subsequent detailed design and construction. The first two phases are due to be completed by winter 2018 to 2019.

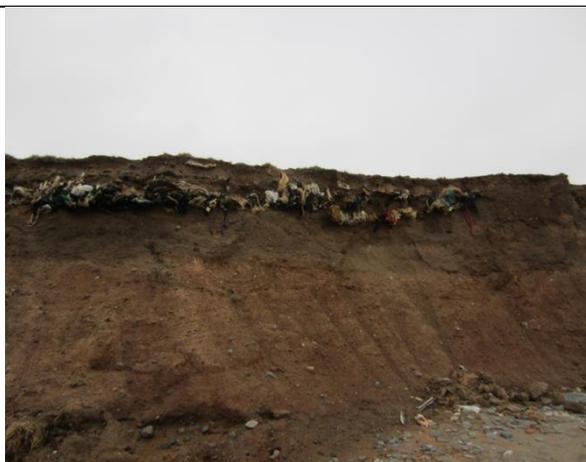
A rock revetment has been constructed along the south part of this frontage, providing protection to the recently decommissioned South Walney landfill site. There is also a rock bund fronting the northern part, giving some protection to historical landfill sites previously managed by Cumbria County Council. The Walney Island Strategy identified that the defences vary in condition and performance along the frontage with some sections expected to fail within 0 to 5 years. There is a short stretch, at the northern end of the former landfill site is undefended and the cliffs are actively eroding (see Figure 15).

Figure 15 Area C, showing no protection to cliffs and exposure of waste. Taken from CWG (2014).

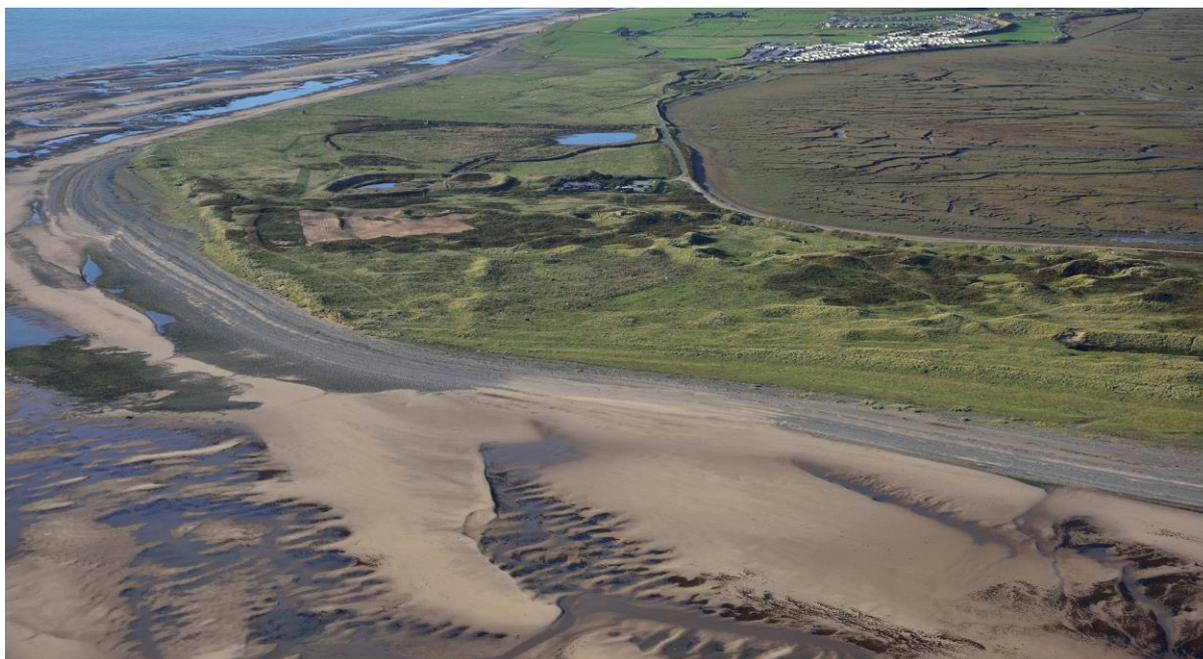
At Pho Hill and Hilpsford Scar there have been significant changes as the coastline here naturally realigns (see Figure 16). This is reflected by both significant changes in beach level and retreat of the cliffs and dunes. At Pho Hill this erosion is not just driven by storms, with recession recorded prior to storms in 2013 of around 7 m. A further 12 m occurred in 2013 and 2014 and 6 m in 2015 and 2016 (CH2M, 2018). At Hilpsford Scar, there has been erosion and retreat of the fronting shingle bank, with around 25 m change between 2012 and 2016, but the impact of this has not yet been observed along the dune face.

Figure 16 South End Haws, here there has been shoreline change as the coastline realigns. 2015 Aerial photograph © North West Regional Monitoring Programme.

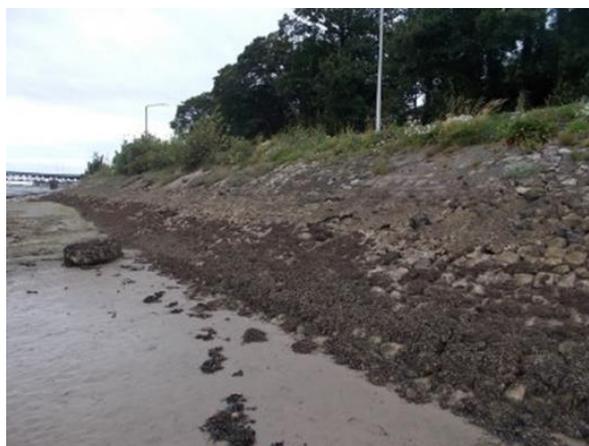
The latest asset inspection (Barrow Borough Council, 2016) records the current condition as Fair, but identified that there have been numerous repairs to the structure over time, including more recent concrete repairs. Estimated residual life is 5 to 10 years (Barrow Borough Council, 2016).

However, the inspection noted the following areas of concern:

- areas where washout has occurred and further repairs are required,
- severe cracking, loss of joint material and loss of stone from the revetment,
- increased undercutting at the toe in areas.

Figure 17 Vickerstown Promenade sloping revetment (Barrow Borough Council, 2016).
