Flimby

Including Fothergill

S.19 Flood Investigation Report

3rd and 5th December 2015

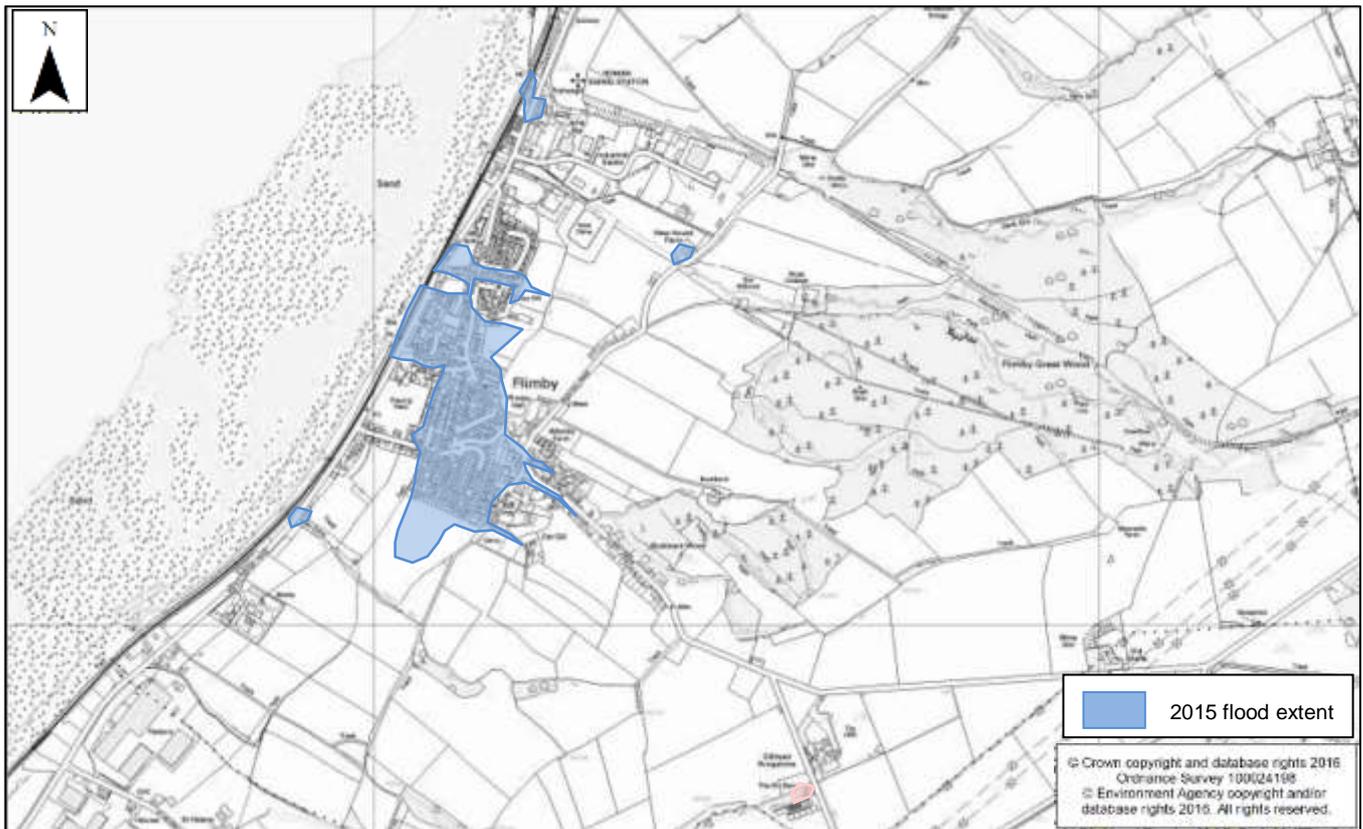
Figure 4: Extent of River (Fluvial) Flooding* in Flimby 3rd December 2015

The flood outline identifies the maximum extent of flooding. Not all properties within the extent area were flooded.

For this report, the flooded area has been divided into 6 sub-areas for investigation. These are based on flood flow routes. These sub-areas are shown in **Figure 4**:

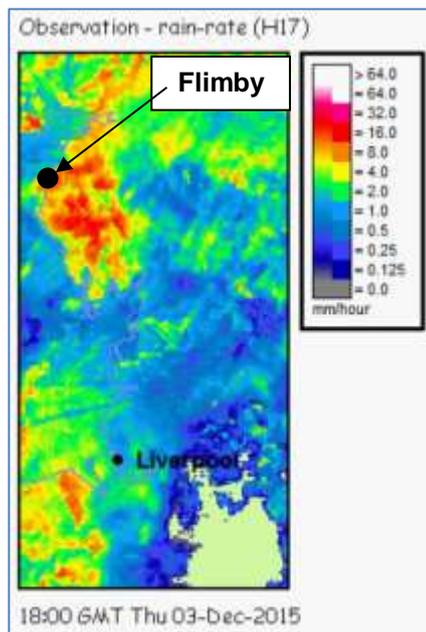
Figure 1 Rainfall Intensity Radar over Cumbria 3 December 2015 18:00

On the afternoon and early evening of Thursday the 3 December between Flimby and 19:30 hrs, an extreme rainfall event affected West Cumbria. The epicentre of the flooding was the west facing upslope areas near the coast, especially in the areas between Flimby and Maryport, **Figure 6**. In one 15 minute interval, 7mm of rain was recorded.

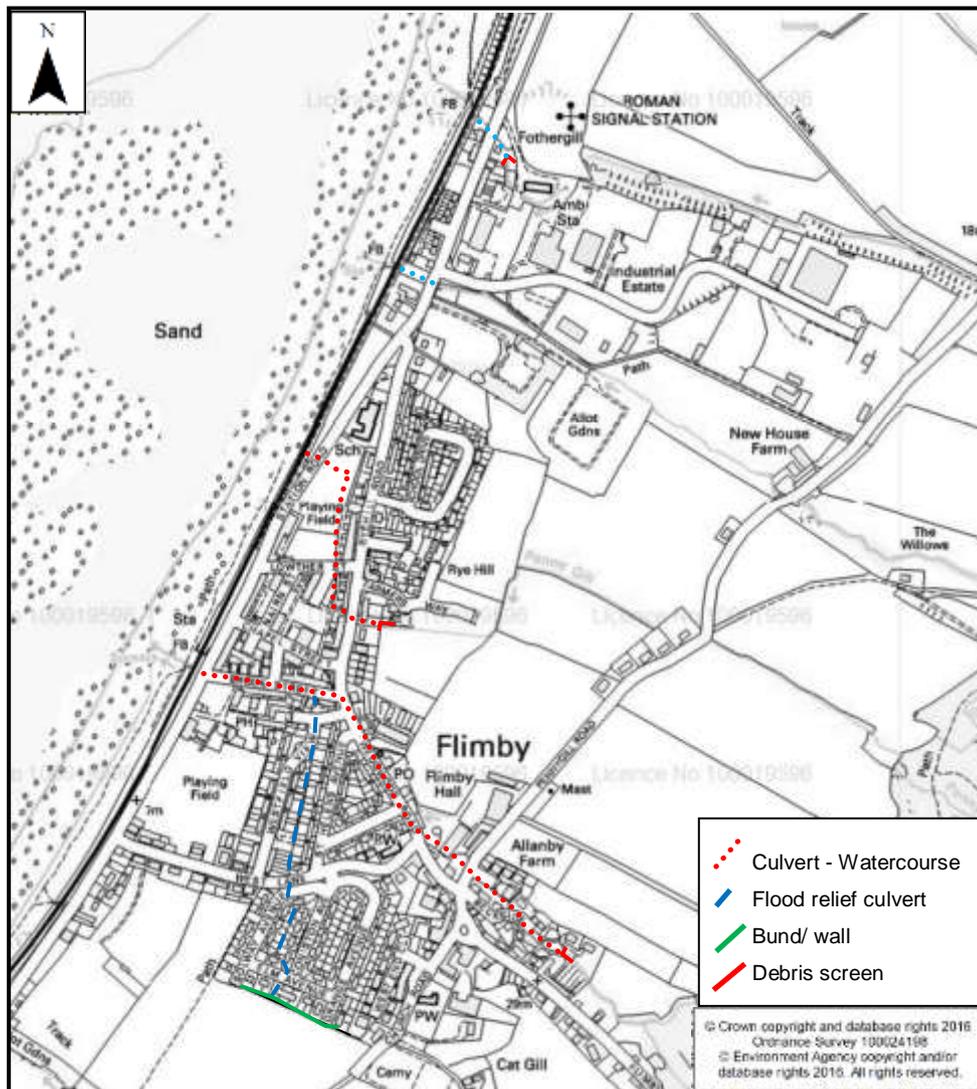
Figure 7 Flood Defences in Flimby

In the field behind the properties in Elm Avenue there is a concrete sandbag wall with concrete box culvert following the old watercourse at a higher level. This flood relief culvert runs at the rear of properties in Coniston Avenue and Solway Avenue before crossing West Lane to run along the rear of the properties in Westfield View and St Helens Avenue. This then joins Flimby Gill (Barrel Arch) in Brook Street, **Figure 7**.

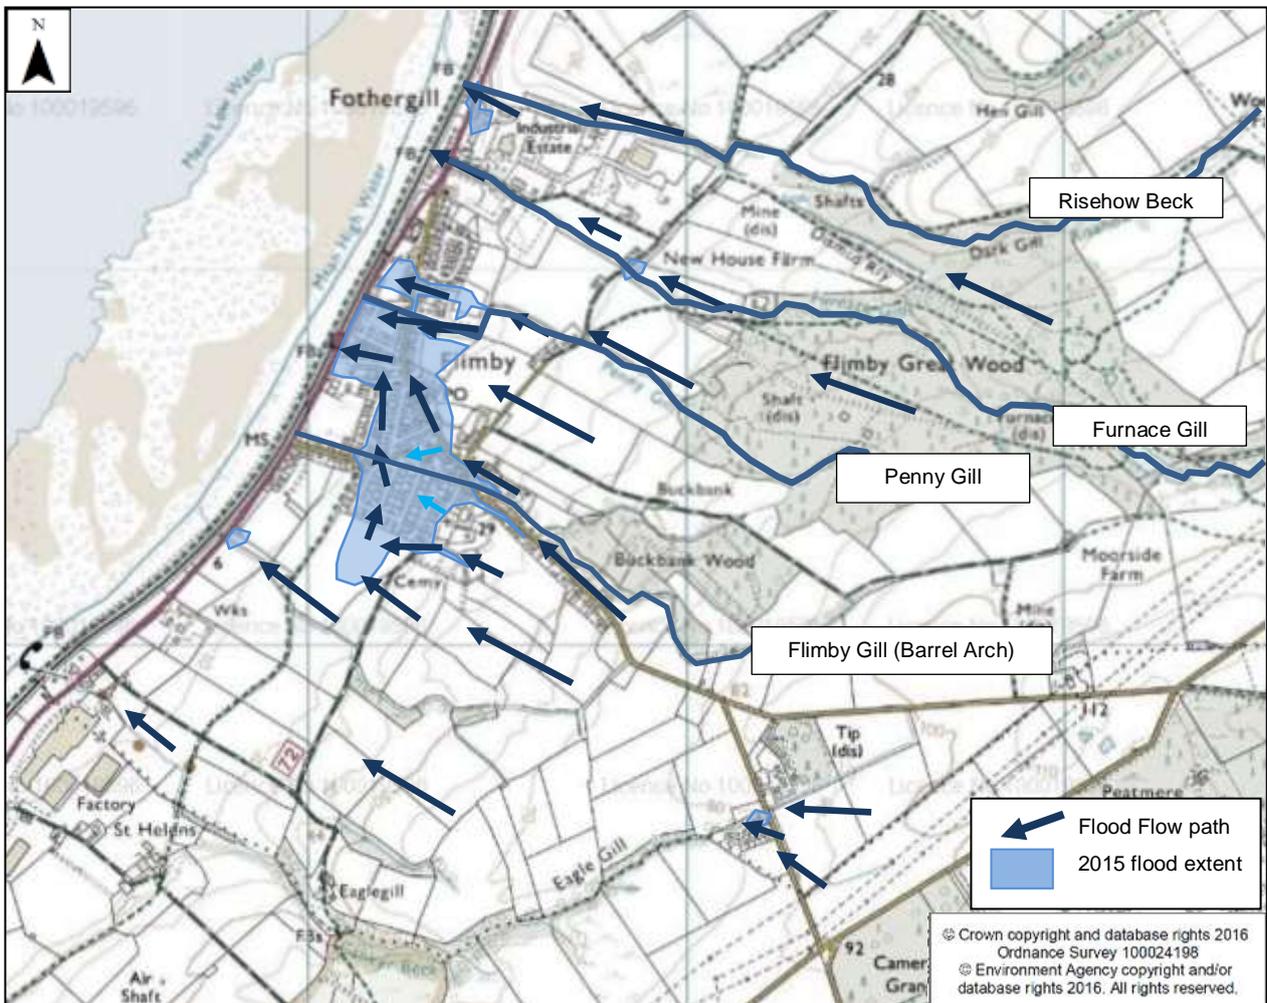
Figure 8: Summary of flood flow routes through Flimby

There were a number of flooding flow routes during the event. These are summarised in **Figure 8**. The details of these flow routes and the flooding within each of the identified areas is discussed in the 'Impacts and Likely Causes of Flooding' section, below.

With ground already saturated the intensity of the rainfall event turned roads into rivers. Road drains were overwhelmed and water followed the route of least resistance to flood into homes and gardens. Water was trapped on flatter ground where it collected increasing the depth as there was no flow route out causing further flooding to property.

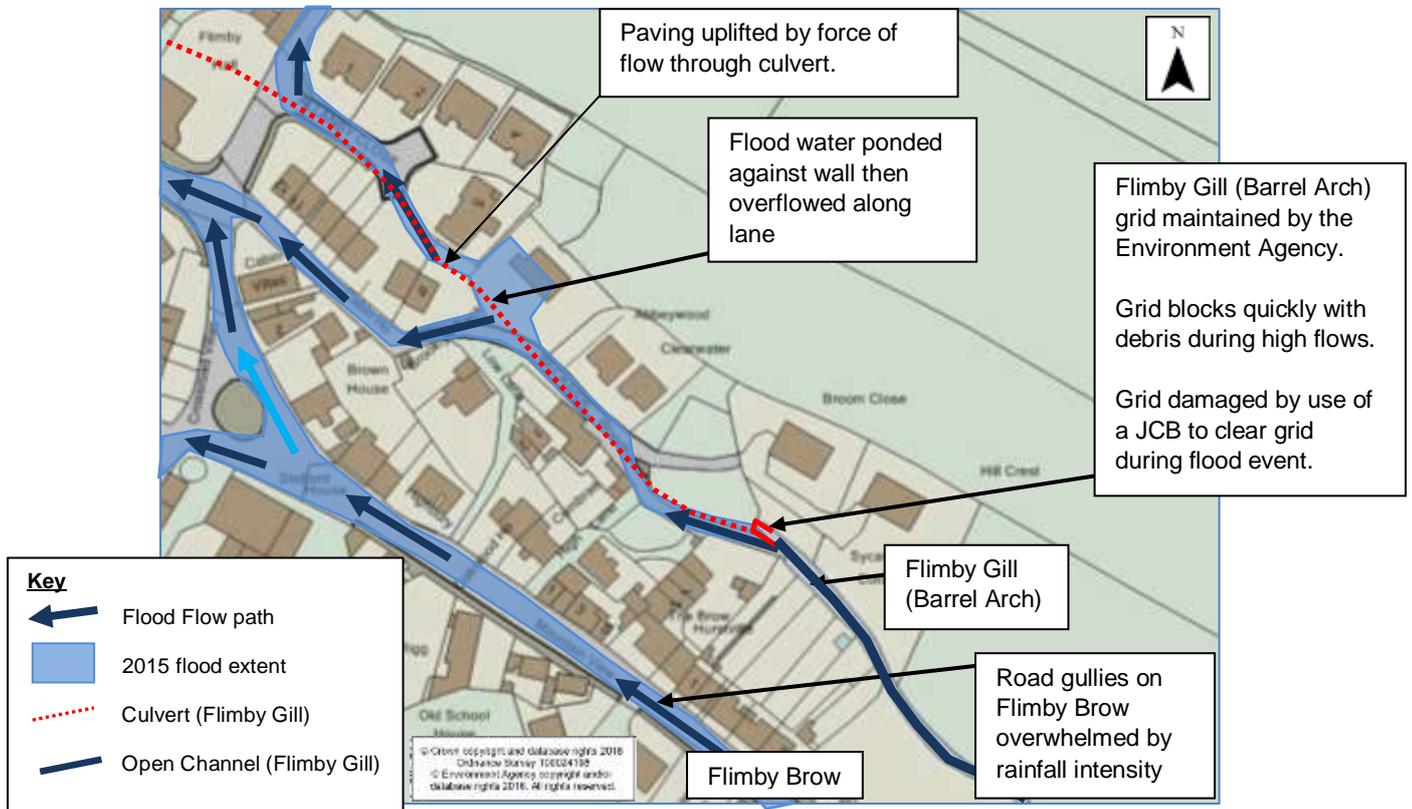
Figure 9: Flimby Gill and Flimby Brow flooding mechanisms

The Environment Agency maintains a debris grid on the culvert entrance of Flimby Gill (Barrel Arch) which was cleared of debris prior to the flood event on 3 December 2015.

During the intense rain event on the 3rd December the grid screen became blocked with wood debris washed down from the woodland, upstream of the culvert. This resulted in the flow from the gill overflowing down Beckside and ponding behind the wall to the rear of 6 Allanby Close, **Figure 10**. It then overflowed down onto Wedgewood Road past Flimby Hall. During this event the grid was damaged by a JCB being used to try and clear the debris from the grid, **Figure 11**.

The intensity of the rainfall was such that the road gullies could not cope with the volume of water. Flimby Brow became a torrent of water, flowing down Church Road and joining the flood flow from Flimby Gill on Wedgewood Road. Crossroad Villas are in a dip behind the road island which protected them from the flows.

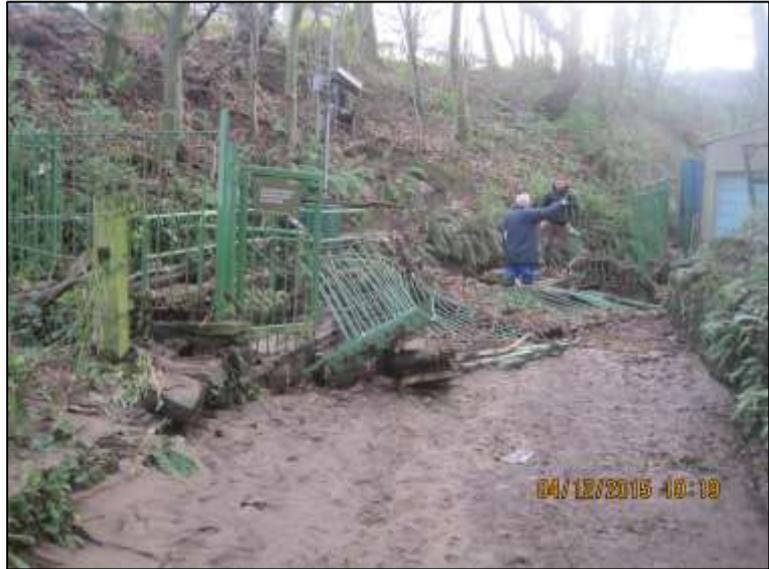
Figure 11: Flimby Gill (Barrel Arch) grid 4/12/16

Further prolonged rainfall was experienced on the 5th December. During the previous event on the 3rd December, the decking above the Flimby Gill grid was removed or became detached. This enabled debris to ride over the screen into the culvert and caused a blockage, although this was not known at the time. The blockage resulted in the surcharging of a manhole and flooding on Beckside on the 5th December.

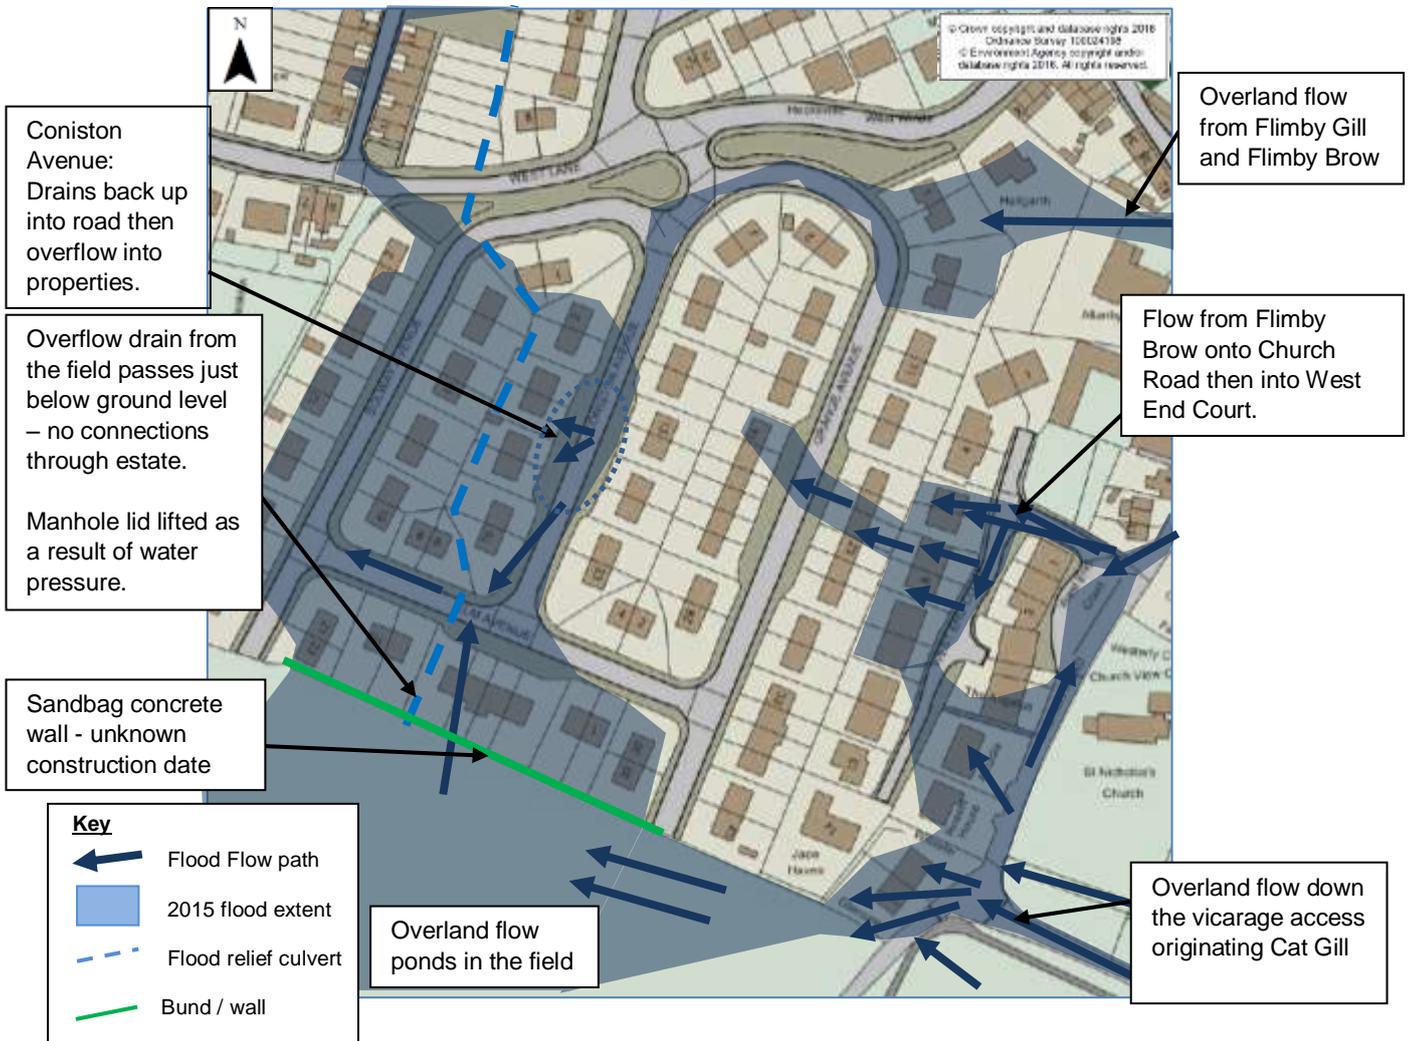
Figure 12: Elm / Coniston / Grange / Solway Avenue and Church Road / West End Close mechanisms

It is estimated that approximately 45 properties flooded within this area, **Figure 12**. Flooding on Coniston Avenue initially started about 15:30-16:00 on Thursday 3 December 2015. The initial flooding came from the road drains which are connected to the combined sewer system. The flooding peaked at approximately 18:00 but lasted until the early hours of Friday 4 December. The water peaked at a depth of approximately 400mm in Coniston Road spreading out onto Solway Ave and Elm Ave. Flood water originating from Cat Gill and Flimby Brow flowed down Church Road via West End Close onto the estate, increasing the depth of water. Some properties narrowly missed being flooded as their floor levels have been raised by the housing association. Although they were surrounded by floodwater, no ingress occurred.

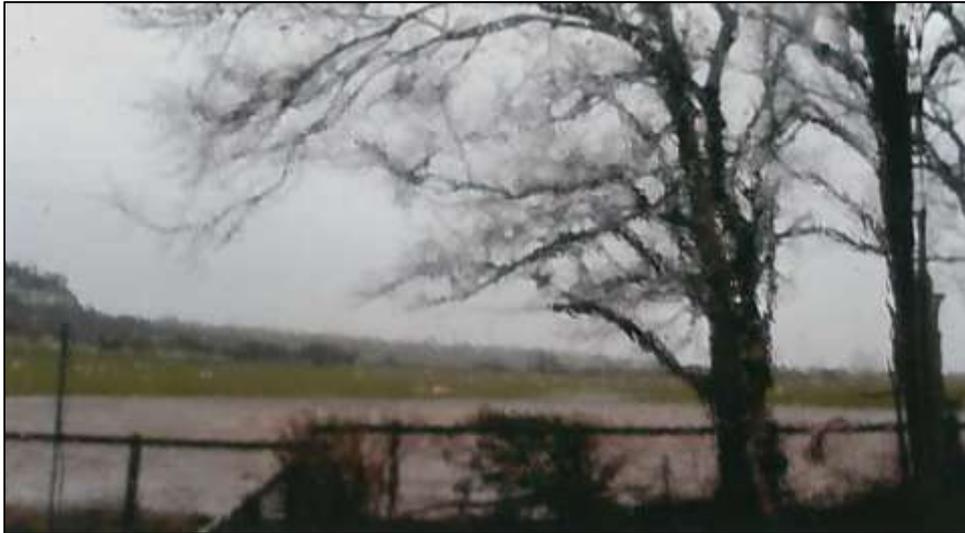
Figure 13: Flooding in the field behind Elm Avenue

The field behind the properties on Elm Avenue regularly collects water, **Figure 13**. Historically, a watercourse followed the field boundary before flowing under the rear gardens of Coniston Ave and along the rear of St Helens Avenue to join the Flimby Gill (Barrel Arch) culvert in Brook Street, **Figure 7**. A higher level concrete culvert follows this route from the field behind Elm Avenue. There is also a concrete sandbag wall which follows the field boundary, increasing the potential storage of the field. The construction date of this wall and culvert is unknown.

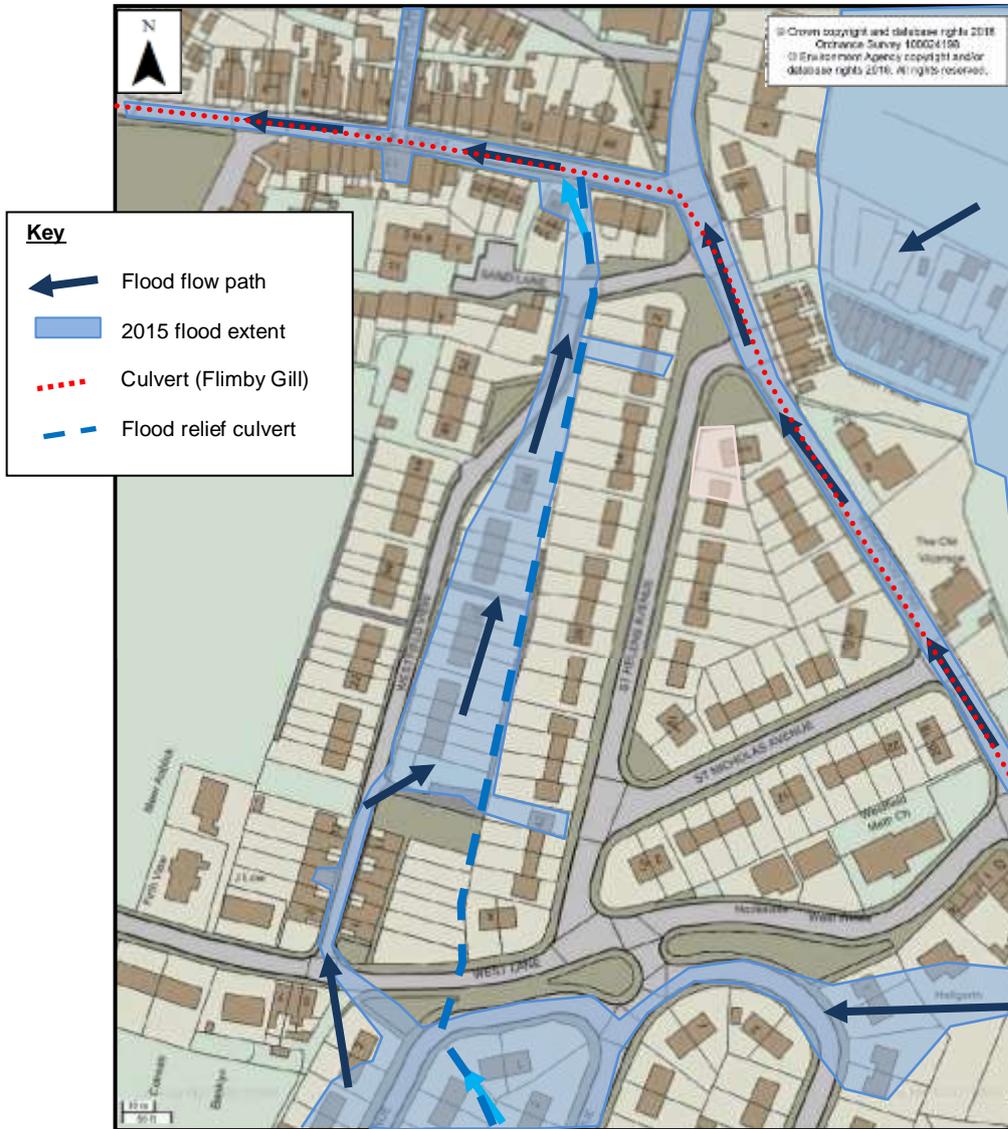
Figure 15: Westfield View Flooding Mechanisms

Westfield View flooded from overland flow via the road network. The direction of the flow was heavily influenced by the camber of the road and dropped kerbs. The water flowed through from Westfield View and Wedgewood Road onto Brook Street, **Figure 15**. Approximately 15 properties flooded in this area.

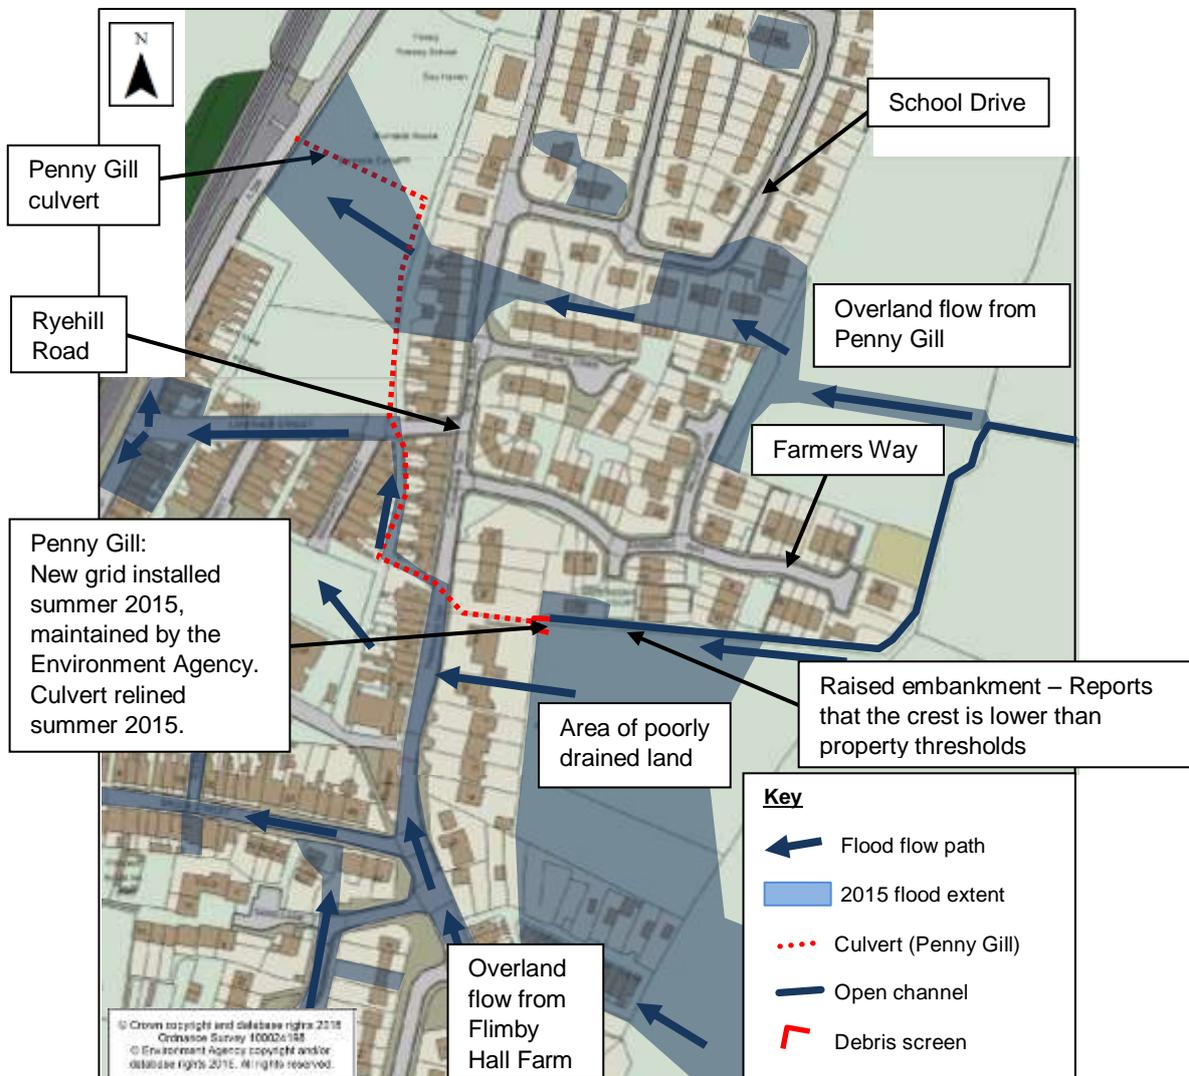
Figure 16: Penny Gill and overland flow flooding mechanisms

Penny Gill was overwhelmed by the rainfall on the afternoon and evening of the 3rd December 2015. The source of Penny Gill is located in Flimby Great Wood where it descends the steep hill and flattens out in the Farmers Way area before entering a culvert which flows under the Flimby, **Figure 16**. The culvert did not have sufficient capacity to contain the flood flows generated during the rainfall event of the 3rd December. This resulted in overland flow across Ryehill Road and down the back lane of Cooperative Terrace, flooding property.

Before Penny Gill reaches Farmers Way, flood flows spill overland to pond behind School Drive. As the direct flow route to Penny Gill grid no longer exists, the flood waters spill through the path between School Drive and Ryehill Crescent and onto Ryehill Road, **Figure 17**. Property on Ryehill Road is on the floodwater flowpath through to the playing fields. The line of the watercourse flows under the A596 and railway line and discharges into the sea.

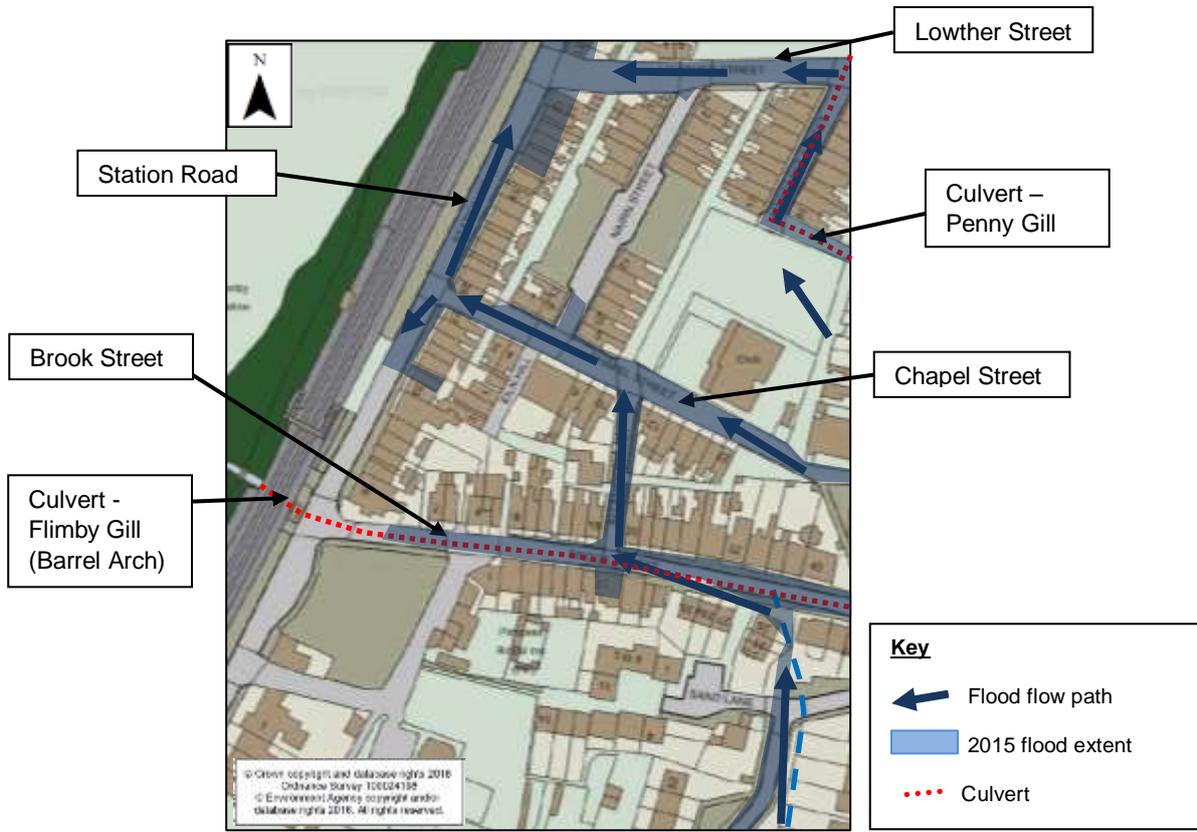
Figure 18: Overland flows from Penny Gill and Flimby Gill (Barrel Arch)

Flood waters from both Flimby Gill (Barrel Arch), Penny Gill and Cat Gill all drain to the centre of Flimby. Flooding occurs along roads, pathways and through gardens and green spaces before eventually finding a route, via drains or overland flow, out to sea, **Figure 18**. Only a small number of properties along these roads have been identified as being flooded.

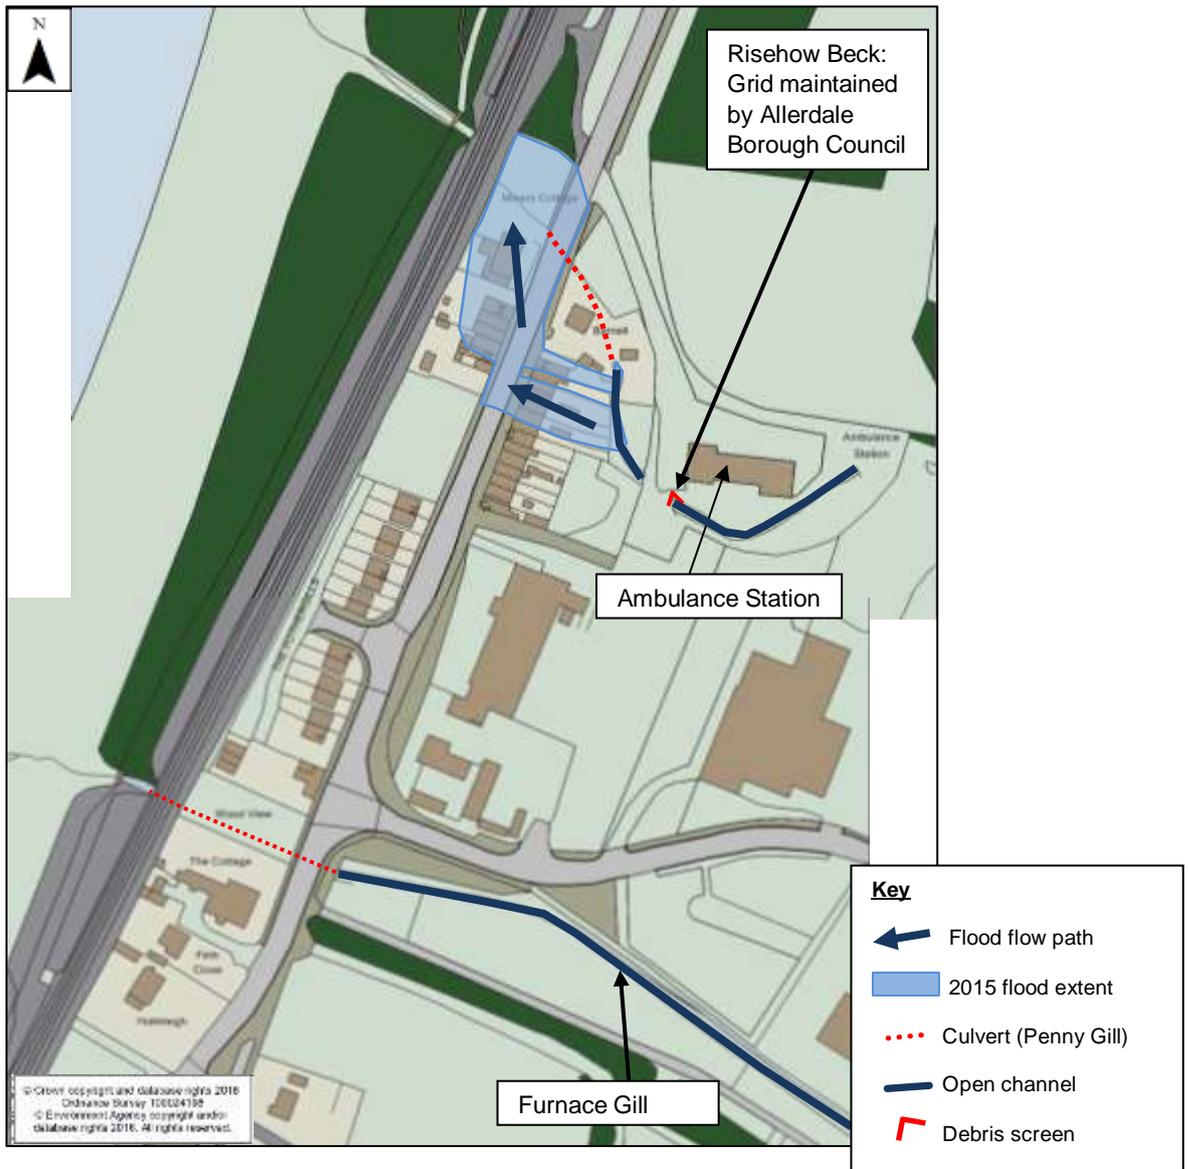
Figure 20: Risehow Beck flooding mechanisms

Risehow Beck was overwhelmed by the volume of water. The grid on Risehow Beck blocked and the watercourse flooded through properties onto Fothergill Main Road (A596), **Figure 20**. Twelve properties on Fothergill Main Road have been identified as having flooded. Vehicles passing through the floodwater caused bow waves and exacerbated the flooding in property.

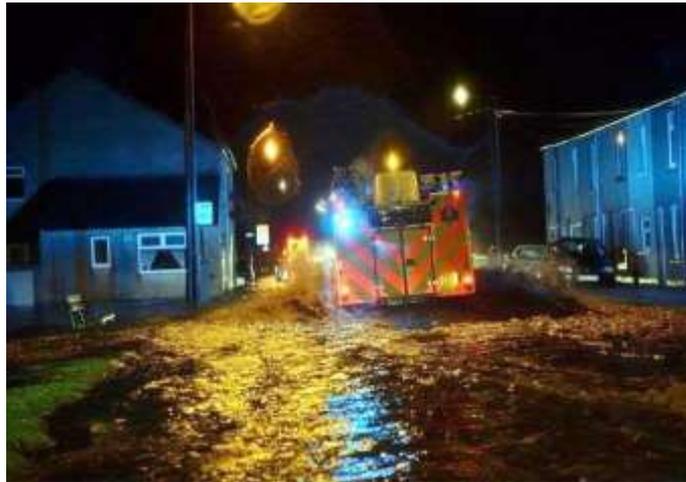
Figure 21 Main Road Fothergill - Risehow Beck flooding

During the flood event, the Fire & Rescue Service were called to Main Road between 18:50 and 20:00 on Thursday 3 December 2015. An appliance from Workington came to assist, **Figure 21**.

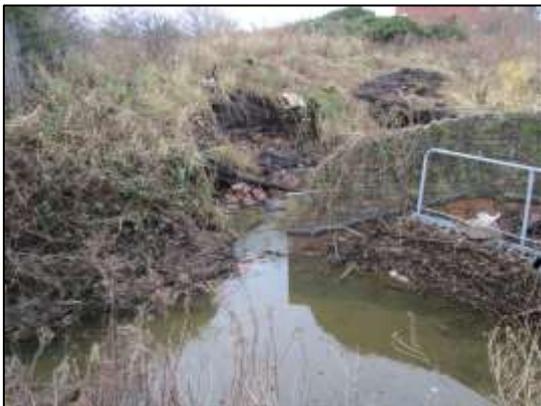
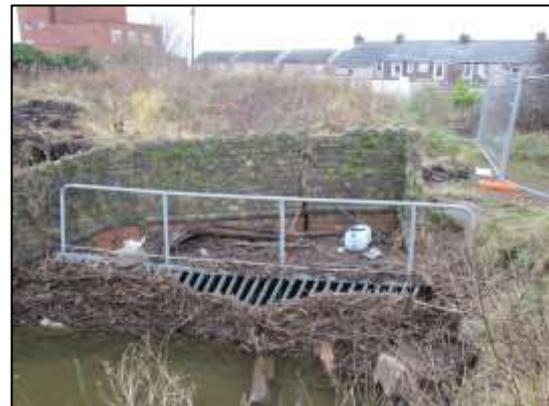
Figure 22: Risehow Beck grid - erosion on left bank

Risehow Beck had a new debris grid installed in 2012. During the flood event the grid suffered erosion on the left bank and behind the structure, **Figures 22 and 23**.
