Wetheral

(The Mews, The Arches, Green Farm and
Greystones)

Flood Investigation Report

Flood Event 17th July 2011

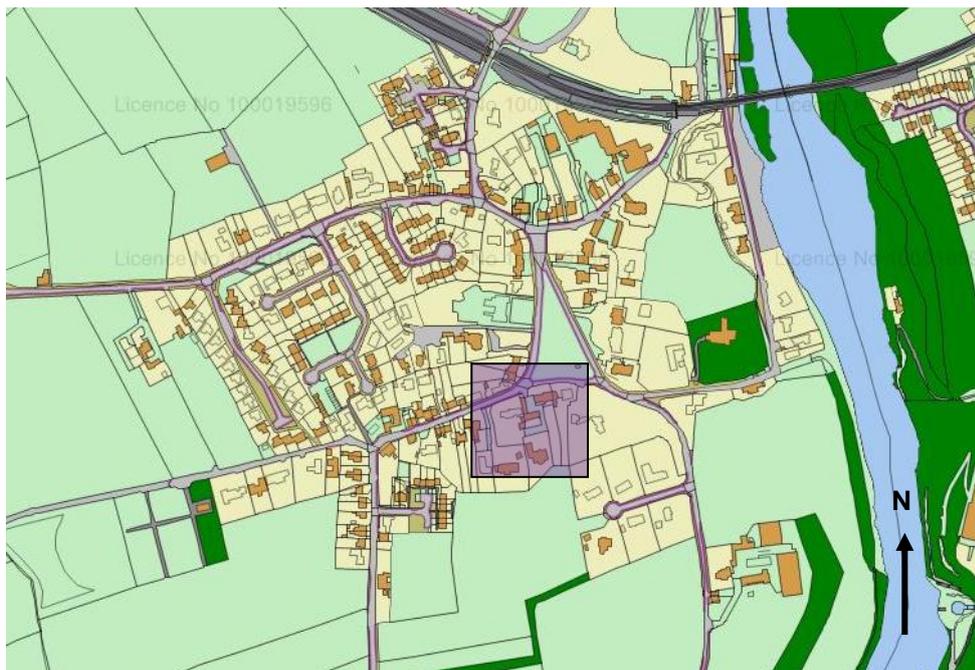
Figure 2 Collection of developments affected in Wetheral

Wetheral is located on the western side of the River Eden, approximately 5 miles from Carlisle to the west (Grid reference NY 46600 54336). The area affected by the flooding is located alongside Steele's Bank Road. A collection of developments around the old farm house are affected by the flooding.

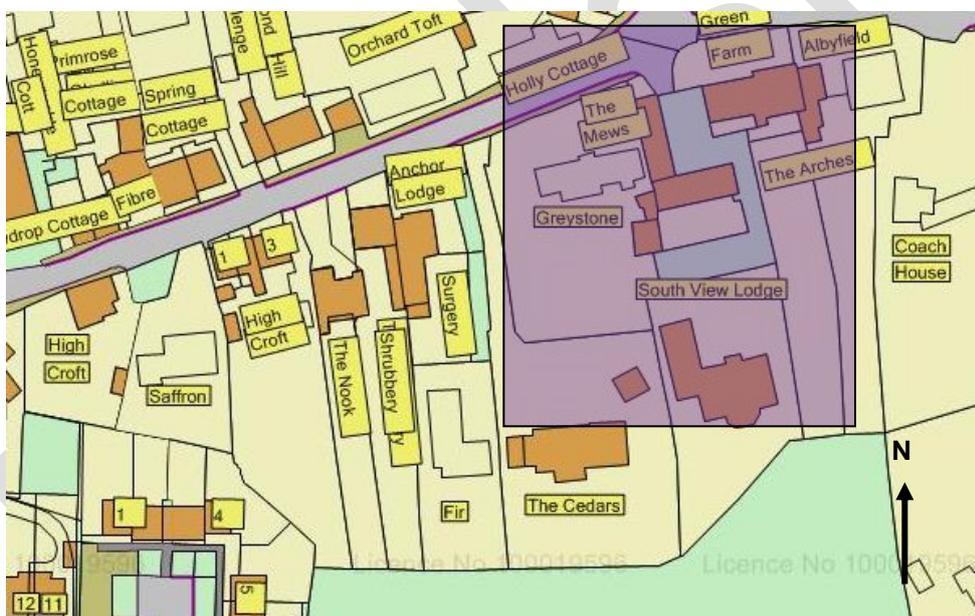
Fig 3. Names of properties

The access alongside “The Mews” is shared by “The Mews”, “The Arches” and “South View Lodge”. This can be seen in figure 3 below.

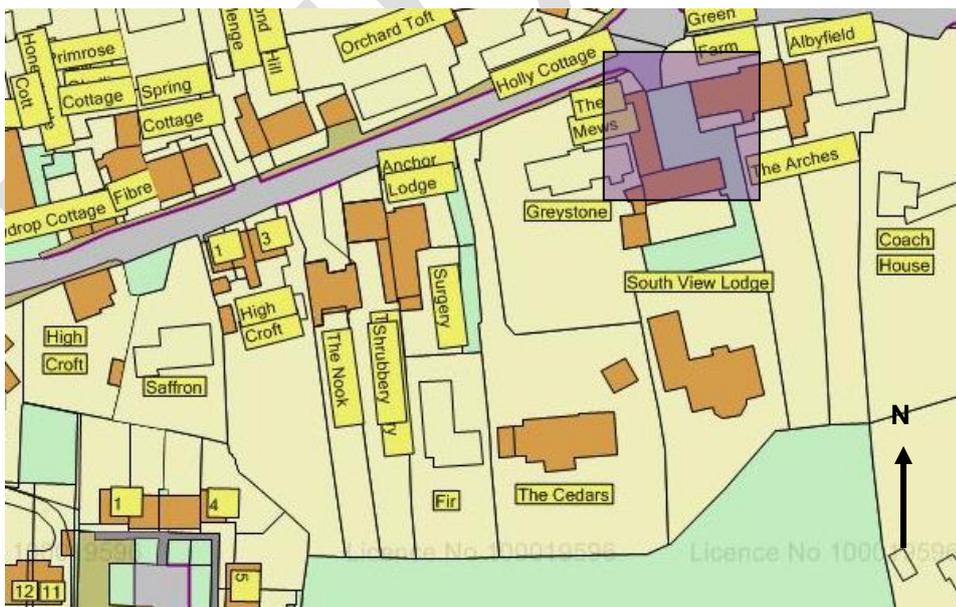
Figure 5 Location of works

UU have carried out works in the courtyard manhole to prevent the manhole and gully surcharging with sewage. The effluent in the sewer connection cannot discharge to the sewer in the road as it reaches capacity in rainfall events. UU have inserted a non-return valve and pump to ensure that during surcharge the effluent is pumped out of the manhole and into the sewage flow in the sewer in the road (Steele’s Bank). This will further minimise the risk of flooding in the courtyard. Similar non-return valves have been installed at “Green Farm” and “Greystones”.

United Utilities have also carried out temporary work to improve surface water drainage by inserting a slot drain and bund across the entrance to the courtyard in order to divert surface water run-off from Steele’s Bank road before it enters the courtyard. This discharges to the road channel on the lower side of the courtyard entrance.

It is noted that since the installation of the pumped non-return valves and the slot drain and bund that there have not been any incidents of flooding in the courtyard.

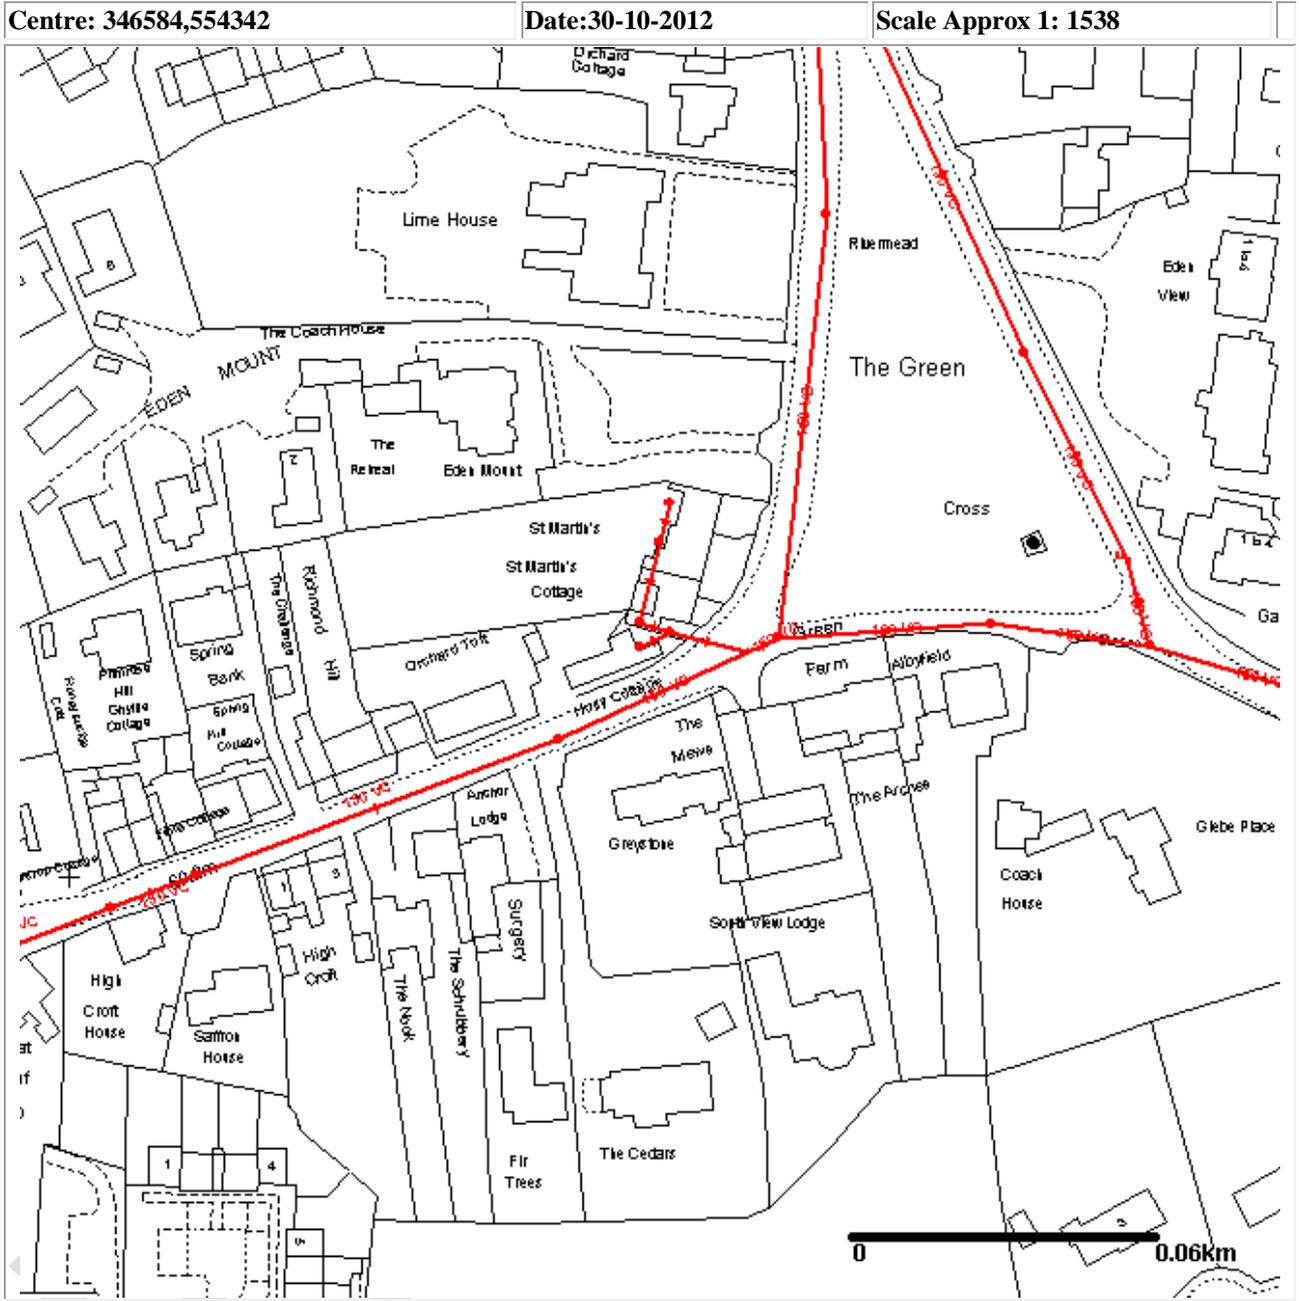
Extract from Map of Public Sewers

The sewer which surcharges into the courtyard used to be a private sewer for the properties; "South View Lodge", "The Arches" and "The Mews". However since the change in UU's responsibilities this is now a public sewer owned by UU from the point where "South View Lodge" access meets "The Arches".

The combined sewer (conveying both foul and surface water) in the road (Steele's Bank) serves the properties to the west / uphill of the collection of properties which flood. This sewer is likely to have been extended to accommodate new developments.

The flooding occurs when the combined sewer in the road (Steele's Bank) reaches capacity in periods of heavy rainfall. This causes the systems which run through the courtyard and from "Greystone" to back up and surcharge through gullies and manholes. Also surface water running into the courtyard area and the rear of "Greystone" is unable to drain into the public sewer and then contributes to the flooding. On one occasion a blockage on the public sewer caused it to surcharge on to the carriageway which caused foul effluent to run into the courtyard area.

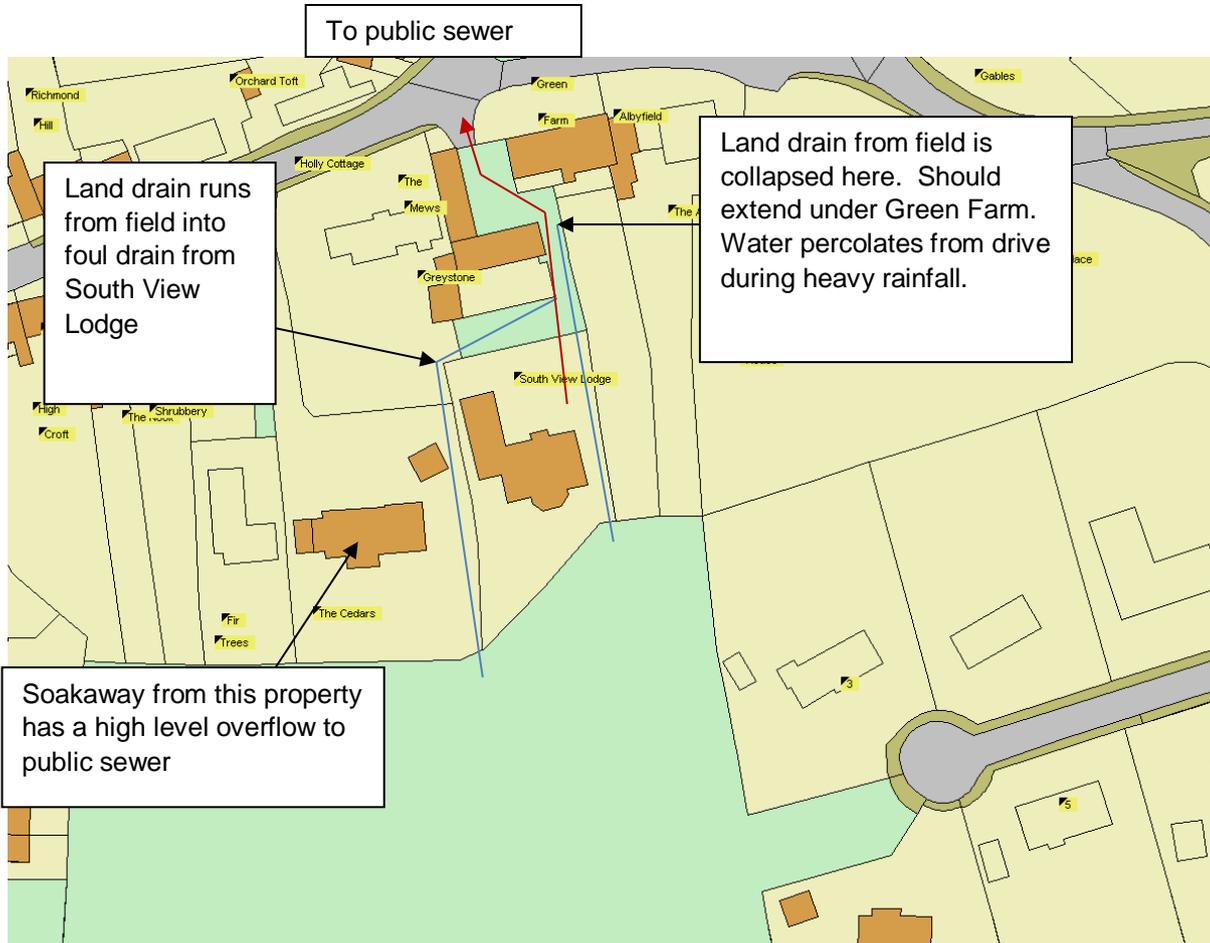
Details of the known land drains flowing towards the courtyard.

Also contributing to the flooding in the courtyard which will affect "The Mews", "The Arches" and "Green Farm" is the volume of surface water from land drains, originating at the rear of "The Arches" and "South View Lodge" that either connect into the foul drains or percolate through the ground outside "The Arches". The water from the land drains are contributing to the flow in the public sewer. The public sewer is not designed to accommodate land drainage and it is difficult to quantify how much land drainage flows into the courtyard through the 2 known land drains contributing to the flooding in the courtyard. The plan in Appendix B shows some of the land drains that are laid towards the courtyard. It is difficult to assess damage that may have occurred to land drainage in fields as the drains tend to be small and manholes are not usually incorporated into the systems. However, damaged field drains in the field behind "South View Lodge" may have the effect of reducing the flow through the two land drains leading to the courtyard. The damaged drain in the drive behind "Green Farm" should be repaired to prevent water bubbling through the ground causing water to run overland to gather in the courtyard.
