# Beetham and Milnthorpe Flood Investigation Report

Mill Weir, Beetham, Cumbria

## Flood Event 5<sup>th</sup>-6<sup>th</sup> December 2015

This flood investigation report has been produced by the Environment Agency as a key Risk Management Authority under Section 19 of the Flood and Water Management Act 2010 in partnership with Cumbria County Council as Lead Local Flood Authority.

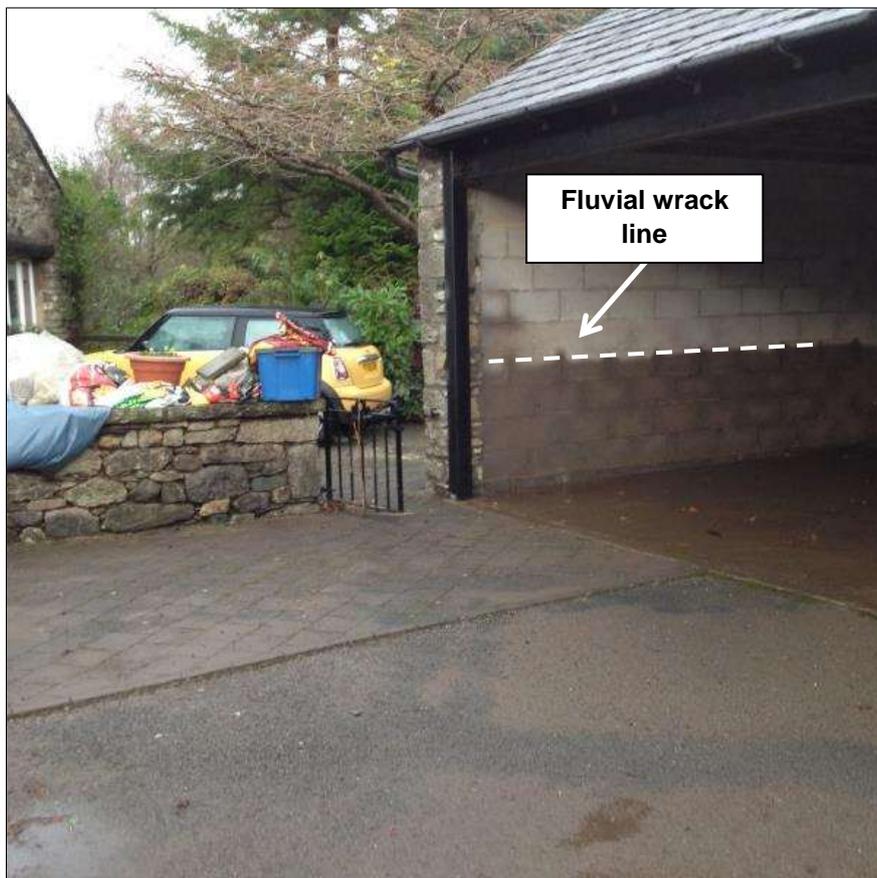
Figure 2: Wrack line in an external garage on the left bank of the River Bela at Parsonage Fold

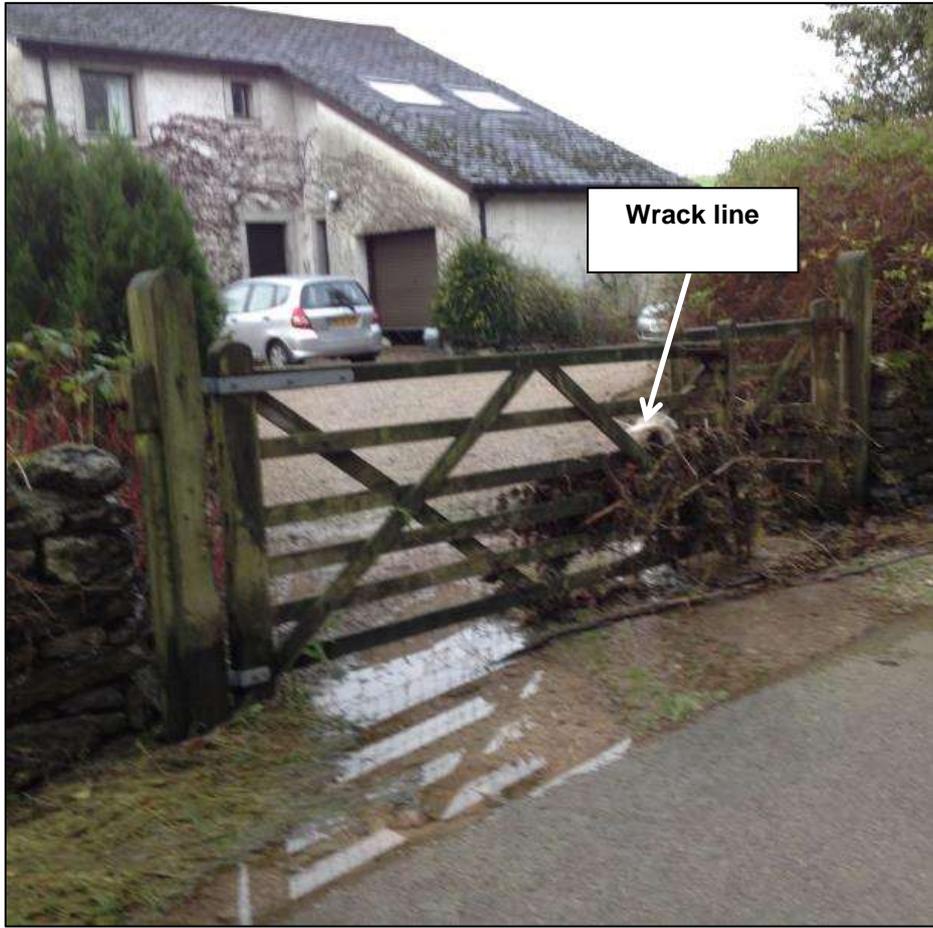
**Figure 3: Wrack in an access gate outside properties on the left bank of the River Bela**

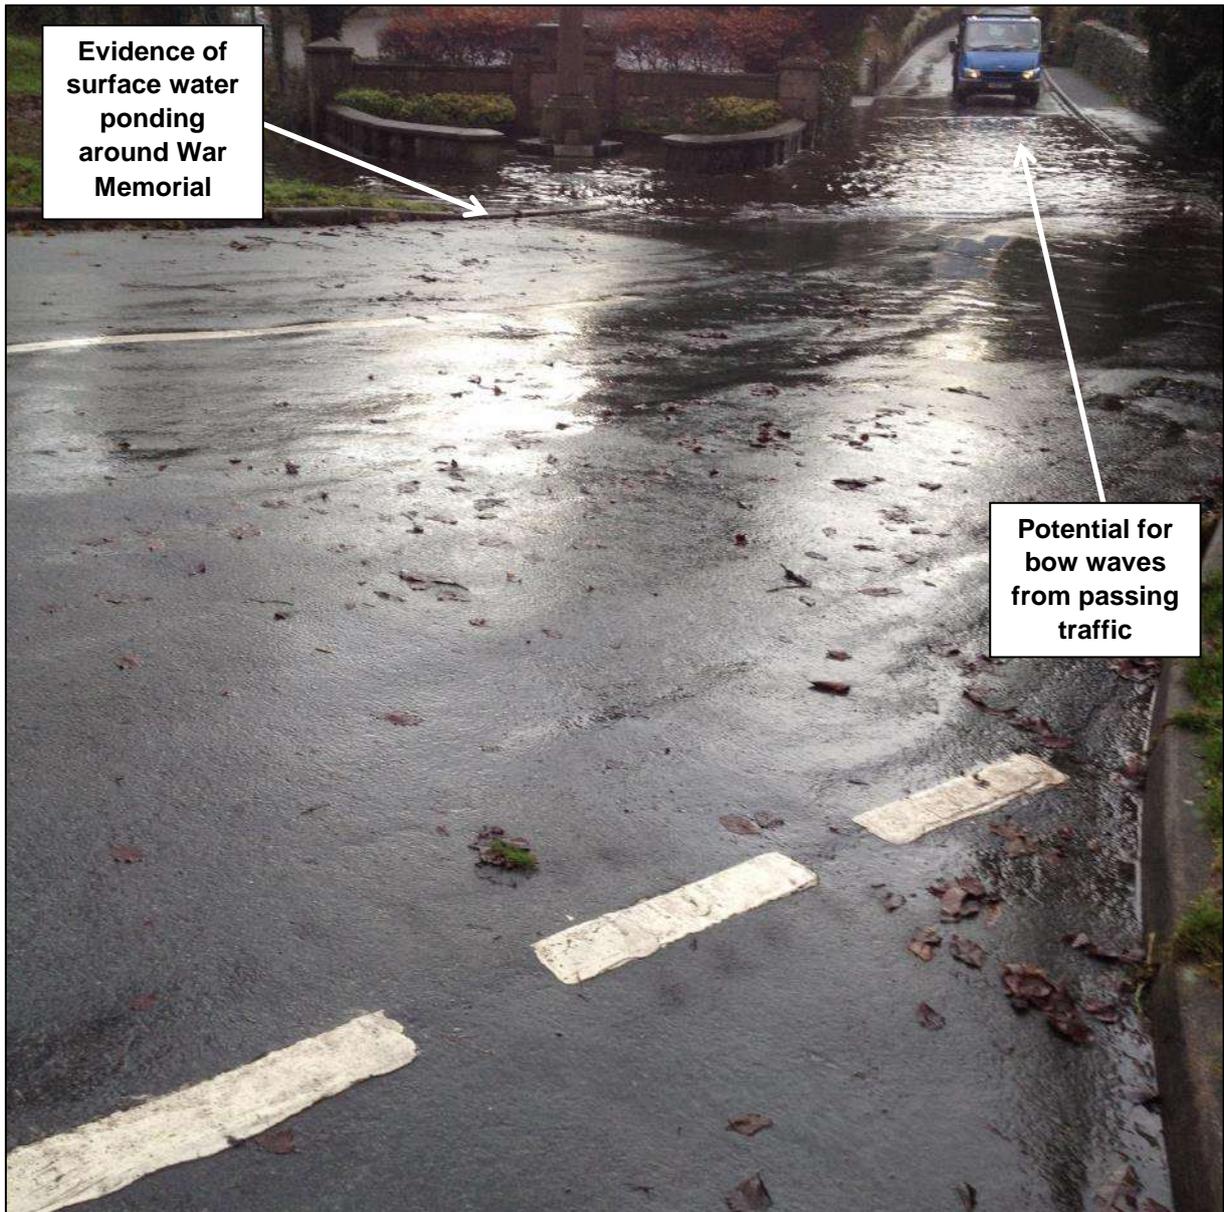
Figure 4: Evidence of surface water flooding around the Beetham War Memorial. Photo taken on 7<sup>th</sup> December at 10:36am.

On the south side of the village Beetham Road joins the A6 near Beetham Bridge. The topography of this road climbs sharply towards the southern side of the village past the War Memorial and towards Saint Michaels Church, cresting around the junction with Stanley Street (Figure 17 and Figure 18). This area was observed as flooded during the event by local residents, as illustrated in Figure 4 earlier in the report. Given the steep topography of the road, it is concluded that this resulted from surface water from the adjacent valley sides, although this may have combined with fluvial floodwater from the River Bela at the bottom of the road near the War Memorial.

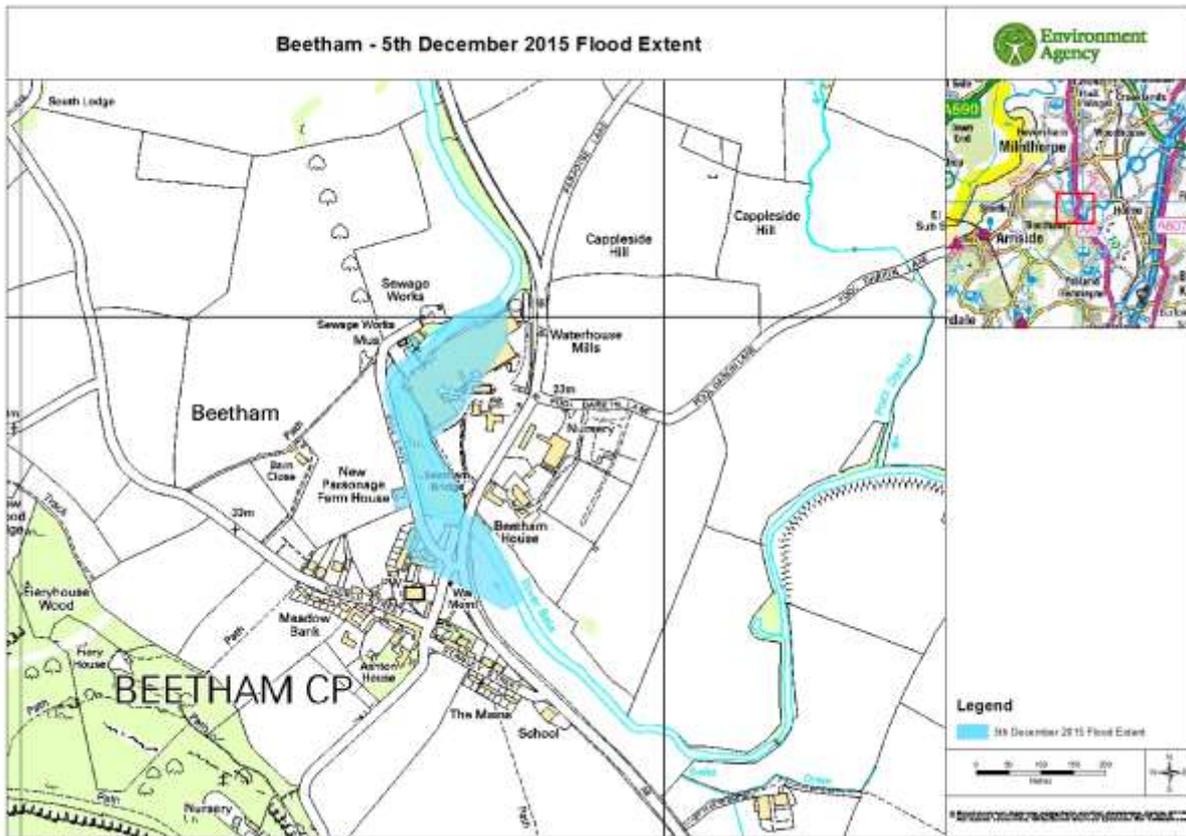
Figure 5: Extent of flooding in Beetham on 5<sup>th</sup> December 2015

The flooding that occurred on the 5th December 2015 in Beetham resulted in eight residential properties as reporting internal property flooding. The majority of these properties are located on the left bank of the River Bela downstream of Beetham Bridge around Parsonage Fold, and reported flood depths of up to 1.5m. Several residents were relocated after the flood due to the severity of the flood damage. The Billerud Korsnäs Beetham factory, which is a mill situated downstream of Parsonage Fold on the River Bela, was also affected by the flooding.

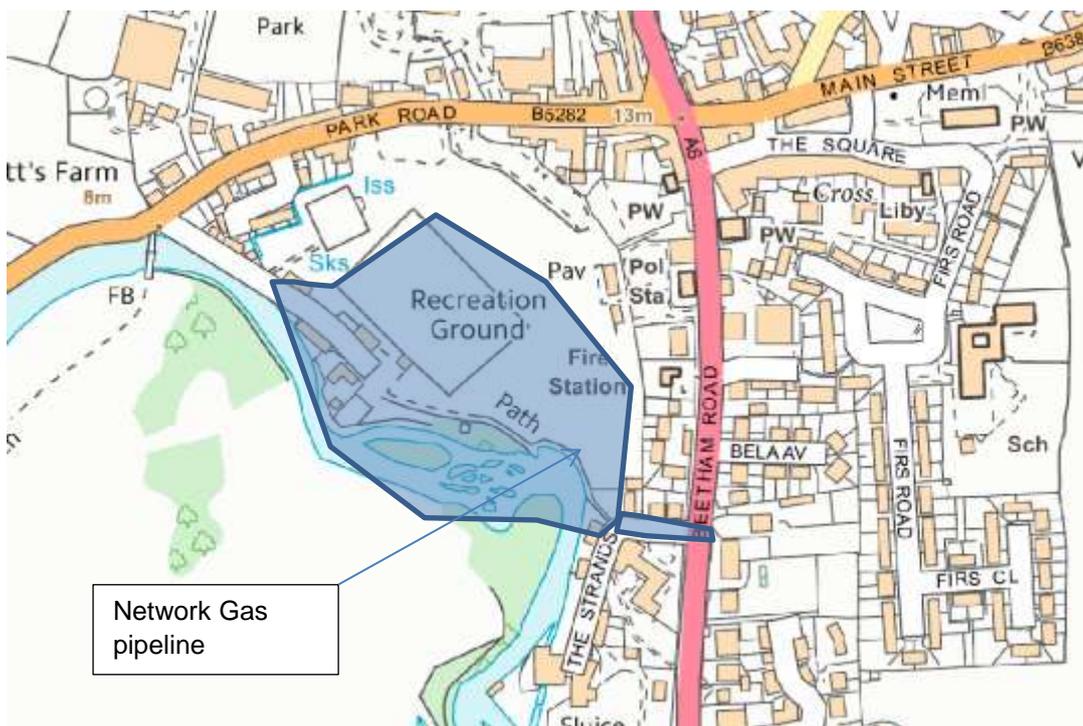
Figure 6: Extent of flooding in Milnthorpe on 5<sup>th</sup> December 2015

The flooding that occurred on the 5th December 2015 in Milnthorpe resulted in six residential properties as reporting internal property flooding. Fluvial flows eroded the embankments near The Strands which came close to undermining the Network Grid Gas main.

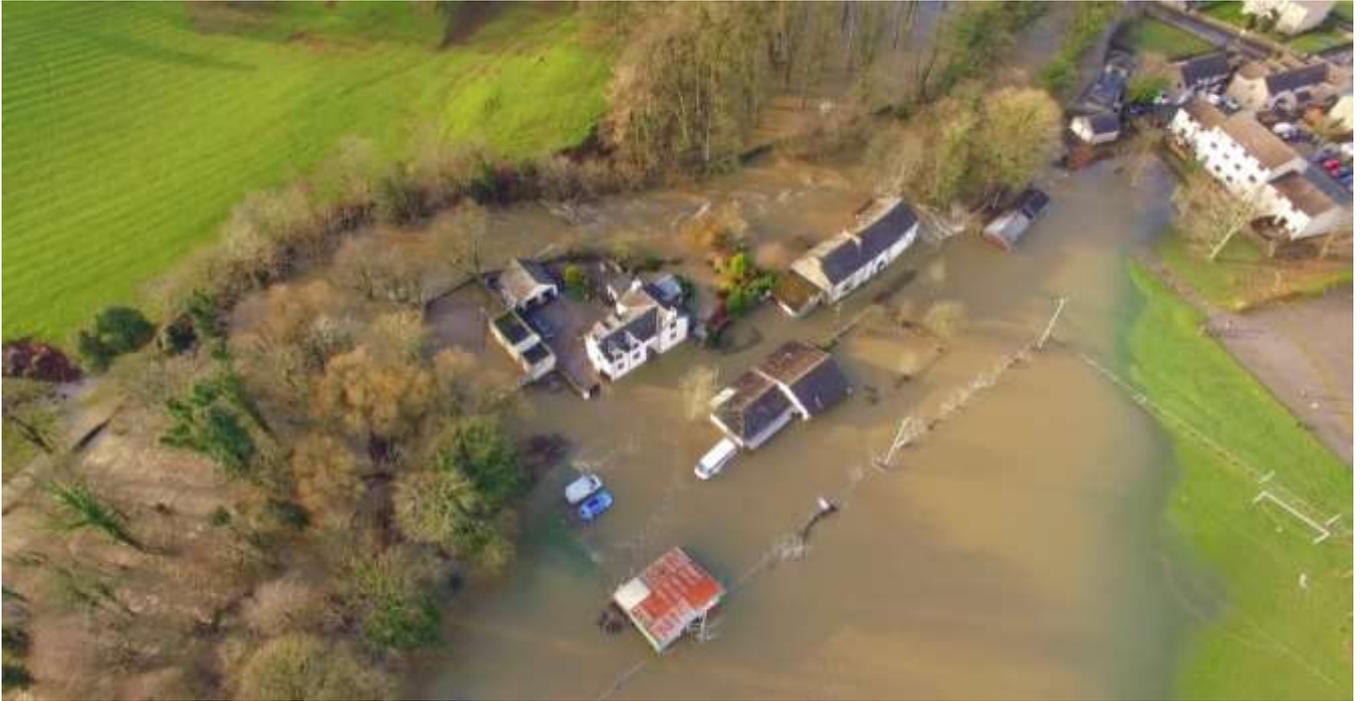
**Figure 7: Aerial extent of flooding in Milnthorpe on 5<sup>th</sup> December 2015**

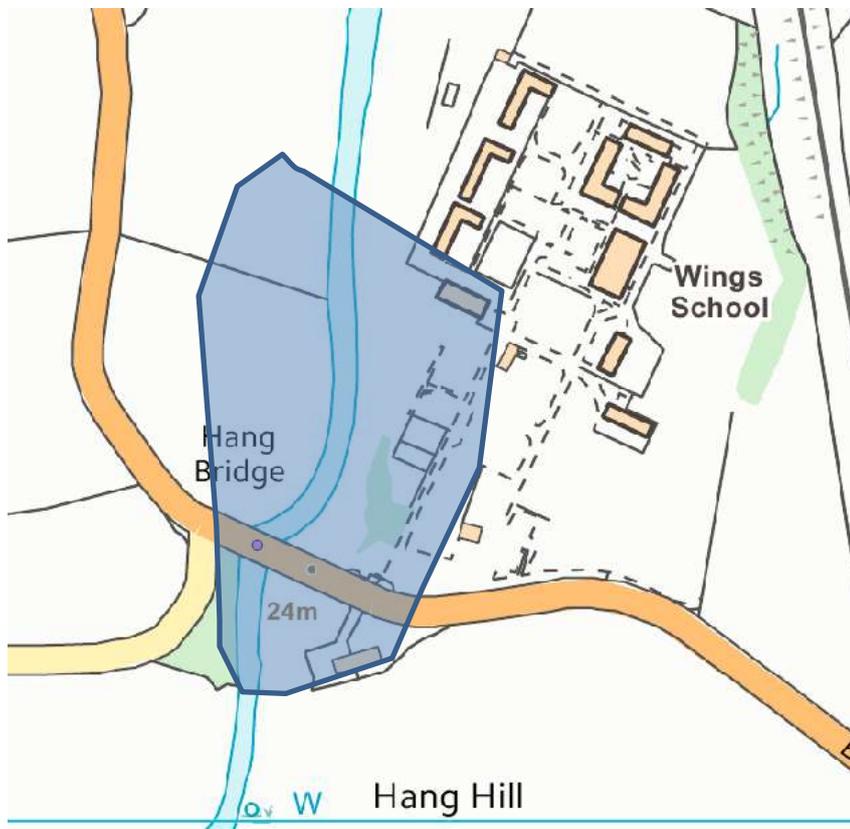
**Figure 8 Hang Bridge Flooding extent adjacent to Wings School Milnthorpe**

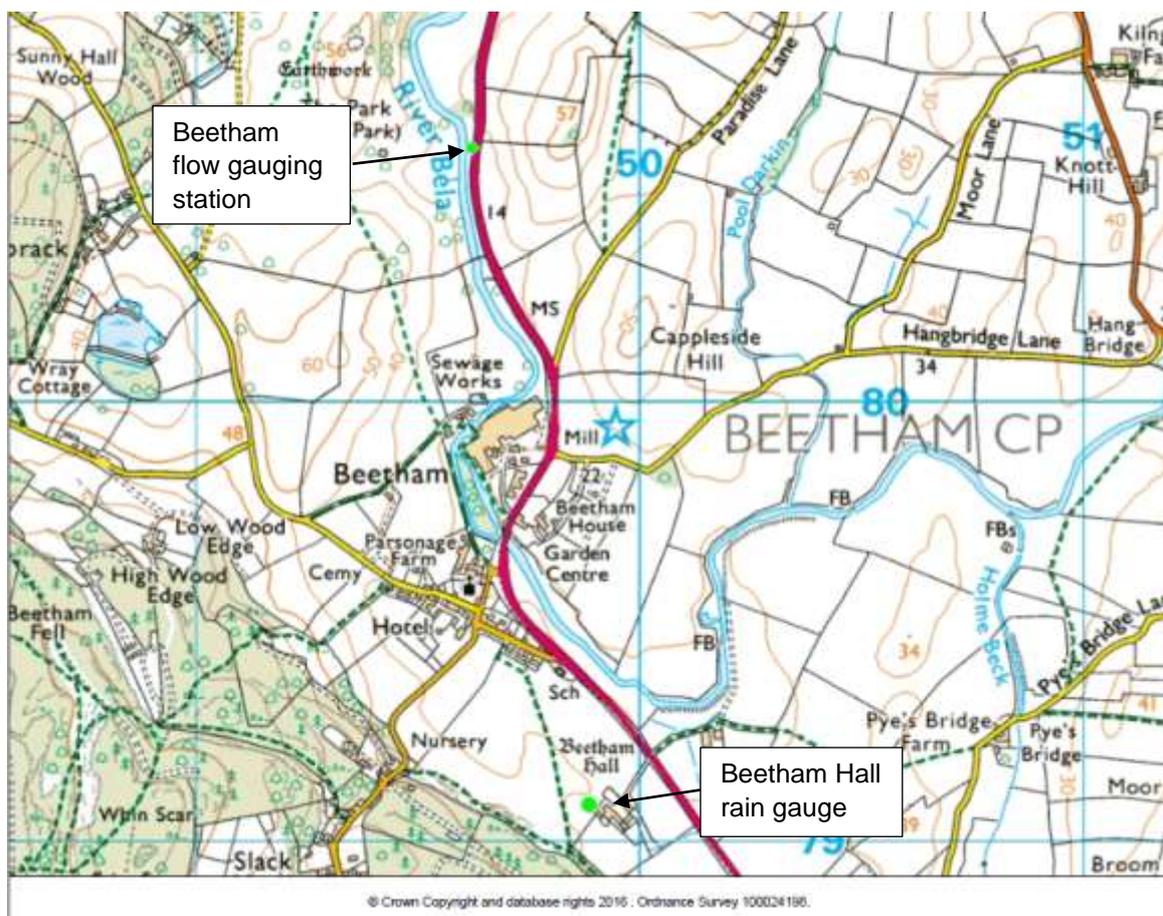
**Figure 8: Location of Beetham Hall rain gauge and Beetham river flow gauging station**

Beetham river flow gauging station is located on the River Bela approximately 800m downstream of the Mill Weir in Beetham, as illustrated in Figure 6. At Beetham gauging station, the peak flow on the River Bela was recorded at 129.0m<sup>3</sup>/s at 01:00 on Sunday 6<sup>th</sup> December. This was the highest river flow ever recorded at the gauge, and far exceeded the previous record flow of 80.1m<sup>3</sup>/s from January 1999.

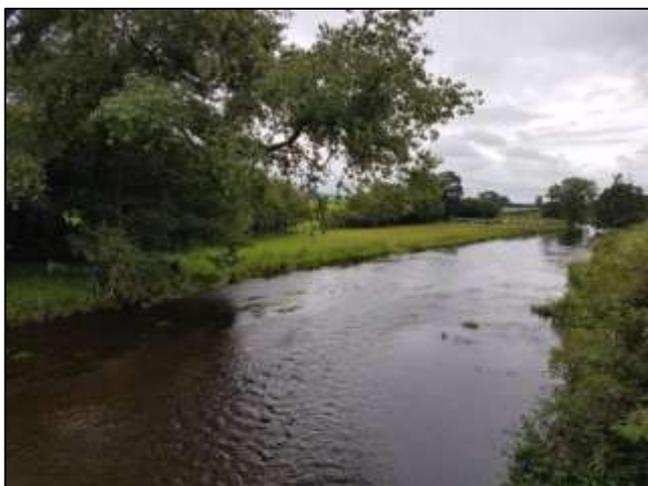
**Figure 9: River Bela, looking upstream from Beetham Bridge**

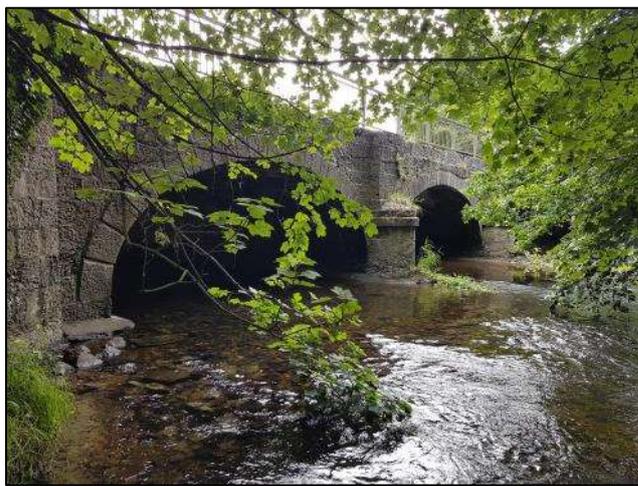
The Capita AECOM survey team commenced the site visit of Beetham with a visual inspection of the River Bela upstream of the A6 road bridge. Upstream of the A6 road bridge the River Bela is flanked by flat, low floodplains that are approximately 50m wide on either side of the river channel (Figure 7). This area affords a substantial volume of floodplain storage, though it has finite capacity which may result in overtopping or outflanking of Beetham Bridge once the capacity has been exceeded. The structure itself is comprised of three arches with two central piers (Figure 8). There is a significant capacity beneath the bridge during normal flow conditions and the soffit is approximately 2.5m above bed level. The structure may, however, constrain the passage of river flows during flood conditions. Structural damage was observed on the boundary wall on the downstream side of the structure (Figure 11).

**Figure 10: Looking upstream at Beetham Bridge**

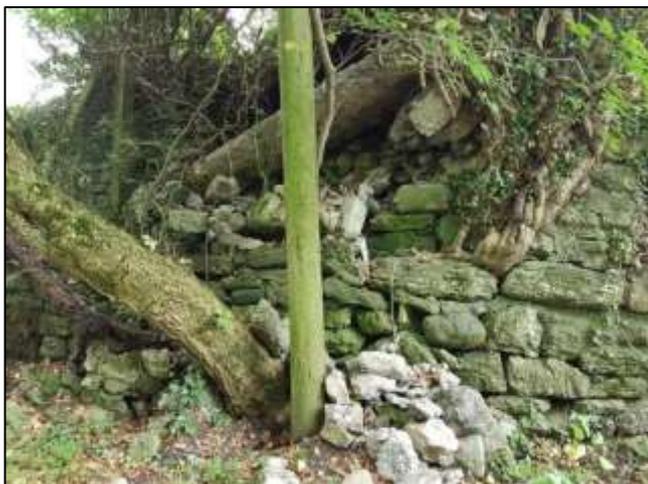
**Figure 11: Structural damage on the walls downstream of Beetham Bridge**

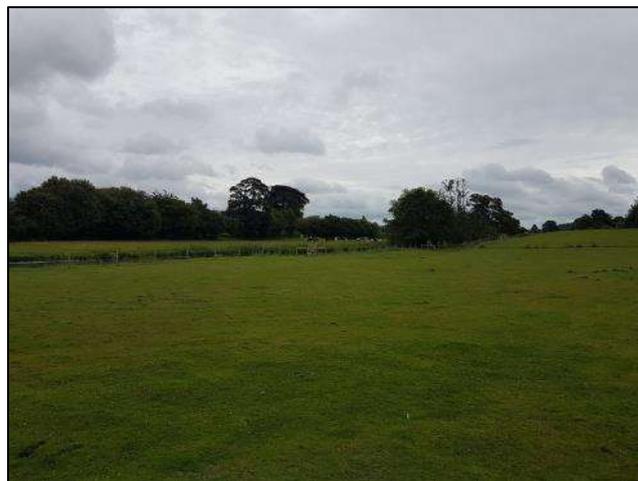
**Figure 12: River Bela floodplain (looking upstream from Beetham Bridge)**

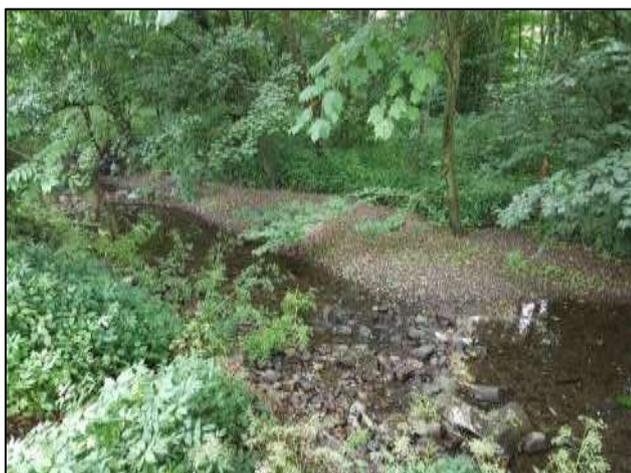
Downstream of Beetham Bridge the River Bela is braided around an established central island that is heavily vegetated. The presence of this island reduces the effective capacity of the river channel which may result in water being displaced laterally into the floodplain as identified through post-event liaison with local Beetham residents. Several residential properties, including the Parsonage Fold development, are present on the left bank of the river at this location and eight of these properties reportedly experienced internal property flooding. Residents reported that in places the flooding was up to a depth of 1.5m and this is corroborated by the observed wrack marks at this location. Figures 2 and 3 earlier in the report show evidence of the flooding that occurred at this location.

**Figure 13: Central island on the River Bela**

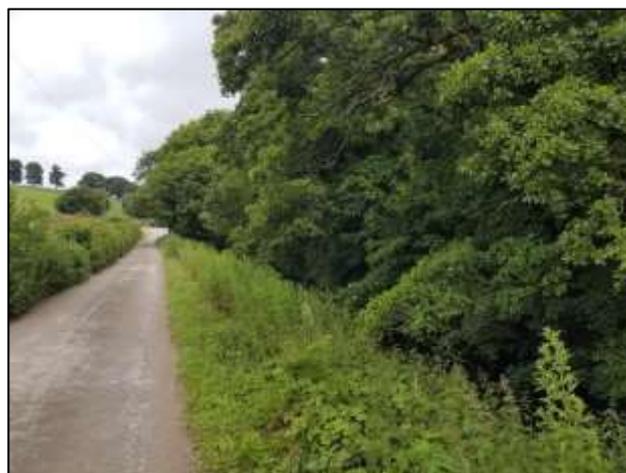
**Figure 14: Looking downstream on the left bank of the River Bela next to the central island**

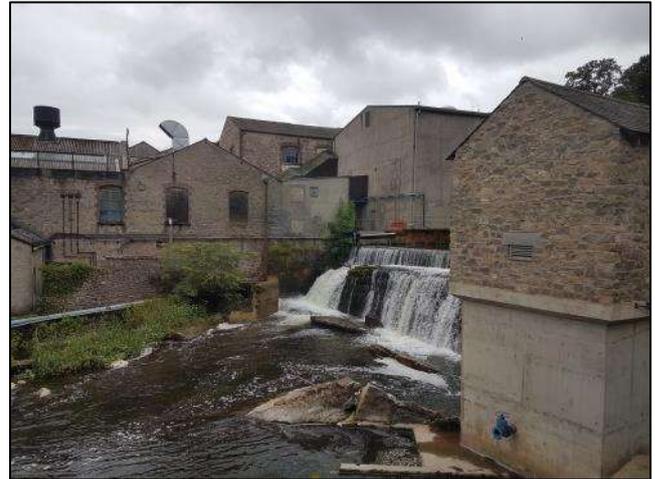
**Figure 16: Looking upstream at the Mill Weir**

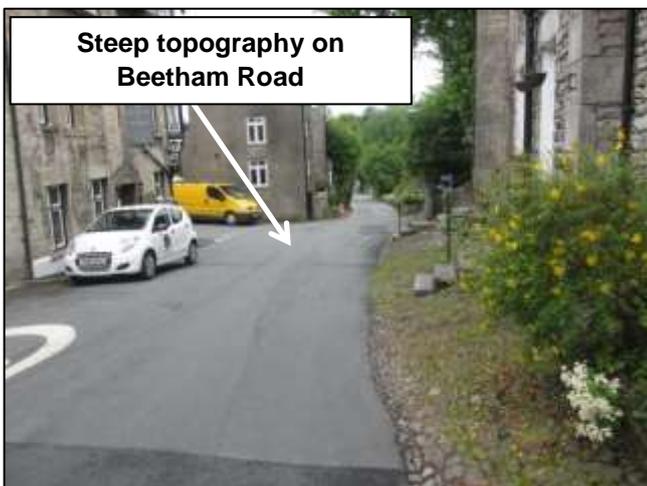
**Figure 17: Beetham Road, looking north towards the junction with the A6**

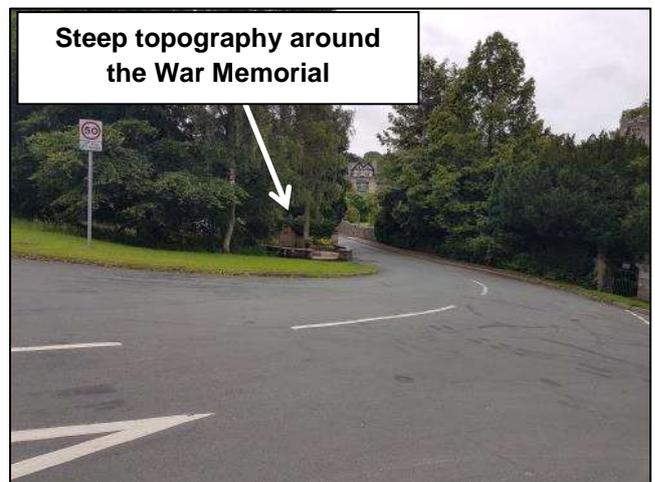
**Figure 18: Beetham Road near the junction with the A6 and the War Memorial**

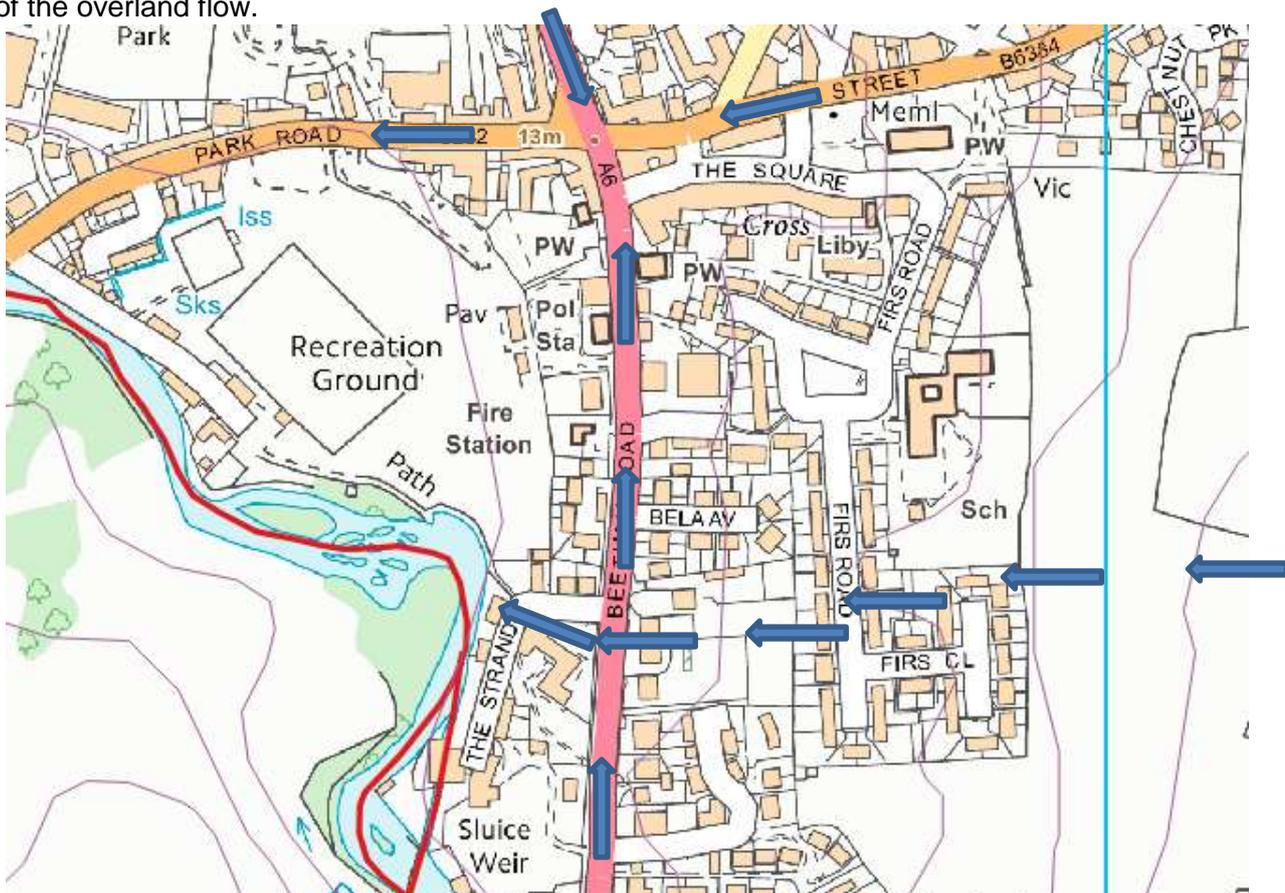
Surface water overland flows from high ground above Beetham Road caused flooding into The Strands but no identified source has been pointed out during the investigation. Therefore below is a guestimate of the overland flow.

Figure 21: Surface water overland flow route.

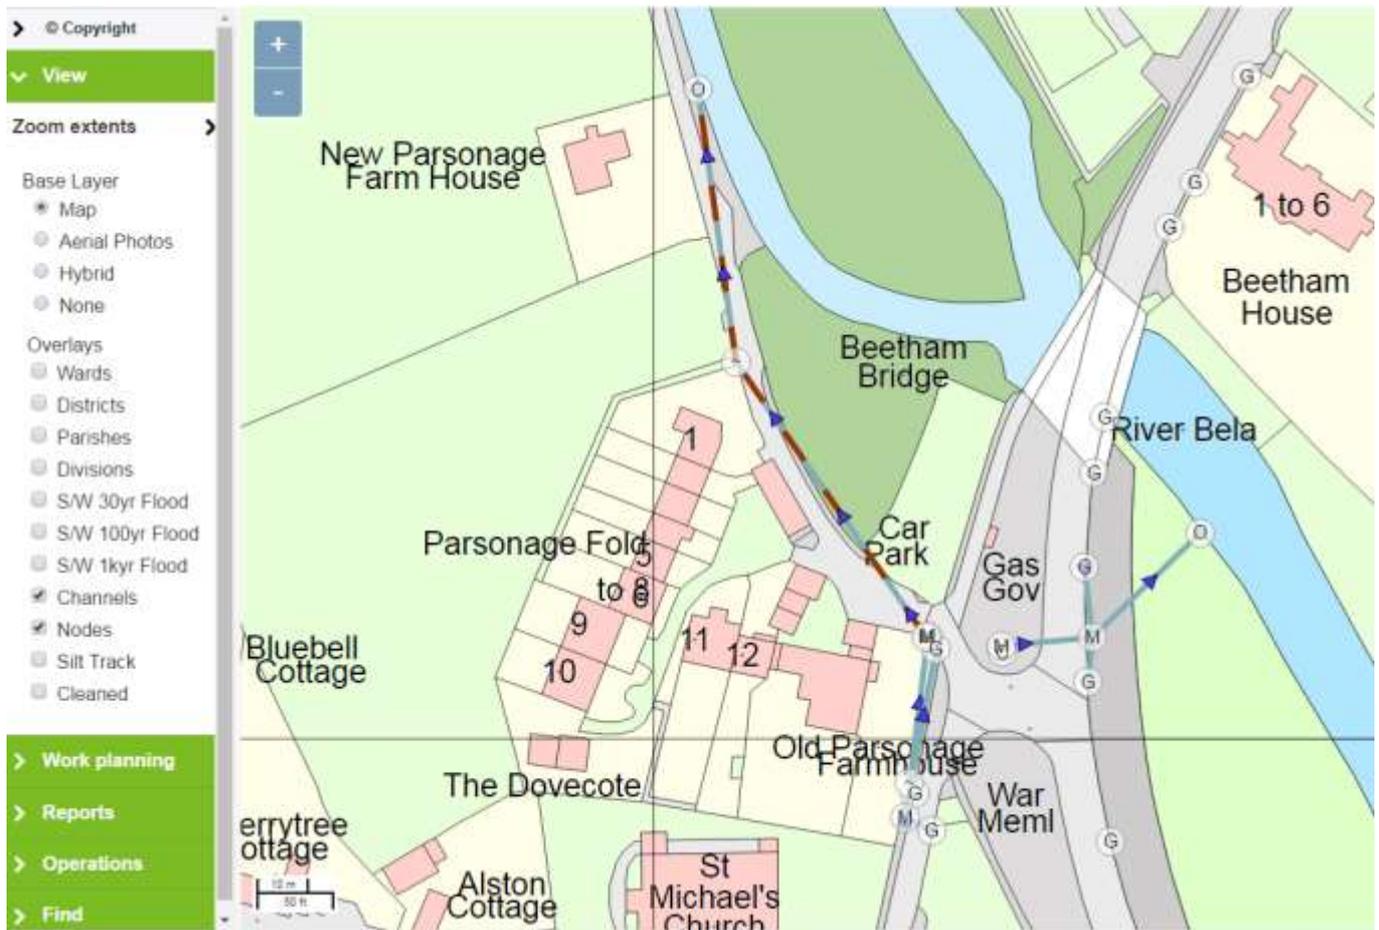
### Beetham

Investigations still to be completed for drainage running down an adopted road past New Parsonage Farm House. Potential relative drainage if existing drainage cannot be improved

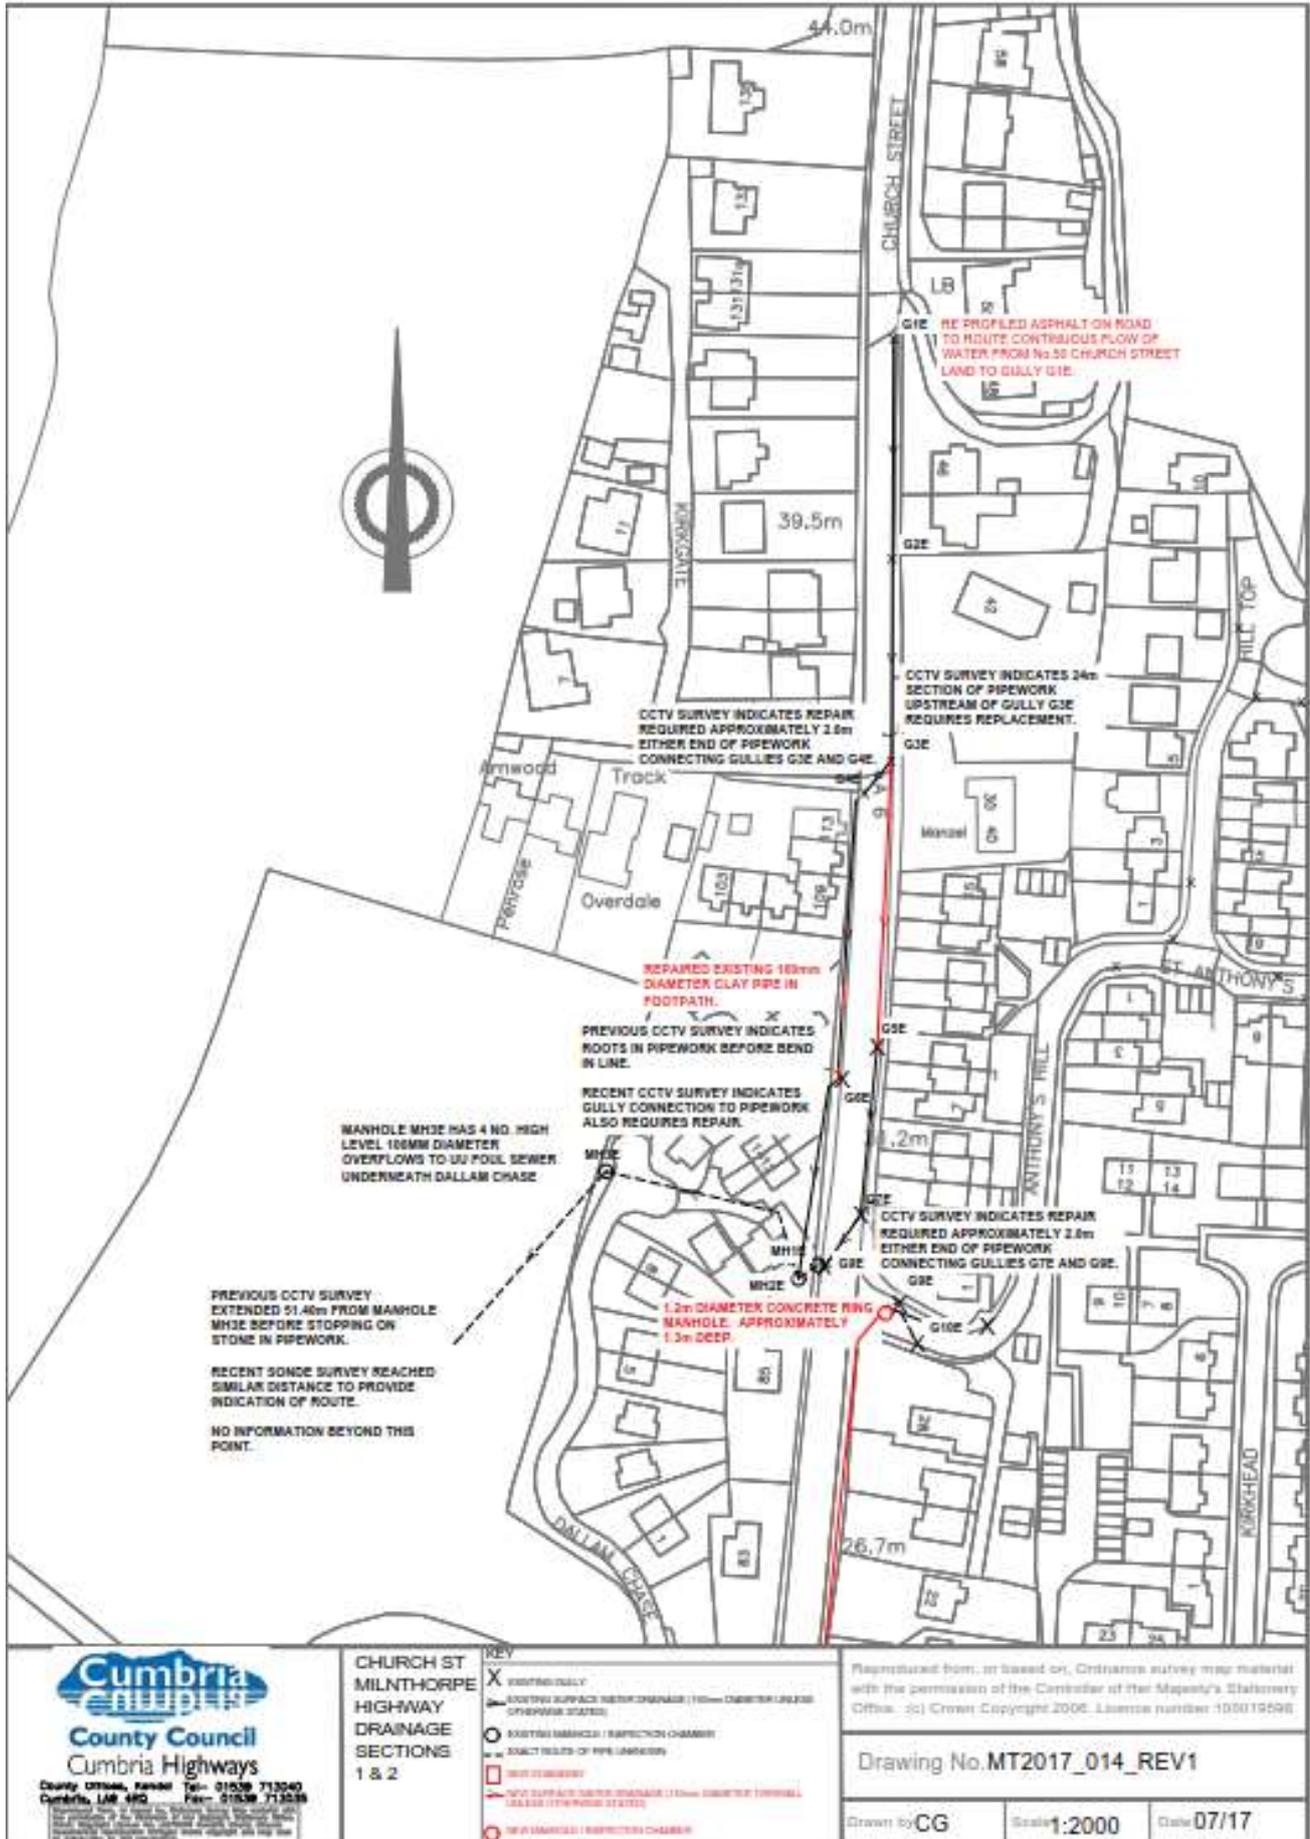
# Milnthorpe

Further drainage investigation Milnthorpe prior to resurfacing summer 2017
