Plumpton

Flood Investigation Report

Flood Event 5 December 2015

This flood investigation report has been produced by Cumbria County Council as a Lead Local Flood Authority under Section 19 of the Flood and Water Management Act 2010.

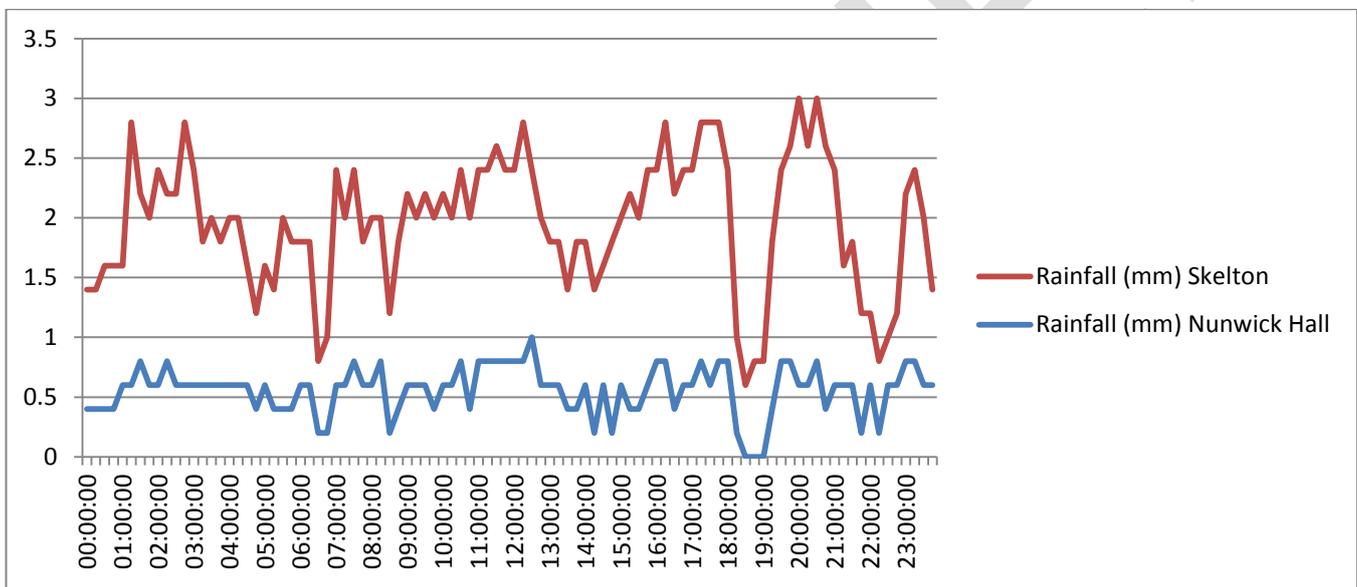
Figure 2: Rainfall data for the 2 rainfall gauging stations closest to Plumpton on 5 December 2015.

Specifically for Plumpton, the two nearest rainfall gauging stations are Nunwick Hall (NY 55404 35978) and Skelton (NY 43590 36078) which recorded rainfall totals of 53.6mm and 135mm on 5 December 2015. The rainfall levels experienced throughout the 5 December 2015 at the two rainfall gauging stations are illustrated in *Figure 2* below.

Throughout the 5 December 2015 the rainfall averages 1.5mm per 15 minute interval throughout the day at the two gauging stations. The rainfall therefore was relatively constant until a peak was experienced at 20:00 of 3.1mm. This peak in rainfall could have contributed towards groundwater reaching saturation point and watercourses to become bank full and flood surrounding areas.

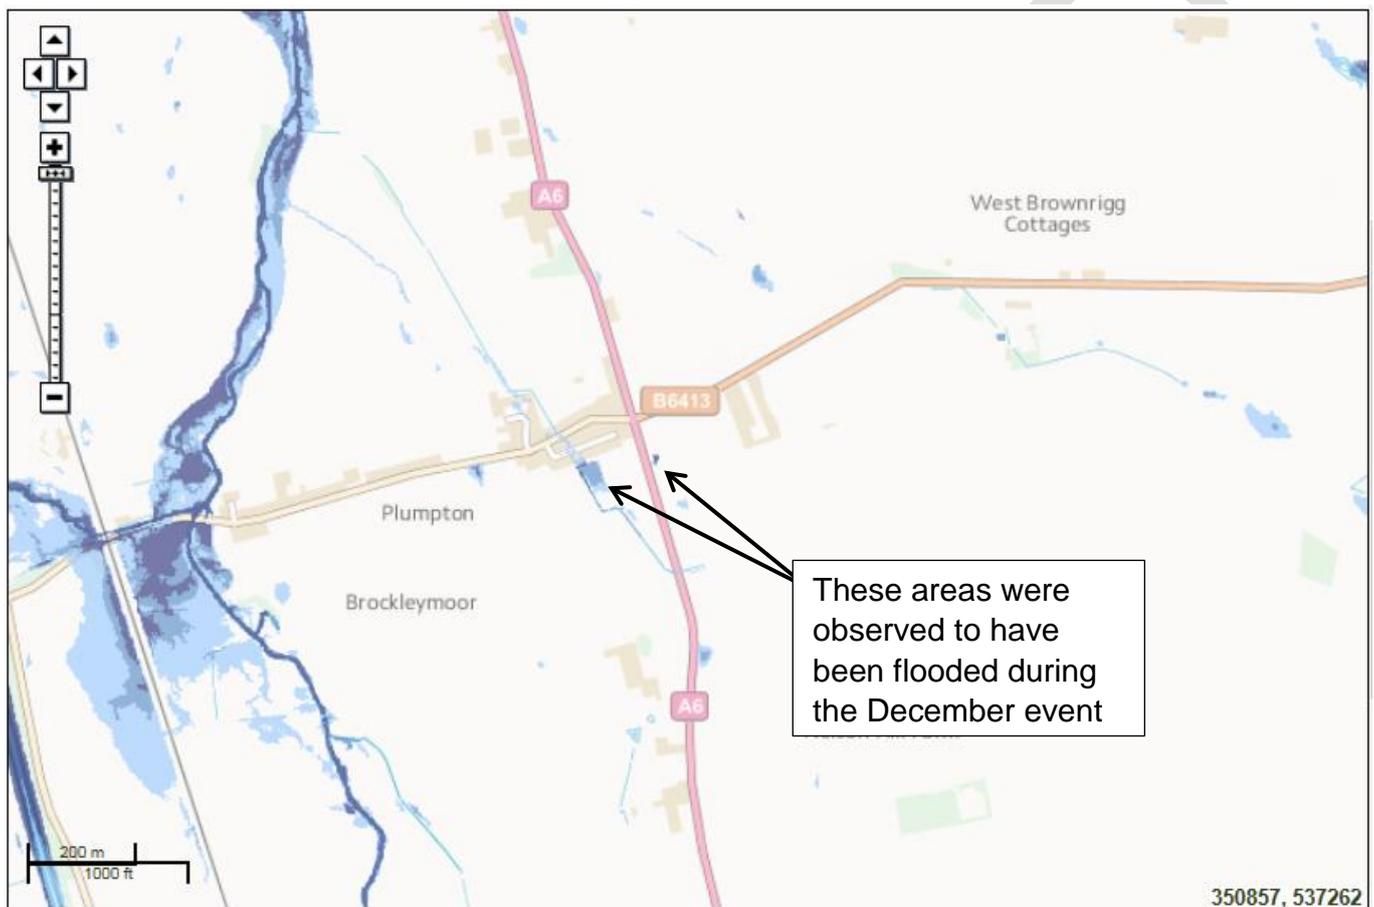
Figure 3: Extract from Environment Agency's Surface Water Mapping for the Plumpton area

The following plans show the Environment Agency mapping of the Risk of Flooding from Surface Water. Although the mapping is used as a guide to indicate at risk areas the map does indicate some of the areas that were affected by the flood during December 2015.

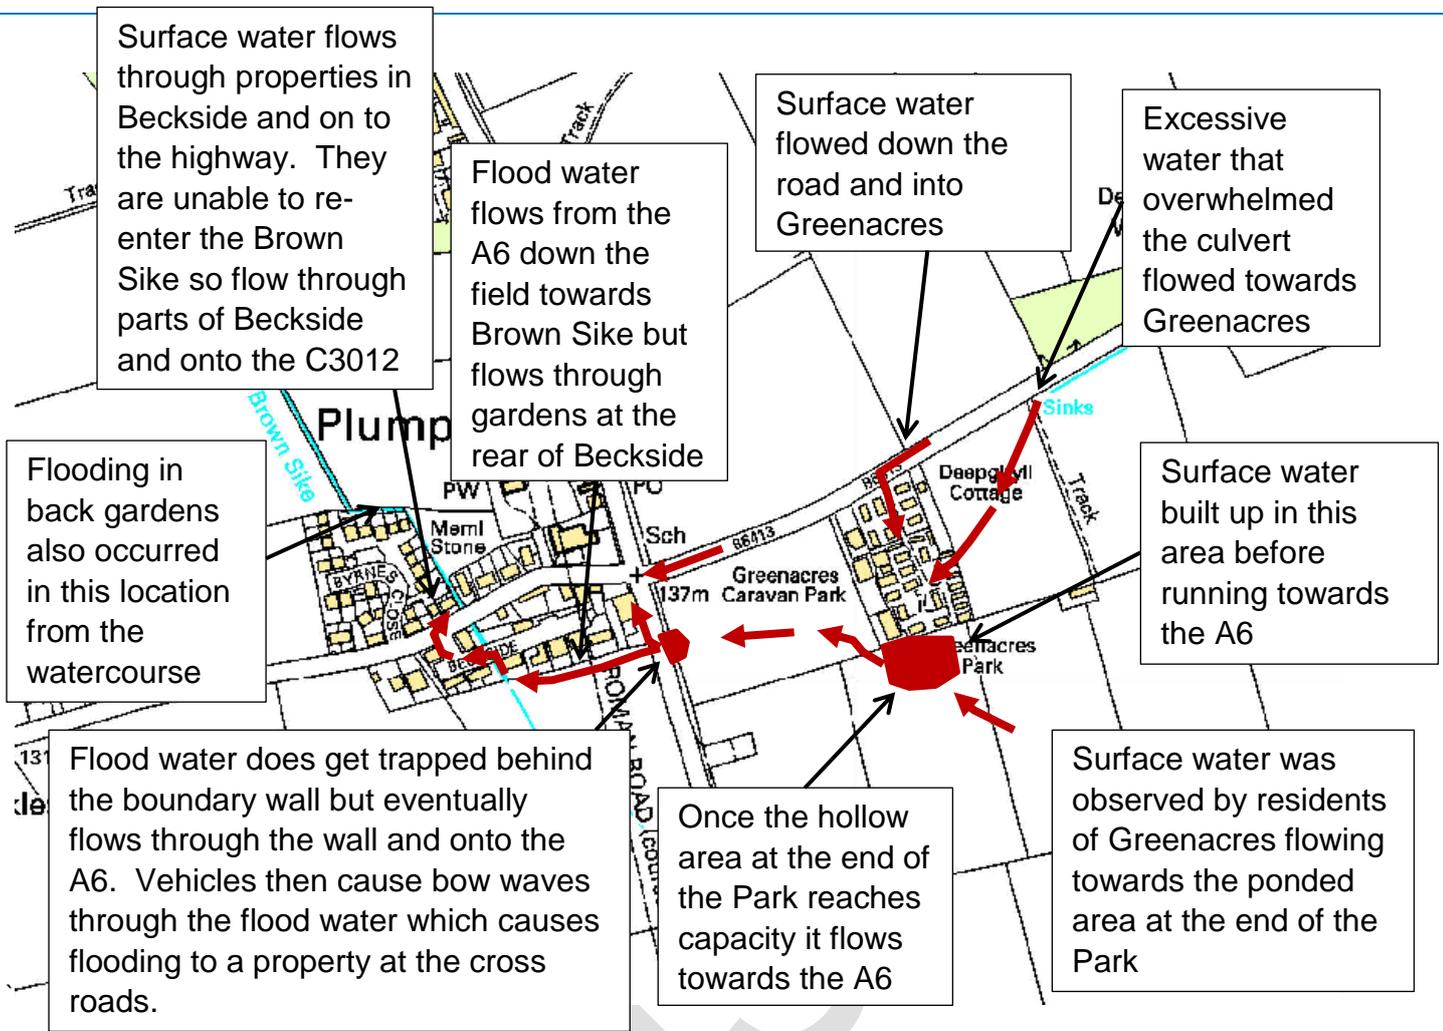
Figure 4: Plan illustrating flow routes around the Greenacres Park area during the December 2015 event

The following plan summarises the information that was obtained from residents and other interested parties following the flooding.

Residents of Greenacres Park were flooded from two sources, the overflow from Brown Sike as it tried to enter the culvert under the B6413 and the field to the south of them.

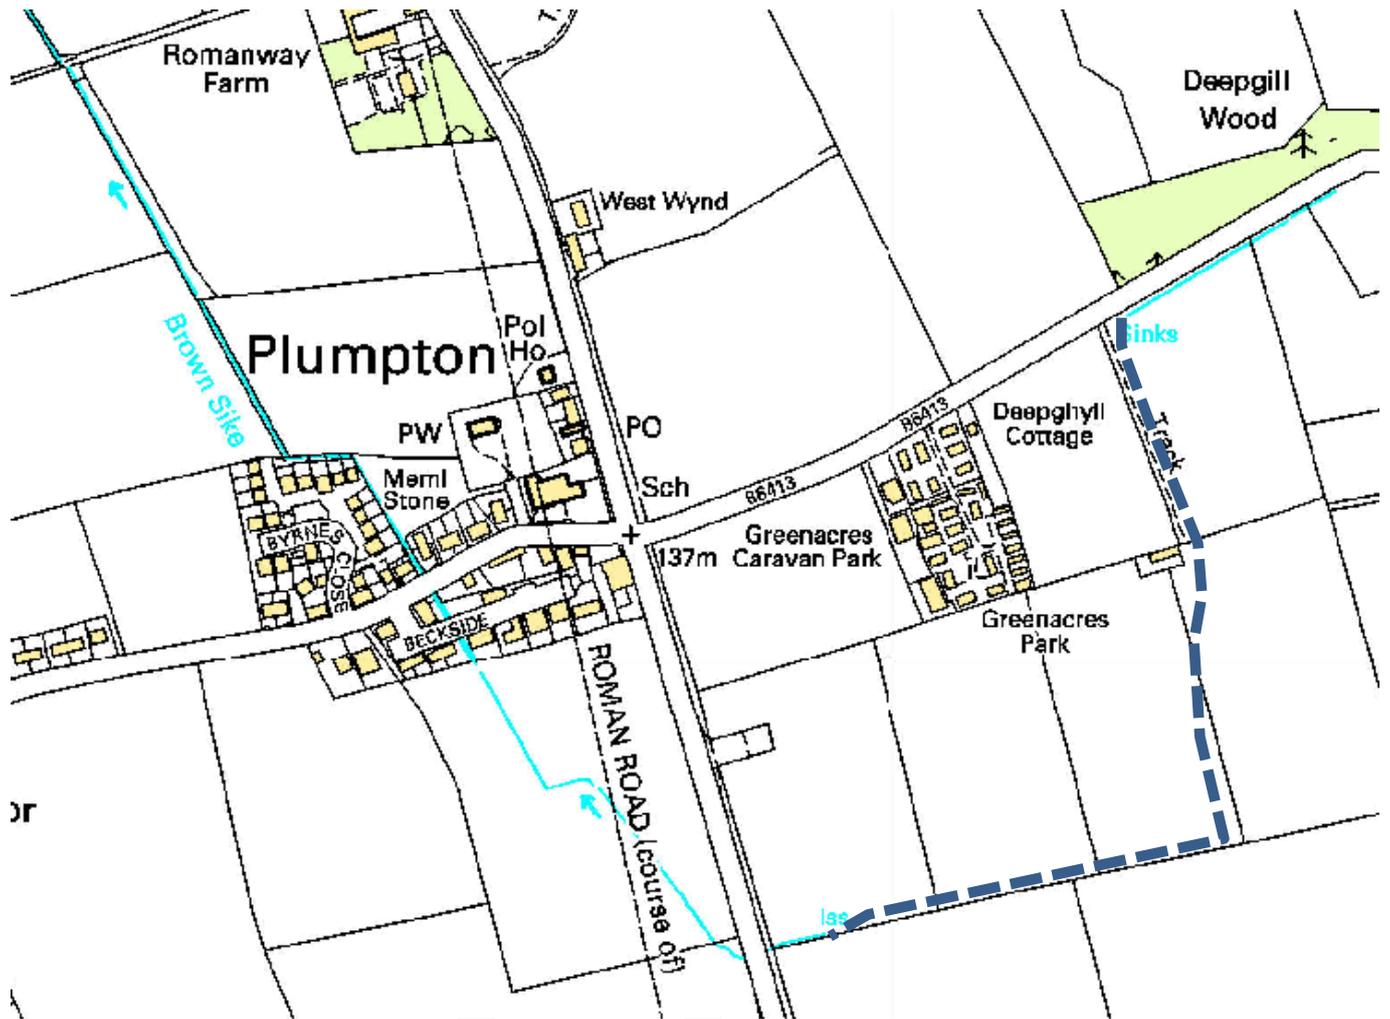
Figure 5: Approximate location of culverted section of Brown Sike

The culverted section of Brown Sike runs from adjacent the B6413 (NGR: 350171, 537256) in a south westerly direction until it discharges into an open section near the A6 (NGR: 349974, 536816). From observations on old maps it appears that this section of watercourse was culverted between 1867 and 1900. The following plan indicates the route of the culvert.

It is understood that some works have been carried out on the culvert at various times, with the most major works being carried out when a major gas main was installed through the field. An initial survey of the culvert has been carried out by a contractor on behalf of the National Grid. The survey has identified some locations where improvements and repairs are required. Although the Utility provider has stated that major works have been carried out by them on the culvert they do not consider themselves to be the riparian owner of the structure.

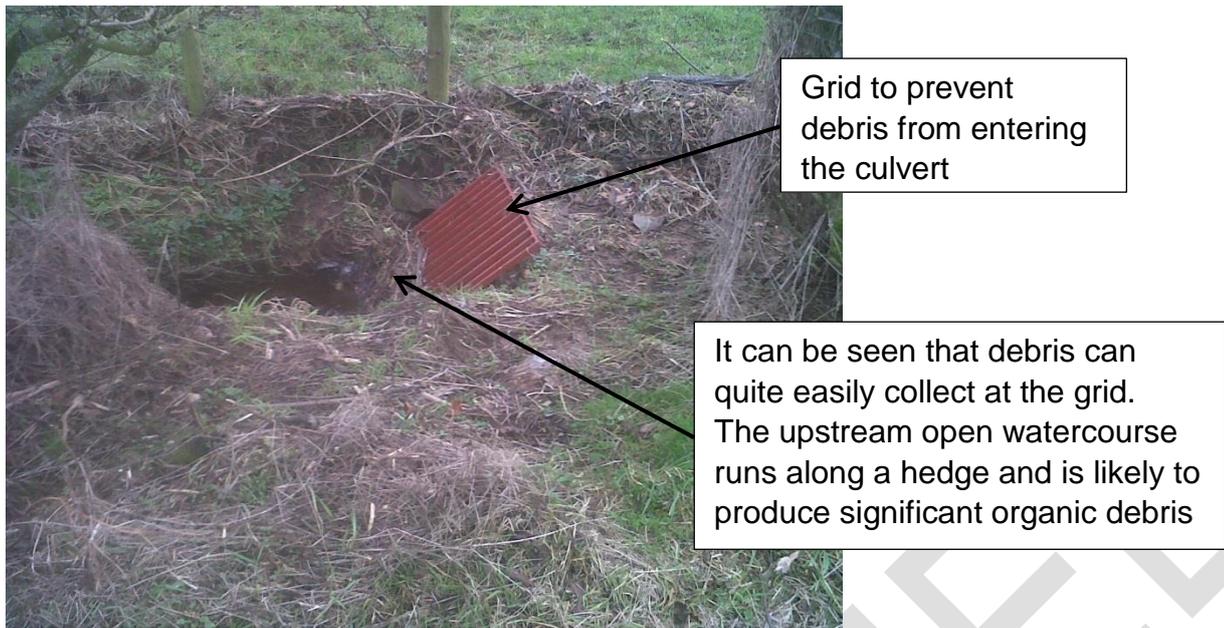
Photograph 1: Grid at the entrance to the culvert next to the B6413

The entrance to the culvert is protected by a grid as shown in photograph 1. This is designed to trap debris from entering the culvert and creating a blockage within the culvert, however, it also creates a zone where debris can collect and block the entrance. Photograph 2 shows the debris that was washed over the field due to either a blockage of the culvert or under capacity of the culvert.

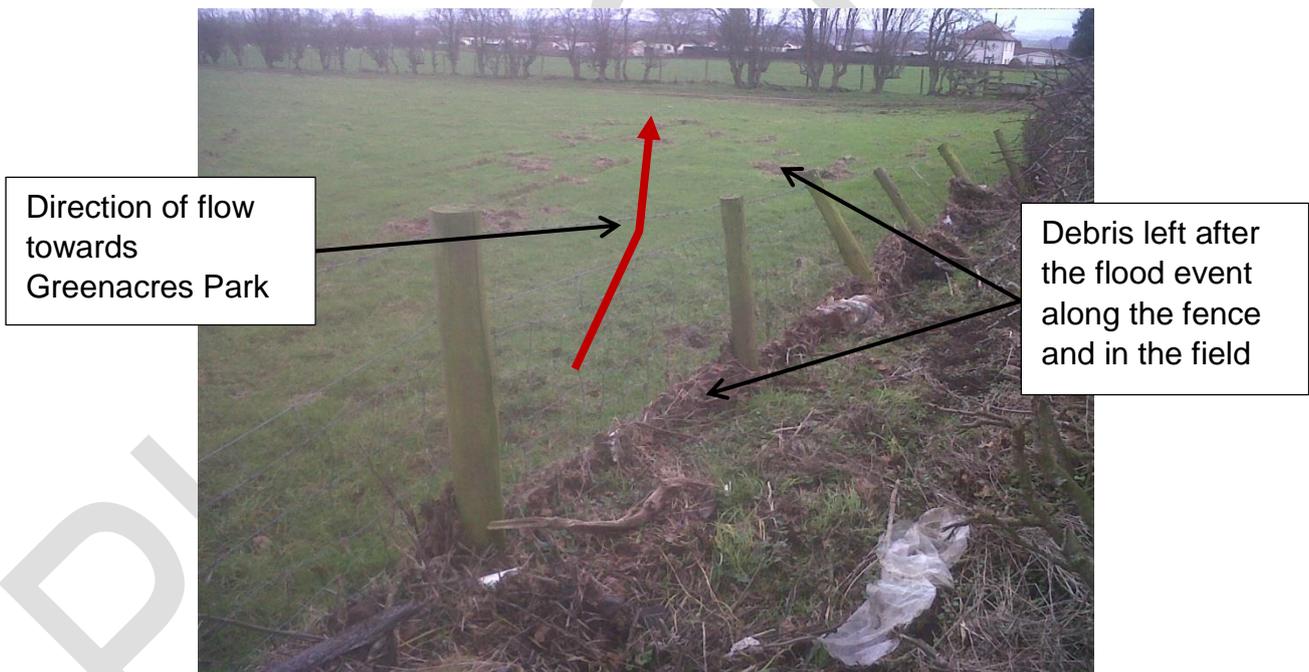
Photograph 2: Debris from the flood water taken after the flooding had ceased

During the December flood event the culvert overtopped allowing flood water to run across the field towards Greenacres Park.

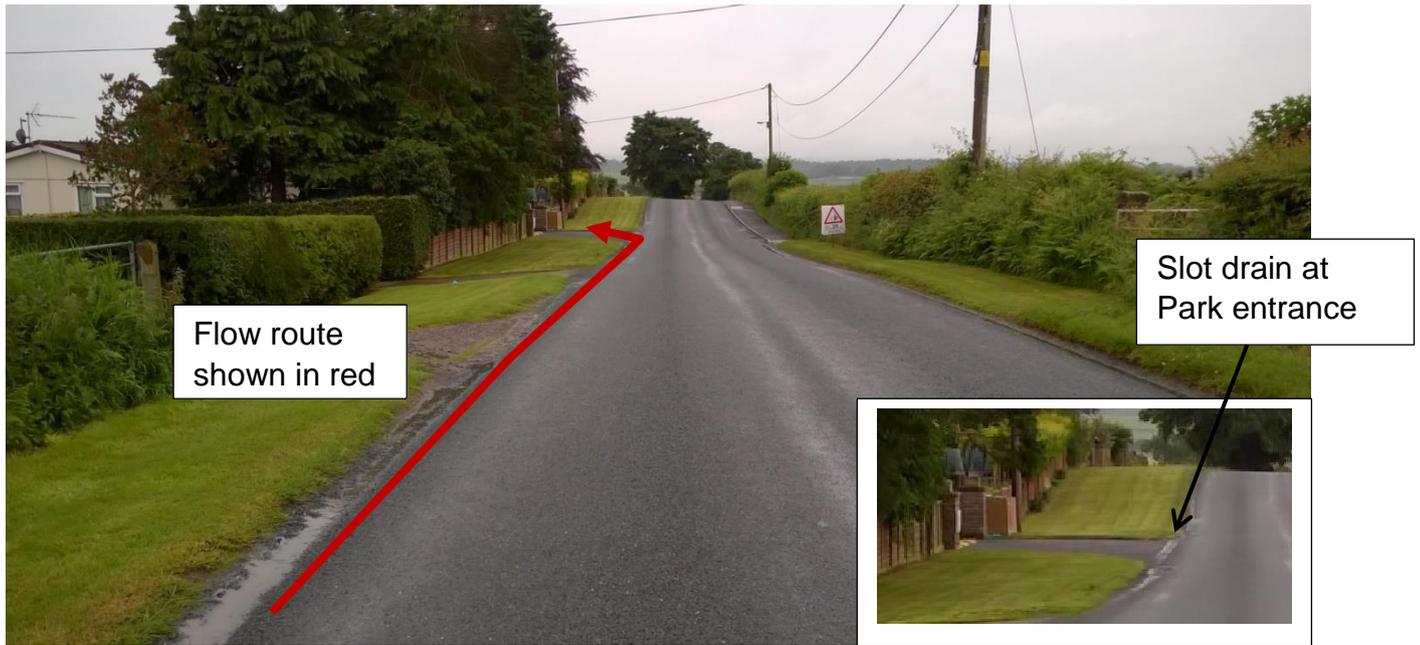
Photograph 3: The B6413 outside Greenacres Park

Another flood route towards Greenacres Park was from the highway. It is evident from the slot drain across the entrance that surface water runoff from the highway has been an historic issue in this area. The entrance to the Park is in an area where there is a dip in the road. It is also understood that the gullies and slot drain discharge to soakaways in the verge and during an event with the magnitude of storm Desmond soakaways are probably very unlikely to operate as they should. Photograph 3 demonstrates the flow routes into the Park entrances.

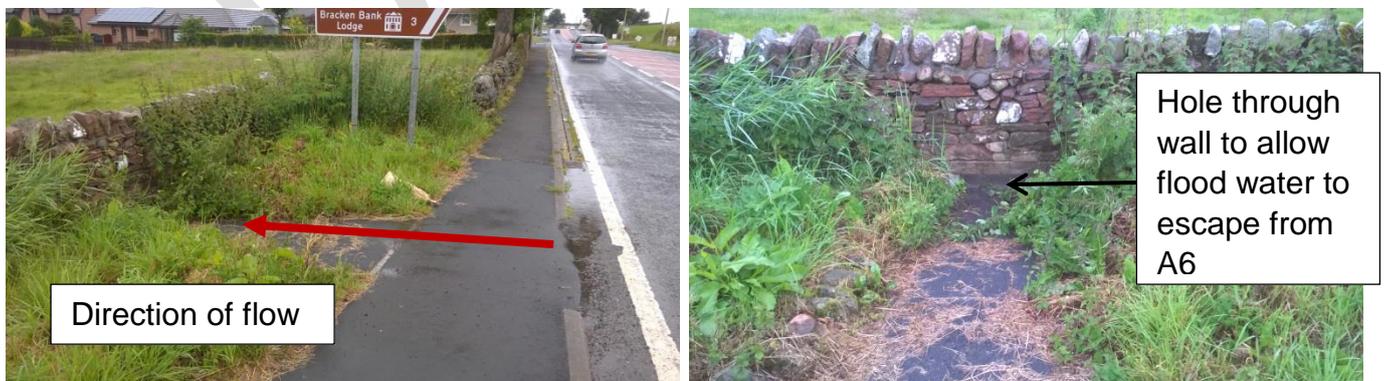
Photographs 4 & 5: Drainage works to alleviate flooding on the A6

The following photographs indicate the work that had been carried out. It is also known that there is a highway drainage pipe from the A6 to Brown Sike in this location and that it appeared to be under capacity for flows produced during heavy rainfall which lead to the installation of the alleviation feature. However, upon further investigation it was discovered that this pipe was severely damaged. Therefore, further works have been completed in October/November 2016 to repair the collapsed drain that conveys drainage from the Greenacres Park area and the A6.

However, even though the above feature was installed prior to the December flood event the drainage pipe was still damaged and there was still flooding on the A6. Vehicle movement through this created bow waves which caused flooding to a property in close proximity to this area.

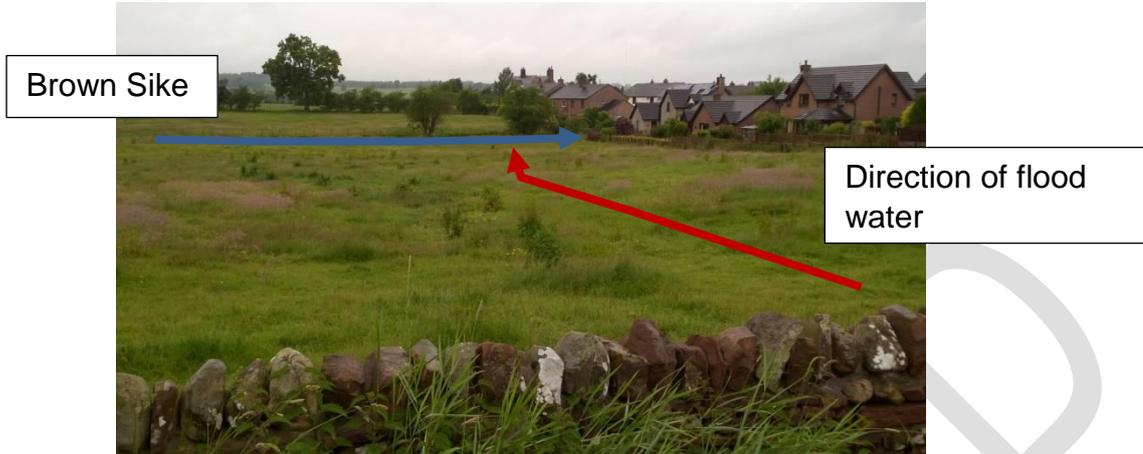
Photograph 6: Looking from the A6 towards the rear of the properties in Beckside

Once the flood water escapes through this hole it flows west to meet Brown Sike again. Photograph 6 shows the location of Brown Sike from the A6.

The flood water from the A6 joins the Brown Sike before it starts to flow through the village of Plumpton; however, as it entered the rear of Beckside it flowed out of bank and through a garden onto the highway. At this point it was unable to re-join the Brown Sike and flowed into a lower area where it caused internal flooding to properties.

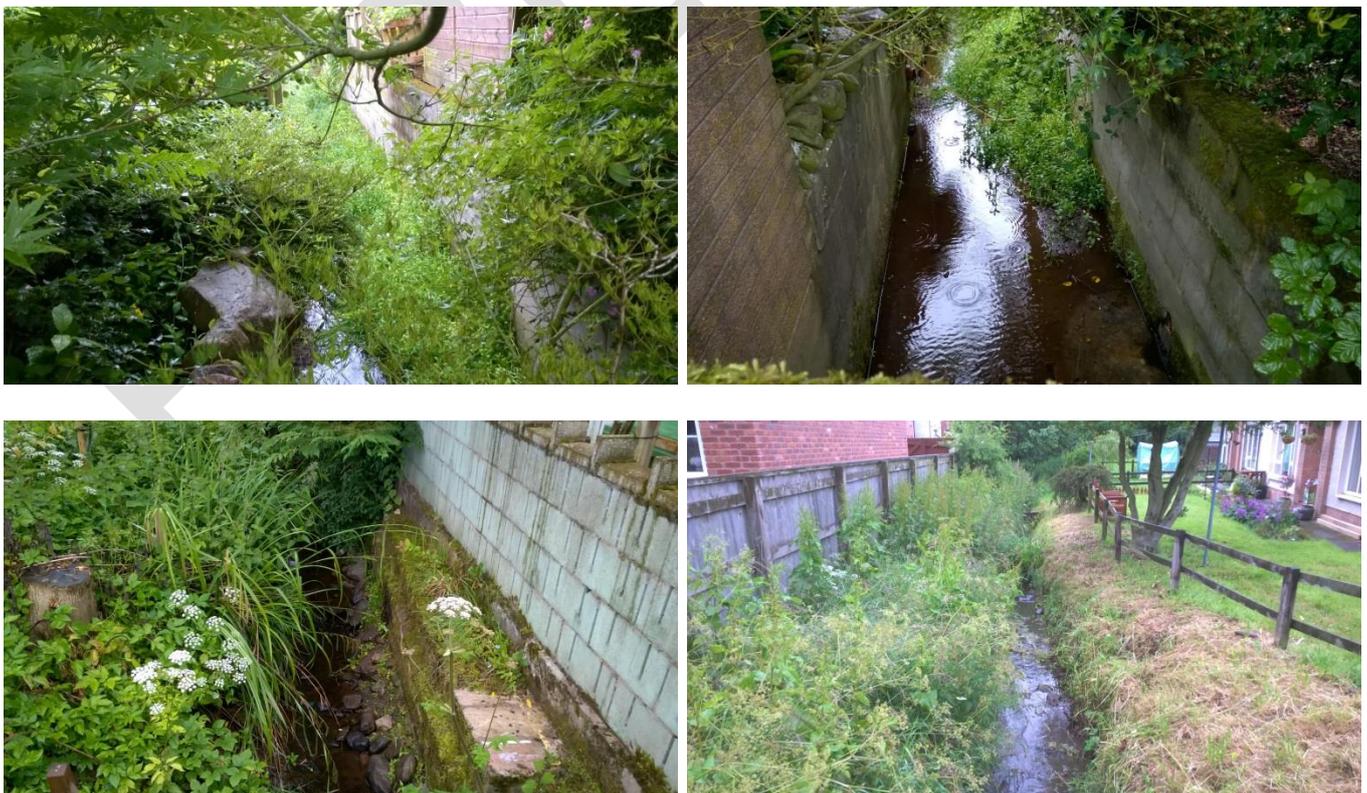
Photographs 7-10: Photographs of the open sections of culvert through Plumpton

The majority of Brown Sike through Plumpton is open watercourse except where vehicle crossing points are required. In the vicinity of Plumpton there are three culverted crossing points. Two are under adopted highways and the third is for the access to the wastewater treatment works. The following photographs indicate the condition of some of the reaches of open culvert through the village.

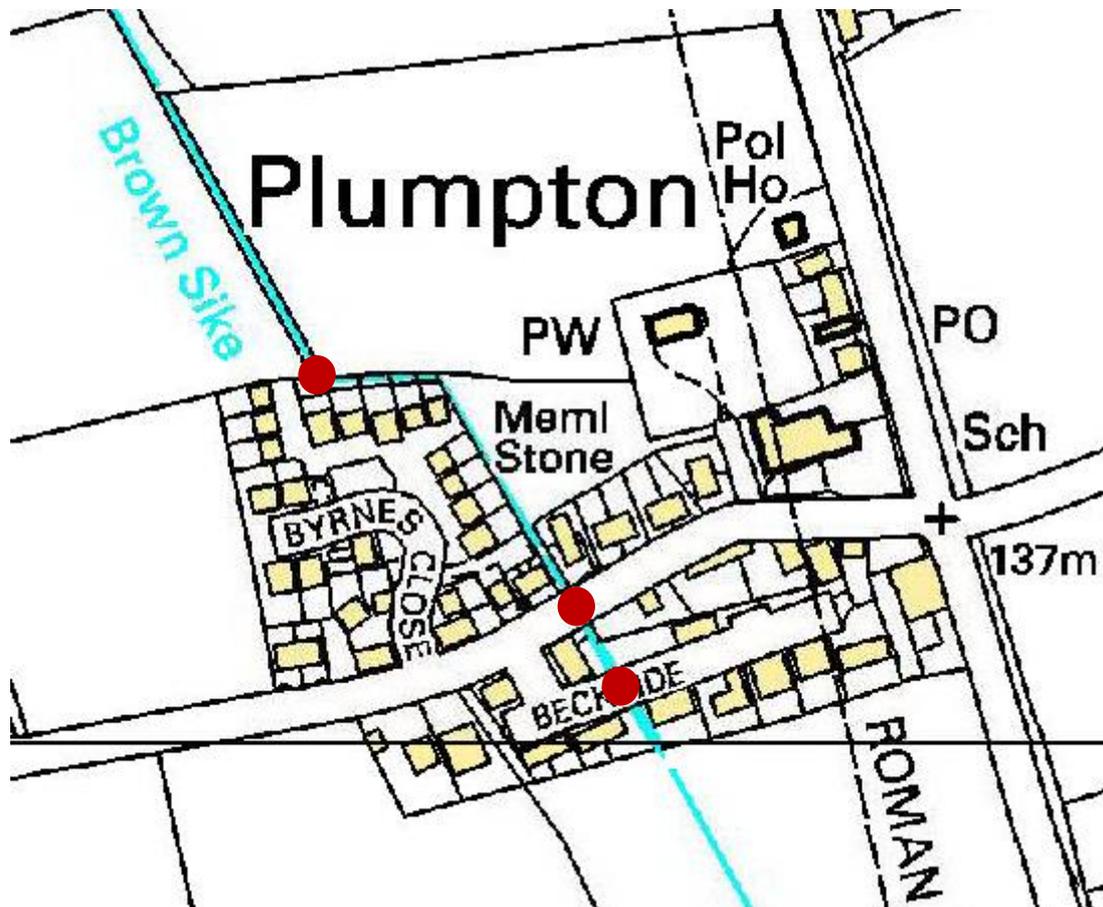
Figure 6: Location of culverted vehicle crossings shown by red dots

The following plan indicates the location of the culverted vehicle crossing points.

CCC has been informed that some of these crossing points had appeared to be causing a backing up effect during the flooding event. It was discovered that following the flood event that part of the structure under the C3012 was damaged and partially blocking the watercourse. As an action following the flooding CCC will carry out an assessment to establish the capacity of each culvert, and where required will work with the relevant owners to increase the size of the structures.

The vehicle crossing at the rear of Byrnes Close was particularly highlighted by the residents as being a restriction and caused the watercourse to back up and flood into some gardens. This vehicle crossing was constructed to allow access to the Wastewater Treatment Works.

Strengthening Defences	Vehicle crossing owners (UU track and public highways)	Where required upsize vehicle crossing culverts	Unknown as this will depend on landowner permissions and budget provision. Funding has provisionally been identified within the 2017/18 highways budget for the public highway crossings.
Upstream Management	LLFA / Eden Rivers Trust / Natural England / Landowner	Investigate possibly of increasing flood storage potential within SSSI	When resources are available.
	MSfWG	Investigate other areas of possible upland storage	When resources are available.
Community Resilience	Residents	Investigate property level protection for affected homes (flood doors, concrete floors etc). Grants available via District/Borough Council	2016
	Community	Consider the formation of a Community Action Group to assist vulnerable within the community	Timescale to be dictated by the community need and their requirements

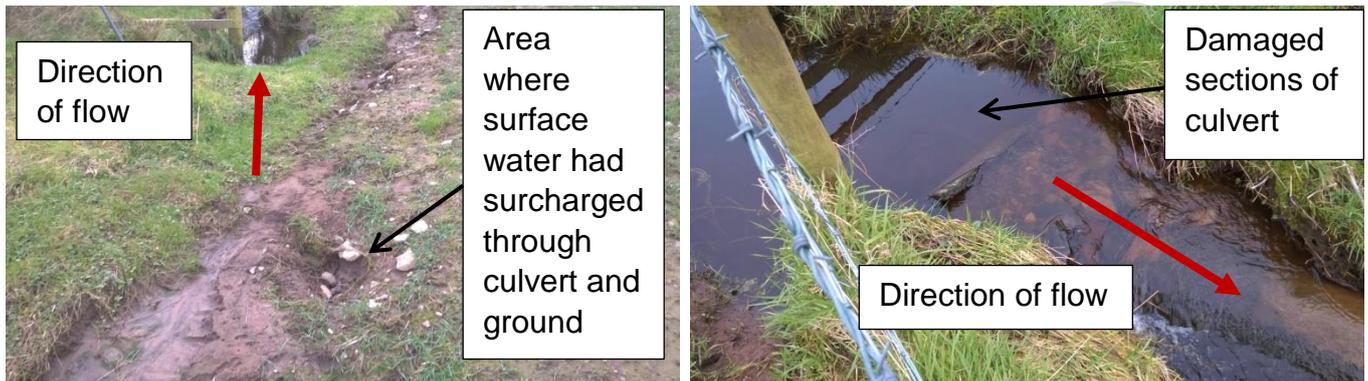
Photographs 11 & 12: Damage at the downstream end of Brown Sike culvert

During investigations it was observed that the downstream end of the Brown Sike culvert appeared to be damaged. Although in normal flows this appears to allowing water to discharge

it is not known if this damage would have created a restriction during the flood event. It is also not known if this damage was caused during the December flood event.

Also the National Grid survey of the culvert indicated that there was also a poor repair on a section of the culvert, although it was not known if this caused debris to collect within the culvert during the flood event. Photographs 11 & 12 indicate the damage to the culvert.

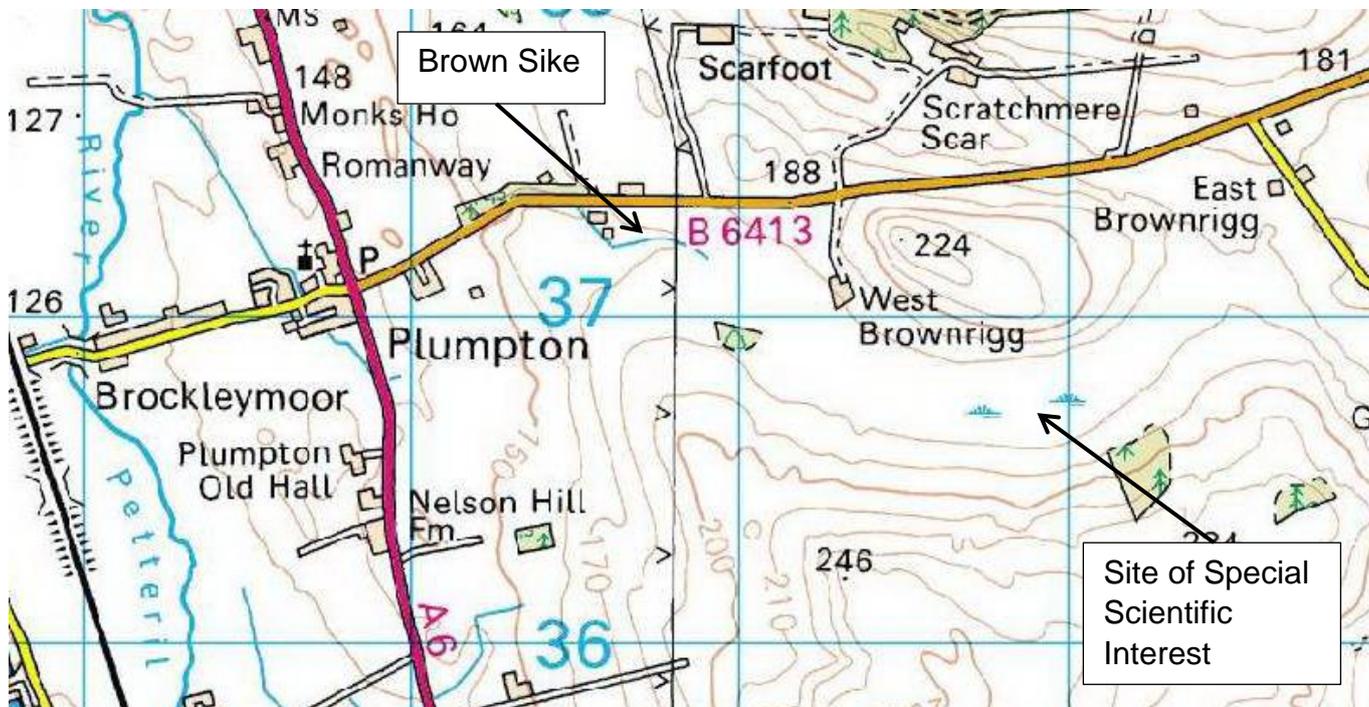
Figure 7: Site of Special Scientific Interest

During investigations some residents commented that there used to be a holding area for water upstream which had limited the flow in Brown Sike. The area in question which is southeast of West Brownrigg is within a Site of Special Scientific Interest (SSSI) and it is understood from the

landowner that works were carried out by Natural England that may have reduced the water holding capacity of the area. This area feeds into Brown Sike. The LLFA will investigate this with Natural England to see if there is any opportunity to increase the water holding capacity of the area particularly during extreme events. The following plan indicates the area.
