Kendal

Flood Investigation Report

Sandylands and Mintsfeet on the 6th December 2015

Flood Event 5-6th December 2015

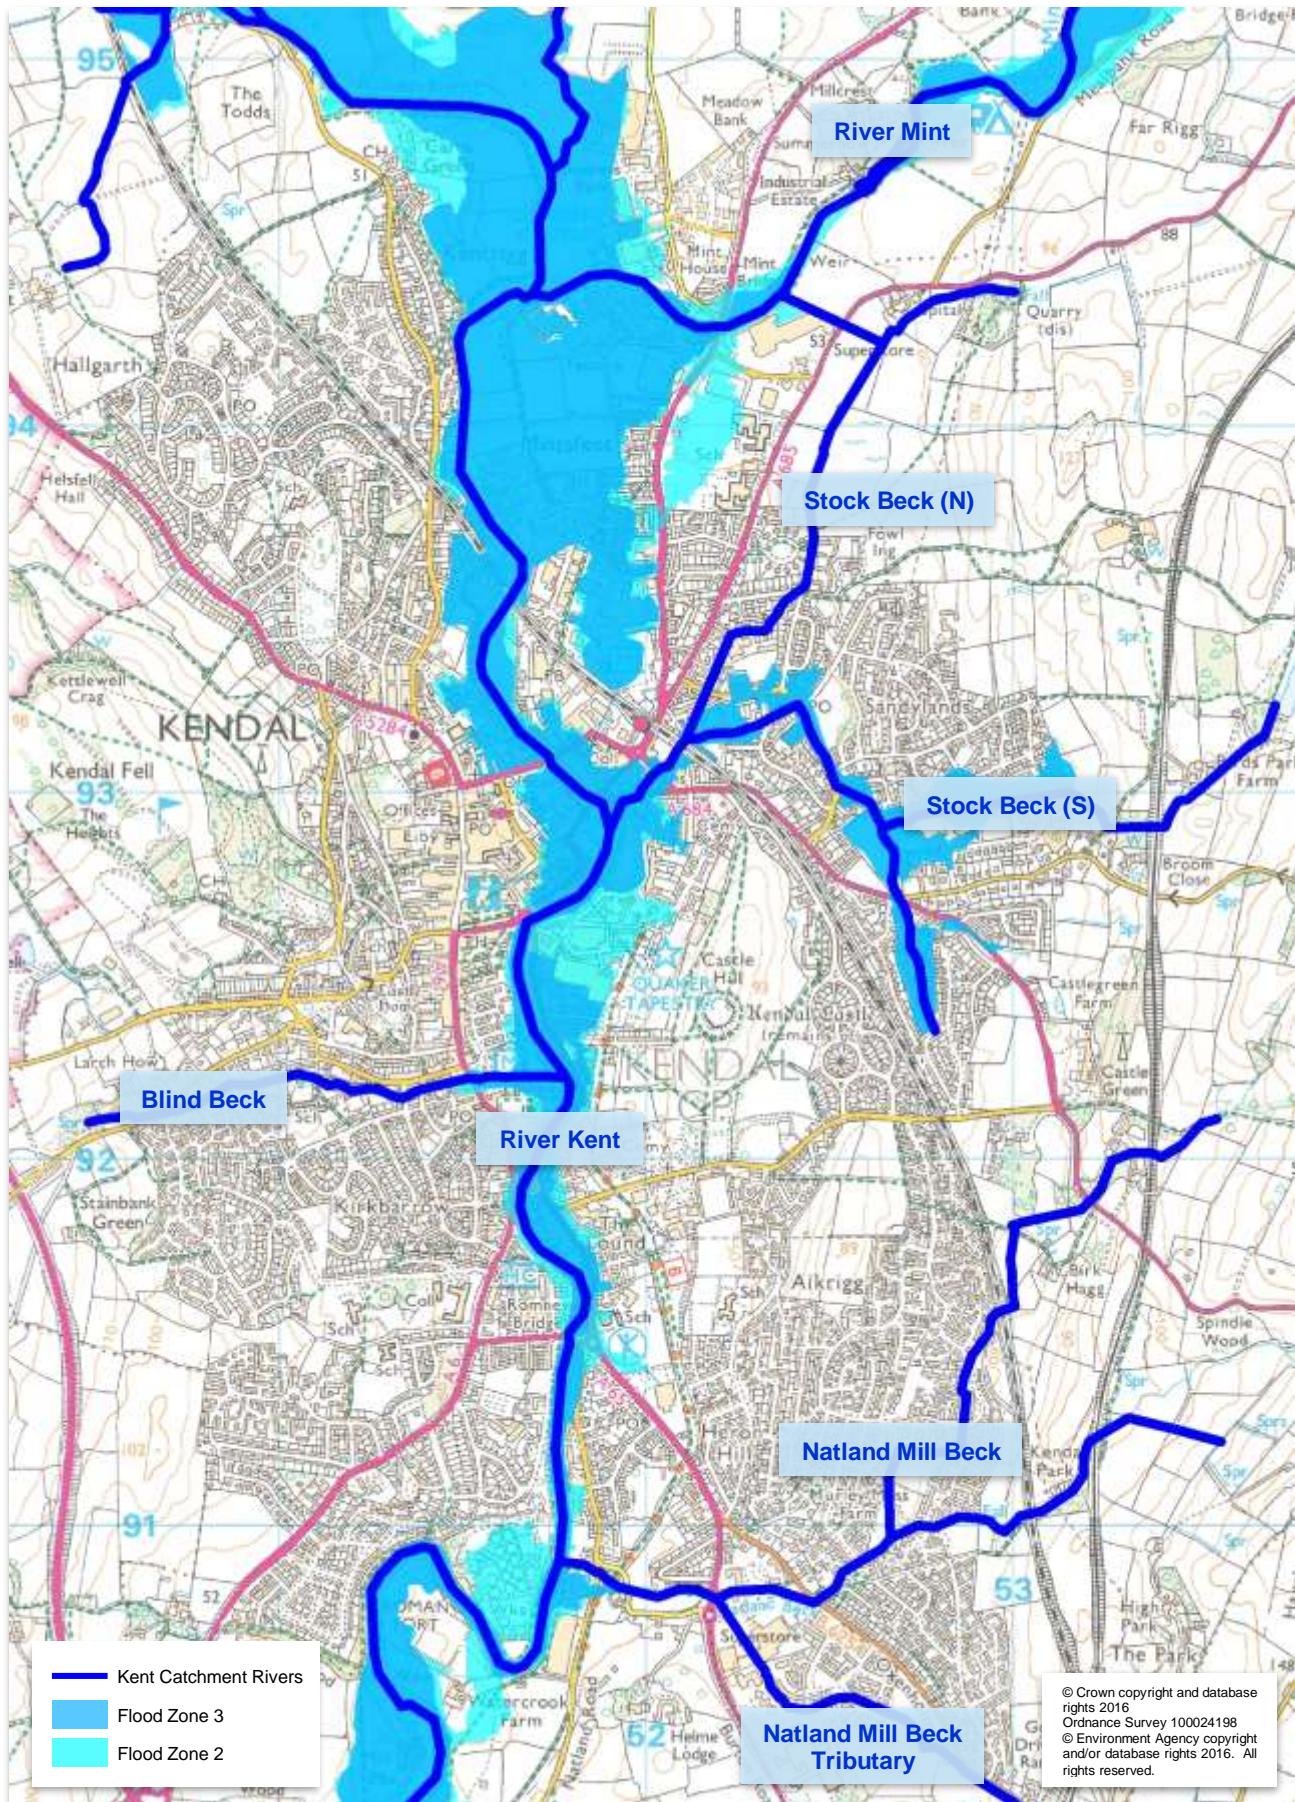
Figure 2: Indicative risk of flooding to Kendal from rivers (fluvial)

Due to its position within the floodplain of the Rivers Kent and Mint, parts of Kendal lie within Flood Zone 3 and are therefore at a high risk of fluvial flooding (see Figure 2). The town is also at risk from other sources of flooding, including surface water (see Figure 3).

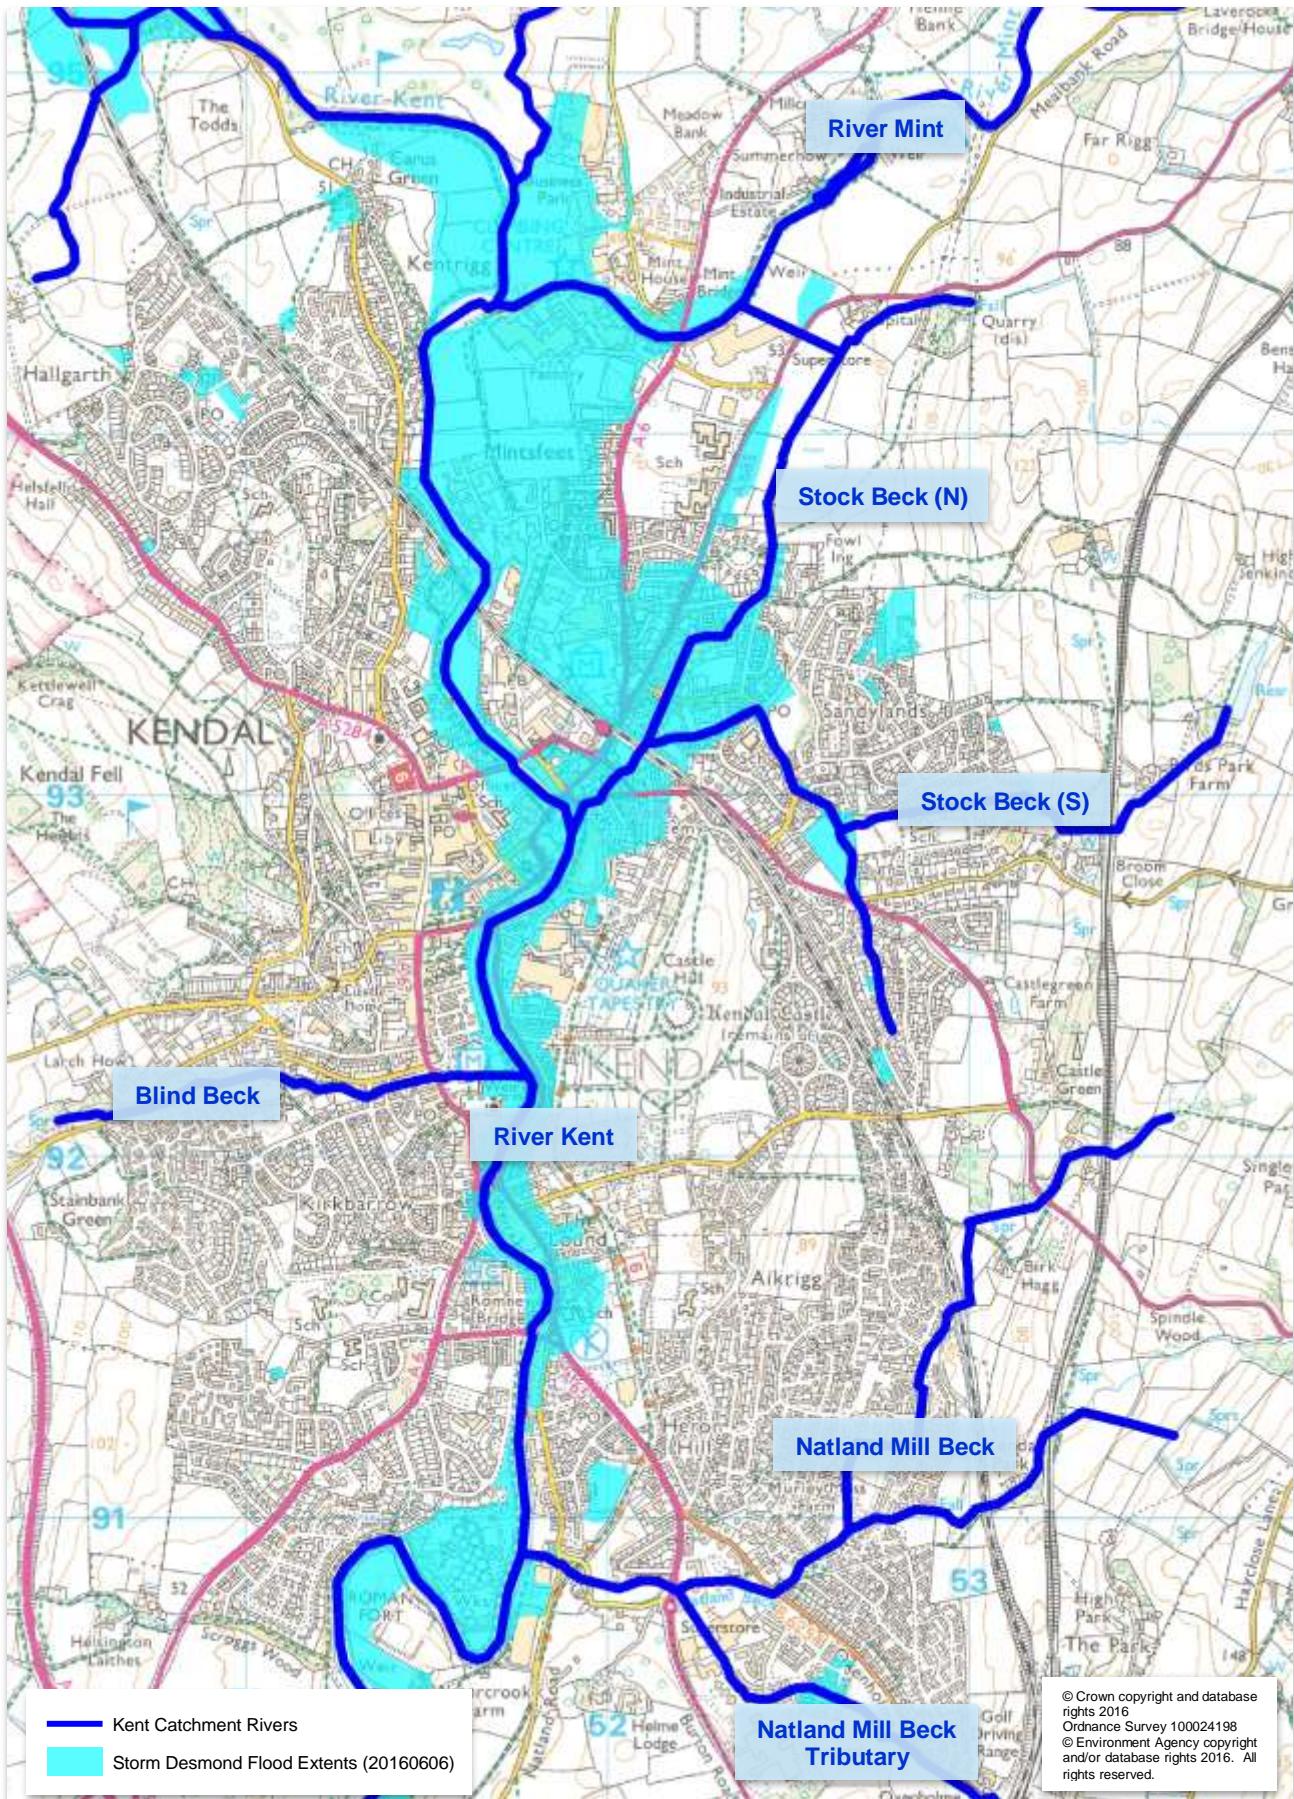
Figure 4: Extent of flooding in Kendal on 5-6th December 2015

Flooding from other sources, including groundwater, surface water run-off, and artificial drainage systems was also reported. Figure 4 indicates the extent of the flooding that occurred in Kendal from all sources following Storm Desmond.

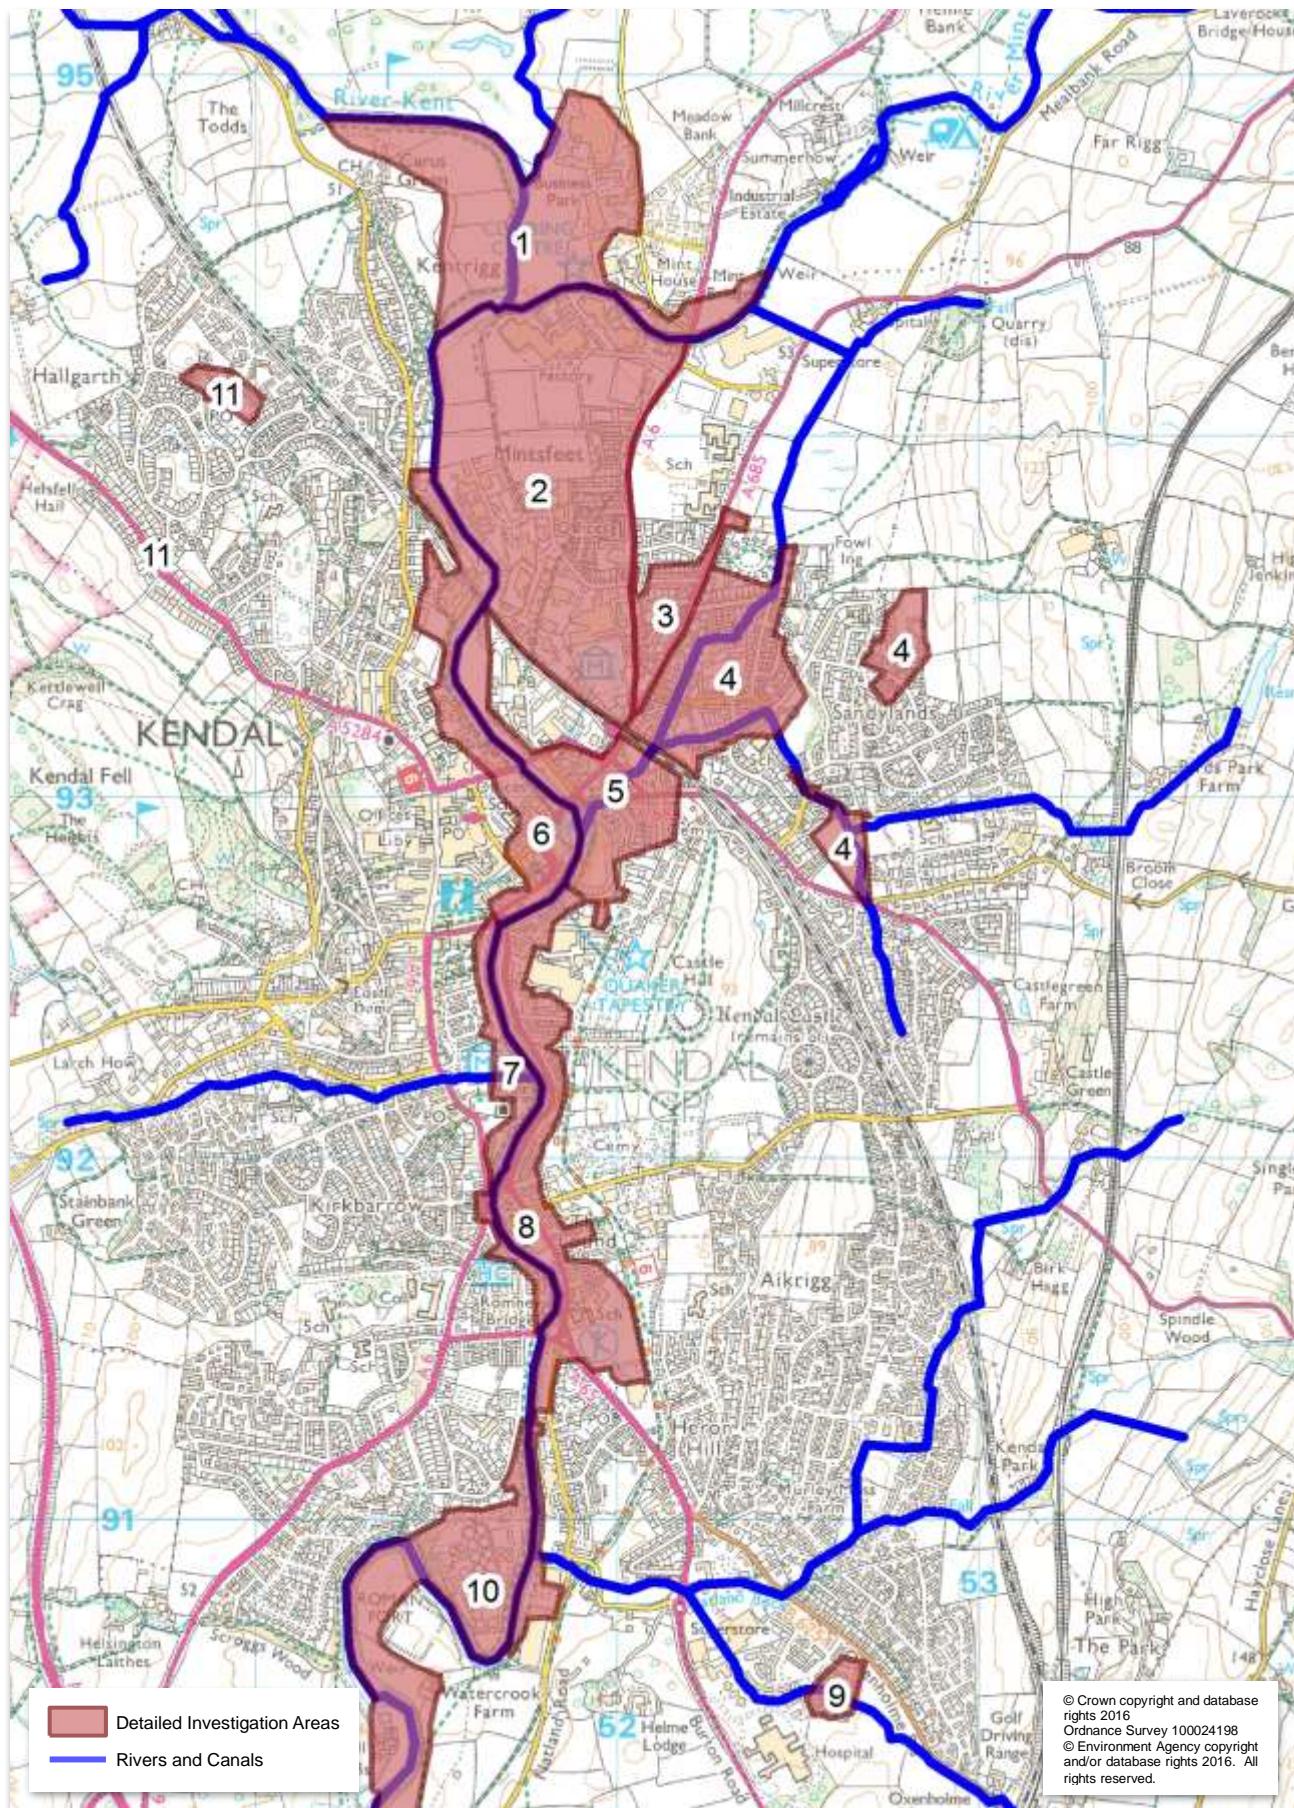
Figure 5: Affected areas subject to detailed investigation

For the purpose of this report, the flooded areas have been divided into 11 sub-areas for detailed investigation. These are listed below and shown in Figure 5:

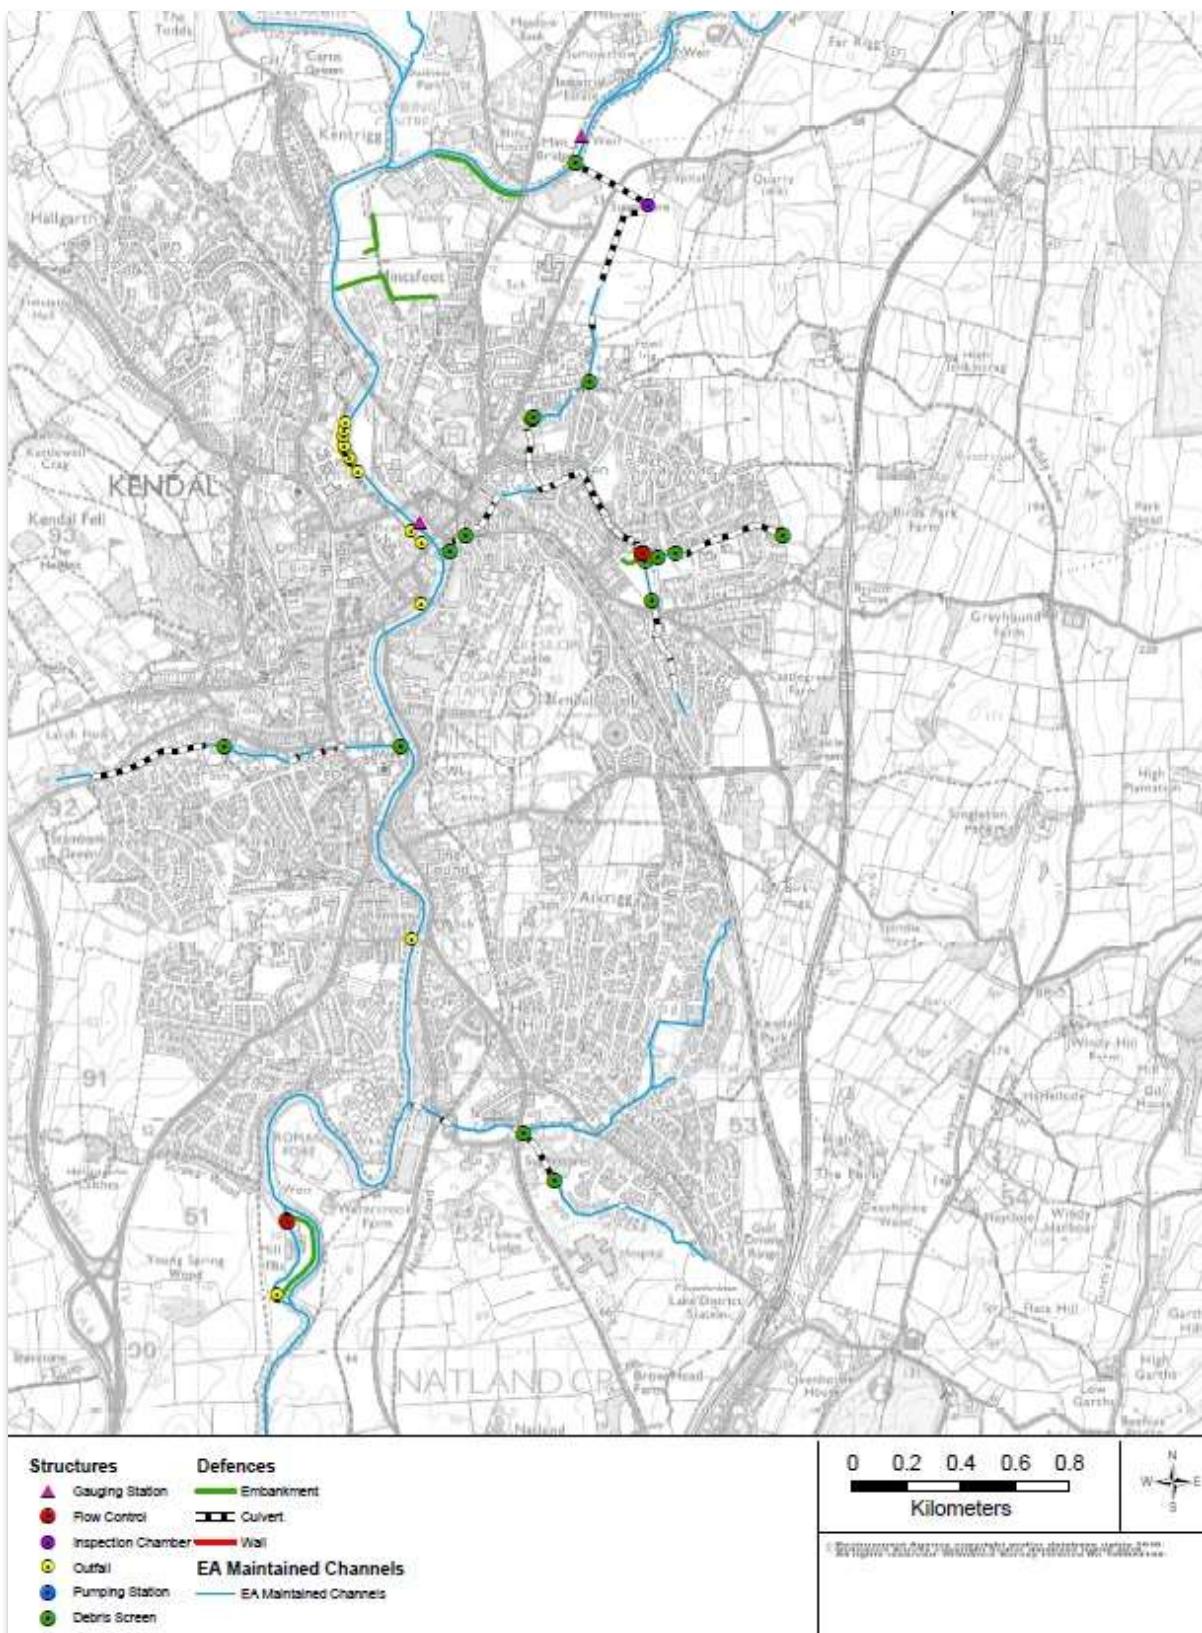
Figure 6: Flood risk management assets maintained by the Environment Agency in Kendal

A map of existing flood risk management assets maintained by the Environment Agency is shown in Figure 6.

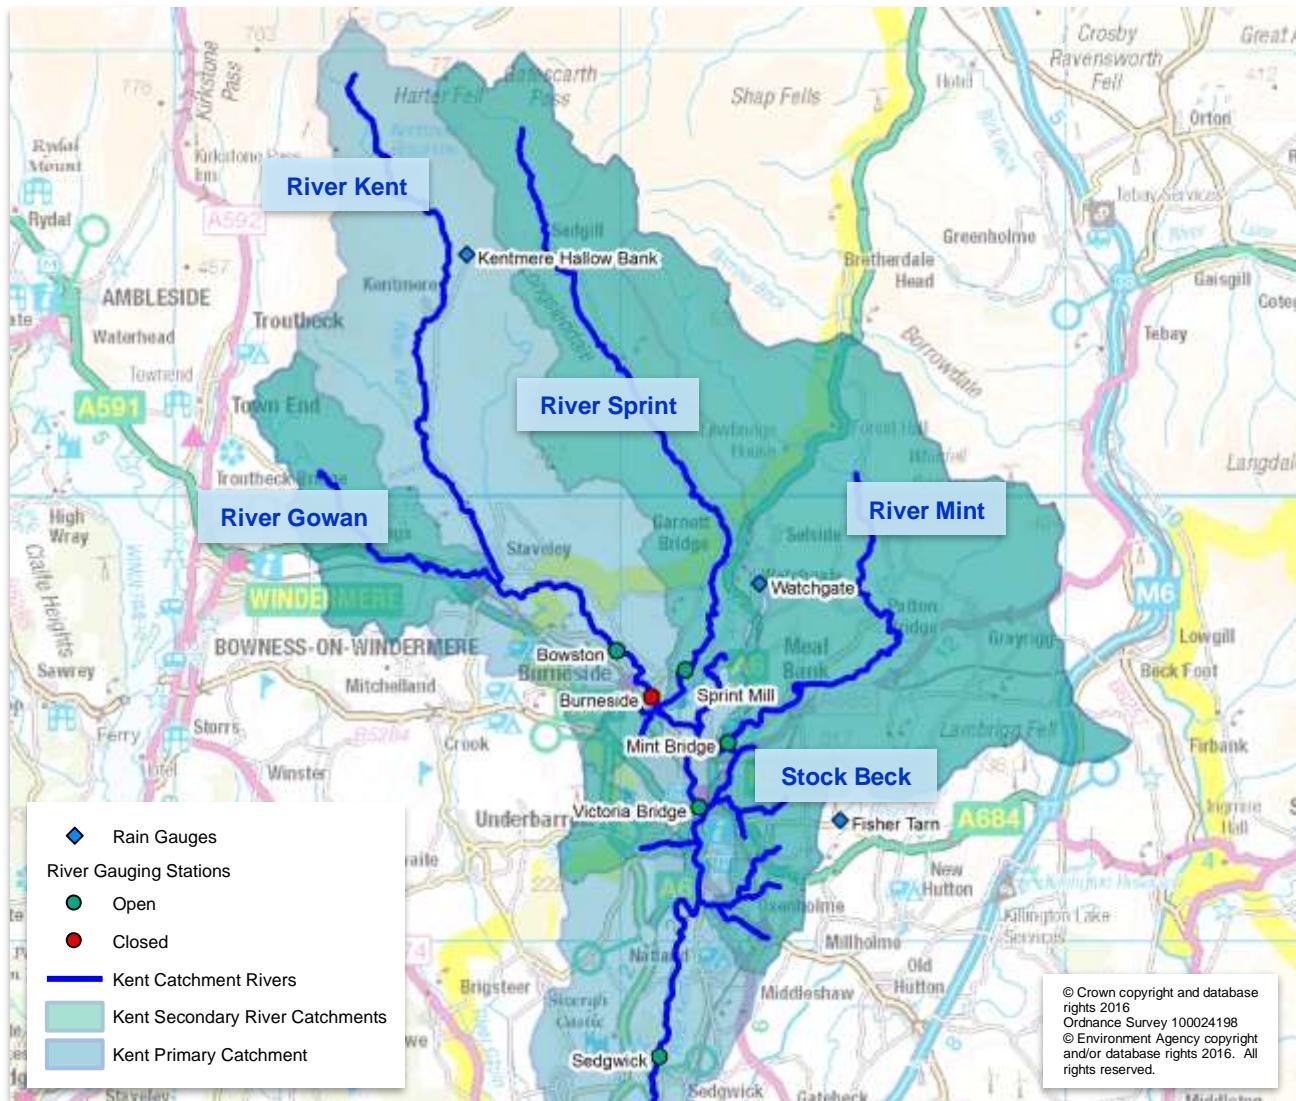
Figure 7: Location of rain gauges and river gauging stations in the River Kent catchment

Within the Kent catchment, Kentmere Hallow Bank rain gauge recorded a total of 225.8mm of rain between 19:00 on 04/12/2015 and 07:45 on 06/12/2015 and at Fisher Tarn, which is located to the east of Kendal; 139.6mm fell in 48 hours. In the River Mint catchment, the rain gauge at Watchgate recorded 181.8mm of rain in 48 hours. This is the rainfall associated with Storm Desmond and this followed a series of smaller rainfall events in the preceding days, which contributed to the already saturated ground conditions in the catchment. Table 3 summarises the rainfall data recorded in the River Kent, Stock Beck, and River Mint catchments during Storm Desmond and illustrates that the data recorded during Storm Desmond far exceeds the previous record gaugings. The locations of the rain gauges are shown in Figure 7.

Five principle flow gauging stations are located within the catchment of the River Kent² (see Figure 7). Three of the stations are located upstream of Kendal, with one on the River Kent (Bowston), one on the River Sprint (Sprint Mill), and one on the River Mint (Mint Bridge). Bowston gauging station replaced Burneside gauging station (now closed) in 1999. Victoria Bridge gauging station is located in the centre of Kendal itself, whilst Sedgwick gauging station is located approximately 6km downstream of Kendal town centre. Together, these stations recorded the fluvial event caused by Storm Desmond, and the recorded data is presented in Table 4, Figure 8 and Figure 9.

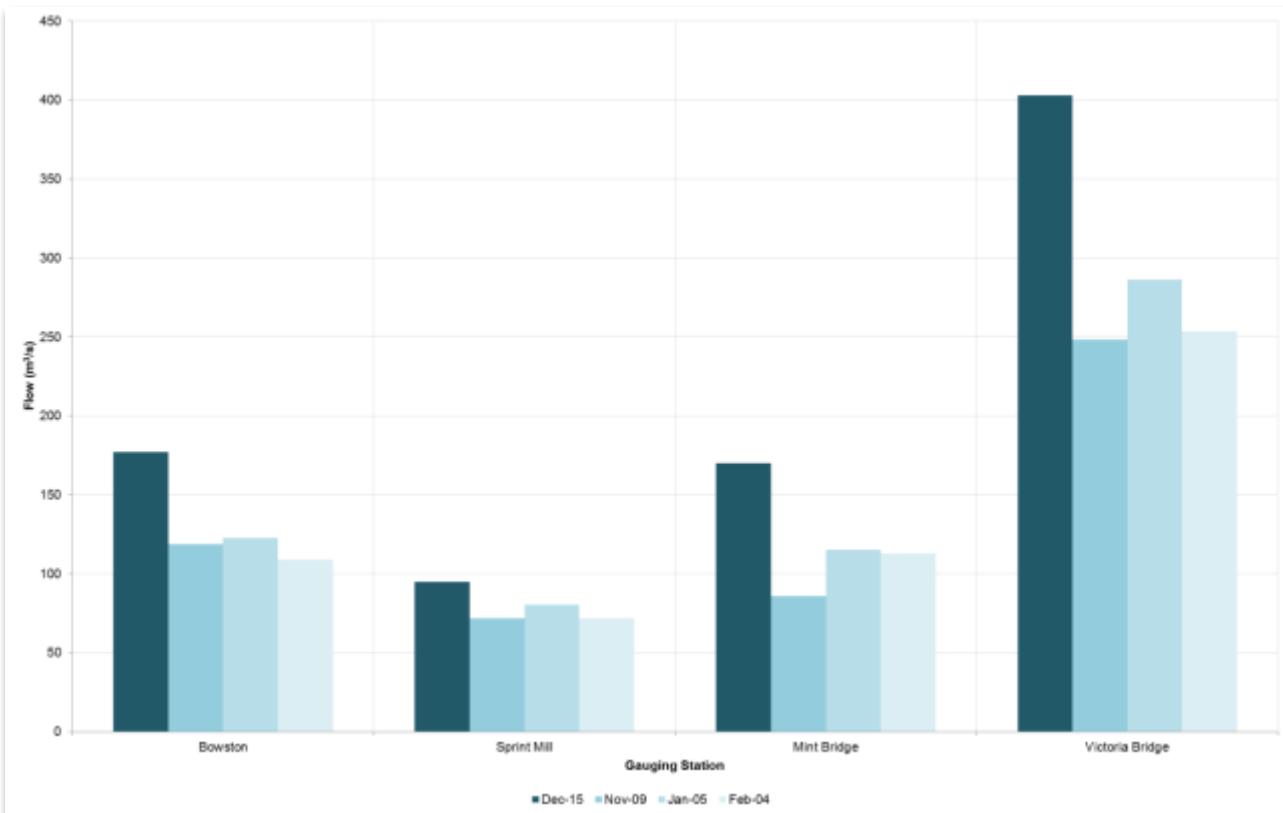
Figure 8: Recorded peak river flows in the River Kent catchment for recent flood events

Gauging Station	River	Area of upstream catchment (km ²)	Peak flow (m ³ /s)			
			Dec 2015	Nov 2009	Jan 2005	Feb 2004
Bowston	Kent	71	177.0	118.9	122.5	109.0
Sprint Mill	Sprint	35	94.8	71.7	80.5	71.9
Mint Bridge	Mint	66	170.0	85.9	115.4	112.8
Victoria Bridge	Kent	183	403.0	248.4	286.5	253.6
Sedgwick	Kent	209	526.8	-	347.0	312.0

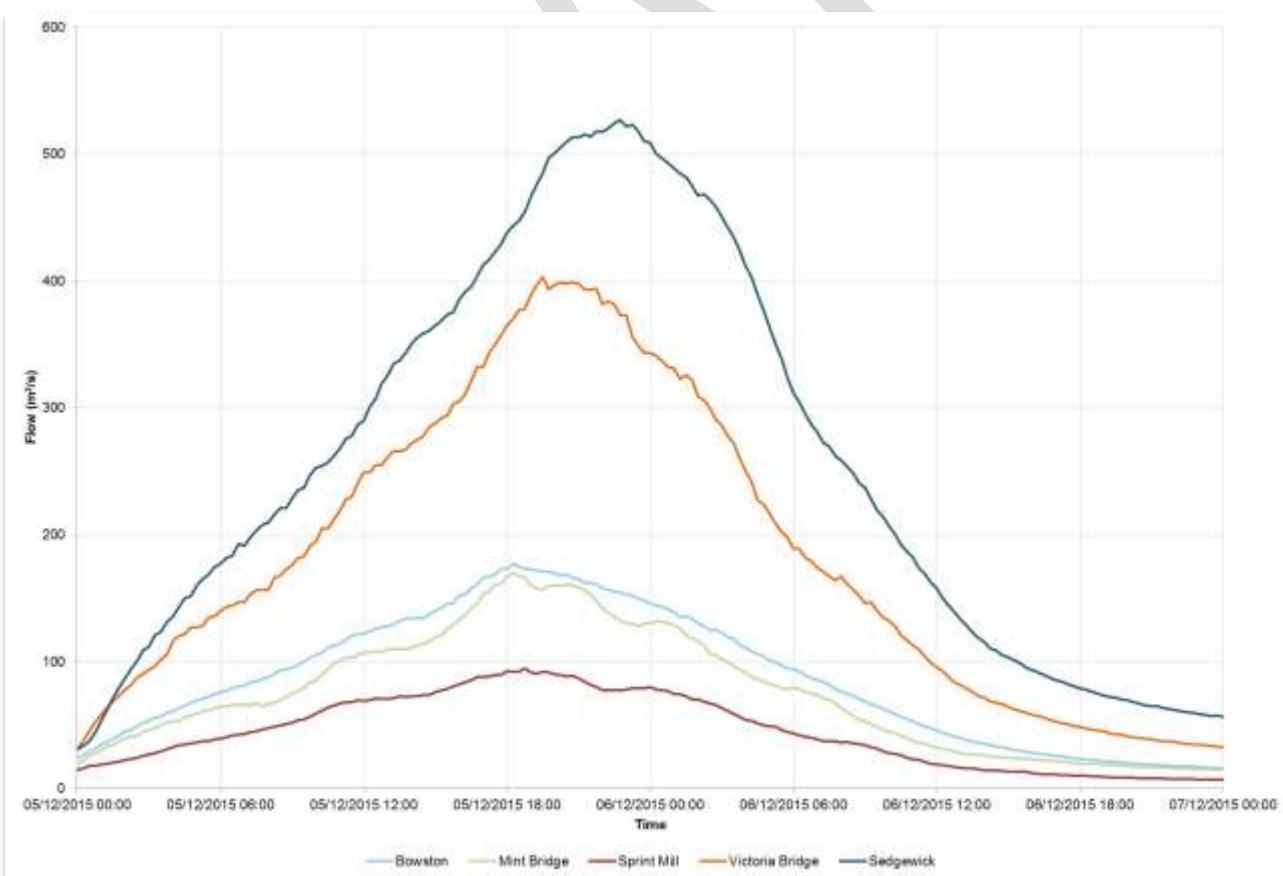
Figure 9: Gauged river flows at various locations in the Kent catchment on the 5th-6th December 2015

The recorded peak flow at Victoria Bridge gauging station was greater than any flow previously recorded at this location on the River Kent, and initial analysis of this data suggests that the December 5th event had a 0.5-0.67% probability of occurring in any given year (Annual Exceedance Probability or AEP). In reality, the peak flow in the River Kent was higher than the 403m³/s measured at the gauging station. This is due to the bypassing of the gauging station that occurred as floodwater passed through Mintsfeet and Longpool and became impounded against the Oxenholme-Windermere railway embankment.

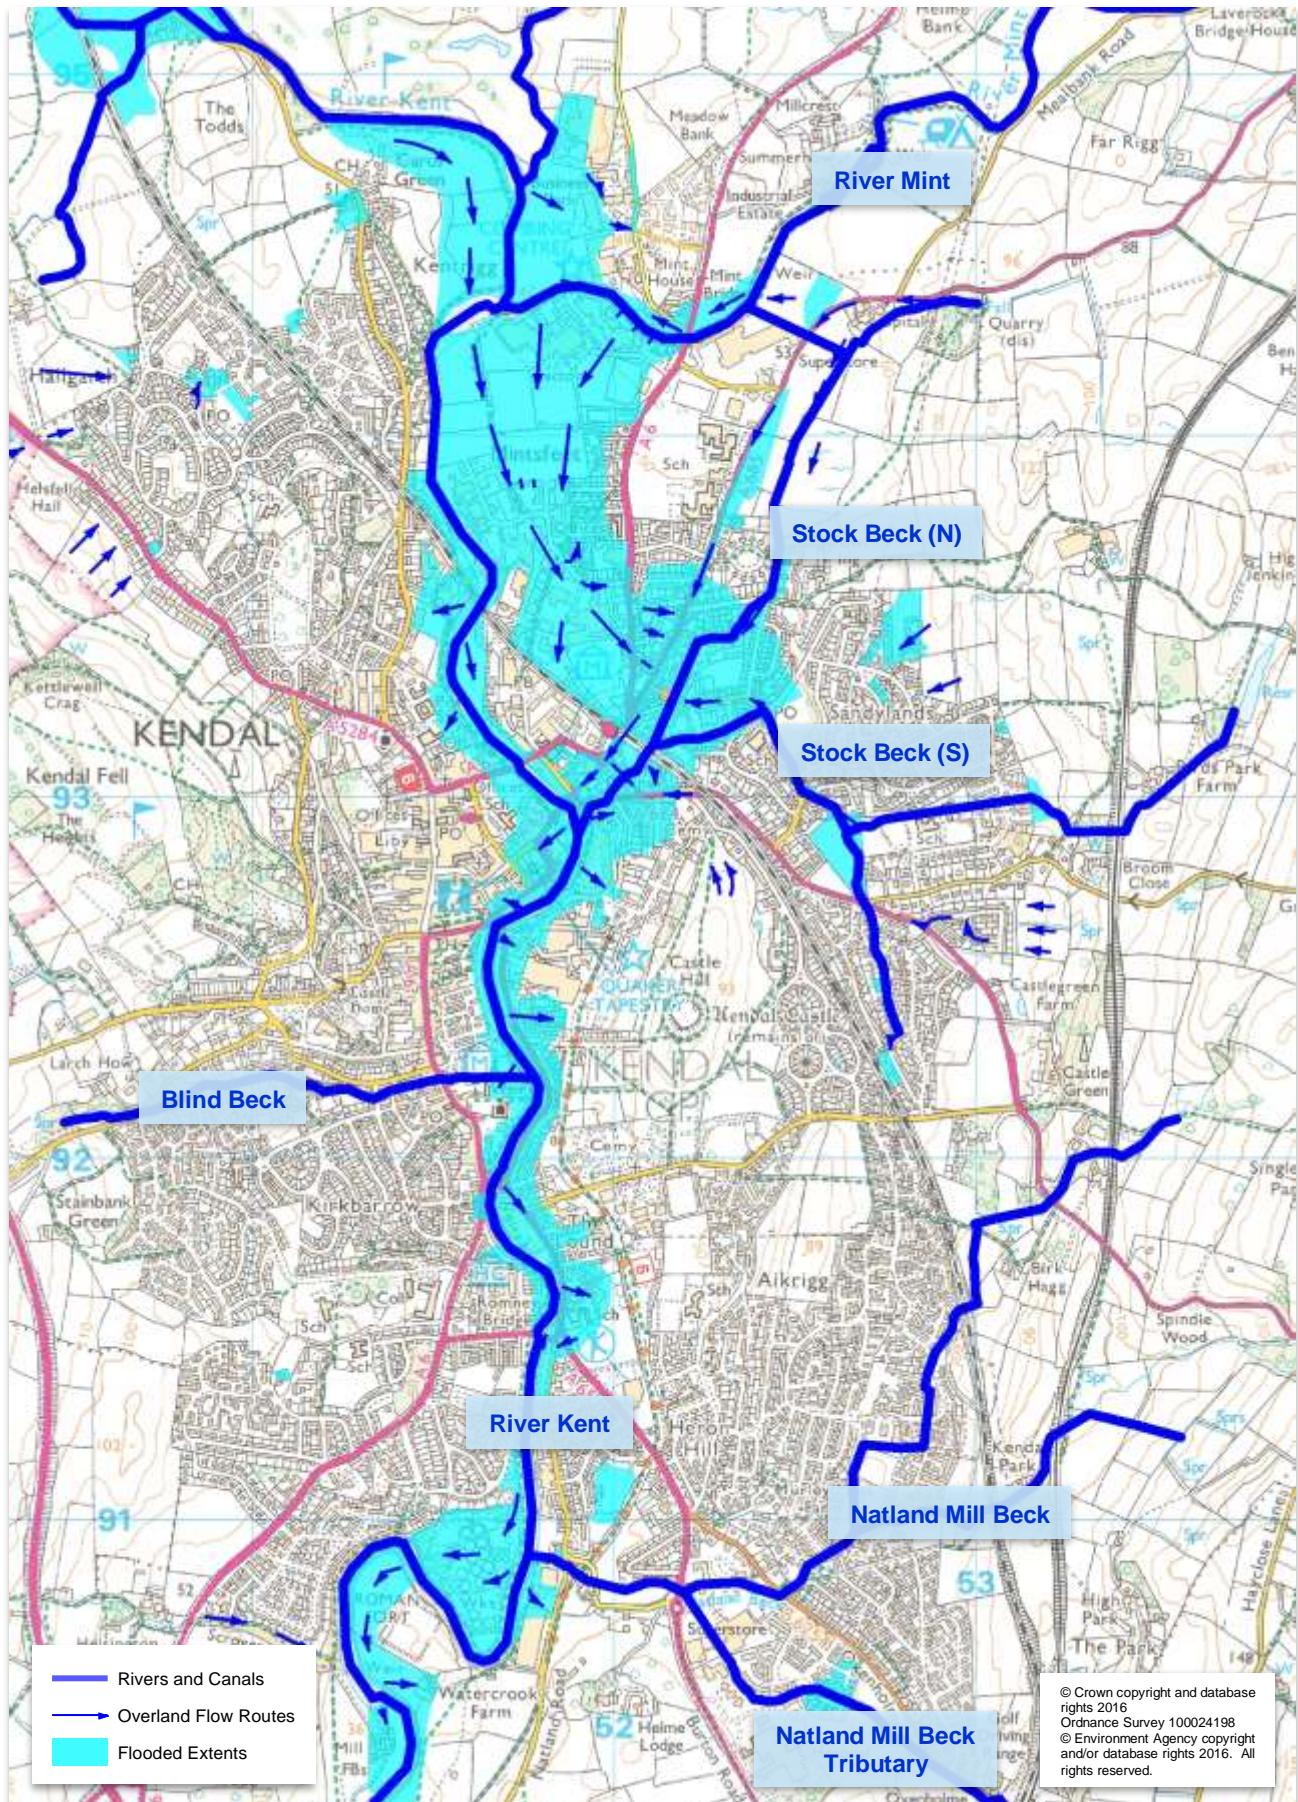
Figure 10: Principle overland flow routes through Kendal

Detailed flow routes are also identified in the Likely Causes of Flooding section of this report. However, an overview of the principle flood flow routes through Kendal is presented in Figure 10. This figure shows the dominant flow paths within the town, but there is evidence that these changed over the course of the event as different sources of flooding came into play and flood waters in some areas began to recede.

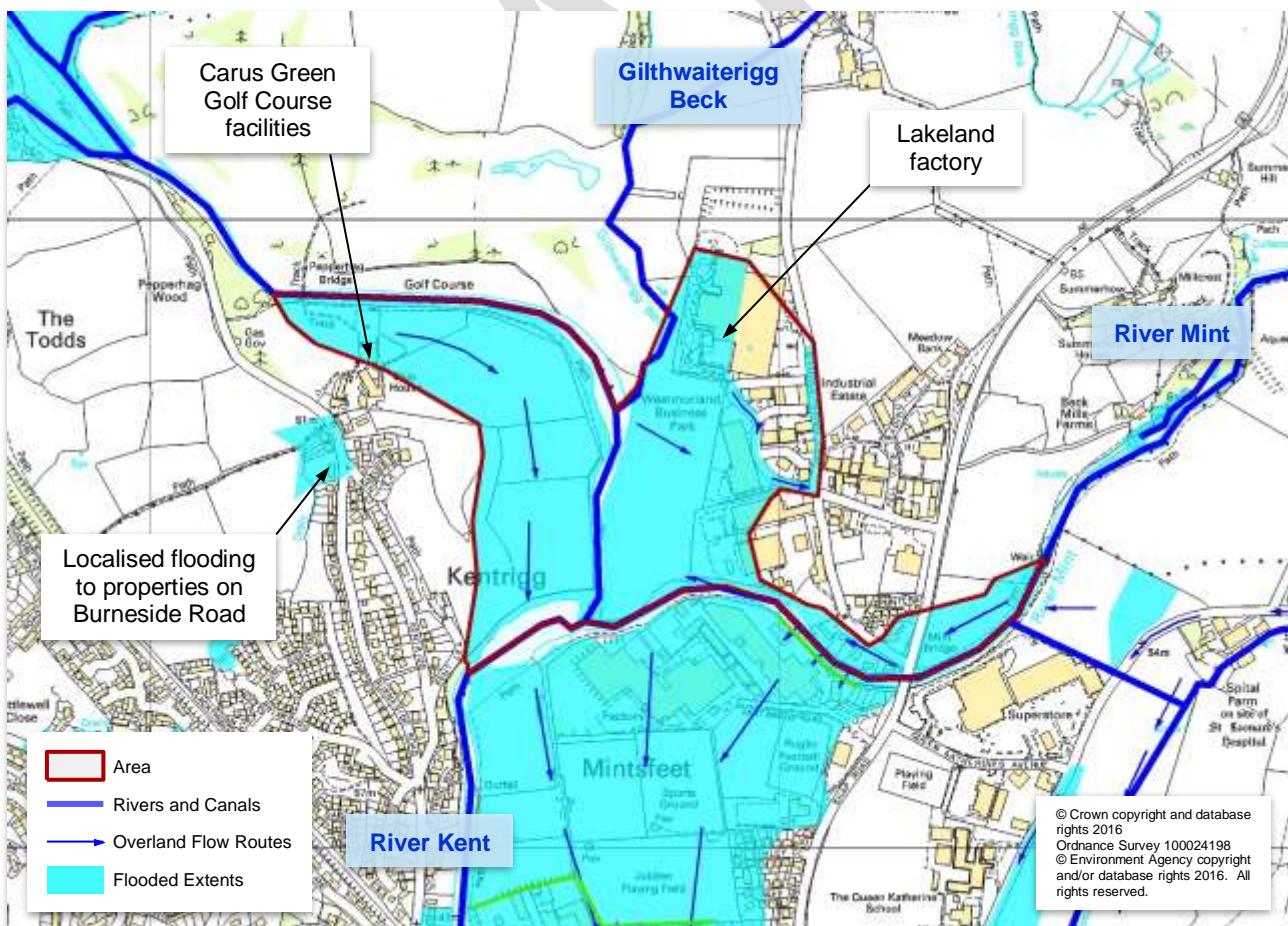
Figure 11: Overland flow routes in the Kentrigg and Carus Green area

Kentrigg is located in the north of Kendal on the River Kent and close to its confluence with the River Mint. Flooding in this area was predominantly caused by the fluvial event on the River Kent, with parts of the Westmorland Business Park on the left bank of the River Kent also affected by flooding from Gilthwaiterigg Beck.

Fluvial flooding from an ordinary watercourse resulted in five properties on Burneside Road, opposite Kent Lea, being affected. Investigations suggest that this was caused by an obstructed culvert.

The principle flood mechanisms and overland flow routes are shown in Figure 11, with a timeline of the key events given in Table 6.

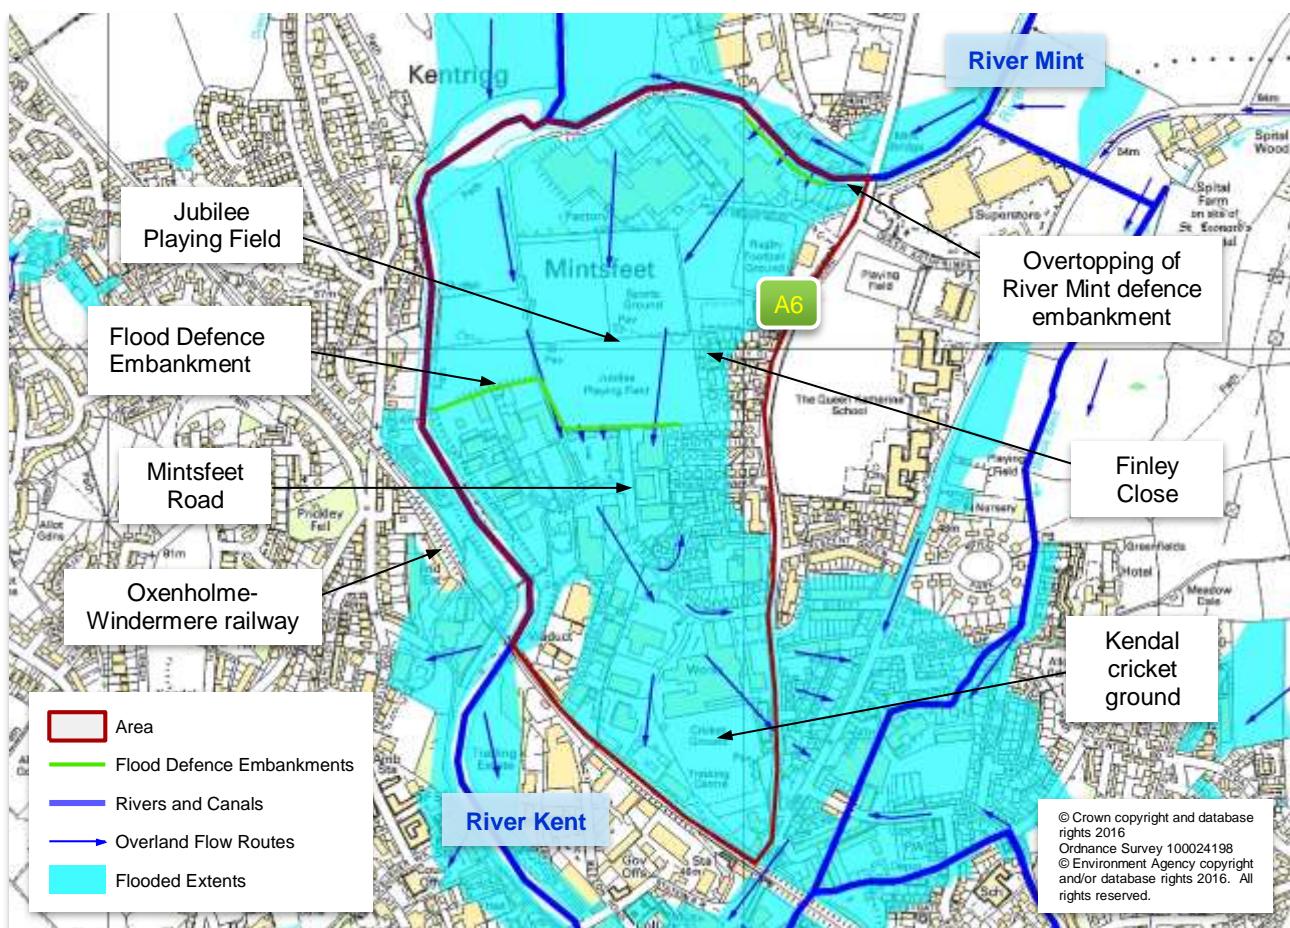
Figure 12: Overland flow routes in the Mintsfeet area

The Mintsfeet area, enclosed by the Rivers Mint and Kent to the west of the A6 Shap Road and north of the Oxenholme – Windermere railway line, comprises a mixture of residential, commercial, and green field land uses. The area was badly affected and the principle source of flooding was from the fluvial event on the Rivers Mint and Kent. Residential and commercial properties on and around Mintsfeet Road suffered significant damage and commercial property in the Lake District Business Park was also affected. The principle flood mechanisms and overland flow routes are shown in Figure 12, with a timeline of the key events given in Table 7.

The area of Mintsfeet was hit by significant overland flows from the Rivers Mint and Kent. It appears that the most significant of these originated where the two rivers join together to the north-west of the Lake District Business Park. In addition to this, the existing flood defence embankment on the left bank of the River Mint as it passes the business park began to overtop at around 15:00 on 05/12/2015 and was subsequently damaged. The overtopping is understood to have occurred when flow in the River Mint reached around 120m³/s and the wrack mark was found to be between 600 and 900mm above the embankment crest at this location.

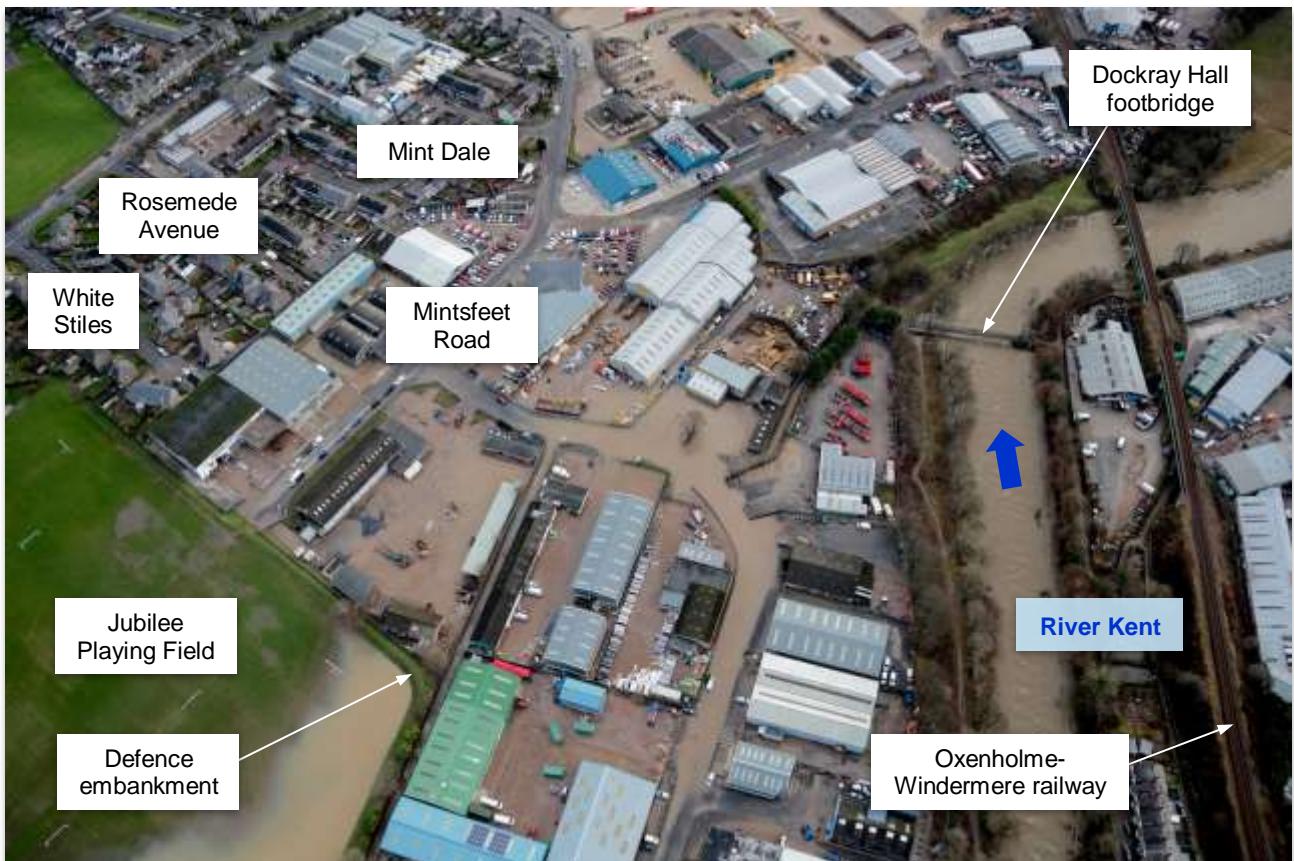
Floodwater from these sources was then able to flow through the business park and across the Jubilee Playing Fields to the south, where it was initially impounded against the existing flood defence embankment highlighted on Figure 12 and shown in Figure 13.

Figure 13: Aerial photograph from 6th December showing the flooding in Mintsfeet and the existing flood defence embankment along the south and western boundaries of the Jubilee Playing Fields

Whilst the embankment in the Jubilee Playing Fields impounded floodwater initially, the sheer magnitude of the flood event meant that it was overwhelmed. This caused flooding to residential properties on Finley Close, Finley Drive, White Stiles, Rosemede Avenue and Mintsfeet Road, with internal flood depths reported to reach 1.2m (see Figure 14). Commercial properties on Mintsfeet Road, including those in the Mintsfeet Industrial Estate were also affected. In addition to the damage caused by internal flooding to property, the combined depth and velocity of the floodwater resulted in widespread structural damage, with a number of boundary walls destroyed in the area.

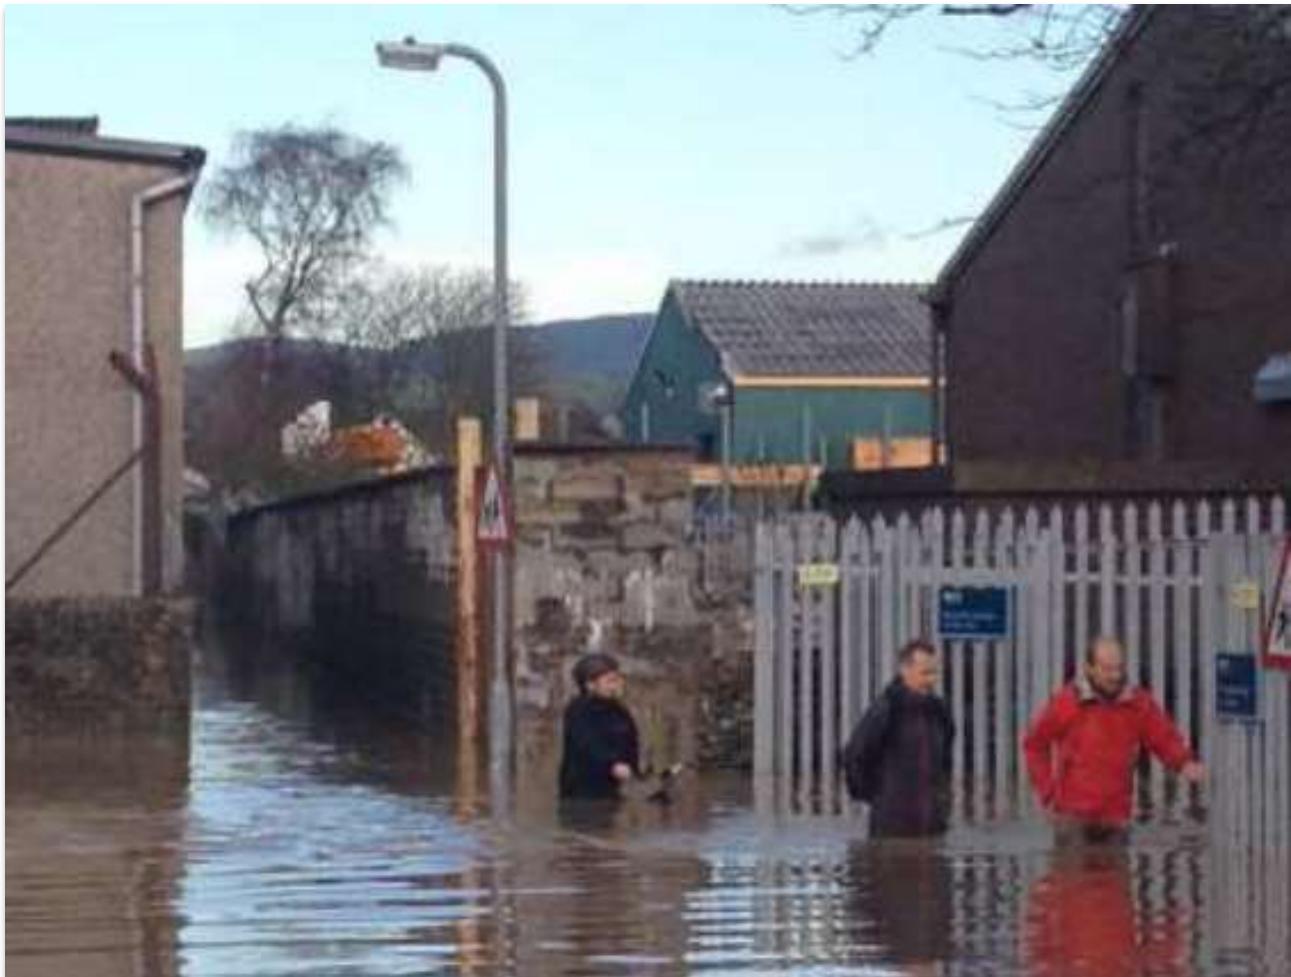
Flooding in the Mintsfeet area took days to drain away. This is due to there being a limited number of surface water outfalls. The combined sewer network in the Mintsfeet area is pumped and the pumping station was damaged during the flooding. This essentially meant that a small Combined Sewer Overflow (CSO) was the only available outlet for the flood water, which drained over a period of days.

Figure 14: Flooding in the Mintsfeet area

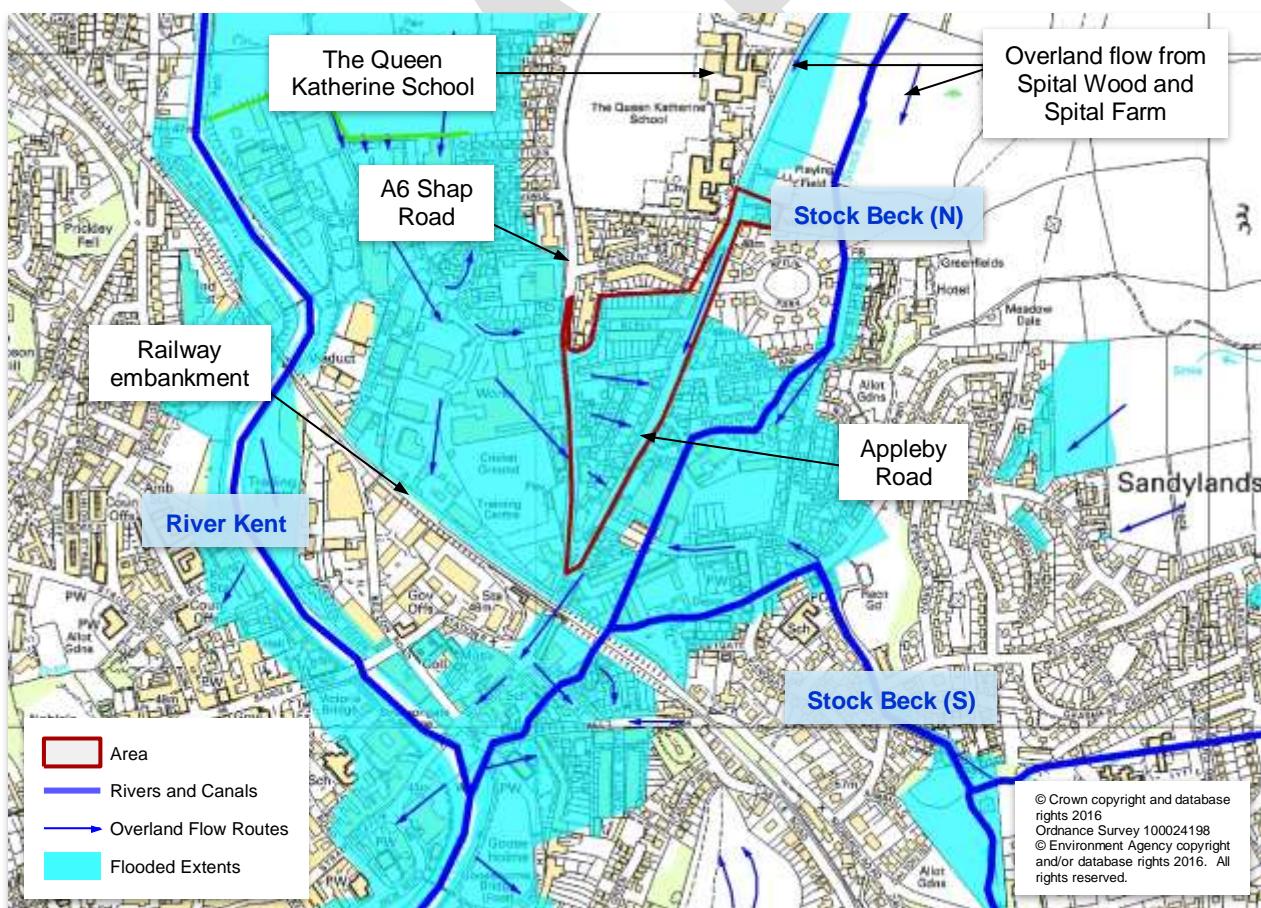
Figure 15: Overland flow routes in the Shap Road and Appleby Road area

The principle flood mechanisms and overland flow routes in this area are shown in Figure 15, with the aftermath of the flooding in the area shown in Figure 16. A timeline of the key events is given in Table 8.
