Kendal

Flood Investigation Report

Sandylands and Mintsfeet on the 6th December 2015

Flood Event 5-6th December 2015

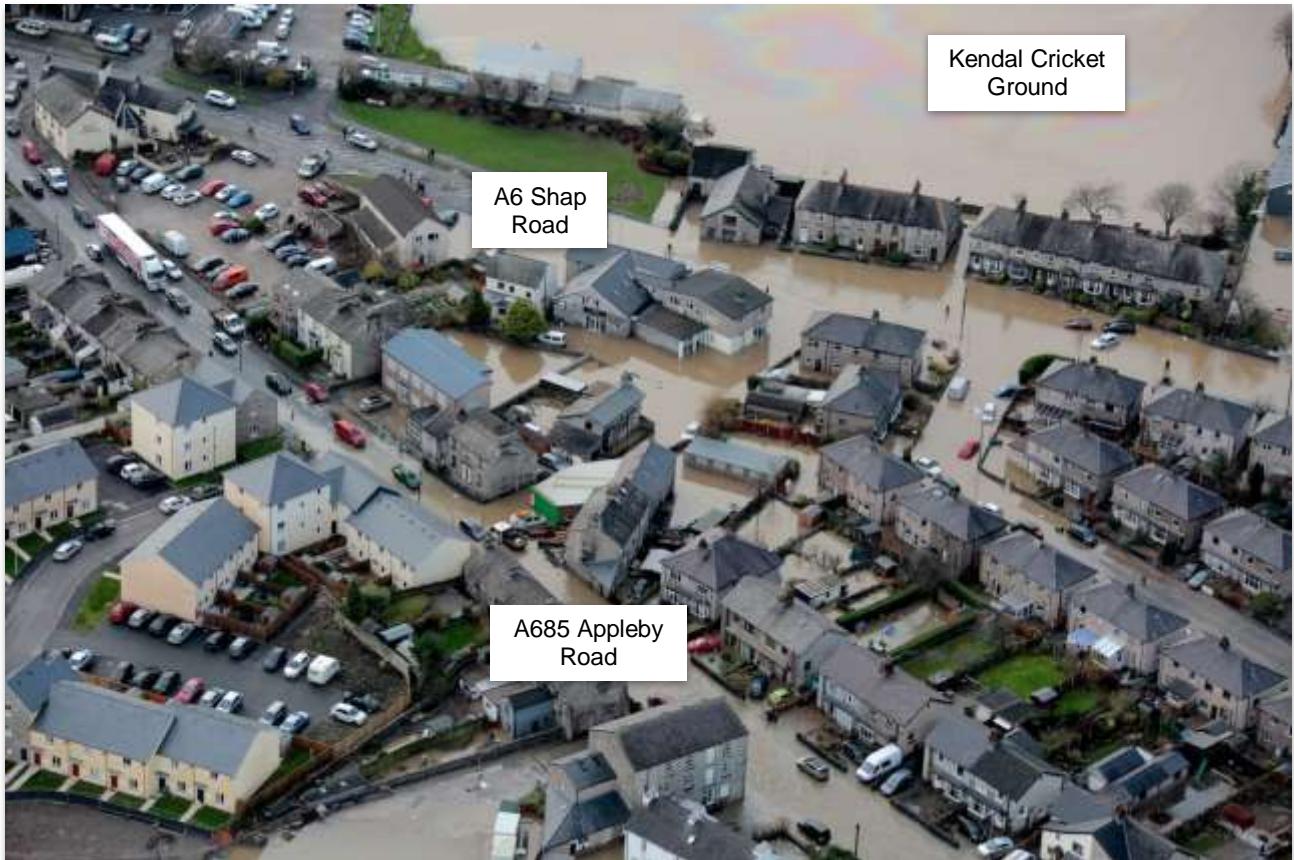
Figure 16: Aerial photograph of Shap Road and Appleby Road area on 6th December 2015

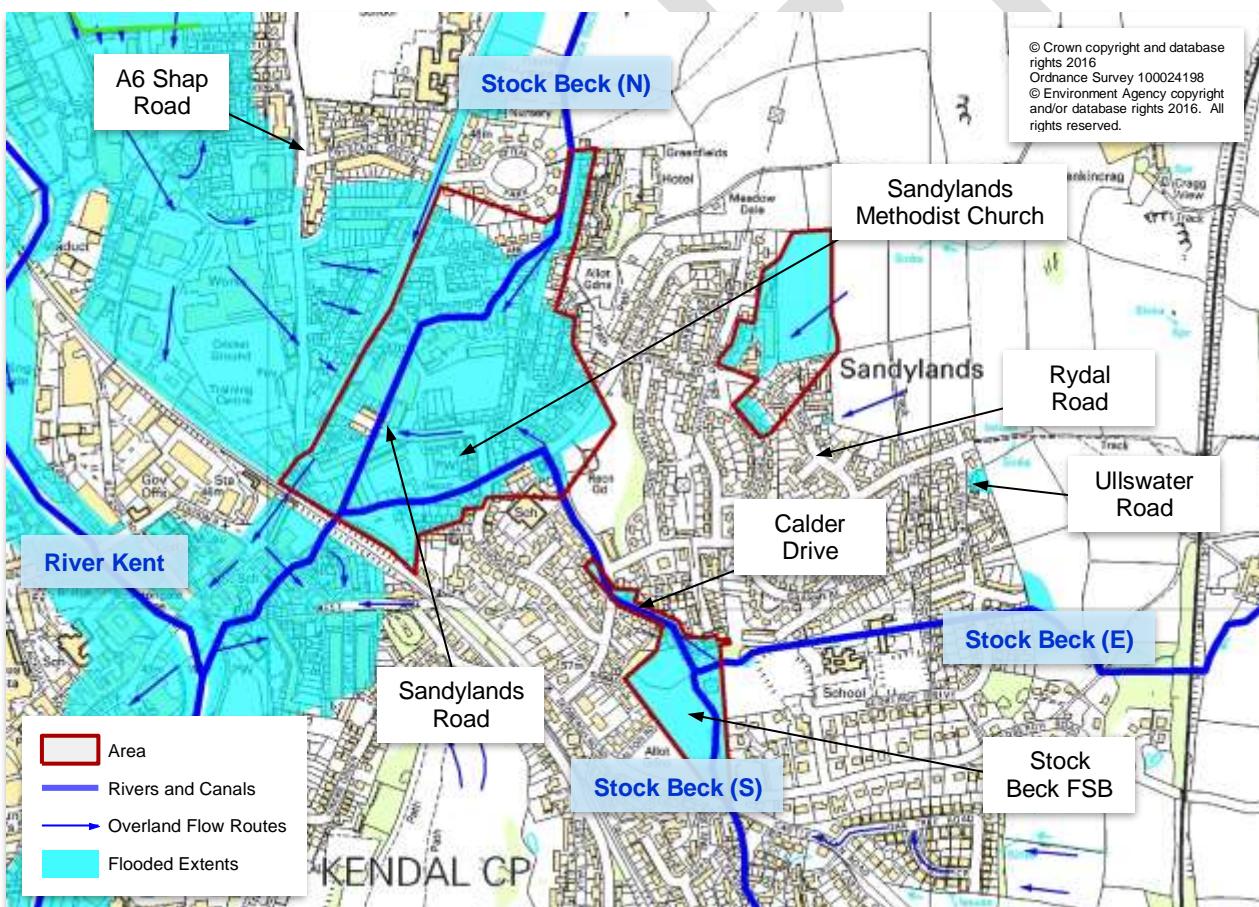
Figure 17: Overland flow routes in the Shap Road, Appleby Road and Sandylands areas

Reports and evidence suggest that the flooding in this area was caused by multiple mechanisms. The area is situated immediately adjacent to Mintsfeet, and so was affected by flood flows from the Rivers Mint and Kent as per Area 2. In addition to this, the Stock Beck system, which comprises three tributary watercourses, flows through the area and is culverted for much of its length. Flooding was reported from a number of manholes associated with this culvert on Sandylands Road and damage was caused to part of a footpath on Eastgate, where the culvert roof was lifted up by the water pressure. Furthermore, overland flow was observed from the 'north' Stock Beck tributary down Appleby Road, affecting properties on Appleby Road and in the Longlands View and Fowling Lane areas (see Area 3: Shap Road and Appleby Road).

The principle flood mechanisms and overland flow routes in this area are shown in Figure 17, with the aftermath of the flooding in the area shown in Figure 18. A timeline of the key events is given in Table 9.

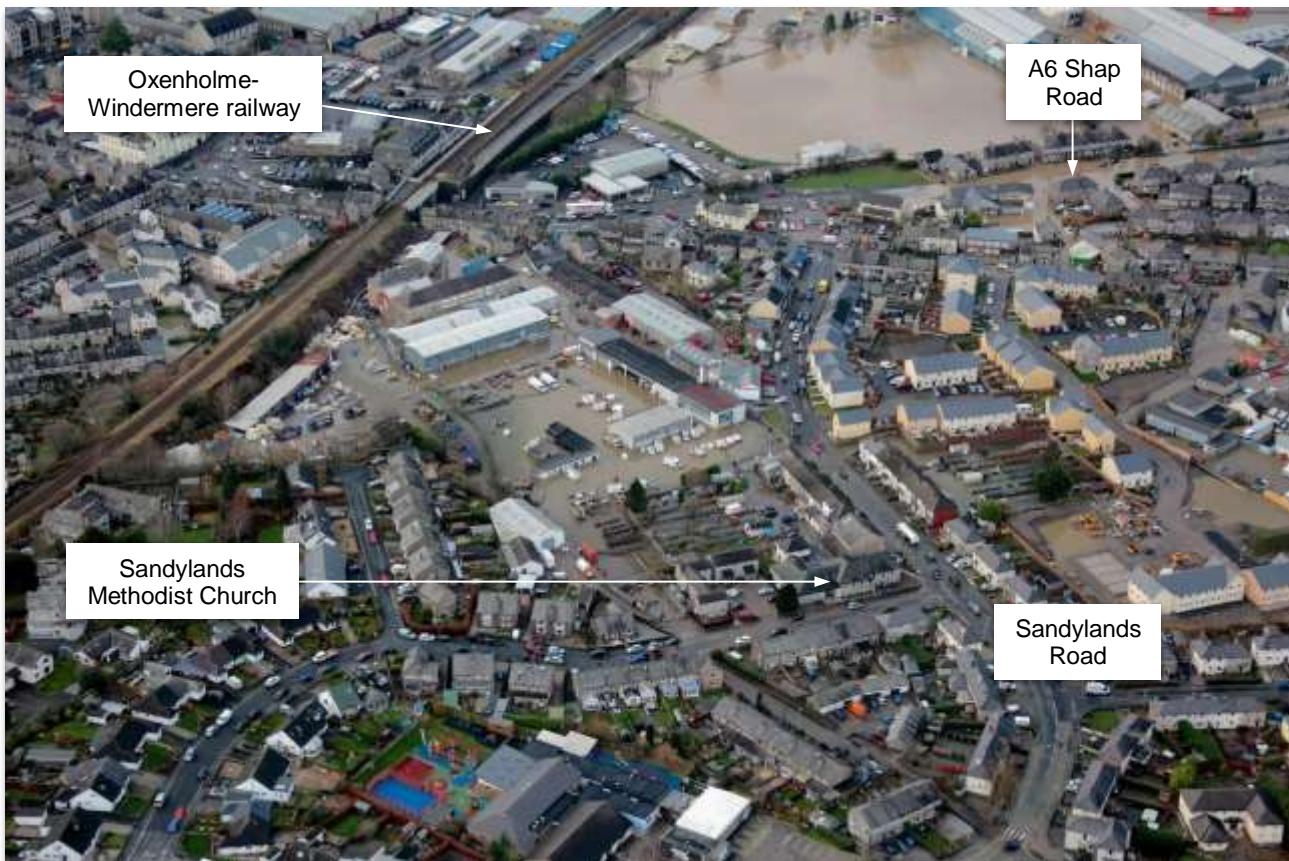
Figure 18: Aerial photograph of the Sandylands area on 6th December 2015

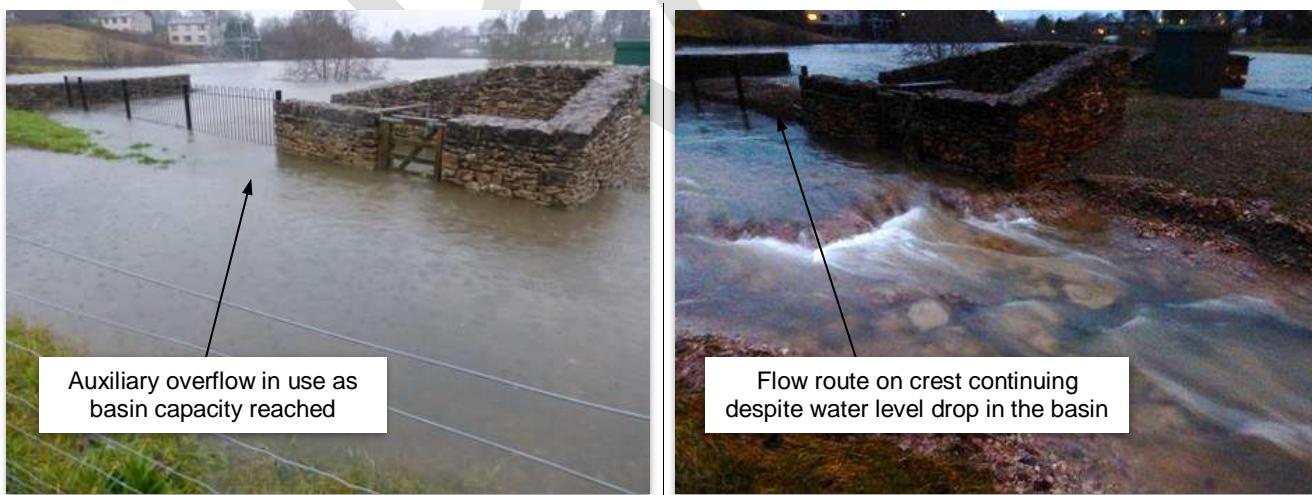
As the event progressed, properties on Calder Drive were affected by overland flow caused by problems associated with the performance of Stock Beck FSB. This storage basin is located upstream of Calder Drive and on the confluence of the two southern tributaries to the Stock Beck watercourse system (see Figure 6). It is an online flood storage basin and immediately downstream of the confluence, the watercourse discharges through the water-retaining embankment via a flow control structure. This flow control comprises an orifice/penstock (principle control) and a high level weir and spillway (secondary control and auxiliary overflow).

Environment Agency telemetry, which monitors water levels at the FSB, indicates that the basin spillway level was reached around 12:45. The telemetry indicates that levels within the FSB continued to rise through the afternoon, before peaking around 18:00 and slowly receding through the late evening and into 6th December. During the Storm Desmond event, it is apparent from photographs taken on the afternoon of 5th December that the capacity of the storage basin was reached. In Figure 19, the photograph on the left clearly shows that at 16:00, the basin is full and the auxiliary overflow (a protected section of embankment shown in the foreground of the photograph) is in use.

**Figure 19: Stock Beck FSB at 16:00 05/12/2015 (left) and at 08:57 06/12/2015 (right)**

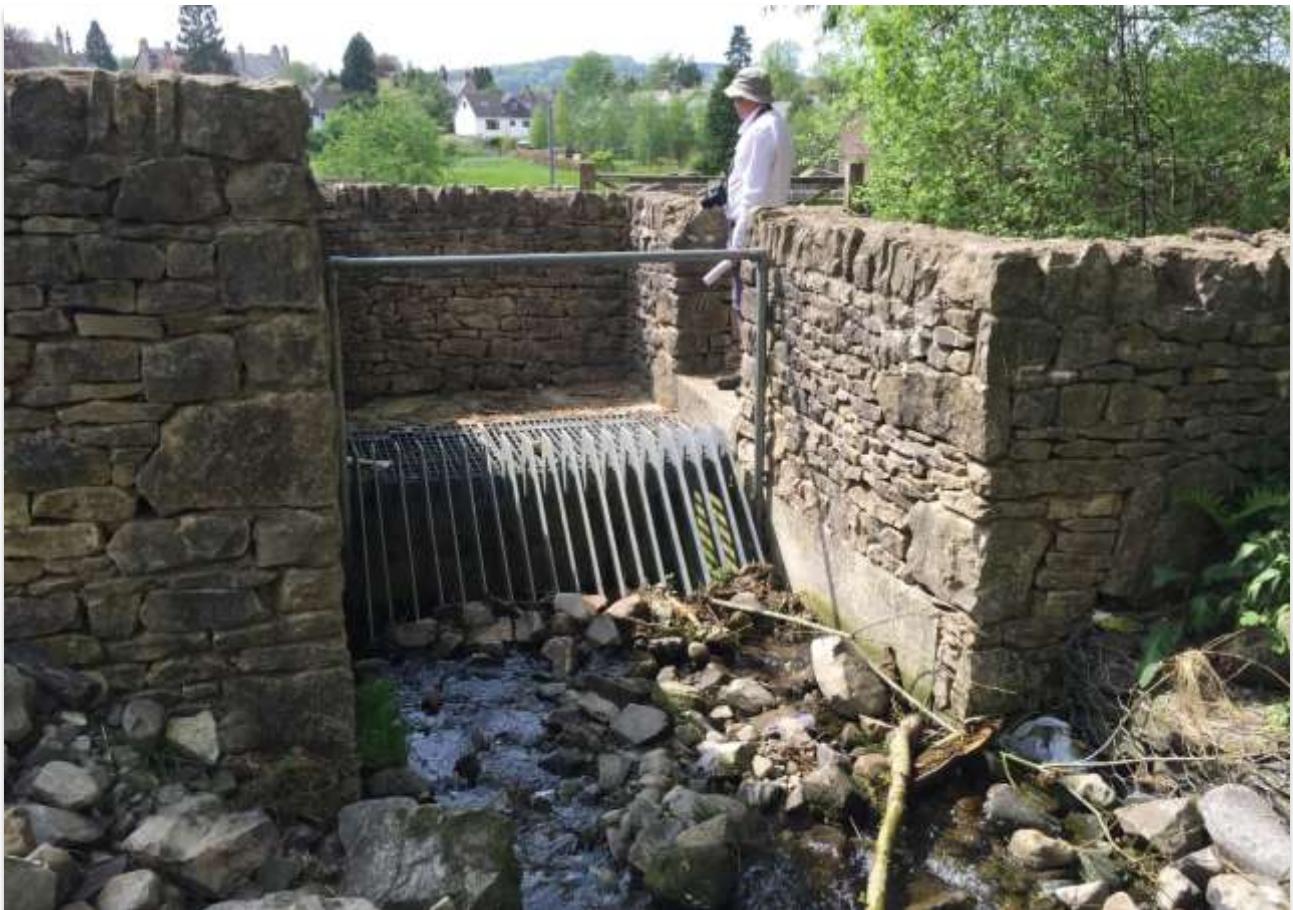
embankment crest. As it meets the embankment, the watercourse then enters into culvert via a trash screen and drop structure as shown in Figure 20.

Figure 20: Stock Beck tributary culvert inlet to Stock Beck FSB

During the event, the trash screen was blocked by debris and the inlet capacity of the culvert exceeded, causing water levels to back up. A significant amount of debris was washed down onto the screen from a damaged outfall structure immediately upstream, which became blocked and surcharged. As a result, a significant amount of material was scoured from behind the structure (Figure 21). Unfortunately, the design of the inlet structure is such that the access provided to allow the screen to be cleared also provided the pathway for the water to escape. Flows passed through the gated opening as opposed to entering the culvert and spilled onto the basin embankment crest. The topography of the crest is such that these flows were then channelled along the crest (as opposed to spilling back into the basin) before continuing into Calder Drive.

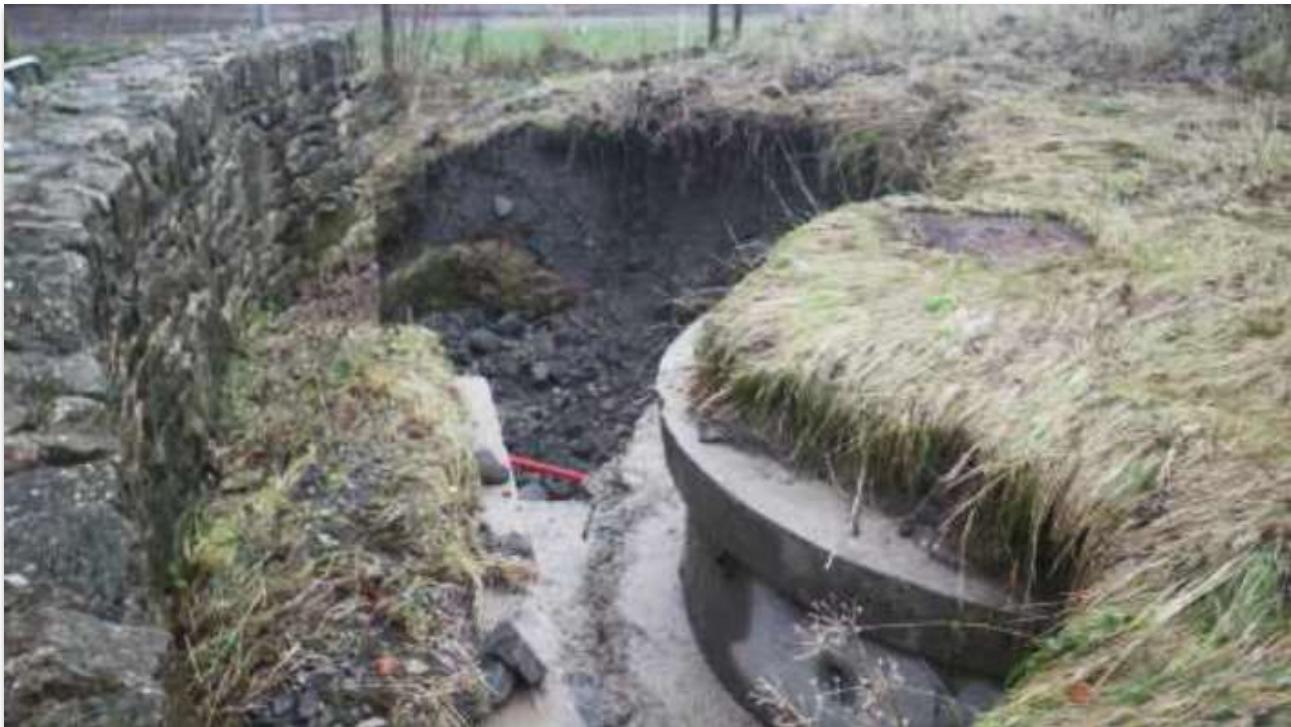
Figure 21: Scour damage to rear of outfall structure upstream of Stock Beck FSB

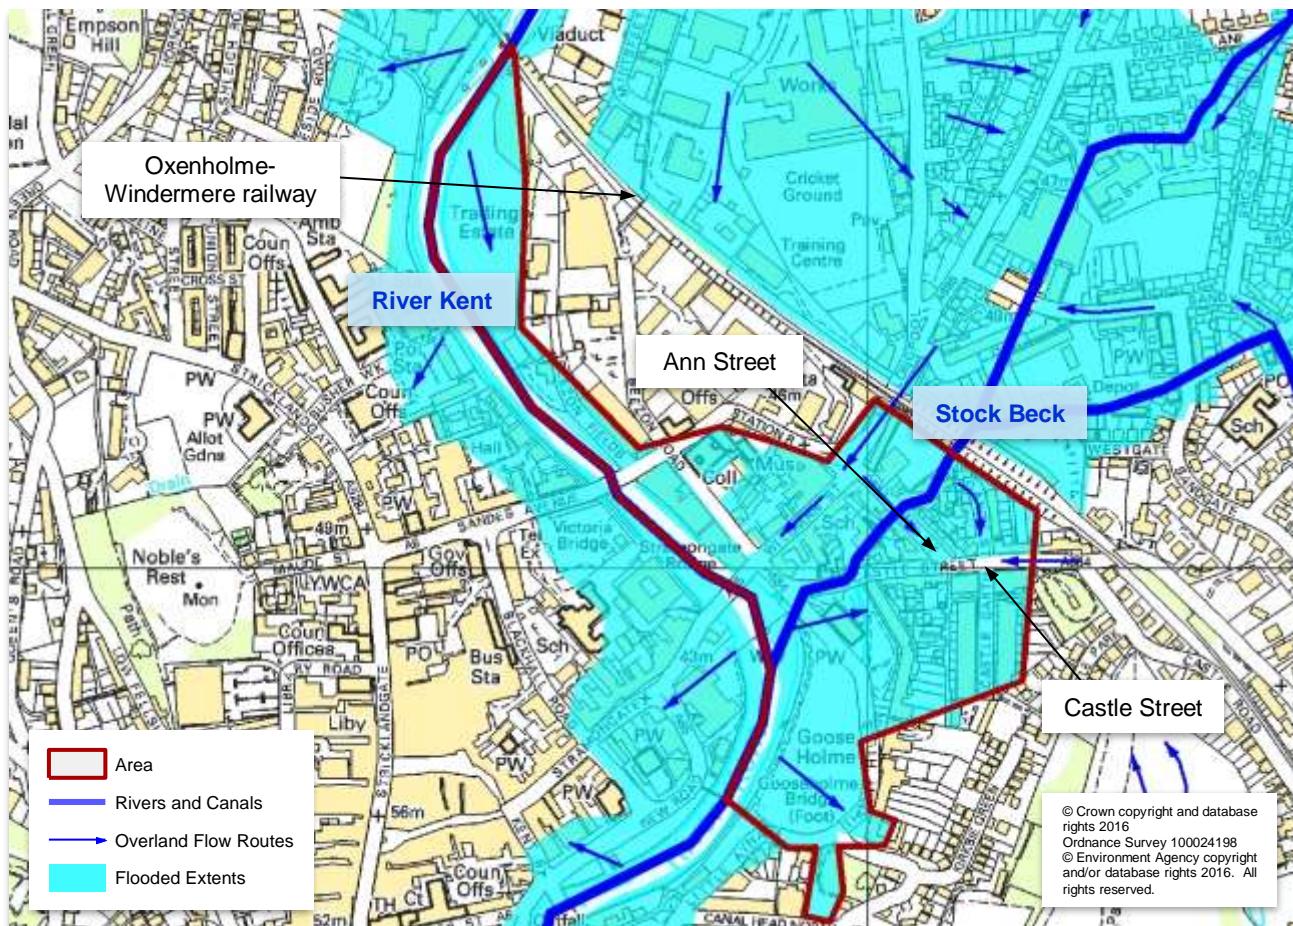
Figure 22: Overland flow routes in the Wildman Street, Ann Street and Castle Street area

The principle flood mechanisms and overland flow routes in and around the Ann Street and Castle Street area are shown in Figure 22, with a timeline of the key events given in Table 10.

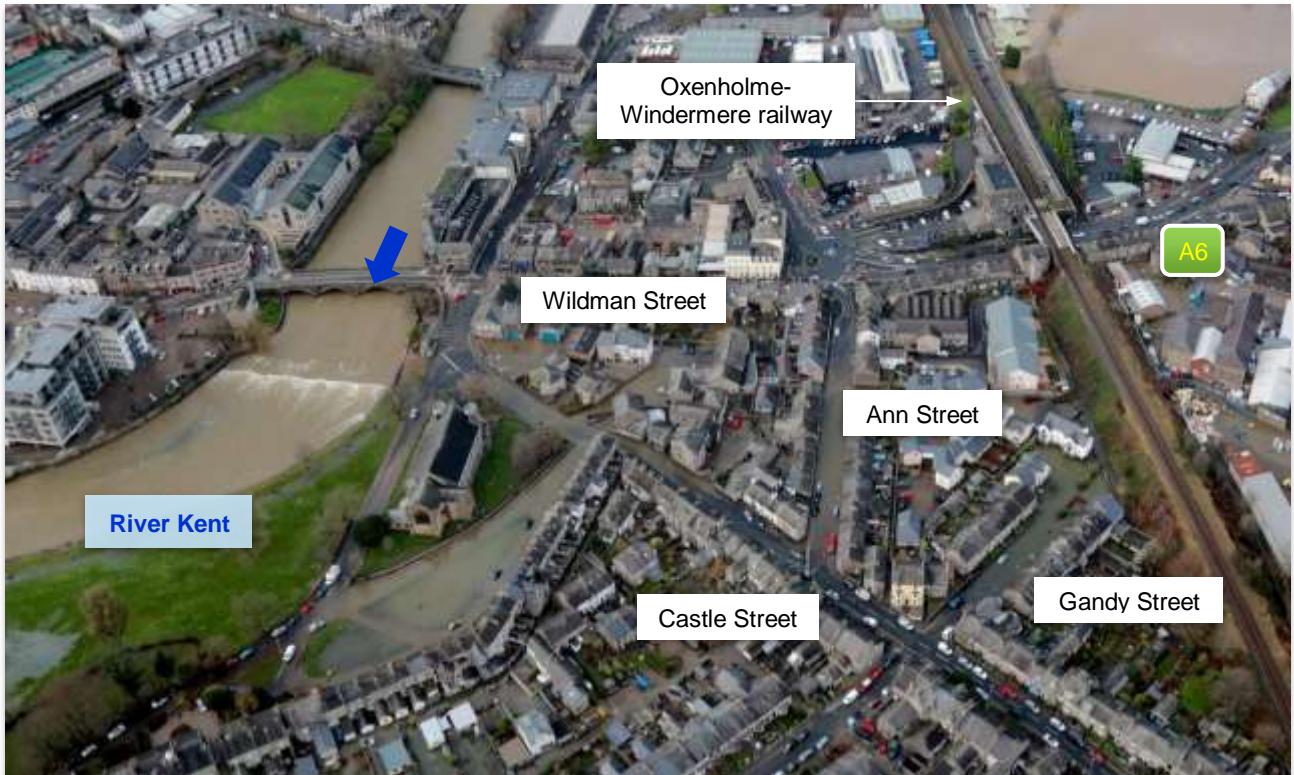
Figure 23: Aerial photograph of the Ann Street and Castle Street area on 6th December 2015

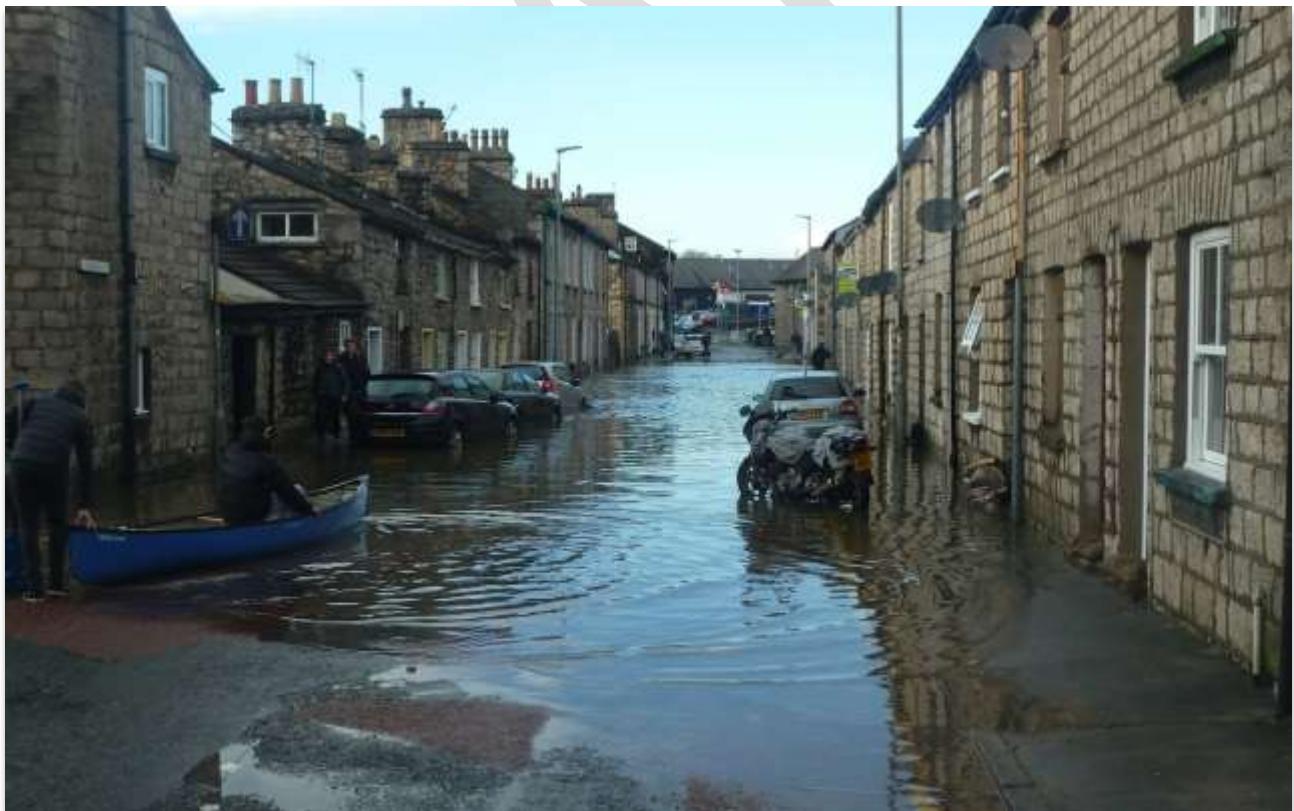
Figure 24: Ann Street in the aftermath of the event on 6th December 2015

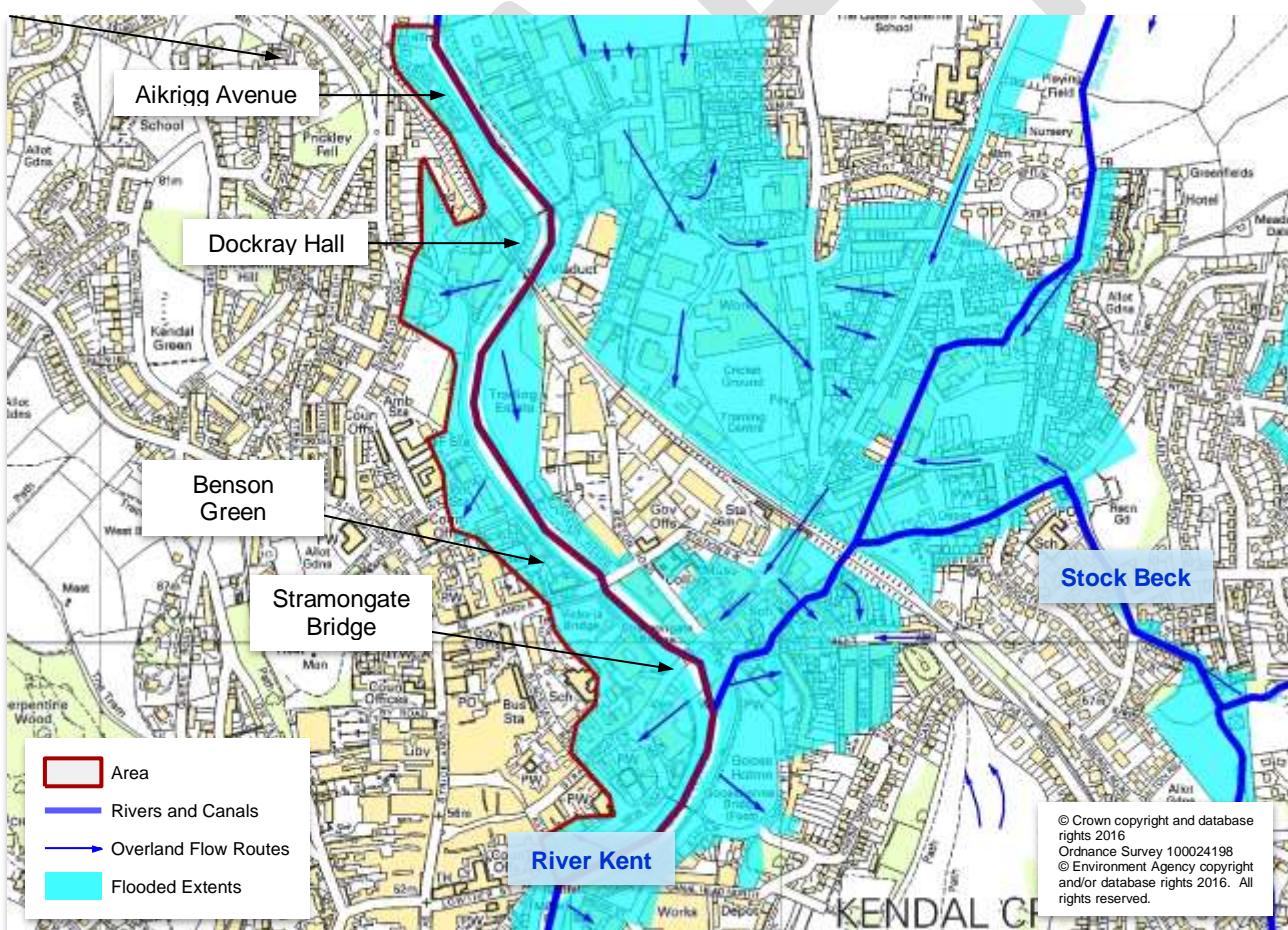
Figure 25: Overland flow routes in the centre of Kendal

Figure 25 indicates the key overland flow routes and a timeline of the key events in the centre of Kendal is given in Table 11.

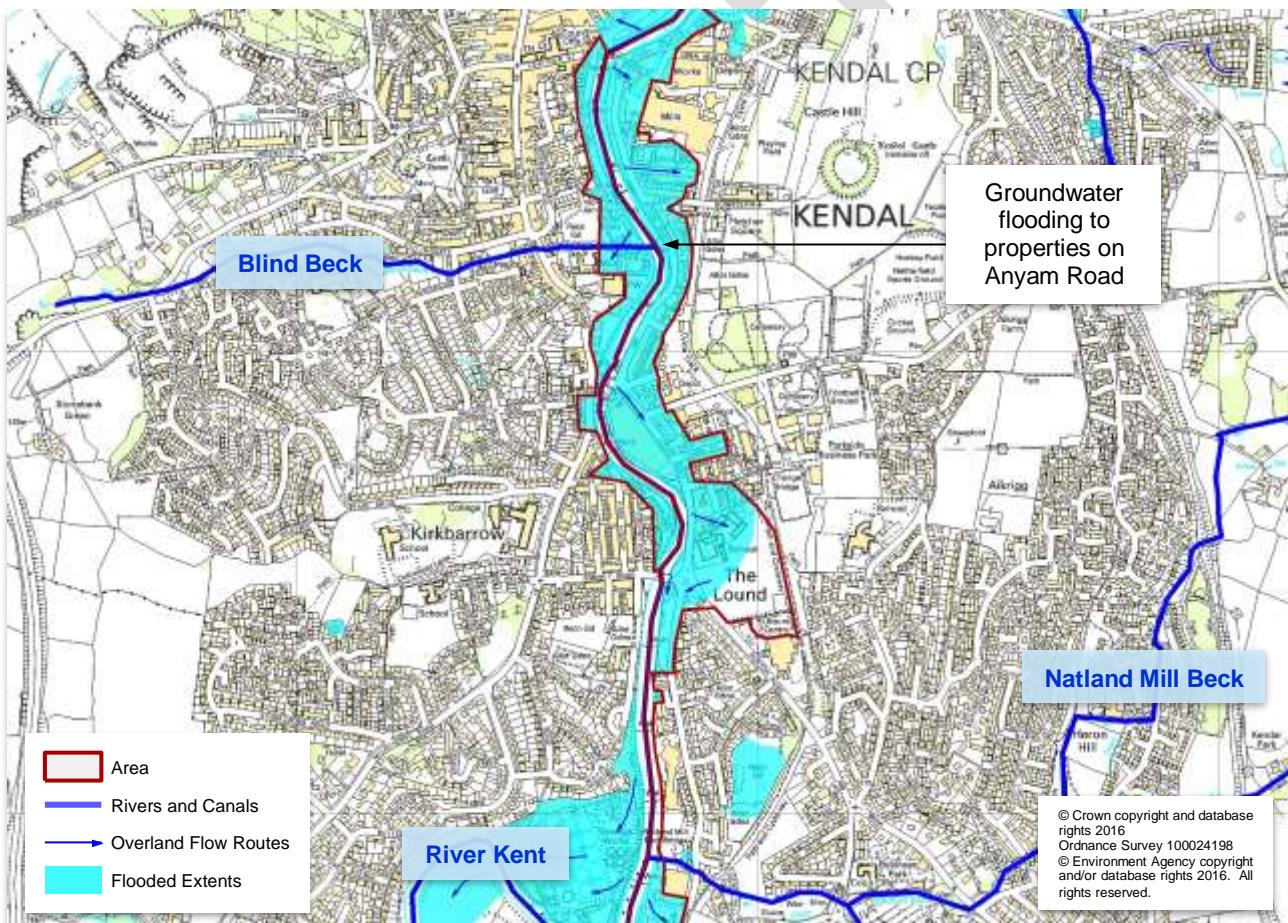
Figure 26: Overland flow routes on the left and right banks of the River Kent through Kendal

Figure 26 indicates the key overland flow routes and a timeline of the key events is given in Table 12.

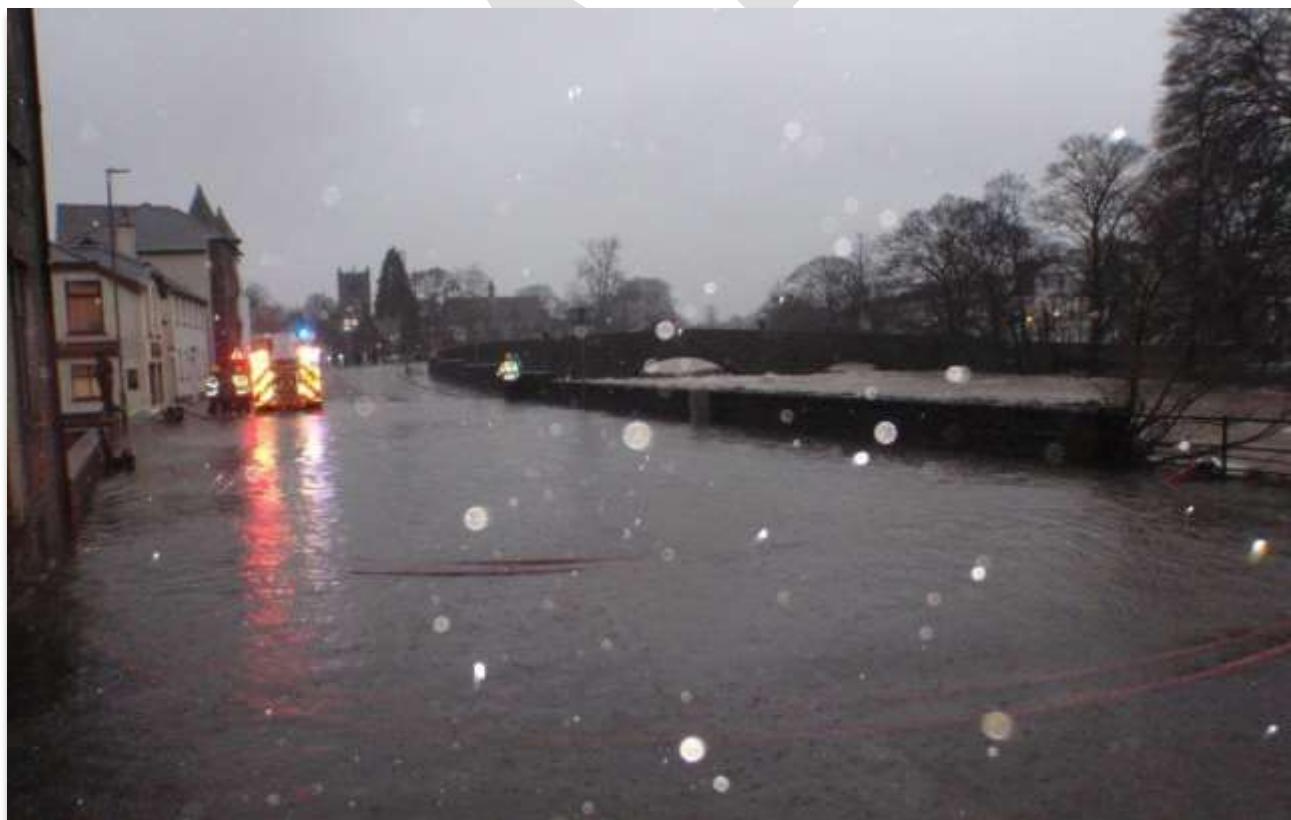
The east and west sides of Kendal are connected by a series of bridges over the River Kent and these have varying ages and construction types. The bridges include road bridges, pedestrian footbridges, and a railway viaduct, and are thought to have exacerbated the flooding along the banks of the River Kent. Evidence suggests that these bridges reached their capacity during the event and Figure 27 shows the water level in the River Kent approaching the soffit of the eastern arch of Nether Bridge. The railway viaduct is also thought to have had a role in diverting flow in the River Kent into the Mintsfeet area. Further investigatory work is required to fully assess the role of the bridges and to identify where conveyancing improvements can be made.

Figure 27: Nether Bridge, taken on the right bank of the River Kent looking north

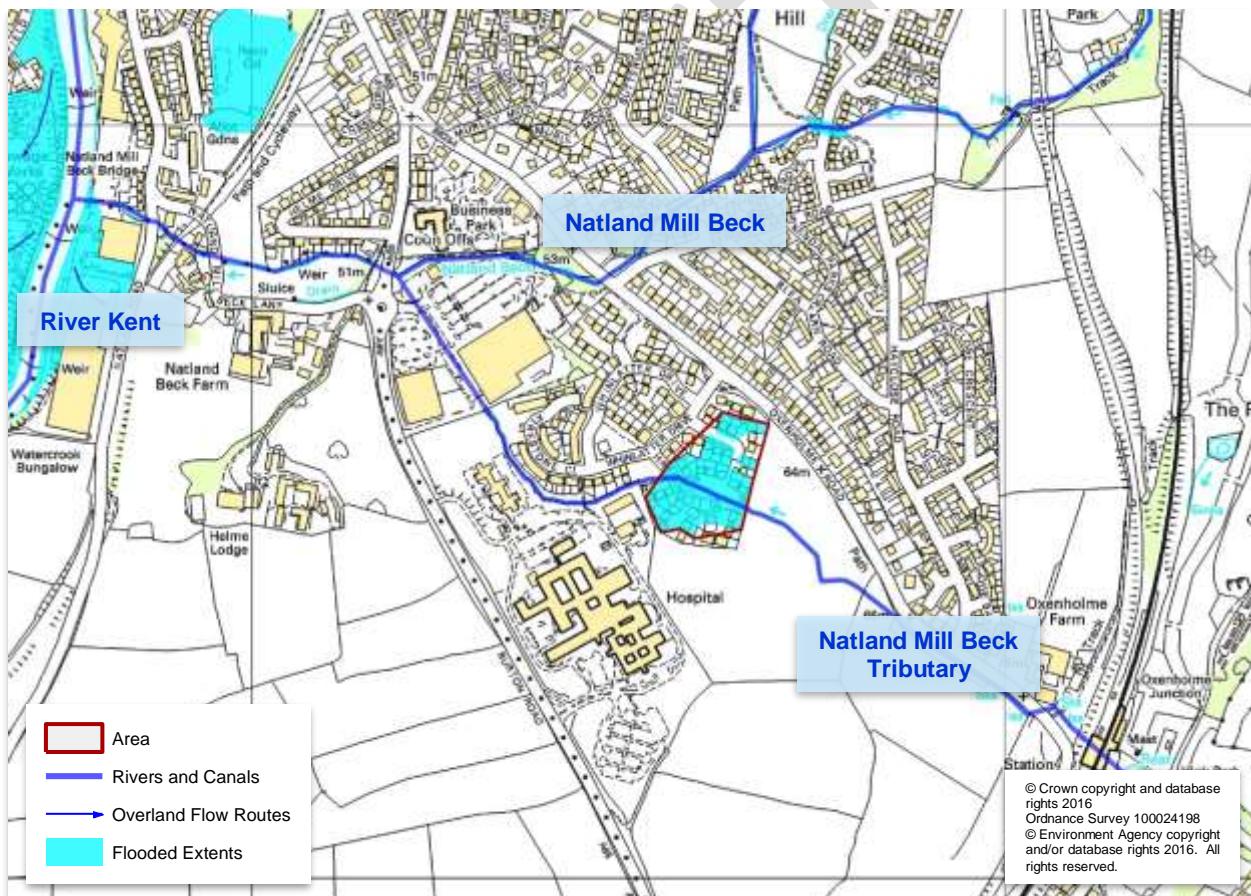
Figure 28: Affected areas around Natland Mill Beck and Natland Mill Beck Tributary

Reports from local residents who observed the flooding mechanisms were that the Natland Mill Beck Tributary exceeded its channel capacity in the fields upstream and flowed out of bank across the fields towards Blencathra Gardens and Hardknott Gardens. There were also observations of a blockage where the watercourse flows underneath a fence line at the eastern extent of the estate. The blockage at the fence line was caused by debris - including bed material from the watercourse that had been scoured by the velocity of the water - becoming trapped on the fence. This blockage resulted in flow leaving the watercourse channel on the right bank, flowing through properties on Blencathra Gardens and Hardknott Gardens before re-joining the channel. The affected area is shown in Figure 28.

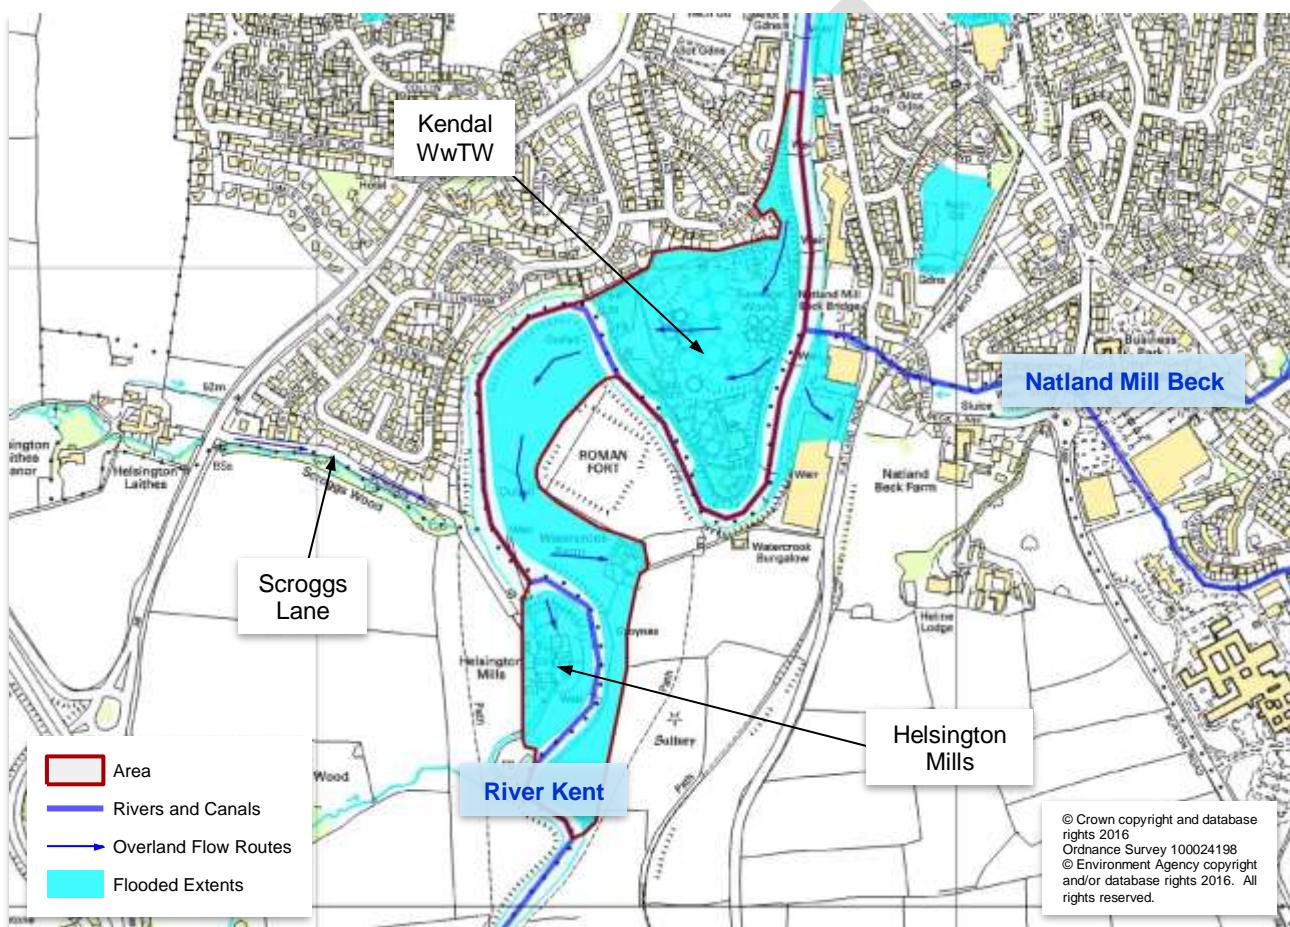
Figure 29: Overland flow routes at Kendal WwTW and Helsington Mills

Figure 29 indicates the key overland flow routes, with the aftermath of the flooding in the area shown in a timeline of the key events given in Table 14.

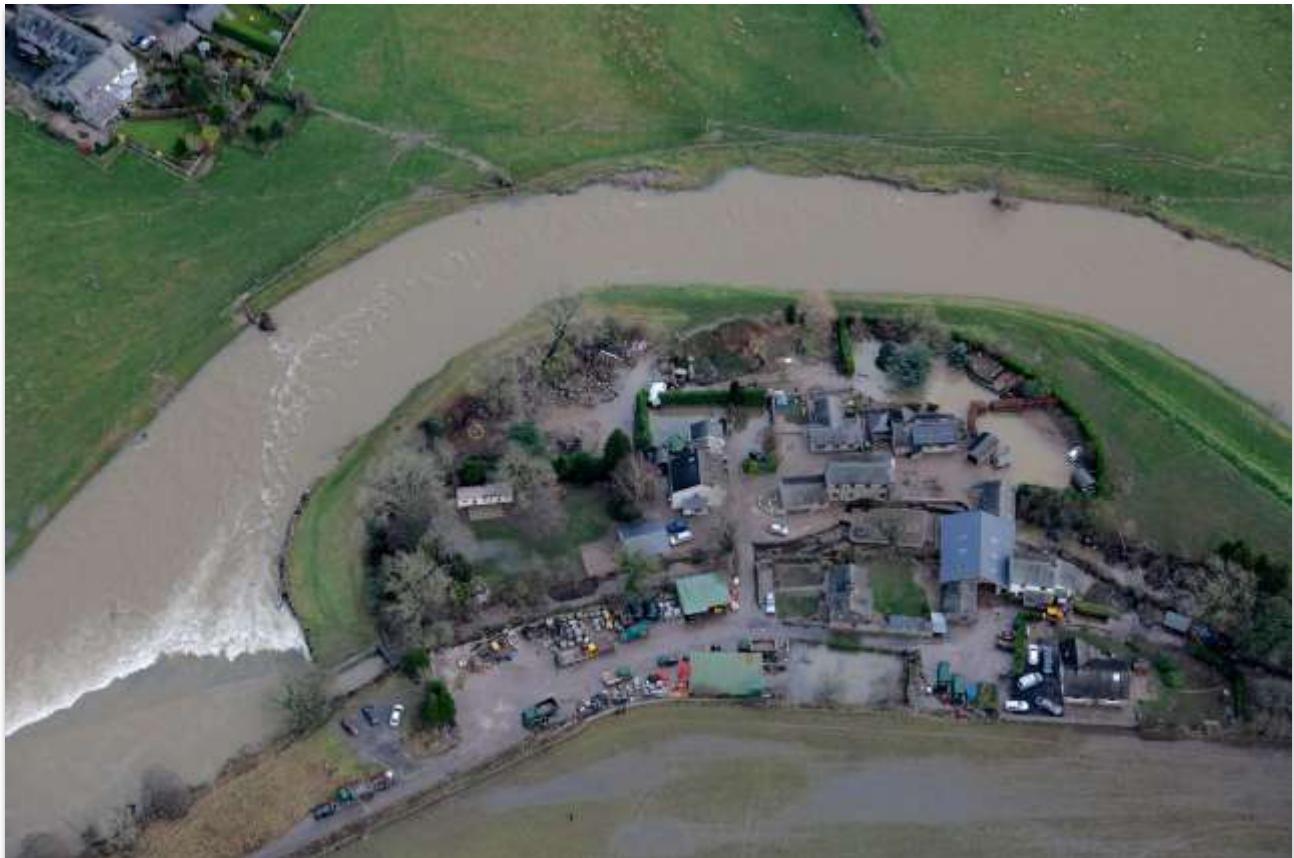
Figure 30: Aerial photograph of Helsington Mills on 6th December 2015

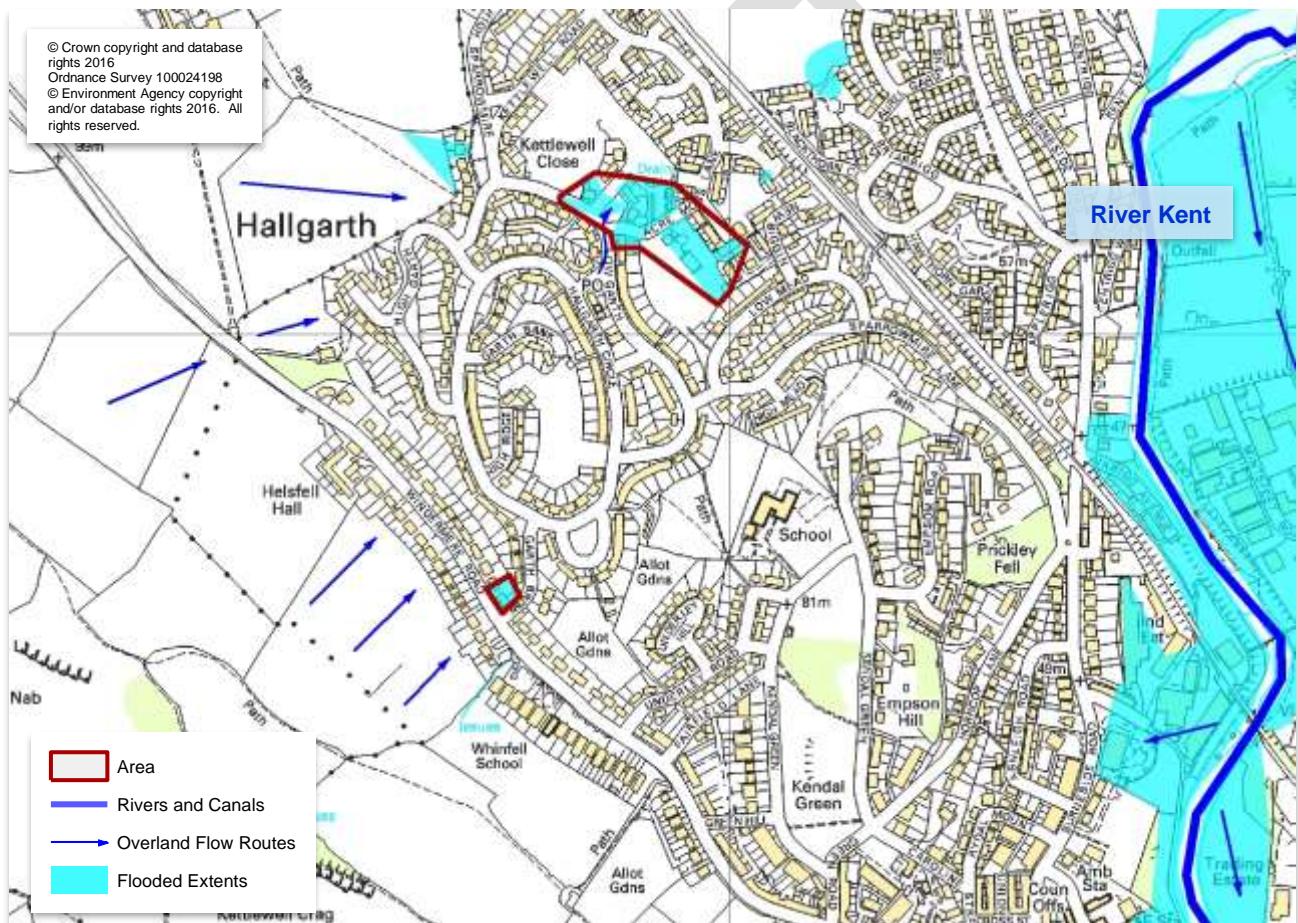
Figure 31: Overland flow routes in the Hallgarth area

The principle flood mechanisms and overland flow routes for the Hallgarth area are shown in Figure 31.
