# Ambleside

## Flood Investigation Report

**Old Bridge House, Stock Ghyll, Ambleside**

## Flood Event 5-6<sup>th</sup> December 2015

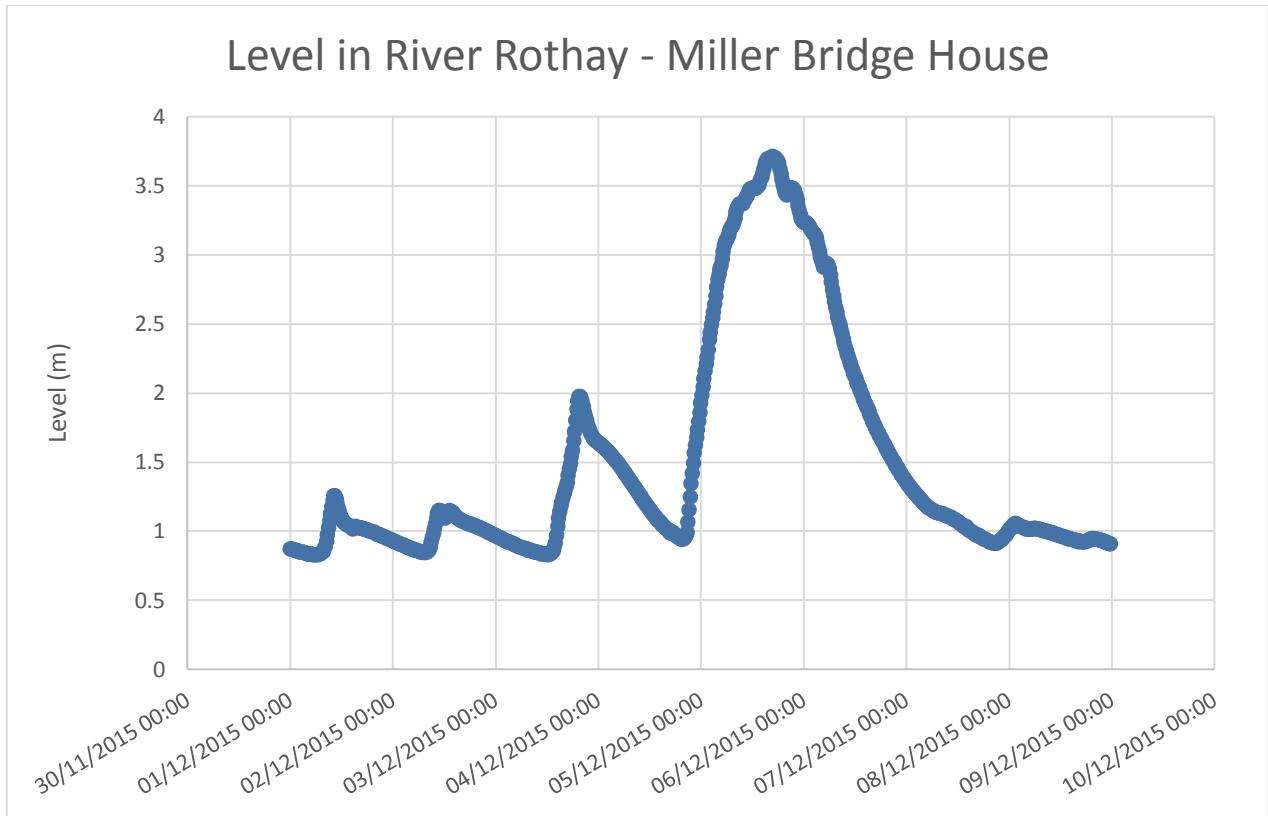
**Figure 10 - Levels Recorded at Miller Bridge House Gauging Station on the River Rothay from 01/12/2015 to 08/12/2015.**

A peak level of 3.714m (44.148mAOD) was recorded at Miller Bridge House on the River Rothay during 5th December 2015. This exceeded the previous highest recorded level of 3.517m (43.951mAOD), recorded during the November 2009 flood event. Table 3 shows the highest recorded peak flood levels at the Miller Bridge House gauge.

Figure 10 shows the levels recorded by the Miller Bridge House river monitoring gauge. This shows the time and duration of the flood event on the 5<sup>th</sup> and 6<sup>th</sup> of December, and illustrates the magnitude of the flood event.

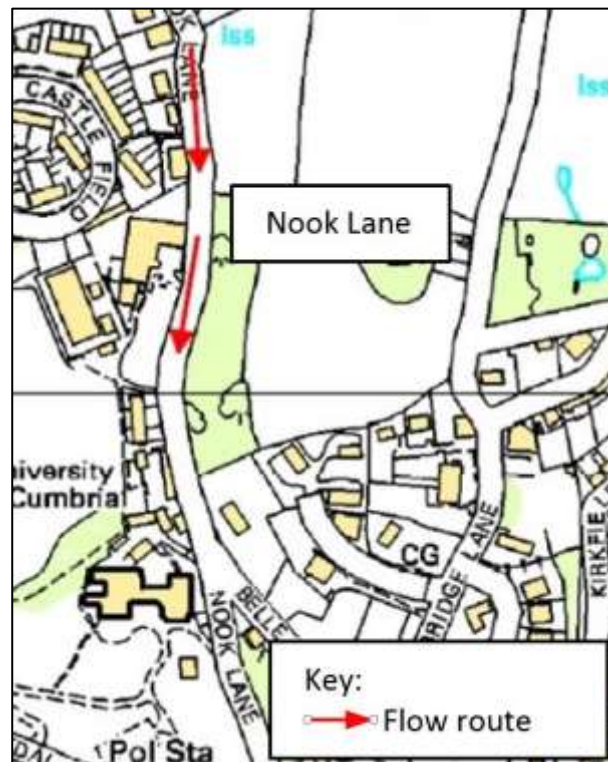
Figure 11 – Flow route down Nook Lane

Nook Lane is located in the northern part of Ambleside. As a result of the prolonged, intense rainfall, it was reported that there was surface water flow on Nook Lane. Local residents reported that a property boundary wall had been weakened by flood water. There is an ordinary watercourse that flows across fields to the east of Nook Lane, which is then culverted (piped) under Nook Lane when it reaches the road. Following the flood event, site investigations identified that the culverted watercourse, which flows west towards Greenbank, appeared to be blocked.

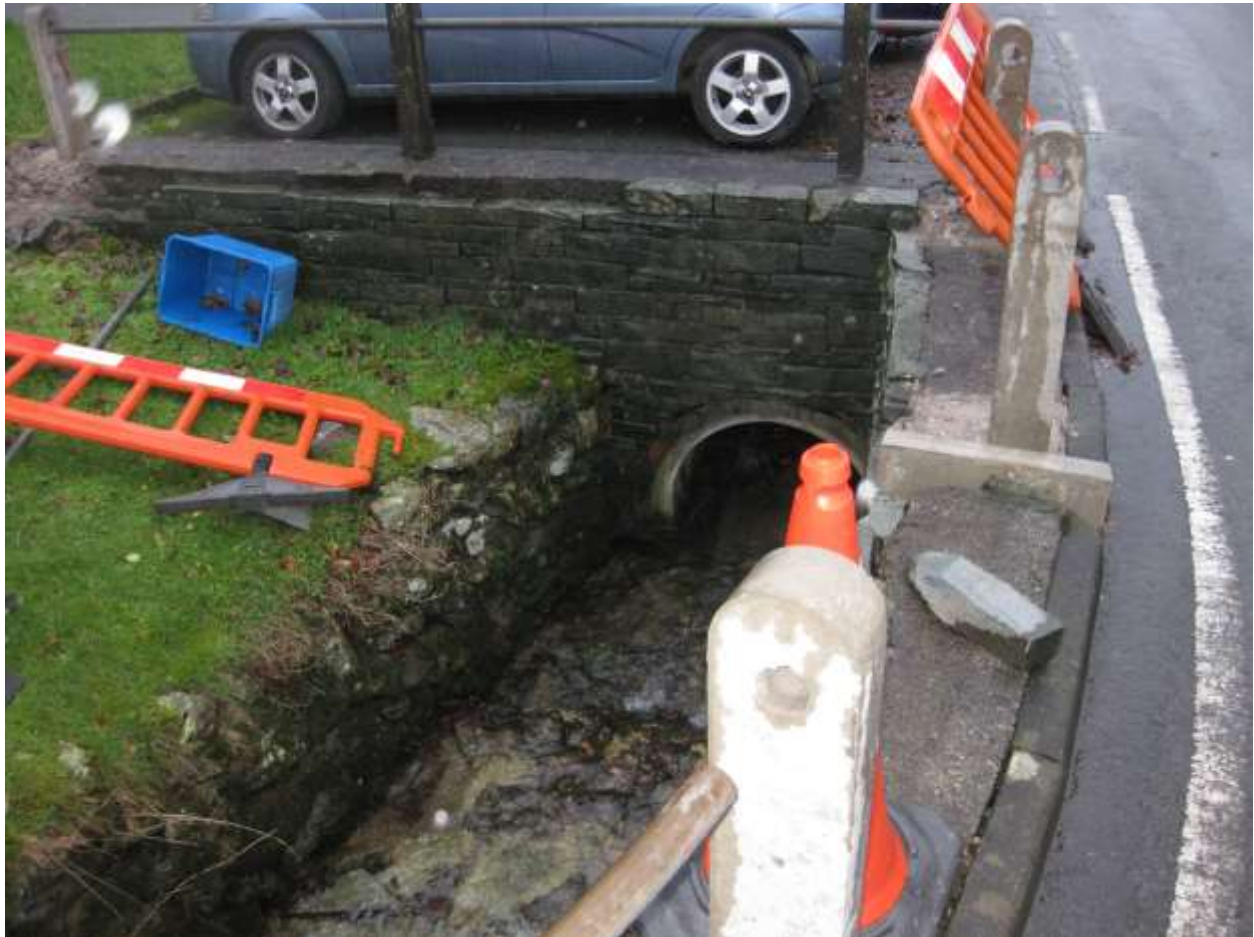
**Figure 13 – Culvert on Greenbank Ghyll, which runs parallel to Greenbank Road**

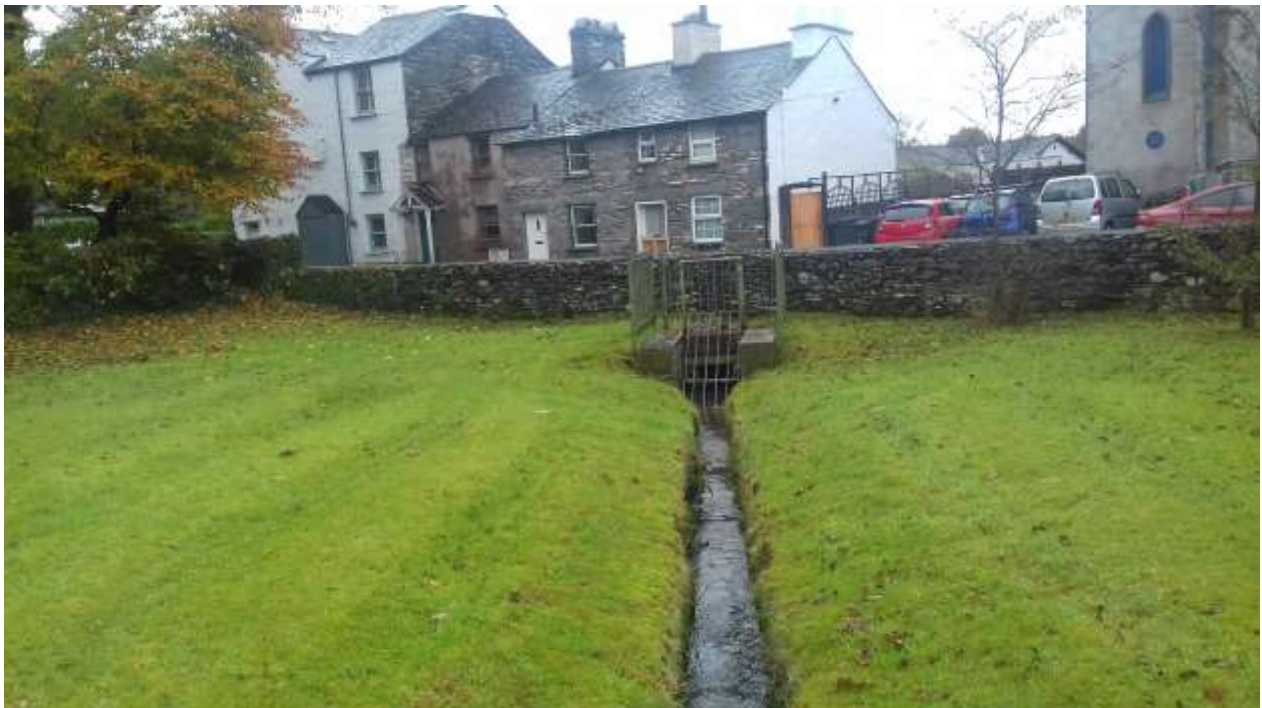
At the southern end of Greenbank Road, Greenbank Ghyll enters a culvert which flows under Rydal Road, as illustrated in Figure 14. A local resident reported that during the flood event water levels built up behind the dry stone wall to the north of Rydal Road (the dry stone wall can be seen downstream of the culvert inlet in Figure 14). Eventually the water that had built up behind the dry stone wall made its way onto Rydal Road, and began to pool on Rydal Road in front of the cottages shown in Figure 15. Water was observed to be flowing around the western end of the terrace of cottages and into their rear yards, where it was being retained by the property boundary walls. Due to the drainage holes within the property boundary walls being approximately 18 inches above ground level, this led to water levels building up in the area around the cottages and on Rydal Road. Eventually, the water level stabilised in the area, possibly due to the water level reaching the height of the drainage holes. Subsequently, a section of property boundary wall that had been retaining water collapsed.

**Figure 14 – Culvert inlet on Greenbank Ghyll, just upstream of Rydal Road and opposite cottages shown in Figure 15**

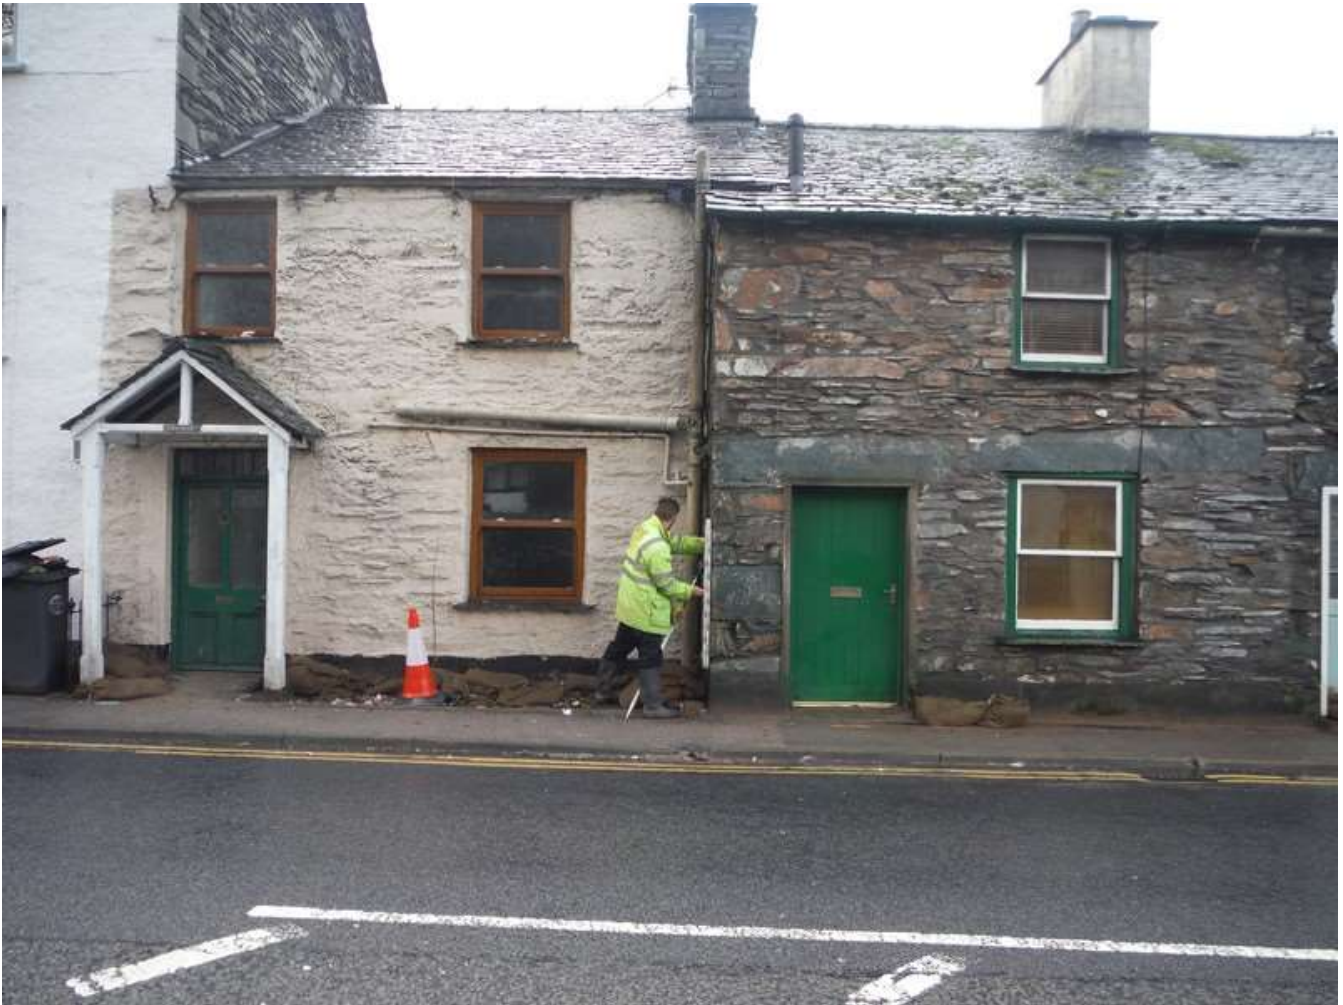
Figure 15 shows the recorded water level at the cottages on Rydal Road, as indicated by one of the owners.

**Figure 15 - Recorded water level at row of cottages on Rydal Road, situated opposite the Greenbank Ghyll culvert inlet shown in Figure 14**

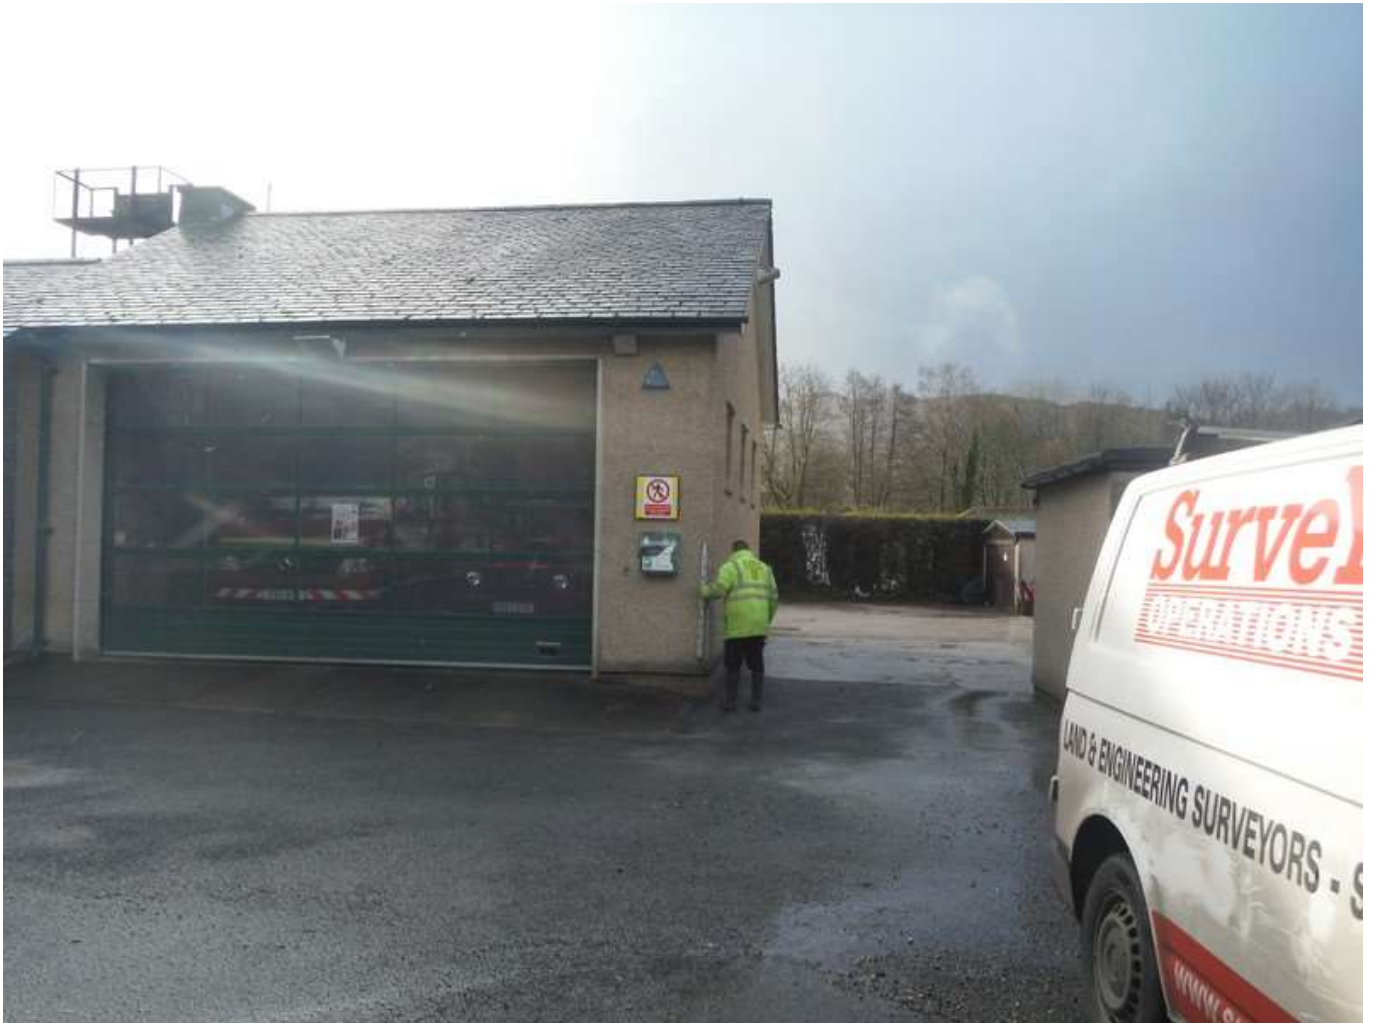
Figure 17 shows the recorded water level on the building belonging to the Fire and Rescue Centre. Local residents on Stoney Lane reported that they did not believe that the Fire and Rescue Centre flooded internally, despite being surrounded by water during the flood event.

**Figure 17 - Recorded water level at the Fire and Rescue Centre**

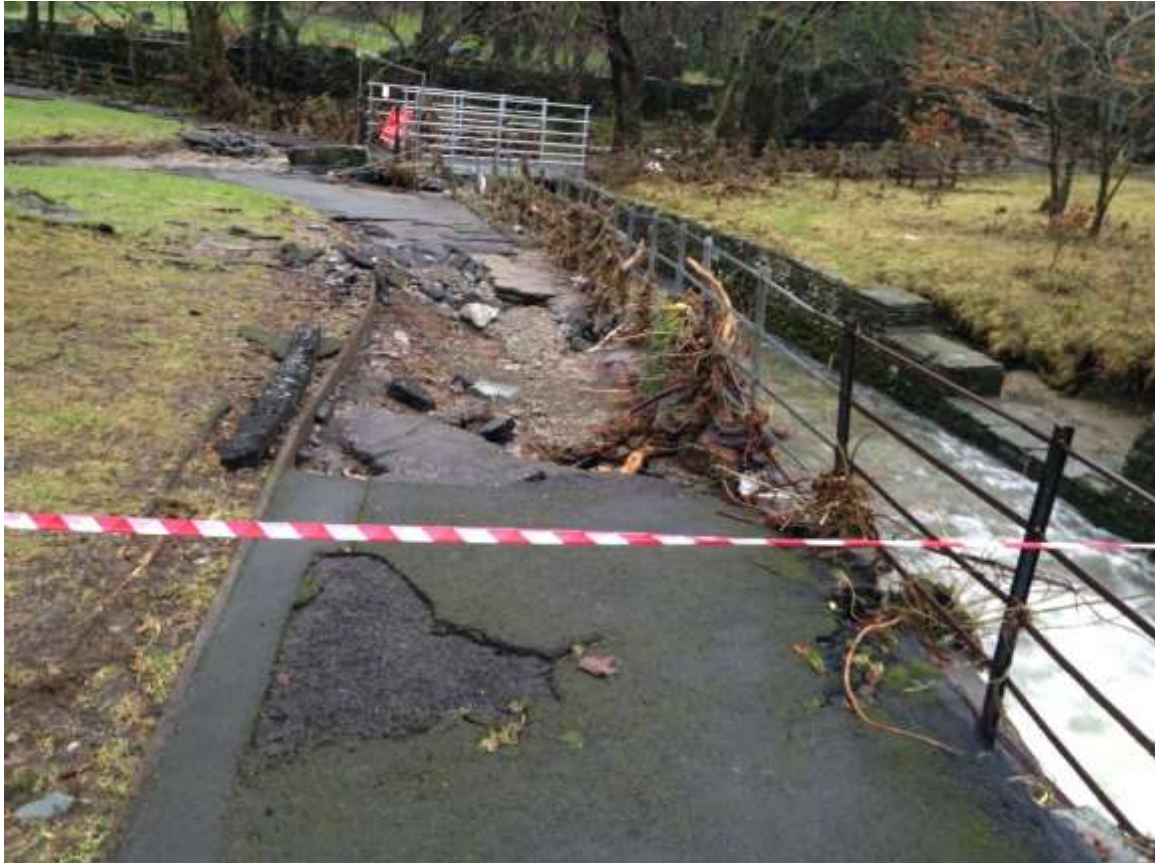
On the left bank of Stock Ghyll, water exceeded channel capacity and flooded the adjacent car park, and continued to flow in a south-westerly direction across the floodplain of the playing field. As a result of the significant out-of-bank flows across the floodplain, the velocity of the flows caused damage to footpaths, retaining walls and railings in the park, as illustrated in Figures 18 and 19. To the rear of the car park, a row of terraces on Millans Park which back onto the car park suffered basement flooding. The resident of Rose Cottage, which is situated immediately upstream of Rydal Road adjacent to Stock Ghyll, reported that the basement of the property flooded through the flag flooring.

**Figure 18 - Flood damage caused to a footpath by Stock Ghyll in Rothay Park. Note the level of the debris in the railings.**

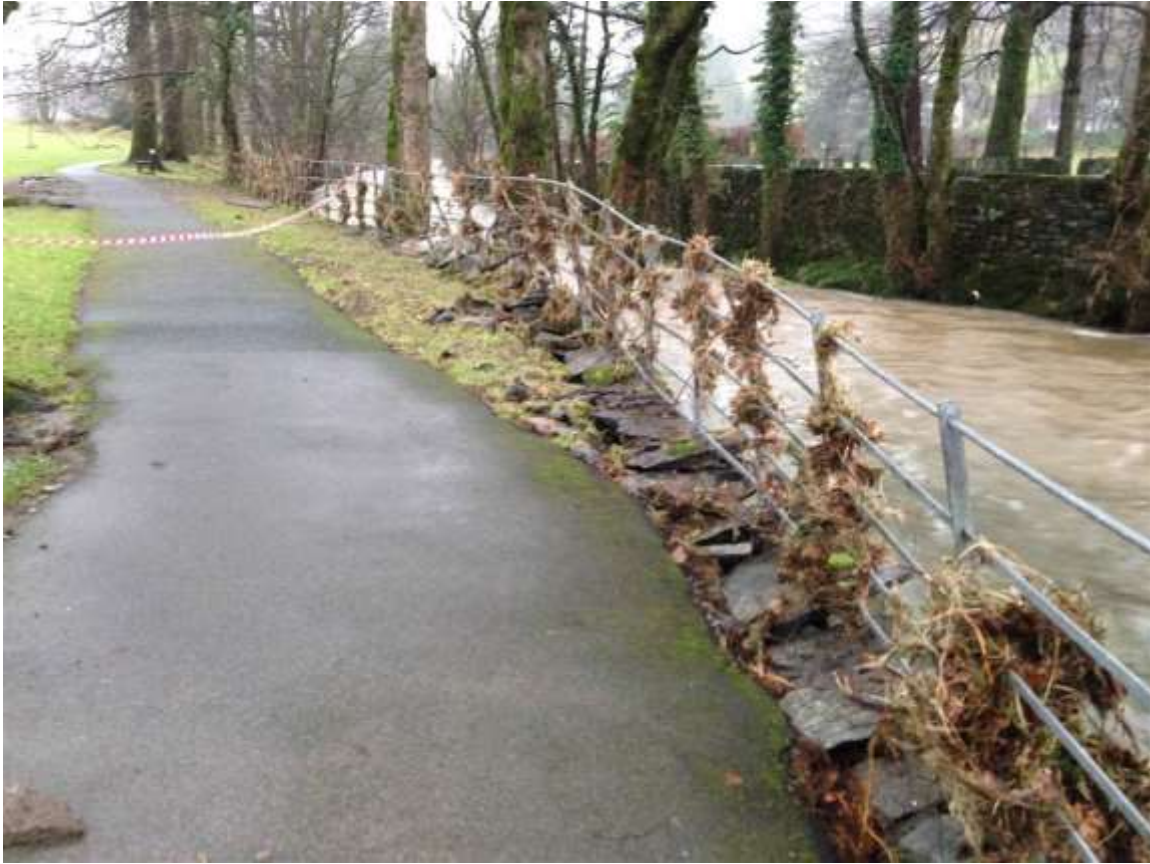
**Figure 19 - Flood damage caused by Stock Ghyll in Rothay Park. Note the level of the debris in the railings.**

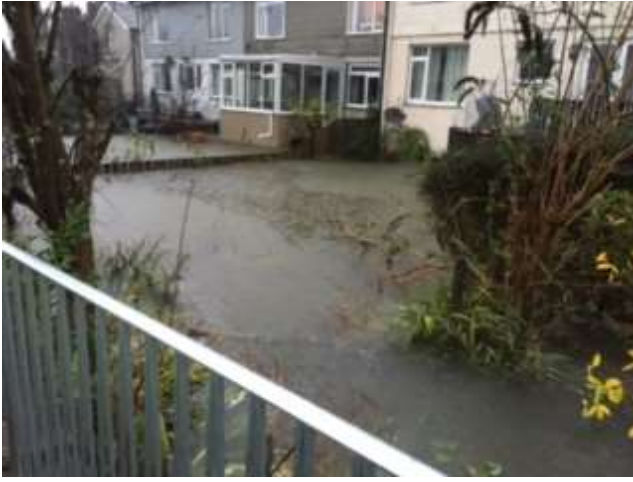
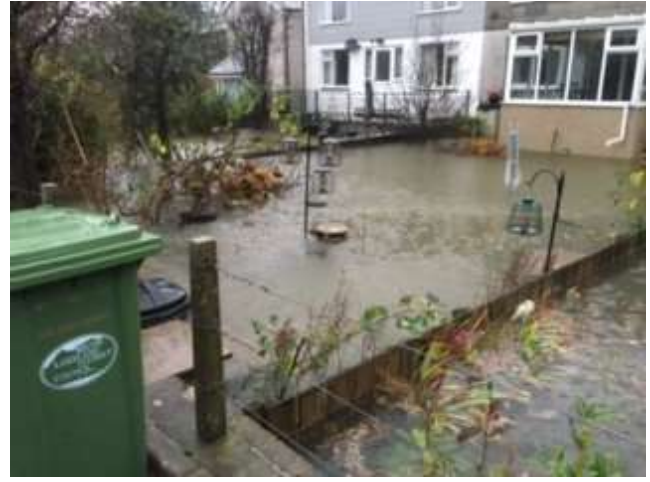
In Figures 21 and 22, flooding affecting the front gardens of properties on Wansfell Road is shown.

**Figures 21 and 22 - Properties affected by flooding from Fisher Beck on Wansfell Road**

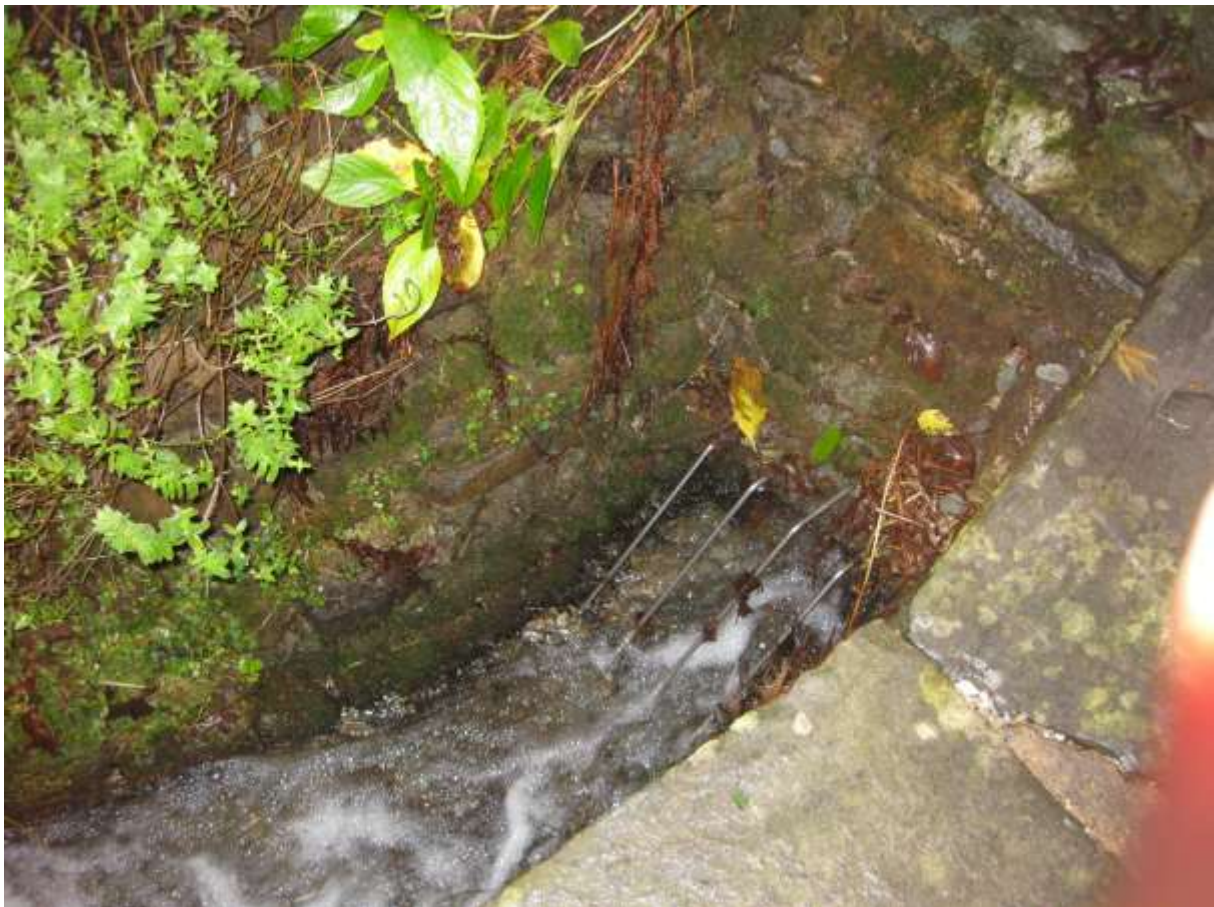
Water flowed down the steep Fisher Beck Lane towards the Old Lake Road, before reaching the Fisher Beck Hotel. Because of the limited capacity of the culvert under Lake Road, combined with the overland flood flows from upstream down Bluehill Road and Wansfell Road, water continued to flow overland in a westerly direction over Lake Road.

**Figure 23 – One of the culvert trash screens on Fisher Beck. Note the limited culvert capacity.**

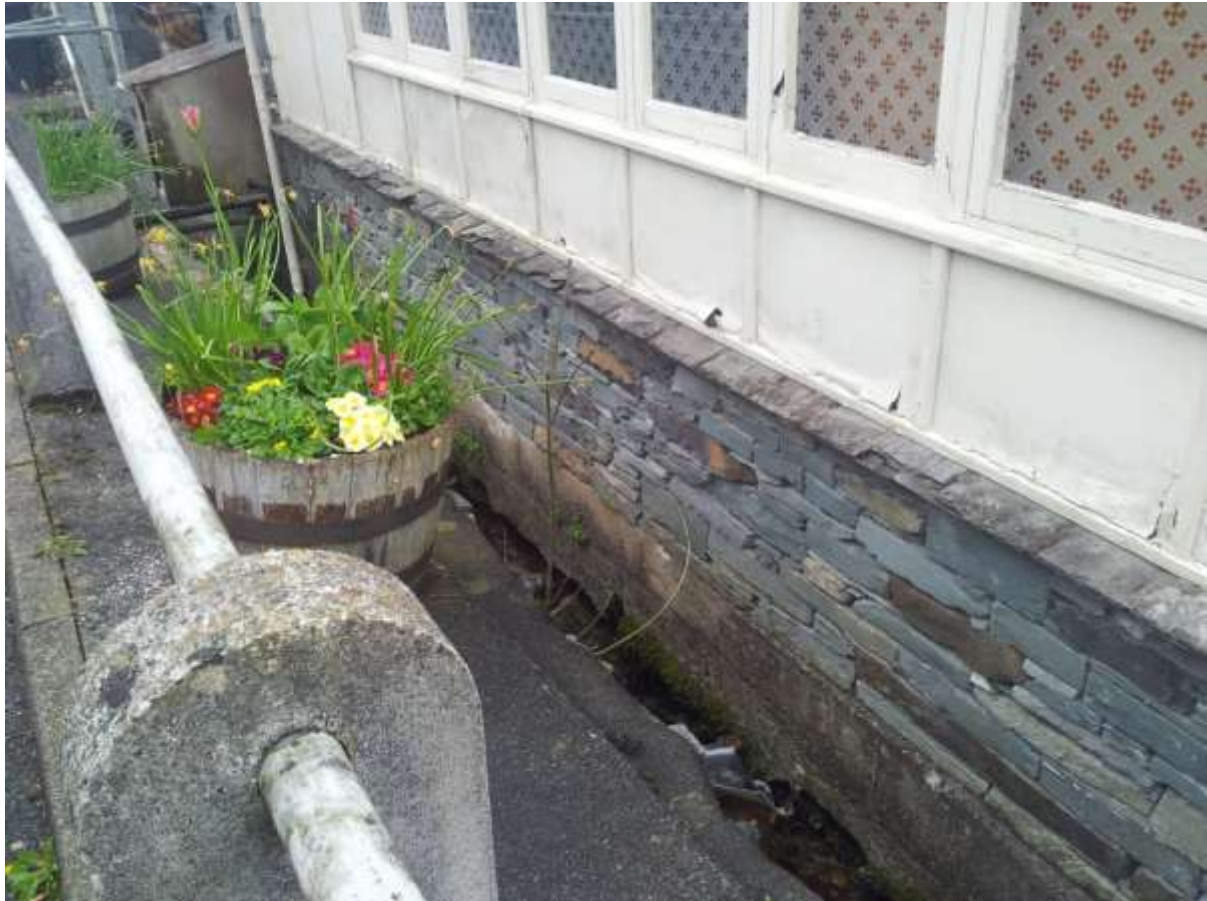
Figure 24 shows the narrow Fisher Beck channel adjacent to The Log House, where out of channel flows pooled around West Ing on the left bank of Fisher Beck, before flowing through the garden wall and affecting Fisher Beck Cottage downstream. At Fisher Beck Cottage, a culverted section of Fisher Beck surcharged, breaching the culvert roof and creating a hole in the garden.

**Figure 24 - Narrow Fisher Beck channel running alongside The Log House  
Borrans Road**

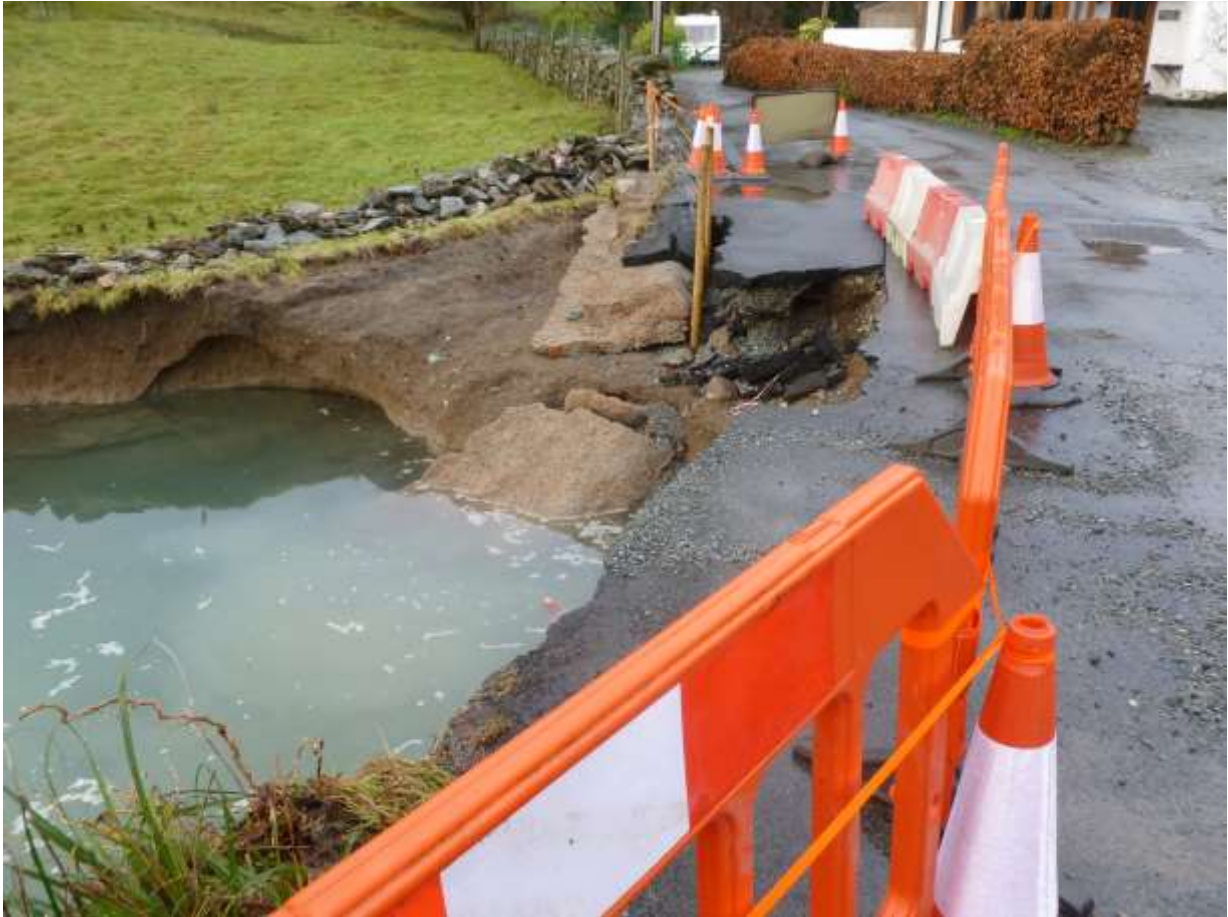
**Figure 27 - Flood damage by River Rothay on Under Loughrigg Road**

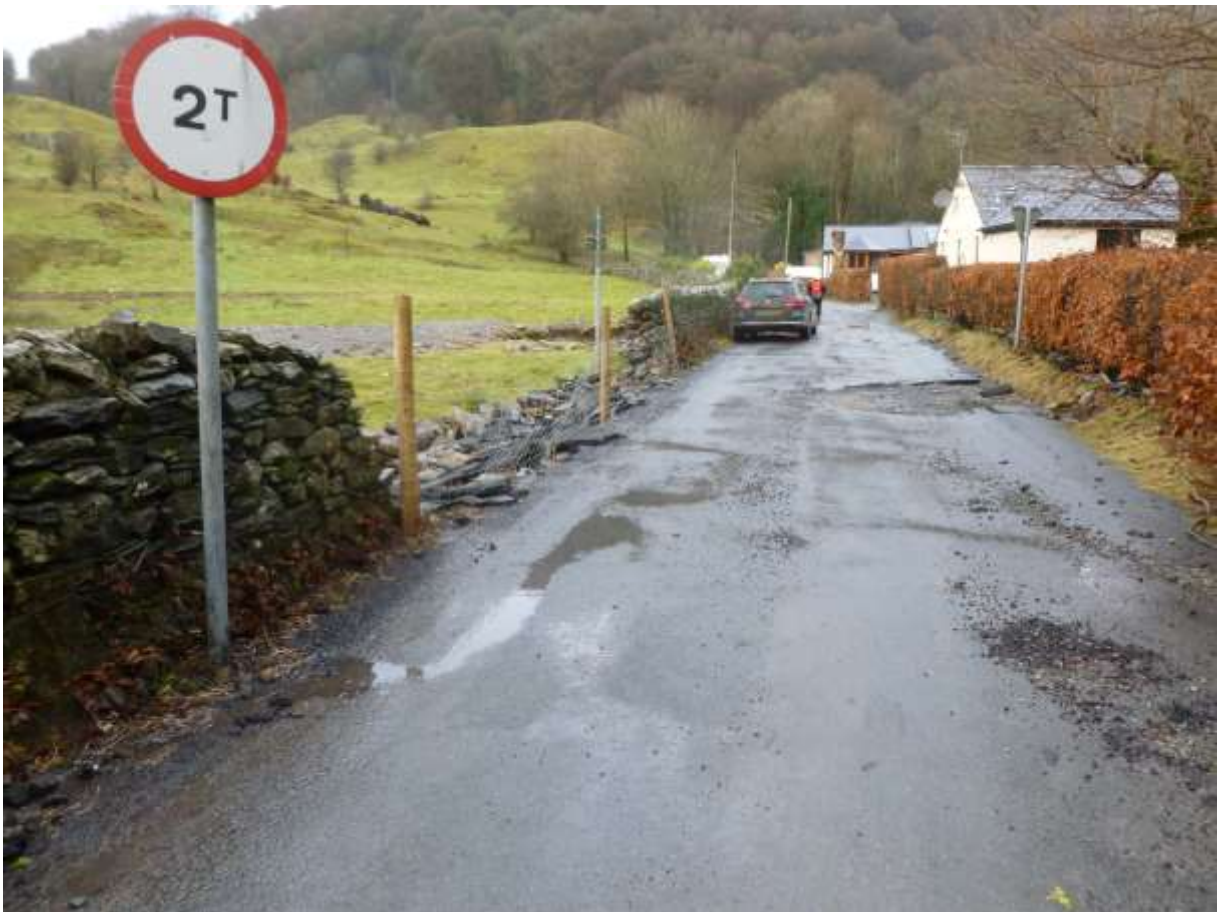
**Figure 28 - Flood damage by River Rothay on Under Loughrigg Road**
