Newbiggin House Farm, Near Waberthwaite Flood Investigation Report 32

Flood Event 30/8/2012

Published

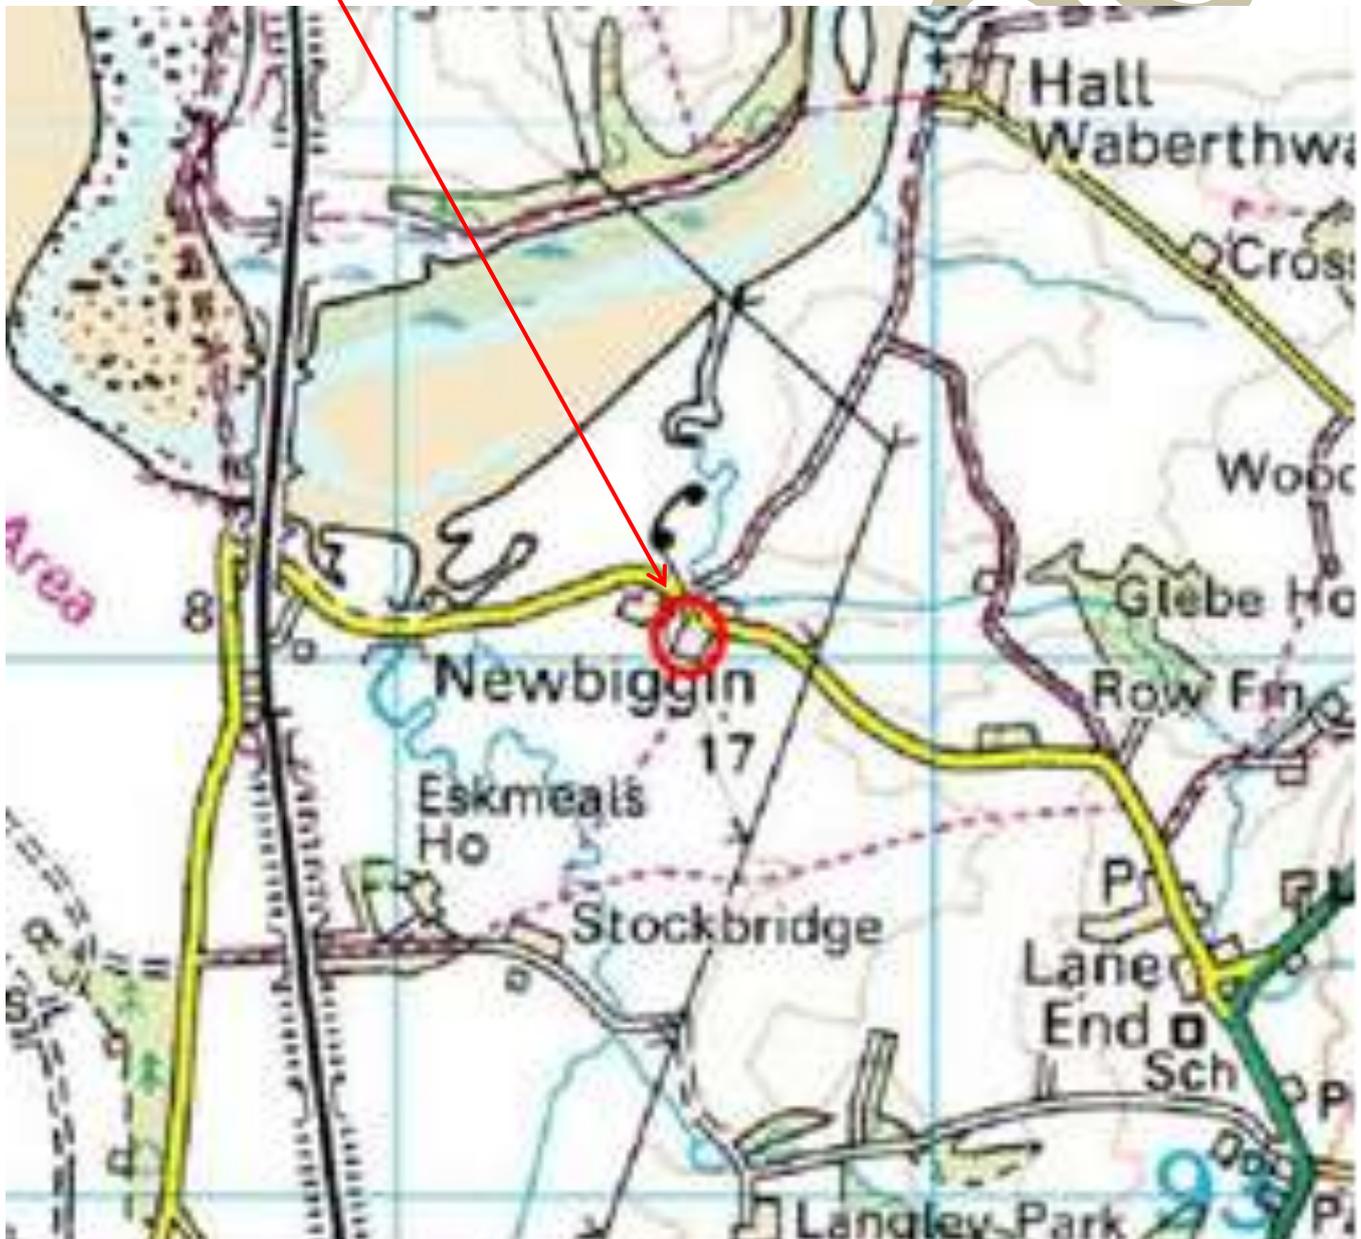
Figure 1: Location of Newbiggin House Farm.

Newbiggin House Farm is on low lying, fairly flat land, adjacent to the River Esk estuary, as shown in Figure 1, below. Whitrow Beck, a tributary of the Esk, runs past the front of the farm to the north. A much smaller stream runs down the side of the farm on the west. This unnamed stream takes water from the fields behind the farm to the south, the source of the run-off that flooded the property.

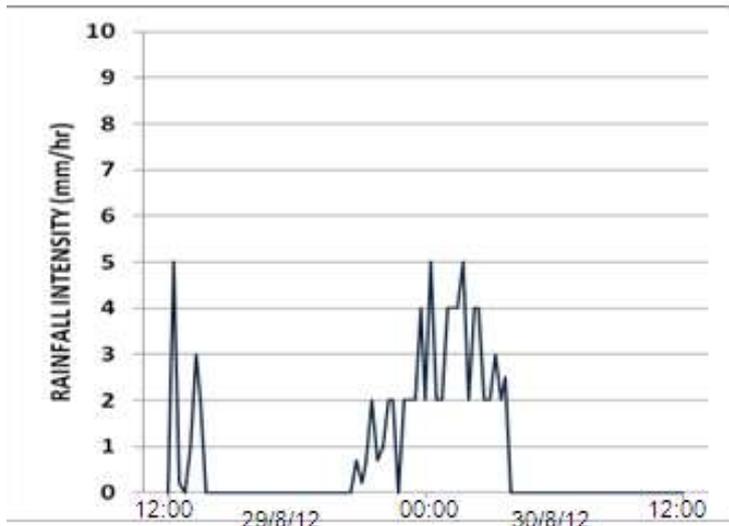
Figure 2. Storm intensity at Newbiggin Farm from 12pm 29/8/12 to 12pm 30/8/12

No rain gauge data is available and the following has been calculated from radar data. Peak rainfall at Waberthwaite was about 6mm/hr and occurred at about 1:30am. The rain started at 8:40pm and finished at 3:50am with 17.2mm falling in that period. This rainfall is not particularly unusual and suggests that the property could suffer frequent flooding. Waberthwaite was at the southern edge of the storm that tracked over Copeland that night and so did not receive the same rainfall recorded at other locations.

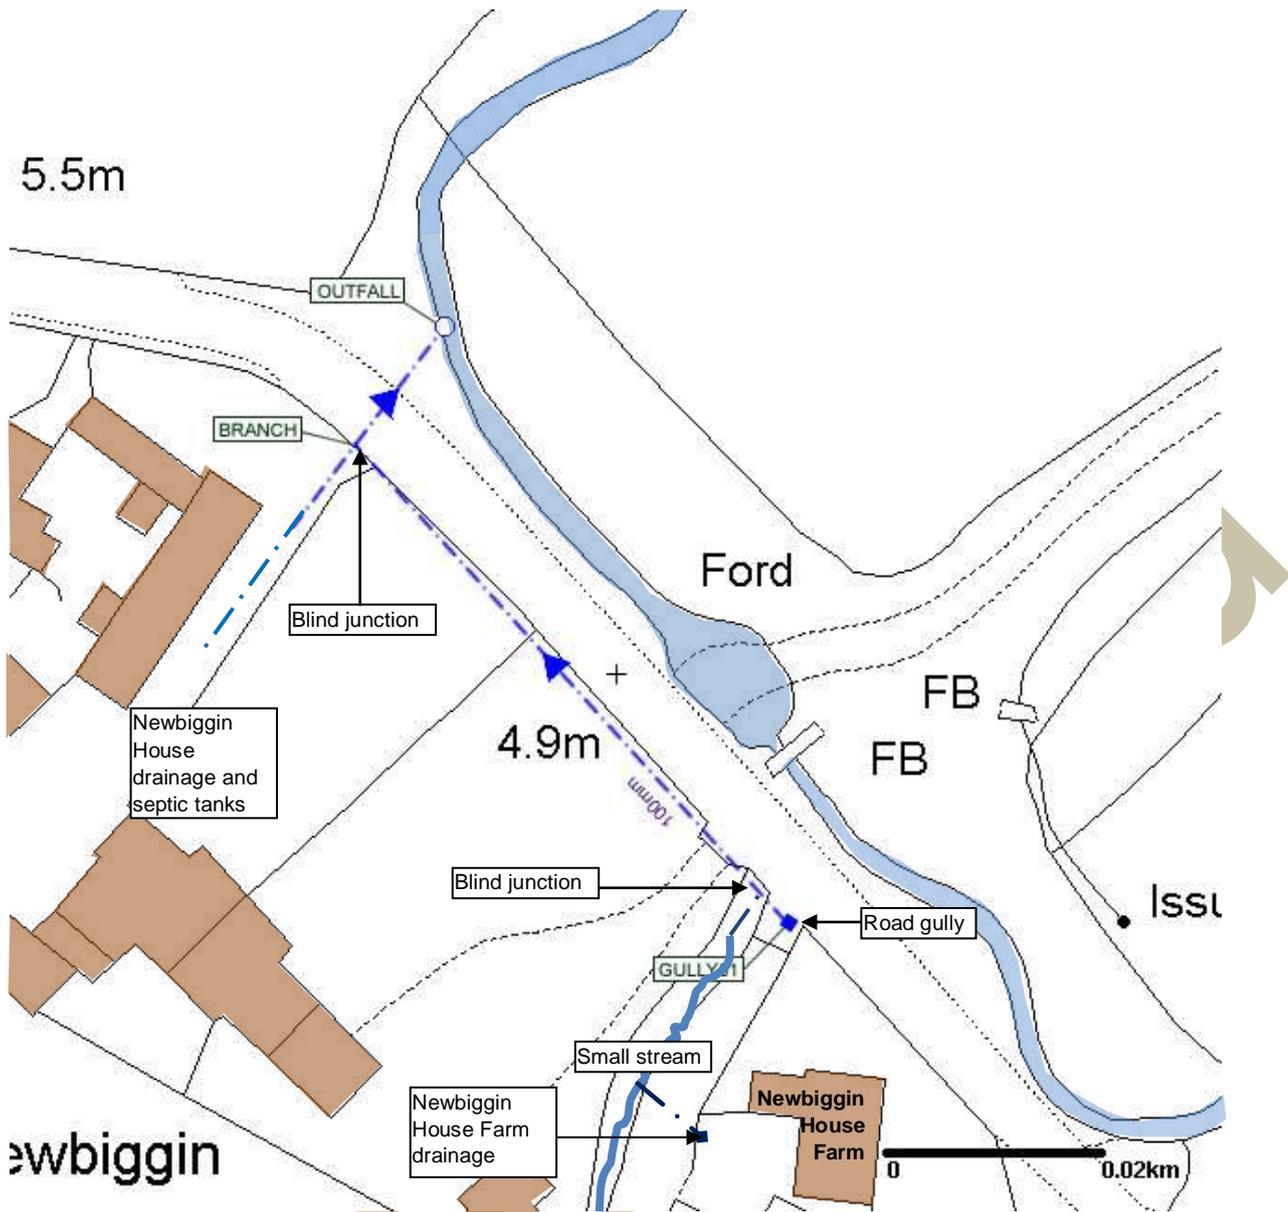
Figure 3. Drainage Layout at Newbiggin House.

A plan of the layout of the highway system found is shown on Figure 3. The drainage from the yard discharges to the small stream which connects to the highway drainage. The drainage system also takes septic tanks from adjacent properties, through which it passes, and then it crosses the road and discharges into the watercourse. The system will most likely be classed as a watercourse where the stream joins it and therefore be the responsibility of the riparian landowners. The riparian owners are the owner of Newbiggin Farm next door for most of its length and Cumbria County Council as Highways Authority where it passes under the road.

The jetting and CCTV survey of the system, starting at the road gully, was carried out on Tuesday 23/10/12. The gully had no inlet and one outlet and which was full of debris. The outfall into Whitrow Beck was very difficult to locate but was discovered 80m away where the beck turns away from the road. This outfall was also blocked by sediment. The jetter went downstream from the gully to the blind junction and upstream from the outfall past the blind junction in front of Newbiggin House.

The camera had a restricted view after only 5m from the road gully and only managed to get 12m downstream from the gully in total. It was prevented from going further by debris in the pipe and the pipe condition. The location of the junction with the small stream could not be identified. Problems in the pipe upstream of where the stream connects will be Highways Authority responsibility. There is likelihood that the pipe is in a similar poor condition further downstream where it is riparian responsibility.

Action by	Recommended Action	How
County Highways	CCTV survey and jetting	COMPLETED – partially successful 23/10/12.
Riparian Owner	Clearing the beck of gravel and silt at the outfall to the system.	This would be an on-going maintenance responsibility which would fall on a riparian owner who would need to be identified.
LLFA	Identify riparian owner of Whitrow Beck at the outfall location.	
LLFA / CBC	Identify the location of the outfall and connections of the small stream alongside footpath.	Dye testing / digging / CCTV
Cumbria County Council Rights of Way / Land Owner	Improve maintenance of existing drainage alongside footpath.	Installation of catch pit manhole at the blind connection to the drainage system.
Land Owner / County Highways	Drainage from Newbiggin House Farm could be connected to the road gully. Flood risk could be reduced by creating an outfall to Whitrow Beck closer to the house rather than implementing improvements to the existing system	Installation of a new outfall to be created where the beck is much closer to Newbiggin House Farm to receive the drainage from this property and the highway gully.

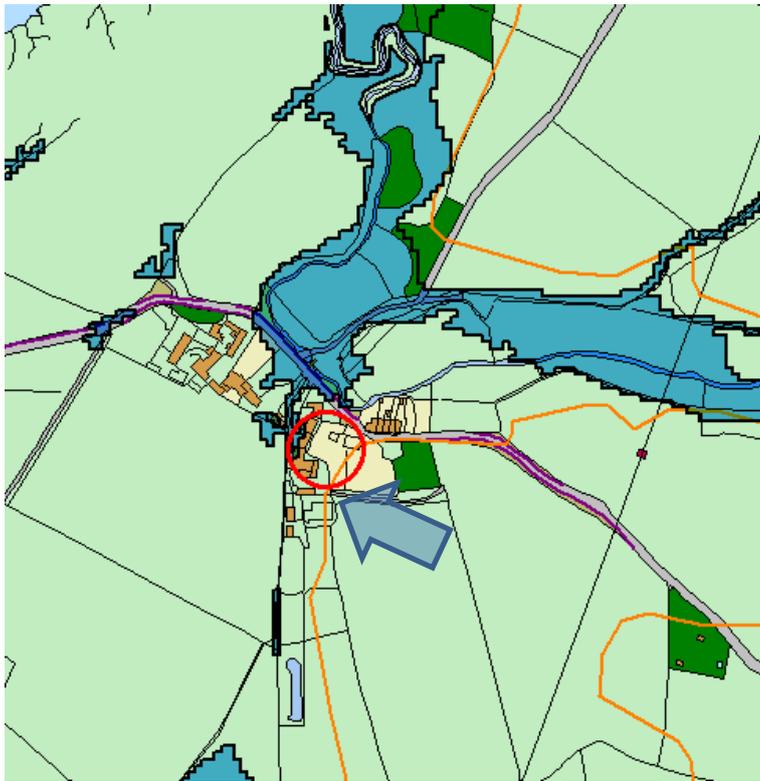
Figure 4. Expected surface water flooding (blue shading) and direction of flow (blue arrow) at Newbiggin House Farm (red circle)

The property is on fairly flat ground with the field behind only slightly higher. The plan on the left shows where surface water is expected to flood in a 1 in 200 year rainfall event (0.5% chance of occurring in any year). Newbiggin House Farm falls into this zone but it is not expected to flood from the 1 in 30 year (3.33% chance) rainfall event.

The orange line is the 10m AOD contour and looking at the topography there is only a very small catchment that would be expected to flow through the yard. A generous estimate would be a catchment of 6800m² mostly flowing from the land to the east of the property. Much of this catchment is within the farm curtilage which includes buildings covering an area of 4400m².
