Carlisle

Flood Investigation Report

Flood Event 5-6th December 2015

This flood investigation report has been produced by the Environment Agency as a key Risk Management Authority under Section 19 of the Flood and Water Management Act 2010 in partnership with Cumbria County Council as Lead Local Flood Authority.

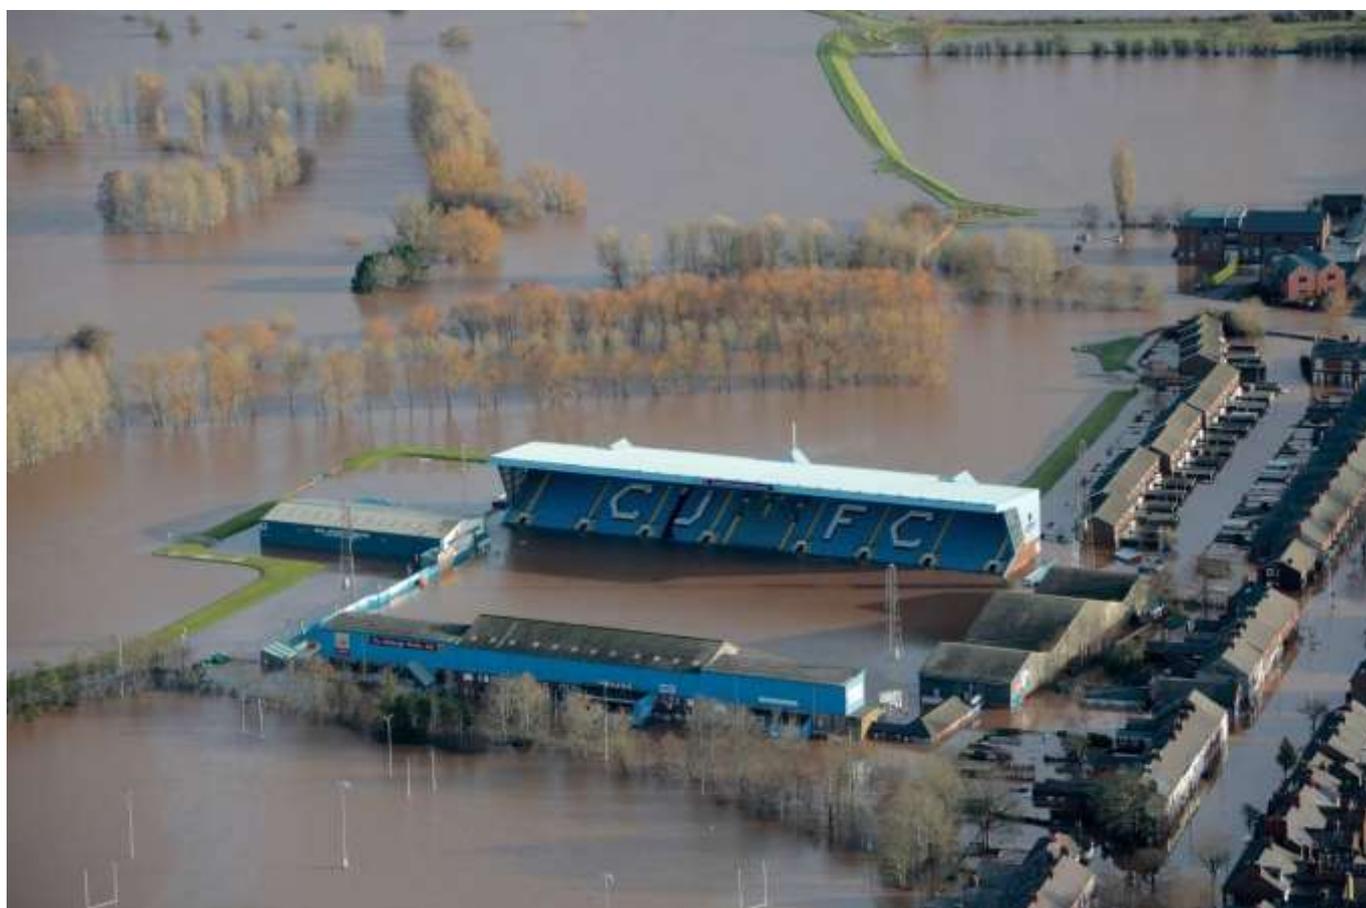
Brunton Park football ground 6th December

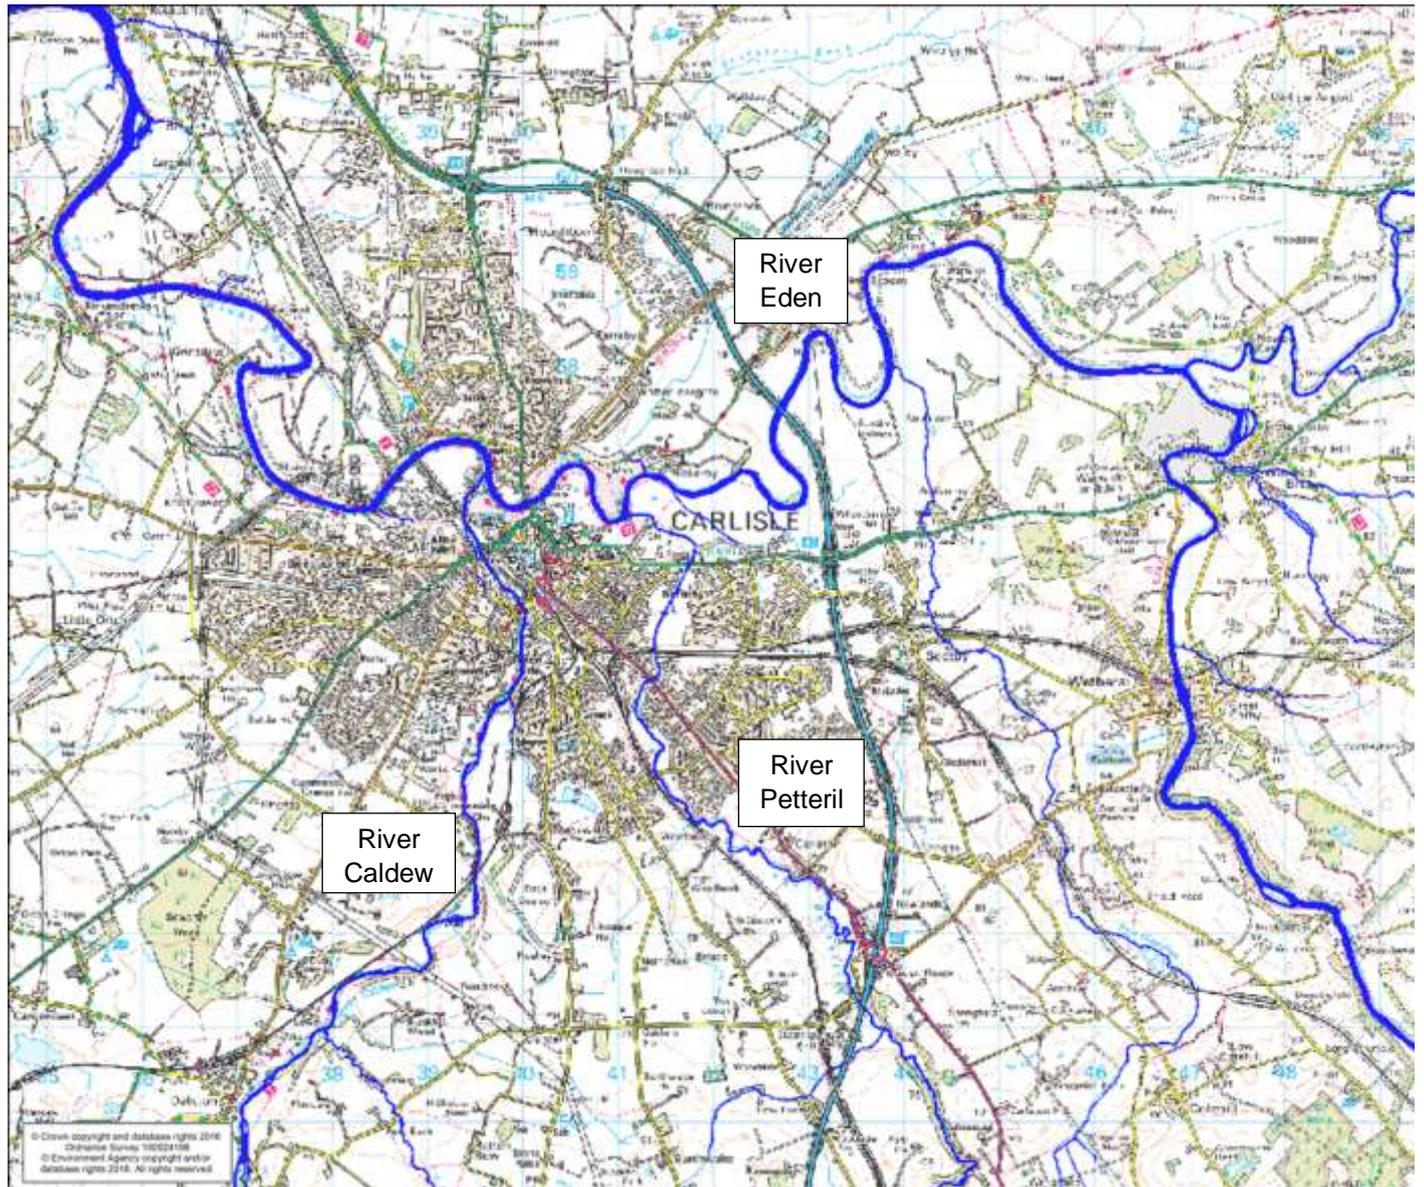
Figure 1: Location of Carlisle and Major Rivers

Carlisle is the county town of Cumbria and a major city with a population of approximately 74,000^{*}. The city is an economic and industrial centre for Northern England and the Scottish Borders and is also a tourist destination due to its roman heritage and nearby Lake District National Park. Carlisle lies at the confluence of three major rivers, **Figure 1**.

The River Eden meanders in a westerly direction through northern Carlisle with a contributing catchment of 2275km². The Eden downstream of Carlisle becomes influenced by both tidal and fluvial sources but through the city remains fluvial dominated. The upper catchment is predominately rural with main local tributaries being the Rivers Irthing, Petteril & Caldew.

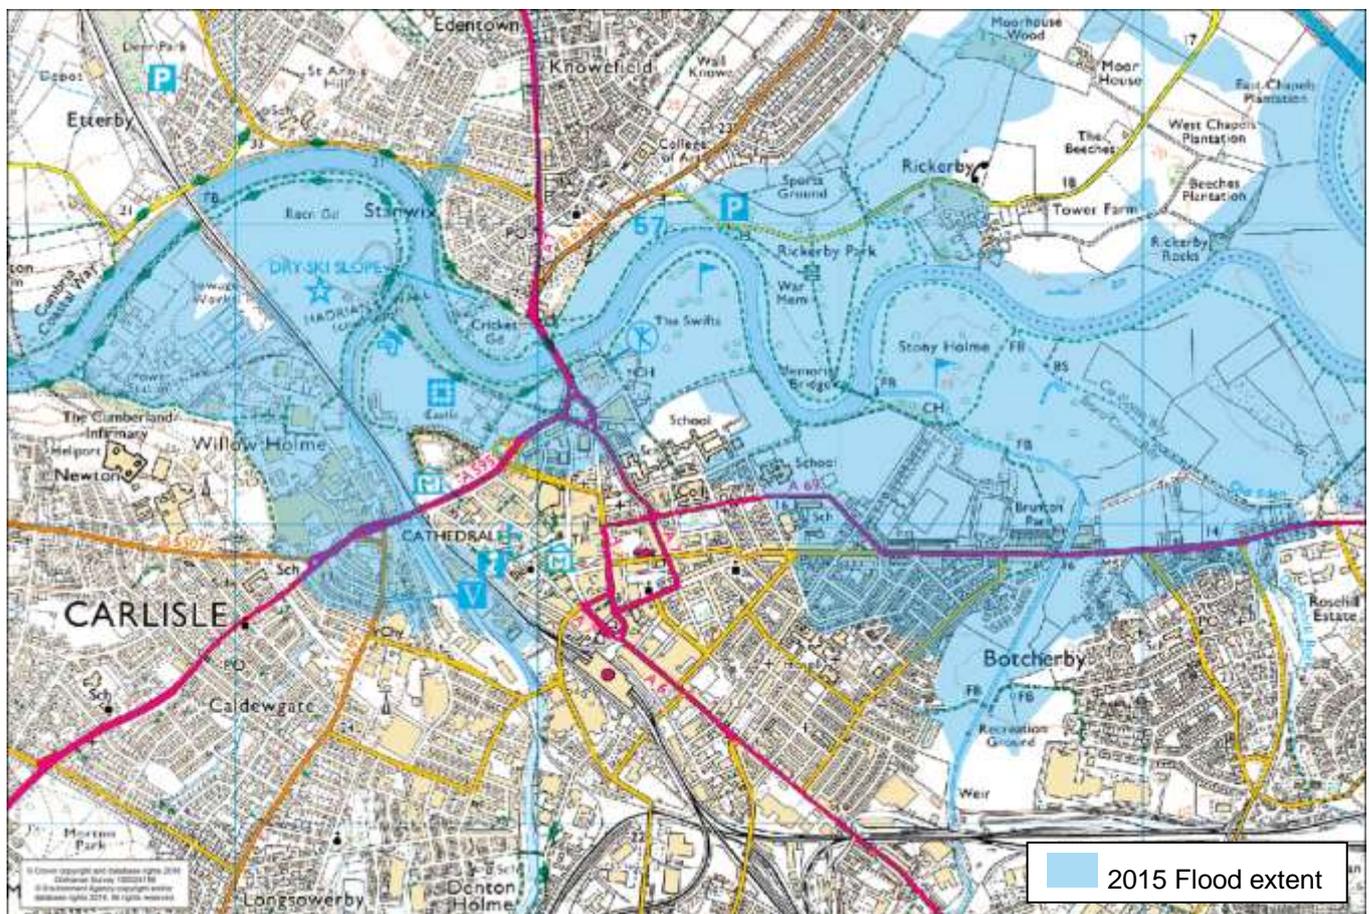
Figure 2: Extent of Fluvial (River) Flooding in Carlisle on 5-6th December 2015

On 5th and 6th December 2015, approximately 2,100 properties suffered flooding. This flooding can be attributed to a record-breaking rainfall event from Storm Desmond. This led to widespread flooding from the Rivers Eden, Petteril, and Caldew, plus flooding from other watercourses, surface water and drainage systems. **Figure 2** shows the approximate extent of the flooding.

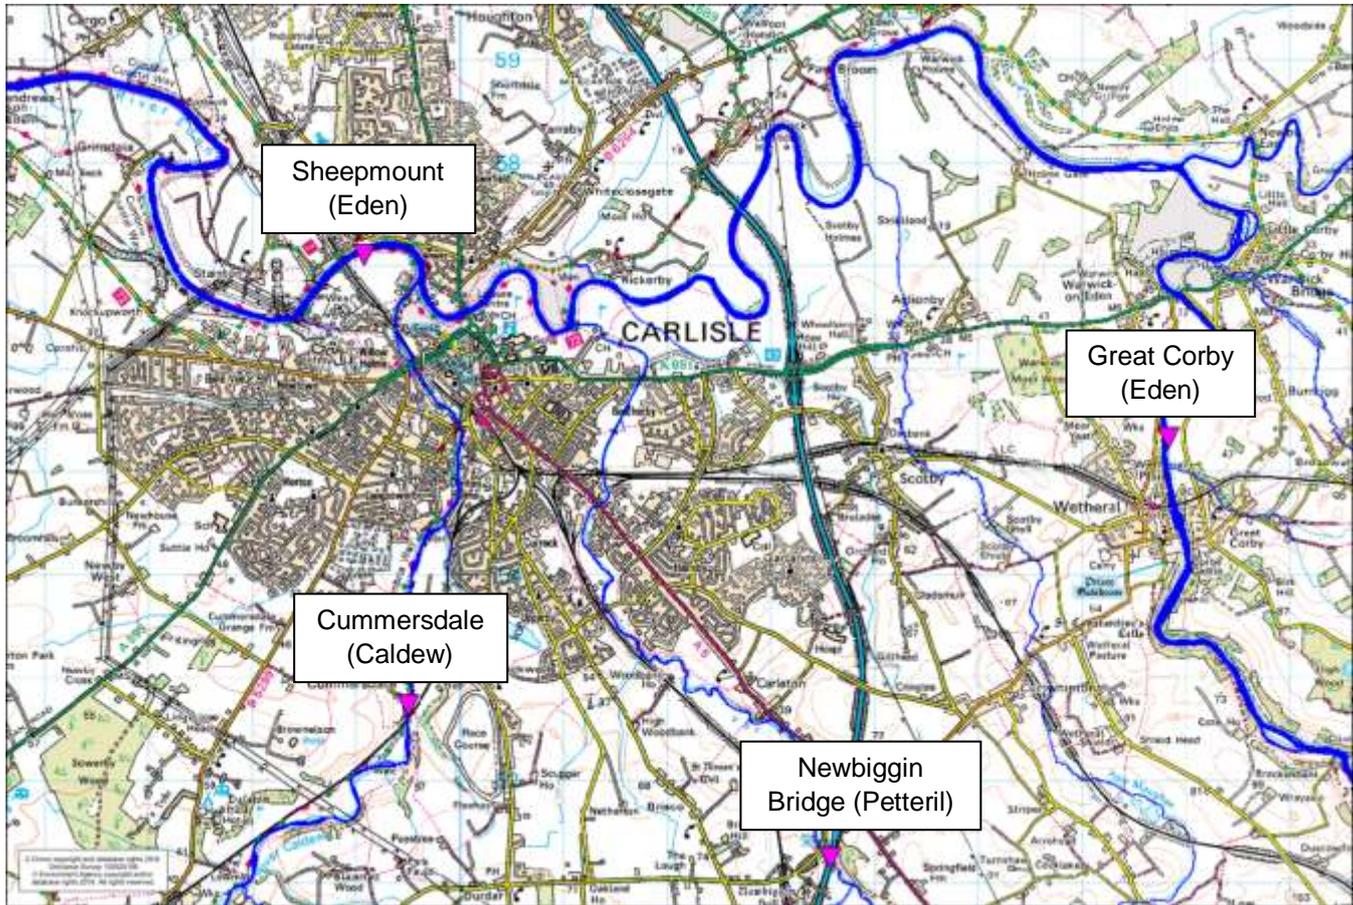
Figure 4: Location of river gauges around Carlisle

There are four river monitoring gauges in the Carlisle area, these are shown in **Figure 4**. The peak flows recorded on the Rivers Eden, Caldew & Petteril are shown in **Table 4**, along with the flows from past flooding events.

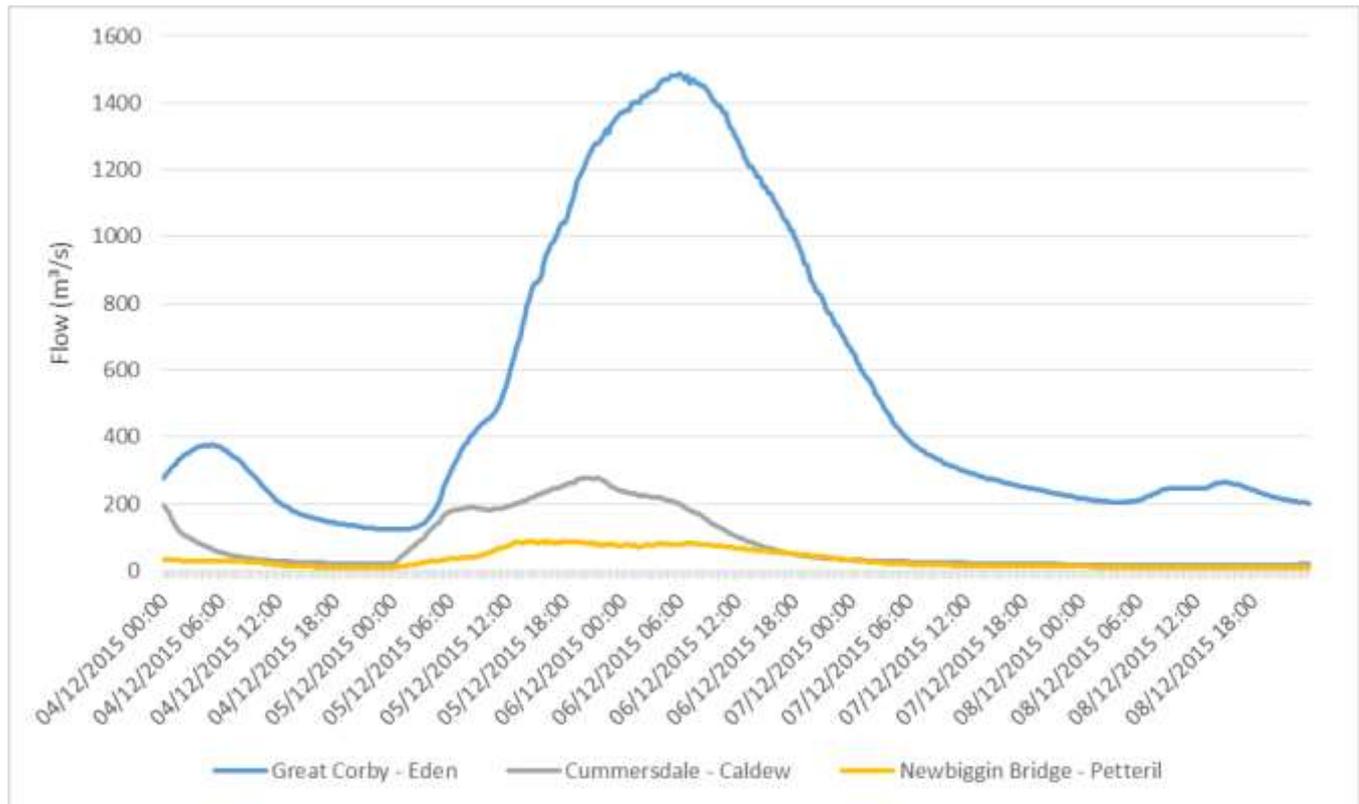
Figure 5: Flow recorded upstream of Carlisle during the December flood event

Figure 5 shows the flow recorded by these river monitoring gauges from the 4th to the 8th of December. This shows the time and duration of the flood event on the 5th and 6th of December and illustrates the magnitude of the flood event and the relative sizes of the three rivers.

- An early sub-peak was recorded on all rivers on the 4th December, causing floodplains storage to fill
- The Petteril peaked at 14:30 on the 5th December with a flow of 89.6m³/s
- The Caldew peaked at 20:15 on the 5th December with a flow of 279m³/s
- The Eden peaked at 09:00 on the 6th December with a flow of 1680m³/s
- The River Caldew had a very drawn out peak, stretching across the Eden peak which is unusual
- There is some uncertainty regarding the River Petteril flows as the Newbiggin Bridge ultrasonic gauge failed prior to the peak and flows were reconstructed from the back up level gauge

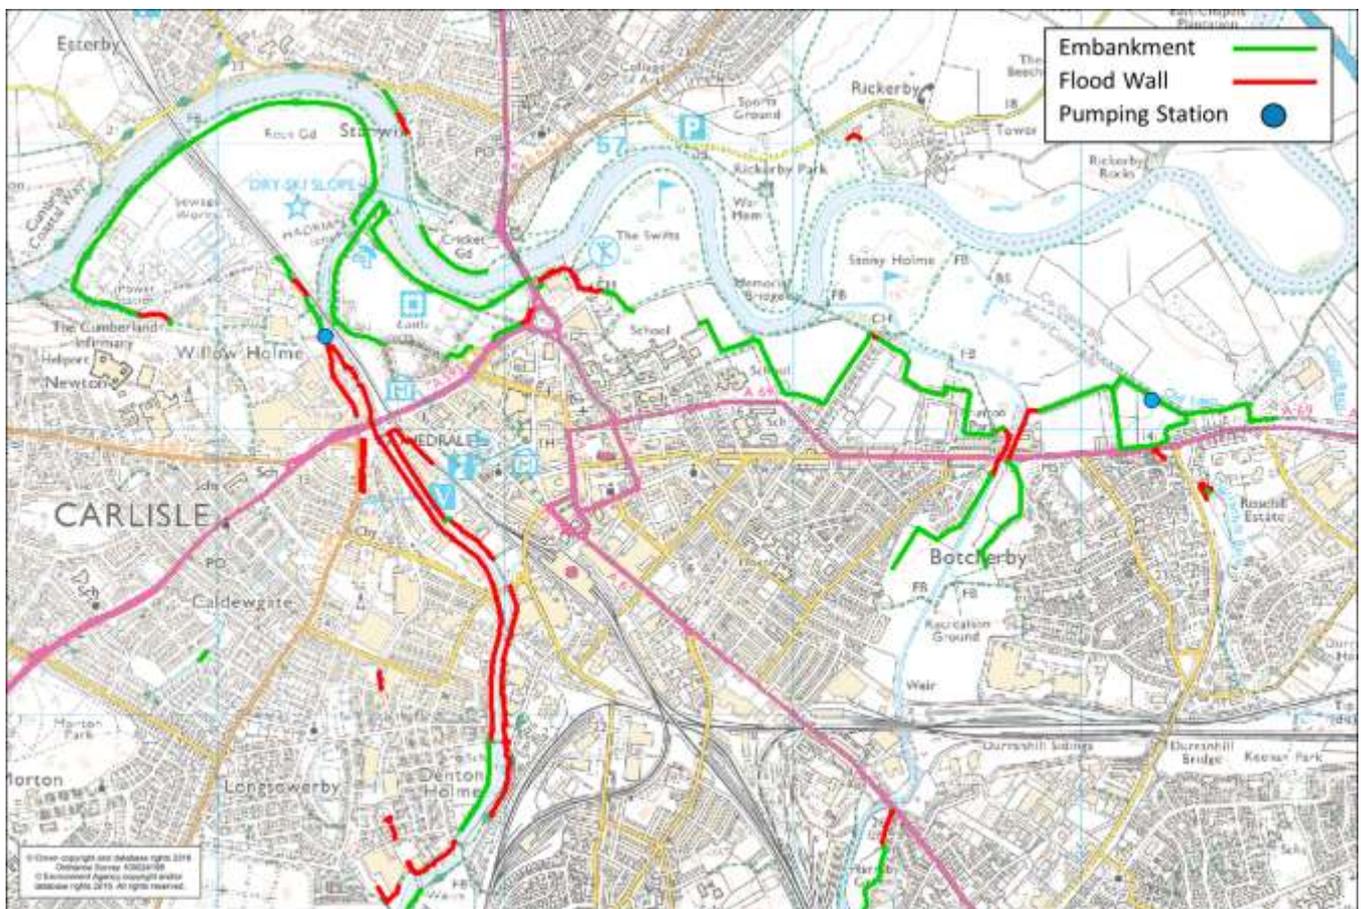
Figure 6: Flood Defences within Carlisle

A map of existing defences is shown in **Figure 6**.

Although defences were overtopped, no defences were breached during the 2015 flood event. In some locations defences were successful in reducing the damage and delayed flooding, which gave residents additional time to prepare and reduce the impact of the flood.

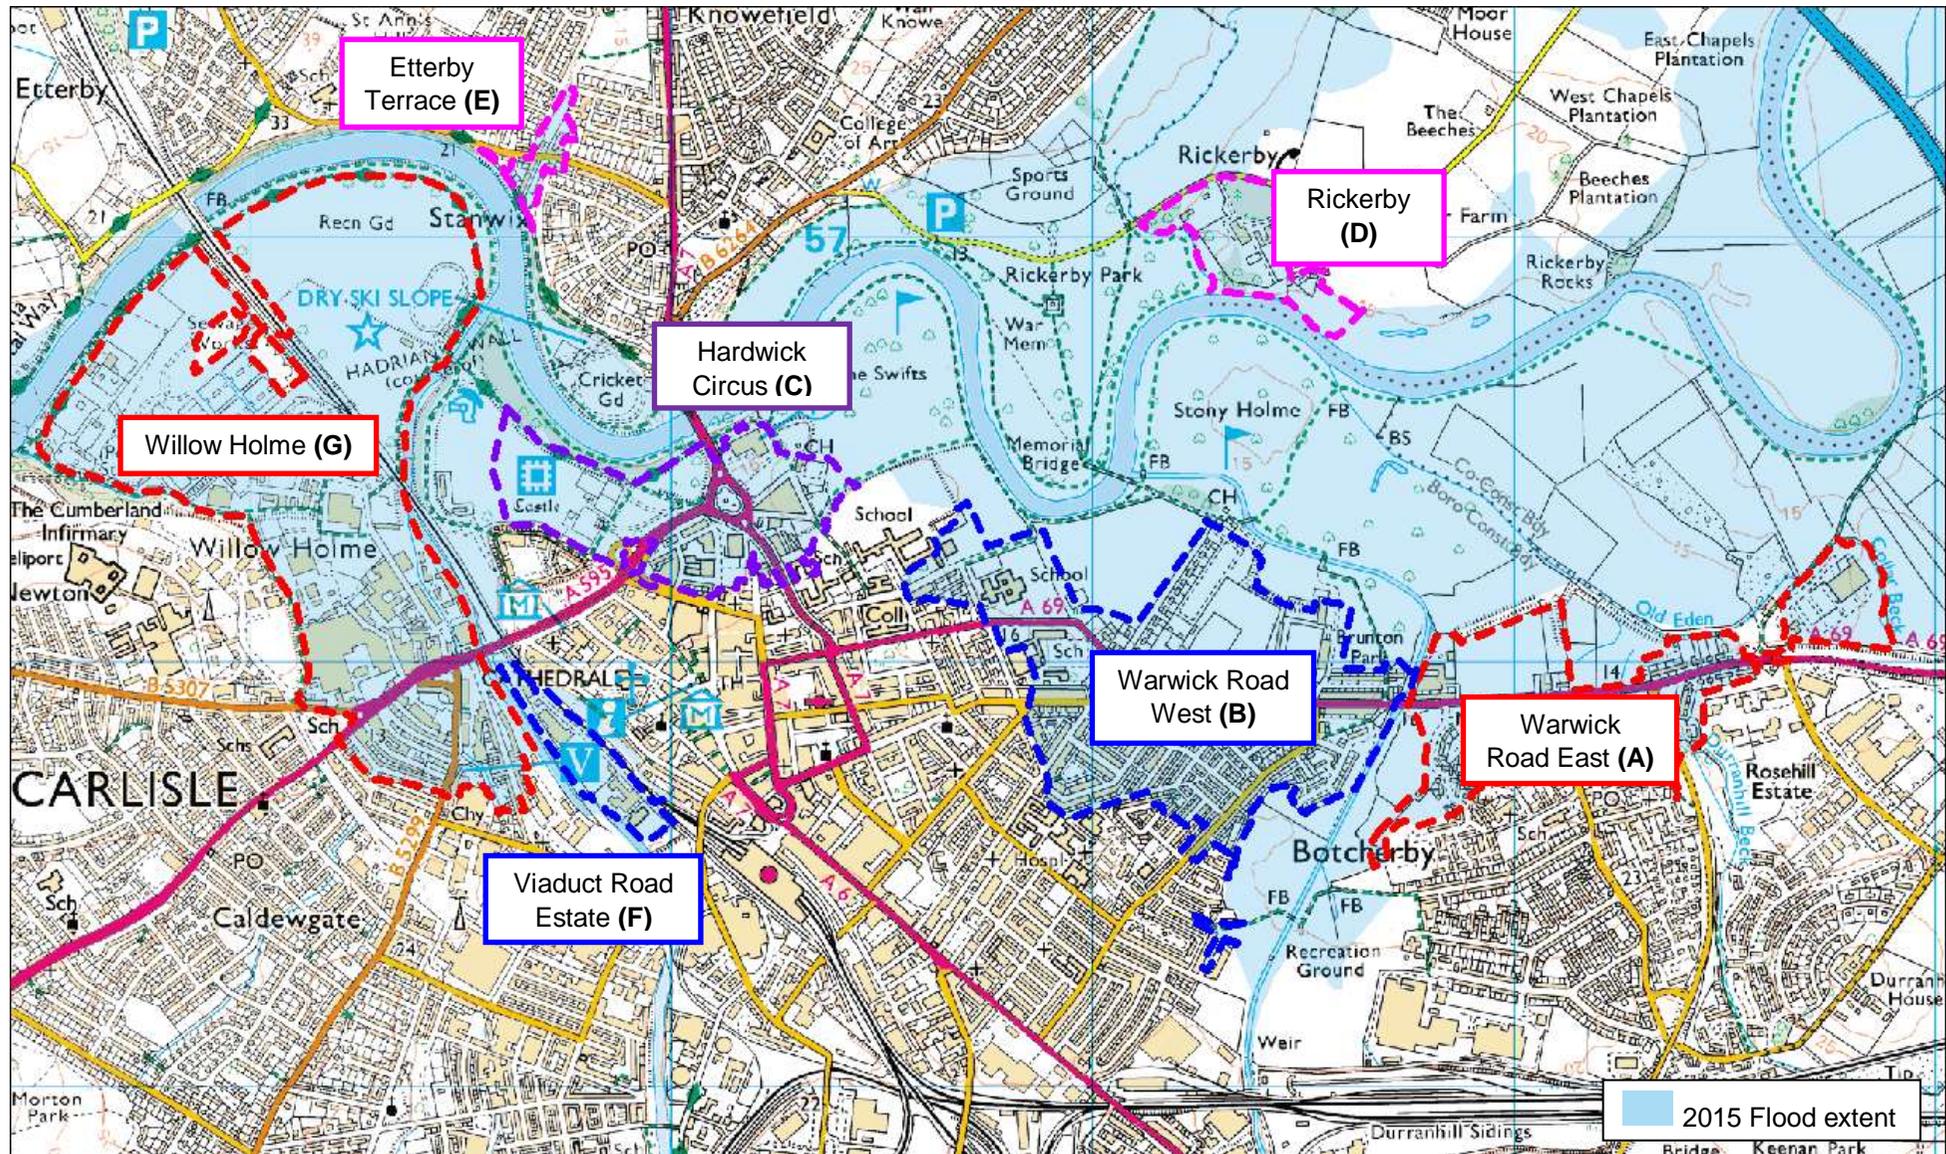
Figure 7: Identification of Areas Flooded

There were a number of flood flow routes during the event. The details of the flow routes into these sub-areas, the likely causes, and the properties flooded are discussed in the following sections of this report. There may also have been other flooding mechanisms that were not identified during this investigation.

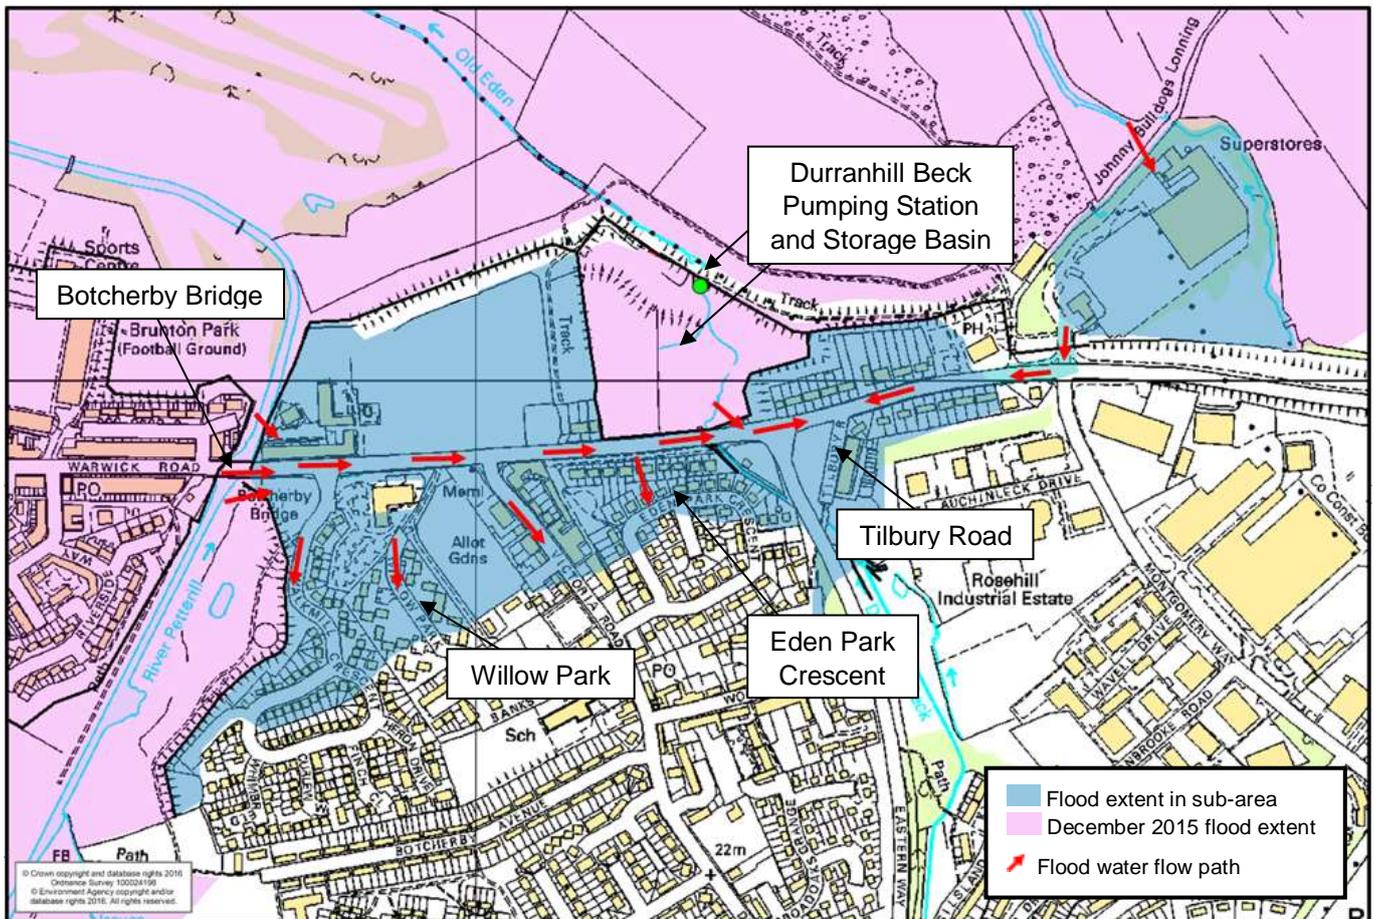
Figure 8: Flood Flow Routes in Warwick Road East area

This area is located on the right bank of the River Petteril and left bank of the River Eden. There is also a smaller watercourse, Durrhill Beck, which flows through the area. Warwick Road crosses the River Petteril at Botcherby Bridge in this location. This area is primarily residential and was flooded from the overtopping of the River Petteril embankments and from the River Eden in the latter stages of the flood event, in addition to the surcharging of drains and road gullies.

The initial cause of flooding in this sub-area was from drains and road gullies surcharging before defences were overtopped. This was reported in Willow Park and Tilbury Road. It was also reported that water came up through the floor of the Premier Inn off Warwick Road prior to water entering from external sources.

Early in the event, Botcherby Bridge acted as an obstruction to flow leading to higher water levels upstream of the bridge and over topping of the left bank. The defences on the right bank were not overtopped however until high water levels in the River Eden caused flow in the River Petteril to back up.

The pumping station on Durranshill Beck pumps water stored in the storage basin when water cannot naturally flow into the River Eden during periods of high river levels. During the flood event the power supply to the area failed; following this the pumping station continued to run on an emergency generator until it exhausted its fuel and stopped pumping. This occurred in the early hours of Sunday morning, but the exact time that pumping stopped was not recorded. Whilst the pump was operational the storage basin for Durranshill Beck worked well and did not fill to capacity.

Following the failure of the pumping station the basin filled and overtopped leading to additional flooding on Warwick Road. It was reported that the flood storage basin embankments ponded the water on Warwick Road and failed to let the flood water back in to the basin. A 15cm wide grip/trench was subsequently cut through the landward embankment by the Environment Agency to allow this water to empty from Warwick Road. This has since been repaired.

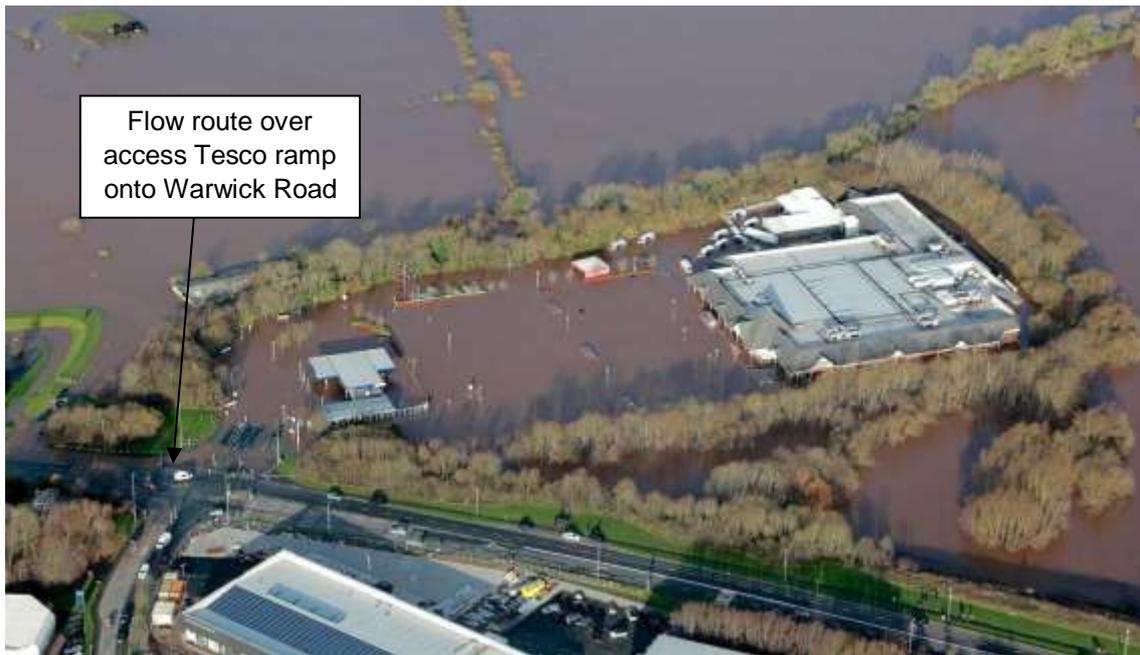
The Tesco store at the east of this area was flooded directly from the River Eden, **Photograph 1**. This store is not protected by flood defences. During the latter stages of the event on Sunday morning flood water overtopped the raised access road to the store (which forms part of the flood defence scheme). The access ramp may have formed a low point in the River Eden defences in this area. This flow route will have contributed to the flooding on the eastern extent of the flooded area of Warwick Road.

Photograph 1: Flooded Tesco store with the flow route onto Warwick Road visible

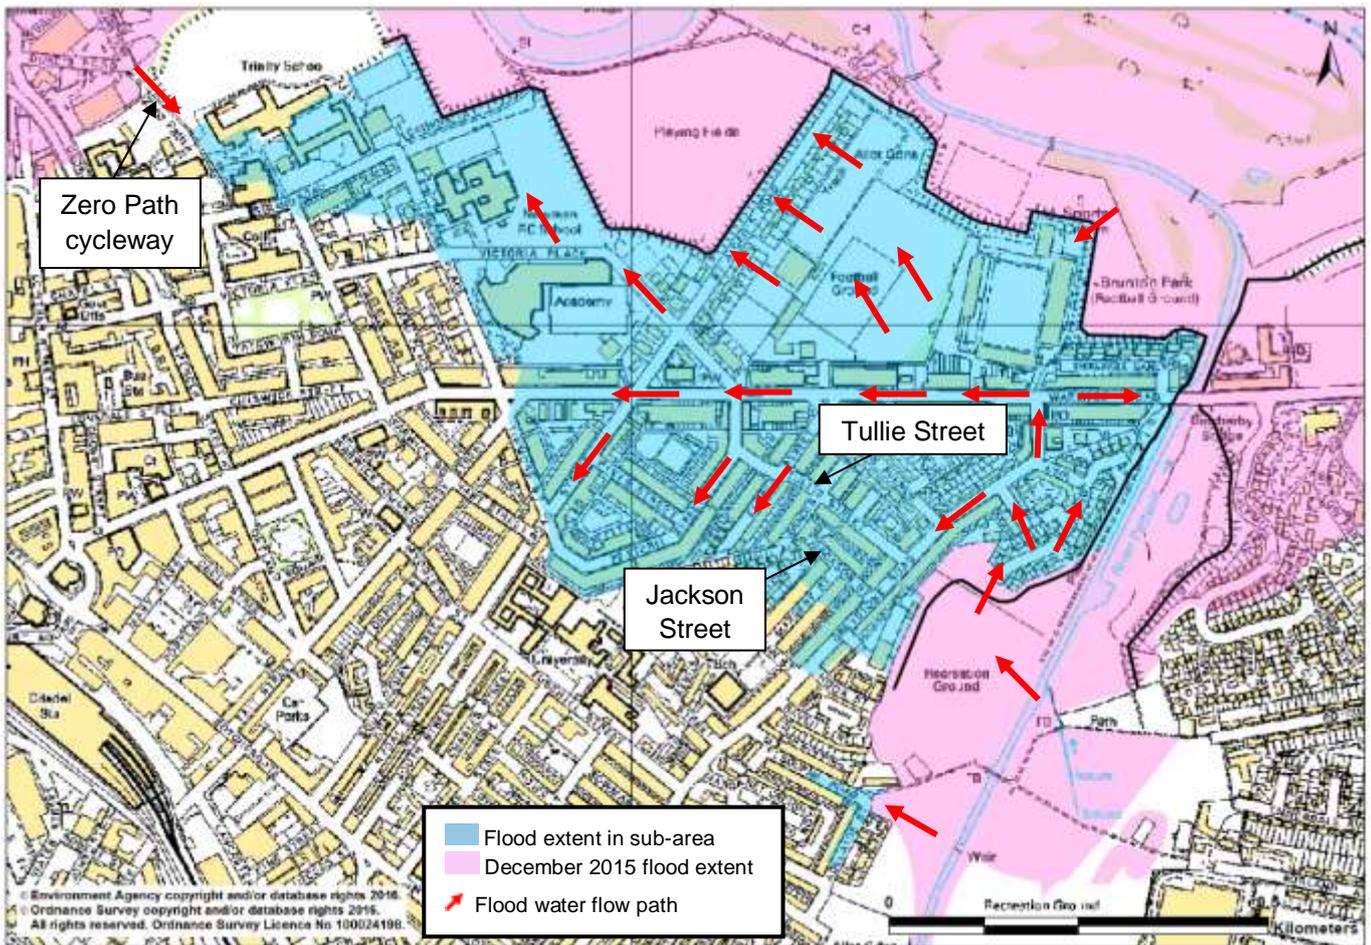
Figure 9: Flood Flow Routes in Warwick Road West area

This area is located on the left bank of the River Petteril on the opposite side of Botcherby Bridge to sub-area A. The flooded area is primarily residential with a number of schools also affected. There are flood defences along the banks of both the Rivers Petteril and Eden consisting of earth embankments and sheet piled walls. There were a number of properties that flooded during the flood event of the 5th and 6th

The main flow route into this area was from defences being overtopped upstream of Botcherby Bridge. The River Petteril overtopped embankments, near the end of Riverside Way, into Melbourne Park which acted as a basin. As with the Warwick Road East area, this was exacerbated by the high levels in the River Eden. The defences within Melbourne Park were also out-flanked, as the river levels were greater than the ground level upstream of these defences. In addition to this, there was some leakage through the defences immediately upstream of Botcherby Bridge; some water was seeping through the corner joint of the defence wall before properties were flooded from the Melbourne Park route. It was also reported that the River Petteril was seeping through the parapets of Botcherby Bridge and between the bridge and the left embankment.

The overtopping of this defence led to flooding in Riverside Way, Greystone Road and Tullie Street at midnight. This flood route then continued to Warwick Road and flooded the neighbouring streets. This flooding extended as far as St Aidans Road and Newman & Trinity Schools. This also led to flood water flowing over Botcherby Bridge into the Warwick Road East area.

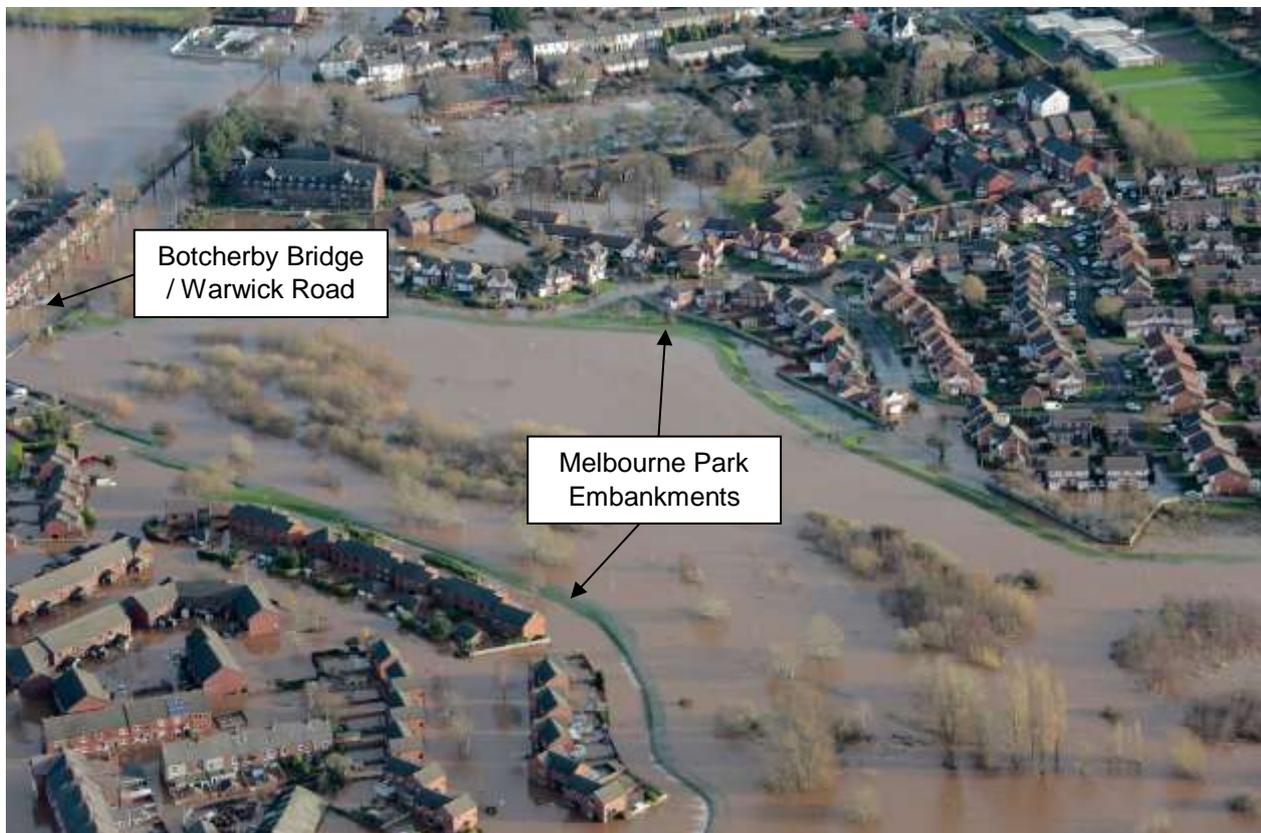
Photograph 2: Melbourne Park and River Petteril during flood event

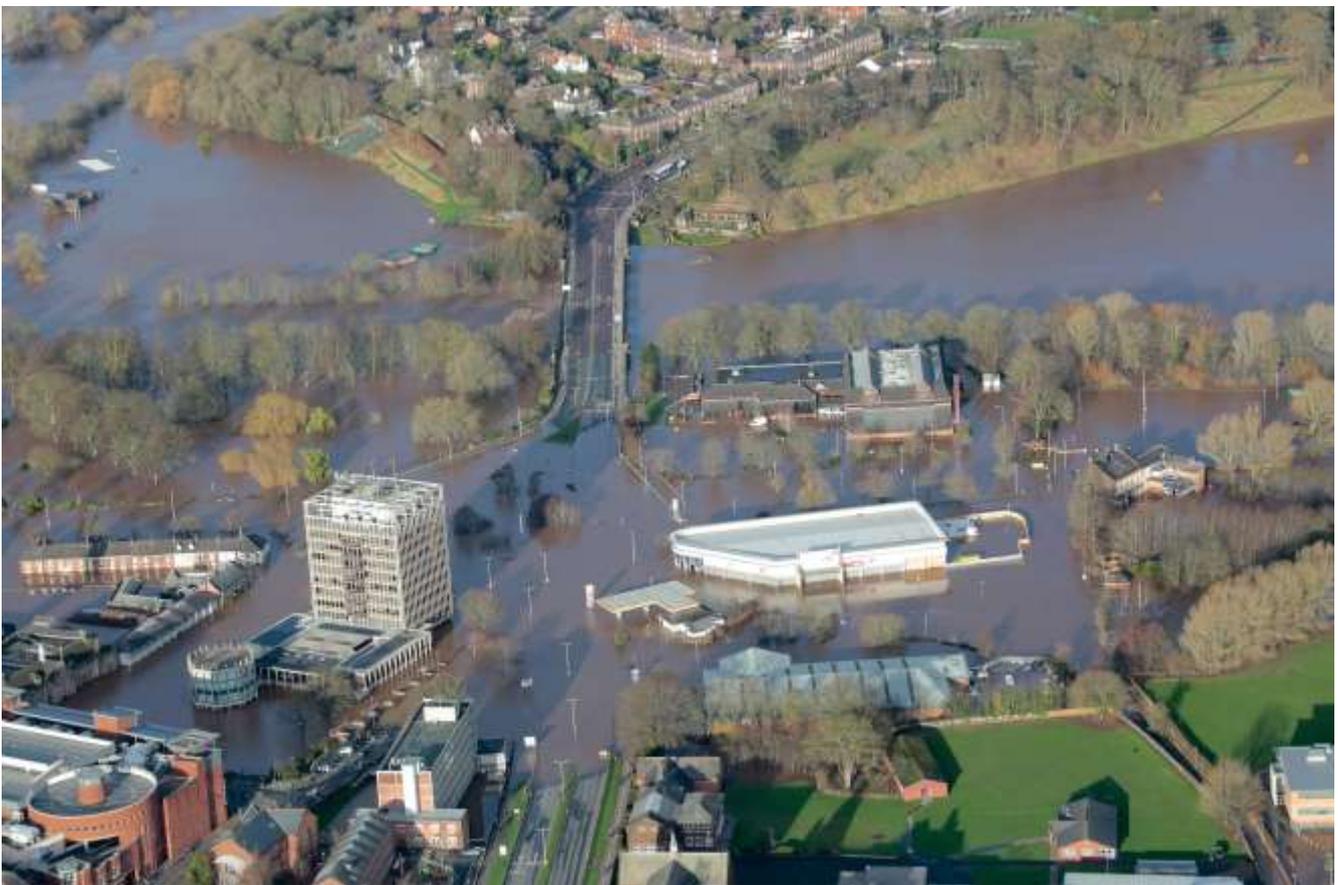
Photograph 3: Hardwick Circus area during flood event

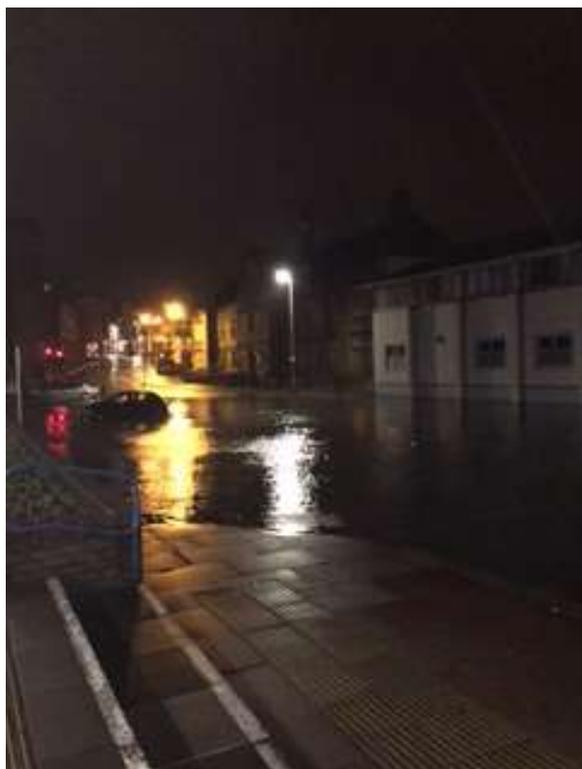
Photograph 4: Rickergate at 23:07 on the 7th December

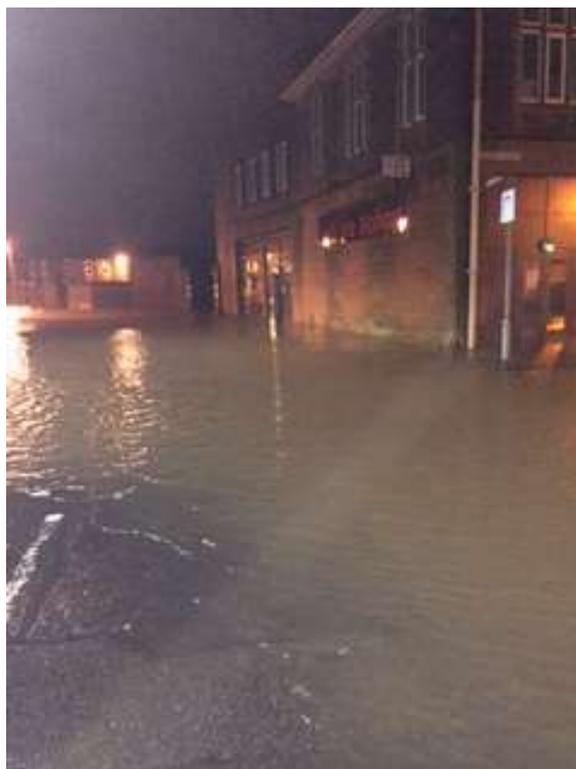
Photograph 5: Peter Street facing towards Corporation Road at 03:23 on the 6th December

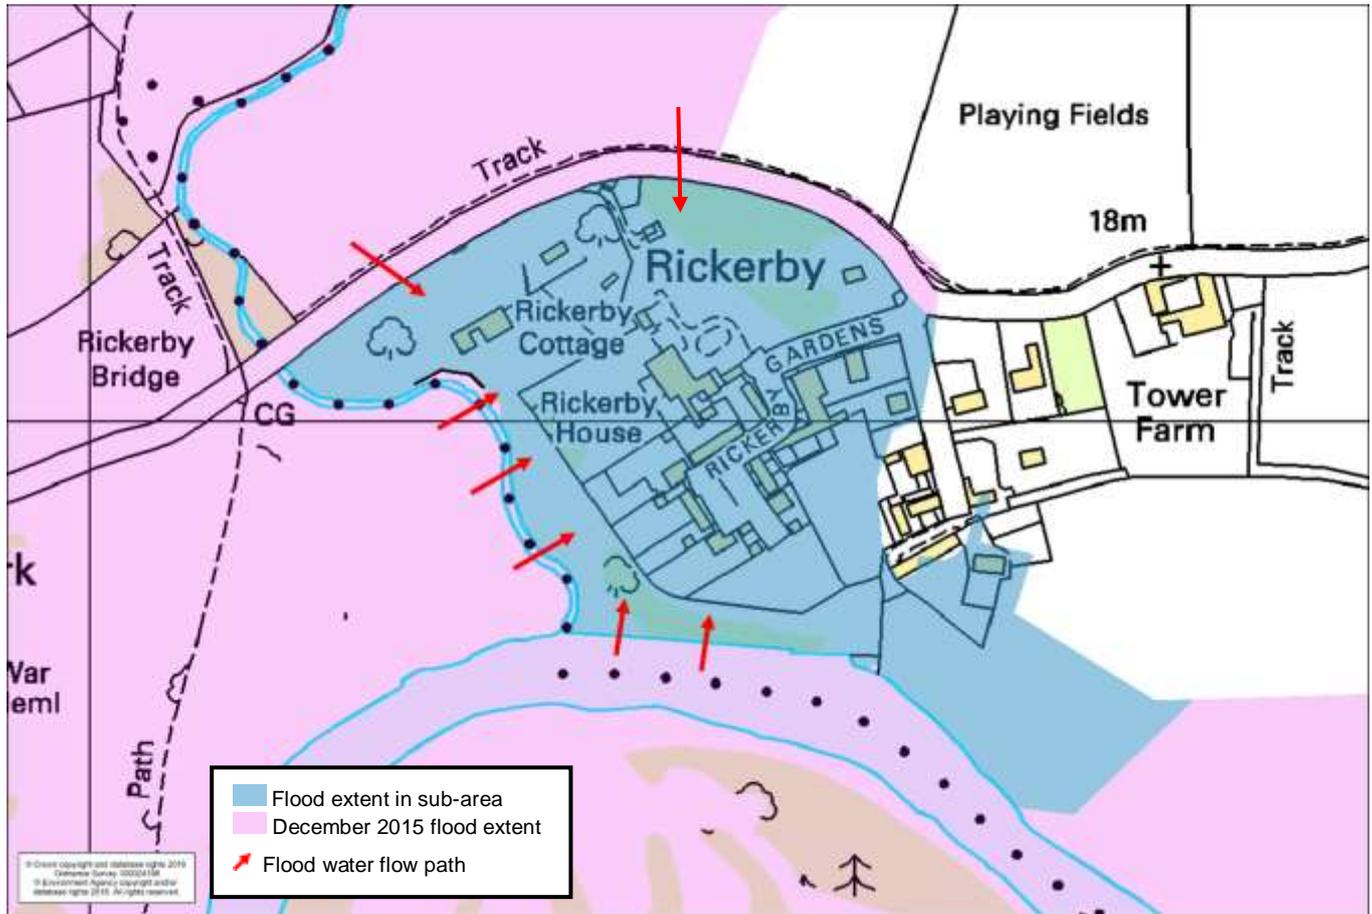
Figure 11: Flood Flow Routes in Rickerby

The majority of properties in Rickerby village are relatively new, and located in a residential development completed in 2004. Despite the village's close proximity to the River Eden there are limited flood defences in this area. The only raised defences consist of a small raised embankment to protect Rickerby House against minor flooding. As the area is at risk of flooding, many of the properties have property level protection.

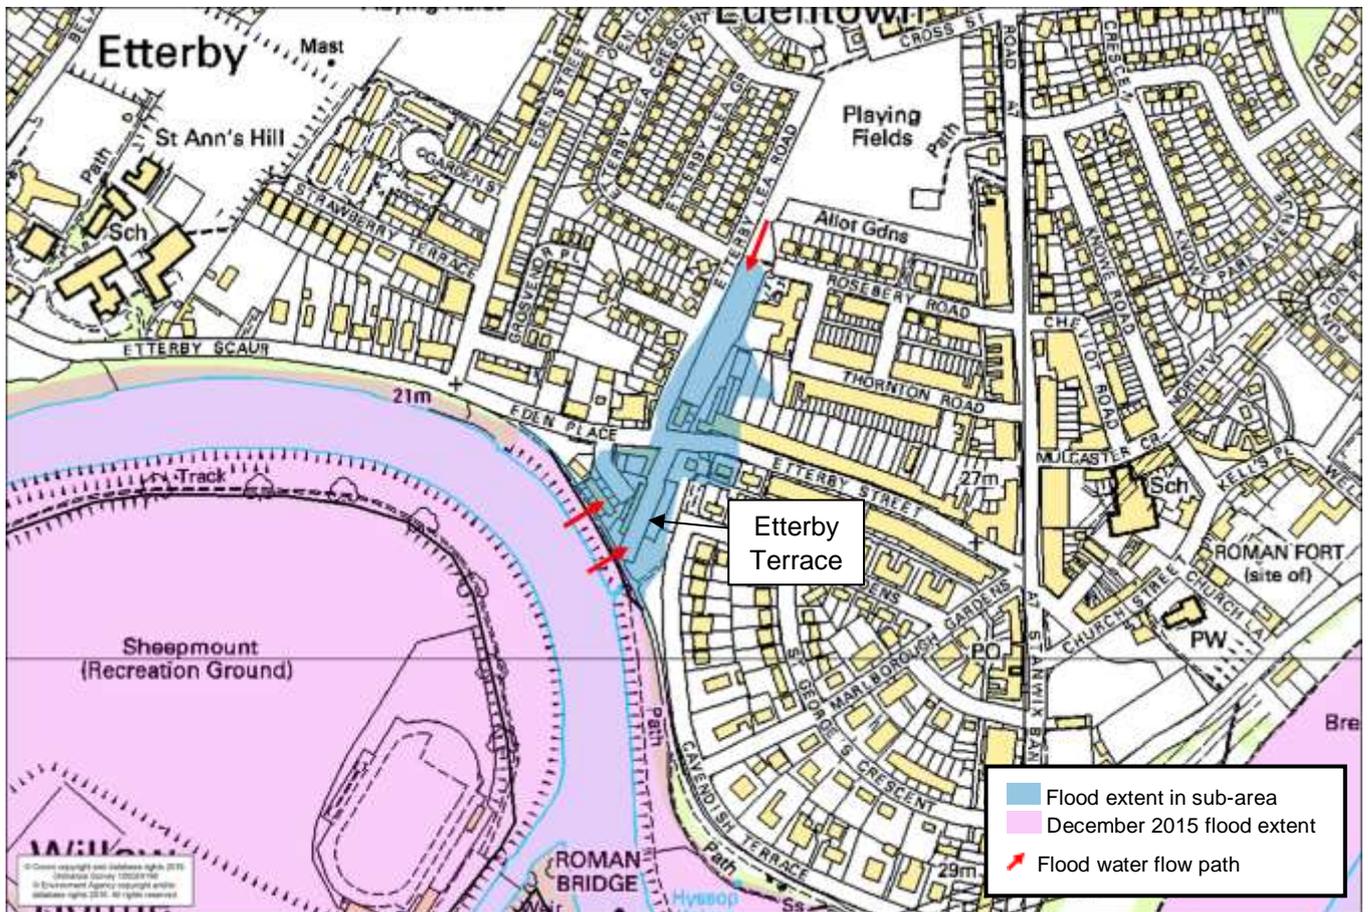
Figure 12: Flood Flow Routes in Etterby Terrace

This is an area of residential properties north of the River Eden. There is a flood defence wall along the River Eden at Etterby Terrace, constructed following flooding to this area in January 2005. There is also a culverted watercourse, Gosling Syke, which passes underneath this area and into the River Eden.

Prior to the overtopping of the defences the properties within this area were flooded from surcharging surface water drains and from water rising through floors. This flooding was from Gosling Syke, a watercourse which passes underneath the area that was flooded. Residents reported that the Gosling Syke outfall is often blocked. However, this flooding may have been caused by high river levels in the River Eden causing Gosling Syke to back up.

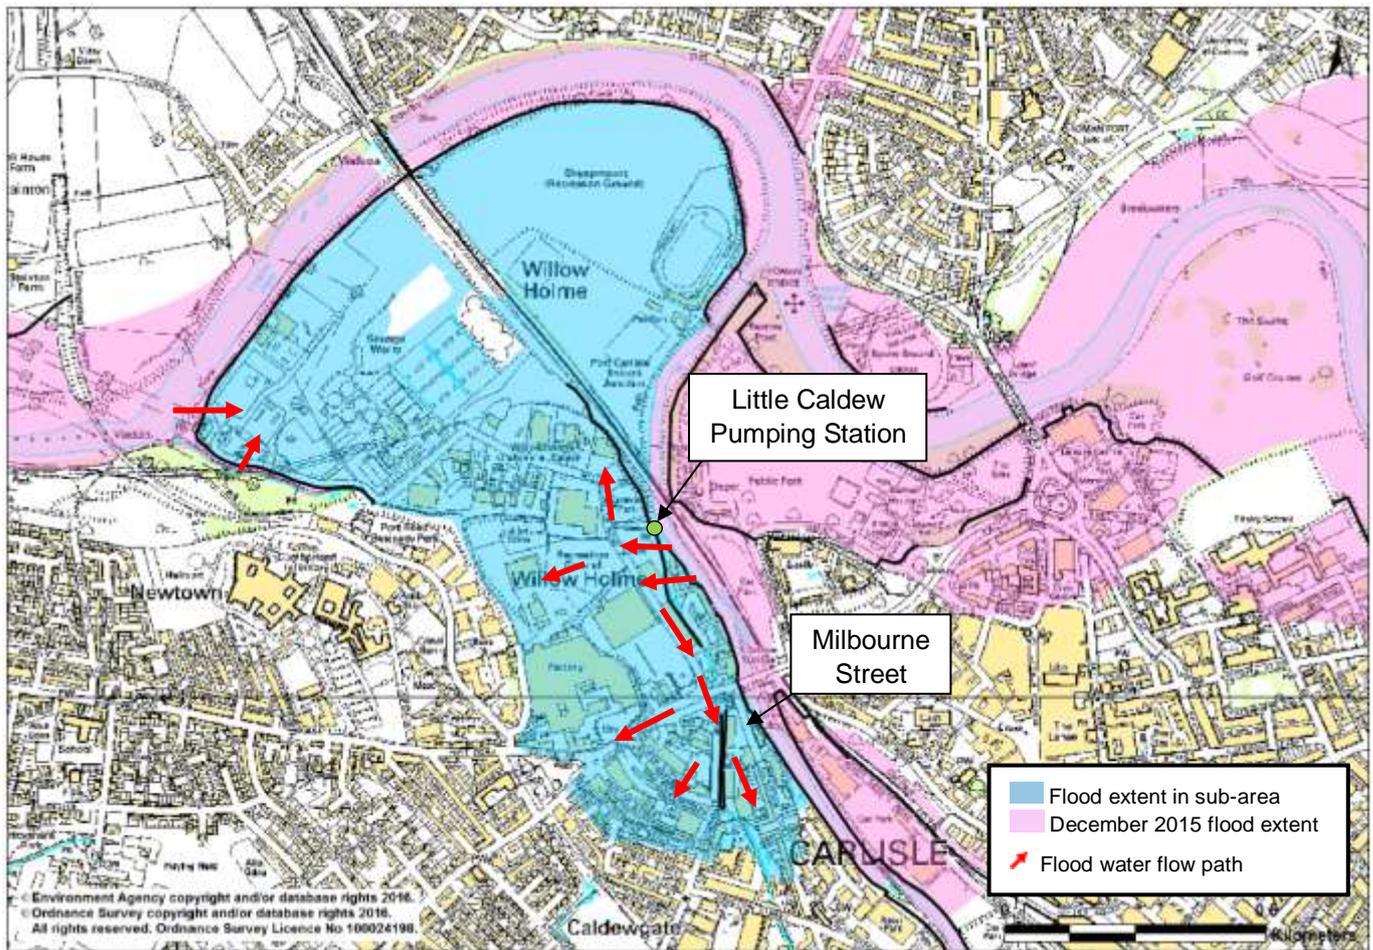
Figure 13: Flood Flow Routes in Willow Holme

This area is adjacent to both the River Caldew and River Eden. A large area was flooded including Carlisle sewage treatment works, Sainsbury’s, Willow Holme industrial estate, the United Biscuits factory and some of the Caldewgate residential area. In addition to the Rivers Eden and Caldew, there are also three smaller watercourses in this area, Parham Beck, Dow Beck, and the Little Caldew.

This was one of the first areas of the city that was flooded, with flooding occurring on the 5th December. This was due to this area being at risk from the River Caldew, which peaked before the Rivers Eden and Petteril. Despite this, defences were not overtopped until after the peak flow in the River Caldew, suggesting that flooding was due to restriction of flow caused by high levels in the River Eden.
