Carlisle

Flood Investigation Report

Flood Event 5-6th December 2015

This flood investigation report has been produced by the Environment Agency as a key Risk Management Authority under Section 19 of the Flood and Water Management Act 2010 in partnership with Cumbria County Council as Lead Local Flood Authority.

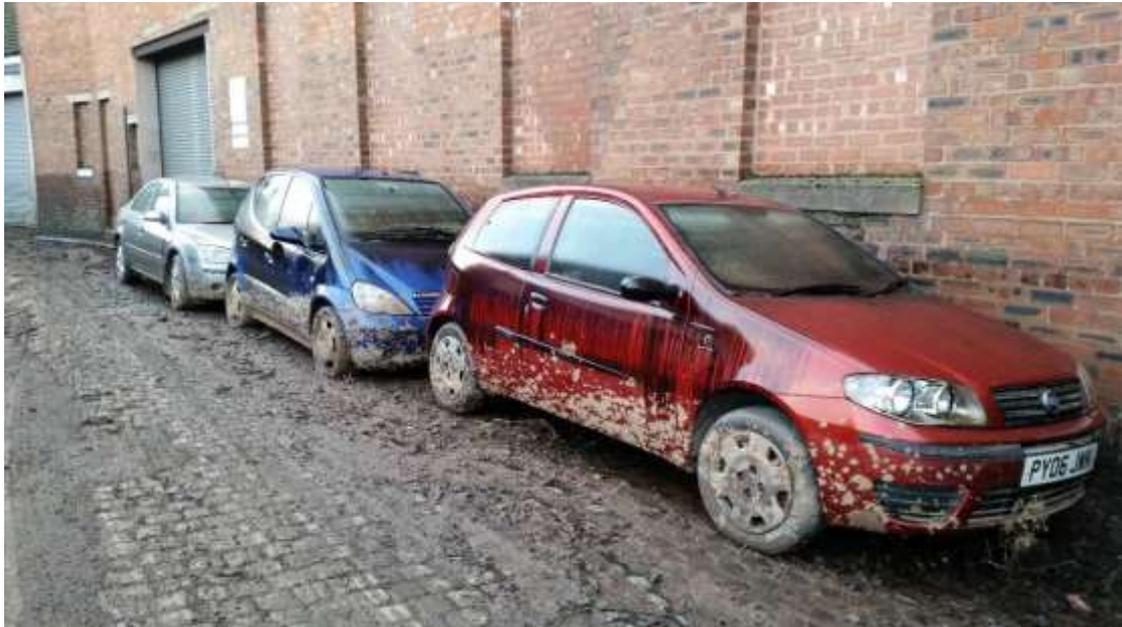
There was a large amount of oil and diesel reported in this area following the flooding. This was from flooded commercial properties dealing in motor vehicles. This created pollution within the flooded area and additional challenges for properties recovering from flooding.

Photograph 6: Cars in Willow Holme area covered with oil following flooding

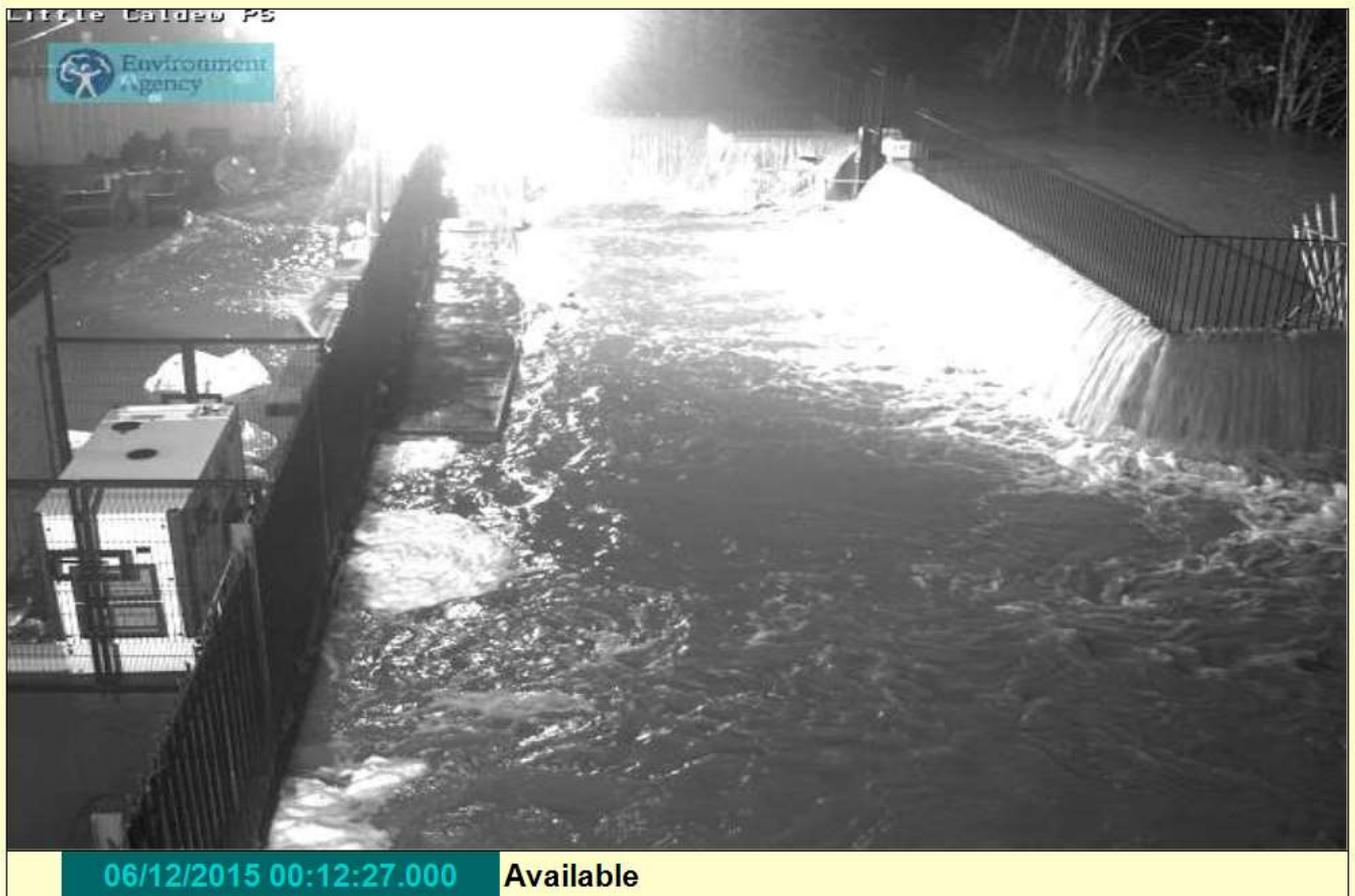
Photograph 7 shows water that has overtopped the defences on the River Caldew flowing into the Little Caldew and then overflowing into the BT Depot at which point the pumping station was inundated.

Photo 7: Little Caldew Pumping Station.

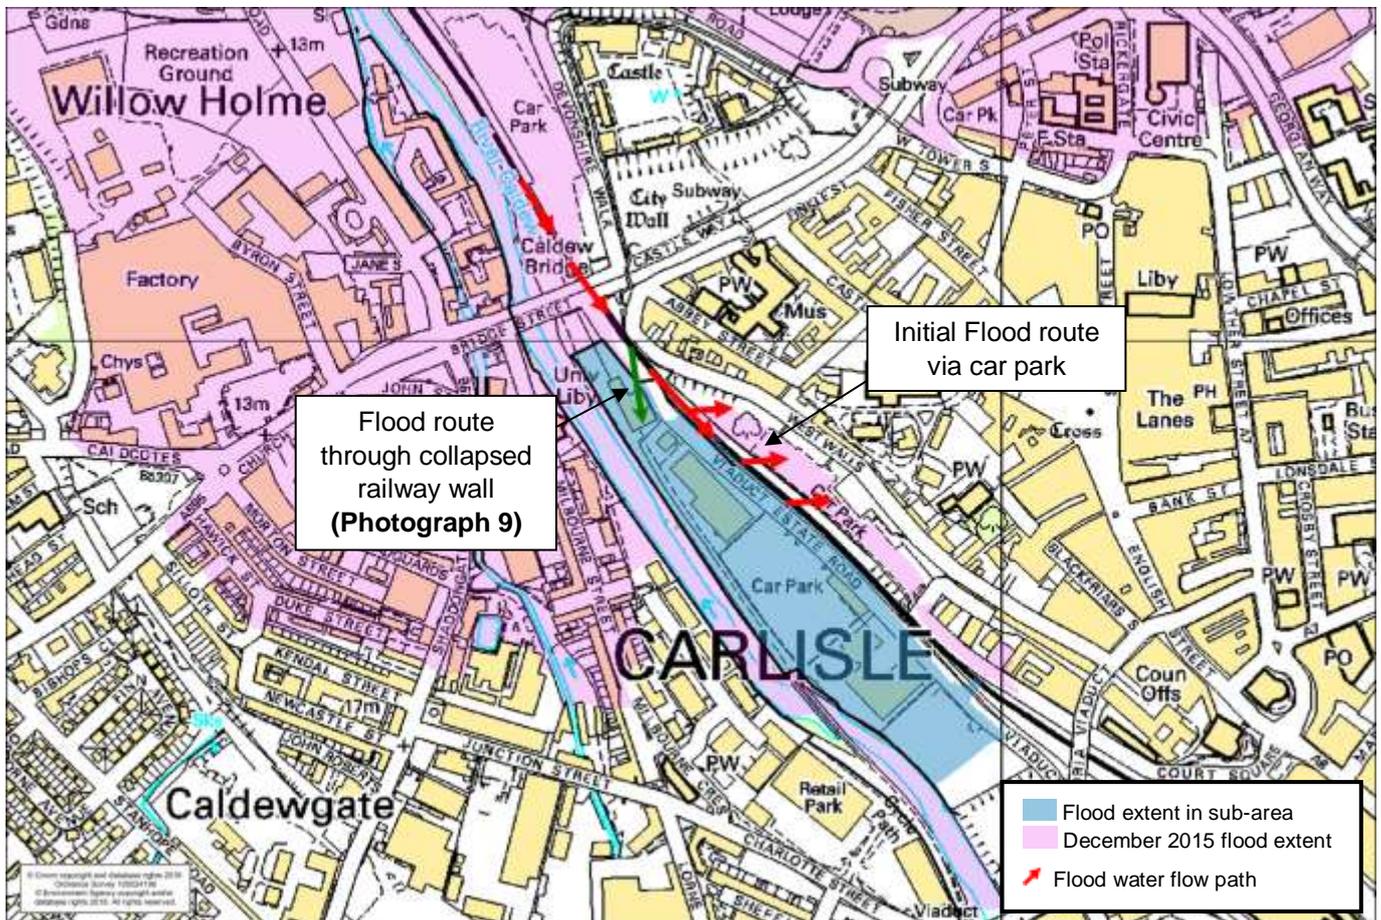
Figure 14: Flood flow routes into Viaduct Estate

The Viaduct Estate is a retail and leisure area located between the River Caldew and the West Coast Main Line railway. The area is protected from direct flooding from the River Caldew by a flood defence wall along the right bank (when looking downstream) of the River Caldew.

Later in the flood event, a section of the railway wall was breached upstream of Caldew Bridge. The wall collapsed onto the footpath indicating that the breach was caused by the water on the railway line. Following this, the flow path into the viaduct estate would be directly from the railway line through this breach. This is the route shown in green on **Figure 14**.

Reports suggest that the railway wall was still intact at 01:00 on 6th December when the car parks and road were already underwater suggesting that the initial cause of flooding in the Viaduct Estate Road area was due to the surcharging of storm water drains, later exacerbated by the collapse of the railway wall and water passing through the arches beneath the railway from the West Walls car park.

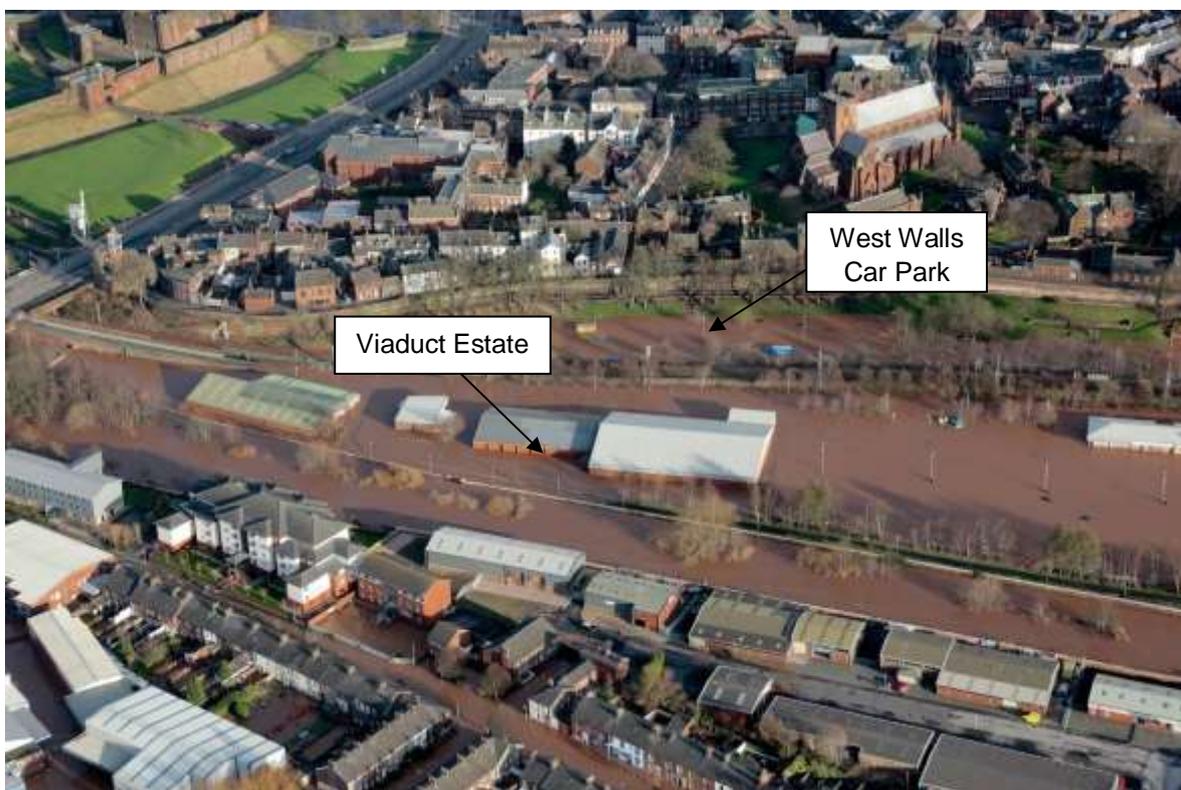
Photograph 8: Viaduct Estate during flood event

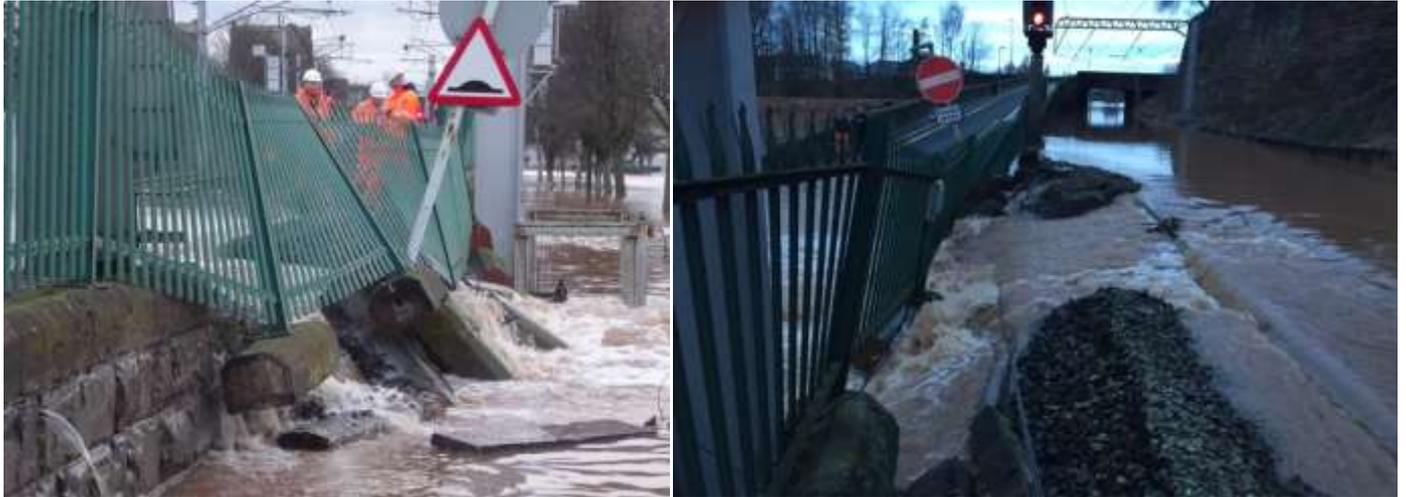
Photographs 9 & 10: Wall along railway at entrance to Viaduct Estate that collapsed during the flood event
