Workington including Barepot and Camerton

S.19 Flood Investigation Report

Flood Event 5-7th December 2015

This flood investigation report has been produced by the Environment Agency as a key Risk Management Authority under Section 19 of the Flood and Water Management Act 2010 in partnership with Cumbria County Council as Lead Local Flood Authority.

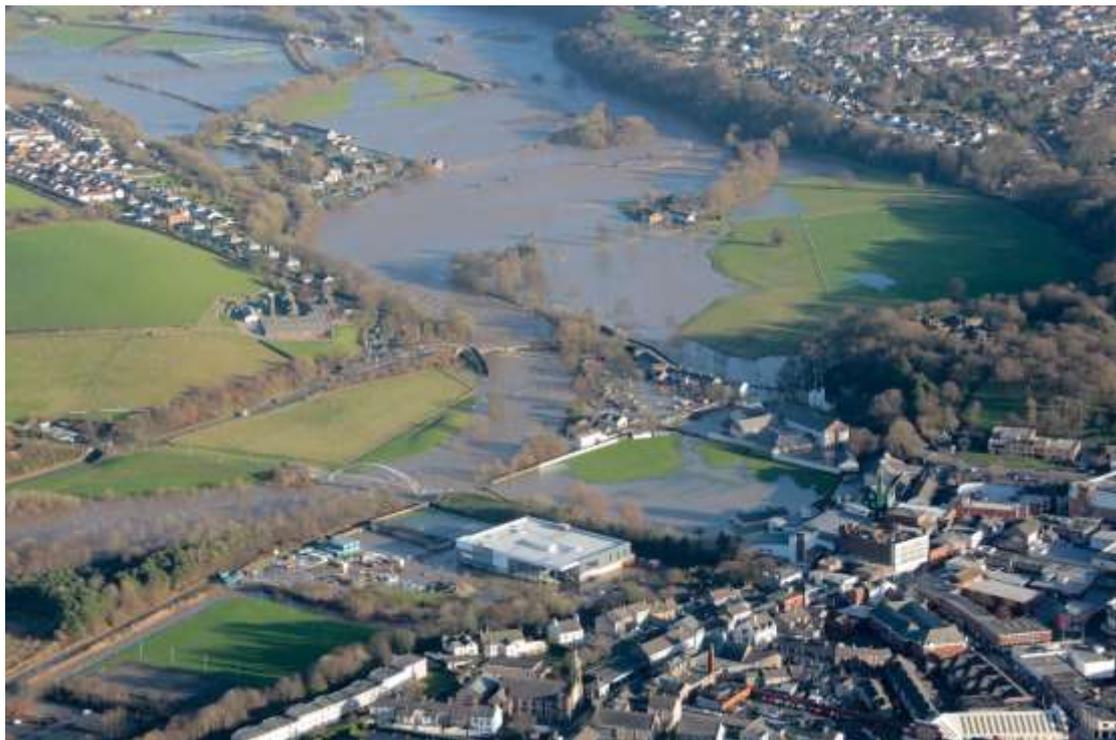
Barepot and Hall Park View, Workington 6/12/15

Photograph provided by Peter Smith Photography. Taken 06/12/2015 12:45

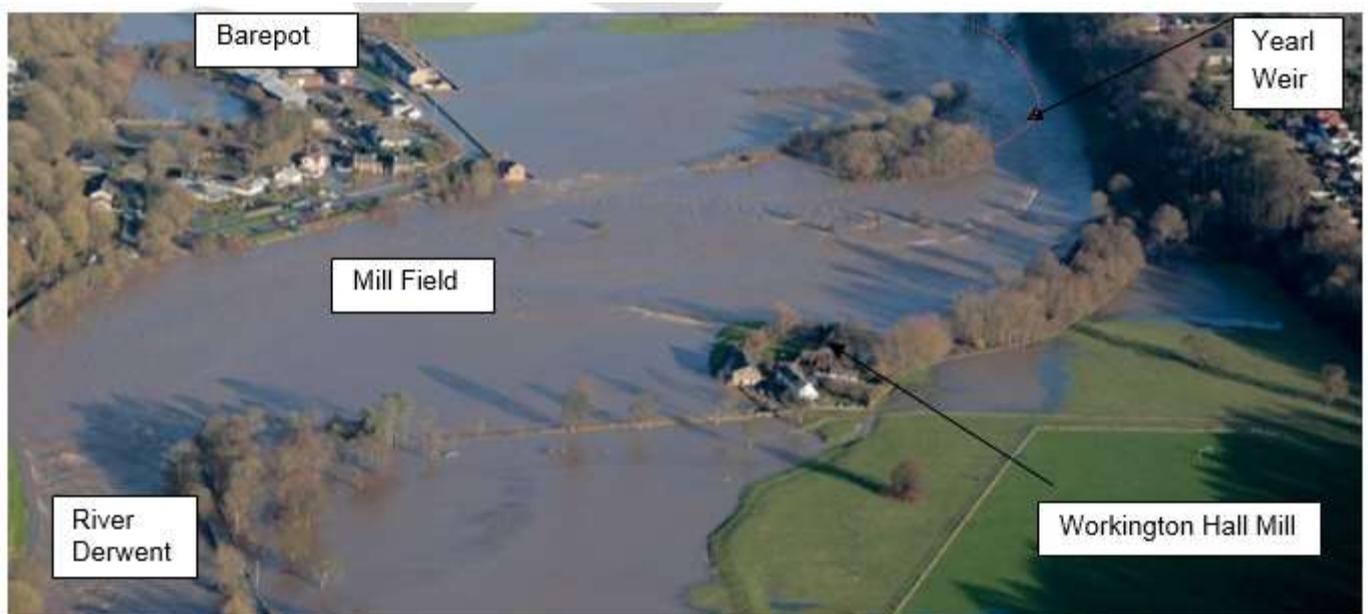
Workington Hall Mill consists of three residential properties built on raised ground in the middle of Workington Hall Park, see **Figure 13**. Mill Field lies to the north, making up the flood plain of the River Derwent which is just beyond, **Photograph 10**. The mill race is fed from the Yearl Weir on the River Derwent. The Workington Hall Mill buildings flooded in 2009. Following this 2009 event, a small bund was constructed to protect the properties. In addition to this, residents also installed personal property protection measures. Some water was seen to flow through the yard of the Mill which is suspected to be back flow, overflowing from the septic tank.

Photograph 10: Workington Hall Mill and Mill Field
Photograph provided by Peter Smith Photography. Taken 06/12/2015 12:45

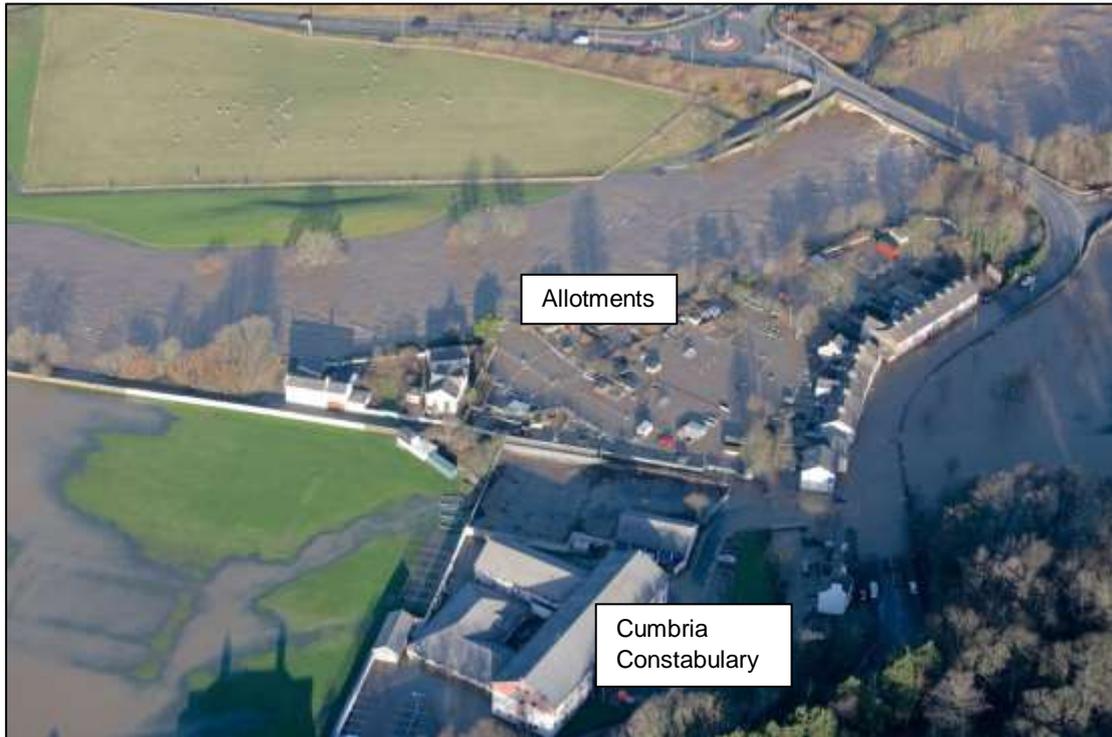
At Hall Park View, the mill race flows under the road and becomes Soapery Beck. The bridge over this section had insufficient capacity during the 2015 event. Flood waters passing across Hall Park View overwhelmed Soapery Beck, and flowed overland through the allotments and through the Police Station into the Cricket Ground, **Photograph 11**. Soapery Beck assists in draining the area but has limited capacity and bridge obstructions, which cause the water to flow out of the channel when the capacity is exceeded.

The River Derwent flooded through Hall Park View for over 48 hours before the water level started to recede. Property numbers 1-5 Hall Brow, are built into the hillside with their basements at ground level at the rear, and first floor at ground level at the front. In these properties the basements flooded from Soapery Beck at the rear. Additionally, property numbers 1 & 2 were reported to have flooded prior to the main flooding event, on the night of the 3rd/4th December due to the intense rainfall impacting surface water drains.

Photograph 11: Aerial Photo Hall Park View
Photograph provided by Peter Smith Photography. Taken 06/12/2015 12:45
