11c11 Outer Leven Estuary

(Technical report by Jacobs)

Policy area: 11c11 Outer Leven Estuary

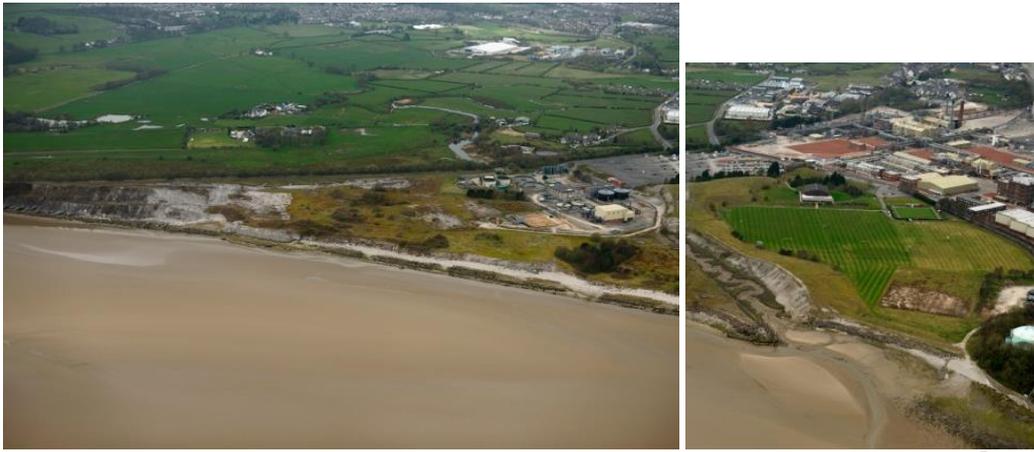
Along this frontage the defences comprise a mixture of defence types (see Figure 2 and Table 1); they are commonly set back from the estuary shoreline, fronted by fringing marsh or reclaimed land, for example see Figure 3 (policy unit 11c11.4), where a slag (spoil) bank fronting the existing defences provides protection. Wave overtopping is known to occur at the lowest section of that slag bank at the south east end (ARUP, 2014).

Figure 3 11c11.4 reclaimed land fronting the Glaxo Factory Site © North West Regional Monitoring Programme, 2015

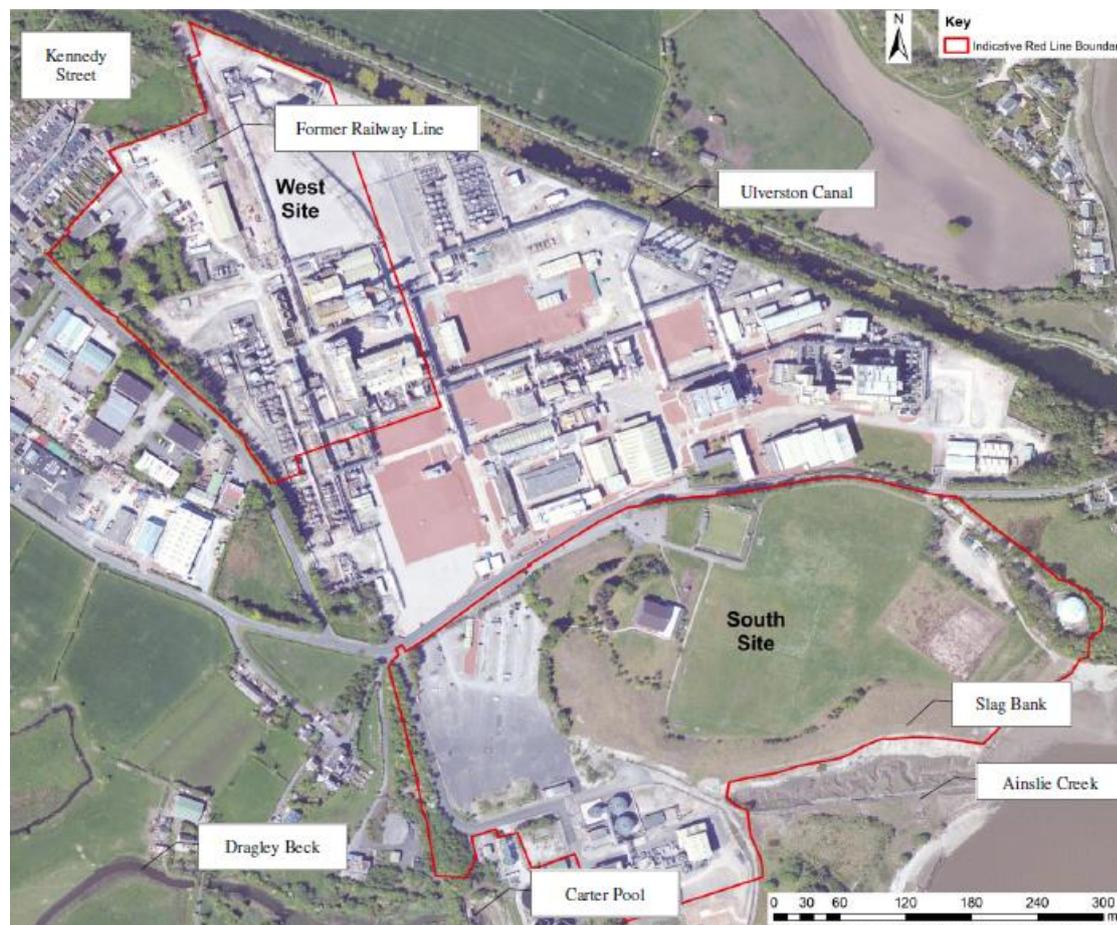
The GlaxoSmithKline (GSK) South Site, as shown in Figure 9, ground comprises thick deposits of made ground (material deposited or re worked by man): mainly ironworks slag which was historically used to reclaim this area from Morecambe Bay. The site investigations undertaken by GSK as part of their proposed site development confirmed no significant soil contaminations, although a trace of asbestos was encountered in one location and it is possible that further asbestos

exists. Pockets of water within the made ground were identified as containing heavy metal contamination, believed to be from the historical ironworks slag tipped from 1870s until the 1960s (Royal HaskoningDHV, 2014).

It is clear from satellite imagery that some of this material (slag) is already eroding into the estuary.

Figure 9 GSK Development Site Overview, with indicative red line boundary (ARUP, 2014)

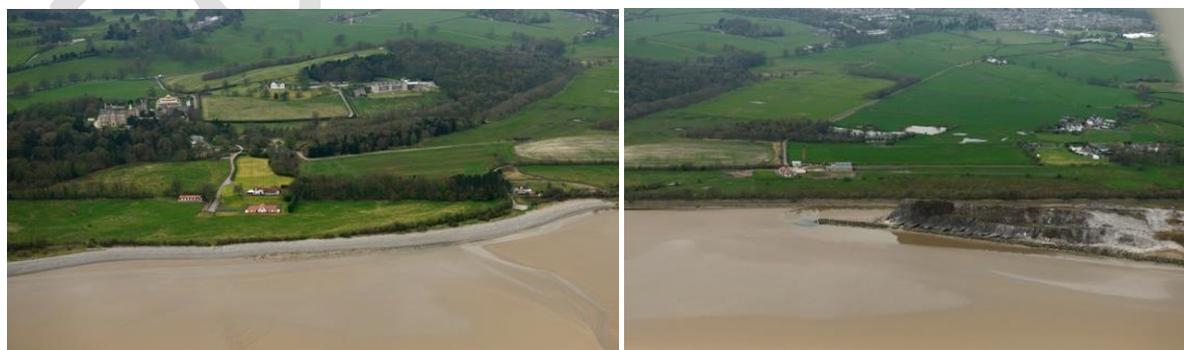
The short term SMP2 policy for this frontage (see Figure 14) is Hold the line, managing the flood and erosion risk by maintaining the existing defences, while investigating the potential to set back the defences in the medium term (Managed realignment). This approach will manage the flood risk to the communities and amenities in the large South Ulverston Flood cell, risk to the historically land fill sites and industrial or commercial sites, avoiding pollution risk. The SMP2 considered that the while there are limited assets at short term risk there is a potential flood route through to south Ulverston that would increase in flood risk with future sea level rise.

Figure 14 11c11.5 Sandhall to Conishead Priory. 2015 aerial photograph © North West Regional Monitoring Programme.
