11c15 Walney Channel (mainland)

(Technical report by Jacobs)

Policy area: 11c15 Walney Channel (mainland)

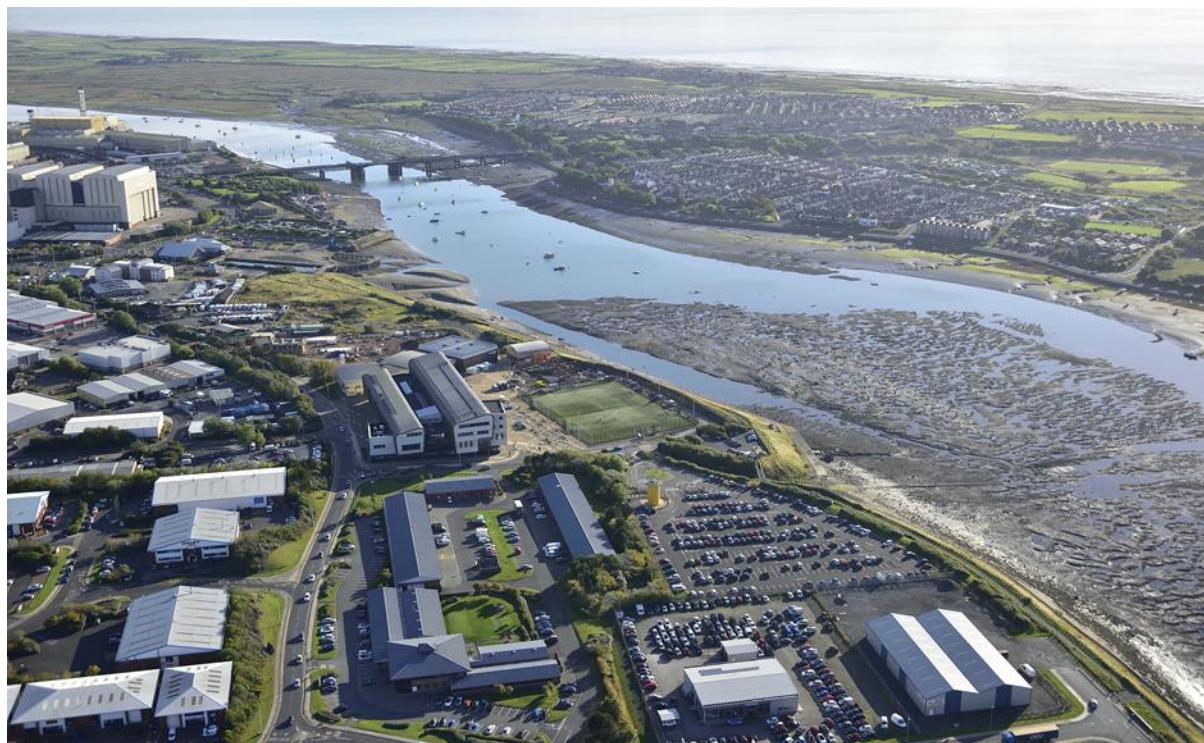
Figure 5 Walney Channel, illustrating the industrial importance of the Barrow in Furness and Barrow Island frontages, including the BAE Systems sit, shown in the top left of the photo. 2015 aerial photo © North West Regional Monitoring Programme.
