# Millom and Haverigg

## Flood Investigation Report

**30<sup>th</sup> September 2017**

This flood investigation report has been produced by Cumbria County Council as a Lead Local Flood Authority under Section 19 of the Flood and Water Management Act 2010.

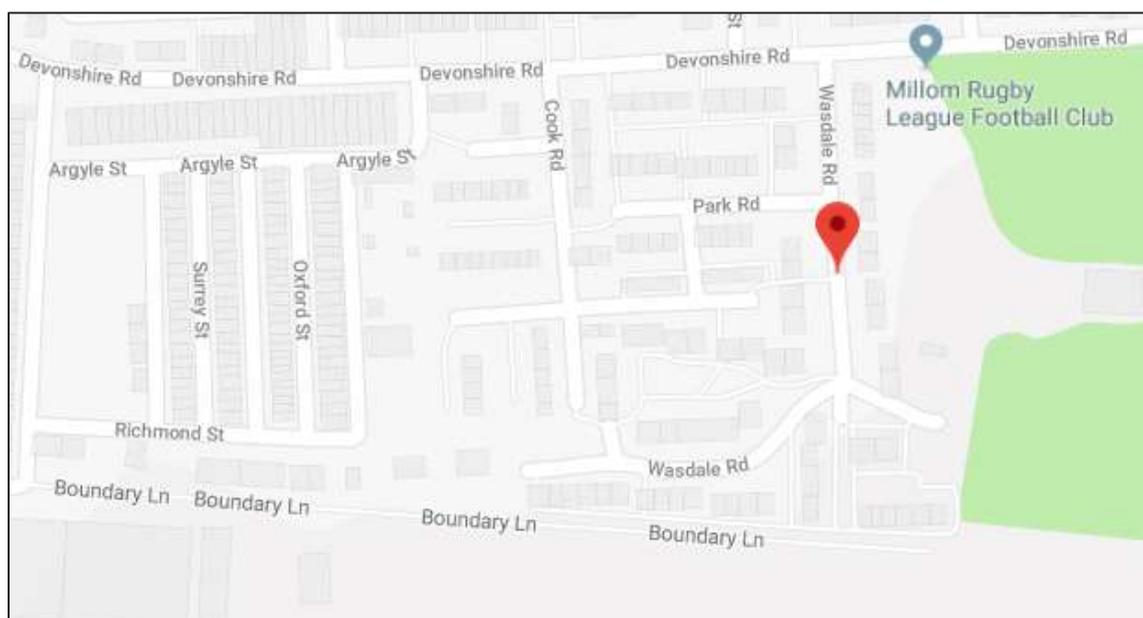
**Figure 20:** Surrey Street / Oxford Street / Richmond Street / Wasdale Road

It is also noted that downspouts from the roofs of these properties discharge direct to the footway and into the highway drainage system. Due to the age of the properties it is unclear what design standards the gully system will have been designed to and it is unlikely that it would have been designed to accommodate a rainfall event such as this. It can also be noted that the surface water that did drain through the gully system also overloaded the combined public sewer system contributing to the capacity issues and surcharging from the public combined sewer.

The Wasdale Road area is of much newer construction and flooding was mainly restricted to external flooding in this area. It is noted from the responses from residents that there appears to be a long standing issue with regular blocking of the foul system, this will be investigated further.

From information gathered regarding this area it is concluded that the likely cause of the flooding is the extreme rainfall event exceeding the design capacity of the drainage systems available.

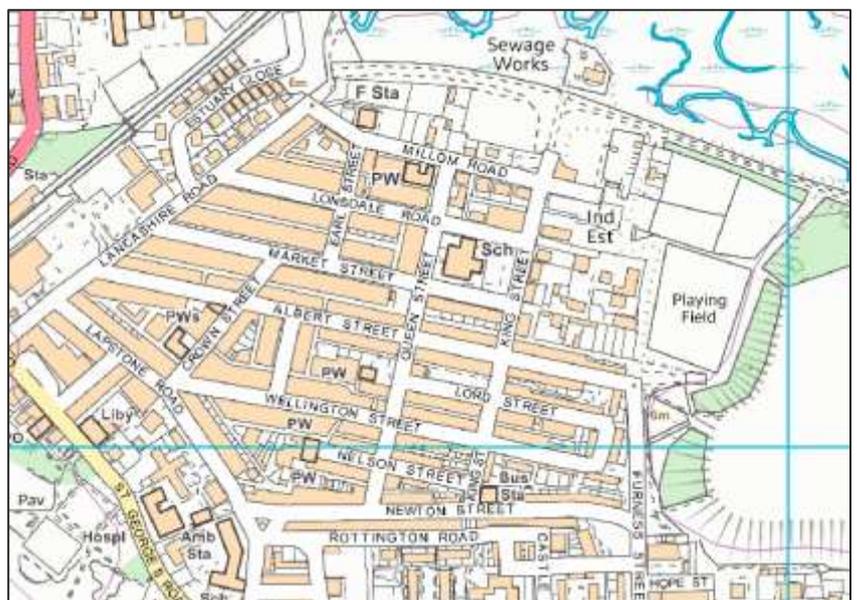
**Figure 21: Lonsdale Road/ Market St / Albert St etc.**

- Some flooding from surcharged drain in back lane of Lonsdale Road

- Flooding began about 10:00 and started to abate between 11:30 – 13:00
- Water was to front step on one property but flooding in from the back
- Gully in back lane covered with soil and weeds
- Who is responsible for cleaning back lanes
- Heavy rainfall from 06:00
- Rainwater on roof looked like a river
- Flooding from back and front in Market Street
- Some of the back lanes appear to be sinking – could this cause a problem
- Earl Street drainage also seemed to impact on the flooding in Market Street
- Were the pumps working
- Flooding also increased by cars driving through the flood water
- Problem with parked cars when gully cleaning
- Leaves and general debris blocking gullies
- How are watercourses managed – never seen any clearing or dredging

The housing in this area is of older construction (pre 1900) and, therefore, the surface water from this area discharges direct to the combined public sewer system. The properties consist of terraced housing with threshold levels very close to or below the level of the highway. It is also noted that downspouts from the roofs of these properties discharge direct to the footway and then to the highway drainage system. Due to the age of the properties it is unclear what design standards the gully system and public sewer system will have been designed to and it is unlikely that it would have been designed to accommodate a rainfall event such as this.

The feedback information from the residents do not suggest that there were problems with the flushing of toilets during this event and information from UU suggested that there appeared to be limited sewage within the flood water which suggested that the flooding was likely to be caused by inability of the heavy rainfall to enter the highway and public sewer system.

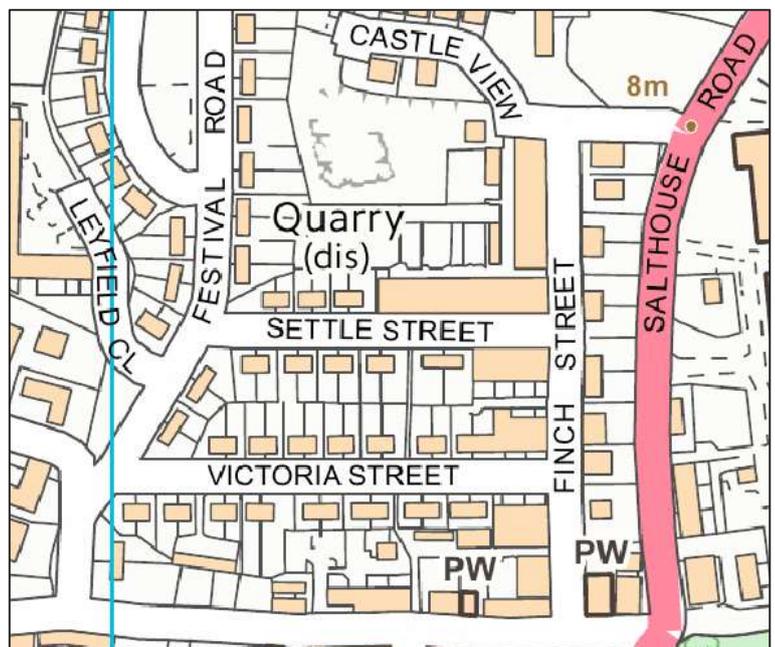
Figure 22: Finch Street / Settle Street

- Flooding has occurred 4 times since 2006
- Flooding from manhole cover in back yard
- Surface water from waste ground behind houses
- Surface water runs like a river when there is heavy rainfall

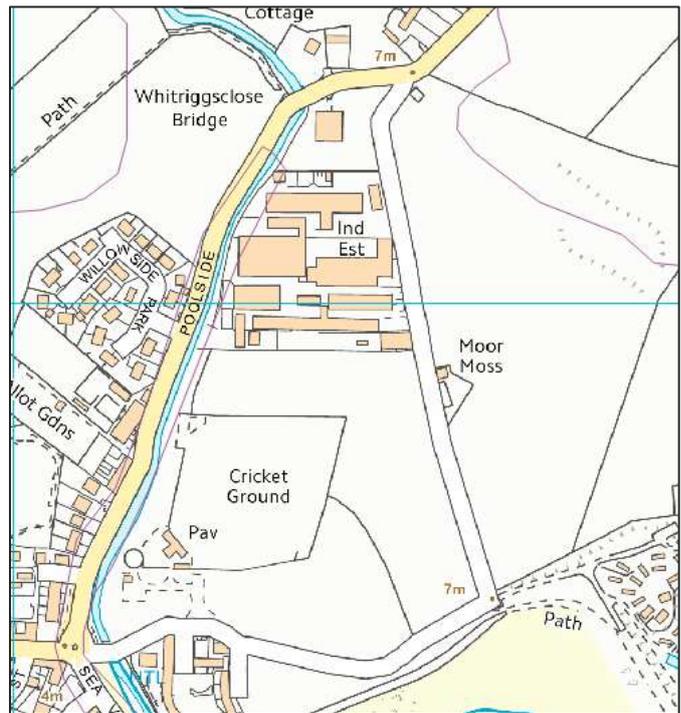
Figure 23: The Old Tannery / Moor Moss

- Flooding caused by flash flooding
- Surface water ran over adjacent fields and onto the highway
- Surface water did not drain for days at some points
- 50mm of water recorded in one property
- Flooding is historic

The only drains found for surface water in this area were highway gullies. These all link into a combined sewer beneath the road that runs toward the sea, falling west half way down the field to the pumping station.

Three of these highway drains were found to be defective (see **figure 24** for reference):-

- Number 1 was heavily silted. This has since been cleared and is now in full working order.
- Number 2 was covered by a sheet, presumably to protect the drain from gravel (see **figure 25**). The sheet has been removed and the gully is fully functional.
- Number 3 has partially collapsed, severing the link between the gully and the combined sewer. This is now scheduled for repair as soon as funds are available.

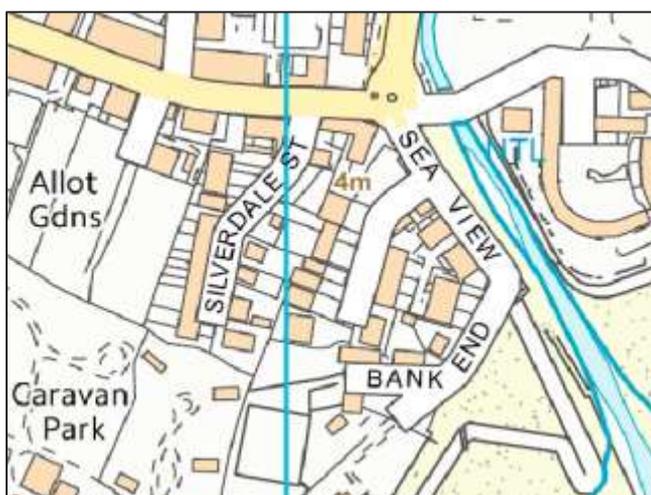
Figure 27: Bank End area

One property was reported as flooded at Bank End with an approximate depth of 60mm, this was caused by flow from surrounding properties and the highway.

It is believed that the flooding is caused due to a low point in the land. Similar to Millom, this area has no surface water drains and relies on the combined sewer for surface water drainage however the sewer was beyond its design capacity.

The Lead Local Flood Authority has since surveyed the highway gully systems and confirmed by dye testing that many discharge direct to the public sewer system. However, on Sea view the highway system discharges direct to Heverigg Pool where an issue has been located and is due for repair as soon as funding is next available.

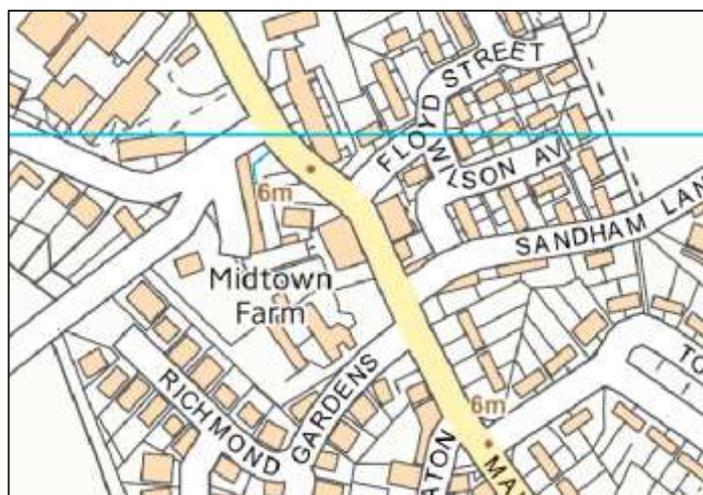
Figure 28: Main Street / North Lane

Five properties were reported as internally flooded at this point. Since the event the LLFA has conducted surveys in and around the area in an attempt to determine the cause. Similar to Millom the surface water around this area all falls into highway drains which are subsequently linked to the combined sewer system.

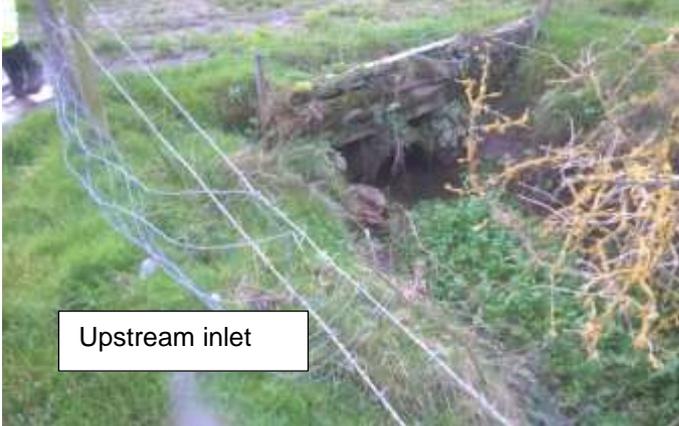
<p data-bbox="866 730 1114 786">Upstream inlet</p>

Asset Name	Levels	Constriction and Dimensions	Comments	Photographs
Crossing 1	U/S IL 3.550

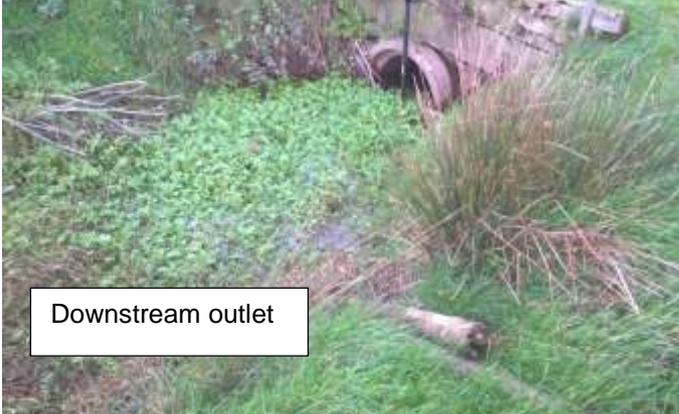
<p data-bbox="842 1178 1114 1234">Downstream outlet</p>
Outfall 1	IL 3.275	Concrete pipe 675mm dia.	Flap valve corroded and fixed in one position – needs attention

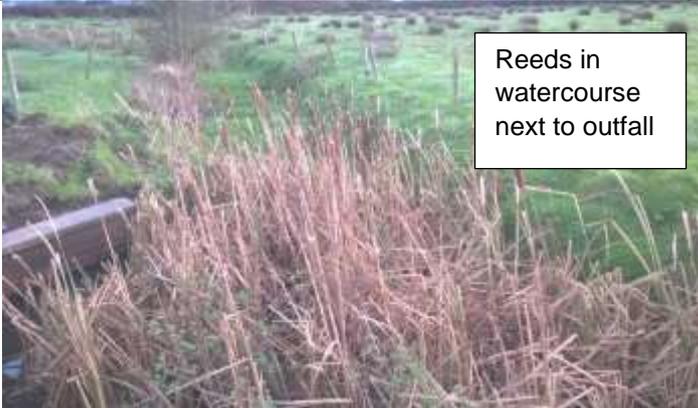
<p>Reeds in watercourse next to outfall</p>
Crossing 2	U/S IL 3.351 D/S IL 3.362	Concrete pipe 1100mm dia.

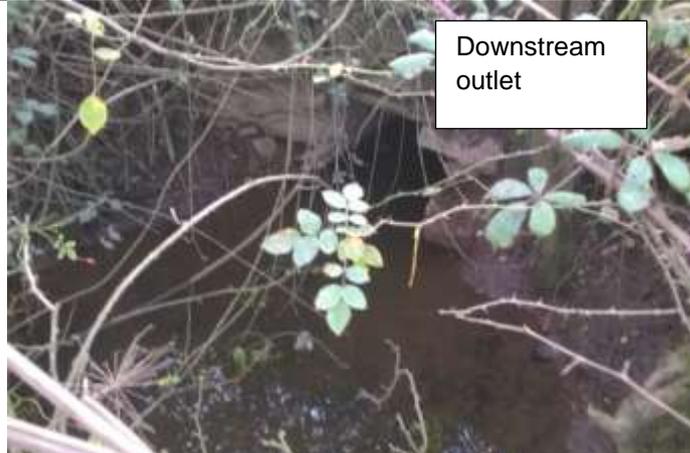
<p>Downstream outlet</p>
<p>Crossing 5</p>	<p>U/S IL 2.859 D/S IL 2.837</p>	<p>Stone culvert U/S 600mm high x 950mm wide D/S 650mm high x 550mm wide</p>	<p>Minor collapse at side of culvert – preliminary discussion with landowner regarding repair during inspection</p>

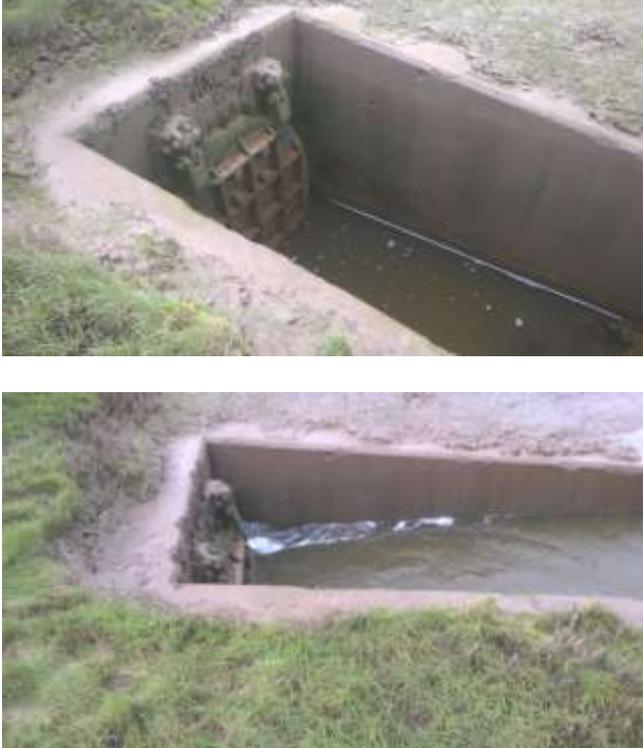
Inlet 2	IL 1.113	Concrete pipe 1700mm dia	Some stones at entrance – would benefit from removal

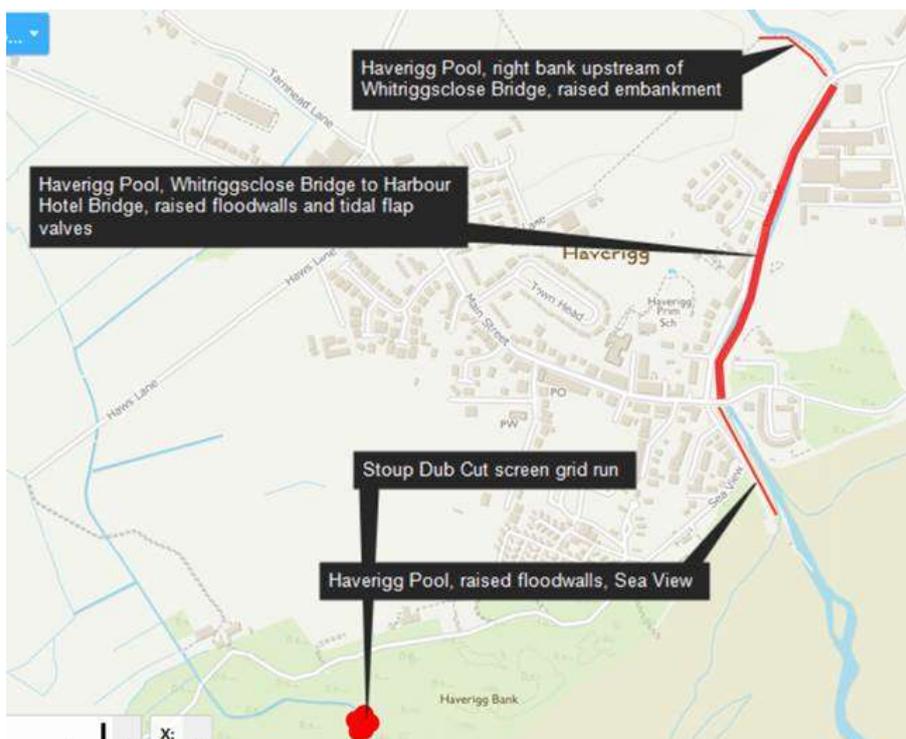
**Figure 20: Assets maintained by EA in Haverigg**

It is considered that the EA assets performed well during the event and there have not been any reports of any back flow from the sea side of the defences during the event. It is therefore considered that the main rivers within both the Millom and Haverigg catchments did not have an impact on the flood event.

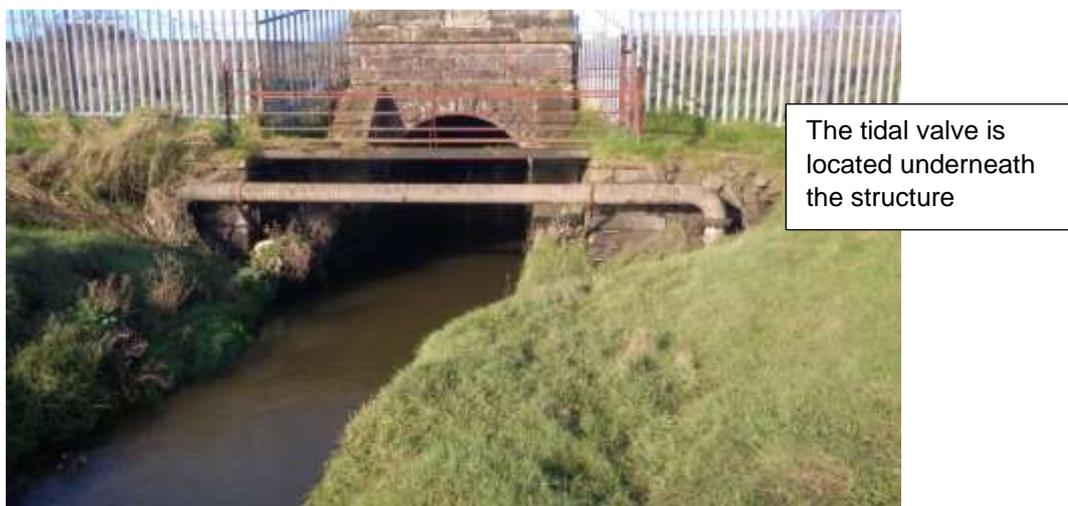
**Photograph 2: Cumbrian Coast Railway Line river crossing**

The Cumbrian Coast Railway Line runs from Barrow-in-Furness to Carlisle passing through Millom. As it passes through Millom it crosses the main river known as Salthouse Pool. In this location there is a river crossing with a tidal flap as indicated in the following photograph.

There is no evidence that any drainage systems close to flooded properties interact with the Salthouse Pool watercourse and, therefore, it is considered that the Network Rail asset has not had any impact on the flooding that occurred on the 30<sup>th</sup> September 2017.
