Holme

Flood Investigation Report

North Road, Holme

Flood Event 22nd November 2017

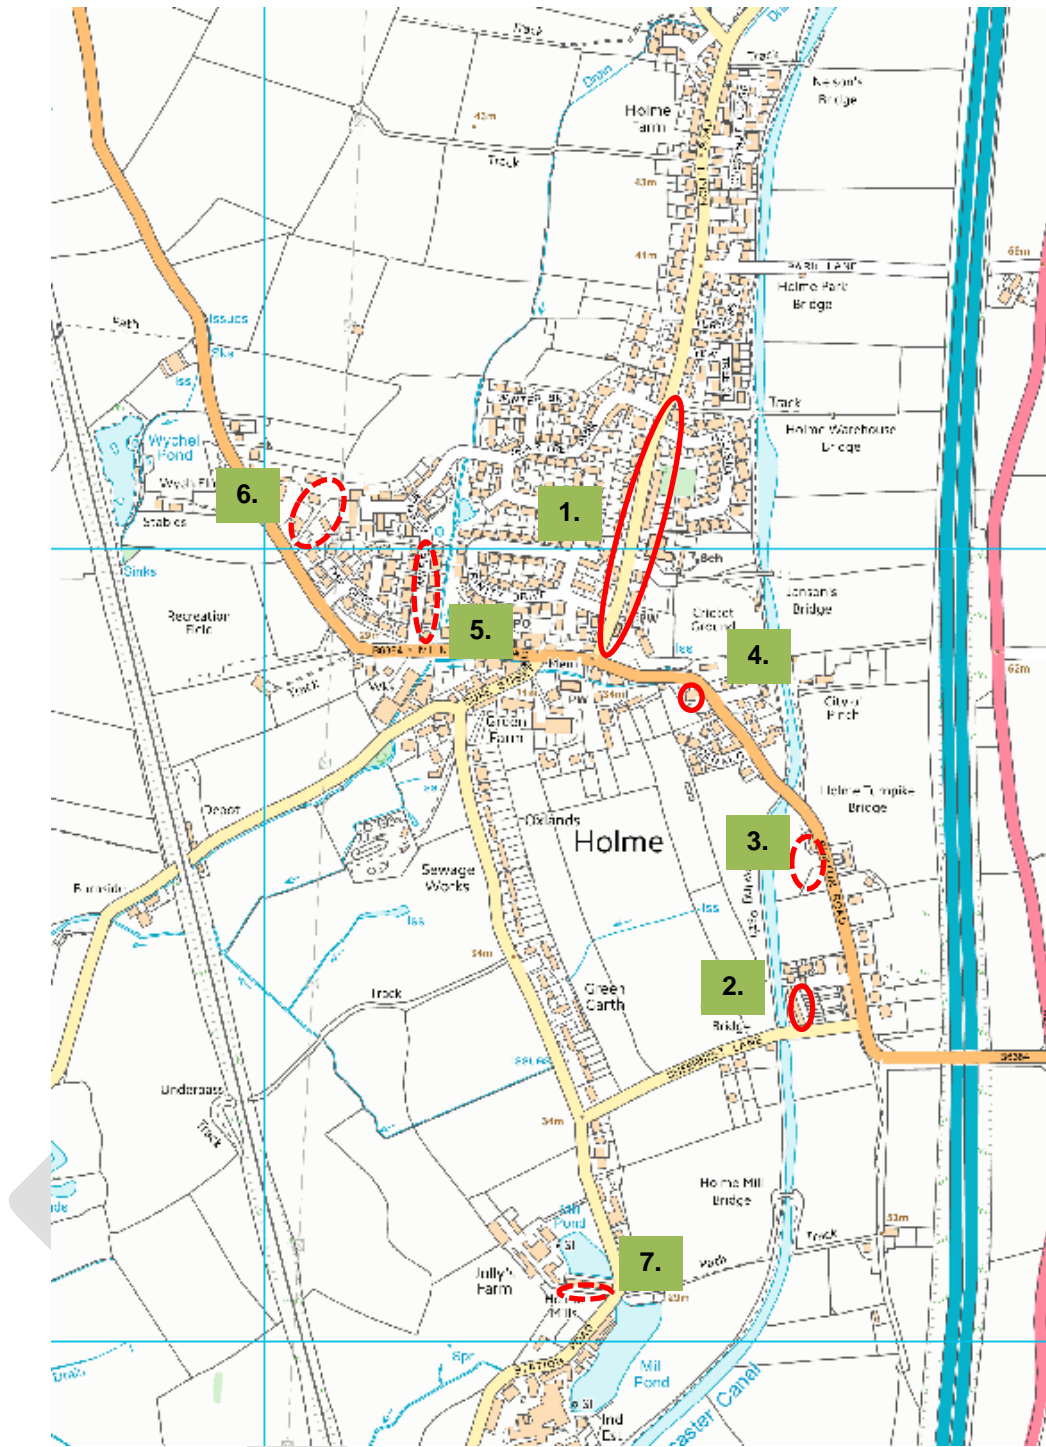
Figure 1: Location of Holme and the sub areas discussed within this report. 1. North Road. 2. Sheerness. 3. Wharfdale Cottage. 4. Brook Cottage. 5. Mayfield Avenue. 6. Silvercroft. 7. Holme Mills

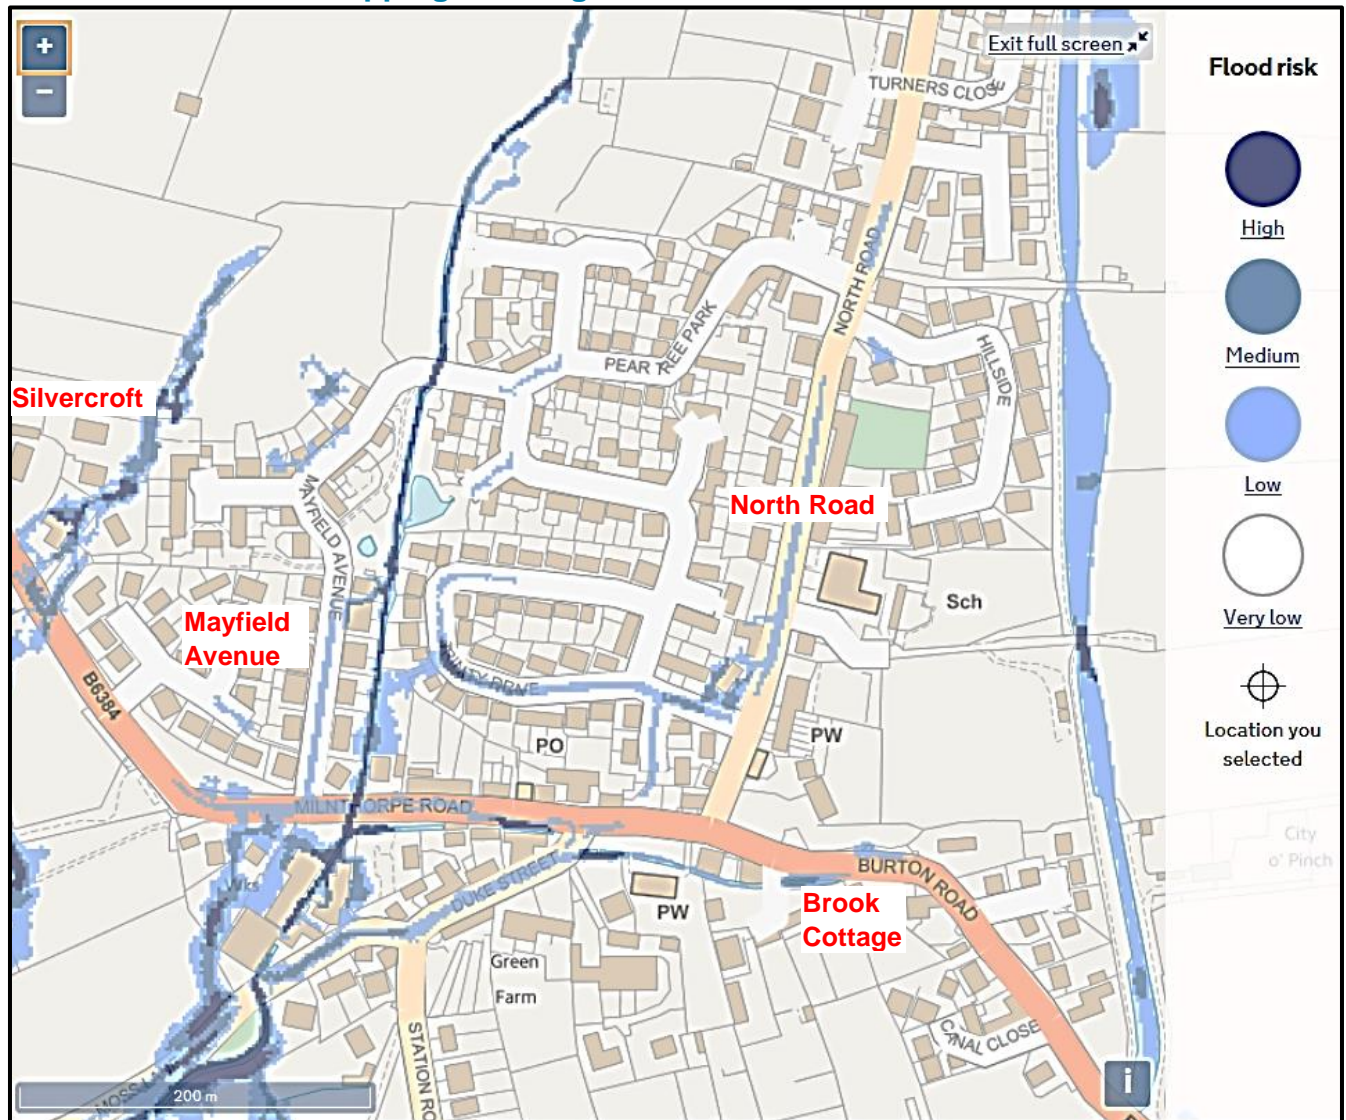
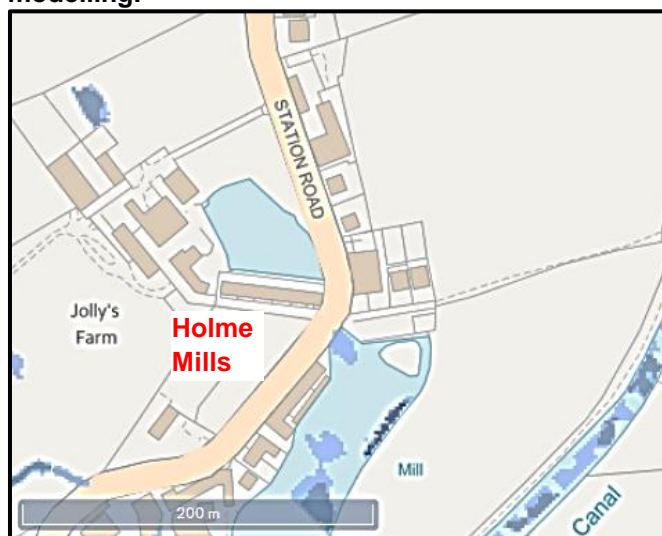
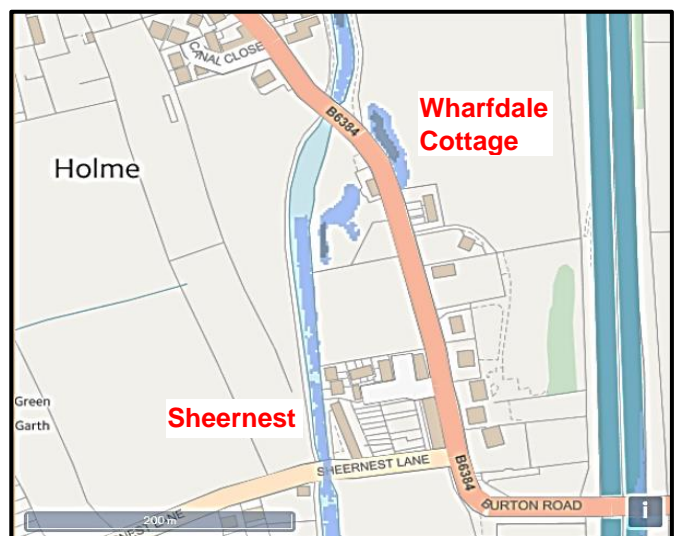
Figures 2, 3, and 4: Long term flood risk from surface water mapping from the Environment Agency. Identification of sub areas. It is notable that the observed flooded areas, as shown in the *Investigation* section of this report, were much more extensive than the areas identified as at risk of flooding by EA modelling.

There is a large amount of uncertainty about where the volume of water that has caused flooding all across Holme came from. Comparing flood outlines (provided in figures 2, 3, and 4 - details taken from <https://flood-warning-information.service.gov.uk/long-term-flood-risk/map>) with the actual flooded areas, the flooding appears to be greater in all locations than would be expected from surface water alone.

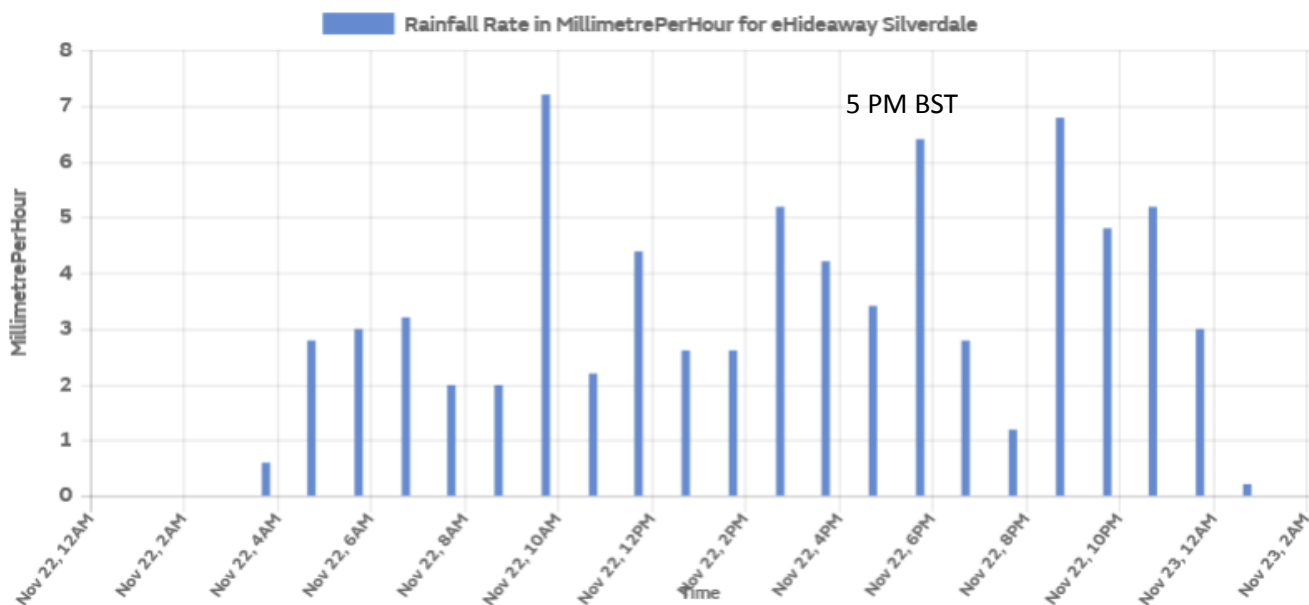
Figure 6: 77mm rainfall in 24 hours was recorded at the nearest gauging station in Silverdale.

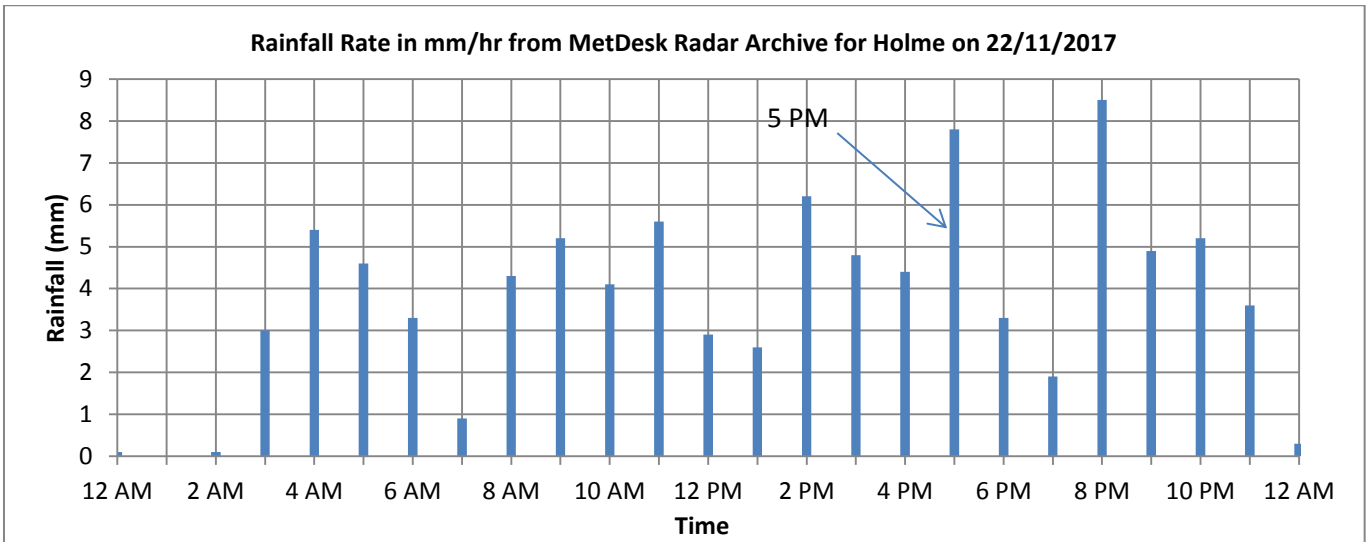
Figure 7: Analysis of radar information suggests 93mm rainfall in 24 hours at Holme.

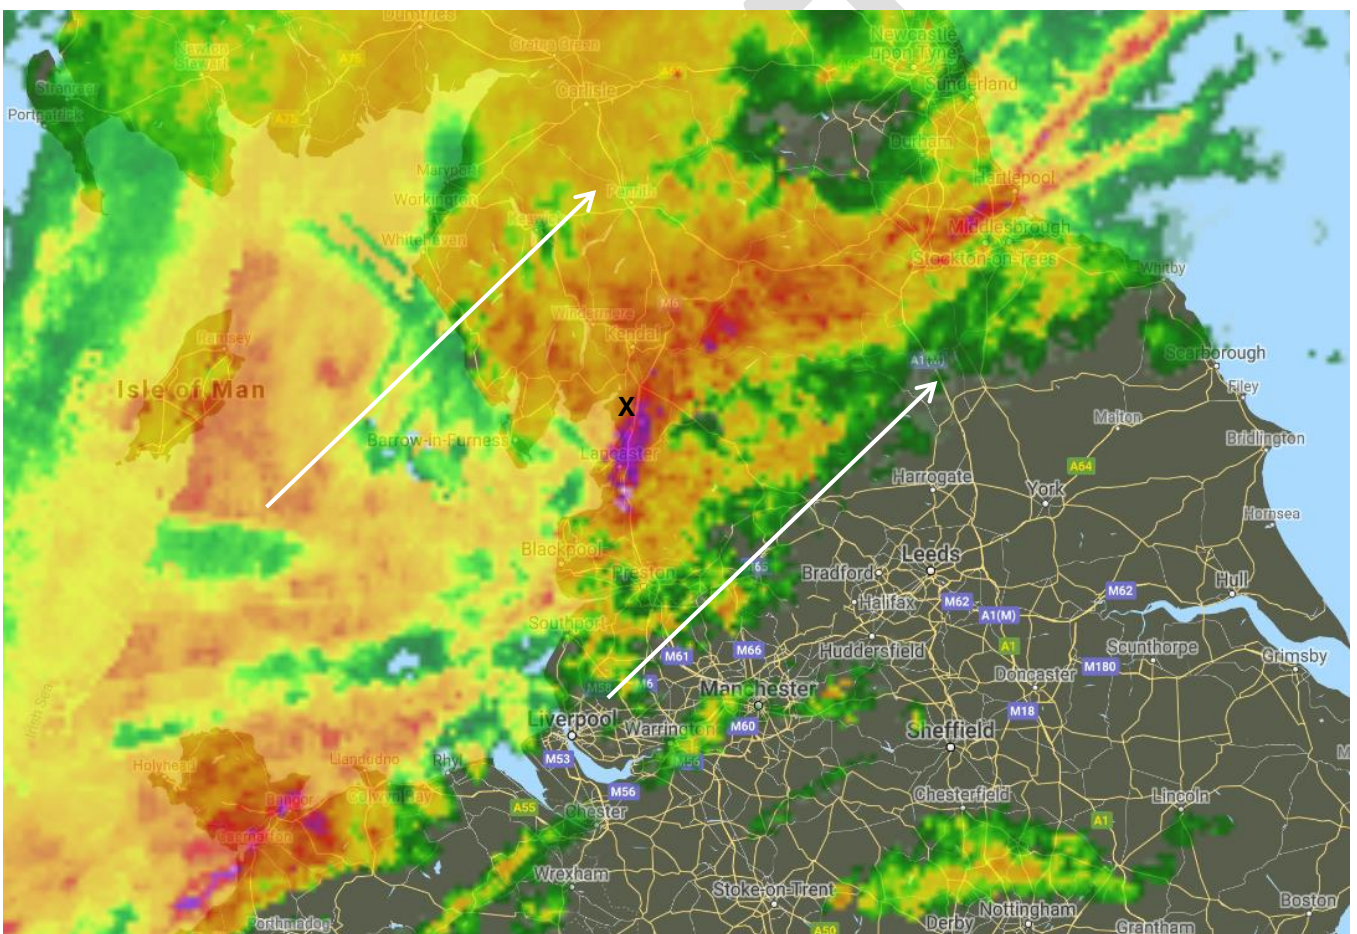
Figure 8: Radar imagery at 19:45 on 22nd November 2017. General track of weather indicated by arrows. The cloudburst over Middlesbrough had been over Holme at 17:00 and the cloudburst then over North Wales reached Holme at 21:30.

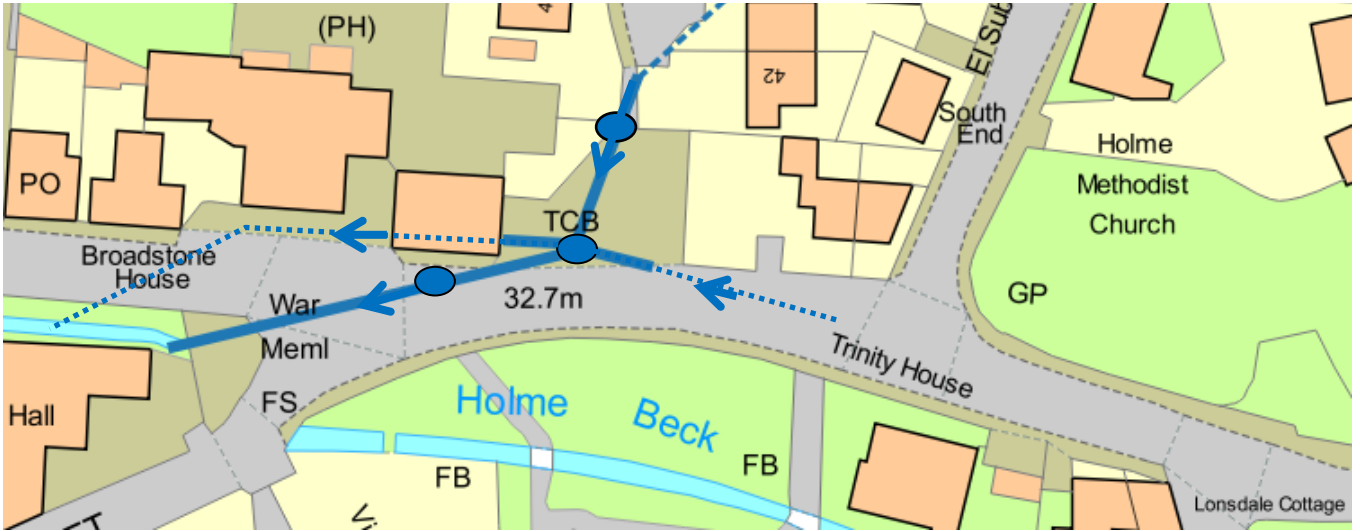
Figure 14: Final part of culvert system near outfall.

The North Road culvert is functional throughout, there is no total collapse. Appendix 1 shows what was encountered in all of the places where our CCTV survey was undertaken.

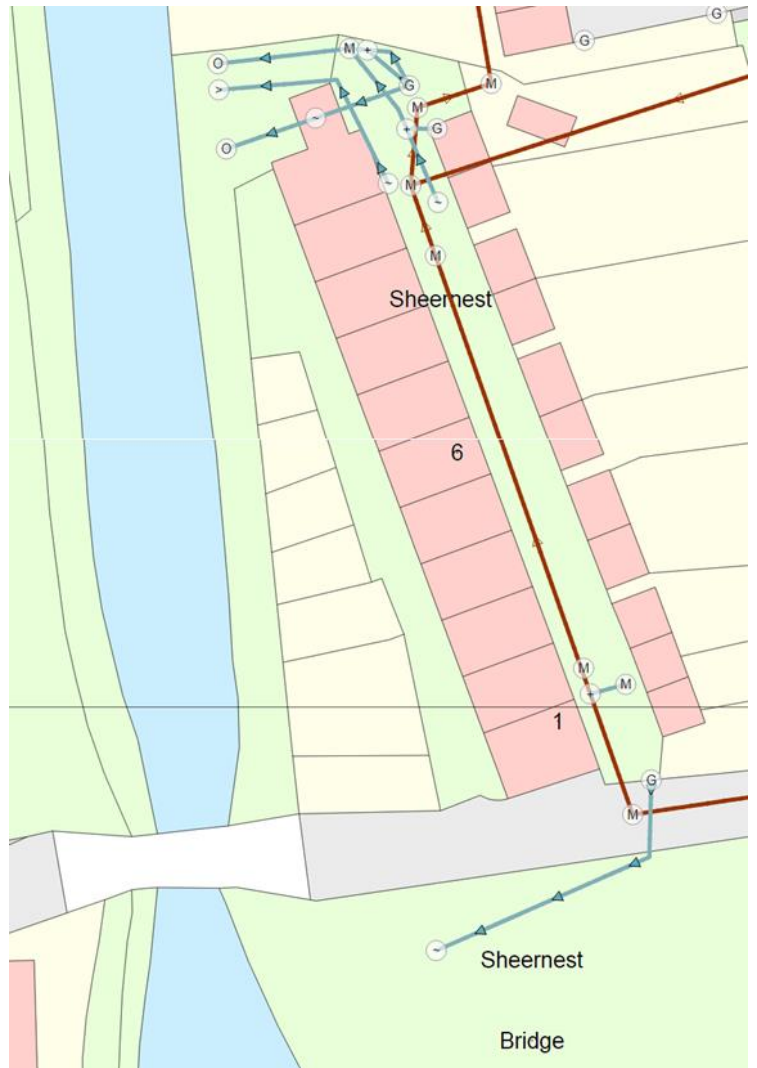
Figure 18: Complex drainage system at Sheernest (red lines are the foul system).

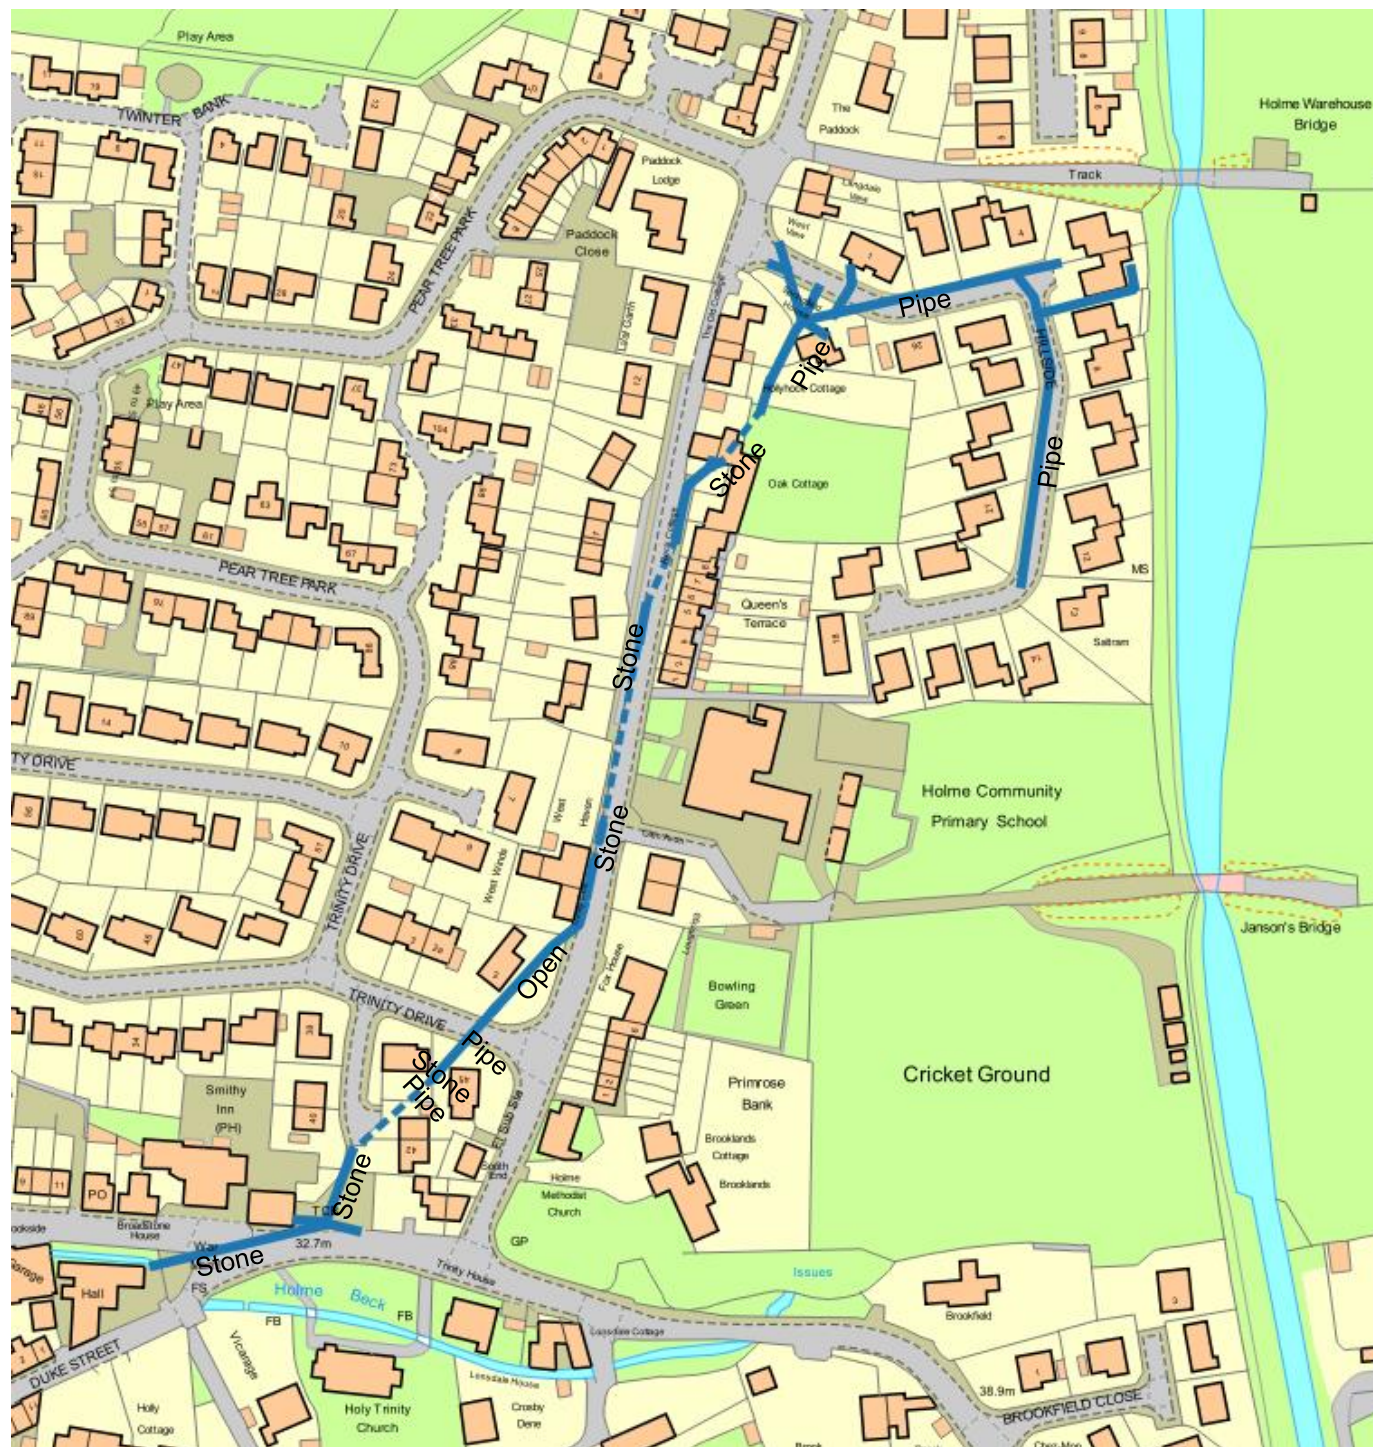
Overview. We were unable to get CCTV footage of the dashed sections. There are no connections coming in from the upstream ends of the system other than roof drainage.

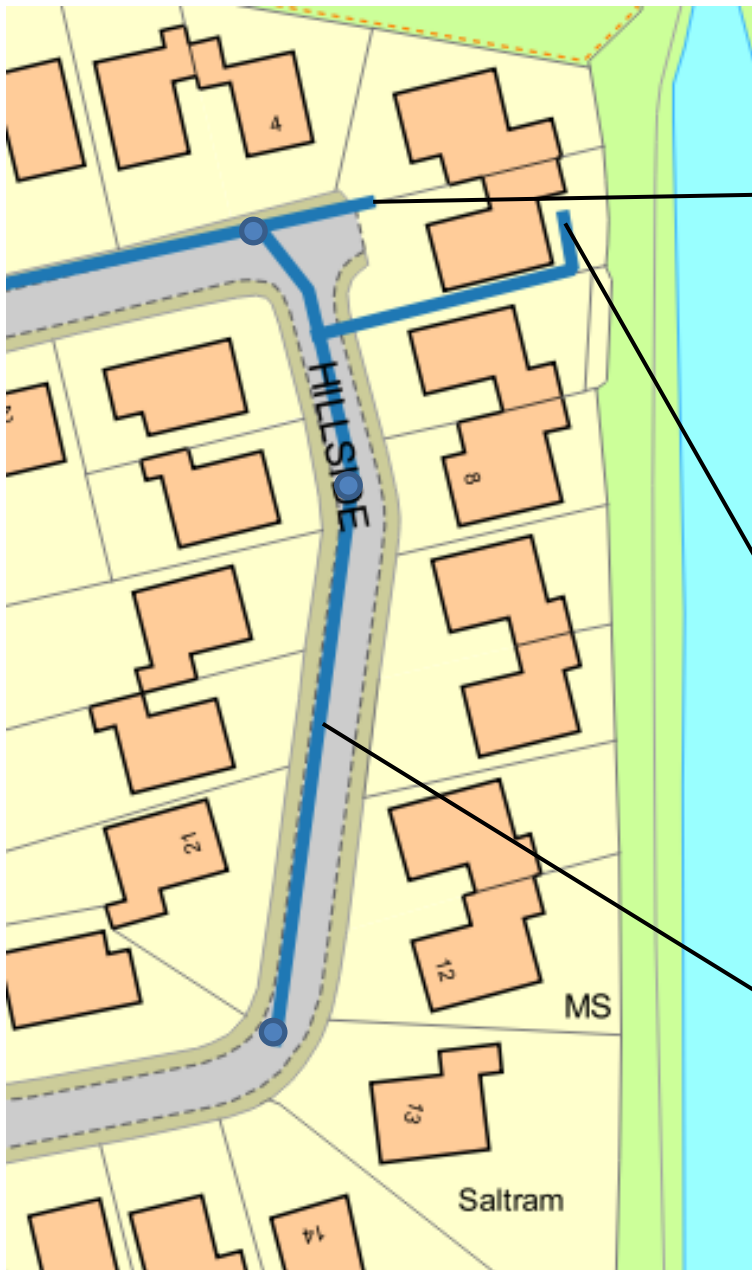
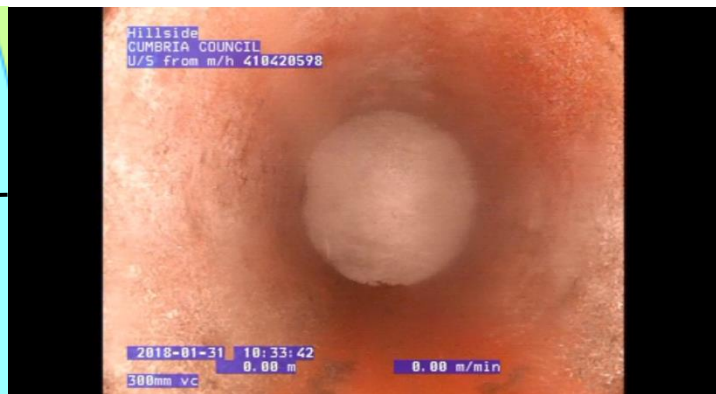
Top of run. Line is capped off with concrete finish. Continues as 225mm dia. clay pipe.

Top of run capped off. Roof drainage of no.6. No other connections.

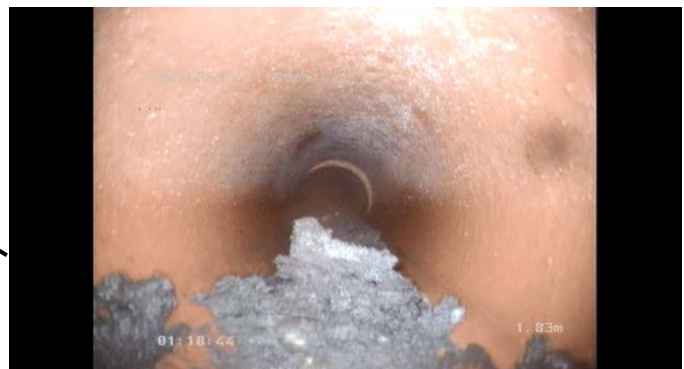
150mm dia. clay pipe. Silt but no defect. Didn't get footage to top of run but starts at no.18 and receives roof, driveway, and highway drainage for Hillside.

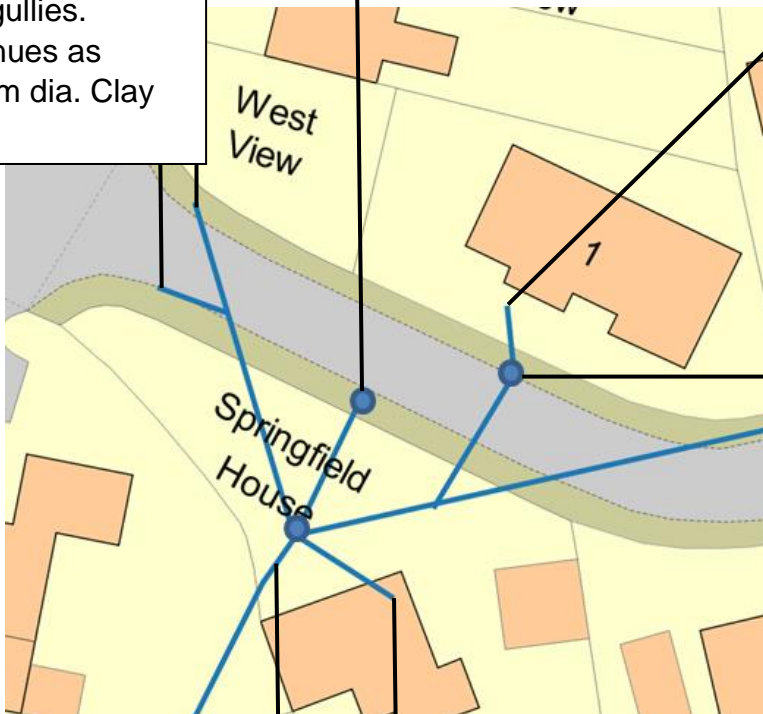
This manhole has gaps in the brickwork which are to allow water in the ground into the system to be drained away. Continues as 150mm dia. clay pipe.

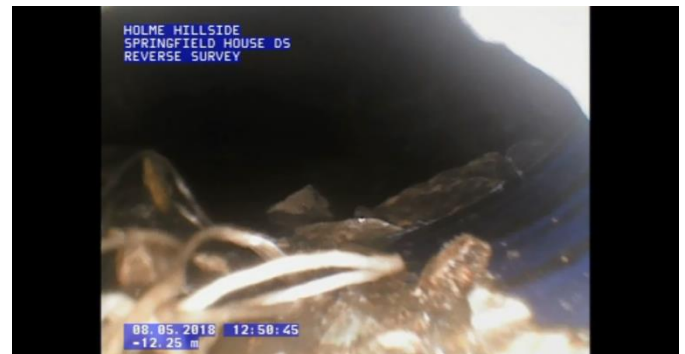
Culvert reduces from 450mm dia. plastic to 300mm x 300mm brick.

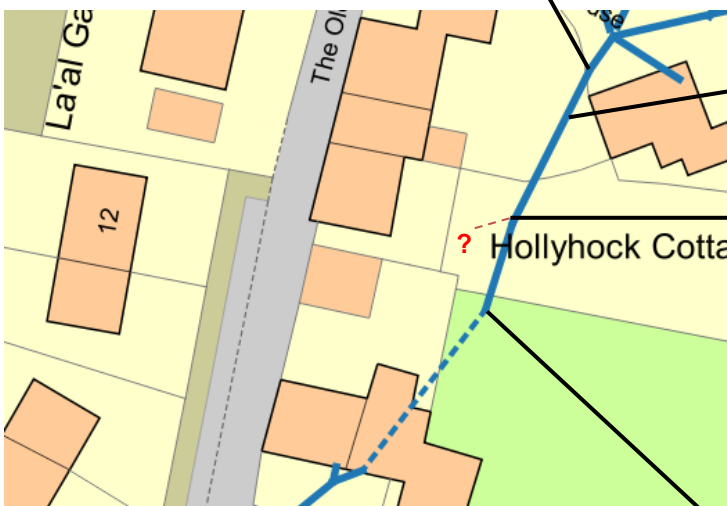
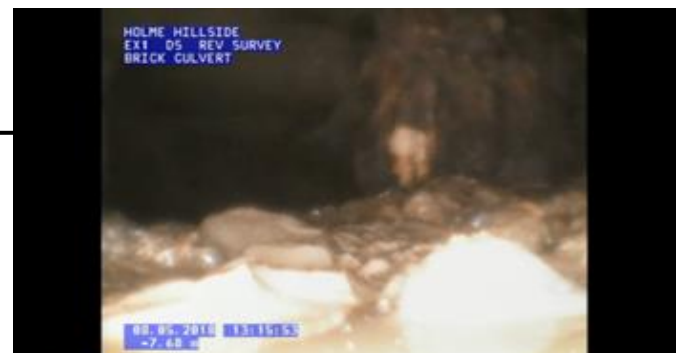
Cannot be sure if there is a split to the right (looking downstream) here.

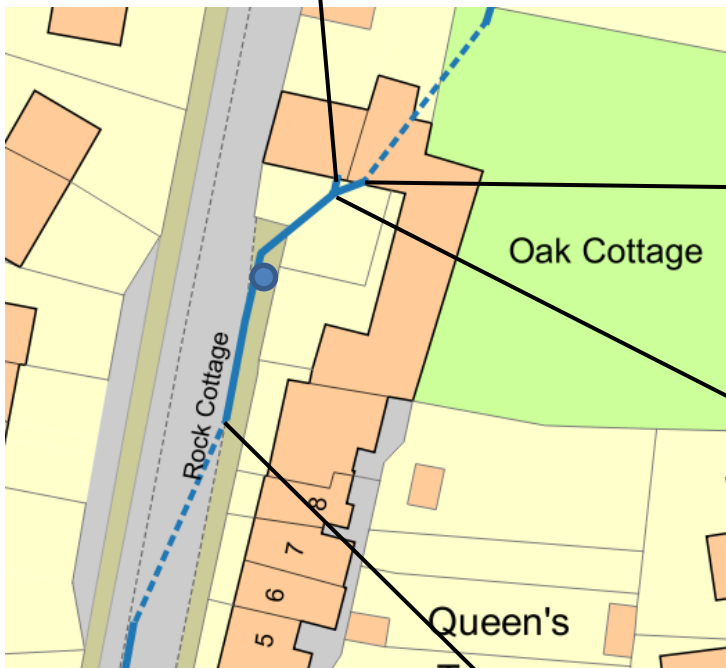
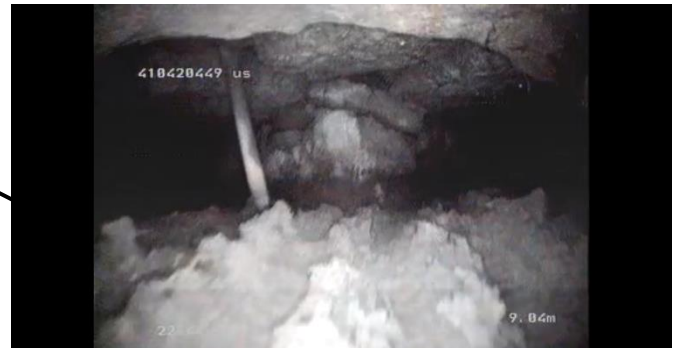
Junction (looking in upstream direction). The flow from Hillside comes through the right branch which is 300mm x 300mm stone.

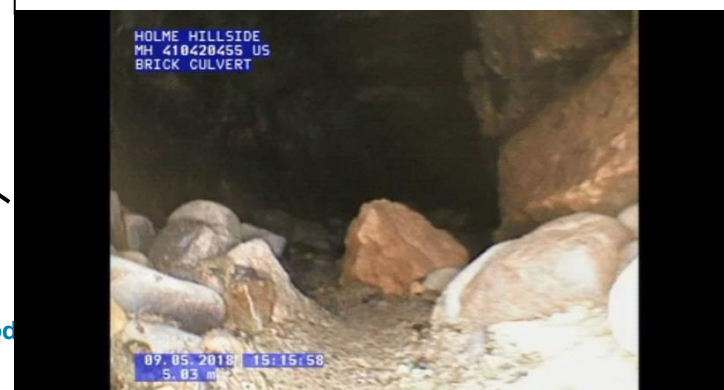
Camera caught in roots. Daylight visible downstream. 450mm x 450mm, brick.

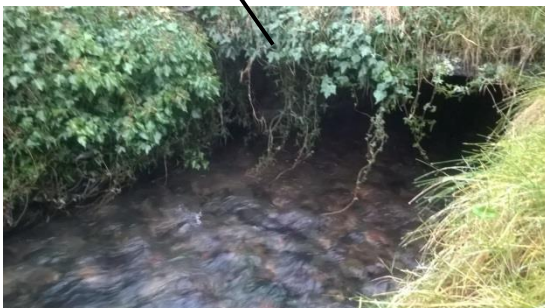
Culvert outfall into Holme Beck at village Hall. 450mm x 450mm brick. Flows well.

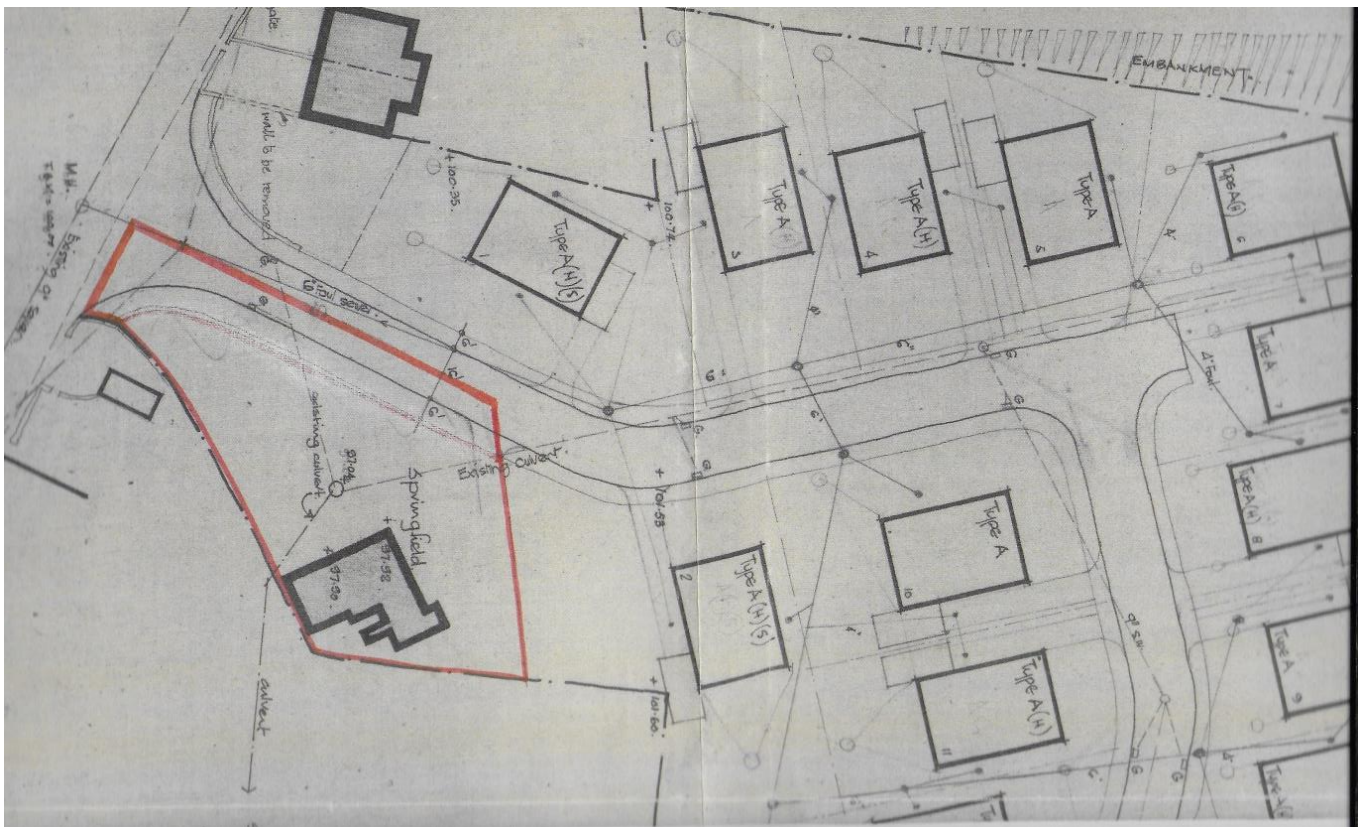
Old plan of Hillfield drainage. Similar but did not correspond to what we surveyed.

NB: Extensive searches were made for this route in our investigation but no such route was ever found.

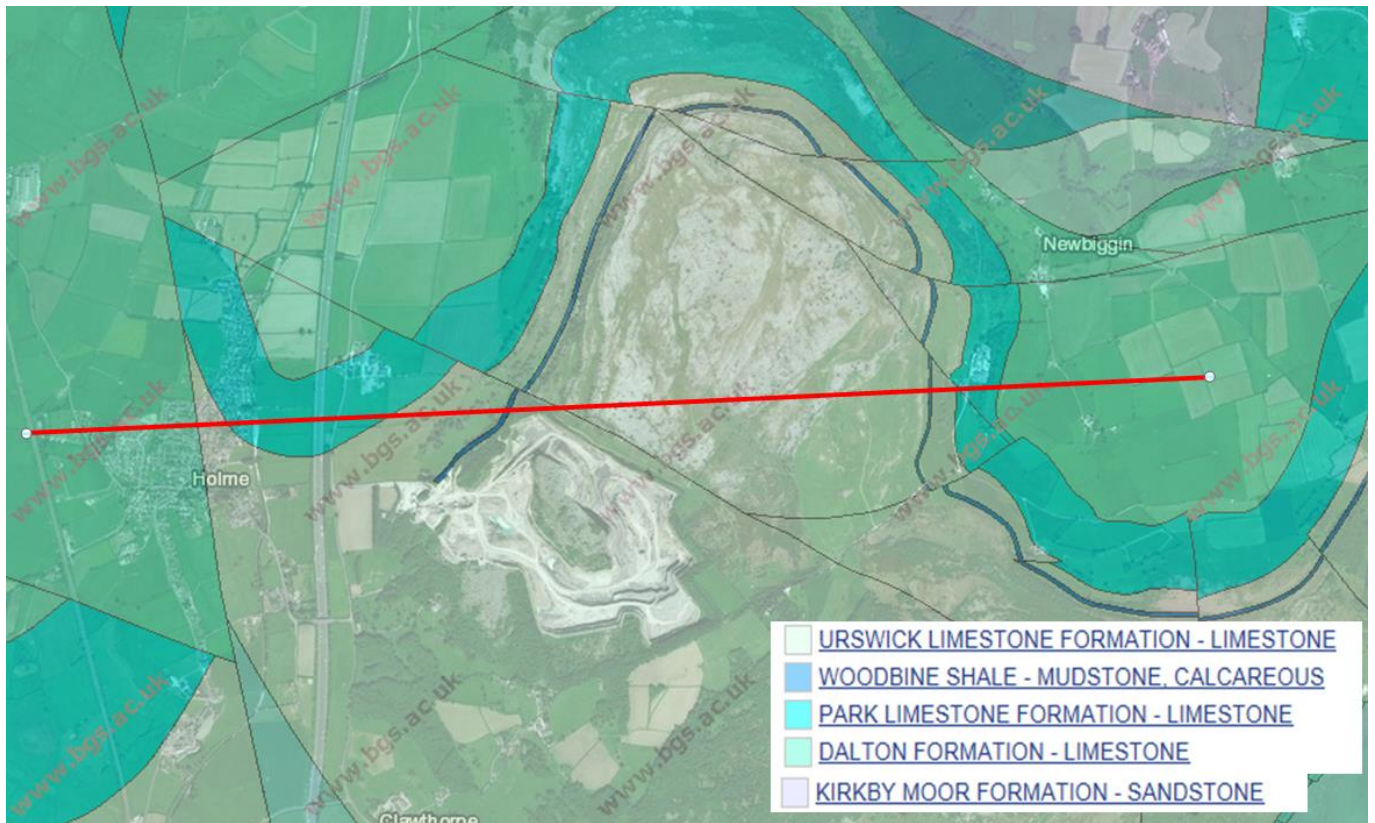
It can be seen from the geological map that there is a geological boundary between two rock types which runs very close to all of the flood locations throughout the village. The cross section reveals the nature of this boundary and it is believed that the Park Limestone Formation is karstic limestone which dissolves forming fissures allowing rapid conveyance of heavy rainfall in underground caverns, because of the slope of the layers of rock it can gather water from the far side of Farleton Fell and bring under the motorway and canal to Holme where it meets the fault line and is forced up to the surface against the less karstic Dalton Formation bedrock.

Geology of Holme map. Red line is the line of cross section.

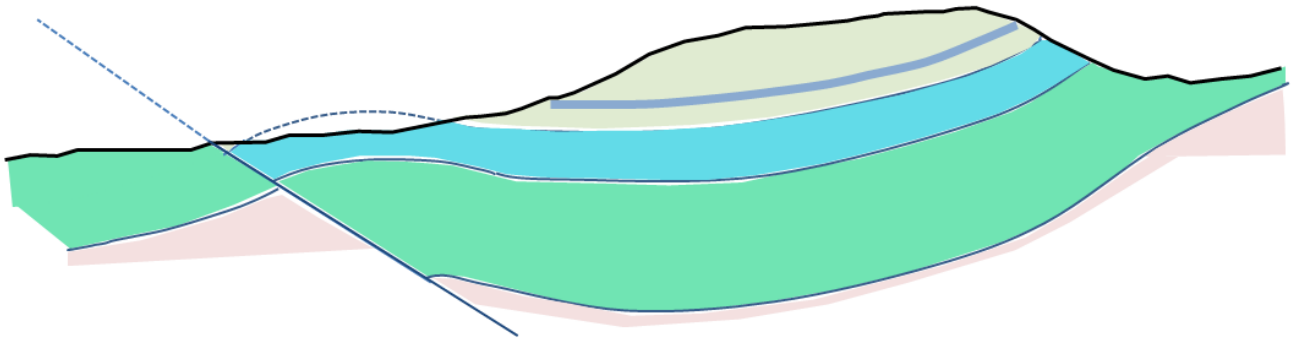
Geology of Holme cross section.

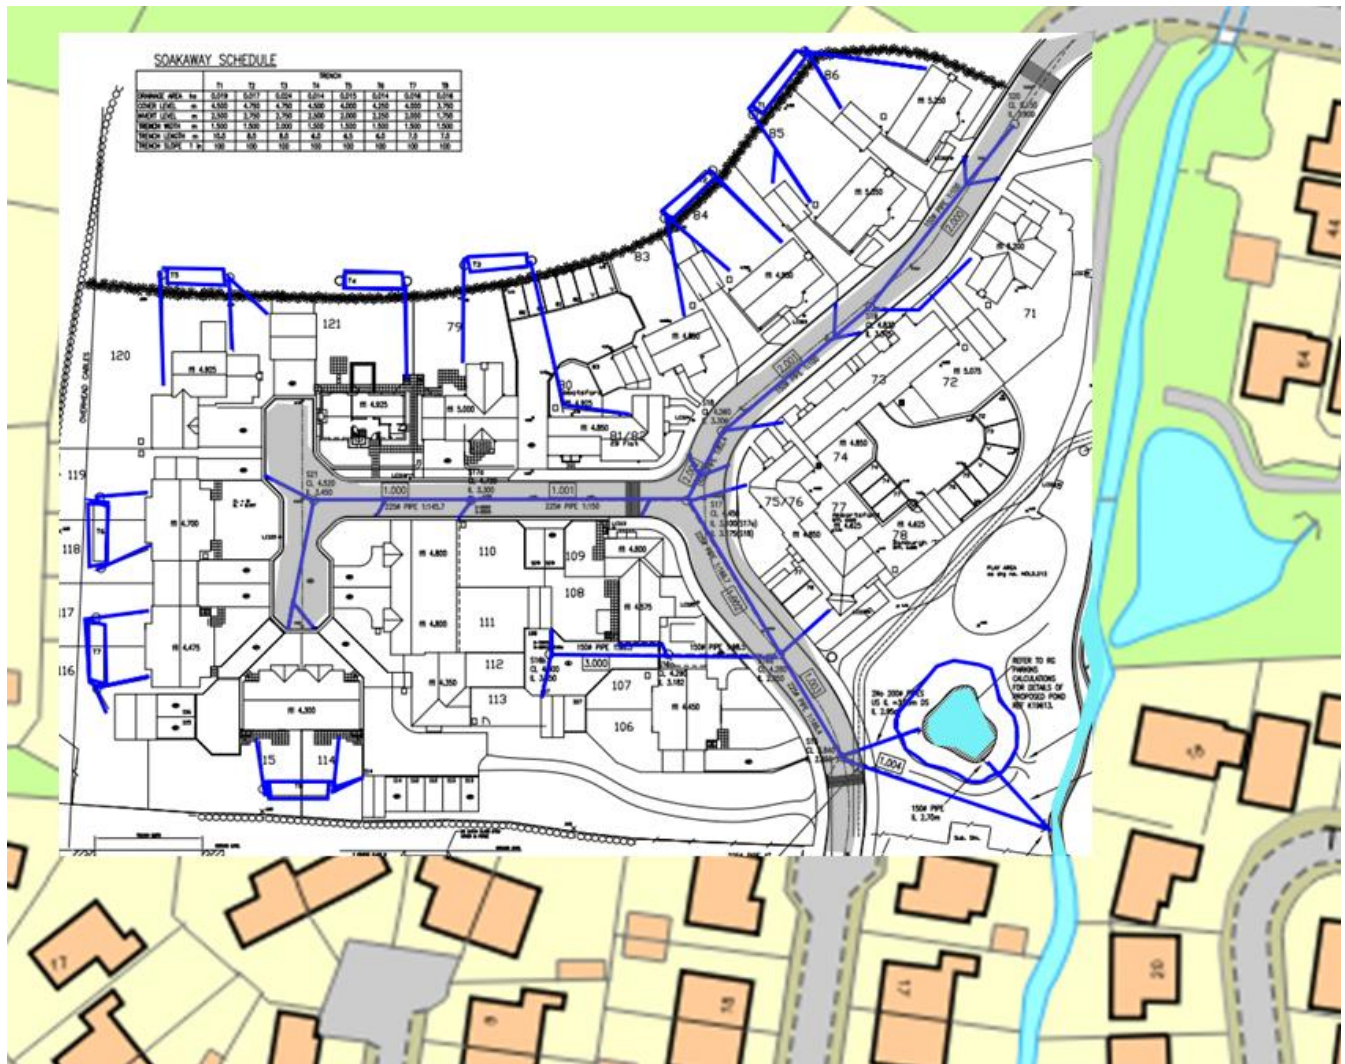
Drainage plan for the 2007 development (with colour added to pick out details) set in its context. The blue boxes are soakaways and the rest of the drainage is shown to go to the beck via a pond which can be bypassed.

There has been frequent garden flooding on the older part of Mayfield Avenue which is said to have started to occur only since the development of the new part of Mayfield Avenue and Pear Tree Park. The gardens fill with ground and surface water which drains away very slowly. This occurs after every medium to heavy rainfall event including on 22nd November 2017. The new part of Mayfield Avenue is drained by use of soakaways. There are two drainage basins serving the development which are meant to hold water to prevent flooding elsewhere in times of flood but they have never held any water in them despite the numerous flood events which have occurred nearby. It can be seen in the drainage drawing that there is a bypass past the drainage basin which could be the reason that the basins never fill with water.
