Kendal

Flood Investigation Report

Sandylands and Mintsfeet on the 6th December 2015

Flood Event 5-6th December 2015

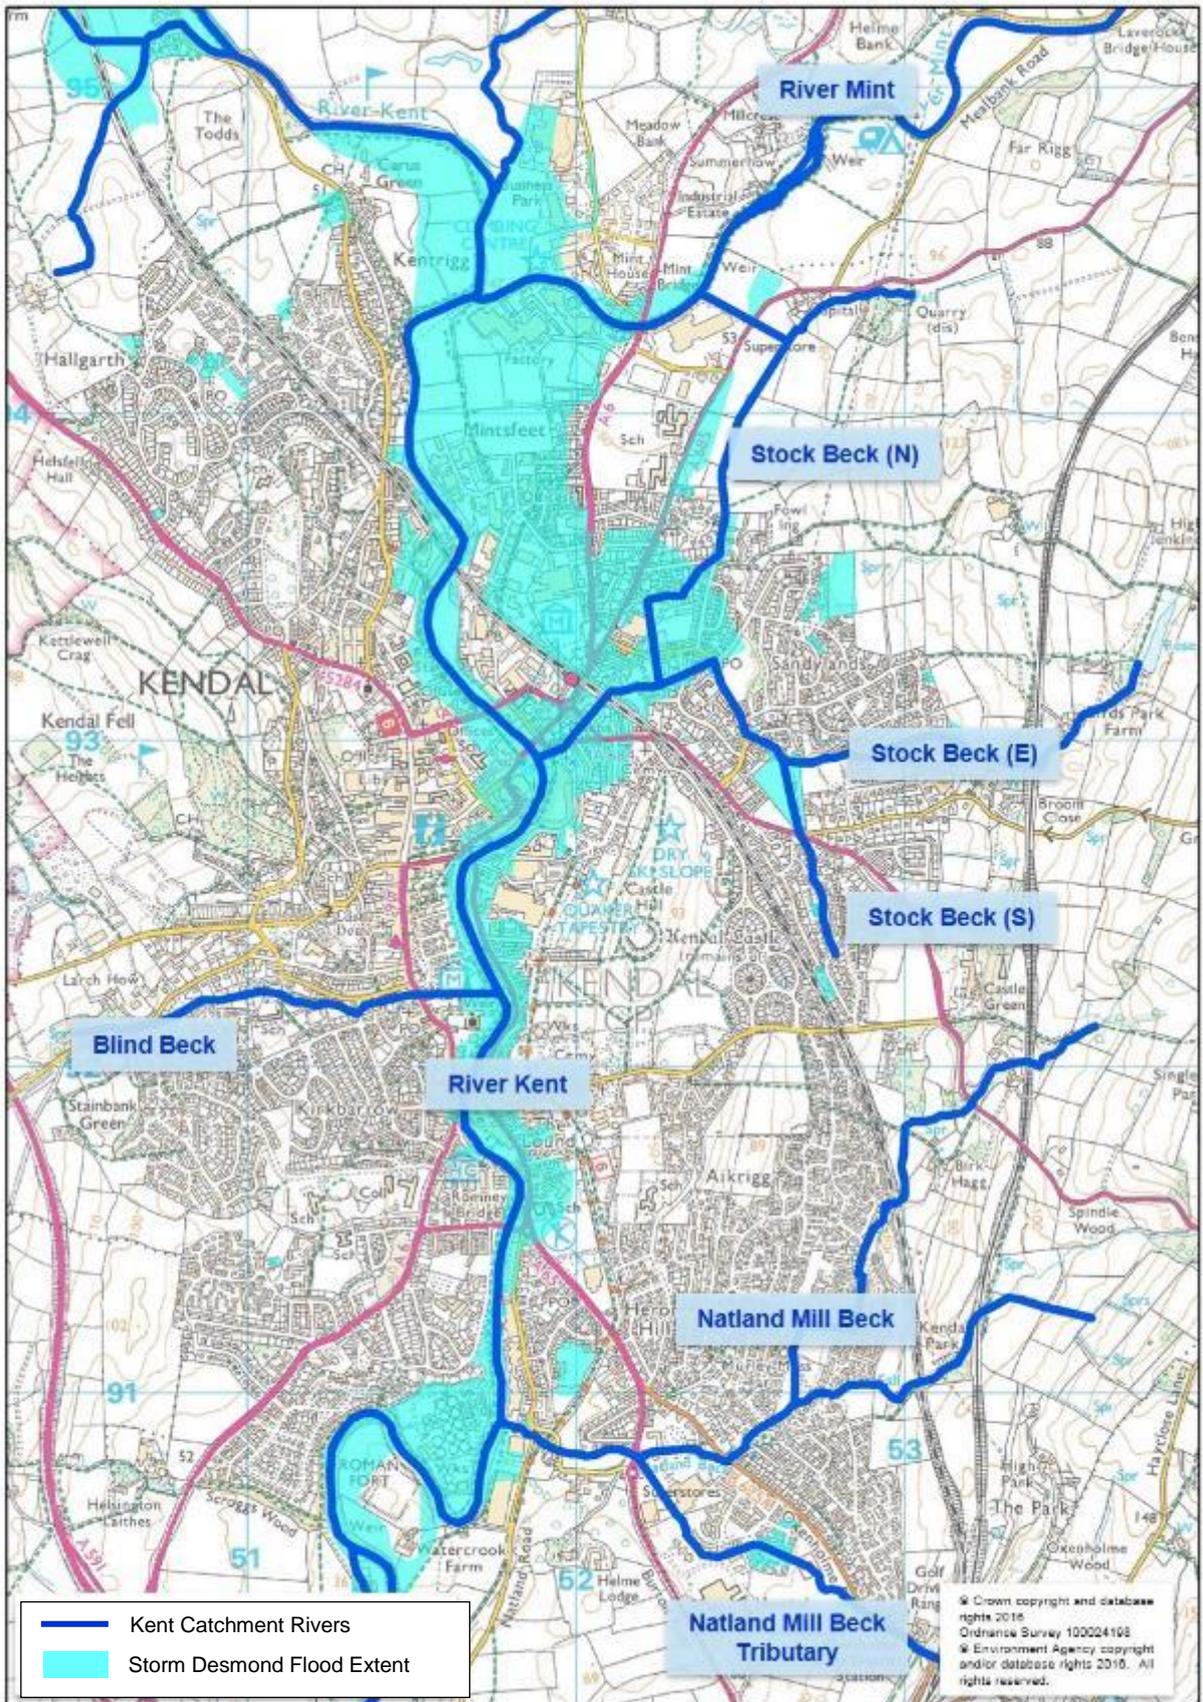
Figure 4: Extent of flooding in Kendal on 5-6th December 2015

On the 5th and 6th December 2015, approximately 2,150 properties in Kendal suffered significant flooding as a result of Storm Desmond, which caused record breaking rainfall over Cumbria and other parts of north-west England. The storm led to widespread river and surface water flooding across Cumbria, with significant flood events occurring on the Eden, Derwent and Kent catchments.

In Kendal, the main source of flooding was from flood water overtopping the left banks of the Rivers Mint and Kent in the Mintsfeet area, located due north of Kendal town centre where the River Mint joins the River Kent. This caused significant flooding to commercial properties in the Lake District Business Park, with overland flood flows then continuing due south across playing fields before flooding commercial and residential properties located between the Oxenholme-Windermere railway line (situated on an embankment) and the A6 Shap Road, including the Mintsfeet Industrial Estate. This overland flow then continued to spread east towards Appleby Road and combined with overland flow from Stock Beck to cause flooding to properties east of Appleby Road in the vicinity of Sandylands Road. Flood water then continued to flow through the railway overbridge at Longpool, which crosses the A6, where further flooding occurred in the Ann Street and Castle Street area.

River flooding also occurred in the immediate vicinity of the River Kent where it flows through the centre of Kendal, with properties on both banks affected. This flooding extended to the southern part of the town, where Kendal Wastewater Treatment Works (WwTW) suffered damage as a result of sewer surcharging and a blocked outfall.

Flooding from other sources, including groundwater, surface water run-off, and artificial drainage systems was also reported. Figure 4 indicates the extent of the flooding that occurred in Kendal from all sources following Storm Desmond.

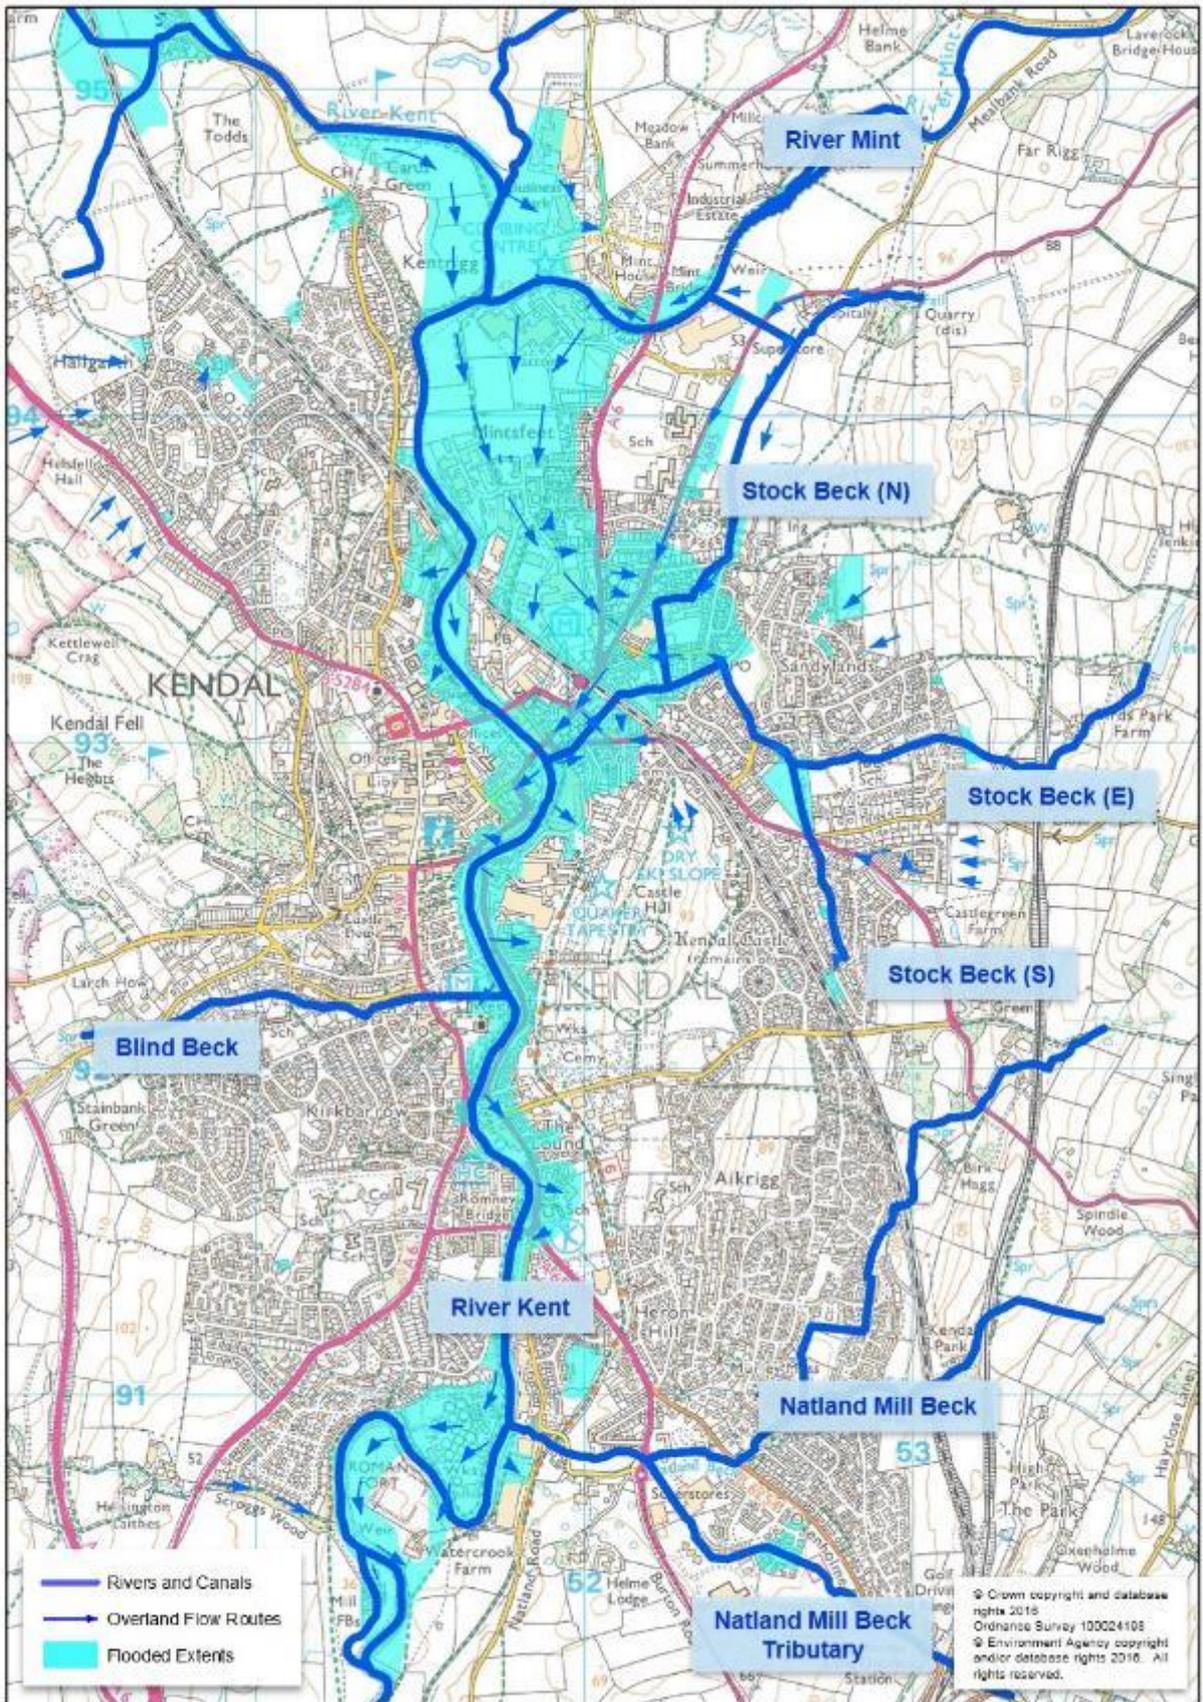
Figure 10: Principal overland flow routes through Kendal

The overland flood flows that caused the flooding in Kendal on the 5th and 6th December 2015 were complex and derived from multiple sources. From the data and evidence obtained both during and after the flood event, it is clear that river, surface water, drainage systems, and groundwater sources of flooding all contributed to the devastation across the town. Generally speaking, the principal source of flooding in Kendal may be attributed to the River Kent, Mint and Stock Beck river flooding. However, in specific areas, the evidence suggests that surface water flooding, groundwater flooding, and flooding from drainage systems played a critical role. In view of this, the sources of flooding in each of the areas identified in Figure 5 are discussed on an area by area basis in the Likely Causes of Flooding section of this report.

Detailed flow routes are also identified in the Likely Causes of Flooding section of this report. However, an overview of the principal flood flow routes through Kendal is presented in Figure 10. This figure shows the dominant flow paths within the town, but there is evidence that these changed over the course of the event as different sources of flooding came into play and flood waters in some areas began to recede.

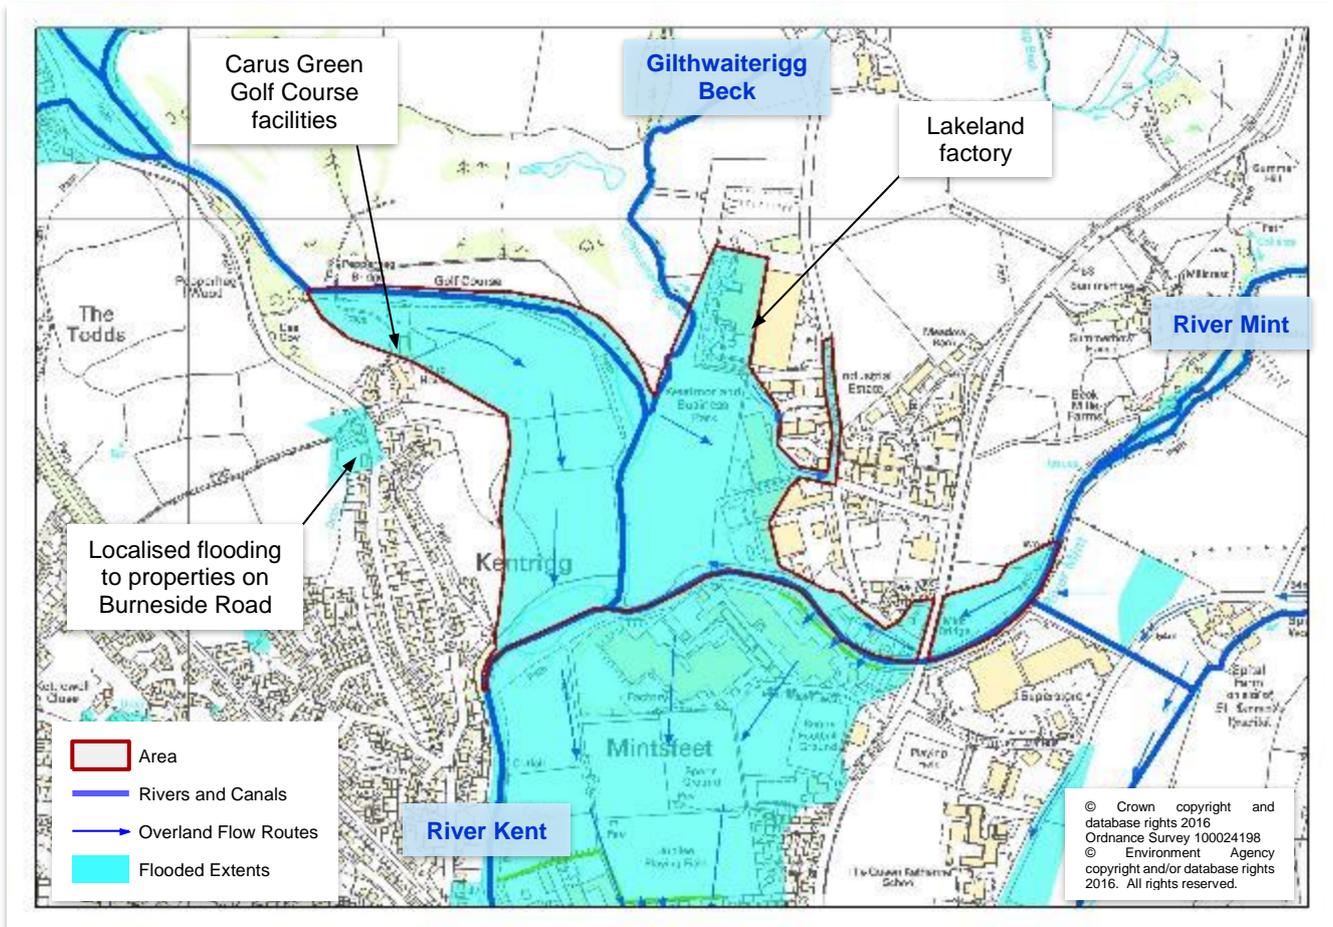
Figure 11: Overland flow routes in the Kentrigg and Carus Green area

Kentrigg is located in the north of Kendal on the River Kent and close to its confluence with the River Mint. Flooding in this area was predominantly caused by the fluvial event on the River Kent, with parts of the Westmorland Business Park on the left bank of the River Kent also affected by flooding from Gilthwaiterigg Beck.

For the most part, the areas of land that flooded are green field areas, including part of Carus Green golf course, where substantial damage was reported on the left bank of the River Kent. Flooding also affected facilities at the golf club (on the right bank of the River Kent), where the depth of water reached 0.6m.

The Westmorland Business Park, within which is a factory for the Lakeland homeware brand, suffered flooding. The Lakeland factory itself was flooded and it is believed that this was caused by groundwater flooding. Flooding to a depth of circa 20mm was reported in an extension built to the north of the site. The shallow depth of water meant that staff were able to clean the premises relatively quickly

Fluvial flooding from an ordinary watercourse resulted in five properties on Burneside Road, opposite Kent Lea, being affected. Investigations suggest that this was caused by an obstructed culvert.

The principal flood mechanisms and overland flow routes are shown in Figure 11, with a timeline of the key events given in Table 6.

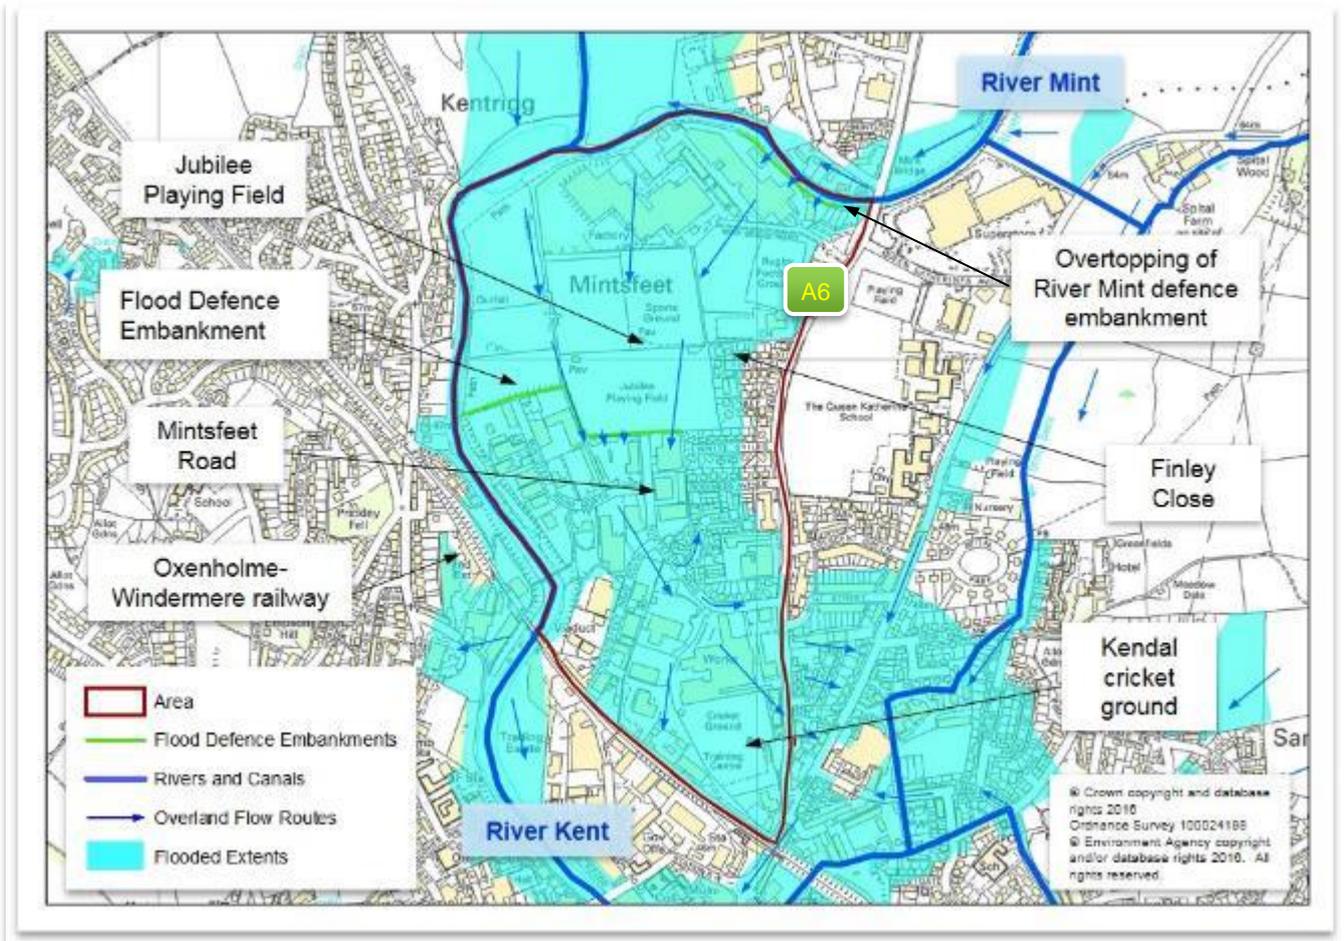
Figure 12: Overland flow routes in the Mintsfeet area

The Mintsfeet area, enclosed by the Rivers Mint and Kent to the west of the A6 Shap Road and north of the Oxenholme – Windermere railway line, comprises a mixture of residential, commercial, and green field land uses. The area was badly affected and the principal source of flooding was from the fluvial event on the Rivers Mint and Kent. Residential and commercial properties on and around Mintsfeet Road suffered significant damage and commercial property in the Lake District Business Park was also affected. The principal flood mechanisms and overland flow routes are shown in Figure 12, with a timeline of the key events given in Table 7.

Floodwater from these sources was then able to flow through the business park and across the Jubilee Playing Fields to the south, where it was initially impounded against the existing flood defence embankment highlighted on Figure 12 and shown in Figure 13.

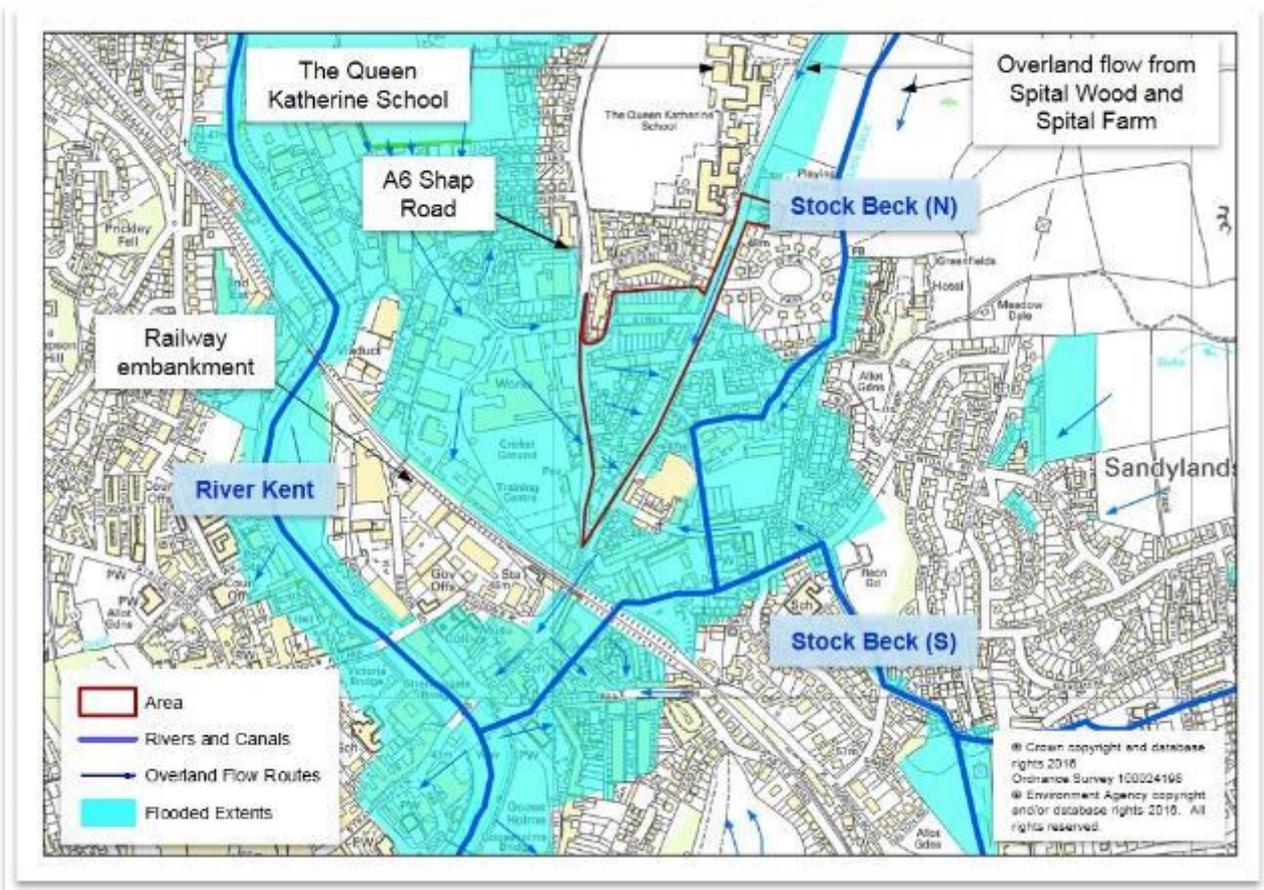
Figure 15: Overland flow routes in the Shap Road and Appleby Road area

Overland flow from the north tributary of Stock Beck formed a significant flow path down Appleby Road. This flow path originated upstream of the Morrison's superstore at Spital Wood, with out-of-channel flows conveyed down Appleby Road and past the Queen Katherine School before flooding properties on and around Mint Street. The Stock Beck culvert opposite the Morrison's store at Spital Farm surcharged (reached capacity and therefore overflowed) during the event and at this location, much of the in-channel flow was diverted to the River Mint via the Stock Beck overflow. Flow that was forced out-of-bank at this point formed a secondary flow path over open fields that then contributed to flooding on Fowling Lane and Broad Ing.

The principal flood mechanisms and overland flow routes in this area are shown in Figure 15, with the aftermath of the flooding in the area shown in Figure 16. A timeline of the key events is given in Table 8.

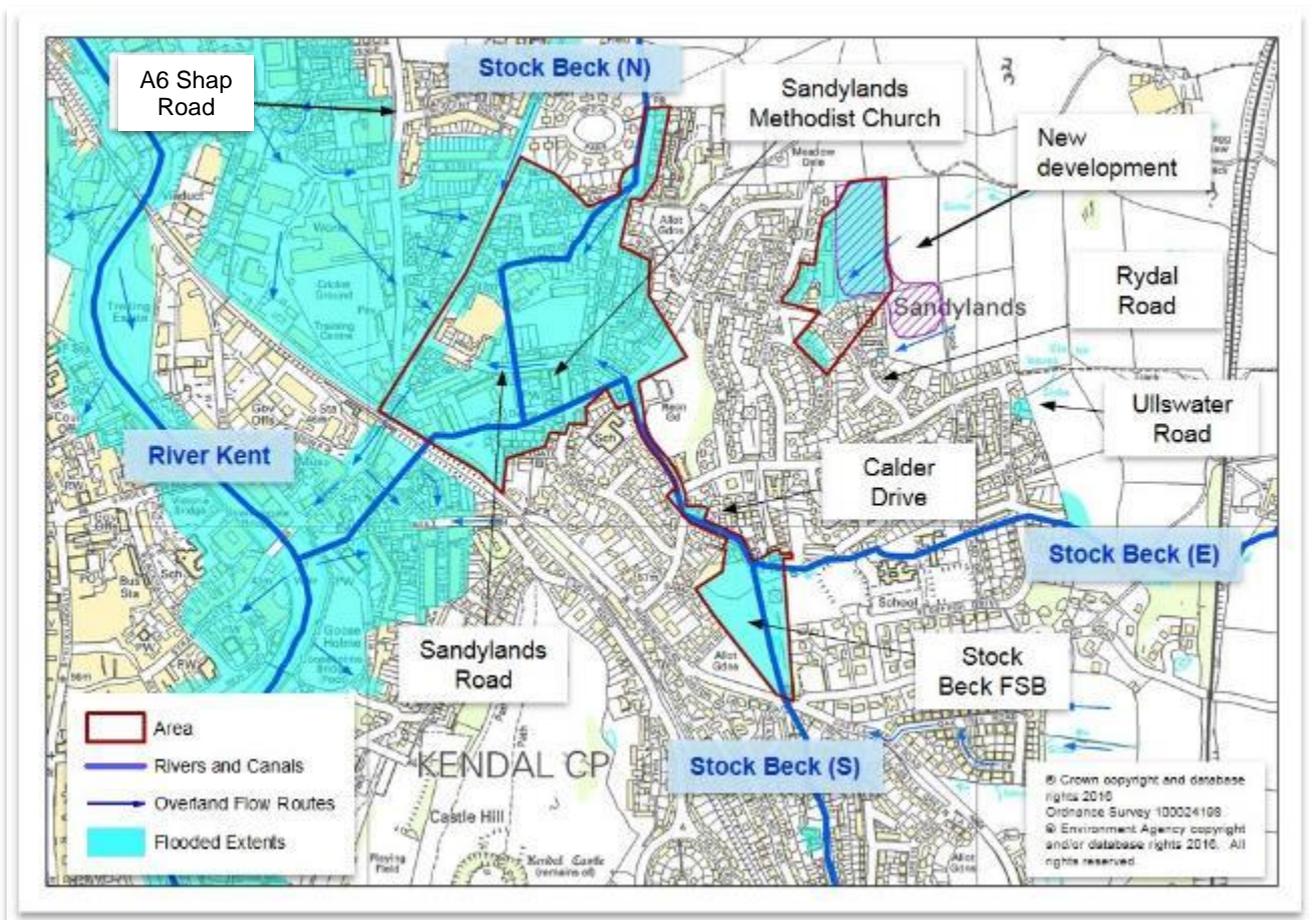
Figure 17: Overland flow routes in the Shap Road, Appleby Road and Sandylands areas

Situated on the east side of Kendal, the Sandylands area has limited coverage within the existing Environment Agency flood warning areas. With the exception of the area in the immediate vicinity of Sandylands Road, it is predominantly outside of Flood Zones 2 and 3, hence the lack of flood warning area coverage. However, on the 5th December 2015, the vast majority of the area between the A6 Shap Road and Jenkin Rise was badly affected by flooding. The area to the east of Sandylands has a number of sinks and springs and is also influenced by the West Coast Mainline, which sits on a raised embankment running north to south. The northern, eastern and southern Stock Beck tributaries all converge at various locations within Sandylands, as illustrated in Figure 17. It should also be noted that prior to being developed, areas of Sandylands were previously swampy land that often became ponds in winter. As a result of development, much of this natural flood storage has been lost.

Reports and evidence suggest that the flooding in this area was caused by multiple mechanisms. The area is situated immediately adjacent to Mintsfeet, and so was affected by flood flows from the Rivers Mint and Kent as per Area 2. In addition to this, the Stock Beck system, which comprises three tributary watercourses, flows through the area and is culverted for much of its length. Flooding was reported from a number of manholes associated with this culvert on Sandylands Road and damage was caused to part of a footpath on Eastgate, where the culvert roof was lifted up by the water pressure. Furthermore, overland flow was observed from the 'north' Stock Beck tributary down Appleby Road, affecting properties on Appleby Road and in the Longlands View and Fowling Lane areas (see Area 3: Shap Road and Appleby Road).

The principal flood mechanisms and overland flow routes in this area are shown in Figure 17, with the aftermath of the flooding in the area shown in Figure 18. A timeline of the key events is given in Table 9.

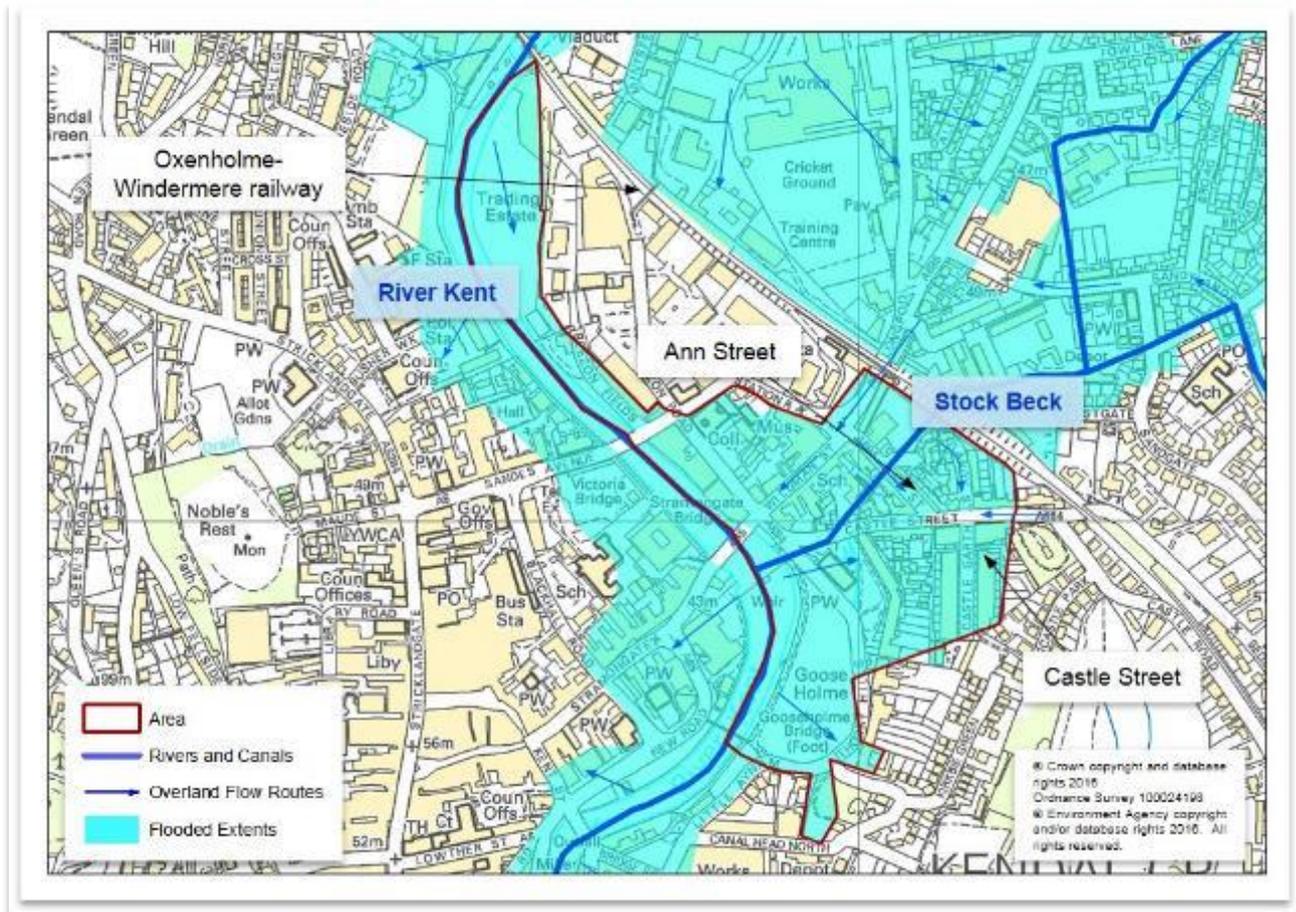
Figure 22: Overland flow routes in the Wildman Street, Ann Street and Castle Street area

Flooding occurred in the Wildman Street, Ann Street, and Castle Street area from a variety of sources, with initial reports of flooding from drainage systems and groundwater, as well as fluvial flooding from Stock Beck, the River Mint, and the River Kent. Whilst the area is situated on the left bank of the River Kent, it was the other sources that initially caused flooding in the area before the River Kent burst its banks in the centre of Kendal.

The principal flood mechanisms and overland flow routes in and around the Ann Street and Castle Street area are shown in Figure 22, with a timeline of the key events given in Table 10.

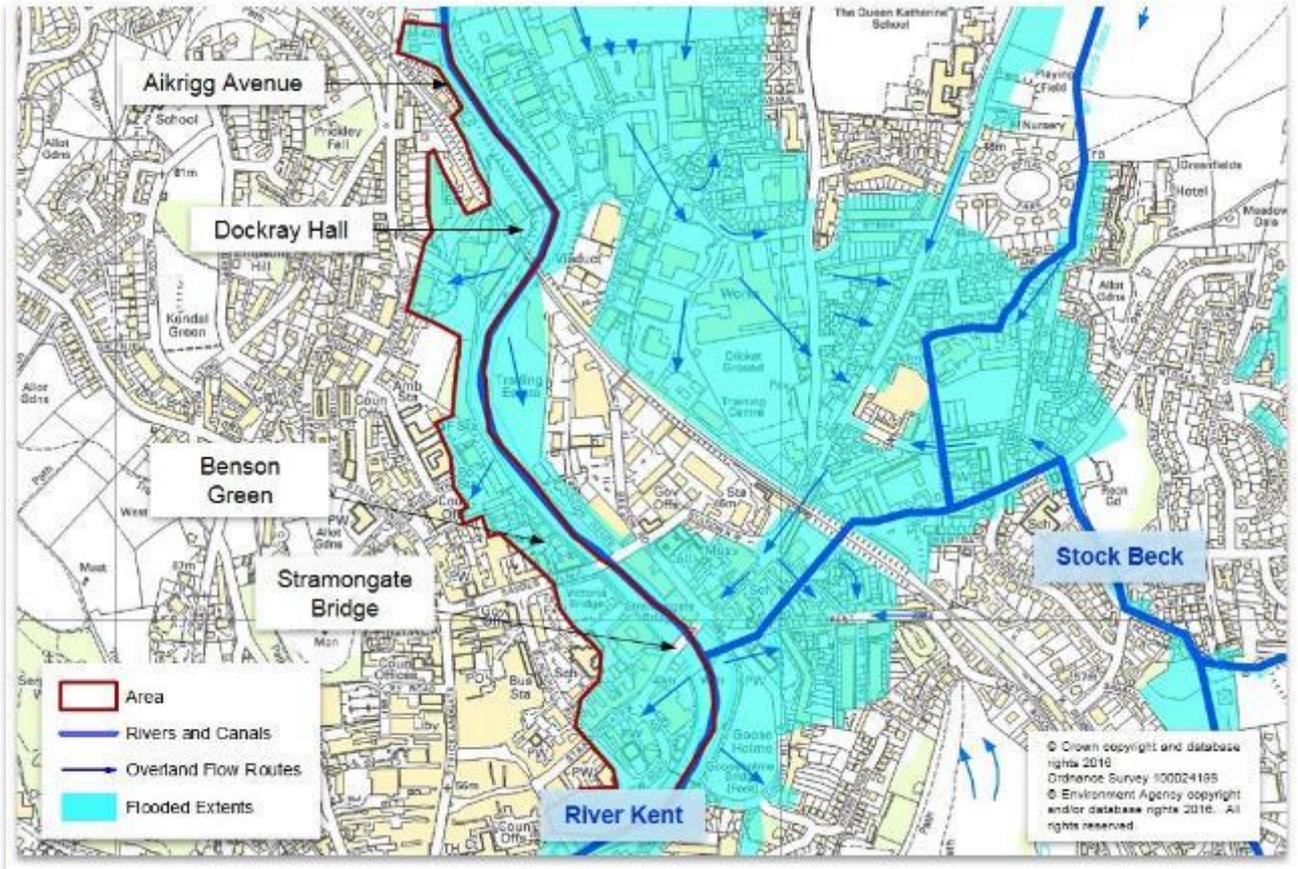
Figure 237: Overland flow routes in the centre of Kendal

In the centre of Kendal, commercial properties on Stramongate and New Road suffered flooding from the River Kent. Overtopping of the right bank of the river downstream of Stramongate Bridge was observed at 17:00 on the 5th December, with the peak river level occurring some four hours later.

Figure 27 indicates the key overland flow routes and a timeline of the key events in the centre of Kendal is given in Table 11.

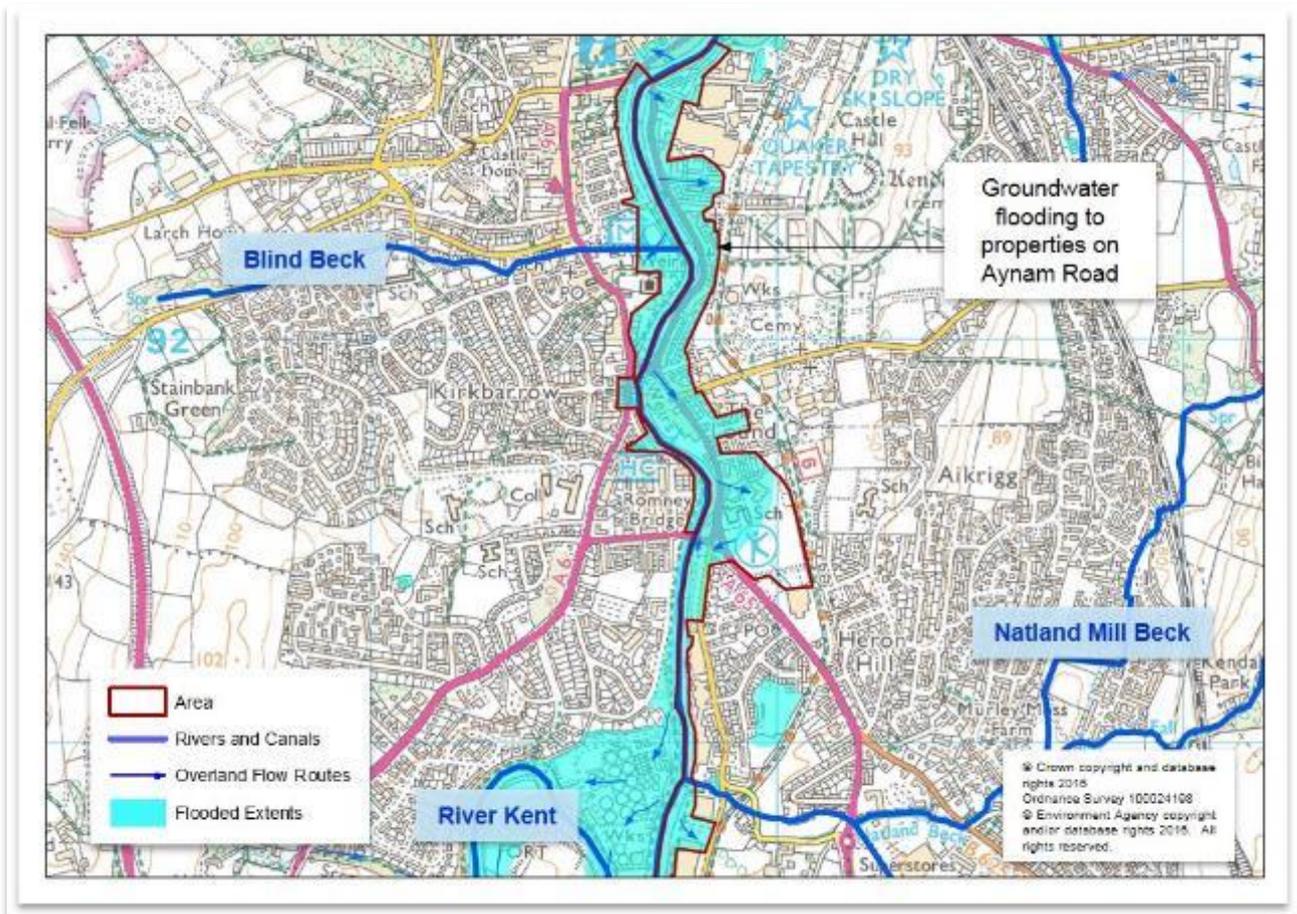
Figure 248: Overland flow routes on the left and right banks of the River Kent through Kendal

It is worth noting at this stage that during the Storm Desmond event, no flooding problems have been reported from Blind Beck, which drains a small catchment west of Kendal.

Figure 28 indicates the key overland flow routes and a timeline of the key events is given in Table 12.

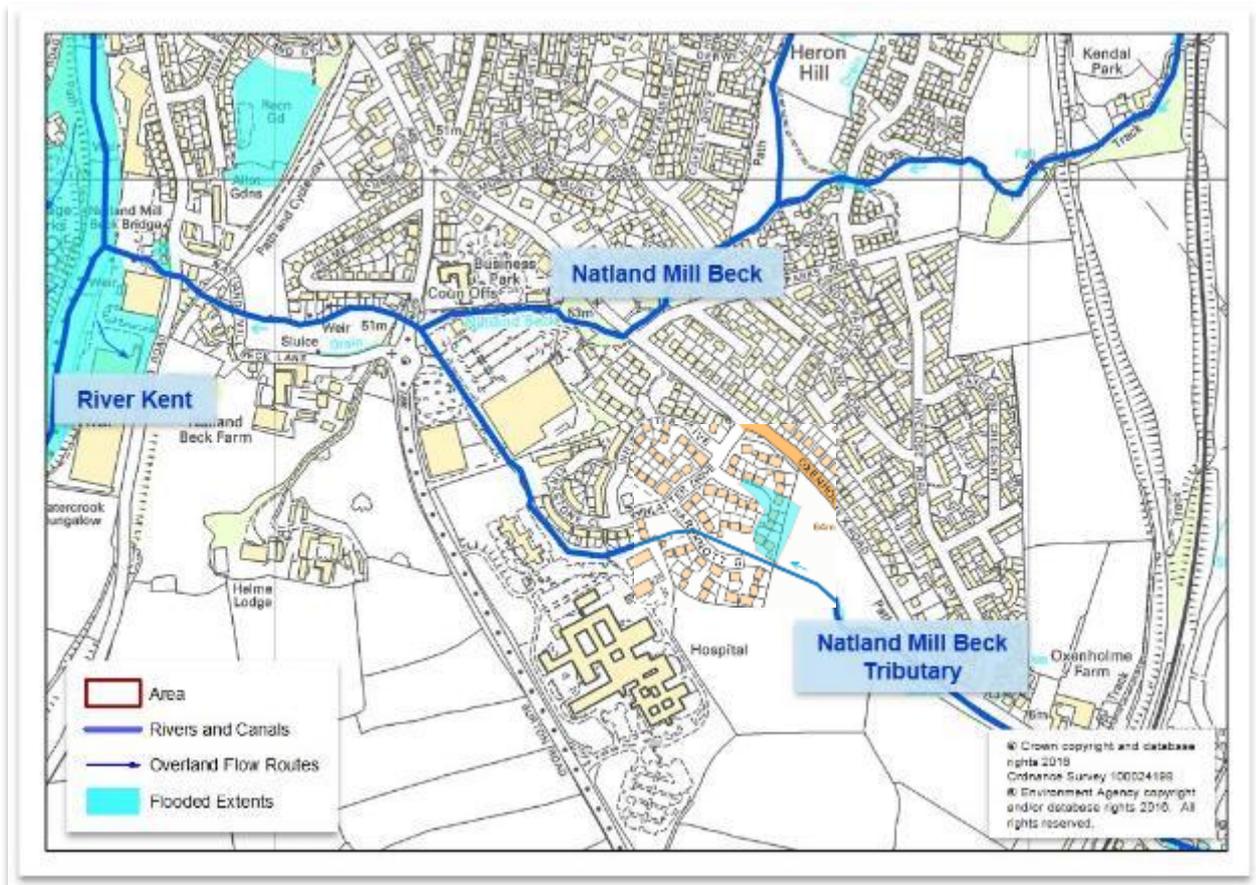
Figure 3026: Affected areas around Natland Mill Beck and Natland Mill Beck Tributary

Natland Mill Beck and Natland Mill Beck Tributary drains a small catchment that includes the south-east of Kendal and discharges to the River Kent opposite Kendal WwTW. The watercourse system comprises three tributaries and localised fluvial flooding from the southerly Natland Mill Beck Tributary affected properties on Blencathra Gardens. This watercourse flows in open channel to the rear of properties on Blencathra Gardens before passing beneath Hardknott Gardens in culvert.

Reports from local residents who observed the flooding mechanisms were that the Natland Mill Beck Tributary exceeded its channel capacity in the fields upstream and flowed out of bank across the fields towards Blencathra Gardens because of a blockage underneath a fence line at the eastern extent of the estate. The blockage at the fence line was caused by debris - including bed material from the watercourse that had been scoured by the velocity of the water - becoming trapped on the fence. This blockage resulted in flow leaving the watercourse channel on the right bank, flowing through properties on Blencathra Gardens before re-joining the channel. The affected area is shown in Figure 30.

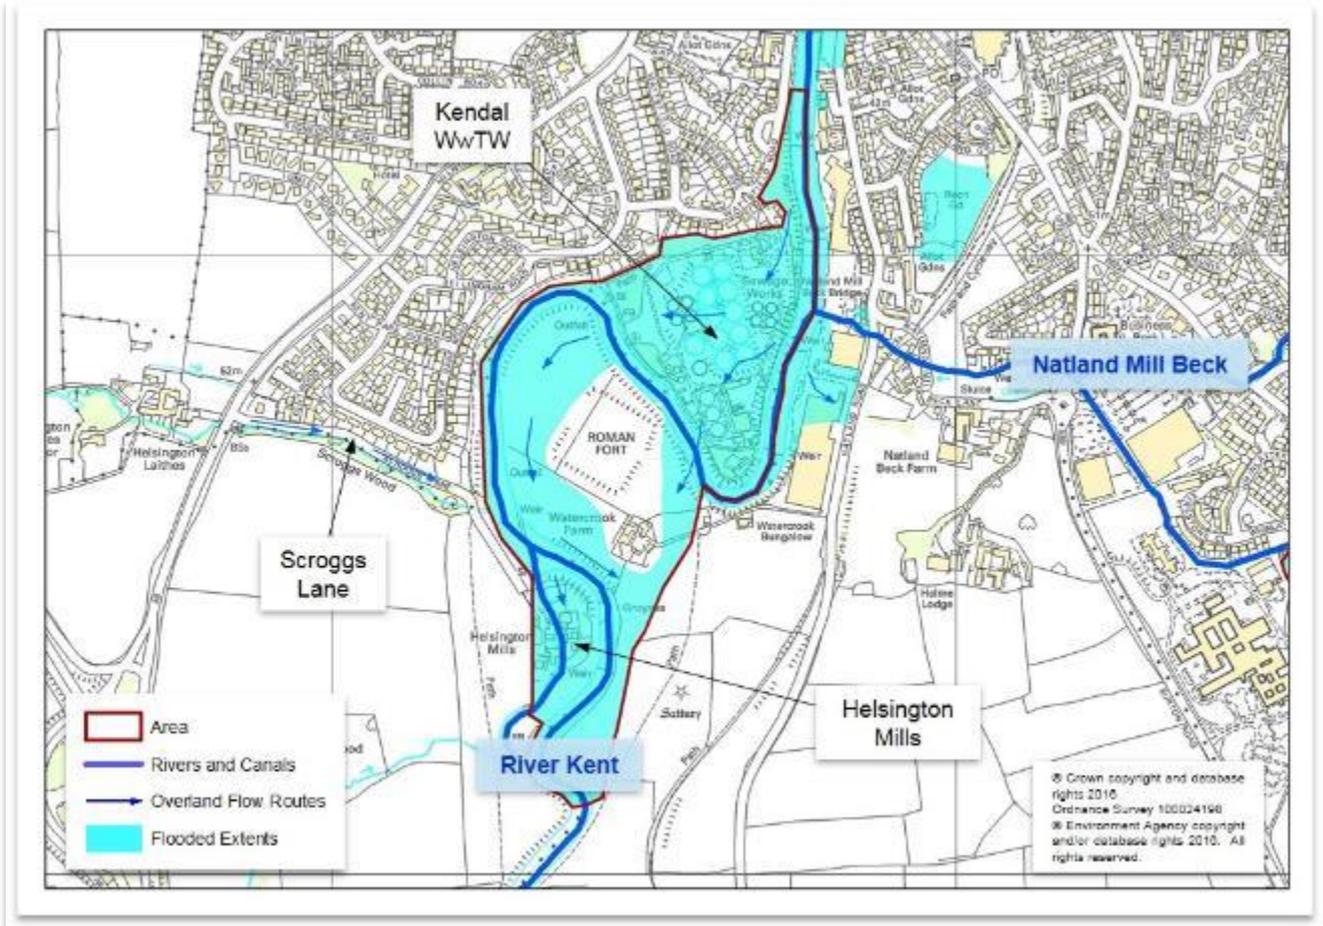
Figure 31: Overland flow routes at Kendal WwTW and Helsington Mills

Further downstream on the right bank of the River Kent, there was a flow route caused by surface water run-off and flow from an ordinary watercourse along Scroggs Lane, which provides access to properties in Helsington Mills. Here, water depths were reported as being 0.6-0.9m. This overland flow combined with fluvial flooding from the River Kent to flood properties in the Helsington Mills development to a depth of 0.9-1.2m.

Figure 31 indicates the key overland flow routes, with the aftermath of the flooding in the area shown in Figure 32 and a timeline of the key events given in Table 13.

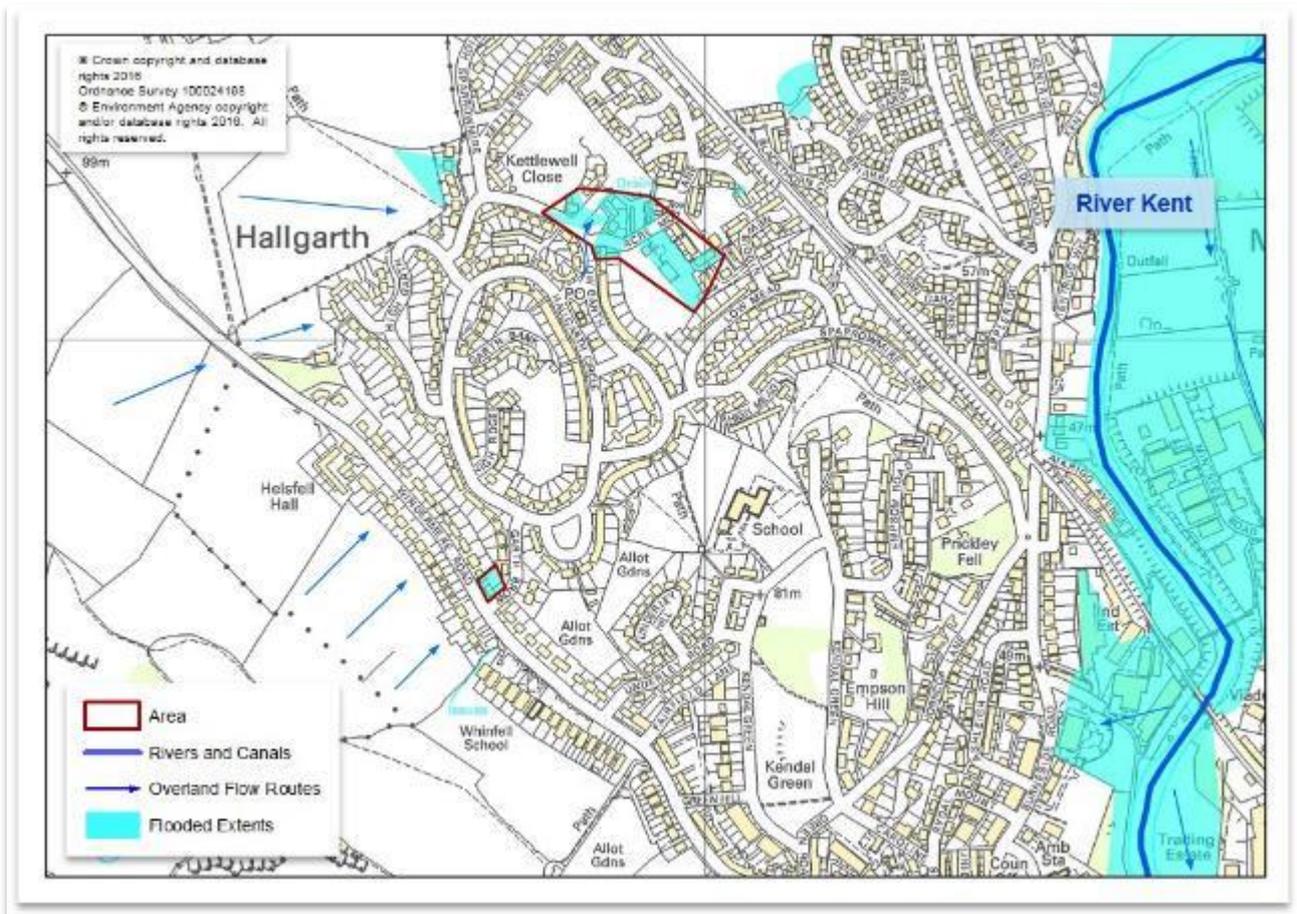
Figure 33: Overland flow routes in the Hallgarth area

Whilst the area was unaffected by the river flooding that affected the north and central areas of the town, parts of the area were affected by surface water flooding. In a similar mechanism to that experienced by properties on Ullswater Road and Rydal Road in Area 3, some properties on the junction between Low Garth and Acre Moss Lane suffered from localised surface water flooding. Other overland flow routes were observed in the area, with surface water run-off from areas upstream of the A5284 Windermere Road channelled down the road itself to an observed depth of 100mm at around 19:00.

The principal flood mechanisms and overland flow routes for the Hallgarth area are shown in Figure 33.

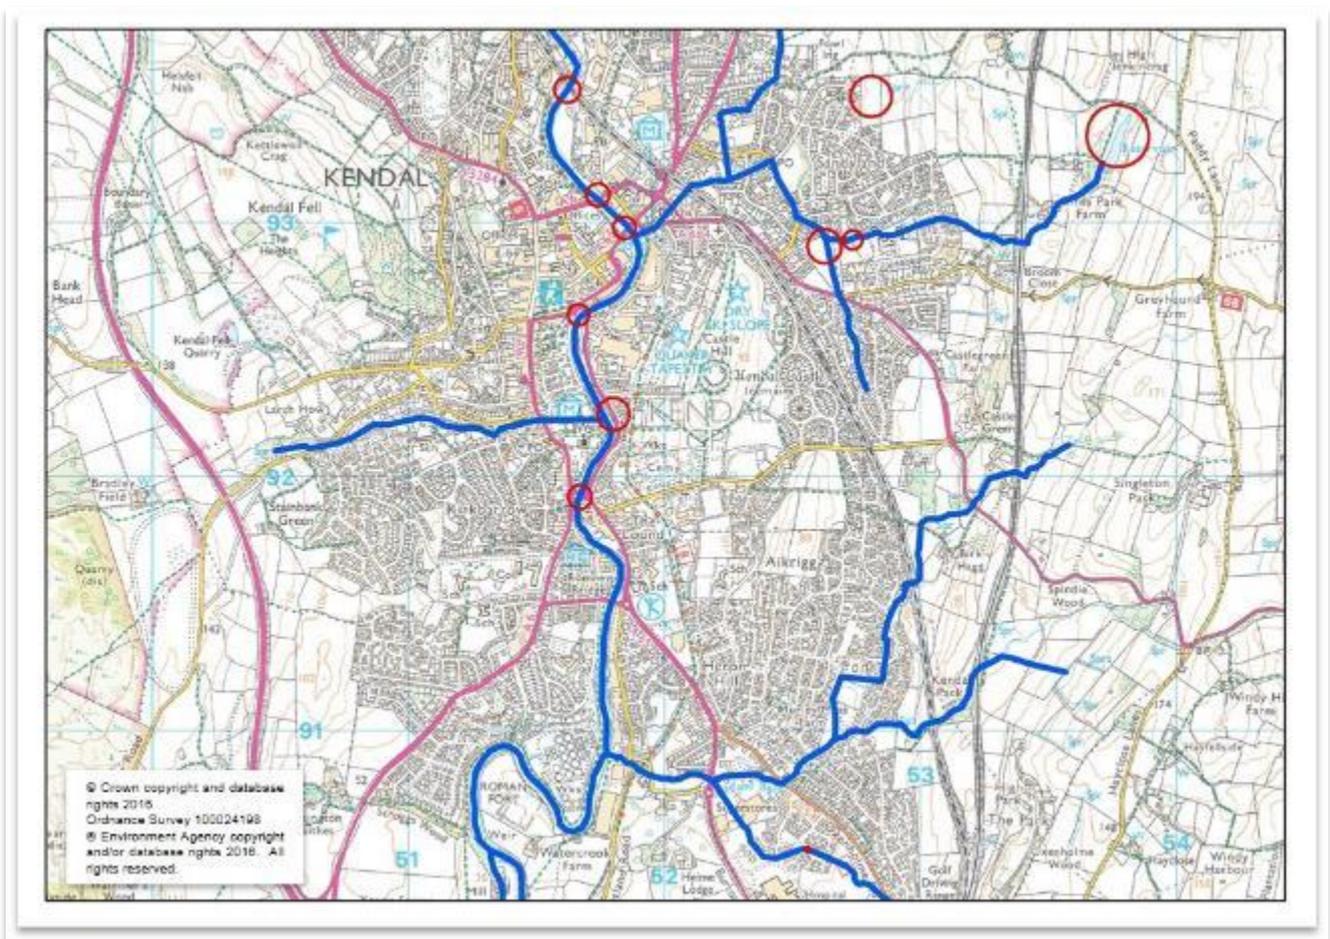
Figure 34: Locations of specific actions identified in Table 14

Cumbria Flood Partnership Theme	Action by	Recommended Action	Timescale
Strengthening Defences	Environment Agency in partnership with Cumbria County Council and Network Rail	Work with Network Rail to understand the interaction of both the West Coast Mainline and the Windermere branch line with the rivers and watercourses in and around Kendal, their effect on flooding and their vulnerability during a flood.	2016-2017
Strengthening Defences	Environment Agency	Review the need and practicalities of deploying temporary defences in certain locations in Kendal as an interim or longer term measure to help reduce flood risk.	2016-2017
