# Keswick

## Sec 19 Flood Investigation Report

## Flood Event 5-6<sup>th</sup> December 2015

This flood investigation report has been produced by the Environment Agency as a key Risk Management Authority under Section 19 of the Flood and Water Management Act 2010 in partnership with Cumbria County Council as Lead Local Flood Authority.

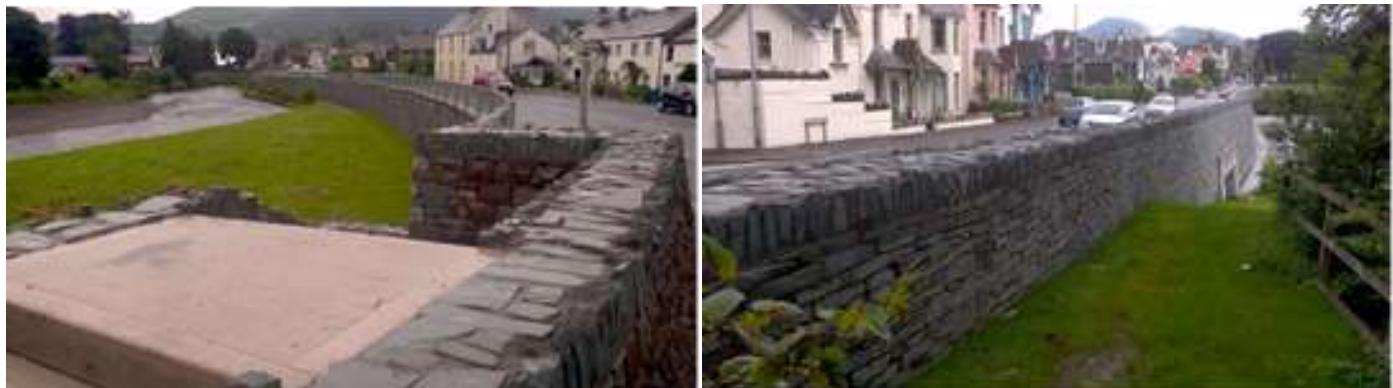
**Photographs 1 and 2: Keswick Flood Risk Management Scheme – Flood wall along High Hill (left) and Penrith Road (right)**

The flood event on 5<sup>th</sup>-6<sup>th</sup> December was of a greater magnitude than the Keswick Flood Risk Management Scheme defences were designed to defend against meaning that defences were overtapped and outflanked. In some locations however, defences were successful in reducing the damage, and delayed flooding, which gave residents additional time to prepare and reduced the impact of the flood.

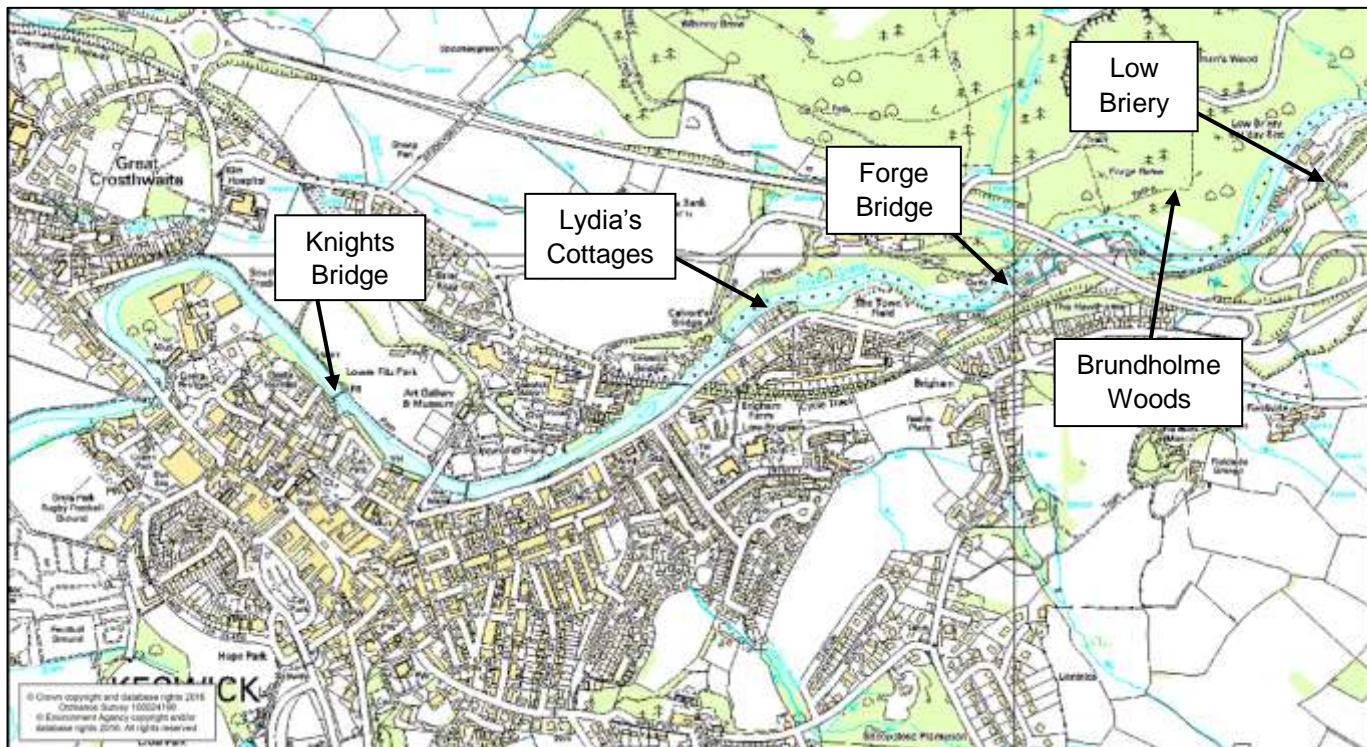
**Figure 9: Areas where significant erosion occurred during flood event**

There were significant erosion issues experienced during the flood event, with several landslides in the river catchment upstream of Keswick. In Keswick itself, the access bridge at The Forge was badly damaged and Knight's Bridge, the footbridge at the top of Stanger Street that connects to Fitz Park, was washed away. There was also significant erosion and a landslip at Brundholme Woods, Low Briery where the Environment Agency gauging station is sited. Severe river bank erosion also affected Lydia's Cottages on the River Greta, with outhouses, boundary walls and services damaged and destroyed. The locations are shown in **Figure 9** below.

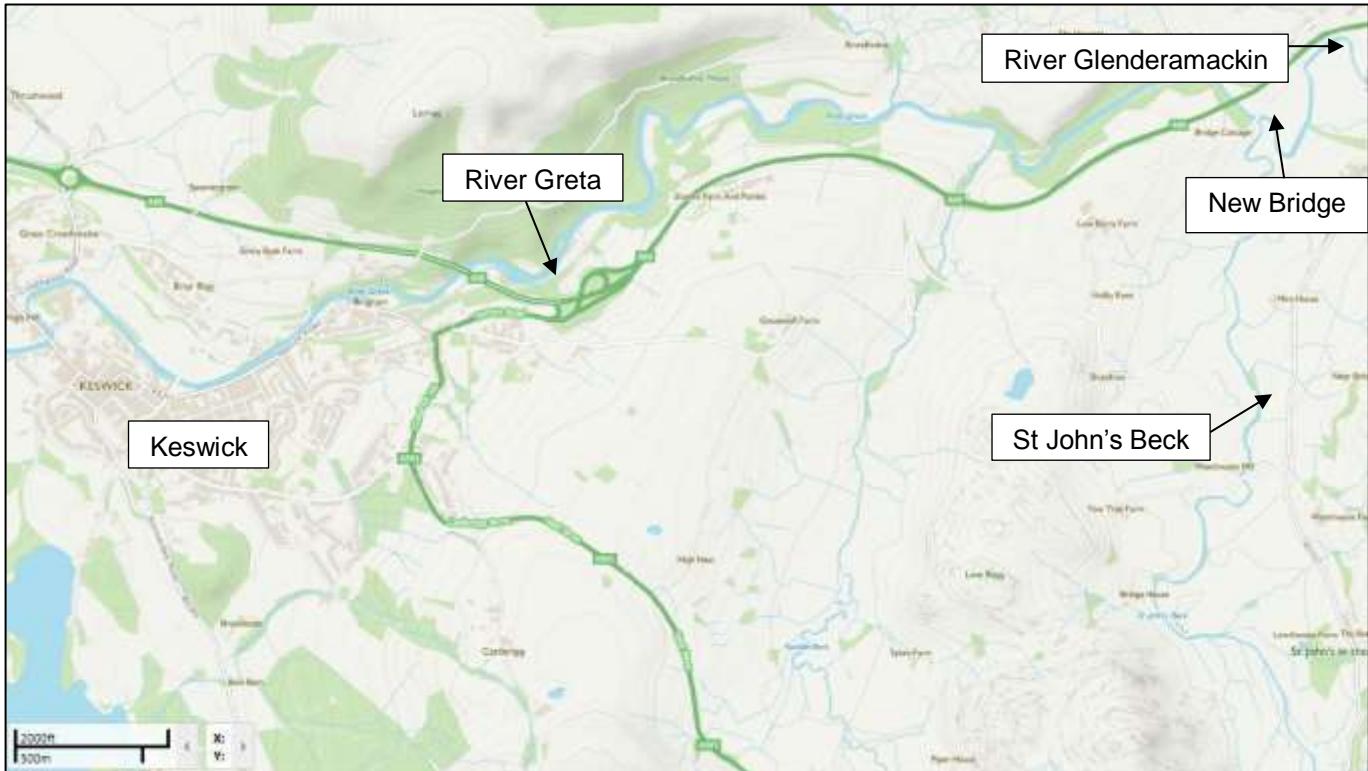
Figure 11: Location of New Bridge

New Bridge is located at the confluence of the Rivers Glenderamackin and St John's Beck, **Figure 11**. The capacity of the structure to permit flows through the arches was exceeded. This resulted in substantial backing up of water and flooding of land upstream, **Photograph 4**. The Glenderamackin sub-catchment comprises a significant portion of the upstream area feeding the Greta and Derwent catchment, and incorporates drainage from the south and east slopes of Blencathra, Trout Beck and Mosedale Beck.

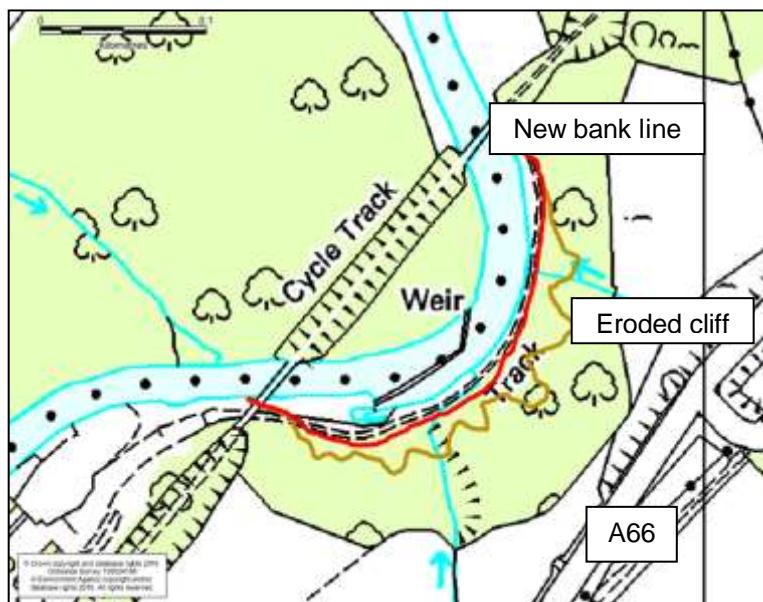
Figure 12: Area of landslip at Low Briery

Low Briery is located approximately 1km upstream of Keswick. This area experienced severe erosion during the flood event and substantial damage and destruction was experienced by the Low Briery Holiday Park. This included the loss of a number of static caravans which were washed downstream into the river. The force of water in this location was such that extensive damage was caused to the Keswick to Threlkeld railway path including two old railway bridges that were washed away and one remaining railway bridge left severely damaged. Approximately 200 metres of the path surface was also washed downstream. The railway path forms part of the Coast to Coast cycle route and is a popular multi-access trail for locals and tourists. Due to the extent of the damage, half of the route is expected to remain closed for up to two years.

Bank erosion and landslips are evident at numerous locations within the Low Briery area including directly opposite the Holiday Park site and upstream of this site below the A66. A significant erosion/landslide feature has been identified on the left bank upstream of the Holiday Park, **Figure 12** and **Photograph 5**.

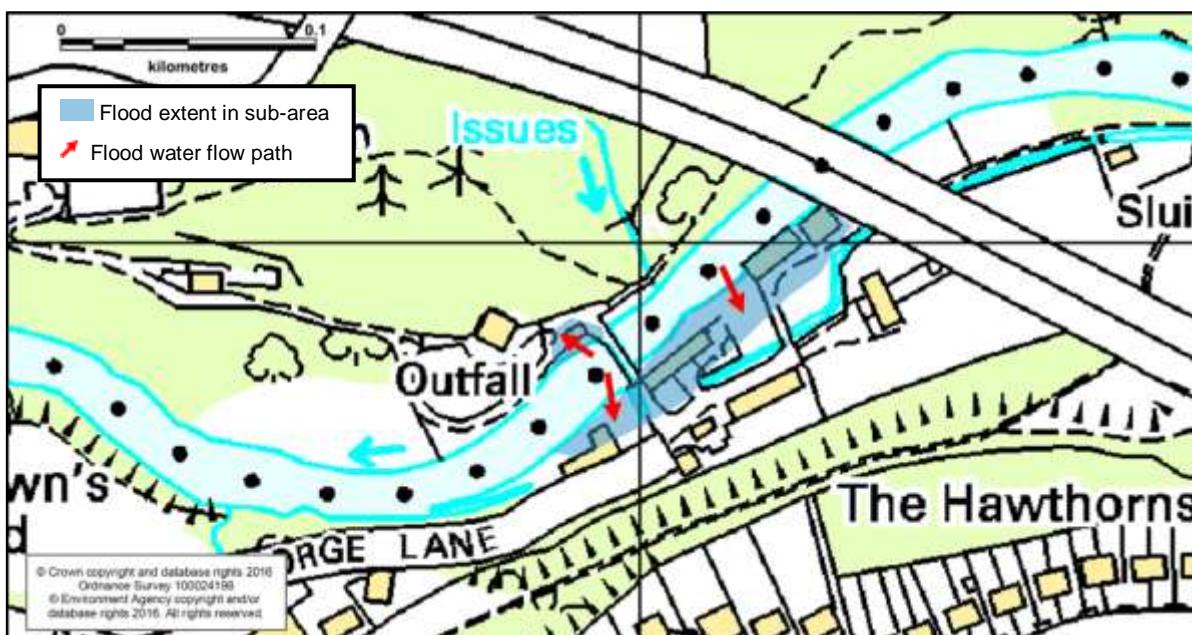
**Figure 13: Source of Flooding and Flood extent at Forge Bridge area**

This is an area of residential properties upstream of Keswick occupying both banks of the River Greta including Bridge House which is tied into the bridge itself, **Figure 13**. Forge Bridge forms a constriction to river flows and can cause elevated river levels immediately upstream.

During December 2015, river levels exceeded the top of the bridge arch. These elevated levels flooded properties 6 to 9 Forge Lane on the left bank. There was also considerable damage to Forge Bridge, as shown in **Photograph 6**, from both the high water level and debris including large trees and caravans. Significant scouring of the river bank also occurred on both the left and right hand sides.

extreme than the 2009 flood event. The flooding in this area was intensified by the failure of the weir located upstream of Forge Bridge which was reported to cause a 3ft wave of water.

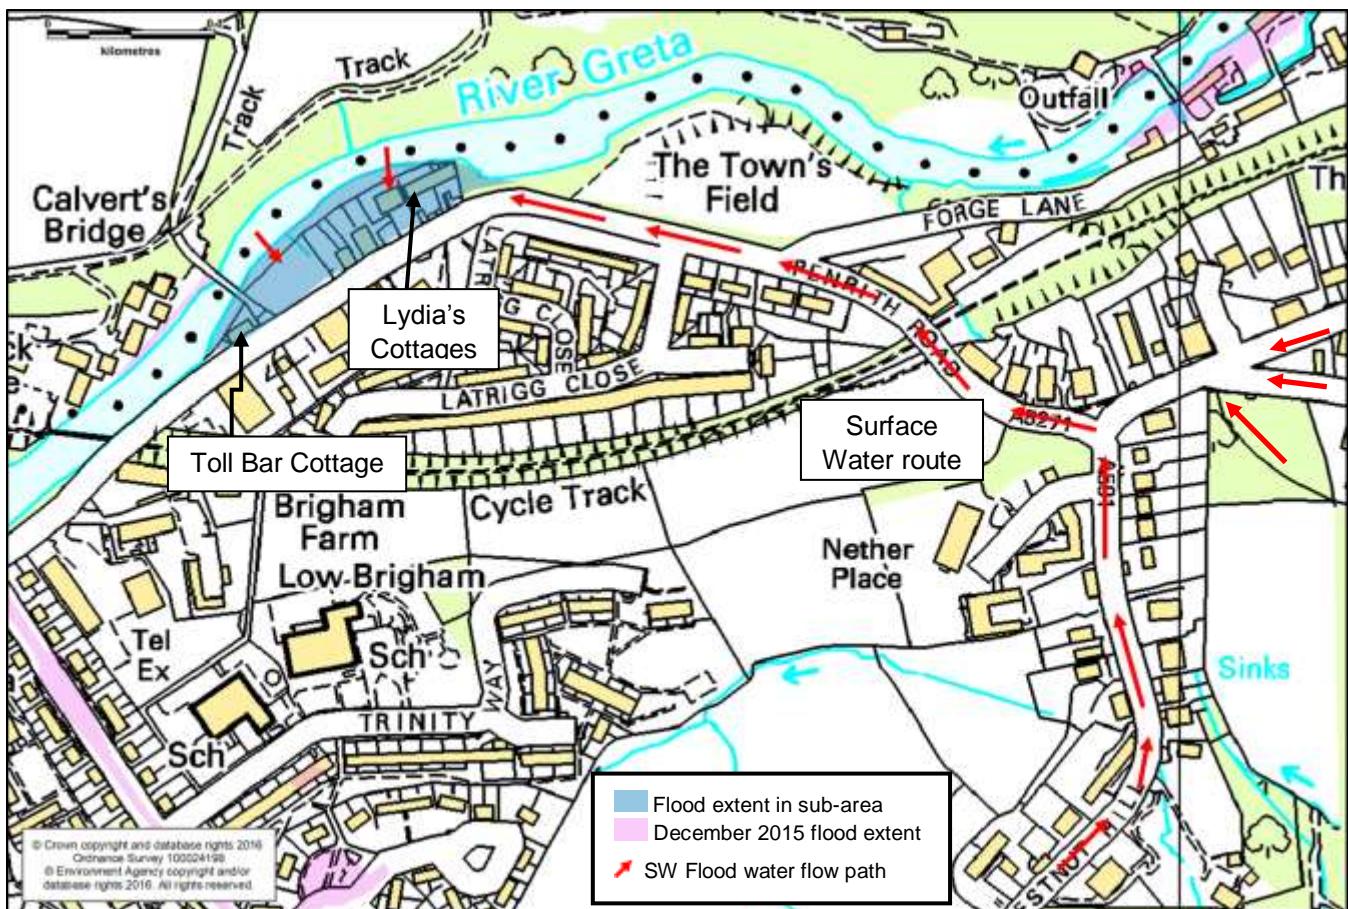
Figure 14: Sources of flooding and Flood extent at Calvert's Bridge

This is an area of flooded properties on the left bank of the River Greta upstream of the town. The river levels exceeded the soffit of Calvert's Bridge, a listed stone arch structure which formed a constriction to flow, **Figure 14**. Calvert's Bridge suffered some structural damage as a result.

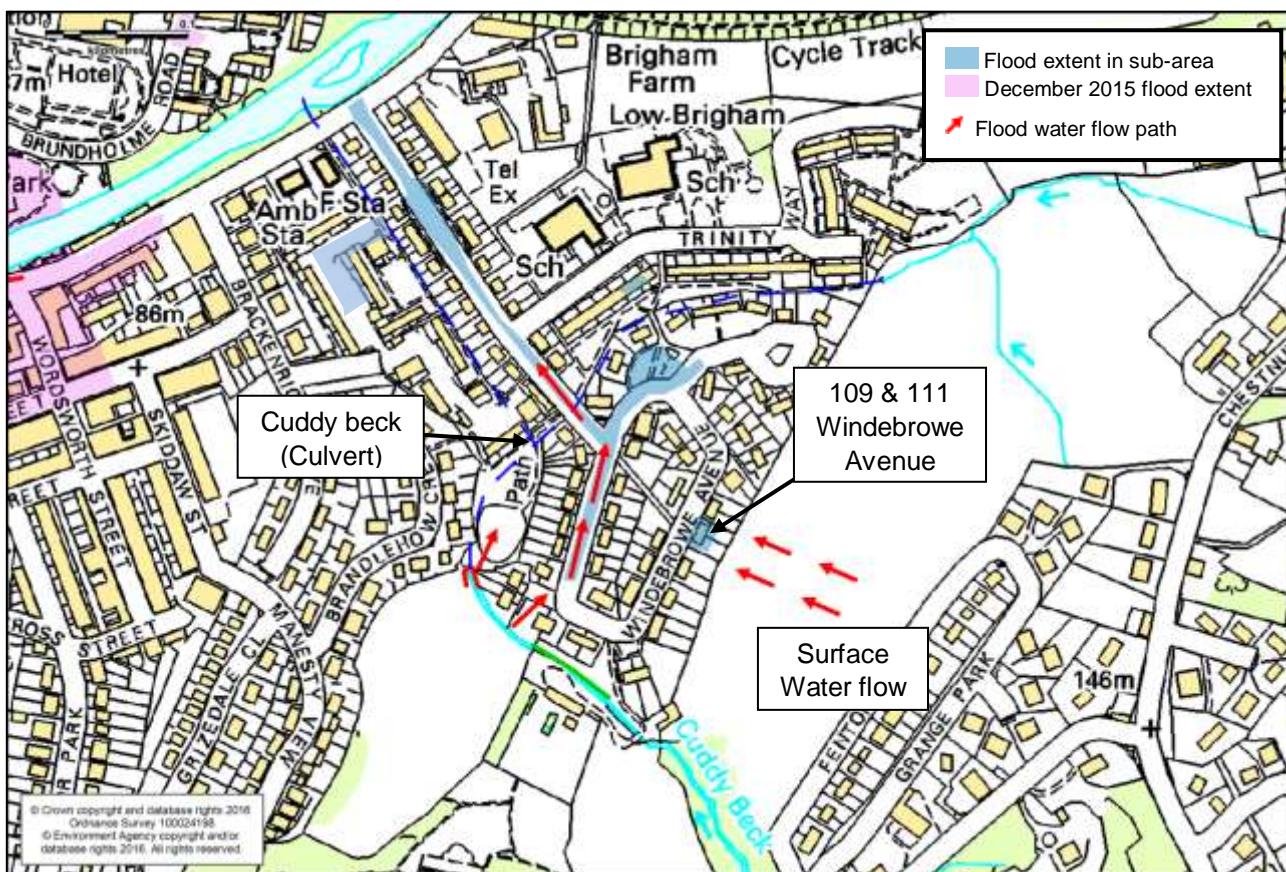
**Figure 15: Source of flooding and flood extent at Windebrowe Avenue and Trinity Way**

This area flooded from surface water runoff that could not drain via the existing surface water drainage system. In this area Cuddy Beck runs from the southeast towards Windebrowe Avenue and discharges to the River Greta via a culvert, **Figure 15**. The culvert could not freely discharge to the river because of elevated river levels, although further investigation will be required to determine whether the capacity and possible blockages of the culvert were also factors. Surface water that could not enter the culvert ran towards Windebrowe Avenue and on to Penrith Road, and flooded some of the properties on the upper end of Windebrowe Avenue.

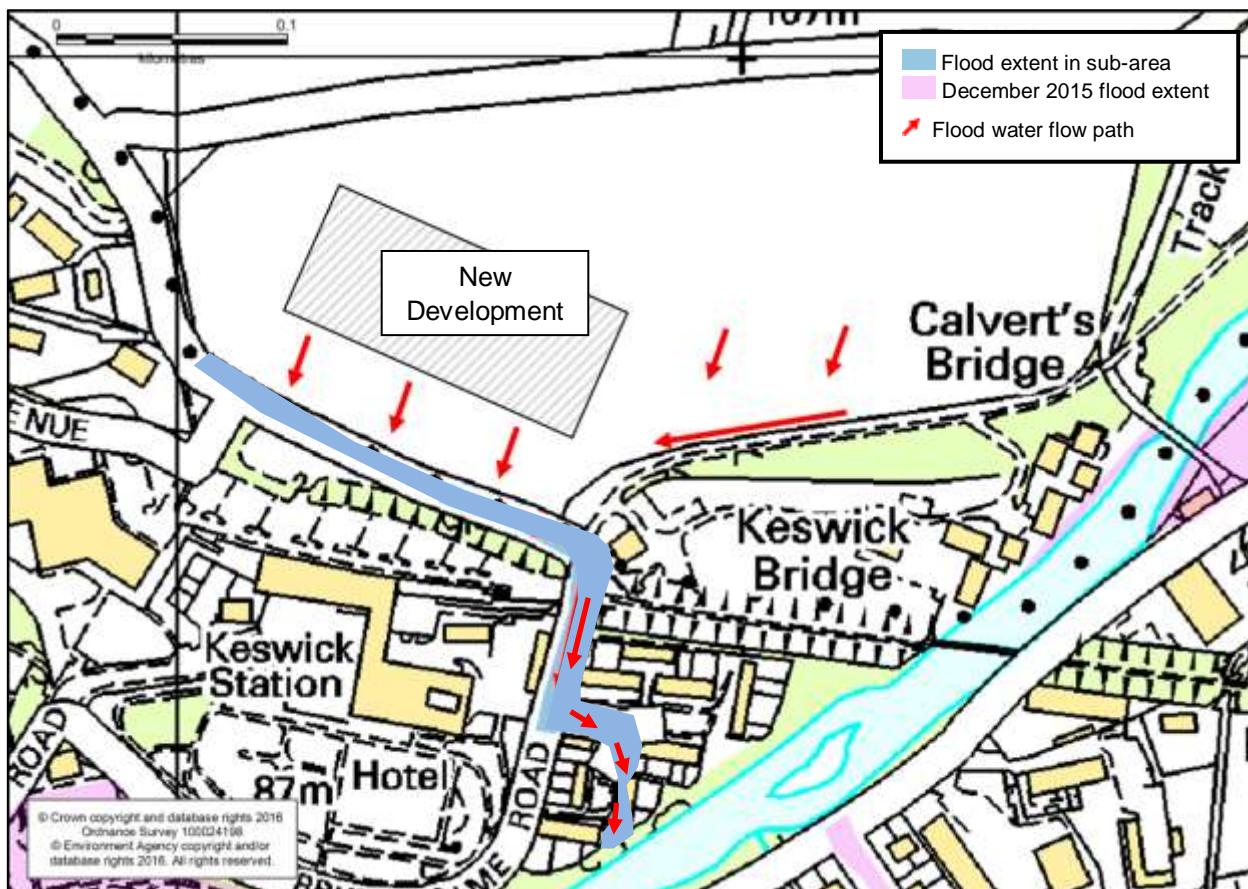
**Figure 16: Source of flooding and Flood Extent at Brundholme Road**

Flooding was observed on Brundholme Road, from surface runoff through the new development area, **Figure 16** and **Photograph 9**. Surface water from the construction site was silty and this blocked the road gullies on Brundholme Road causing local flooding in the area. A constriction of the drainage pipe taking water from Brundholme road has been identified. Two properties were flooded from surface runoff and one property flooded as a result of surface water runoff in addition to ingress from the River Greta.

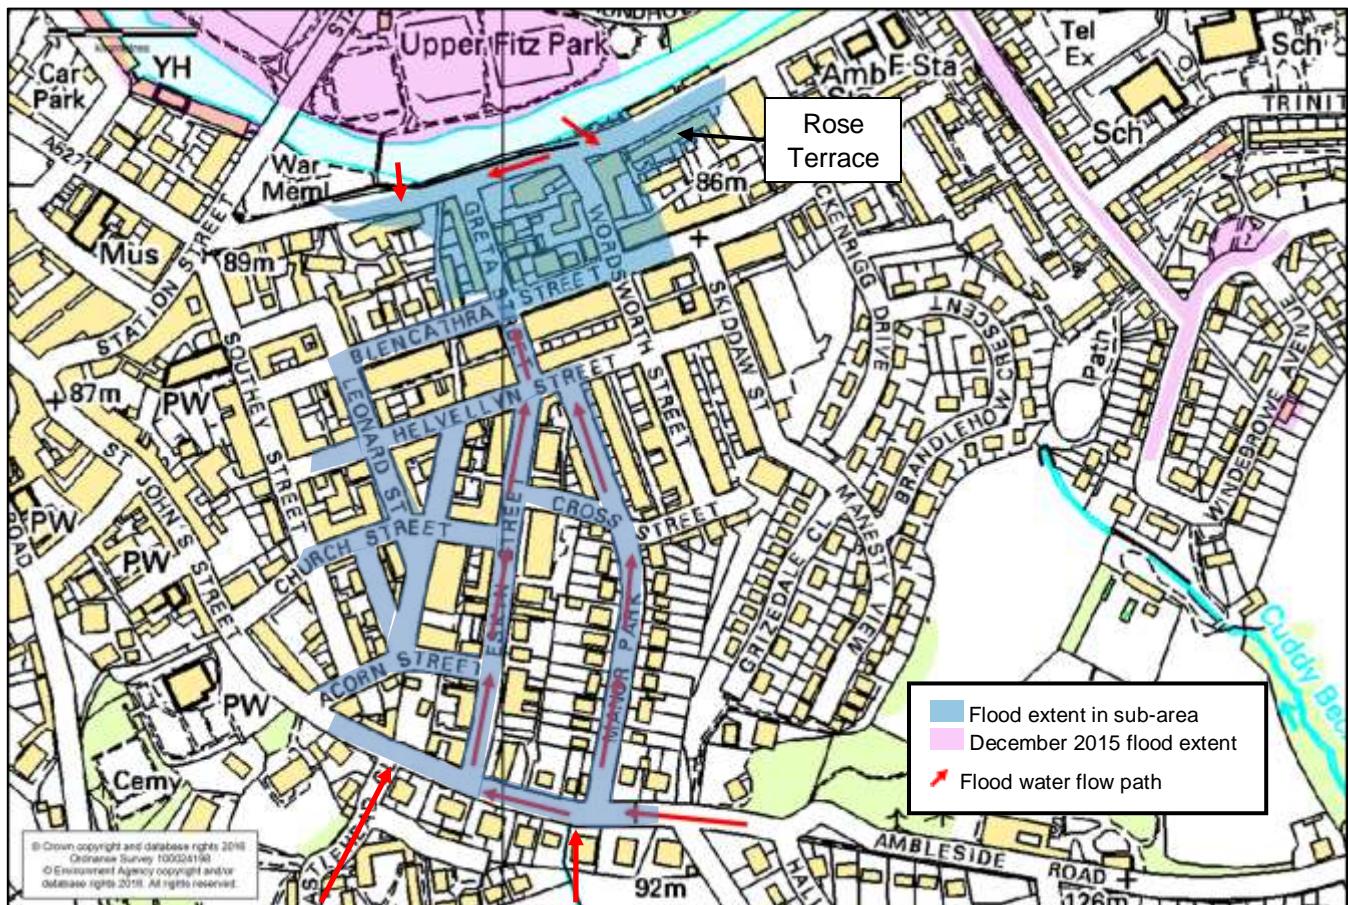
**Figure 17: F flood extent map: Ambleside Road to Penrith**

This is an area of residential properties and businesses on the left bank of the River Greta, outlined by Greta Street, Wordsworth Street, Canister Lane, and Penrith Road, **Figure 17**, which acts as a key access route into the town. A flood defence wall runs along The River Greta and at its upstream limit, terminating at an area of slightly raised ground as shown in **Photographs 10 & 11**.

In addition, surface water runoff flowed onto Ambleside Road, continuing in the direction of the River Greta. Surface water flooded numerous properties within the area between Ambleside Road and Penrith Road. It was also noted that a manhole at the junction of Penrith Road and Greta Street shown in **Photograph 12** started surcharging prior to the river overtopping or outflanking the flood wall.

The River Greta continued to rise, eventually resulting in the outflanking of the wall at its eastern extent. The flood wall was not overtopped at this location, with the exception of a wave created by the access ramp on the left bank of Wivell Bridge, see **Photograph 13**.

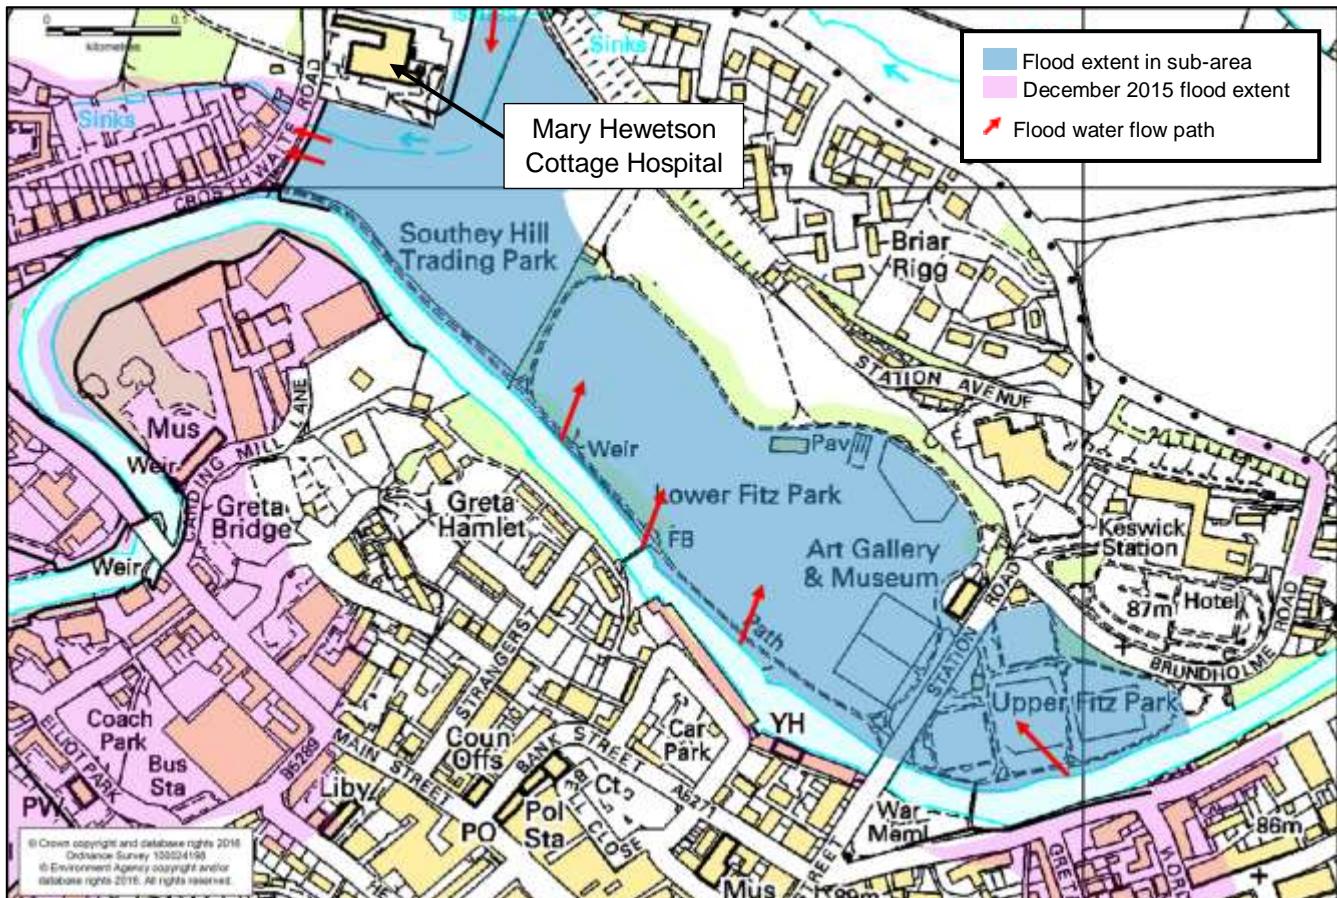
**Figure 18: Source of flooding and Flood Extent map at Upper and Lower Fitz Park**

This area is on the right bank of the river and is divided into upper and lower Fitz Park by Station Road. Upper and Lower Fitz Park are not defended and are intended to be used as flood plain storage during a flood event, **Figure 18**. At Lower Fitz Park, 2m depth of flooding was recorded, and at the football club pavilion, 0.25m of flooding was reported inside the building and 1m outside. The floodwater deposited mud, silts and gravels up to a depth of approximately 300-450mm across the entire park and caused significant damage and destruction to the park facilities, all of which were uninsured, see **Photograph 14**. Approximately 1,200 tonnes of silt was removed in the clear up.

The flood embankment and defence wall along Crosthwaite Road were both overtapped despite efforts by the Environment Agency to bolster the defences with sandbags during the event, **Photograph 15**. There was also some seepage through the base of the vehicular floodgate at the northern end of Crosthwaite Road. Seepage was also observed through the flood defence wall near the upstream end of Crosthwaite Road, as well as further downstream. Water from these routes led to Crosthwaite Road being flooded from Fitz Park. Upstream headwall damage was also sustained by the Station Road Bridge.

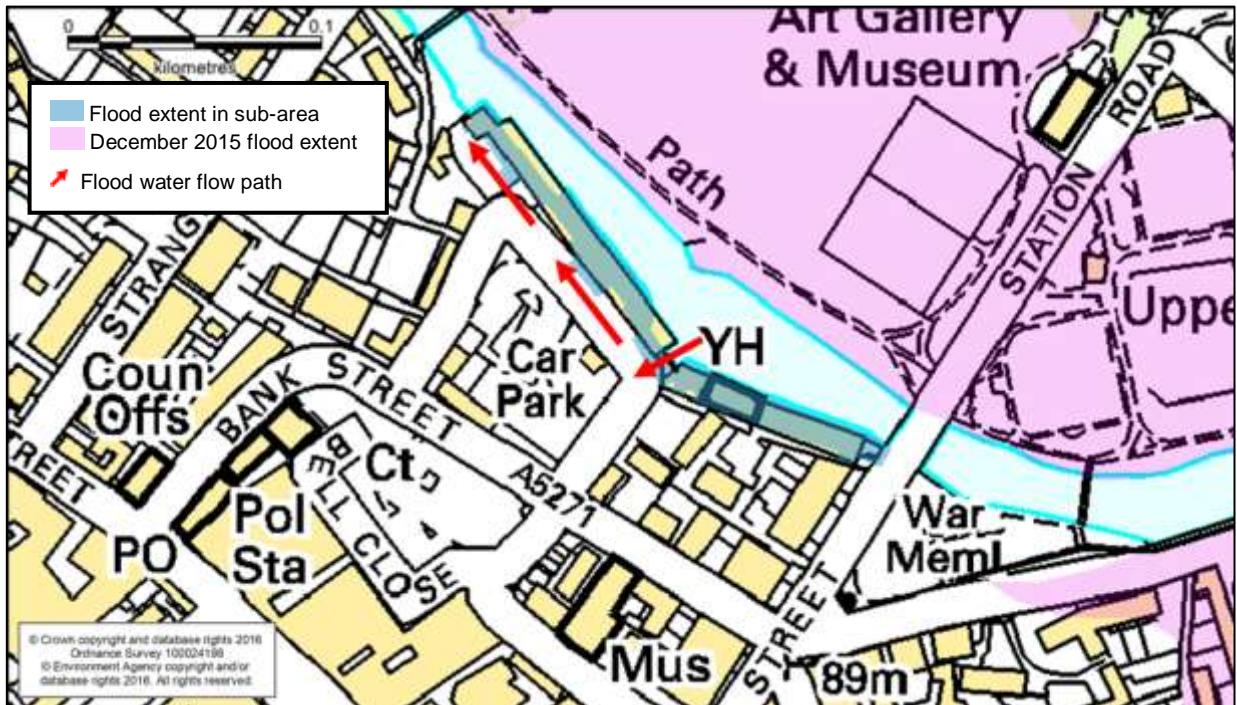
**Figure 19: Source of flooding and Flood Extent at Greta Side**

This area is on the left bank of the River Greta and many of the properties in this section are built along the river bank and form part of the defence line, **Figure 19**. As part of the flood defence works, properties at Greta Side were provided with flood proof doors, the mill race beneath them was sealed, and a short section of floodwall was constructed in a gap between properties adjoining the river. All property level protection, including a pump in the mill leat, were overwhelmed. It was reported that the river overtopped this short floodwall and then flowed through the gap between properties, flooding properties on Greta Side, **Photographs 16 & 17**. However, there was also evidence that water started to collect behind the barrier prior to it being overtopped.

The Environment Agency laid sandbags along this stretch of flood wall to provide additional protection, however this was still overtapped as river levels rose. Residents also reported that floodwater entered the properties through the floors, which, combined with surface water would account for water collecting behind the defences prior to overtopping. Knight's Bridge, the footbridge that connects Millbank at the top of Stanger Street to Lower Fitz Park was washed away during the flood, **Photographs 18 & 19**.

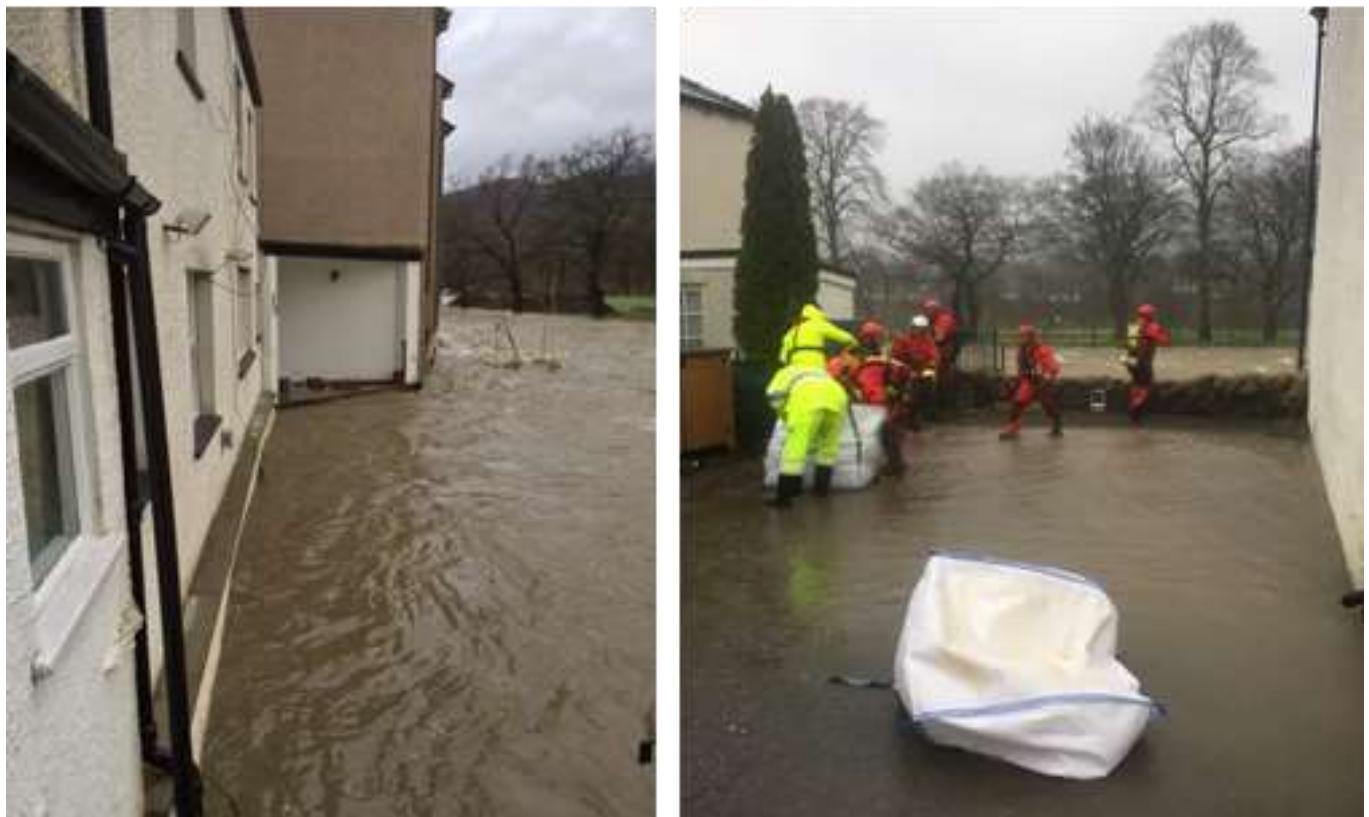
**Photographs 16 and 17: Riverside view of the properties and river flow between properties on Greta Side**

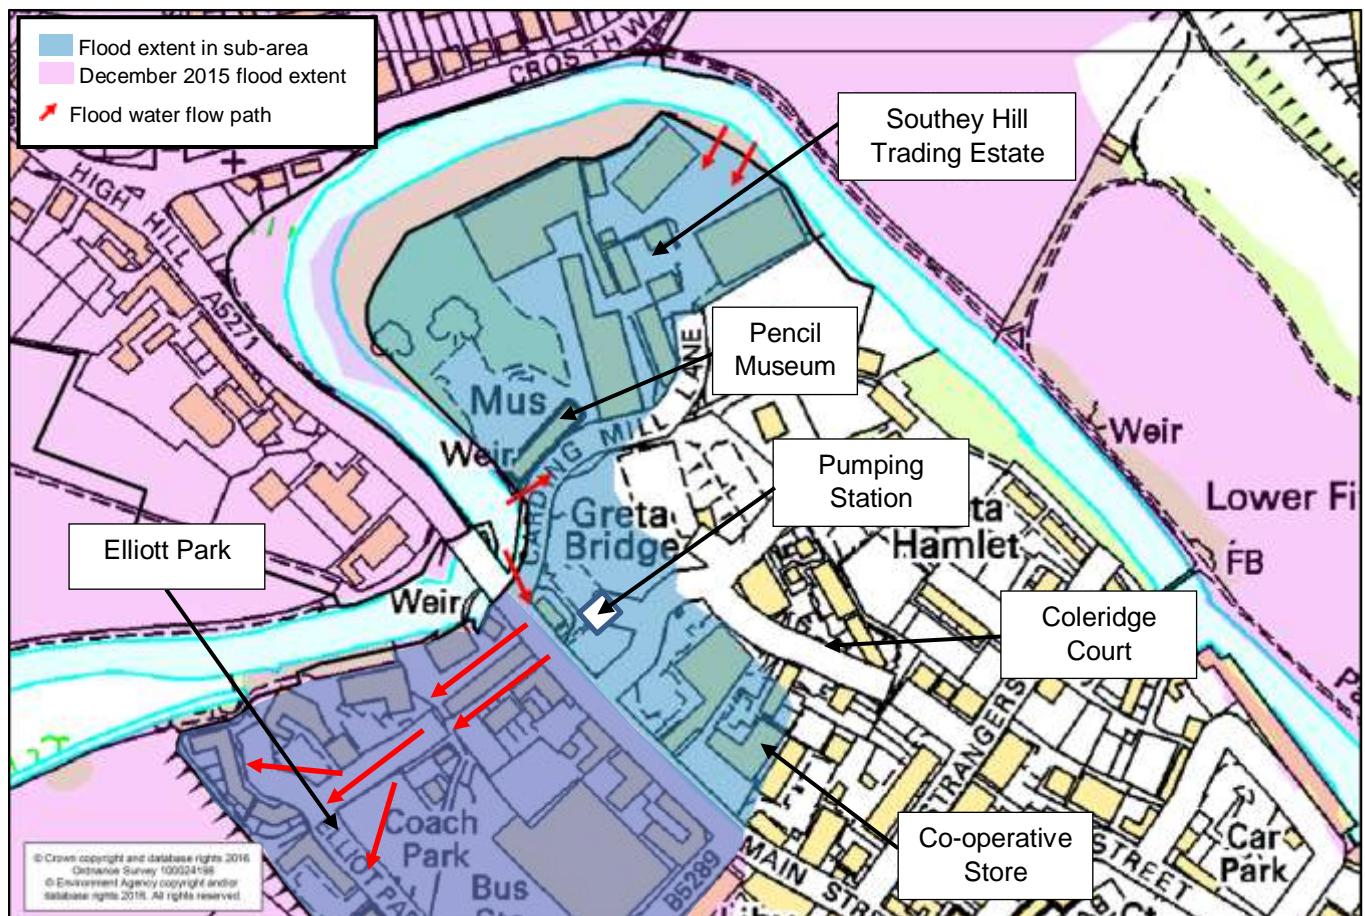
**Figure 20: Source of Flooding and Flood Extent at North of Main Street – Southe Hill Trading Estate/area**

This includes areas on the left bank of the river Greta, within and adjacent to the large meander of the river, **Figure 20**. This area contains numerous businesses including Booths Supermarket, the Pencil Museum, Co-operative store, Parish Rooms, and Rawnsley Centre, as well as the residential properties of Coleridge Court, Main Street and Elliott Park. A floodwall is present along the left bank and a flood embankment is present on the boundary between Elliott Park and the rugby football ground.

At the north end of Southe Hill Trading Park, the flood wall ties into a breeze block wall located on high ground. At the time of the event the cladding had been removed from the top of the wall for maintenance purposes, making the defences more susceptible to early overtapping at this location, **Photograph 20**.

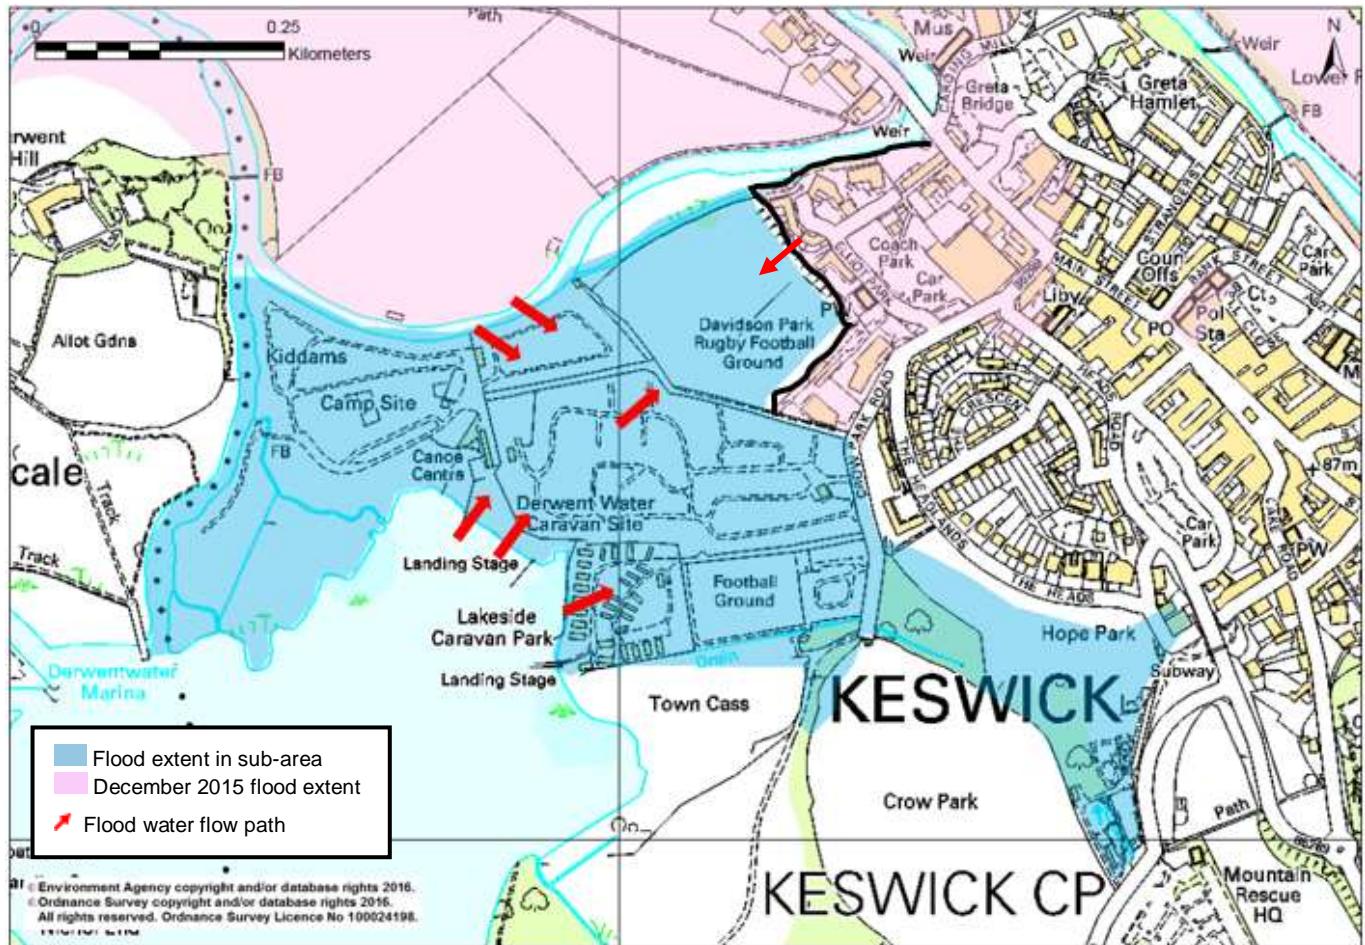
**Figure 21: Source of Flooding and Flood Extent on the South of the Main Street**

This area forms part of the sacrificial flood plain and comprises a number of commercial properties including low lying camping and caravanning sites. There is a flood embankment on the boundary between Elliott Park and the Rugby football Ground, **Figure 21**, designed to prevent flood water from the floodplain entering Elliott Park.

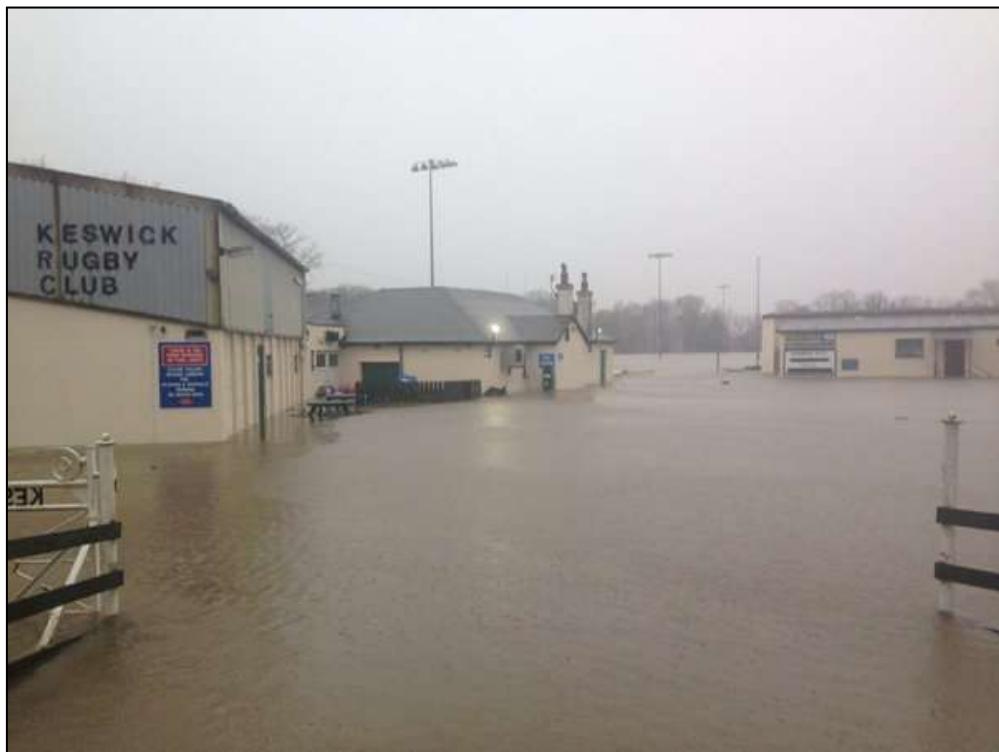
The Rugby football ground and the surrounding area are believed to have been flooded from a combination of flows from the River Greta, and overland flow from Derwentwater, which had flooded across the Keswick lakeside camping and caravan club site, **Photograph 24**.

**Photograph 24: Flooding at Keswick Rugby Club**

In the latter stages of the flood event, flood waters were reported to overtop the flood defence embankment resulting in a flow of water from the Elliott Park side of the defences on to the rugby football club ground.

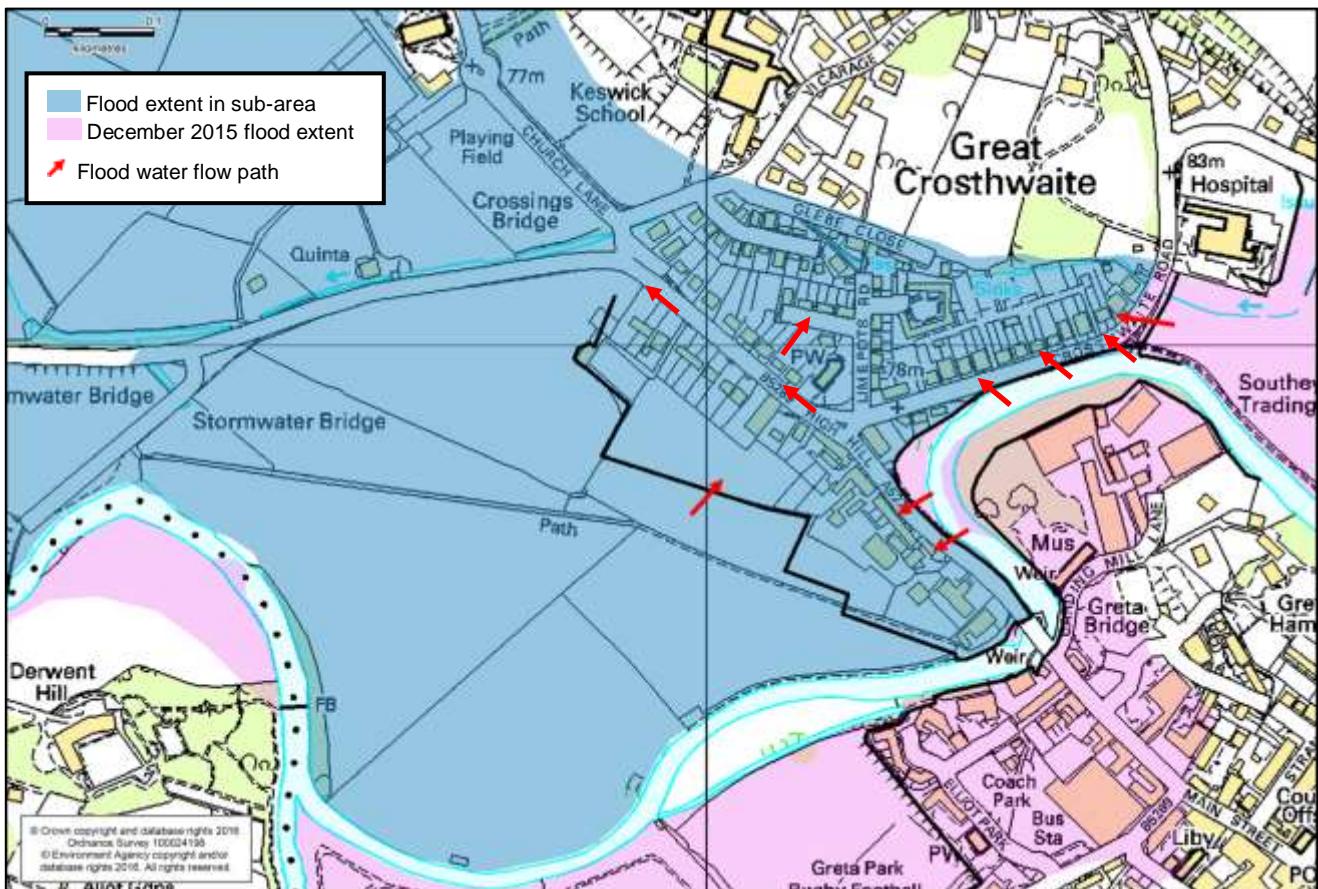
**Figure 22: Source of Flooding and Flood Extent at High Hill**

This area is on the right bank of the River Greta and includes properties alongside Crosthwaite Road, Limepots, Glebe Close, and the area to the south of High Hill road, **Figure 22**. There is a flood defence wall along the right bank of the River Greta bounding Crosthwaite Road and High Hill. The section along High Hill includes glass panel sections to maintain views of the river. There is also a flood defence embankment to the rear of the properties on High Hill road to protect against flows from the River Derwent.

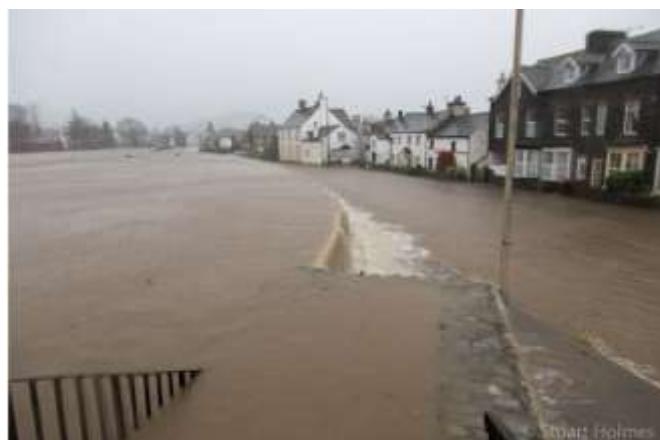
**Photograph 28: Overtopping of flood defences on High Hill Road**

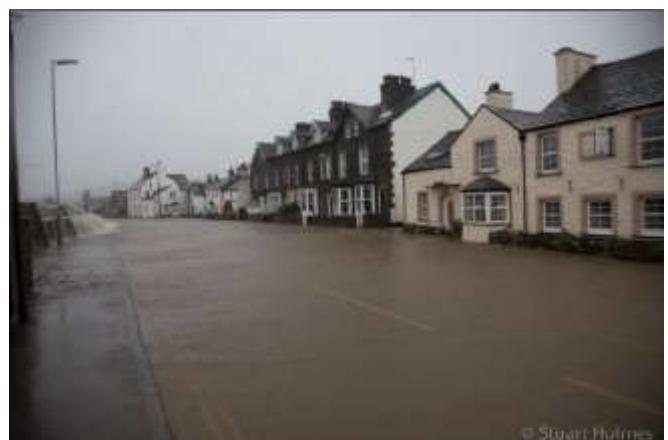
**Photograph 29: Overtopping of flood defences on High Hill Road**

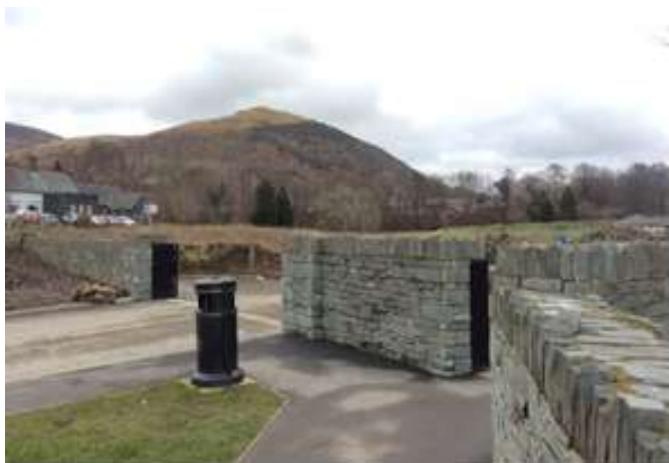
Flooding along Crosthwaite Road initially commenced at 14:20 from overtopping of the embankment immediately north of the floodgate (**Photographs 30 and 31**). The dropped level of wall, where the river turns to run parallel with Crosthwaite Road, was also reported as a susceptible low point. Seepage was observed through the base of the floodgate and through the flood defence wall further south on Crosthwaite Road. As river levels continued to rise, the flood defence wall was overtapped along its

**Photograph 30: Crosthwaite Road flood defence wall**

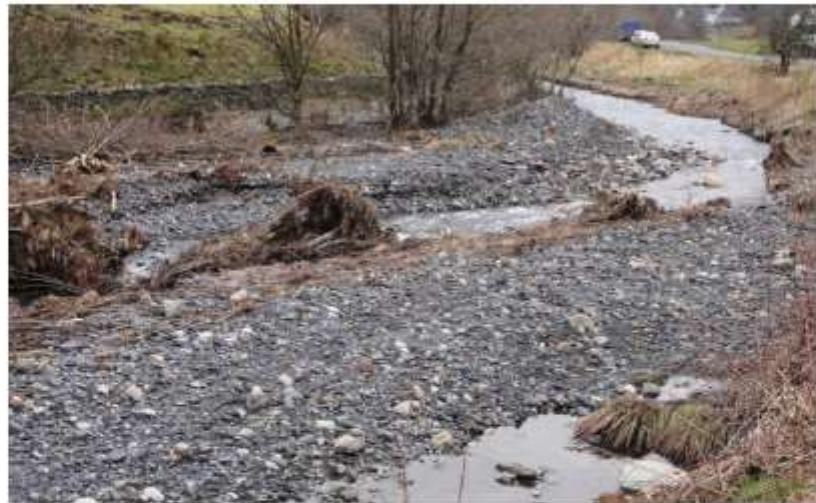
Given the substantial deposition of river gravel debris in the river at Mungrisdale (see Figure 3) it is clear that there were massively damaging flows from way above the village which need to be considered. We would like to see reforestation and natural ‘leaky’ dams on the high fells slowing the flows from Bannerdale Beck, Buffell Beck and the higher reaches of the Glenderamackin.

**Figure 3:** Overbank gravel deposits in the River Glenderamackin near Mungrisdale.

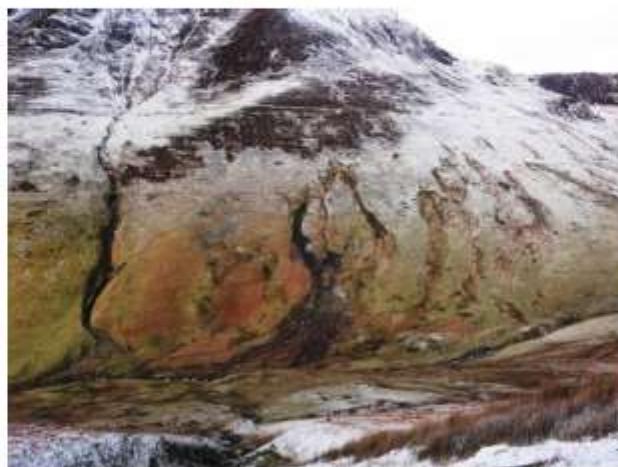
Again, upland management of small watercourses is required. This beck has a steep outfall near Threlkeld and probably causes a lot of scouring/debris to be washed down. There has been some tree planting in this valley but it only covers a very small area. Steep slopes are vulnerable to erosion and this has been demonstrated by a number of landslips (see Figure 4).

**Figure 4:** The bare slopes and erosion features of the Glenderaterra valley.

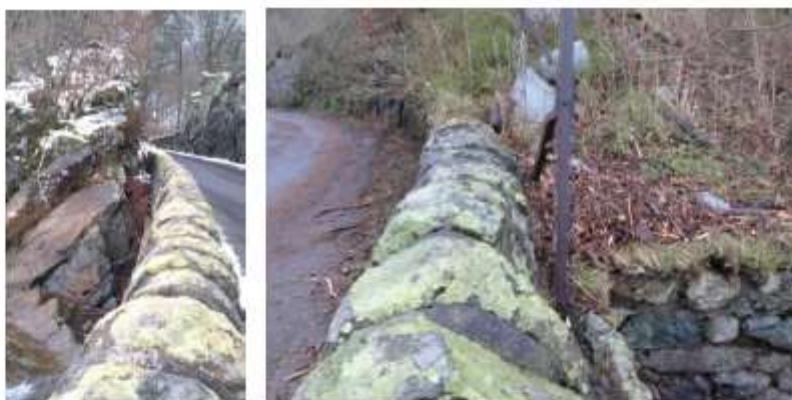
We believe that, at the height of the storm on December 5<sup>th</sup> 2015, the reservoir was within 15 inches of the top of the wall which runs along the road over the reservoir dam. Photographs in Figure 6 show the level of debris on the Thirlmere road wall (right up into the top corner beside the rock outcrop in the photo on the left and on the bank close to the top of the wall in the photo on the right). Figure 7 shows Environment Agency water level data for Thirlmere illustrating how the level was higher than the dam road level during Storm Desmond.

Figure 6: Photographs of flood debris close to the top of the wall that runs along the top of the dam at Thirlmere.

The exceedance of the 1975 PMP for the Cumbrian Fells (against which the reservoir was operated for many years) during Storm Desmond illustrates how the Thirlmere dam and spillway was tested. It is believed that there was little or no management reaction to the water level in Thirlmere during the storm which is a great concern to many local residents. It is requested that the EA examine United Utilities (UU's) management of the Thirlmere water levels and the operation of emergency procedures during Storm Desmond and the future operation of the reservoir given forecasts of the likely total precipitation in future storms in the context of climate change.
