# Keswick

## Sec 19 Flood Investigation Report

## Flood Event 5-6<sup>th</sup> December 2015

This flood investigation report has been produced by the Environment Agency as a key Risk Management Authority under Section 19 of the Flood and Water Management Act 2010 in partnership with Cumbria County Council as Lead Local Flood Authority.

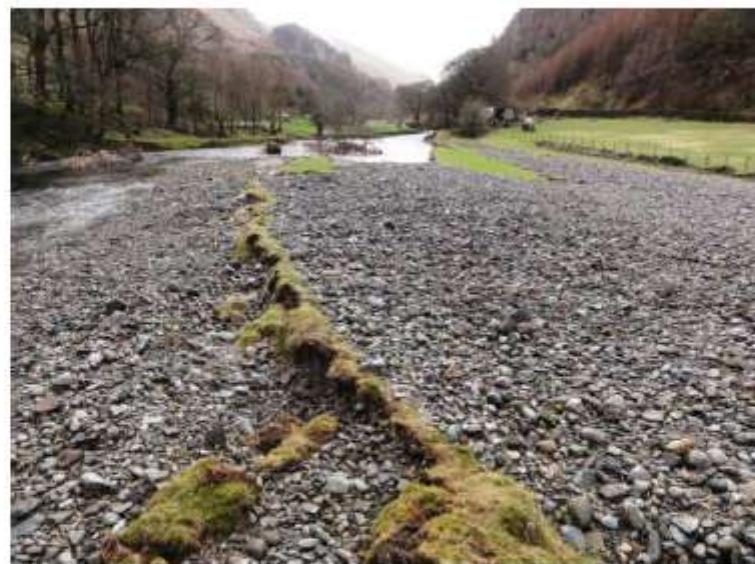
Becks cleared in some places but natural storage and flow barriers created in others. The removal of levees and canalisation should be considered. Figure 9 shows gravel deposited on fields by St John's Beck during Storm Desmond. St John's in the Vale is immediately downstream of Thirlmere and as such it suffers greatly from the failure to manage storm flows through the reservoir. The size and distribution of the gravel in the photograph illustrates the power of the water despite the fact that this location is only 1.5 km from Thirlmere Dam. There is a clear need for improved regulation and management of Thirlmere Reservoir.

**Figure 9:** Gravel deposited on fields by St John's Beck during Storm Desmond.

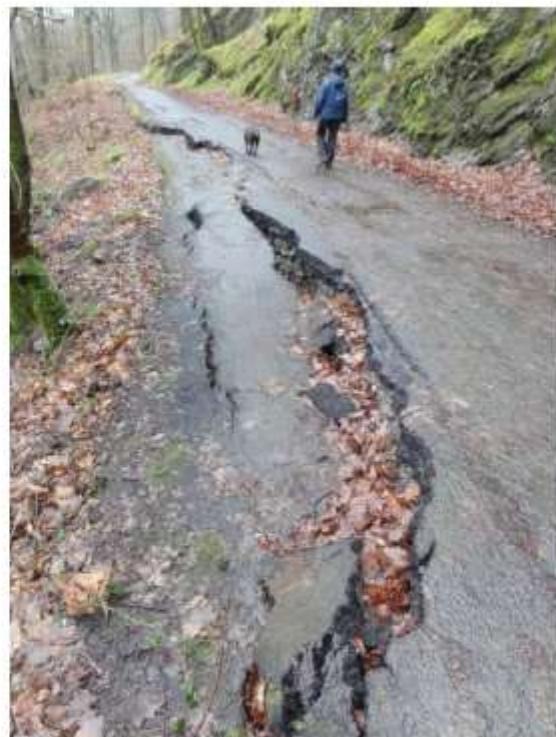
In addition to flooding and damaging infrastructure, Storm Desmond also caused erosion and deposition. While there are many examples of erosion and deposition, e.g. visible river erosion damage to roads, landslips and fields covered in gravel, another less visible effect could be the further weakening of the large slope in Brundholme Woods above the River Greta at Low Briery. One of the landslips in Brundholme is illustrated in Figure 10 below.

**Figure 10:** The top of the Brundholme Woods landslip visible in the minor road through the woods.

The concern is that this very large slope could all become unstable and slump into the river. This could threaten the Low Briery caravan and camping area and could then block the river. If a large volume of water was to collect behind the slump, a sudden breakthrough of water could cause erosional damage and flooding downstream. Figure 11 shows the slope erosion at Low Briery caused by the Storm Desmond floods.

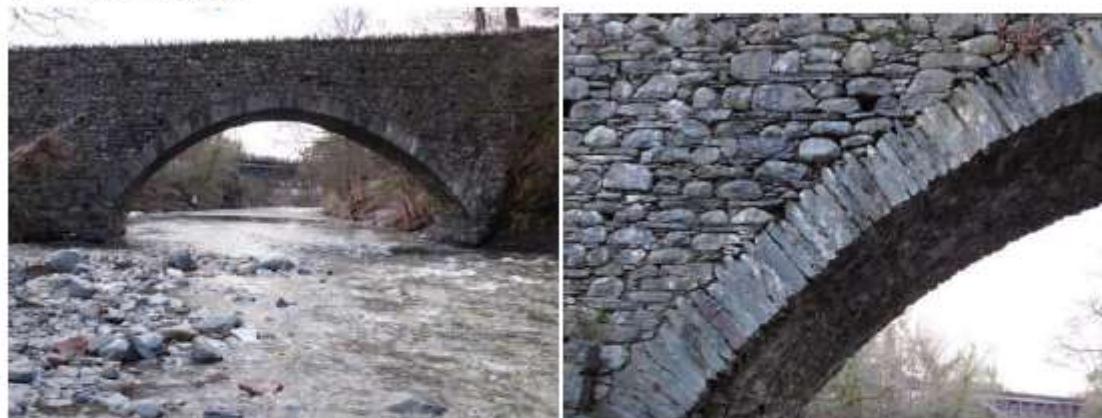
Figure 13: Calvert Bridge.

Properties upstream of the bridge, none of which have ever been known to suffer flooding from the river, did so in December. According to the Environment Agency, the water level on the upstream side of the bridge was 3 metres higher than on the downstream side. Whilst this no doubt benefitted the centre of town, it was at the expense of the upstream properties. If the water level upstream had been just 0.6 m lower, none of the properties would have suffered (unlike their gardens or riverside retaining wall in the case of Lydia's Cottages).

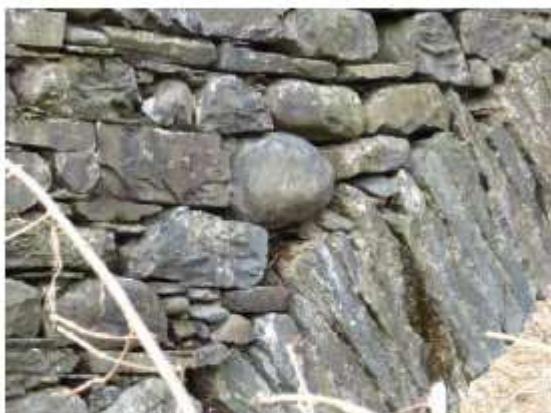
This raises two questions: (i) should this beautiful old bridge, which is part of what makes the Lake District so special, be removed and (ii) would some removal of river gravel help to lower the riverbed under the bridge making it less of a constriction? During the worst of the storm, the river totally filled the arch leaving the bridge vulnerable to collapse. It certainly is now in need of some maintenance work, if it is to survive another similar event.

Figure 16: Front face of bridge.

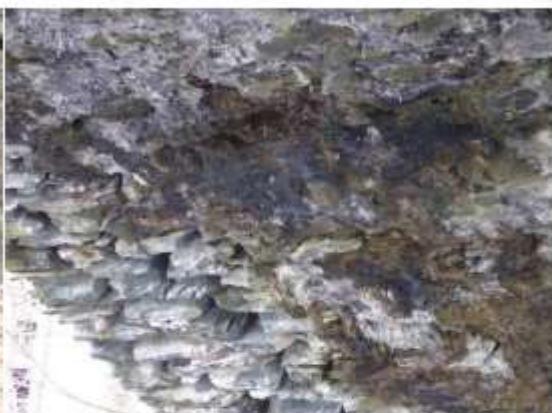
Figure 17: Underside of bridge.

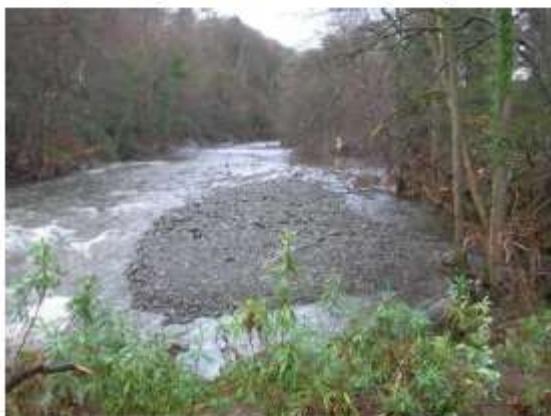
The second option is by far the more attractive but on the subject of stone/gravel removal there is a very serious problem in the whole of the area that needs to be dealt with and this is clearly exemplified by the banks of stones just upstream from Lydia's Cottages.

Figure 18: Stone deposits above Lydia's Cottages

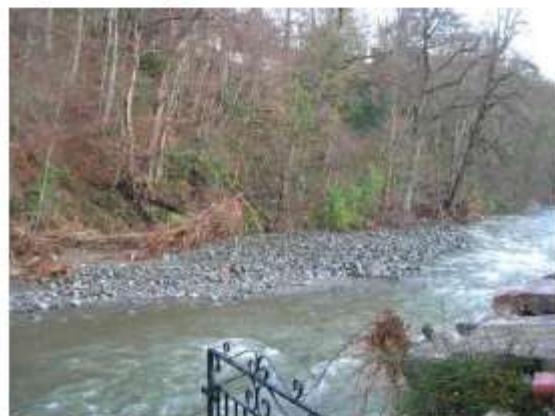
Figure 19: Stone deposits on opposite bank.

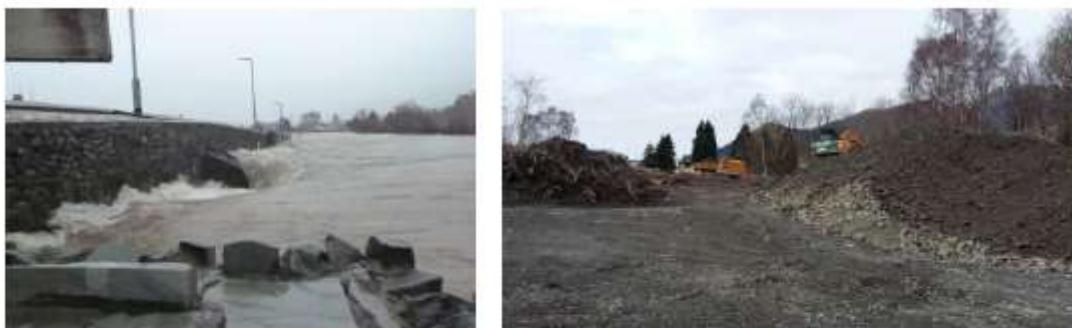
During the December storms the water level downstream of the bridge was witnessed as constant whilst the telemetry levels upstream continued to rise showing that the bridge clearly obstructs the flows of the river at high flows (see Figure 20). It is our view that the bridge should be replaced with a single span bridge and/or supplemented with additional storm culverts to get as much of the flow away from the town itself. Consideration should also be given to compulsory purchase of properties to allow an additional channel to be created, possibly straightening out the river at High Hill Corner to avoid the sharp bends and allow the water an additional, faster route into the flood plain beyond (see Figure 21). Ravensfield being derelict may well provide a useful option for an additional flow. Gravel extraction to be carried out routinely. The flood gates to the car park on Crosthwaite Road leaked at the base. For some inexplicable reason the gates are lower than the flood wall and thus provided a point at which the river overspills first. The bund to the side of the gates also needs repairing where pedestrians have worn it away. Our river defences overtopped where we said they would, the glass panels finished with one lower section and overspilled at a point where more properties were put at risk than before. On Crosthwaite Road the bend that needed additional height has been bolstered with rows of sandbags.

Figure 20: The river Greta at Greta bridge during storm flow and the subsequent removal of gravel.

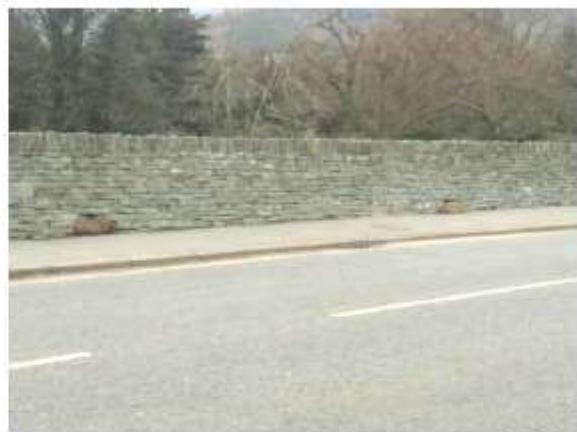
The EA has previously acknowledged that surface water would be trapped behind the river defences. Far from dealing with the issue when the defences were constructed drainage holes were left just above the pavement level in the wall (properties in the area being below pavement height) (see Figure 22). The river flowed back towards homes and flooded them.

**Figure 22: Drain holes left under flood defence wall (sandbags in place).**

- We had asked for the drainage flaps to be 'one way' but they blocked open with debris so local pumping was under pressure with volumes of water from the river. These need to be sealed as soon as possible.
- The Penrith Road side of the walkway up to Wivell Bridge should be of a skeleton construction to let flood water pass through.
- Consideration should be given to a storm drain from the bottom of the lane behind Greta Street going diagonally across the road exiting between Wivell Bridge and the Pups Shelter as this is the lowest point.
