# Sandwith

## Flood Investigation Report No.40

**Flood Events: Summer 2012**

This flood investigation report has been produced by Cumbria County Council as a Lead Local Flood Authority under Section 19 of the Flood and Water Management Act 2010.

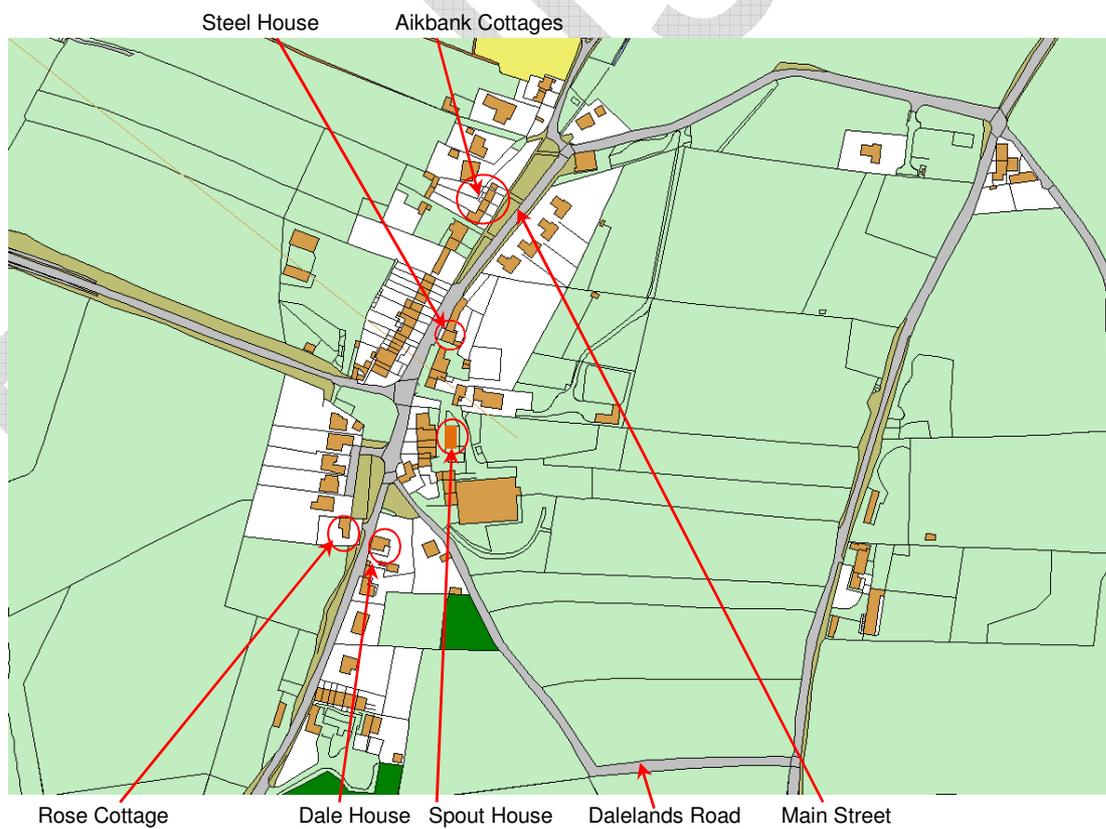
**Figure 3: Flooded Properties Location Plan**

Figure 3 shows the location of Steel House in the village along Main Street. The source of flooding to Steel House was surface water runoff from the fields behind the cottage to the east; see Figure 5 “Steel House Flood Routes”. Following previous flooding, resilience measures were put into place, including a floodgate in the back garden. Unfortunately this was left open on 30<sup>th</sup> August 2012 and some severe ponding was experienced on the low level patio at the rear of the property. When the floodgate was closed it successfully diverted the floodwaters through the adjacent barn.

On the north side of Steel House, Willow Cottage was also affected by surface water runoff from the fields and there was internal flooding to the cottage. Some of this flooding was caused by floodwaters from Townhead fields.
