Warcop

Flood Incident Investigation Report

Warcop, Cumbria

Flood Event 5th December 2015

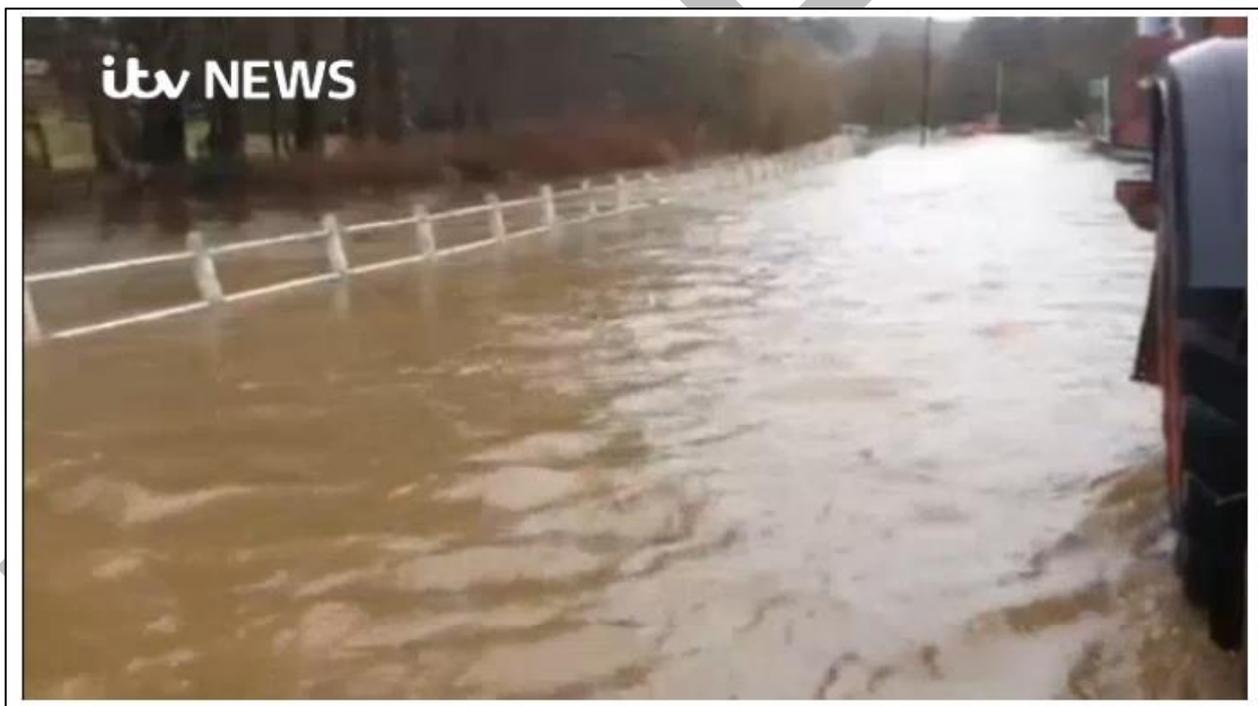
OS NGR NY 74696 15402

Photograph 1: Fluvial flooding on Brookside during the 5th December 2015 Flood Event
Source: ITV [<http://www.itv.com/news/border/update/2016-01-08/watch-flooding-in-warcop/>]

On the morning of the 5th December 2015 Warcop was affected by severe fluvial flooding from the Lowgill Beck and the Crook Beck (**Photograph 1** and **Photograph 2**). The first reported incidents of property flooding occurred at 04:30 hours and the flood reportedly peaked between 19:30 hours and 21:30 hours later that day. The severity and magnitude of the flood flows on the Lowgill Beck resulted in flood damage to the coping and parapet of Warcop Bridge (**Photograph 3** and **Photograph 4**).

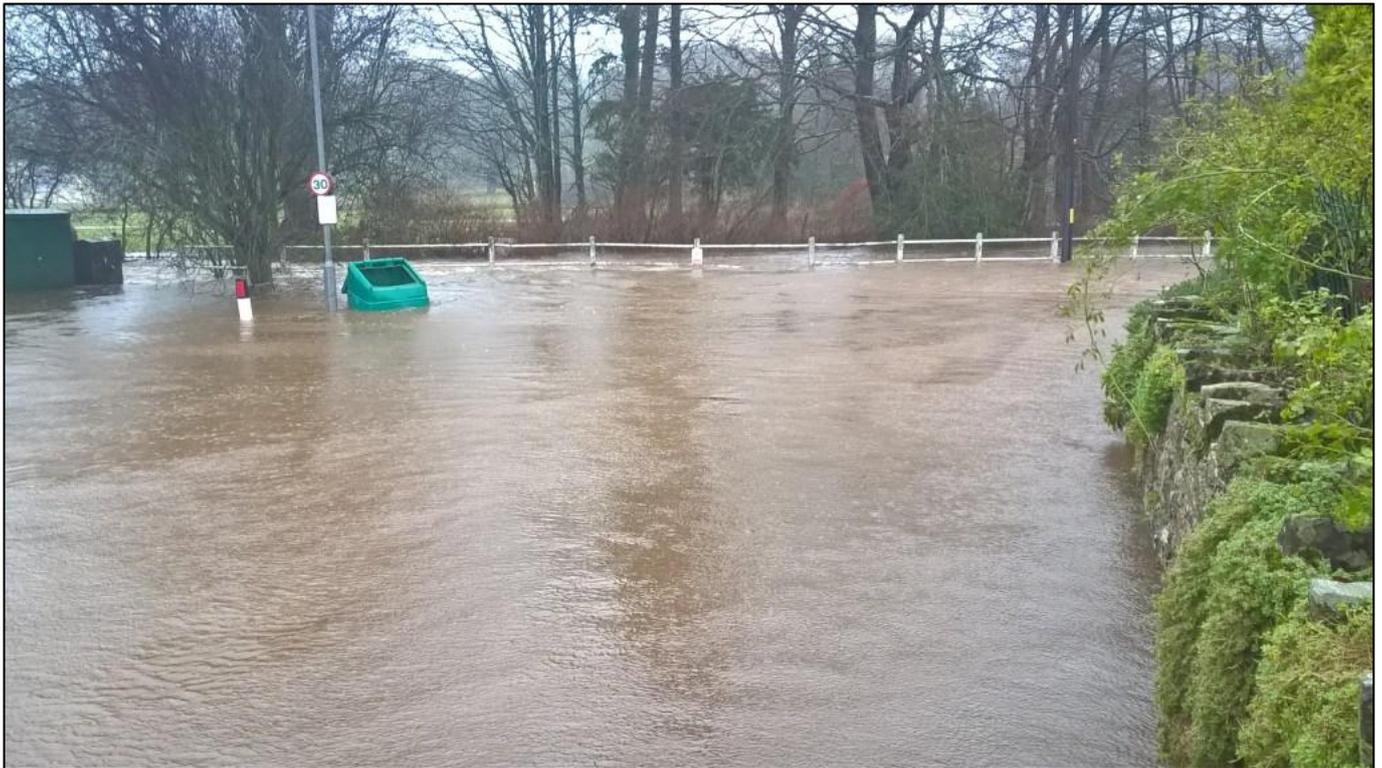
OS NGR NY 74647 15369

Photograph 2: Fluvial flooding on Brookside during the 5th December 2015 Flood Event
Source: ITV [<http://www.warcop.org.uk/warcop-clean-up-after-the-floods/>]

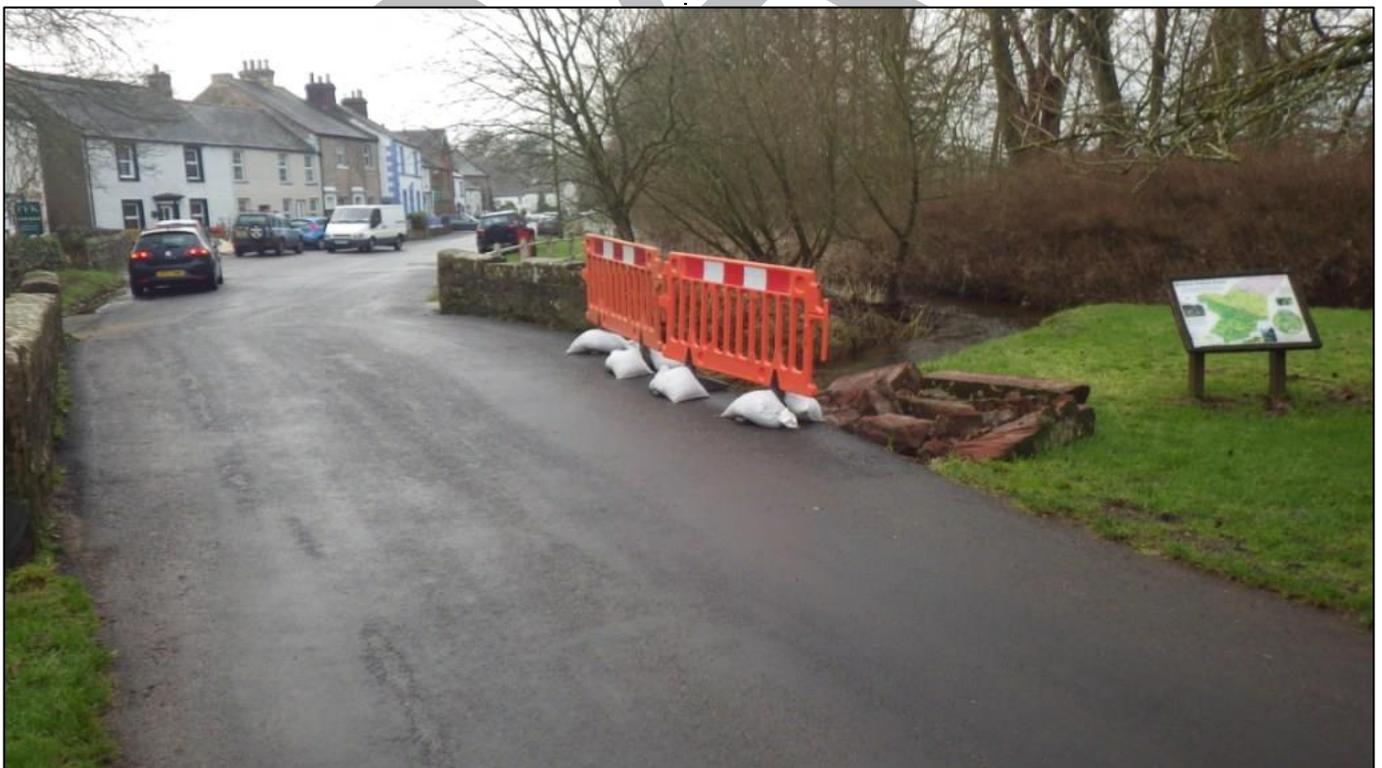
OS NGR NY 74800 15456

Photograph 3: Extent of damage on Warcop Bridge looking downstream
5th December 2015, no timestamp

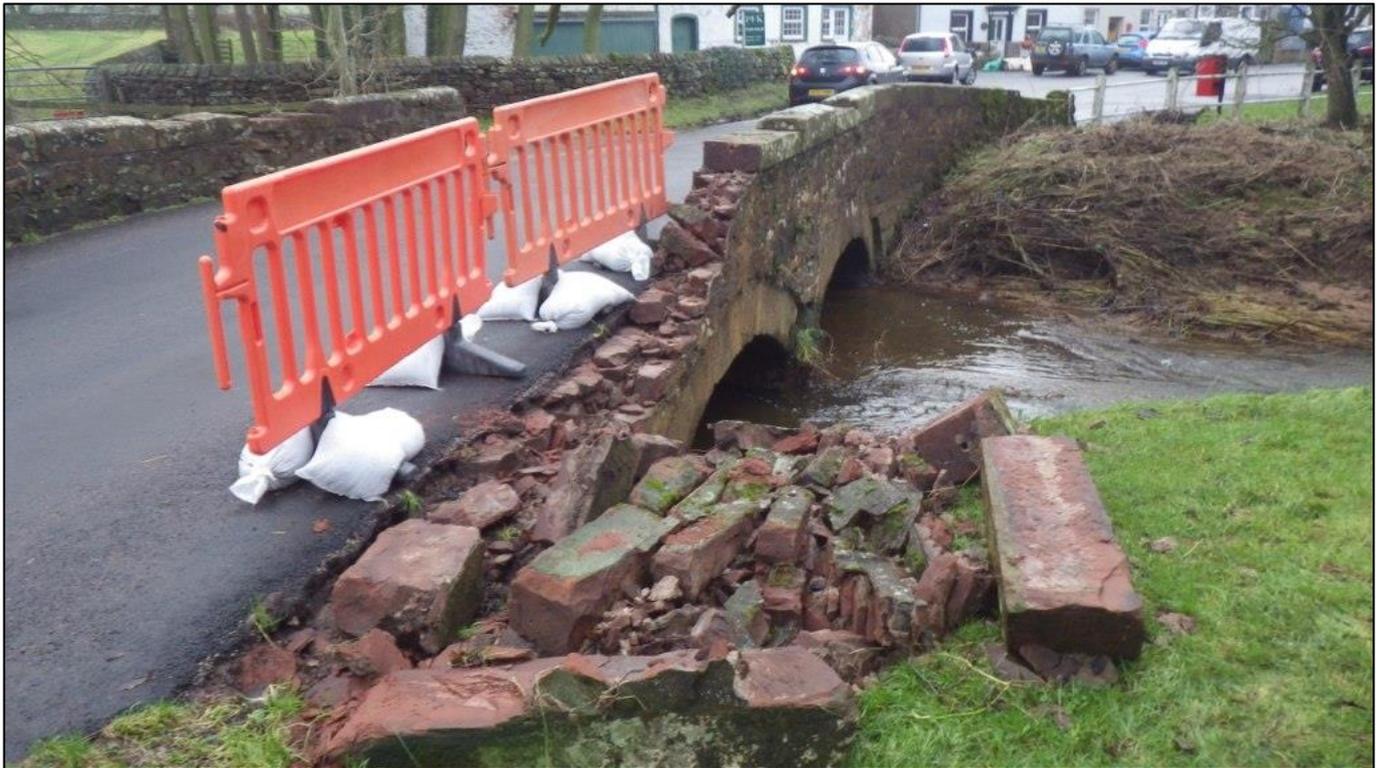
OS NGR NY 74800 15456

**Photograph 4: Flood Damage on Warcop Bridge over the Lowgill Beck, looking south
15th December 2015, no timestamp**

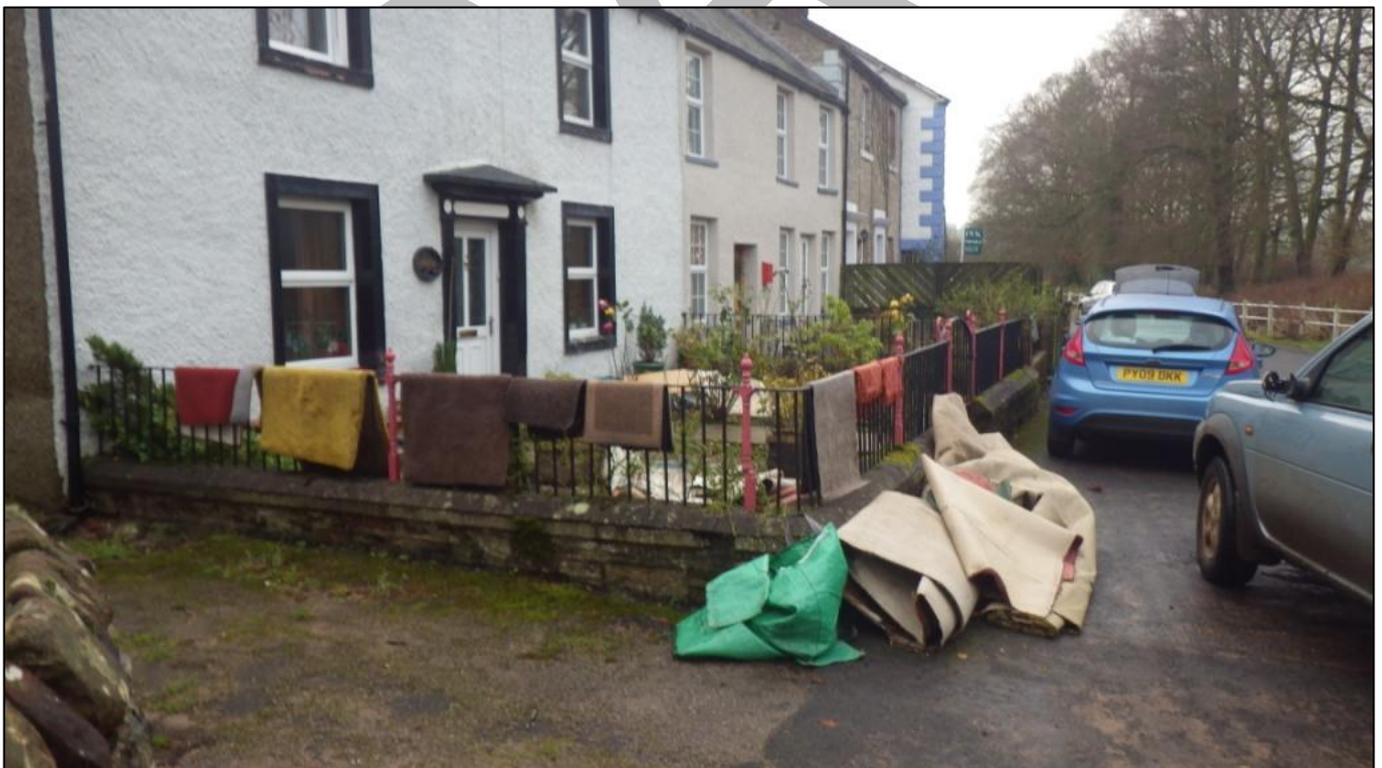
OS NGR NY 74765 15419

**Photograph 5: Residential property flooded on Brookside
15th December 2015, no timestamp**

The flooding in Warcop was made worse by a combination of surface water runoff from the hillside to the south of Warcop and the local sewerage system reaching capacity. The flooding incident resulted in 11 reported instances of internal property flooding (**Photograph 5**) and additional external flooding of outbuildings and gardens (**Photograph 6**).

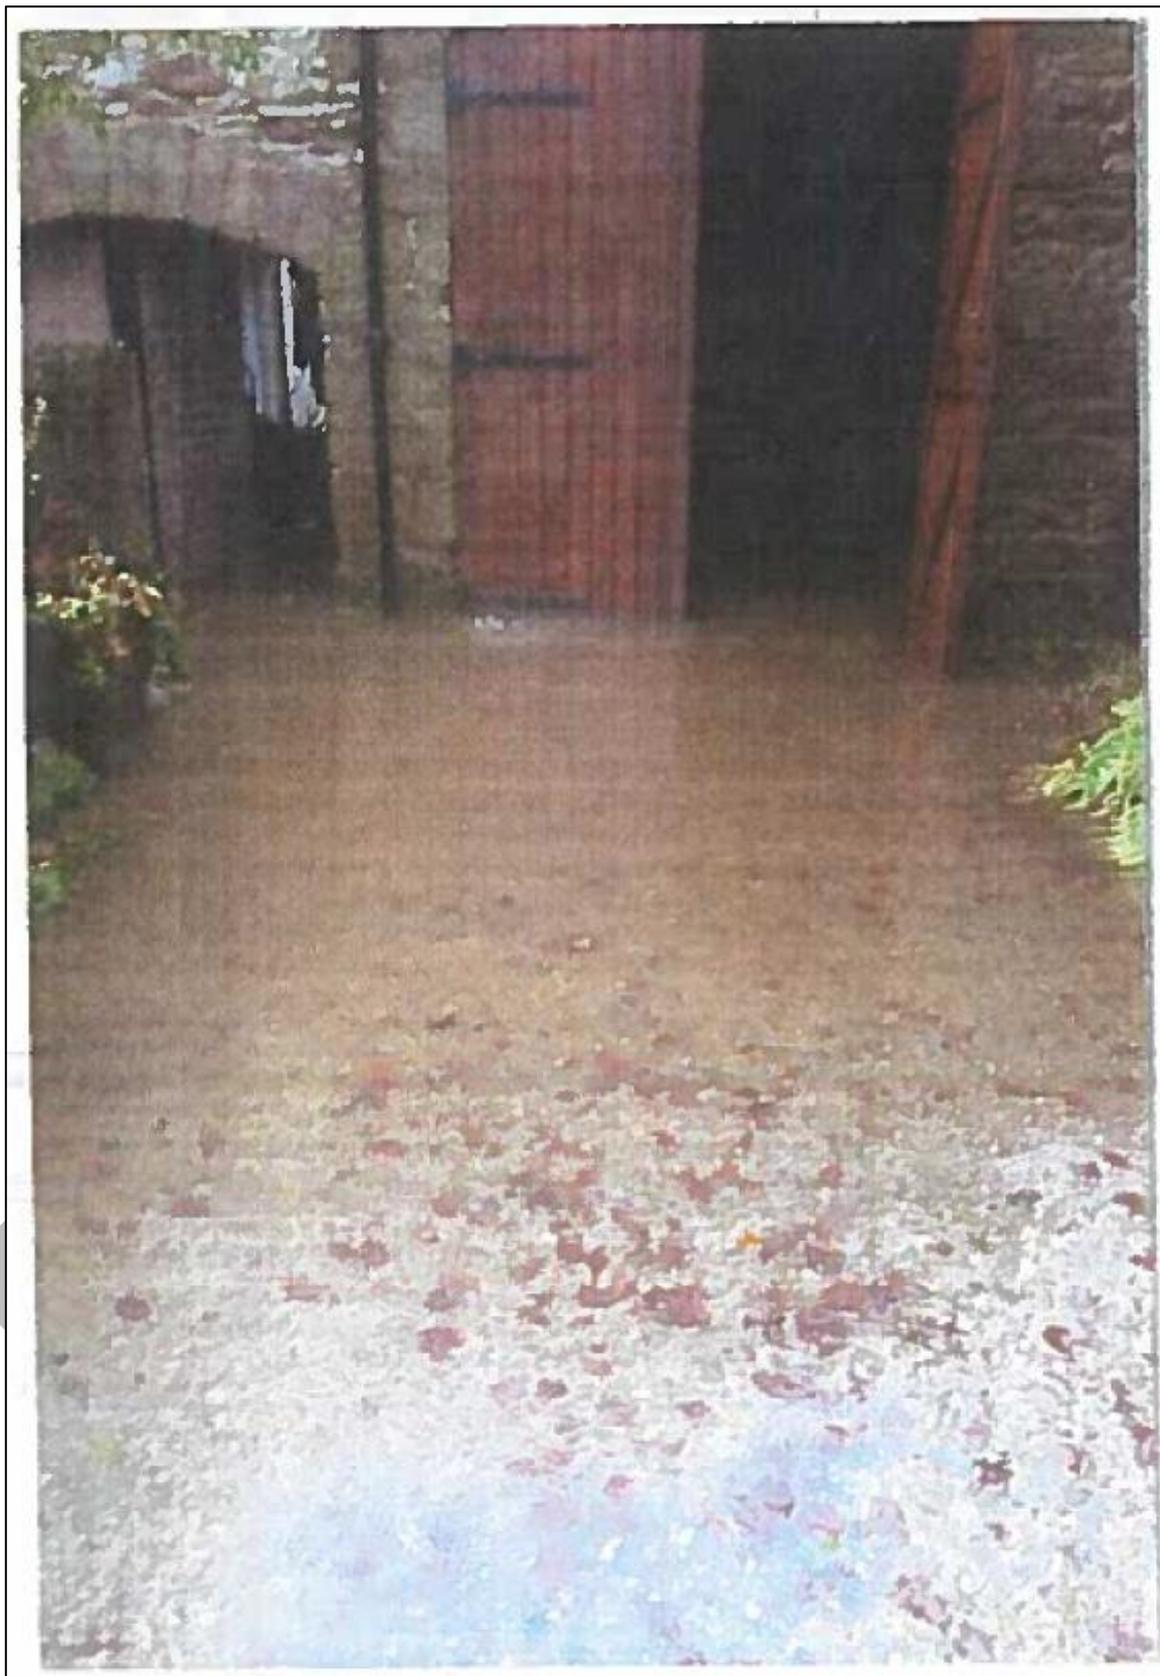
OS NGR NY 74847 15527

**Photograph 6: Outbuildings flooding at the Croft
5th December 2015, no timestamp**

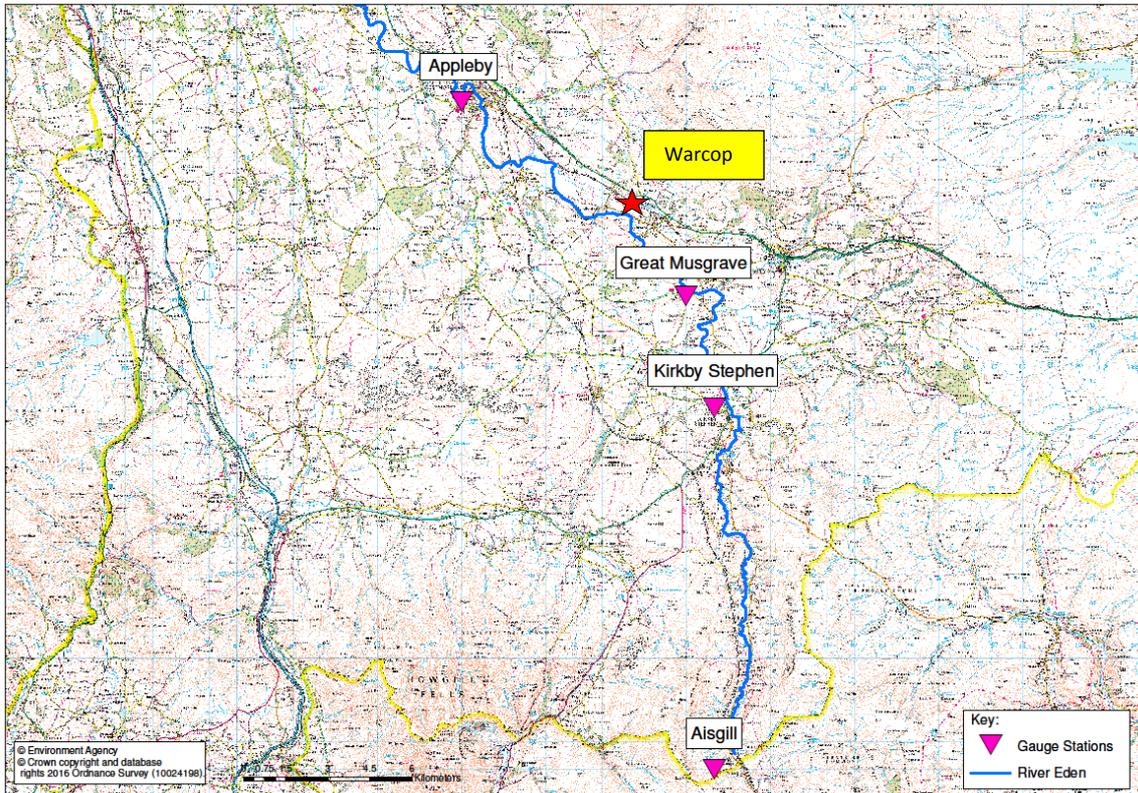
Figure 2: Location of rain gauge stations in the upstream of Warcop

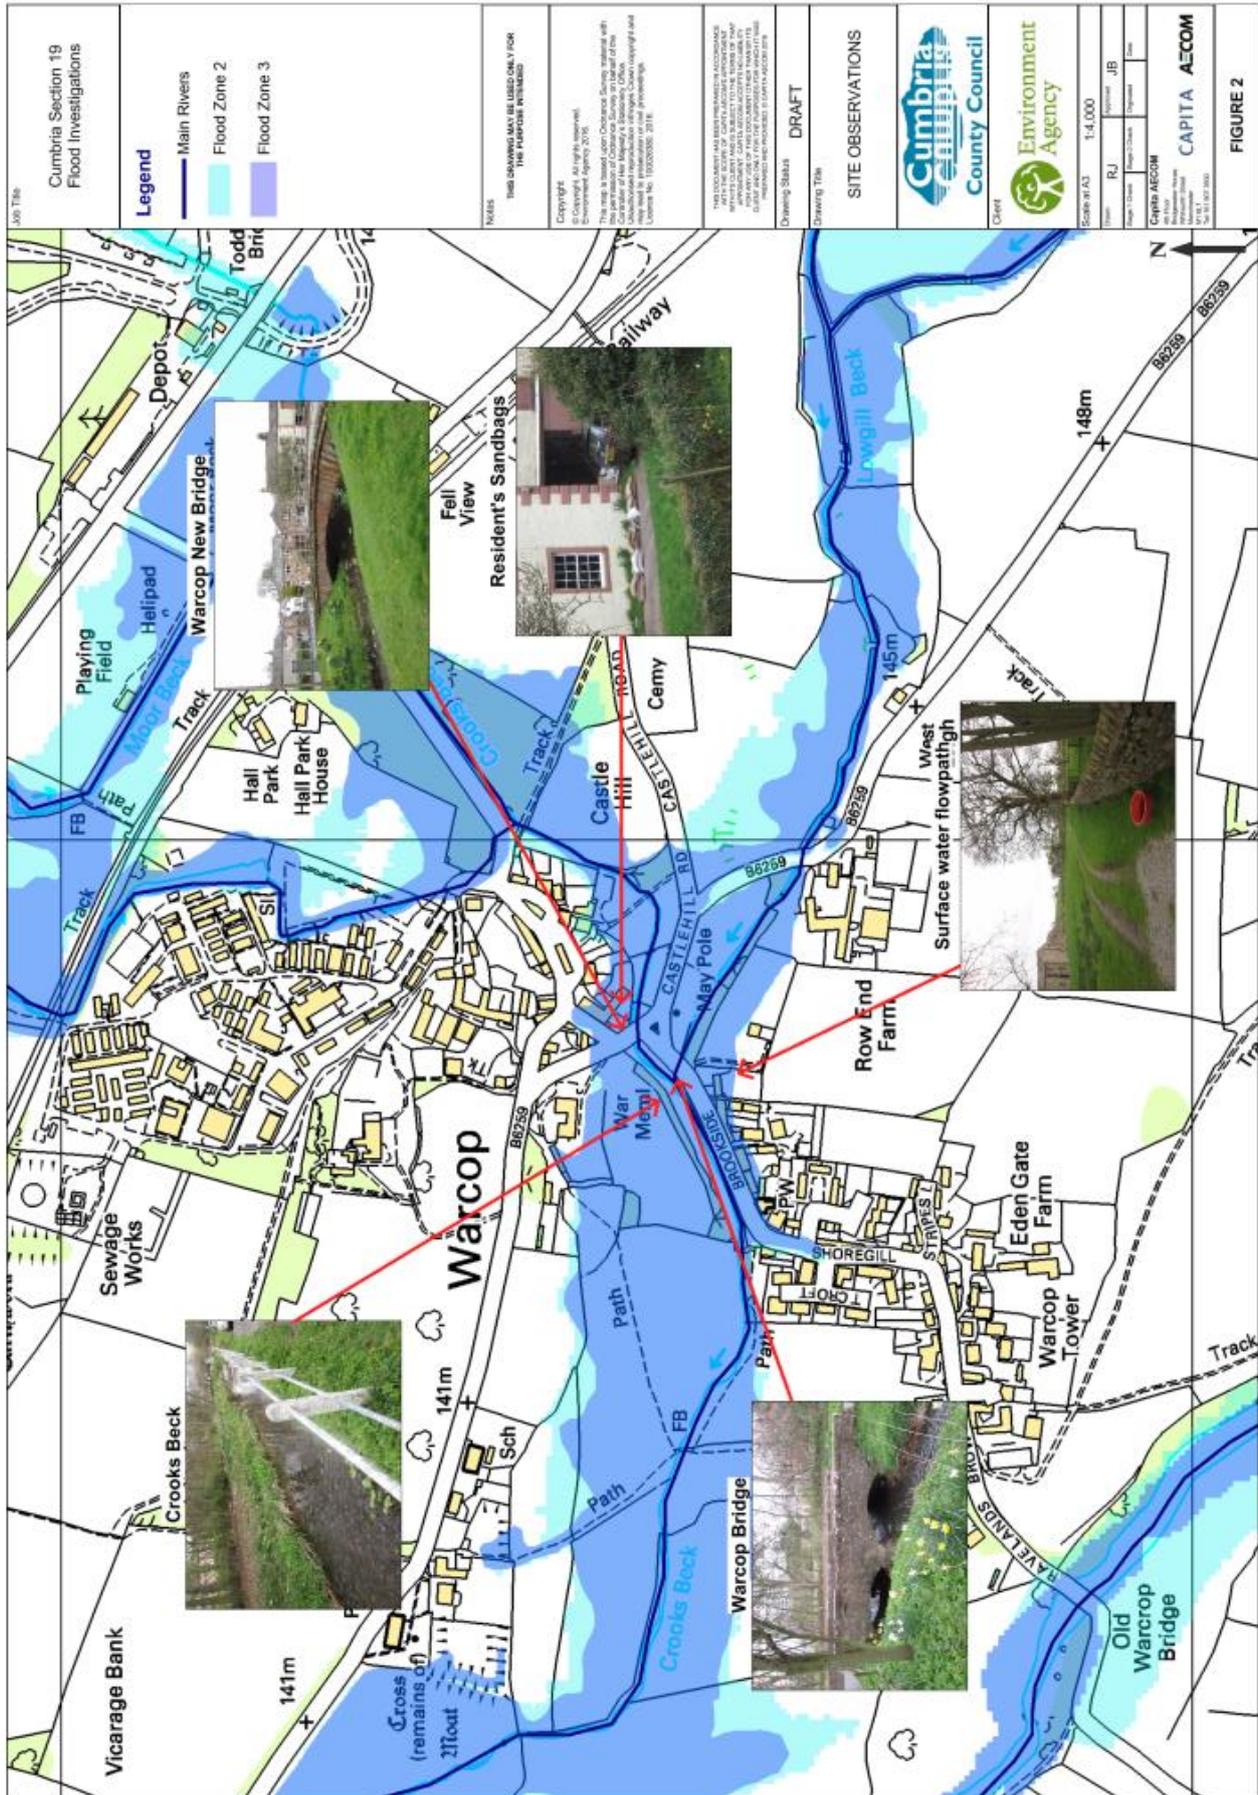
Key features, observations and photographs from the site visit are presented in **Figure 3** (overleaf).

Figure 3 Key Observations

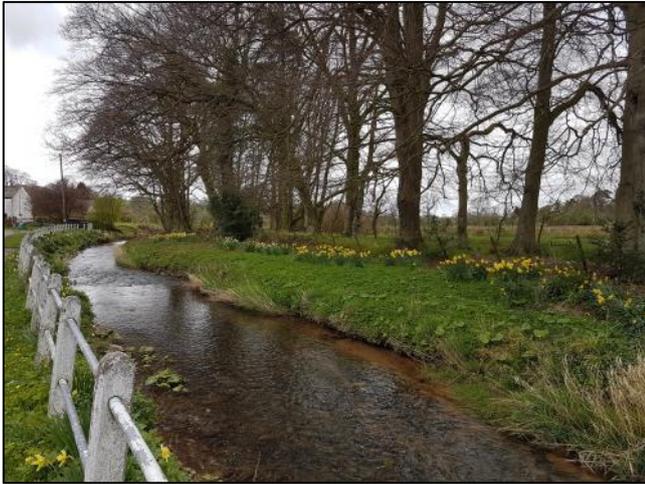
OS NGR NY 74735 15424

The Lowgill Beck is flanked by relatively flat floodplains which are not significantly elevated above the dry weather flow in the watercourse (**Photograph 7**). The floodplains were lightly vegetated and were well maintained at the time of the site visit. Property thresholds on Brookside Road were observed as being only slightly higher than road level which may result in an increased level of flood risk to these properties (**Photograph 8**).

Photograph 7: Crooks Beck looking downstream

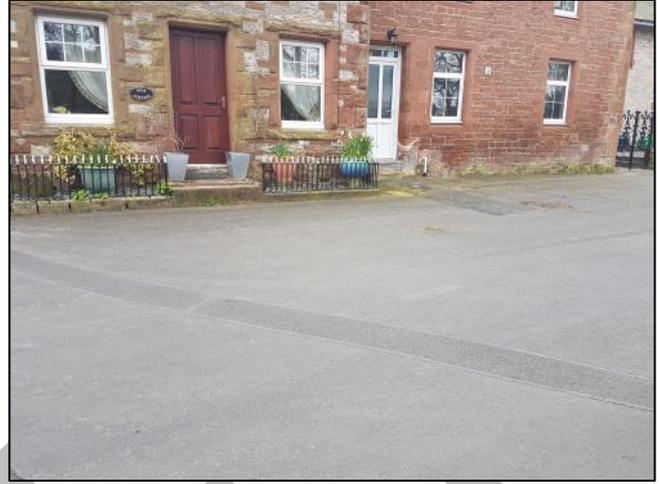
OS NGR NY 74731 15415

Photograph 8: Property thresholds on Brookside Road

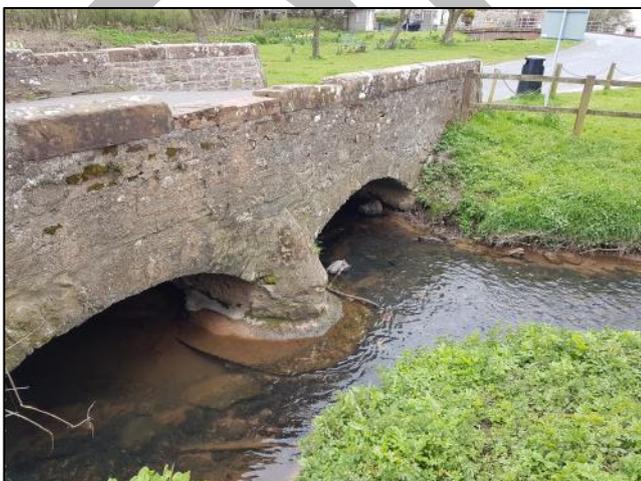
OS NGR NY 74797 15454

Brookside Road passes over the Lowgill Beck via a small twin arch bridge ('Warcop Bridge' as shown in **Photograph 9**). This structure has a very limited flow capacity due to low soffit levels relative to river bed levels. The limited capacity of this structure resulted in floodwater bypassing the structure and damaging the coping and parapet due to the magnitude of the flood flows (as shown previously in **Photograph 4**). At the time of the site visit the flood damage had been repaired and the structure restored to its original condition.

Photograph 9: Warcop Bridge over the Lowgill Beck

- The fluvial flooding was exacerbated by limited capacity under both Warcop Bridge and New Warcop Bridge. The former resulted in damage to the coping and parapet over the bridge, whilst the latter resulted in rising water resulting in external flooding around the adjoining outbuildings.

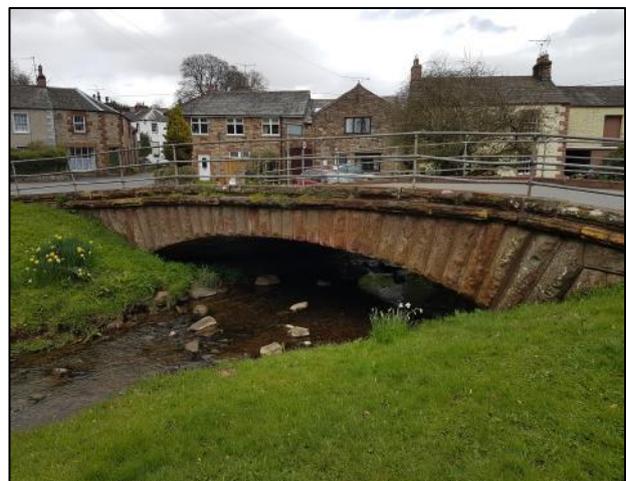
OS NGR NY 74823 15493

A larger arch bridge spans the Crooks Beck immediately north of Warcop Bridge ('New Warcop Bridge'). This structure has a much greater capacity than Warcop Bridge, although evidence of coping loss was observed on site (**Photograph 10**).

Photograph 10: Bridge over the Crooks Beck looking upstream

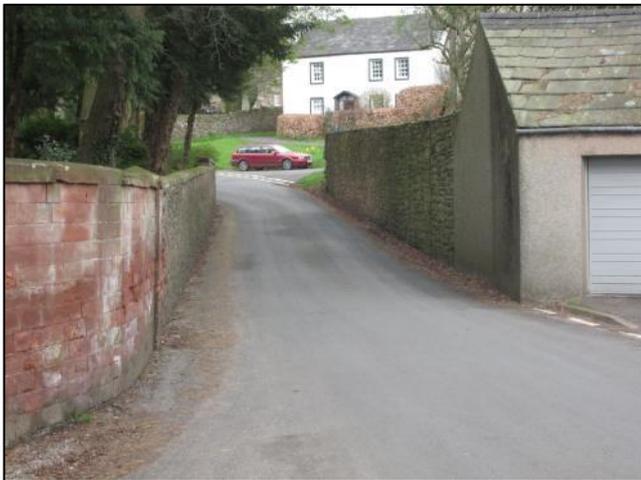
OS NGR NY 74814 15517

There are a number of surface water flowpaths leading into the centre of Warcop due to the topography of the wider river valley (as shown in **Photograph 11**, **Photograph 12** and **Photograph 13**). A significant surface water flowpath was observed by local residents on Shoregill during the 5th December 2015 flooding incident (not pictured) as surface water exceeded the capacity of the local drainage system during the event. This surface water flooding was compounded by blocked drains and gullies in this area and combined with the fluvial flooding on Brookside.

Photograph 11: Potential surface water flowpath on the B9259

Cumbria County Council	Investigate the current performance of the highways drainage network around Brookside and Shoregill. Consider capacity improvements if necessary.	Winter 2016

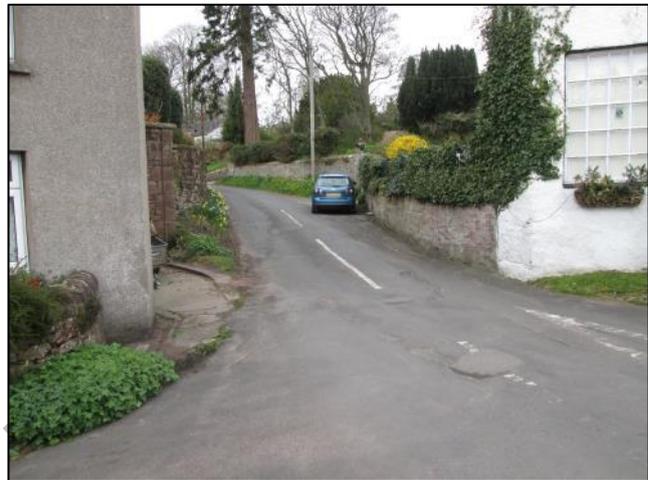
OS NGR NY 74834 15565

Photograph 12: Potential surface water flowpath on the B9259

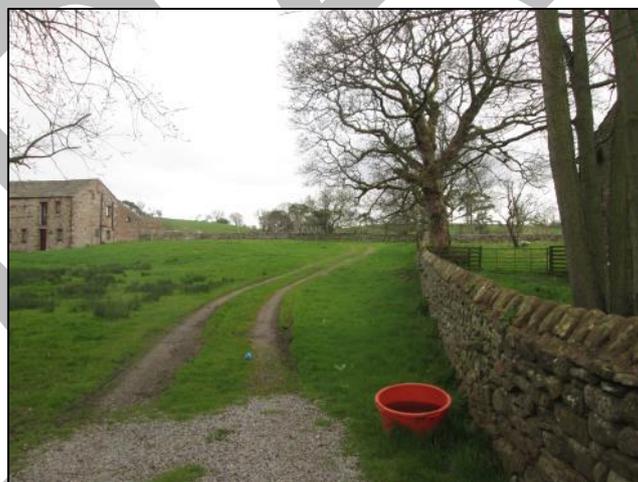
OS NGR NY 74769 15403

Photograph 13: Potential surface water flowpath near Lane Cottage

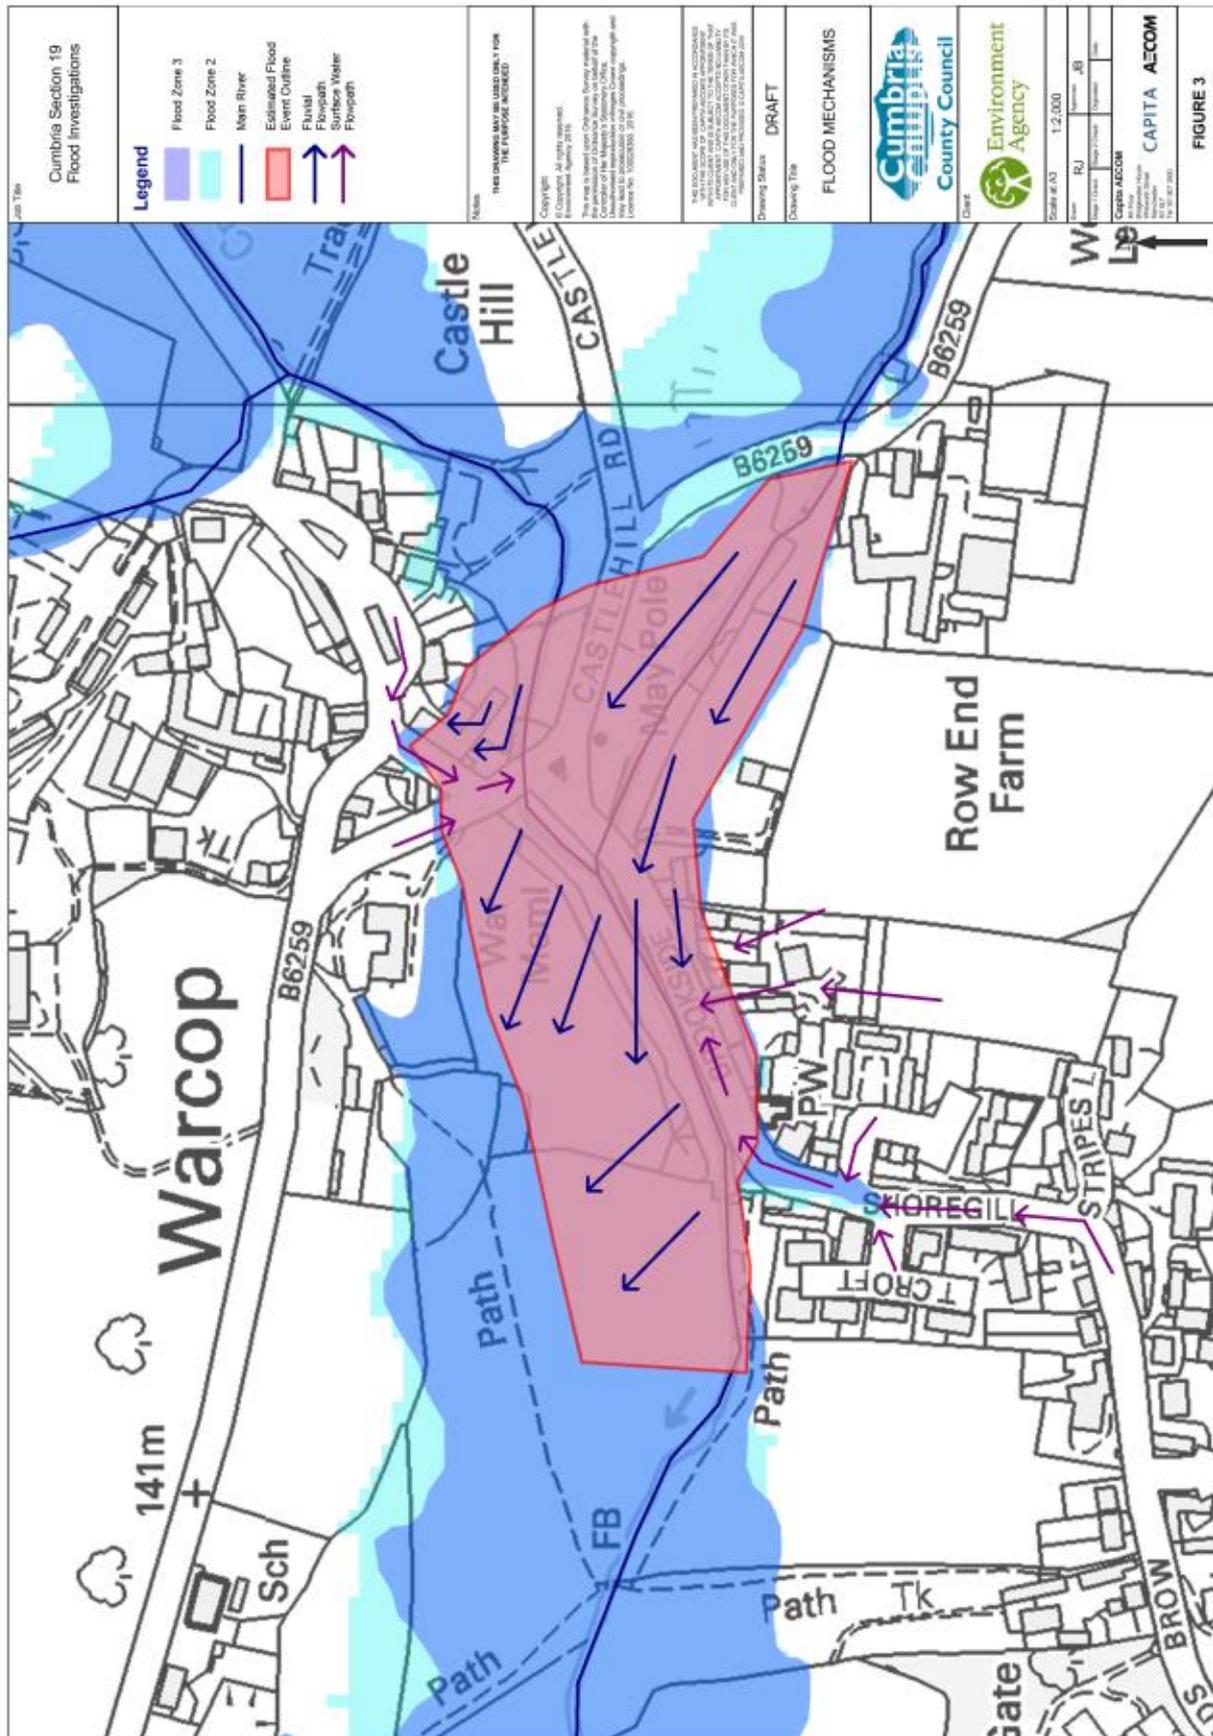
- Significant fluvial flows on the Lowgill Beck and Crooks Beck exceeding the capacity of the river channel and spilling laterally onto the floodplain on Brookside and the area around the Croft

- Surface water from the adjacent valley sides impacted on a number of residential properties around Brookside and Shoregill. The volume of surface water exceeded the capacity of the local drainage network. The effective capacity of the network was also reduced as a result of debris and siltation within the highways gullies at these locations. This source of flooding combined with the fluvial floodwater from the Crooks Beck.

- The local sewerage pumping facility was overwhelmed by the volume of floodwater and resulted in backing up of wastewater entering the system.

The various flooding mechanisms across Warcop are illustrated in Figure 4.

Figure 4 Flooding Mechanisms
