11e6 Silloth to The Grune

(Technical report by Jacobs)

Policy area: 11e6 Silloth to The Grune

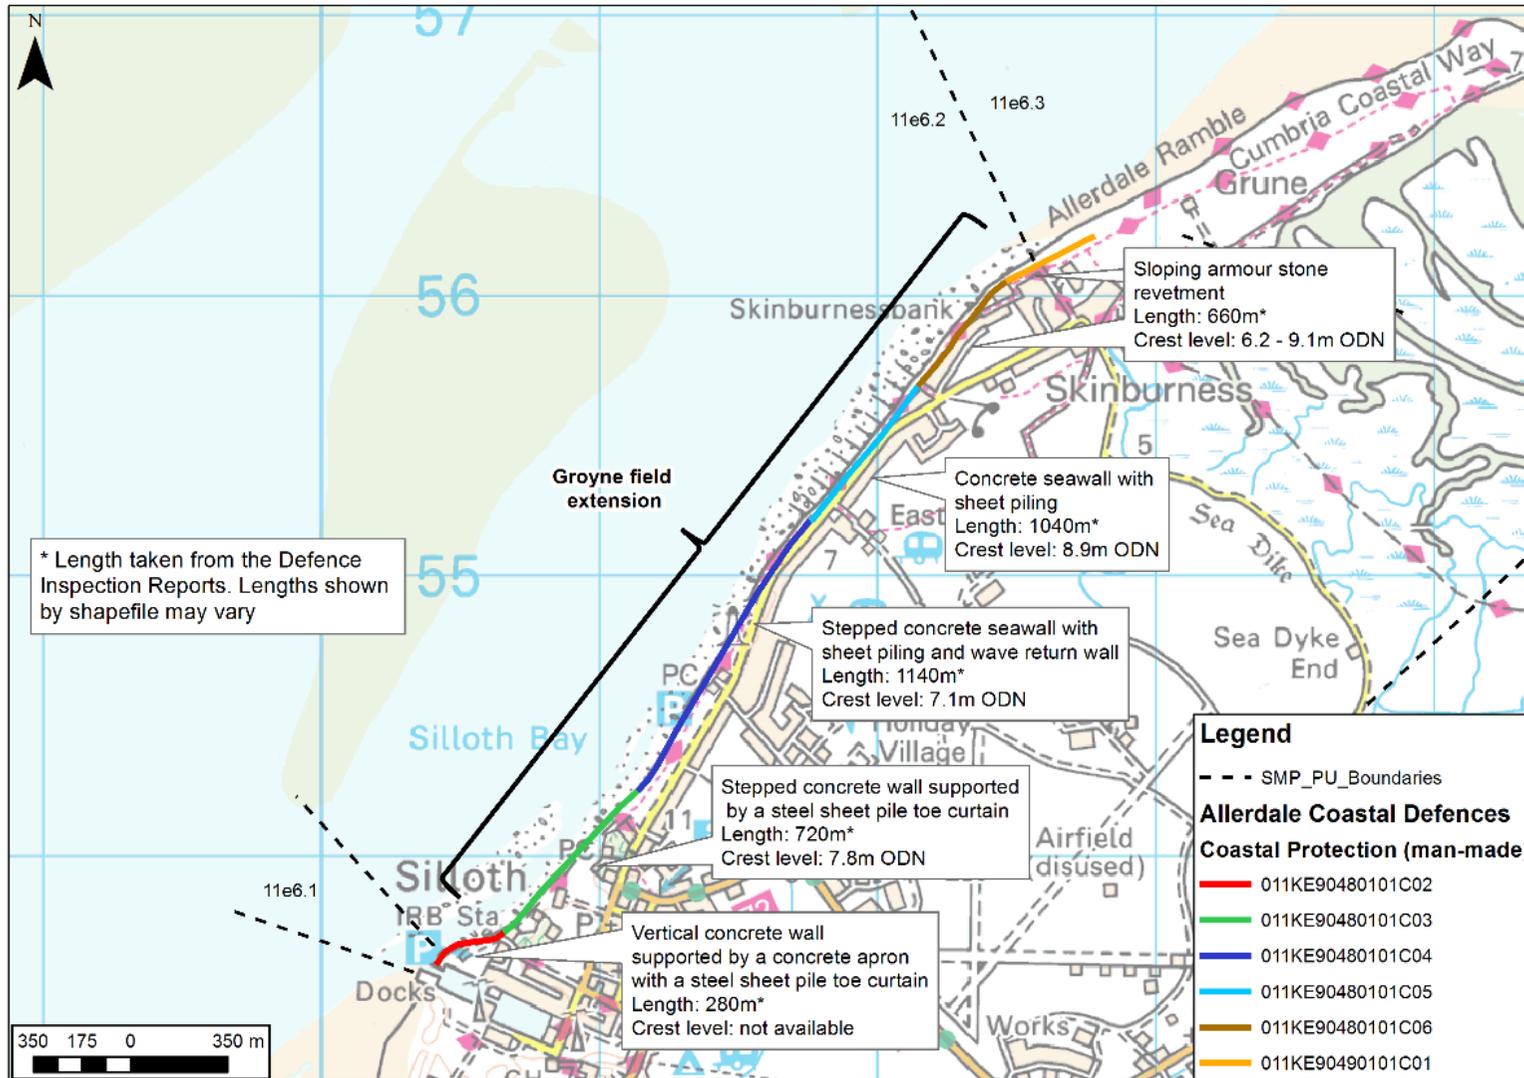
Figure 3 Policy units and summary of defence lengths between Silloth and The Grune. Baseline mapping © Crown copyright and database rights, 2019. Ordnance Survey licence number: 1000019596.

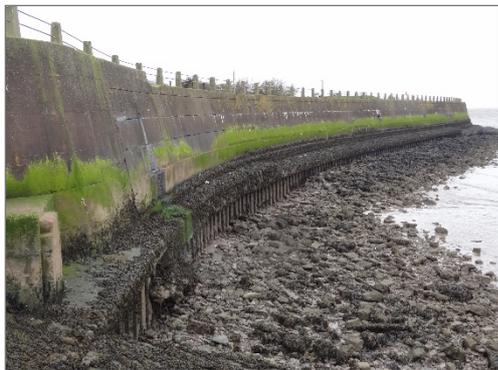
Figure 4 Vertical seawall at Silloth North Pier. Photograph taken during CEUK asset inspection (March 2016).

The defences comprise a vertical concrete wall supported by a concrete apron with a steel sheet pile toe curtain. The beach in front comprises coarse cobbles and shingle. A combination of wave reflections and the proximity of the Swatchway Channel have resulted in the denudation of finer sediments and a narrow beach width.

The structure is exhibiting normal wear and tear for its estimated age (50 to 60 years).

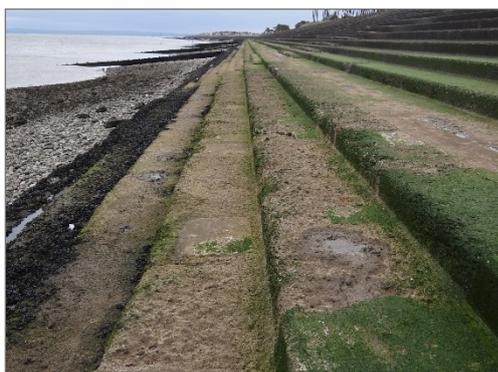
Figure 5 Stepped concrete revetment with sheet piled toe and timber groynes at Silloth. Photograph taken during CEUK asset inspection (March 2016).

The primary coastal defence across this frontage comprises a stepped concrete wall supported by a steel sheet pile toe curtain (mostly buried). The current defences are nearly 40 years old and exhibiting signs of wear and tear, notably:

- Abrasion and surface pitting and spalling to steps
- Cracking, notably at the northern interface with the adjacent defence section.

In addition, there is substantial algal growth on lower steps which presents a health and safety hazard to users. The foreshore is narrow due to the proximity of the Swatchway Channel, is timber groyned across its whole length and comprises a mixture of shingle and cobbles from which the finer sediments have been lost.

Additional quarried cobble has been added to this section since the 1960s. It is the nature of the coarse sediments that are predominantly responsible for the abrasion on the lower steps. Other than the general wear and tear there has been no significant deterioration in condition or major damage to the structure in the past ten years

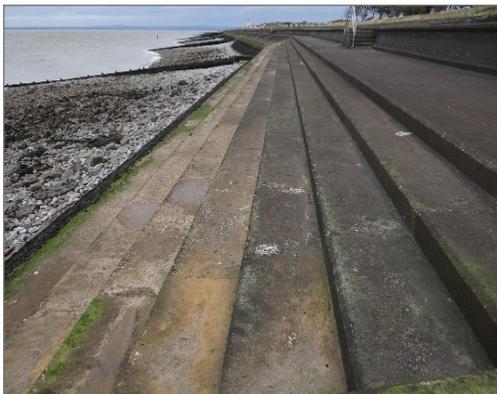
The primary coastal defence across this frontage comprises a stepped concrete revetment (with narrower treads than on the Silloth Bay section to the south), supported by a steel sheet pile toe curtain. At the crest there is a wave return wall with a secondary promenade and rear wall to landward. The current defences are nearly 40 years old and exhibiting signs of wear and tear, notably:

- Abrasion and Surface pitting and spalling to steps;
- Cracking to steps.

In addition, there is substantial algal growth on lower steps which presents a health and safety hazard to users.

Figure 6. Stepped concrete revetment with sheet piled toe, rear wave return wall and timber groynes between Solway Lido and Eastcote. Photograph taken during CEUK asset inspection (March 2016).

The foreshore is narrow due to the proximity of the Swatchway Channel but starts to widen out towards the northern end. It is timber groyned across its whole length and comprises a mixture of shingle and cobbles from which the finer sediments have been lost. Additional quarried cobble has been added to this section since the 1960s. Despite the close spacing of the groynes, there is evidence of northerly longshore drift across this section with steps in level across groynes. The frontage terminates at the slipway at Eastcote where a substantial concrete encasement to a surface water outfall acts as a more substantial groyne preventing upper beach longshore drift.

collapsed in 2011 and 2012 and has not been replaced. Other than the general wear and tear identified there has been no significant deterioration in condition or major damage to the structure in the past ten years.

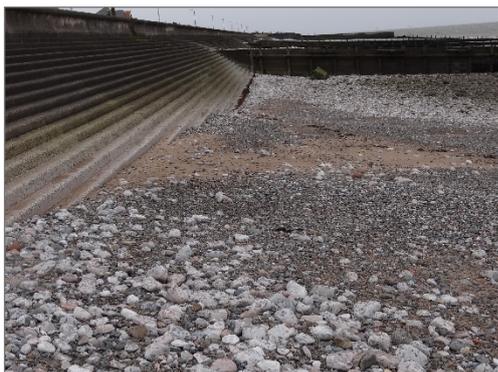
Figure 7. Stepped concrete revetment with sheet piled toe and rear wave return wall and timber groynes at Skinburness. Photograph taken during CEUK asset inspection (March 2016).

The primary coastal defence across this frontage comprises a stepped concrete revetment (with generally equal treads and risers, apart from locally at the northern end where the treads are wider), supported by a steel sheet pile toe curtain. At the crest there is a wave return wall.

It is believed that the current defences were constructed in the 1980s. These are exhibiting signs of wear and tear, notably cracking and abrasion, surface pitting and spalling to steps.

It is the nature of the coarse sediments that are predominantly responsible for the abrasion on the lower steps. There are some missing planks to timber groynes. Other than the general wear and tear identified there has been no significant deterioration in condition or major damage to the structure in the past ten years.

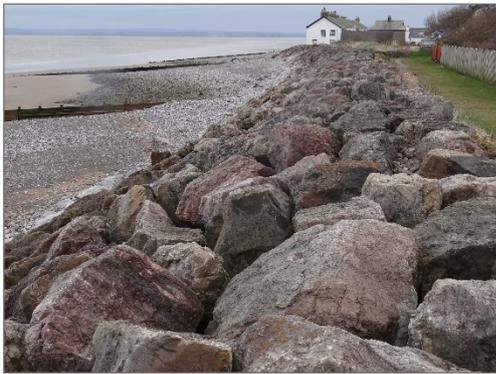
The primary coastal defence comprises a rock armour revetment, most of which dates from 1999, although a short section at the northern end predates that. The revetment is in good condition with no obvious signs of rock movement, although overtopping waters did penetrate through the crest in places during the winter 2013 and 2014 storms. The revetment locally reduces in crest elevation in front of shoreside cottages (seen in background of Figure 8).

Figure 8. Rock armour revetment with timber groynes at Skinburnessbank. Photograph taken during CEUK asset inspection (March 2016).

The foreshore is timber groyned and comprises a mixture of cobbles, shingle and sand. Continued longshore drift northerly evident across this section with upper sections of groynes buried. Additional quarried cobble was added to this section at the end of the 20th century.

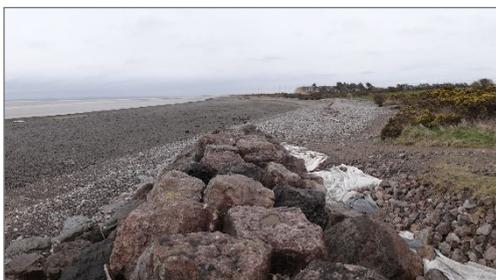
At the northern end, the adjacent undefended frontage of The Grune is setback and the terminal end of the revetment is being gradually outflanked, as can be seen in Figure 9. The northern end of the frontage is only protecting a single property. Improved management of this interface is required.

Figure 9. Terminal end of rock armour revetment at The Grune. Photograph taken during CEUK asset inspection (March 2016).

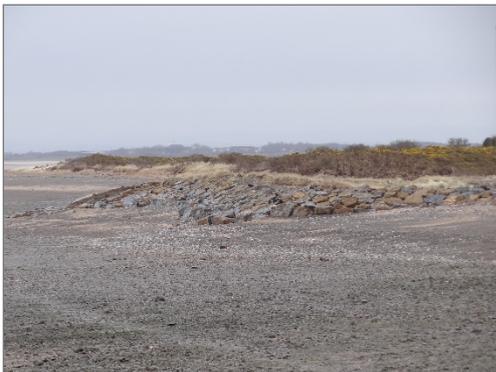
Figure 10. Rock armour revetment at The Grune. Photograph taken during CEUK asset inspection (March 2016).

This section is the only length of artificial defence on The Grune, erected by a private landowner in 2008 to halt ongoing erosion.

The beach conditions are predominantly a mixture of shingle and sand becoming finer in a northerly direction.

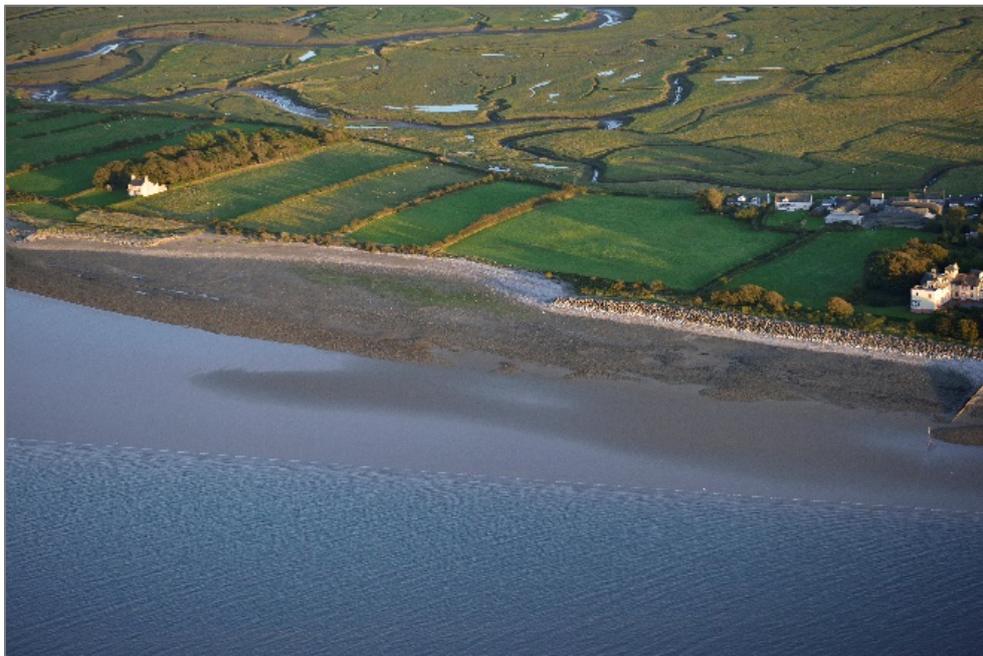
Apart from a short section of local privately funded and managed defences in the vicinity of Grune House (see Figure 12, left) and the terminal end of the hard defences across the Skinburnessbank frontage (see Figure 12, right), there are no defences along The Grune. The two sections of defences are having a local influence on shoreline behaviour with erosion of the adjacent shorelines taking place. This is occurring where lower ground levels mean there is the greatest risk of flood waters linking across the neck of the spit. If this behaviour continues, there is a risk of outflanking in the future, presenting a wider scale risk.

Figure 11 Juxtaposition of private defences on the Grune and terminal end of ABC rock armour revetment at Skinburnessbank. (Photograph © North West Regional Monitoring Programme, October 2015).
